National Park Service
U.S. Department of the Interior

Fort Point National Historic Site
Golden Gate National Recreation Area

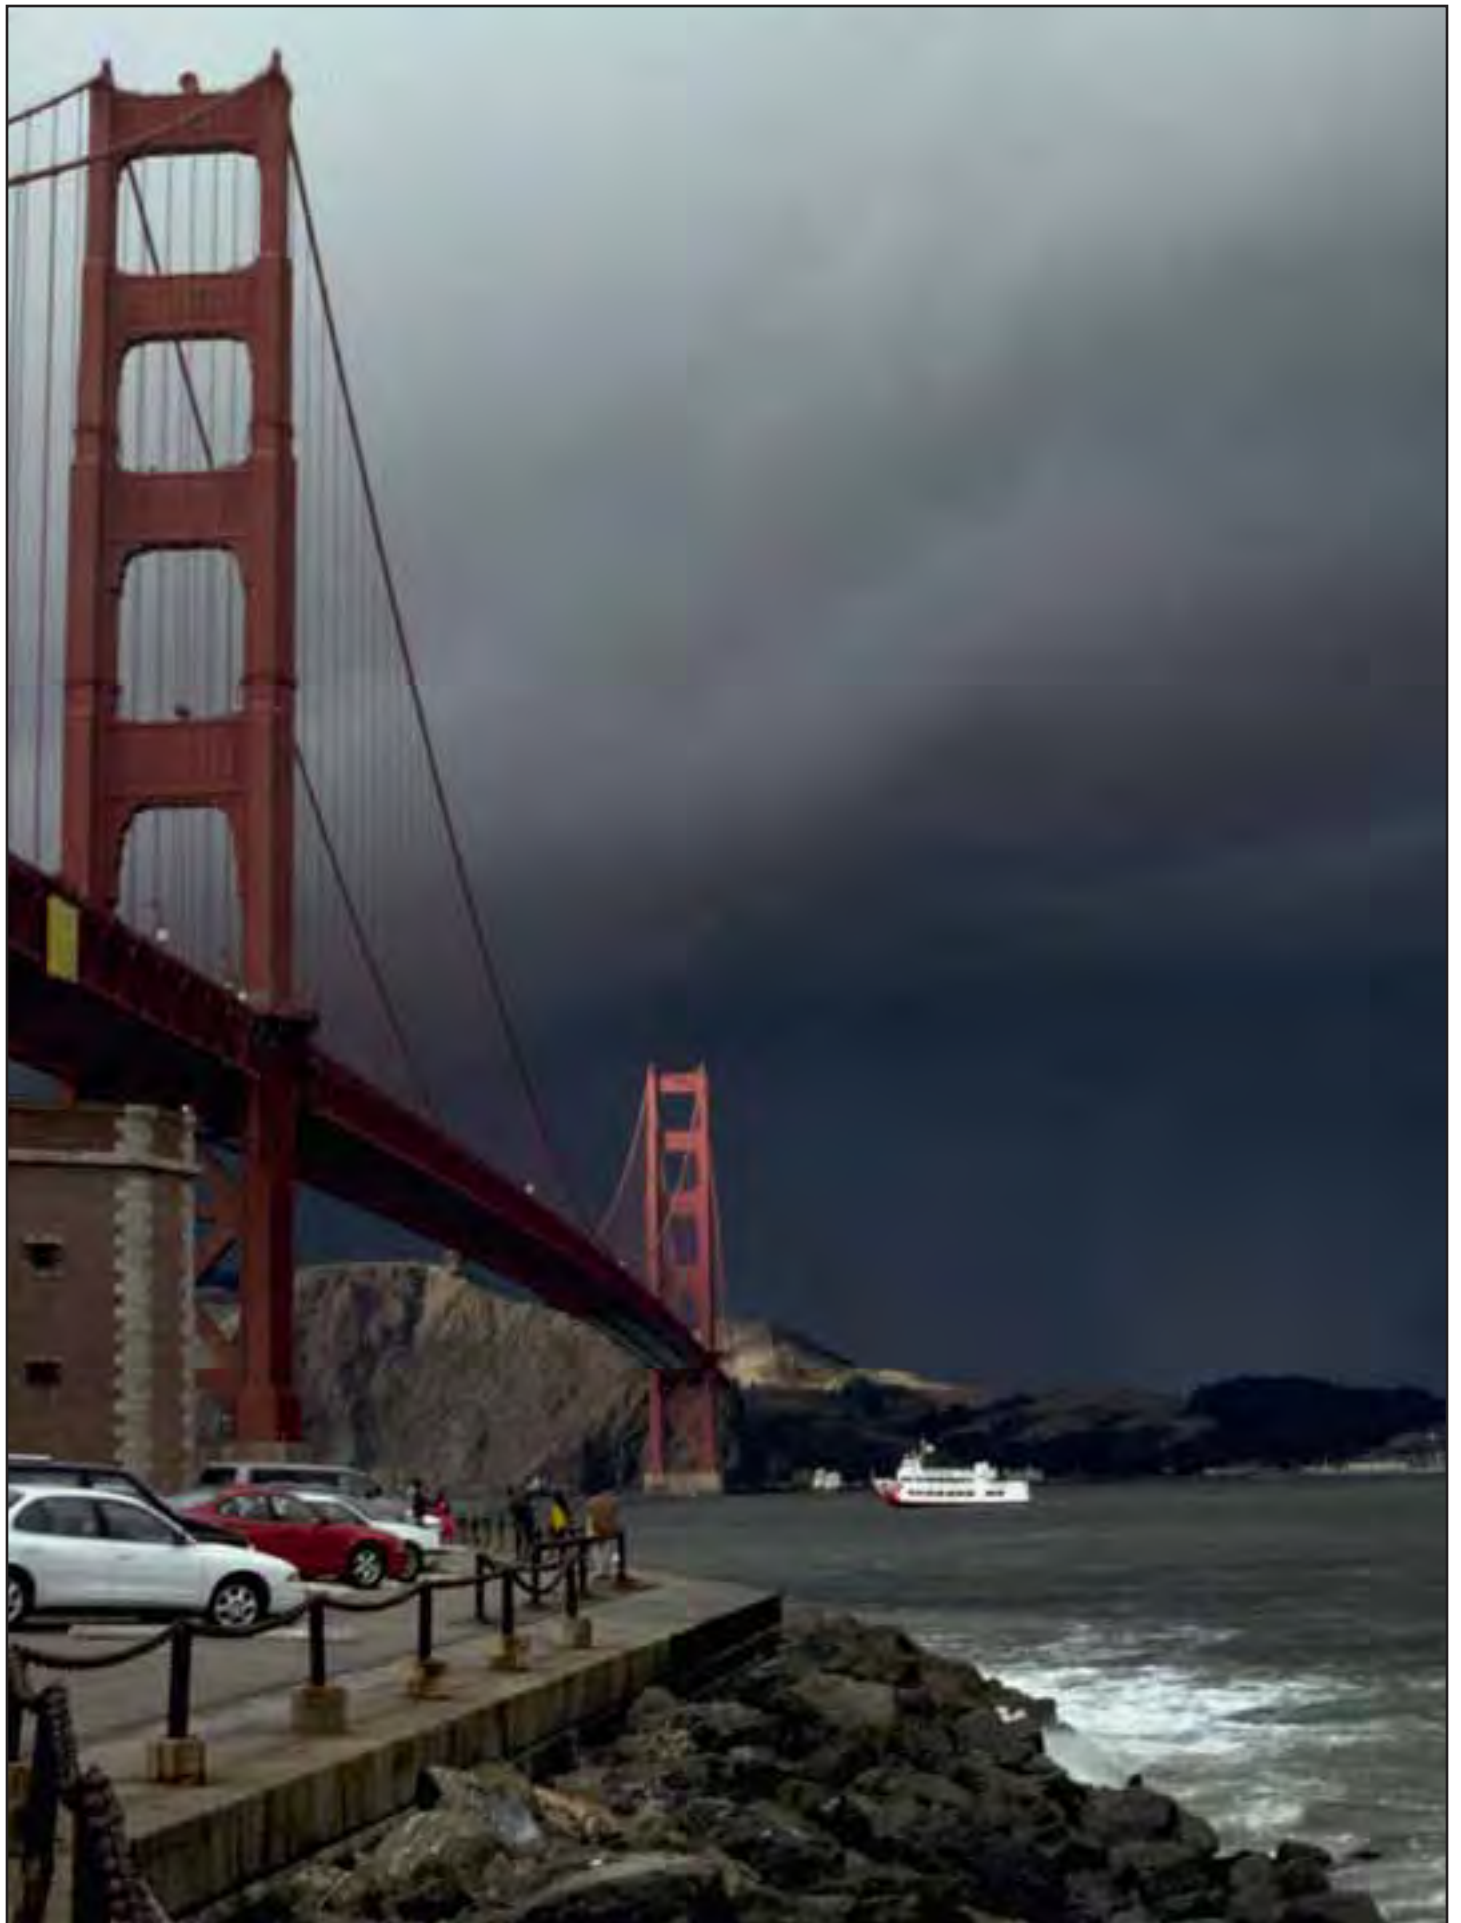
This photo, dated 1910, shows the Fort Point lighthouse keeper's residences located at the south of the fort. Credit: Fort Point NHS Collection, Golden Gate National Recreation Area.

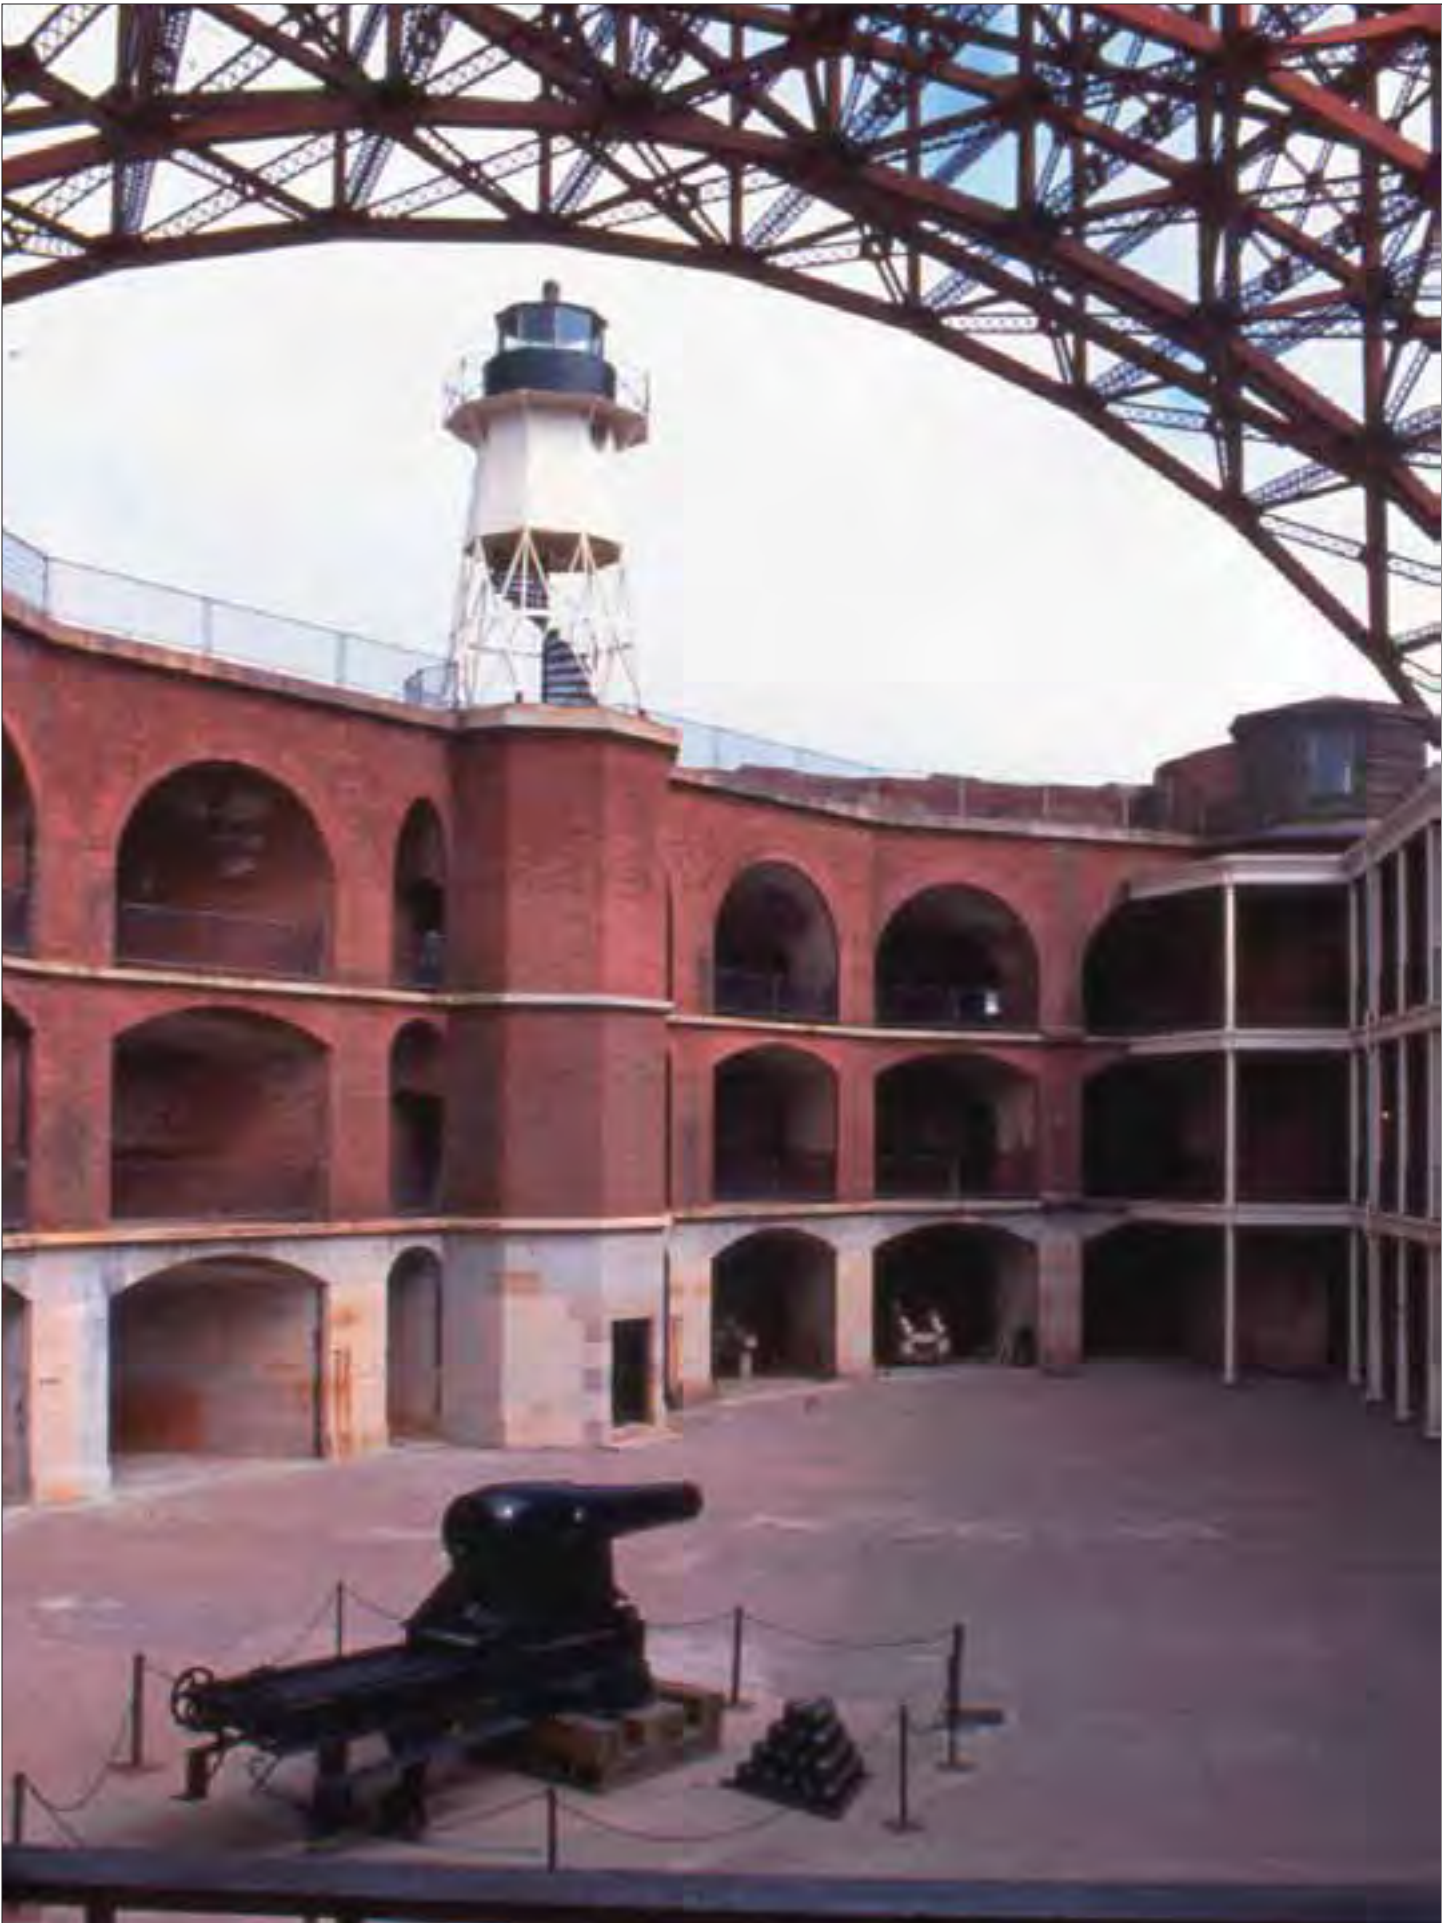
Appendices B: List of Fort Point Documents	151
Appendices C: Supplemental Record of Work Performed	152

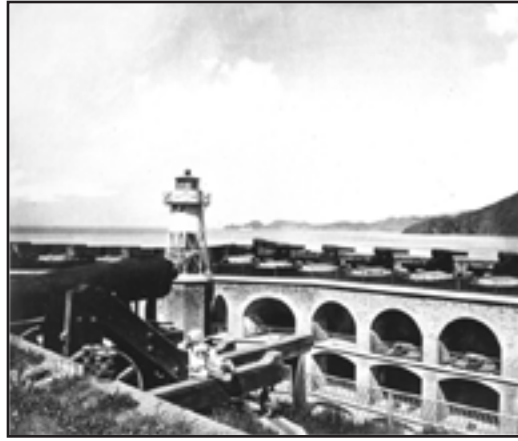
entire tip of the hundred-foot-high peninsula would have to be cut down nearly to sea level to provide a platform for the huge casemated fort.

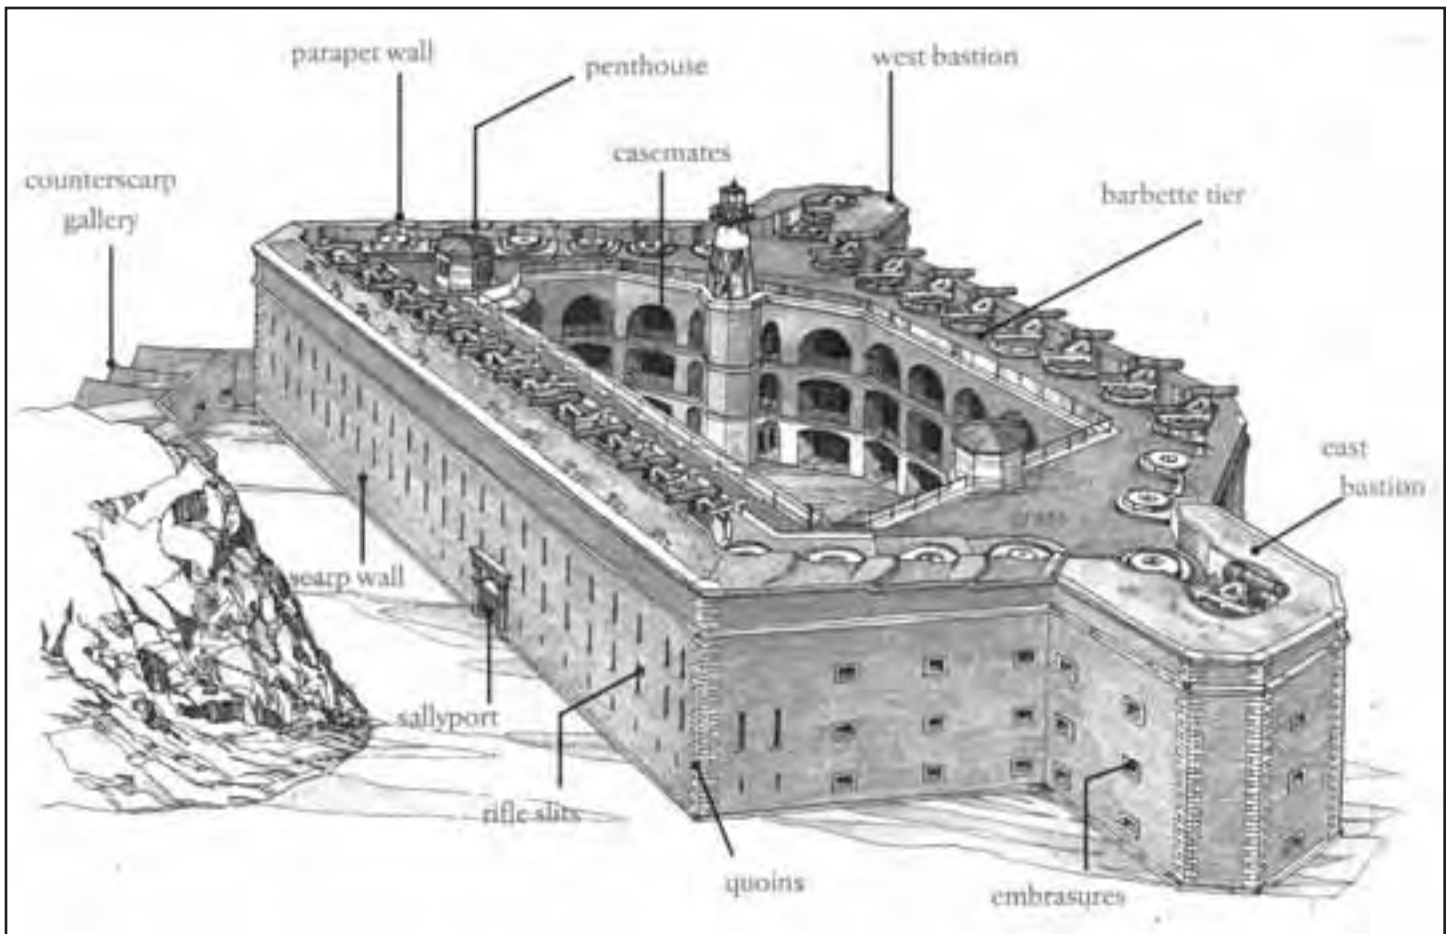
Illustration circa 1991. Courtesy of Lawrence Orsmy.

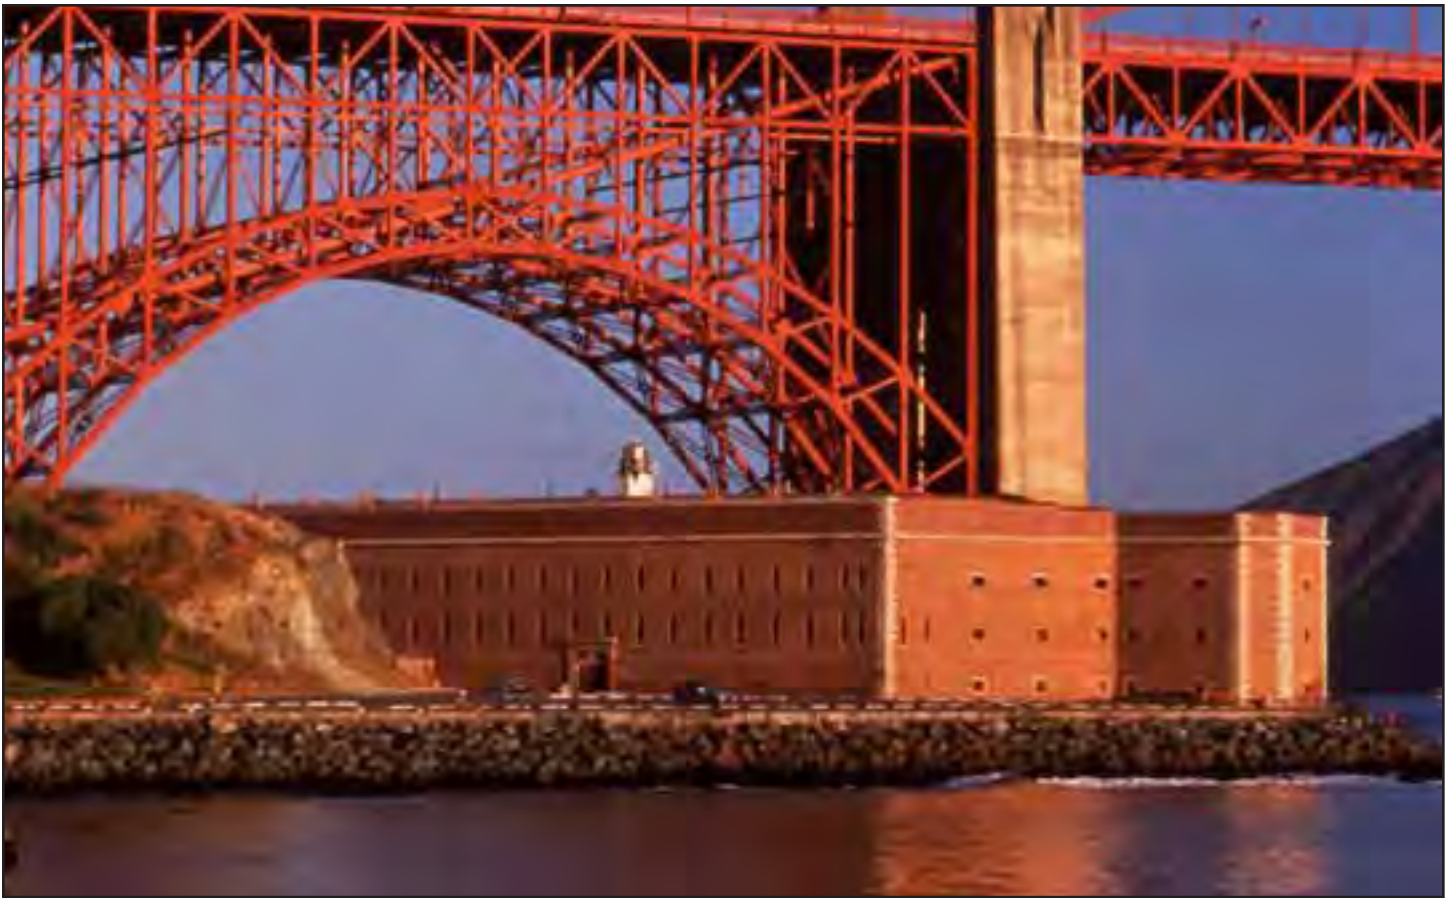
Contemporary view of Fort Point, circa 2000. Credit: Golden Gate National Parks Conservancy.

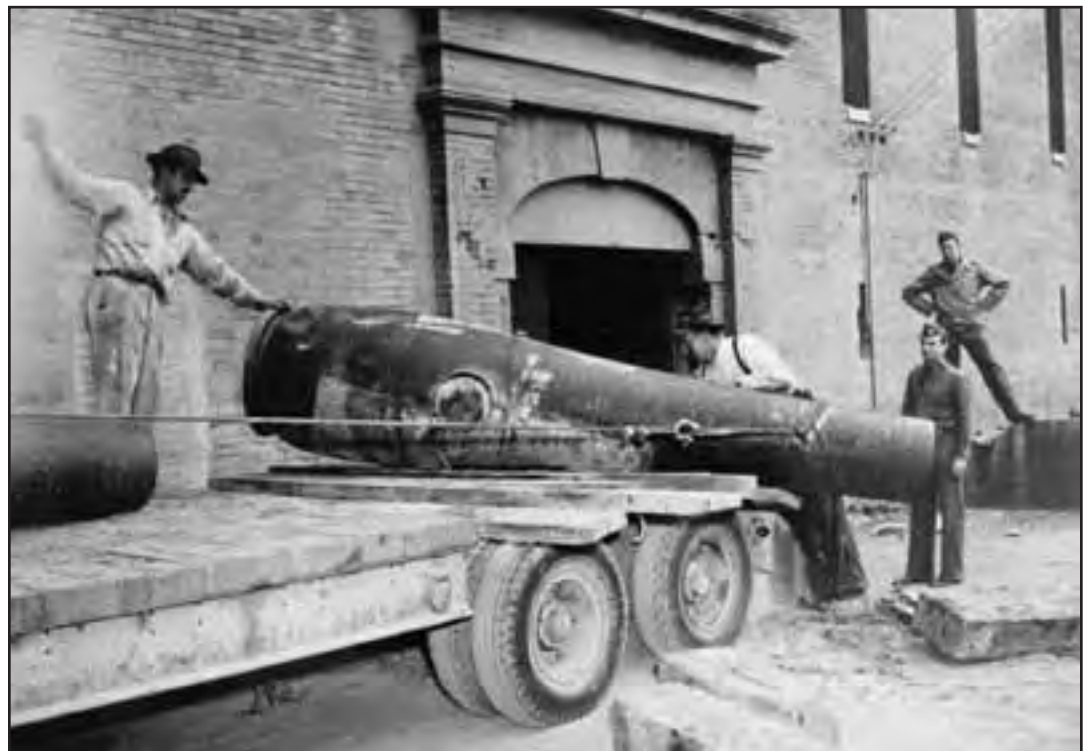
tance to salt corrosion. The fort was soon enveloped in a maze of wooden scaffolding as the huge steel arch was erected over the barbette tier.

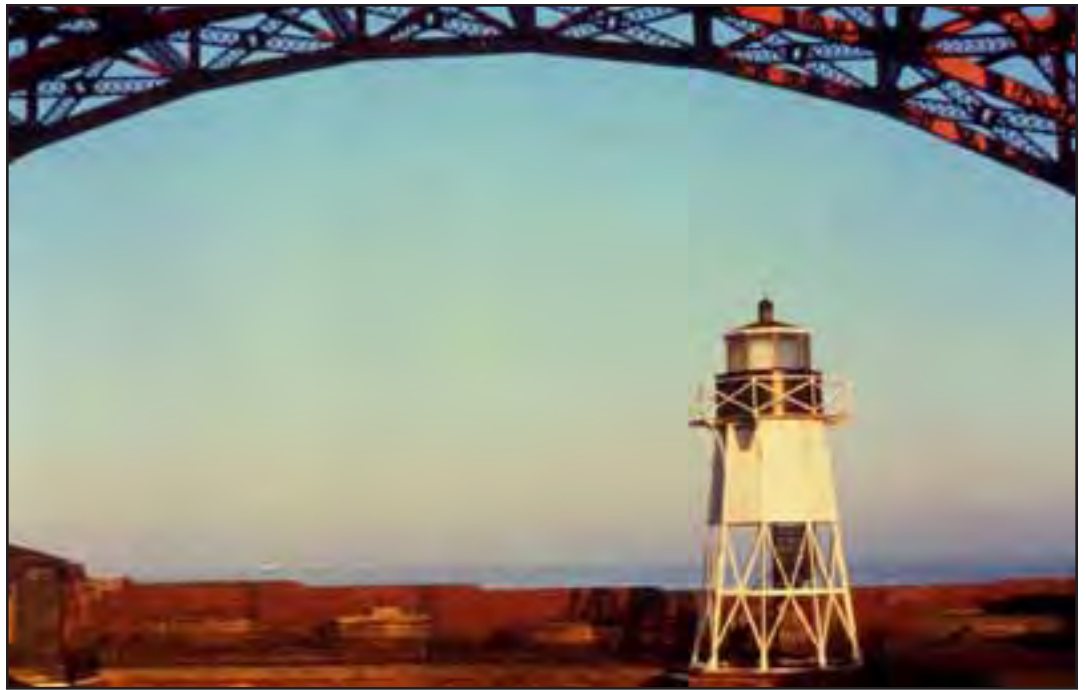
Right: Contemporary view of the Fort Point Lighthouse. Photo circa 2000. Credit: Golden Gate National Parks Conservancy.

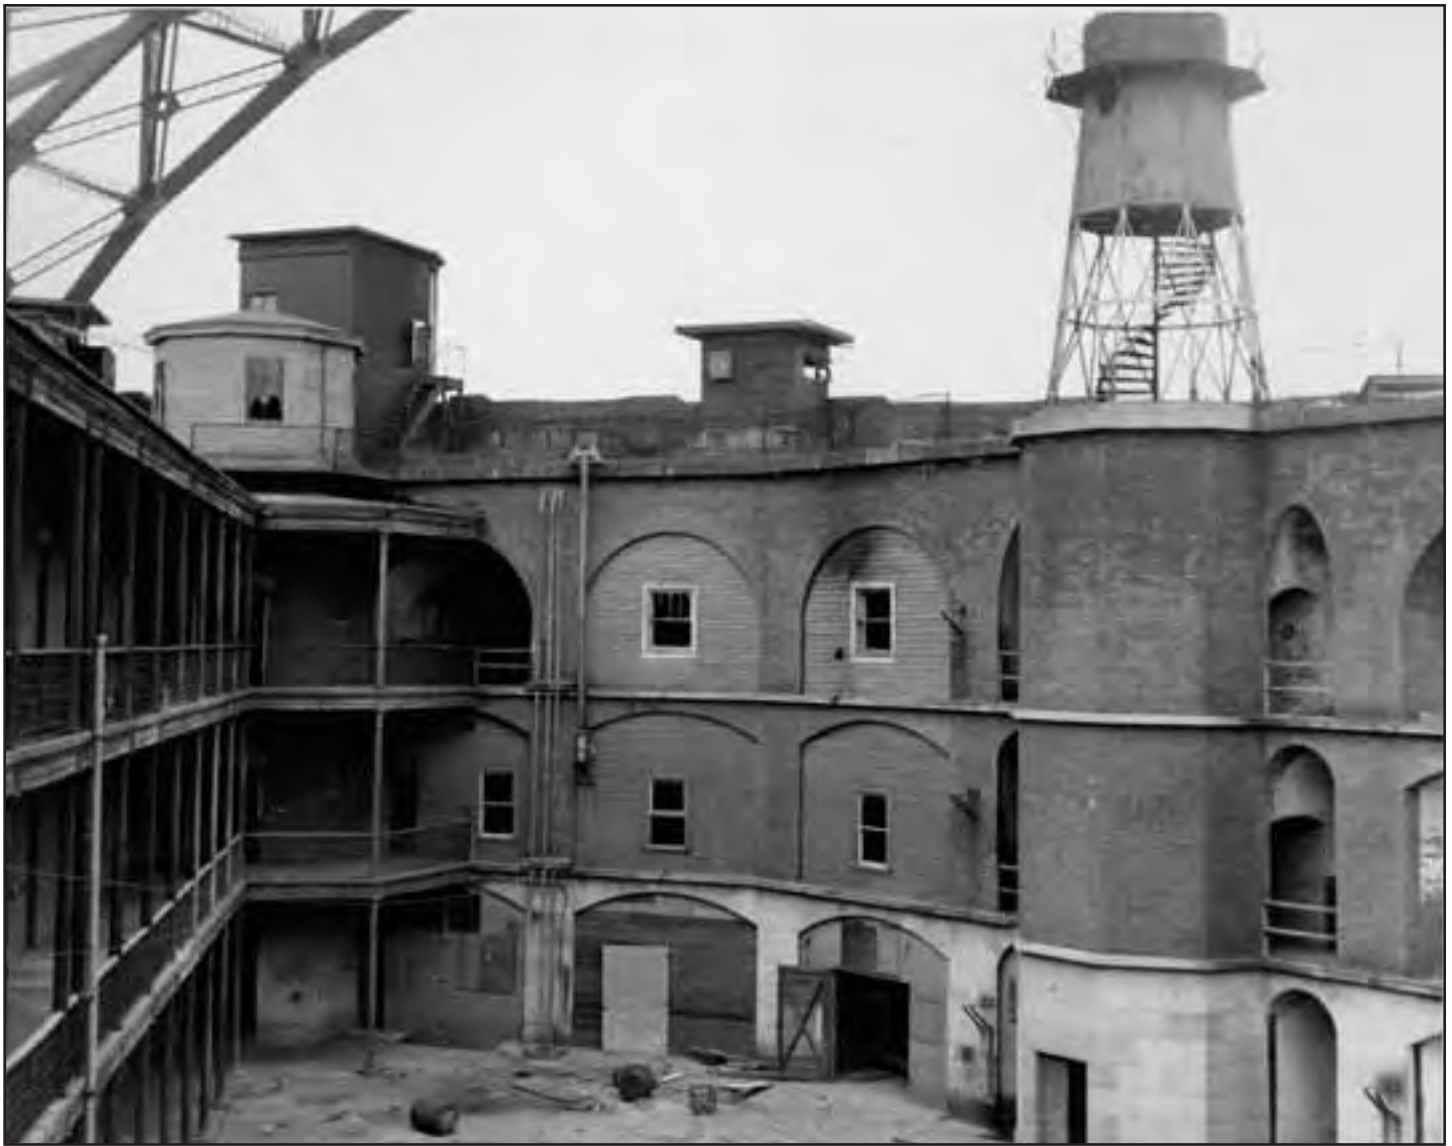
This photo shows the fort in an unoccupied state after World War II. Photo circa 1948. Credit: Fort Point NHS Collection, Golden Gate National Recreation Area.

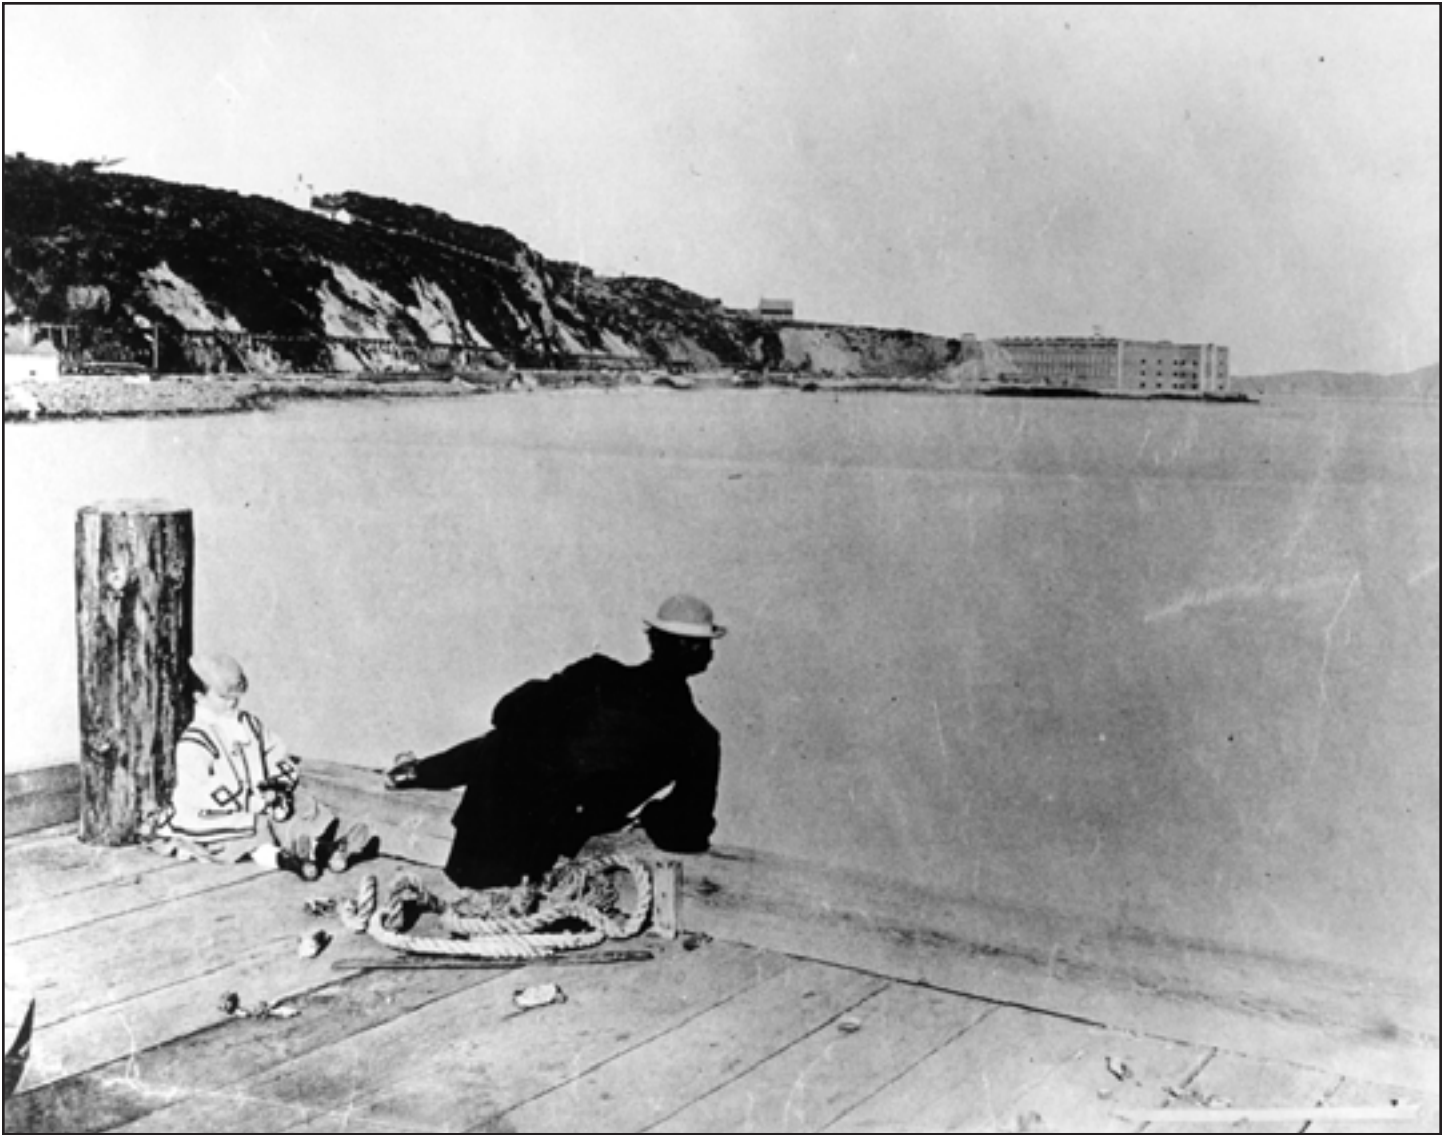
Figure 6. Photograph: Photograph of Fort Point taken by Eadweard Muybridge. Photo circa 1870. Credit: Fort Point NHS Collection, Golden Gate National Recreation Area.

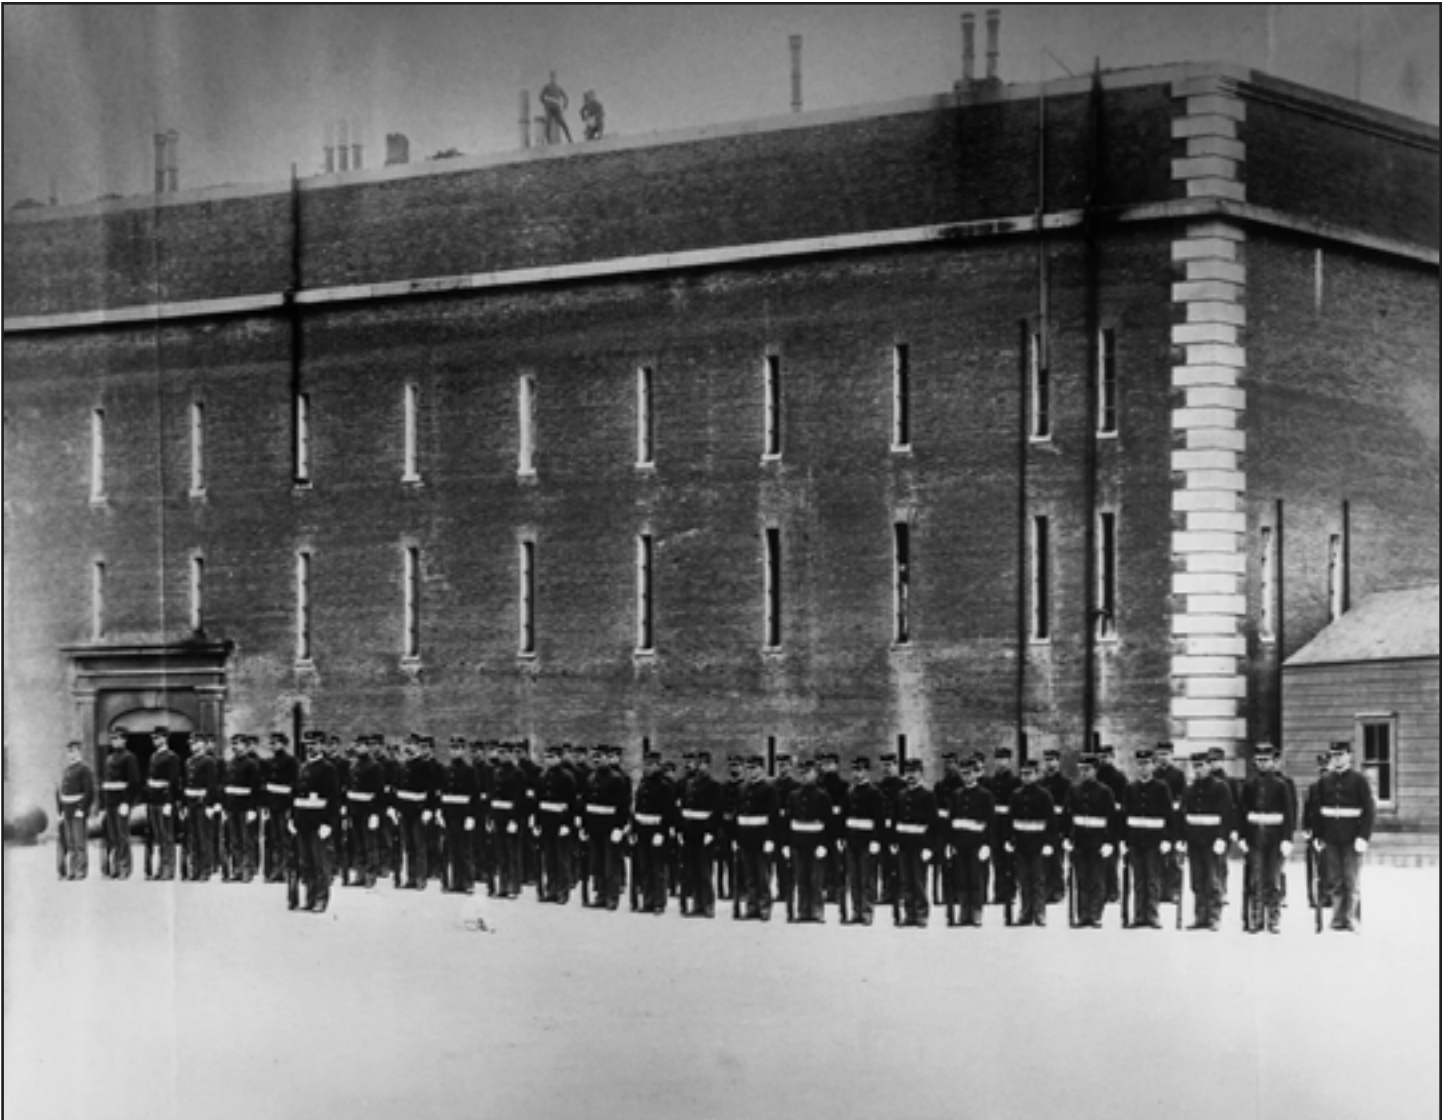
Figure 9. Photograph: Garrison in front of the Fort, circa 1900. Credit: Fort Point NHS Collection, Golden Gate National Recreation Area.

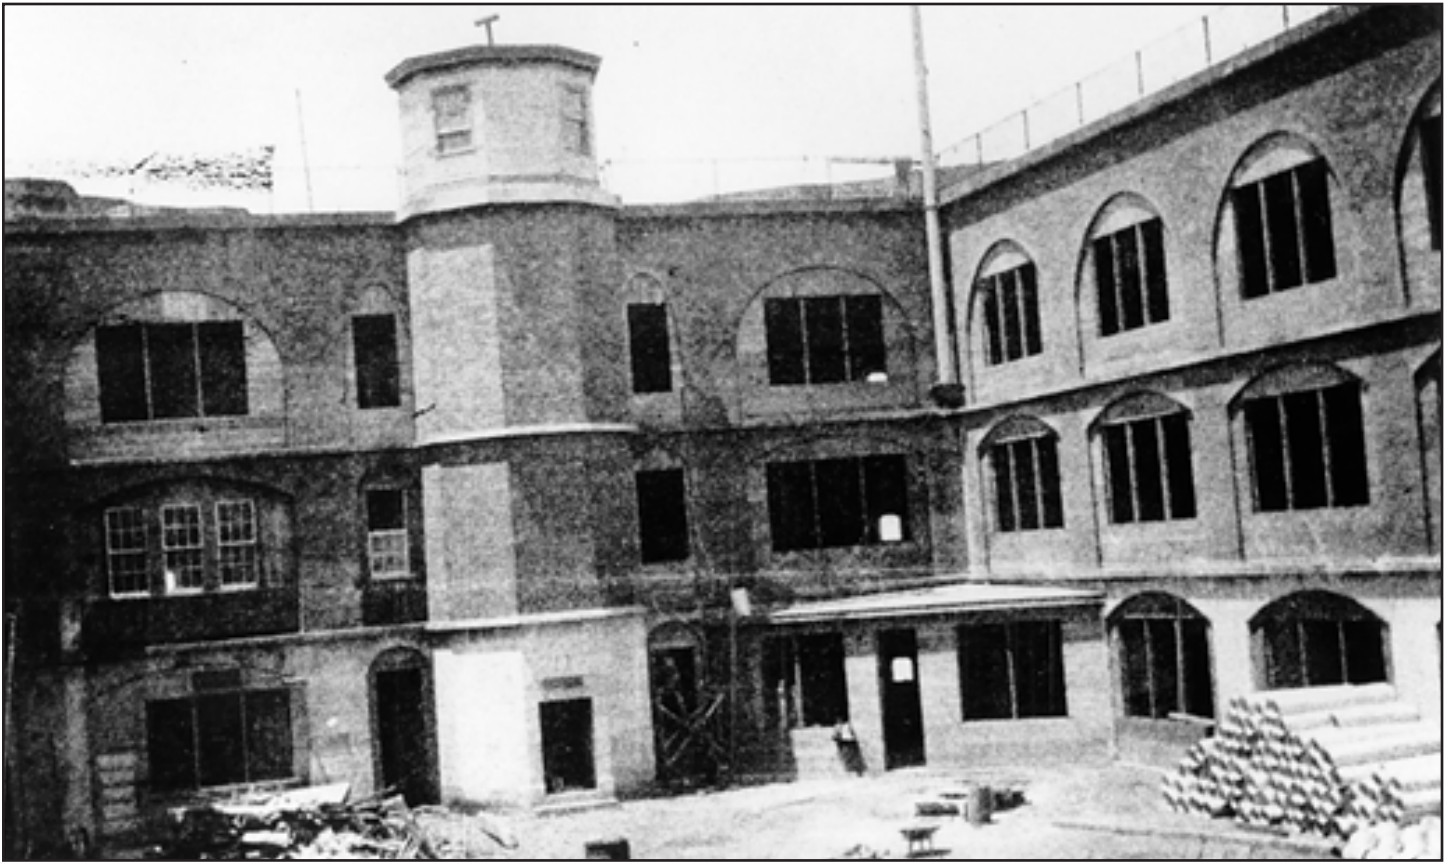
Figure 11. Photograph: Detention Barracks conversion in progress, viewed from the parade, circa 1914. Credit: Fort Point NHS Collection, Golden Gate National Recreation Area.

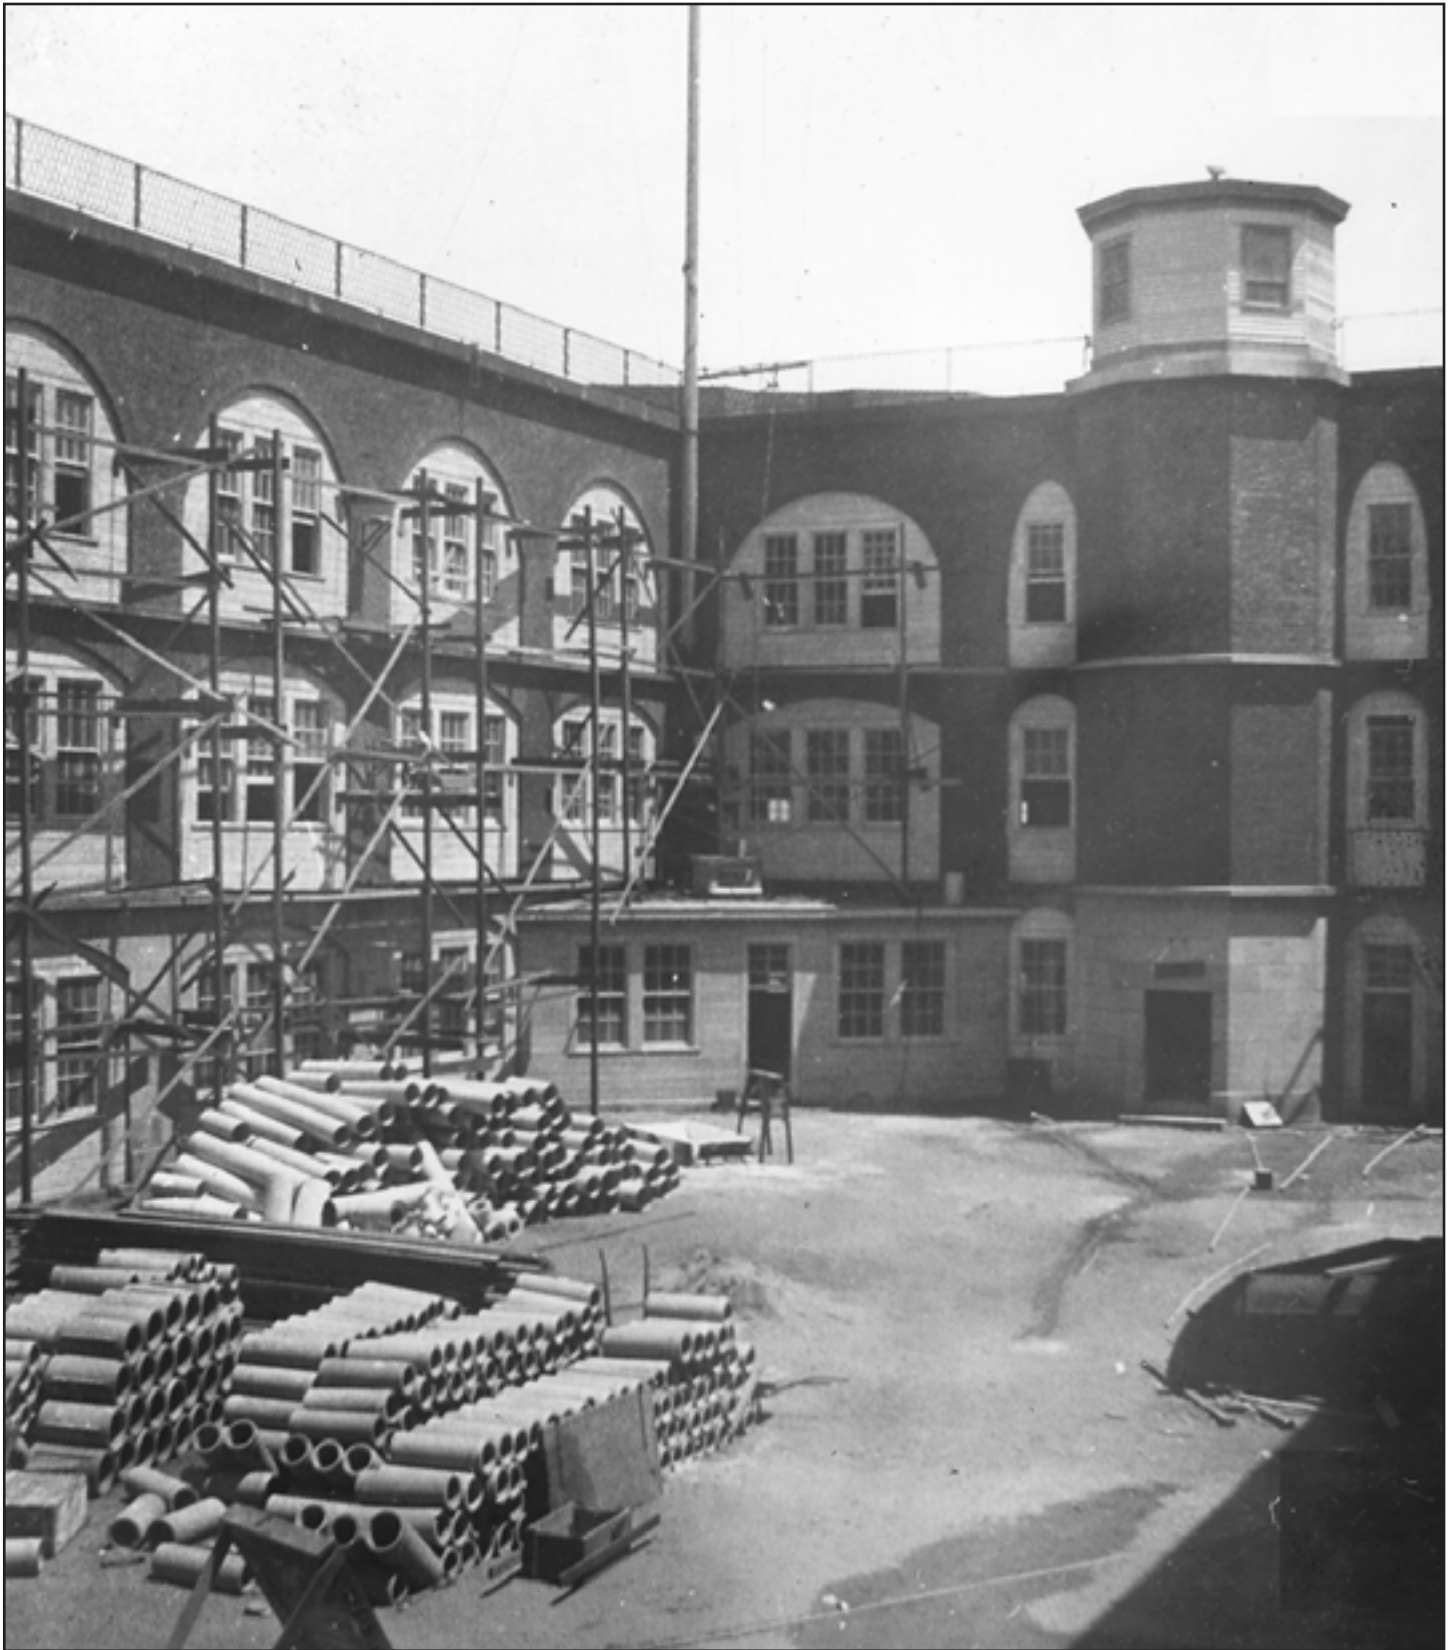
Figure 12. Photograph: Detention Barracks conversion in progress, viewed from the parade, circa 1914. Credit: Fort Point NHS Collection, Golden Gate National Recreation Area.

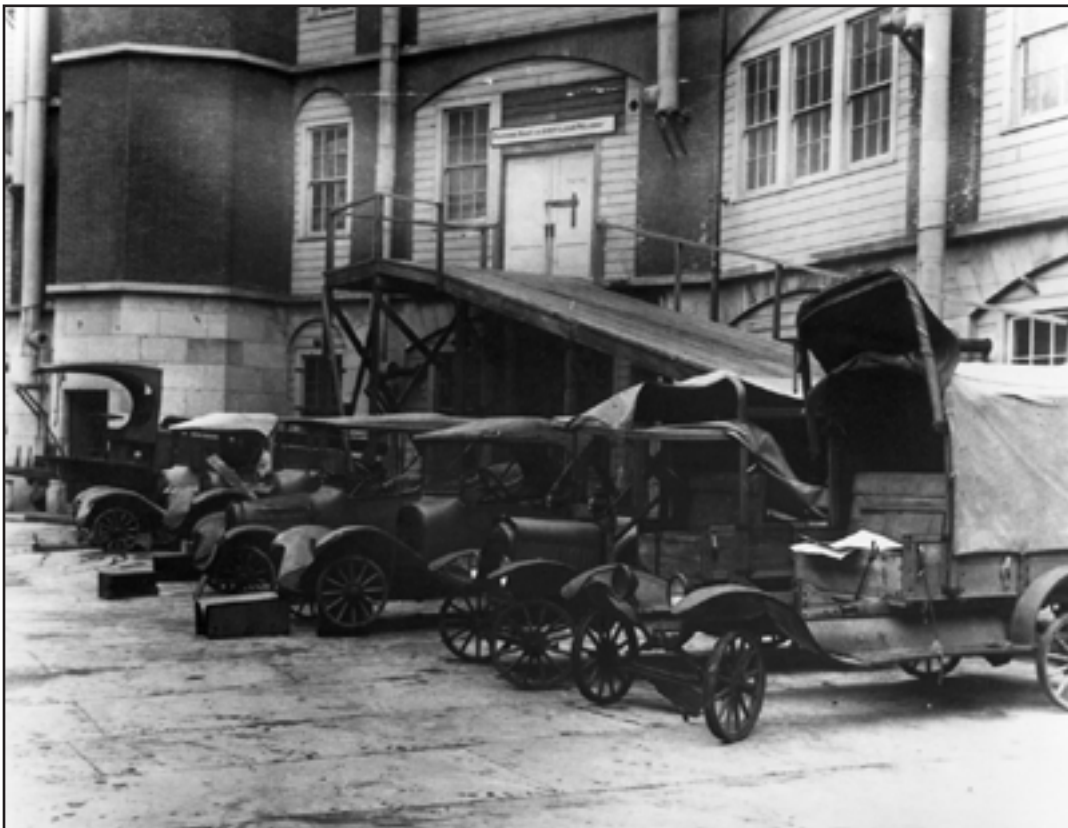
Figure 14. Photograph: Vocational School, viewed from the parade, circa 1924-1925. Credit: Fort Point NHS Collection, Golden Gate National Recreation Area.

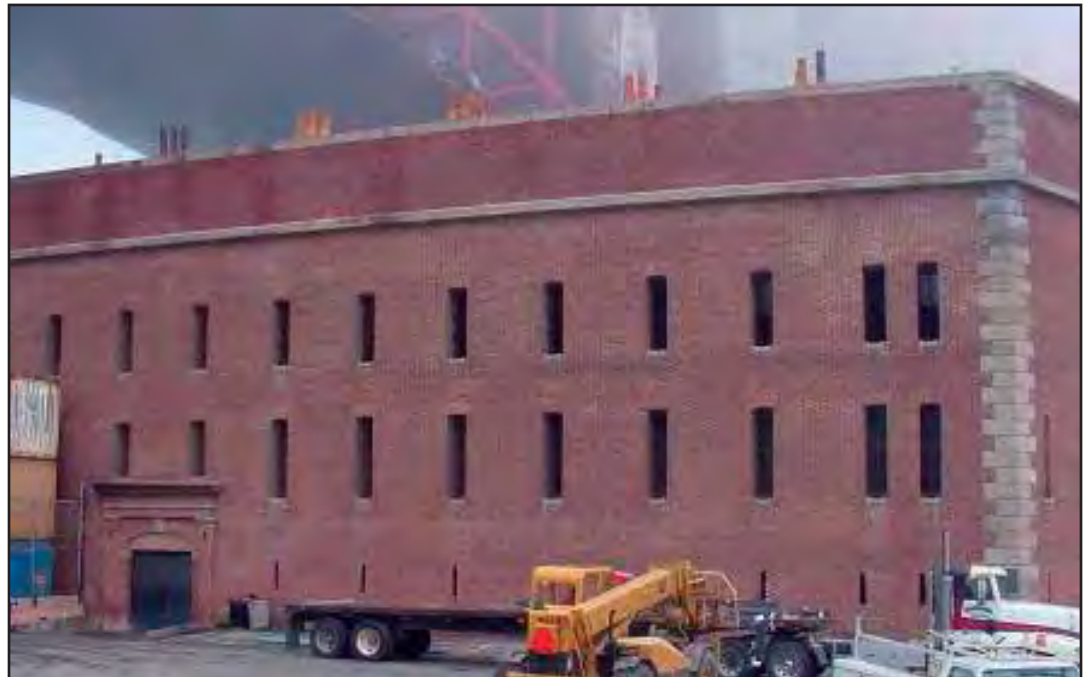
Granite quoins define the edges of the fort. (Jane Lehman, 2005)

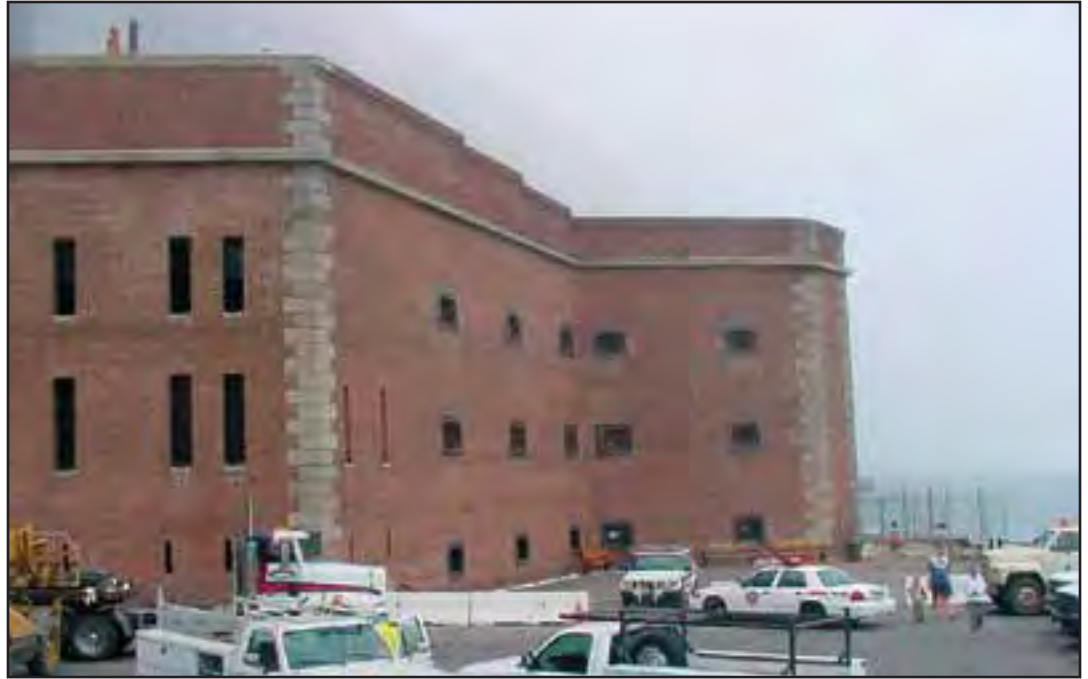
inside the fort near casemate 28. There is a wheel mechanism inside a small recess at the top of each of the brick pilasters that would have originally been part of the drawbridge system; however the drawbridge was never installed so this piece of equipment was never actually used.

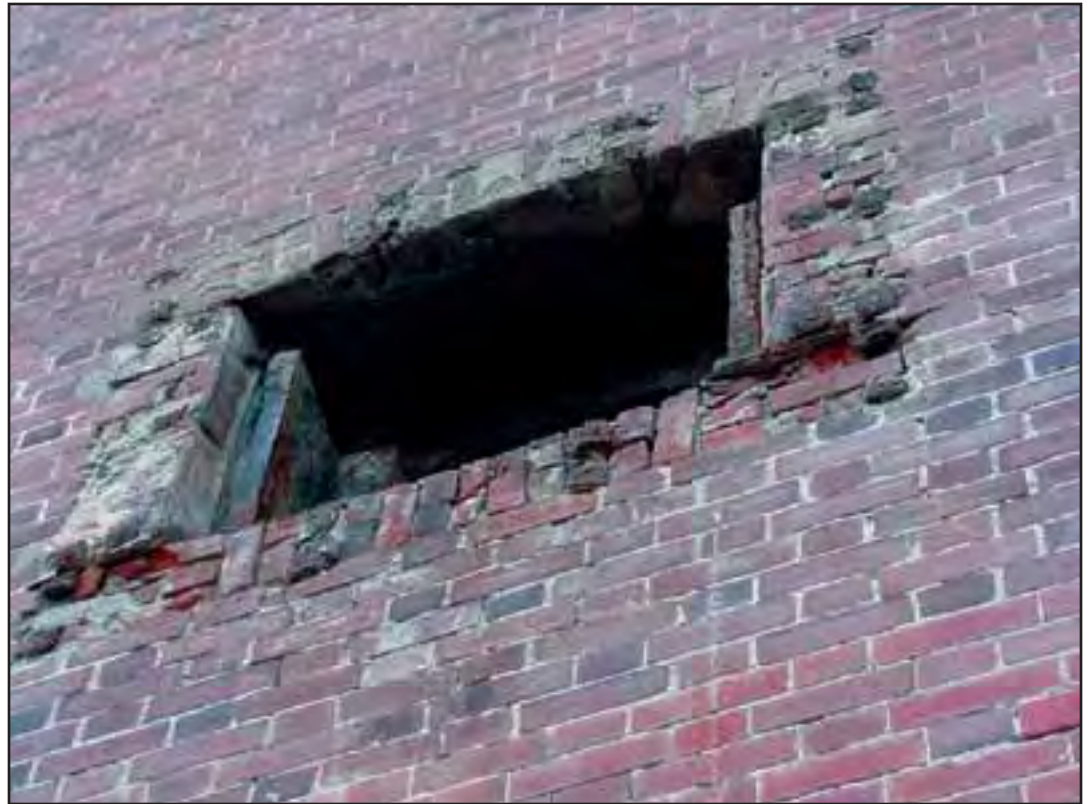
The quoins in the path of the wind and saltwater spray have lost their smooth quarried finish. (Jane Lehman, 2005)

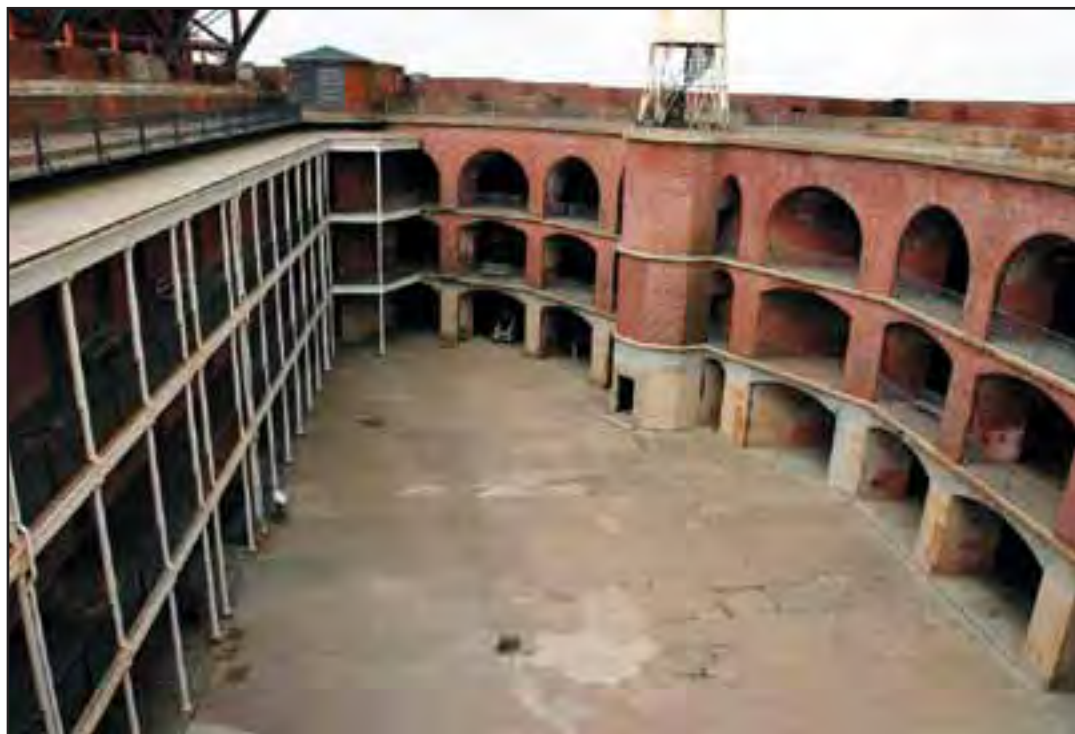
Interior courtyard elevation looking west. The southeast courtyard face is on the left and the lighthouse is partially visible on top of stair #2. (John Martini, 2005)
