National Park Service
U.S. Department of the Interior

Fort Point National Historic Site
Golden Gate National Recreation Area

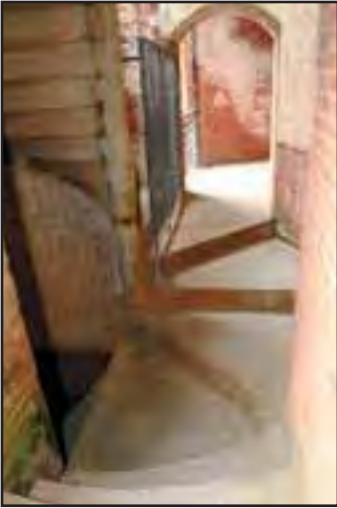
Each landing in the circular staircase is composed of slightly different shaped pieces of granite depending on the floor to floor heights. (John Martini, 2005)

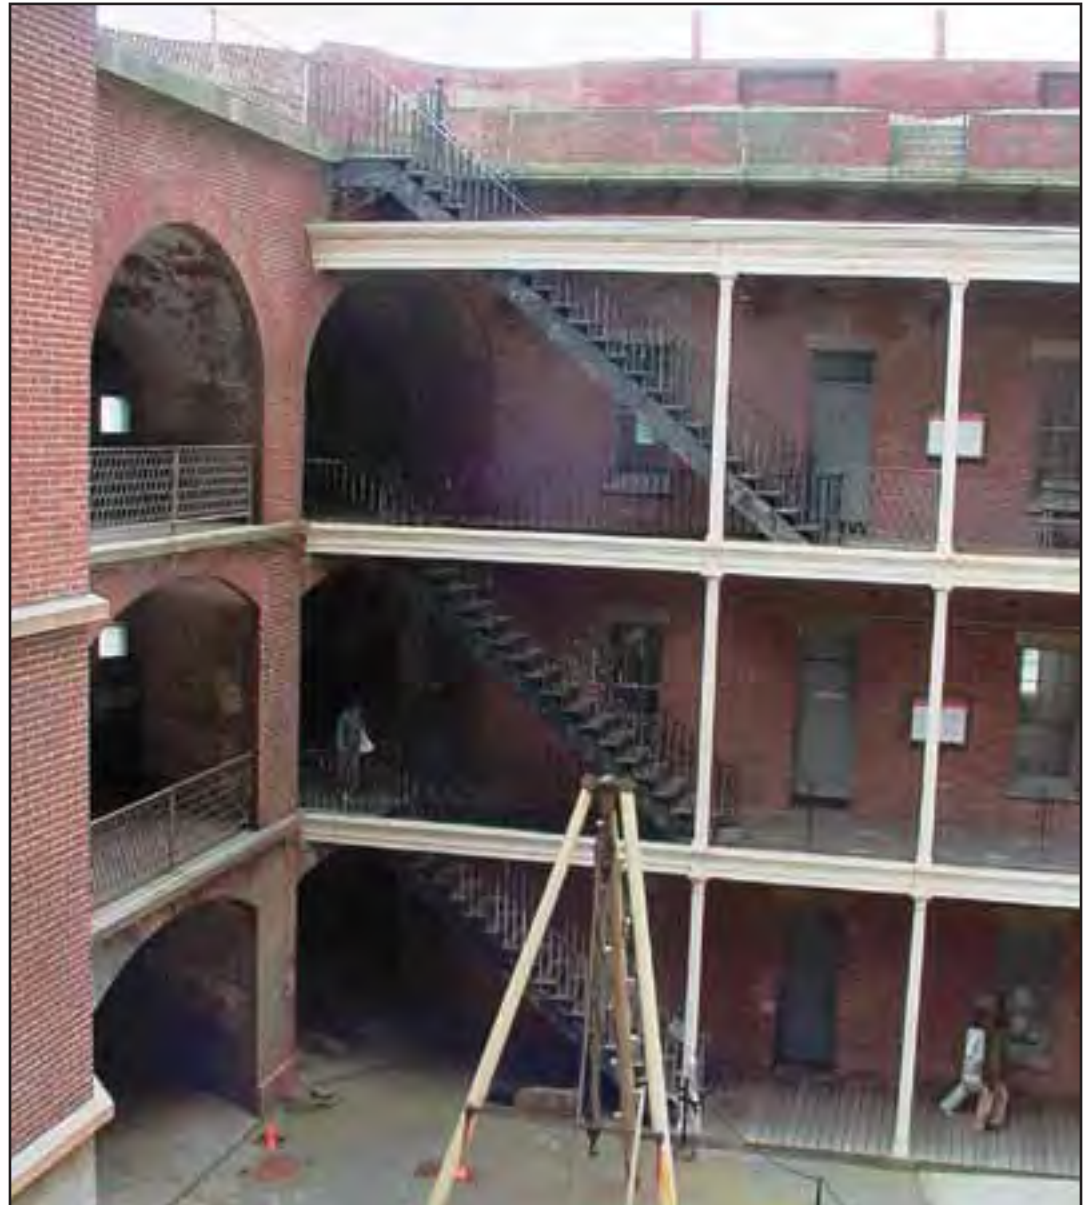
The cast iron staircase at the east end of the gallery is the only straight-run staircase in the fort. (Jane Lehman, 2005)

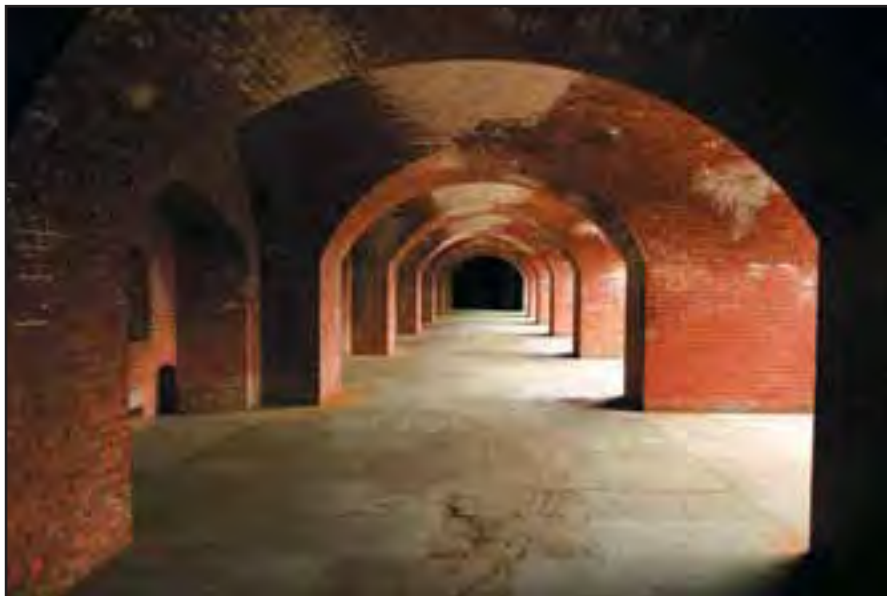
The cannon embrasure openings are 5'-4" wide x 3'-4" high that taper down to 1'-7" wide x 2'-2" high. The embrasures start at 3 ft. above the floor. Below this main opening is a horizontal slit 6" high x 4'-3" wide that held the iron bar on which the cannon pivoted. To either side of this horizontal slit is a rectangular recess with an arched top. This recess, most likely clearance for part of the equipment, is 1'-5" wide x 2' high x 8" deep.

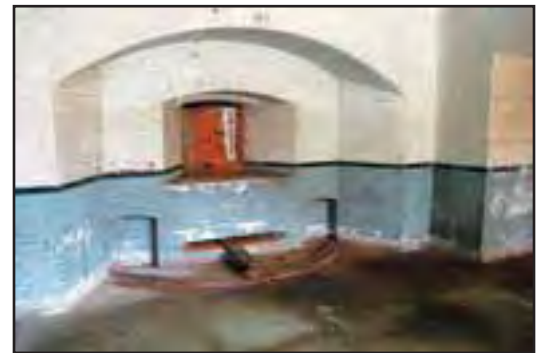
Typical cannon embrasure. This embrasure in casemate 2 still retains part of its original front pintle carriages. (John Martini, 2005)

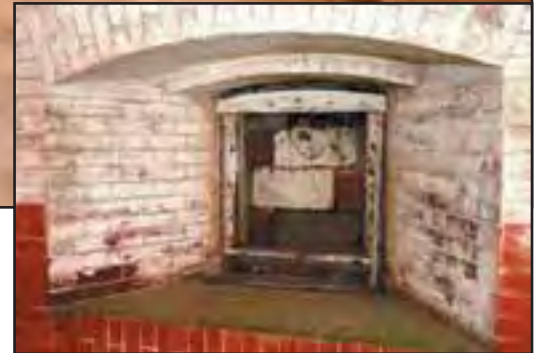
Most of the iron embrasures have deteriorated over the years and the openings have been infilled with brick and block for security purposes. (John Martini, 2005)

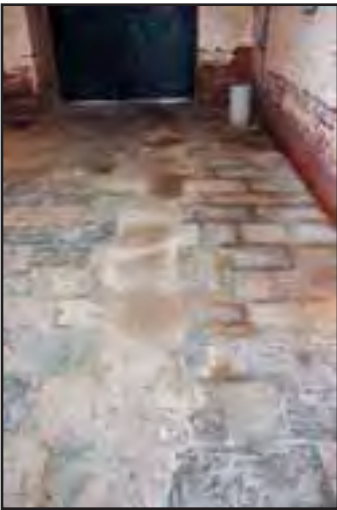
The original granite floors remain in good condition although a large concrete patch exists where a previous water line was installed. (John Martini, 2005)

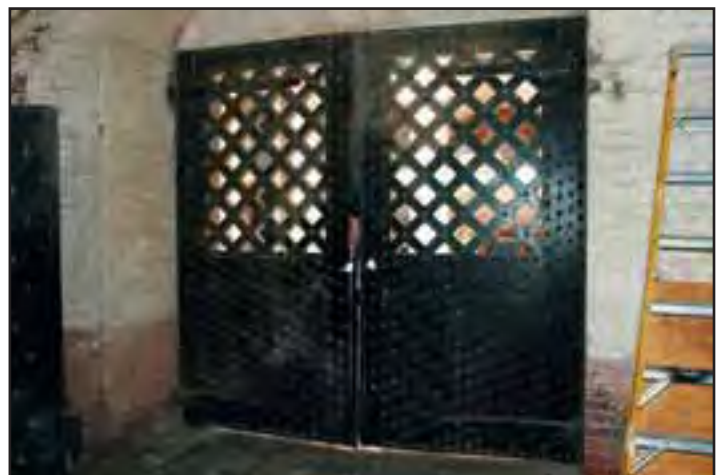
The upper floors are held up by cast iron columns with beams that span between the column and the gorge wall. The ceilings on the 1st and 2nd tiers of the gallery are shallow brick barrel vaults which span between these intermediate beams. These beams are exhibiting some signs of rust, but are generally in good shape. The entire gallery is original and is a very significant feature of the fort.

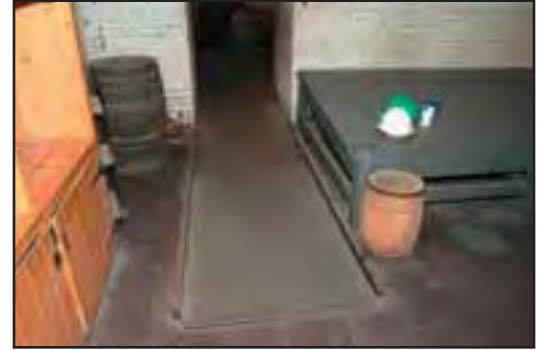
The reconstructed banquette on the right would have doubled as a platform to fire into the sallyport and a sleeping area for the guards. (John Martini, 2005)

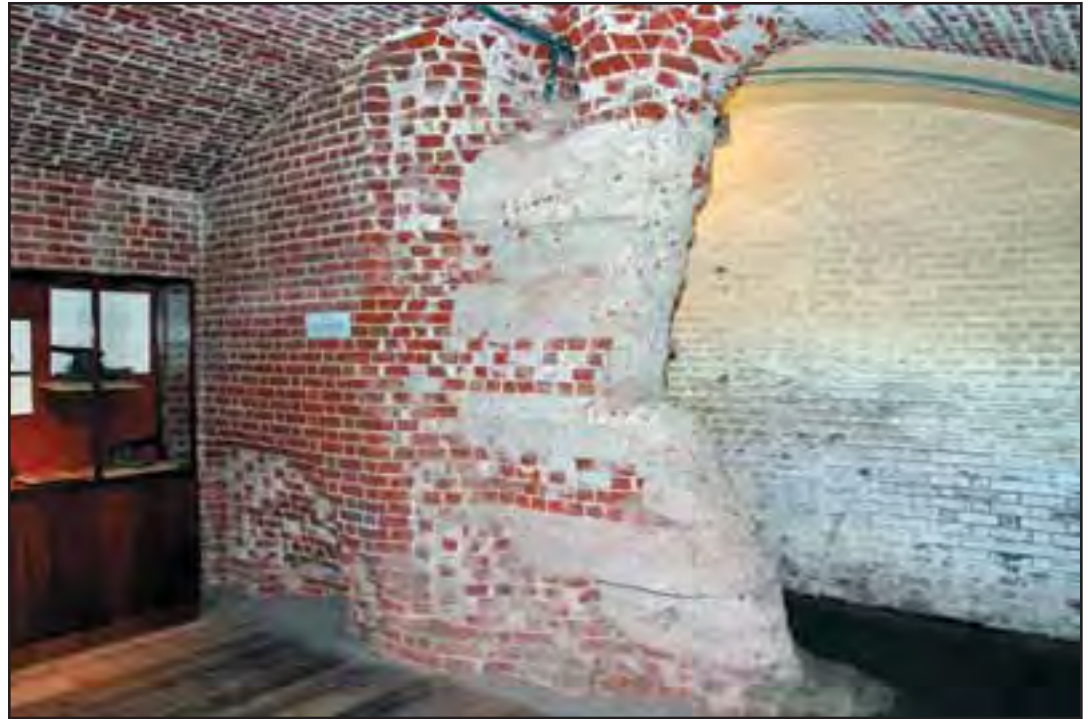
the corridor was removed. This wall shows the four wythes of brick on each side, the concrete infill, and the granite foundation.

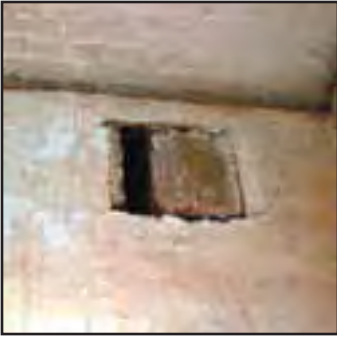
This 12" X 12" metal vent provide the only air circulation into the jail cells when the door was closed. (John Martini, 2005)

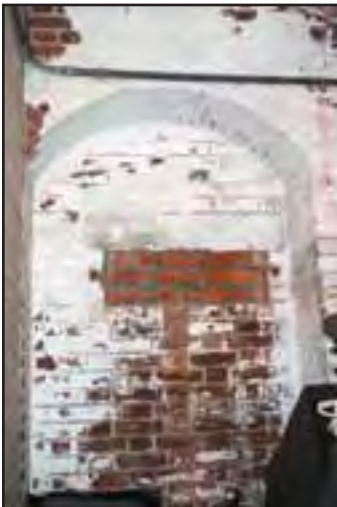
The rifle slit in the corridor of the jail area has been infilled with brick. (John Martini, 2005)

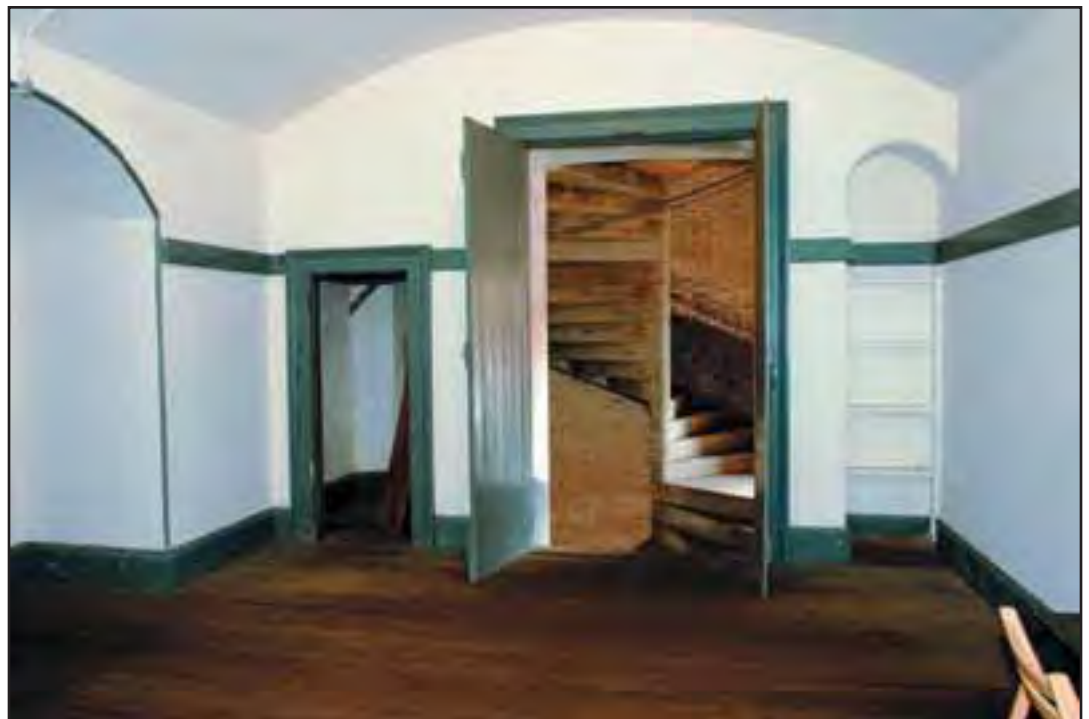
The surgeon's room is accessed directly from stair #1. An irregularly-shaped closet is left of the door and an alcove is on the right. (John Martini, 2005)

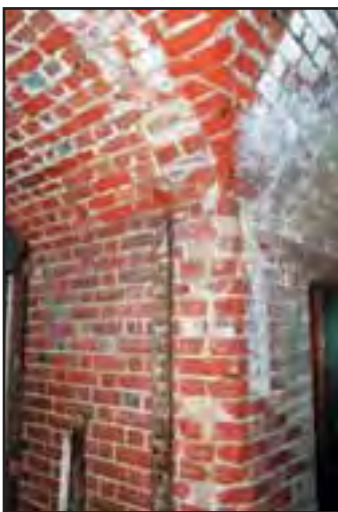
The outline of a previous, original brick wall is visible in the communication arch between enlisted men's quarters 2 & 3. (John Martini, 2005)

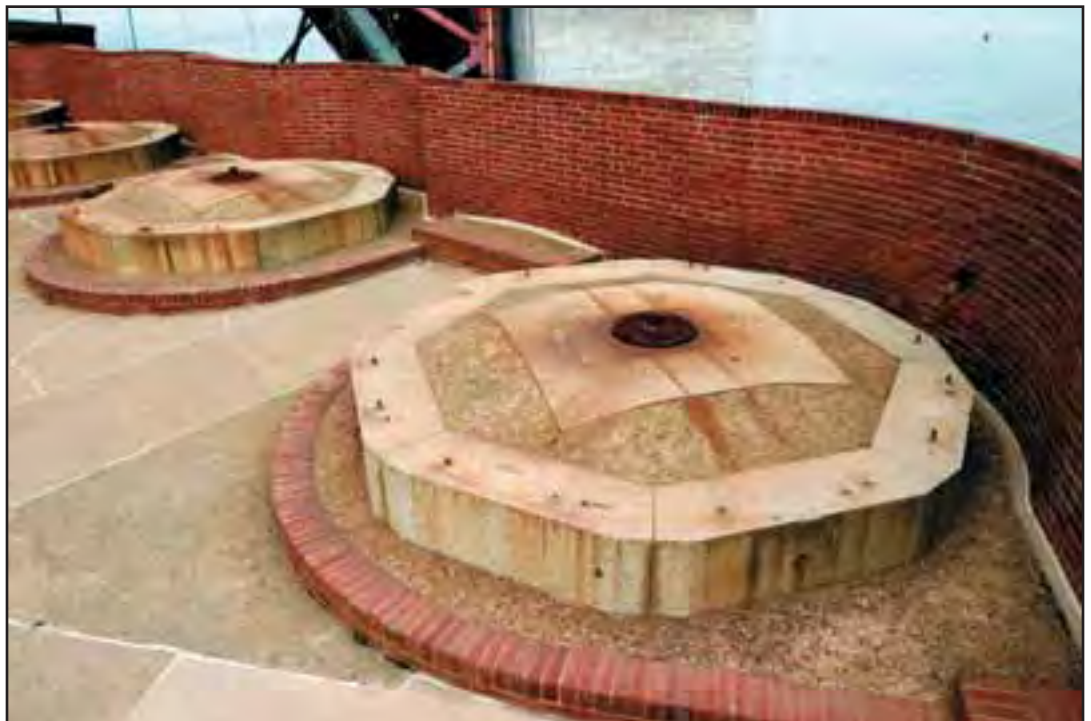
The top of the parapet wall in this area is concrete, but was originally grass. There are several dozen clay flue pipes projecting up through this concrete. There are 3 different styles of pipes, most likely related to the different time periods when they were installed. There are 1" diameter weep holes every 8 ft. in this wall. Although the top is concrete, moisture still appears to be coming from the weep holes, indicating that the concrete is leaking.

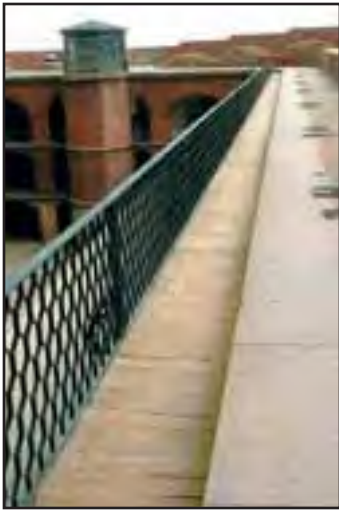
This 3-foot wide walkway and railing above the gallery on the southwest gorge elevation was replaced in a 1973 project. Beyond is the penthouse over stair #3. (John Martini, 2005)

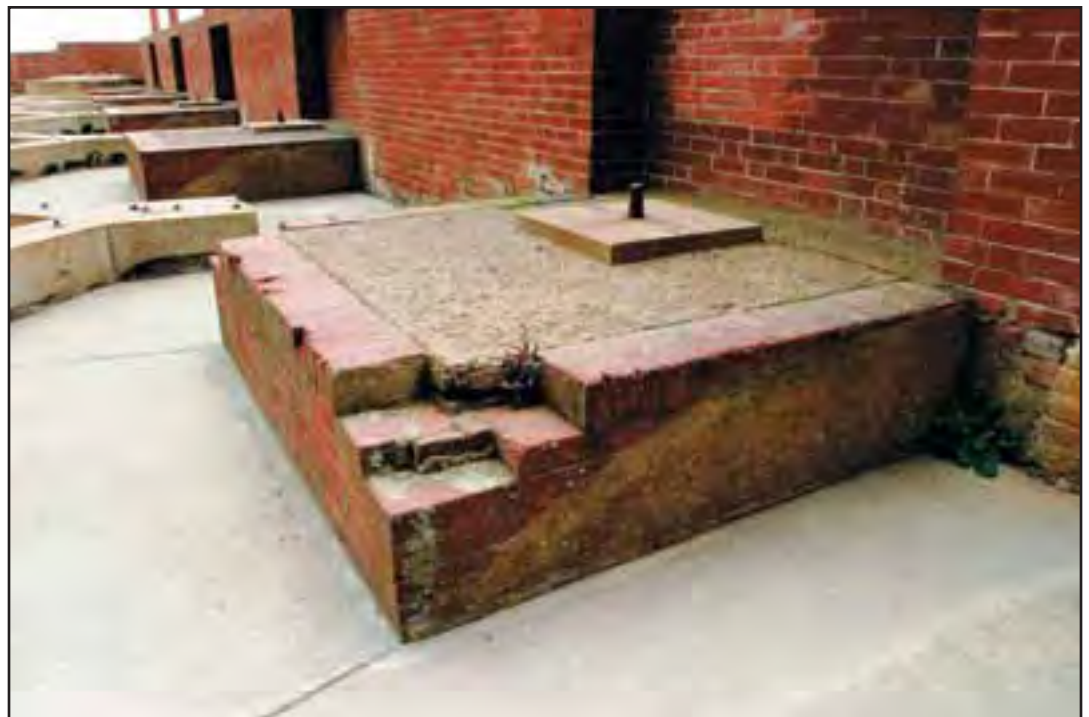
¹ Interpretation Panel, Fort Point Powder Magazine.

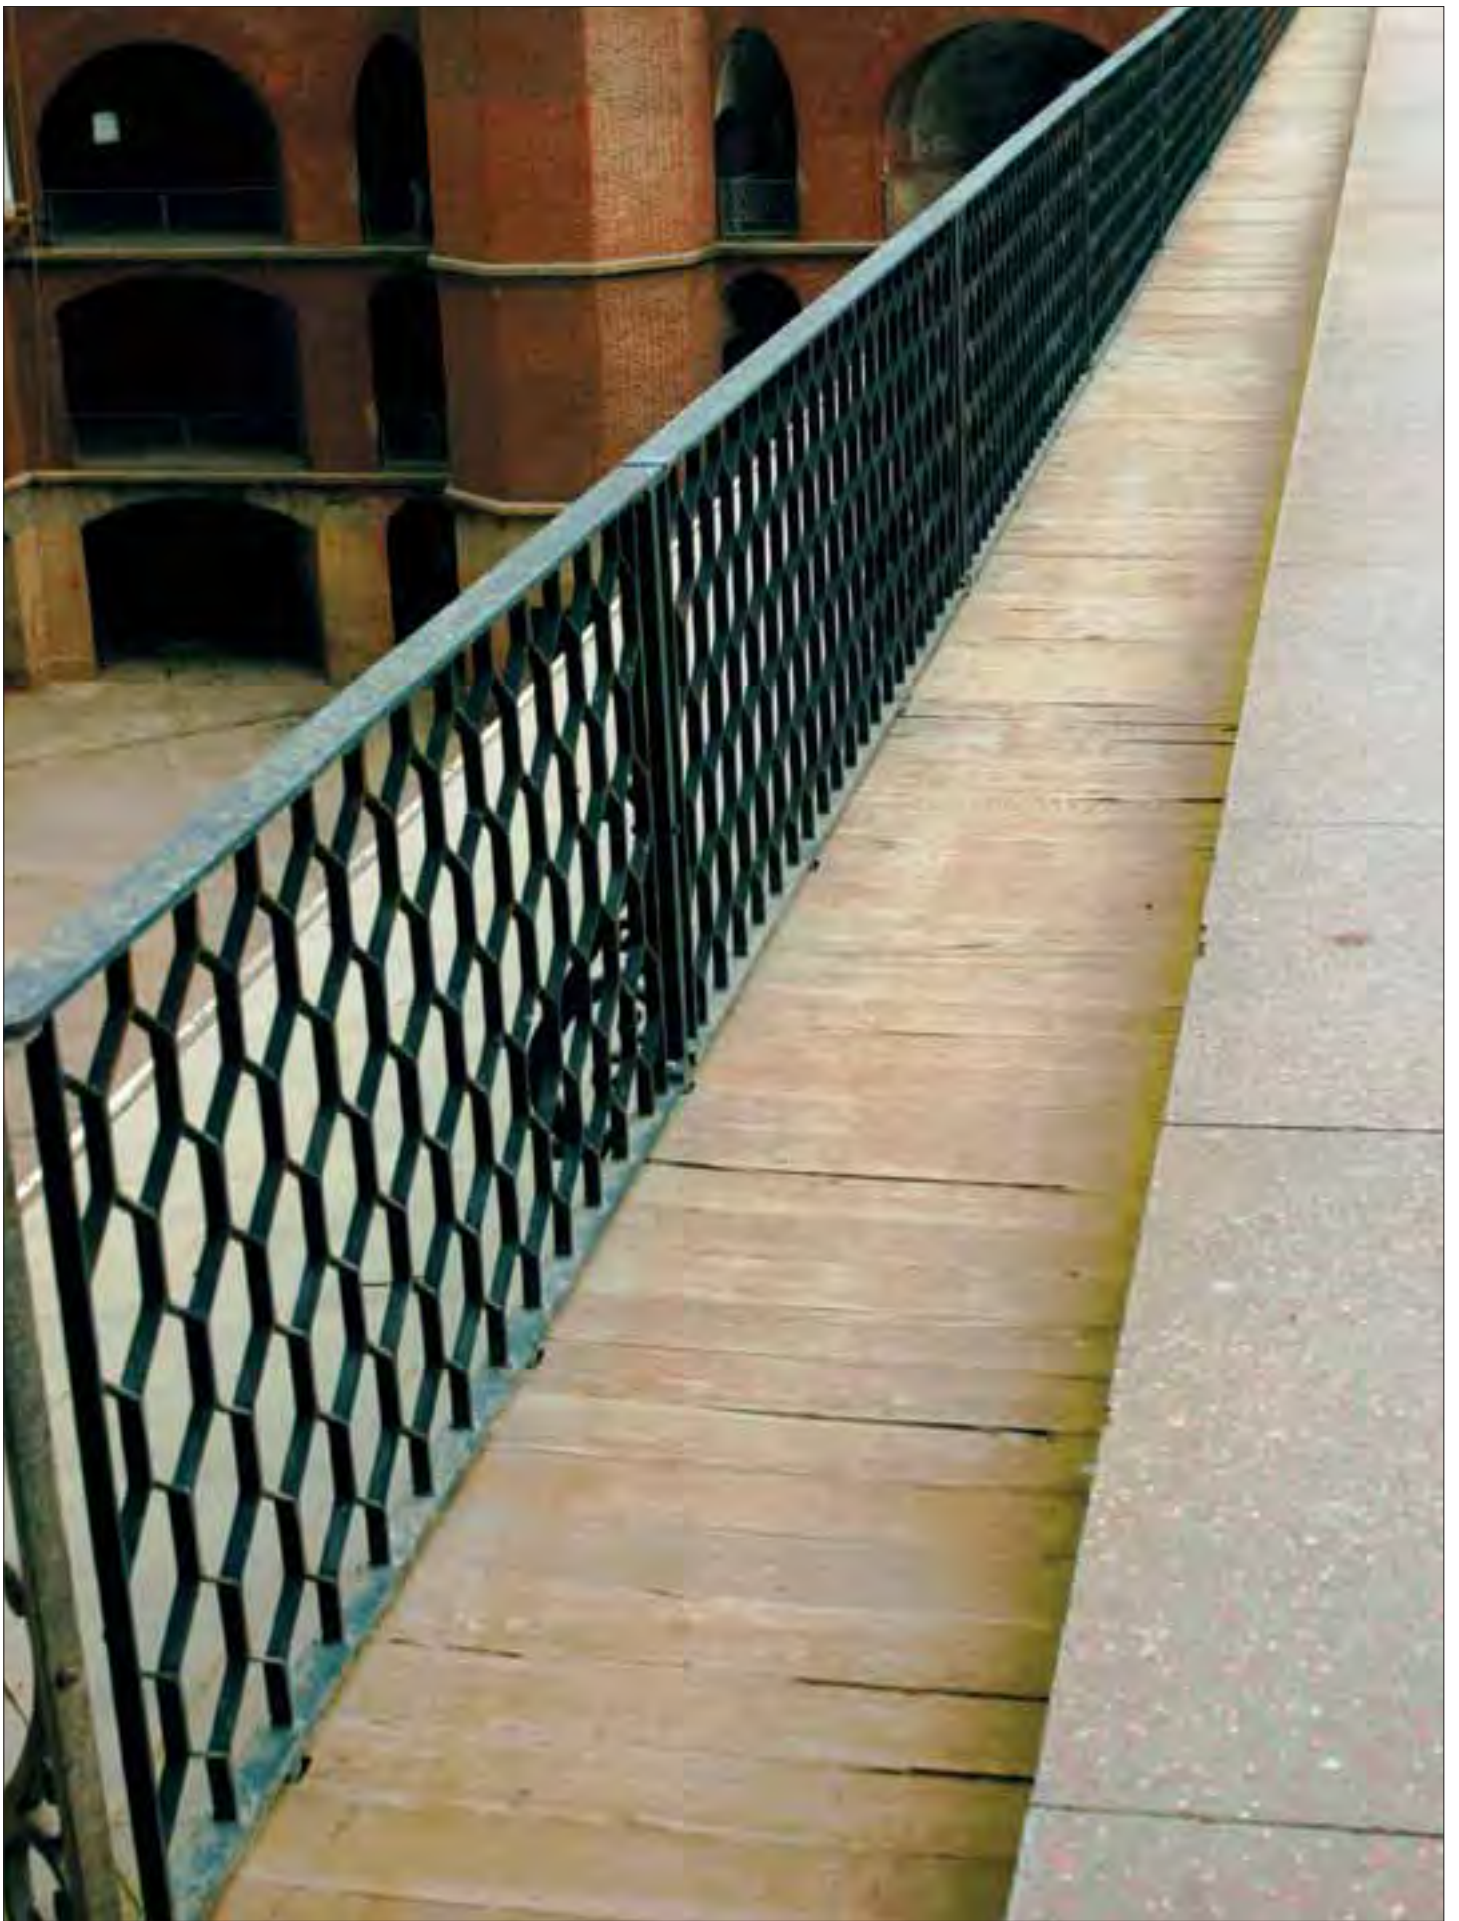
Conditions Assessment and Material Investigations

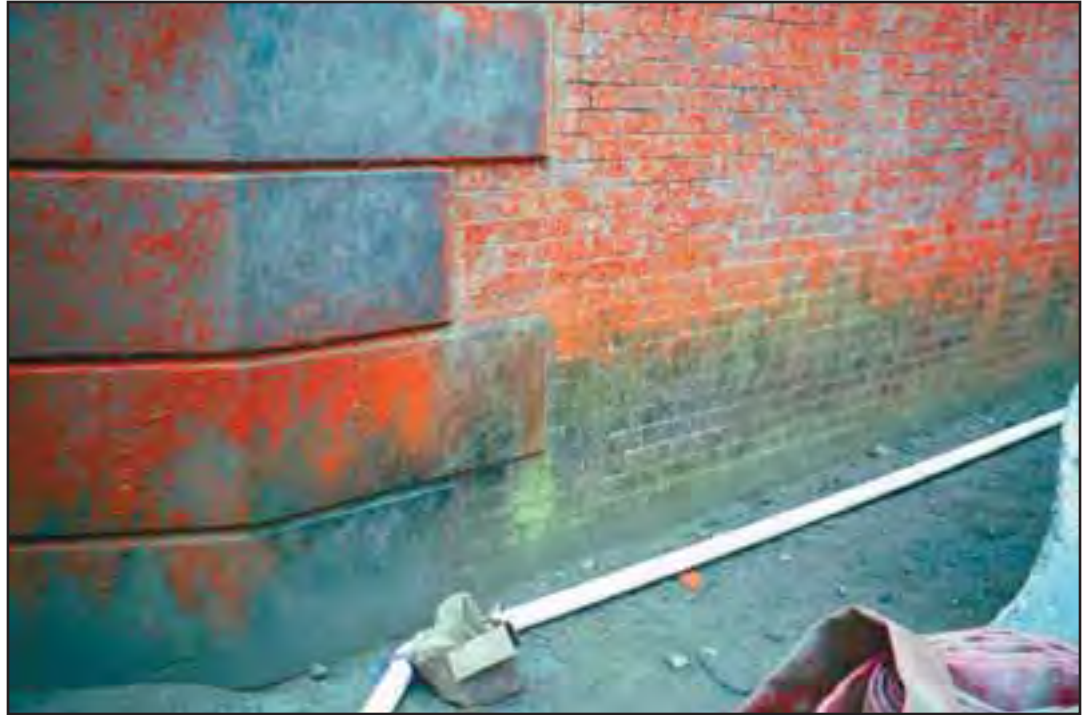
Condition Photo 2:
Intersecting Arch of Casements 98 and 99; Biological growth and efflorescence settle on masonry surfaces. (Courtesy of ARG, 2003)

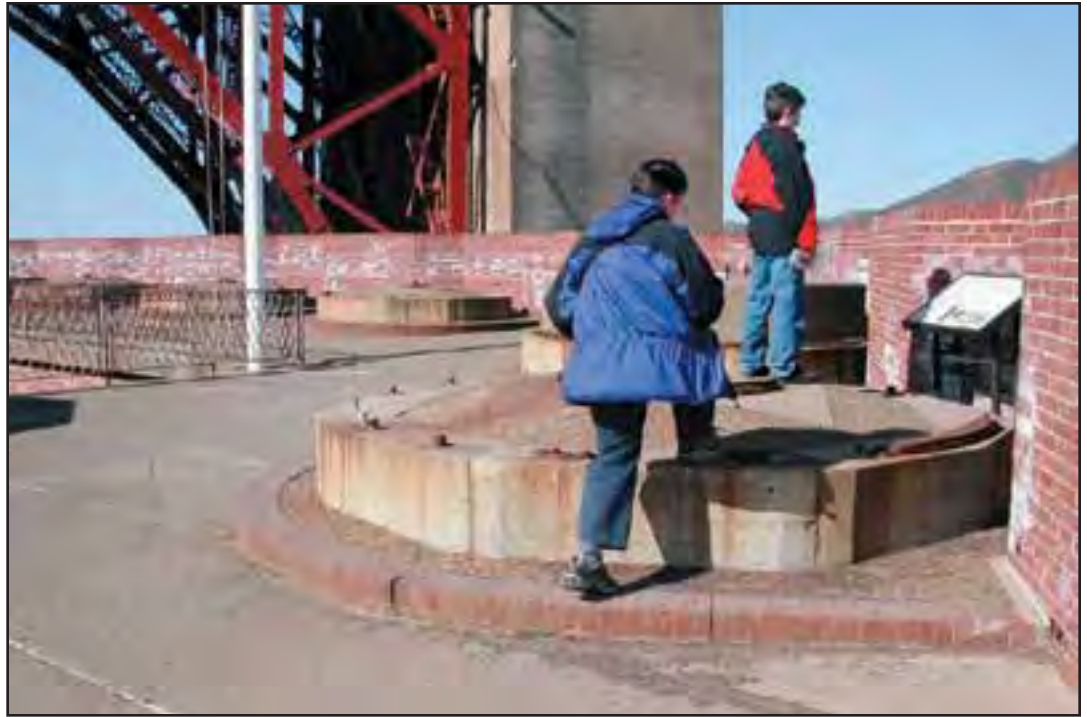
Condition Photo 6:
Top Landing at Barbette Tier; Crack
in granite. (Courtesy of ARG, 2003)

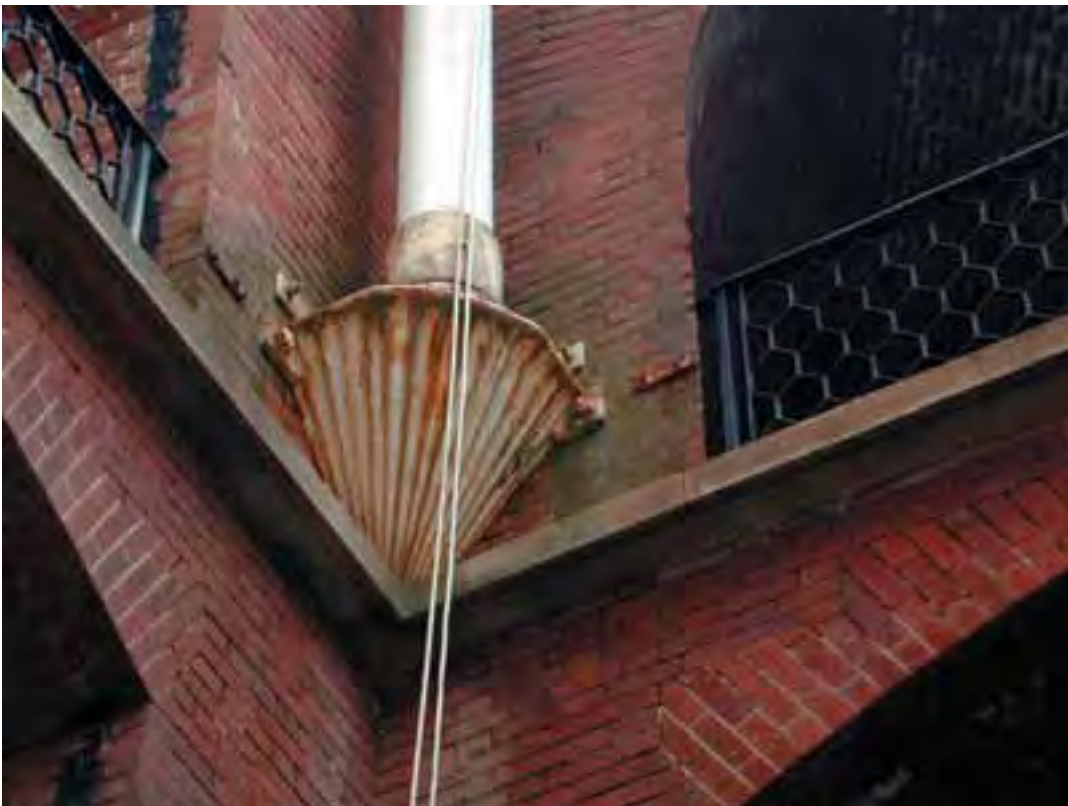
Condition Photo 11:
Biological growth on flagpole.
(Courtesy of ARG, 2003)

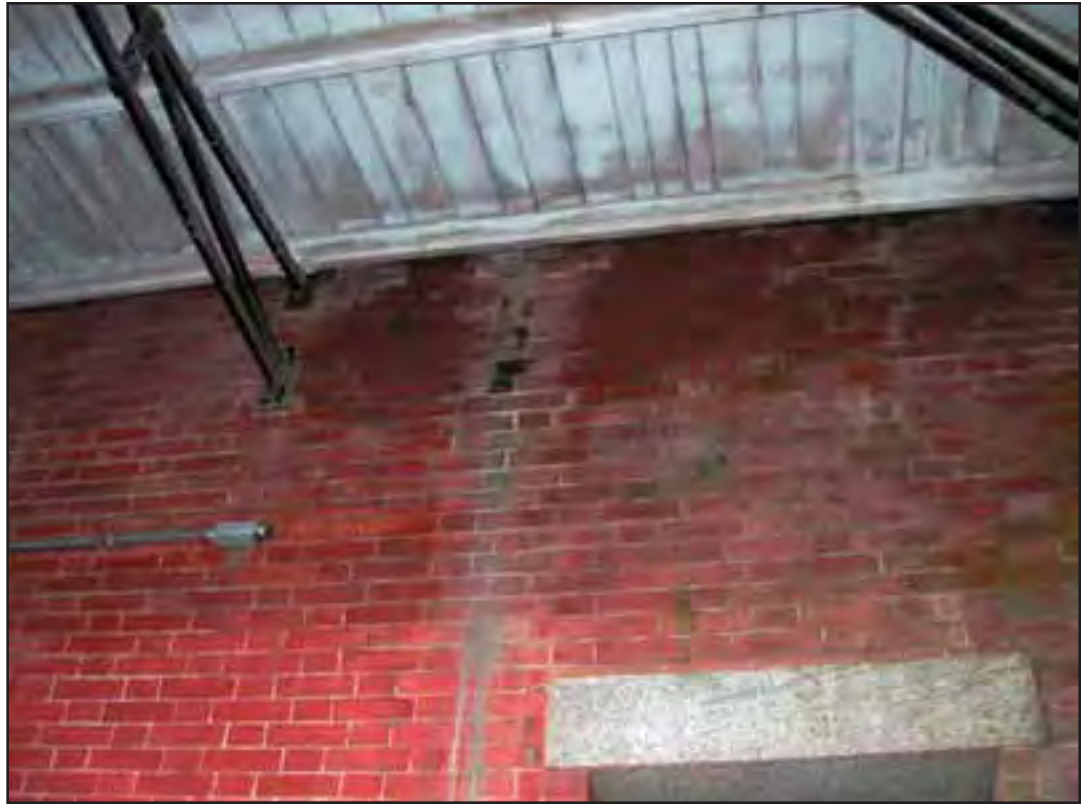
Condition Photo 13:
Stair 3; Missing siding exposes
the structural framing. (Courtesy of ARG,
2003)

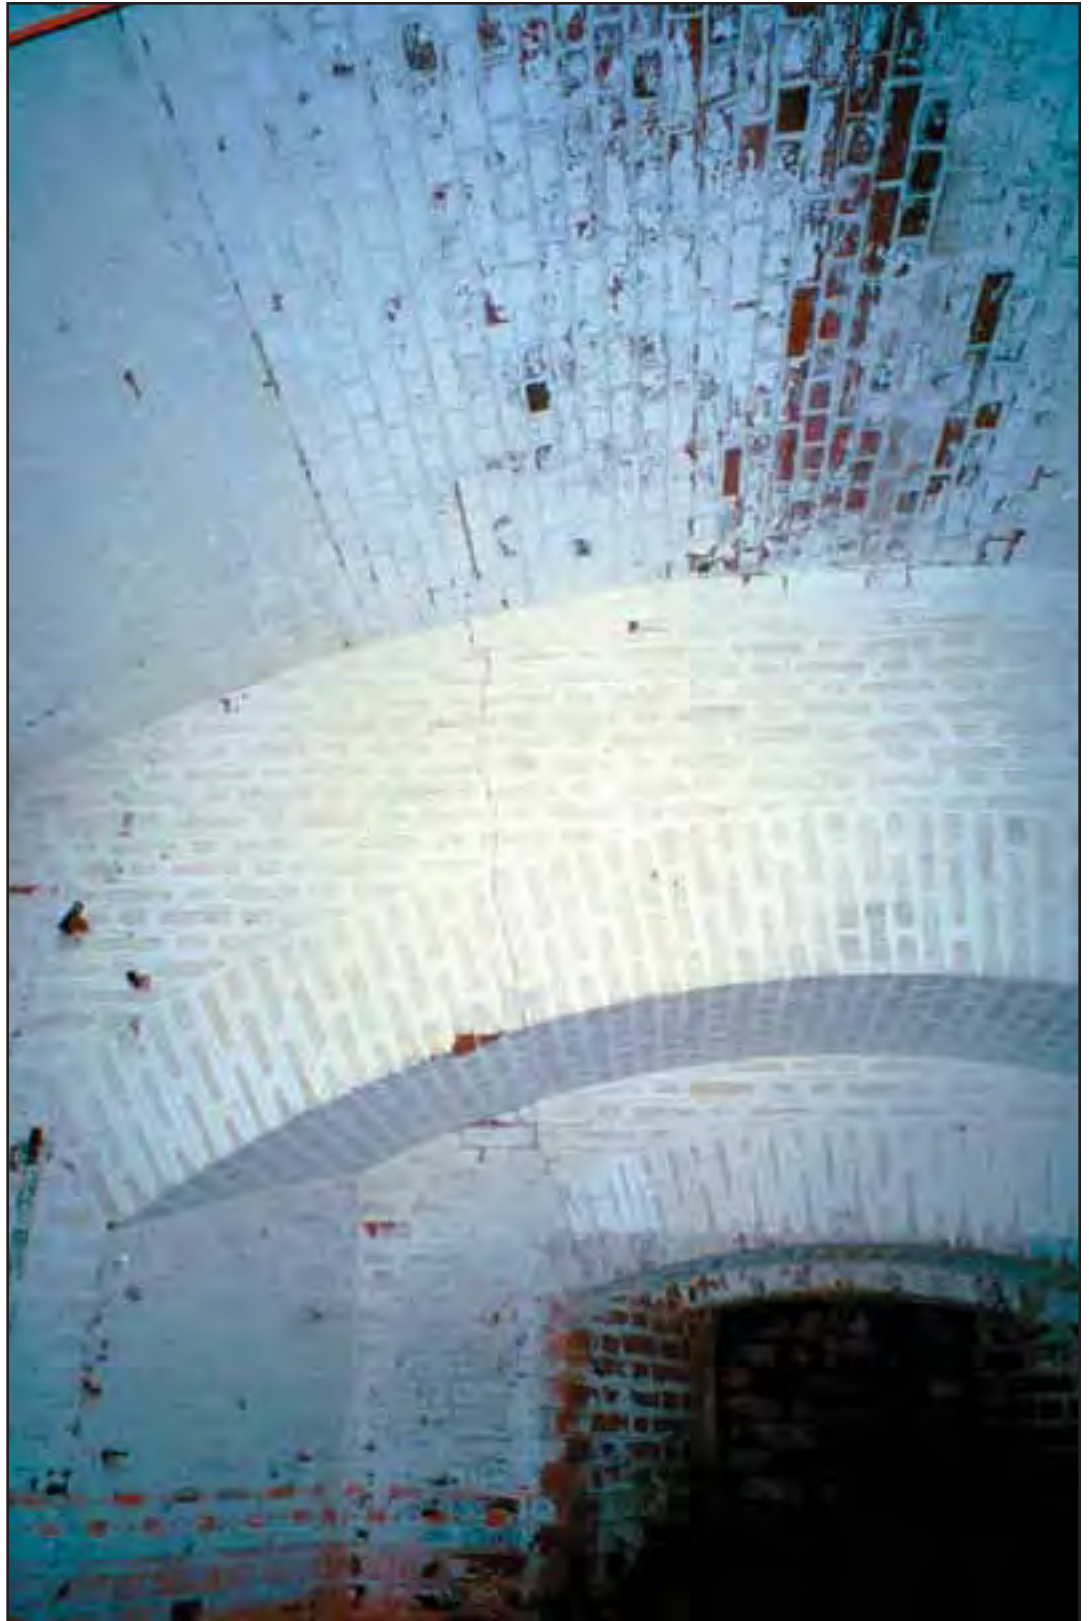
Condition Photo 15:
Casemate 19; Cracks in brick masonry
and joints have failed. The heavily
flaking paint is typical in casements.
(Courtesy of ARG, 2003)

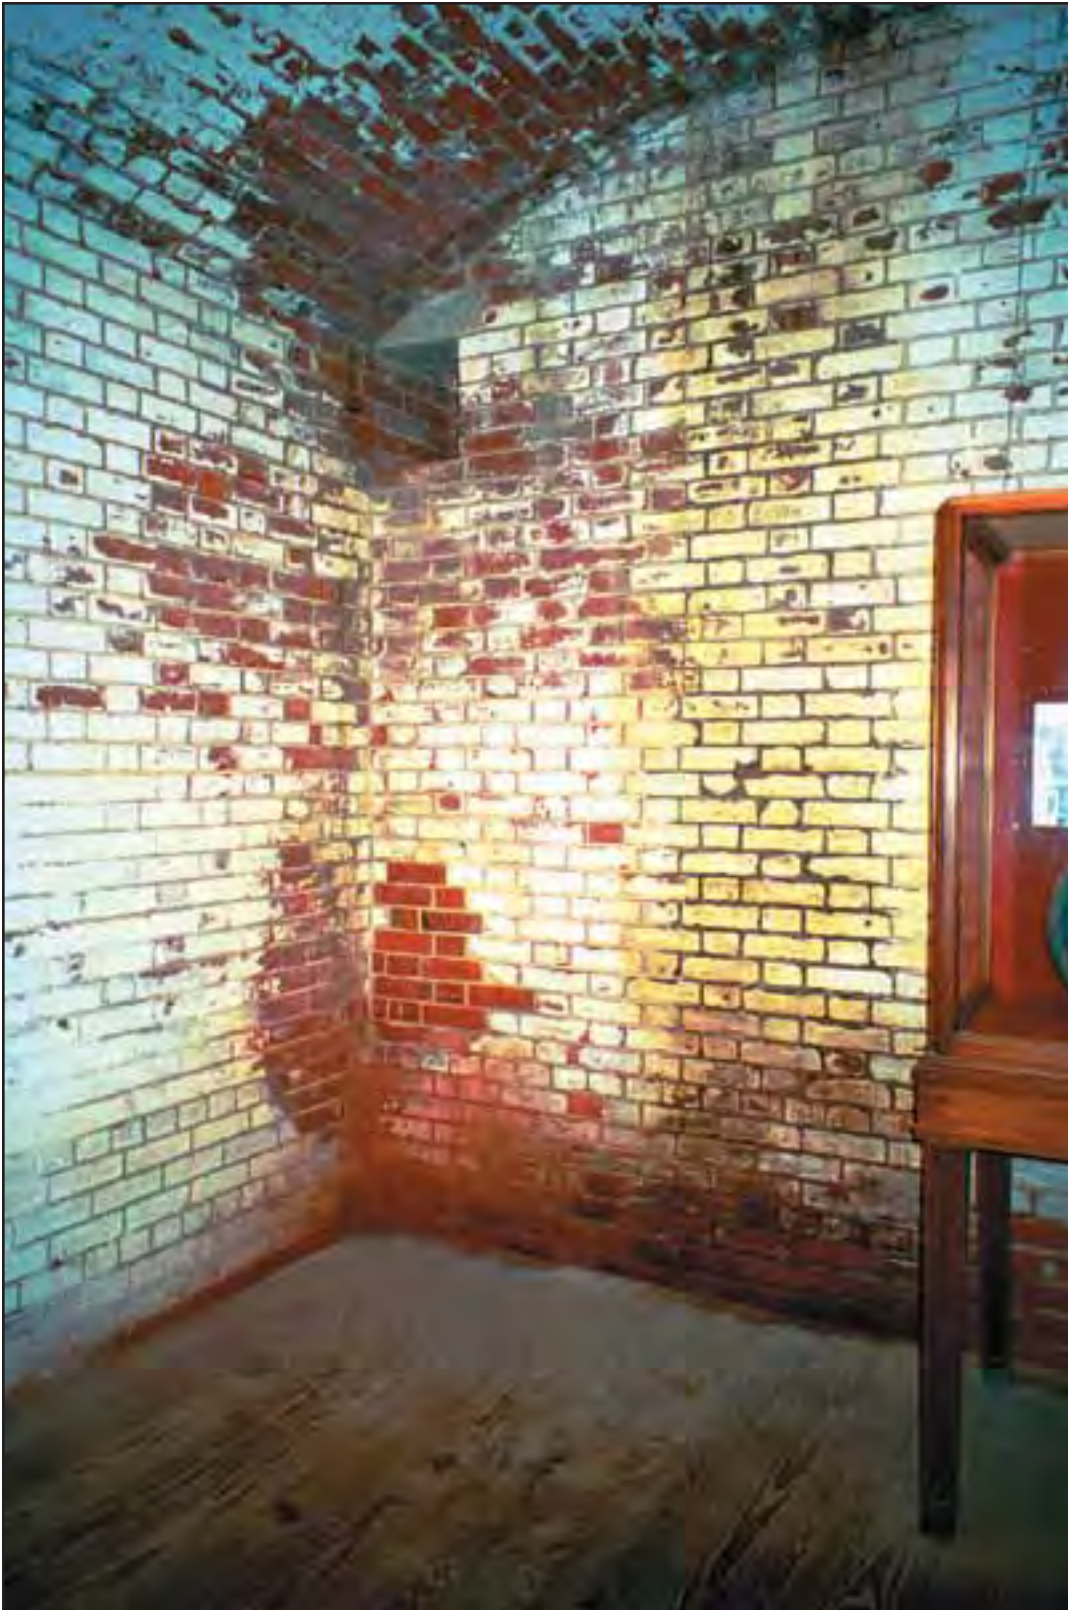
Condition Photo 16:
Casmate 11; Open joints at the
brick masonry and heavy water
infiltration. Biological growth on
the interior brick. (Courtesy of ARG,
2003).

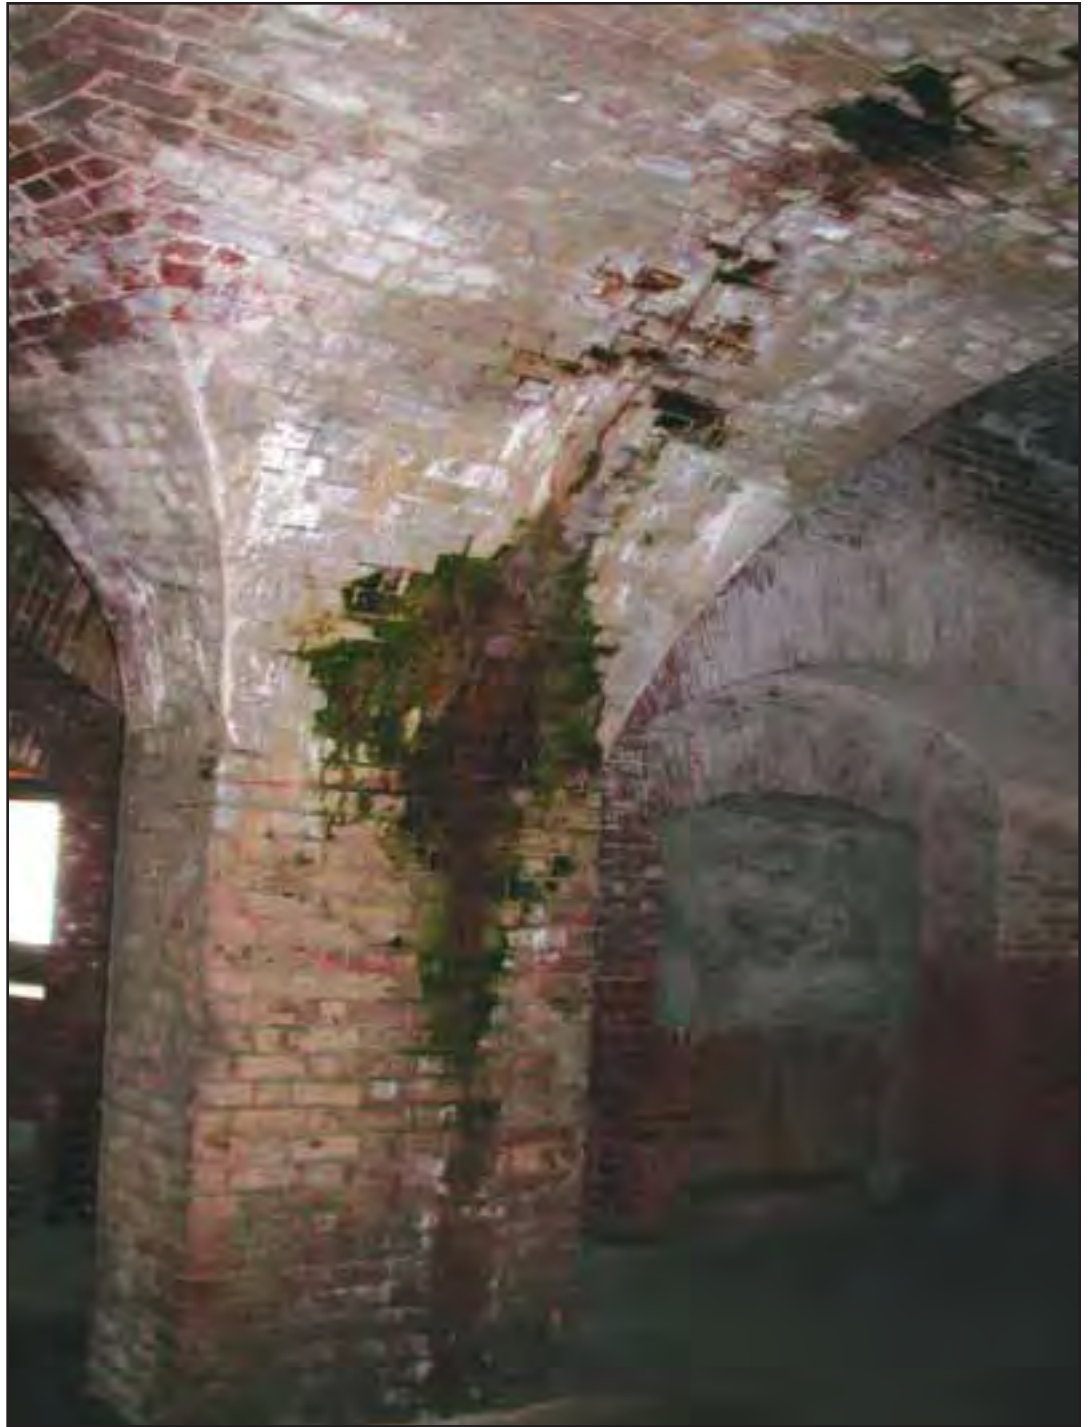
Condition Photo 17:
Casemate 68A- Third Tier; Crack
spanning the arch of a casemate,
typical at the intersection of the east
bastion and arch of the adjacent
walkway. Extensive water damage,
biological growth and efflorescence
of masonry. (Courtesy of ARG, 2003)

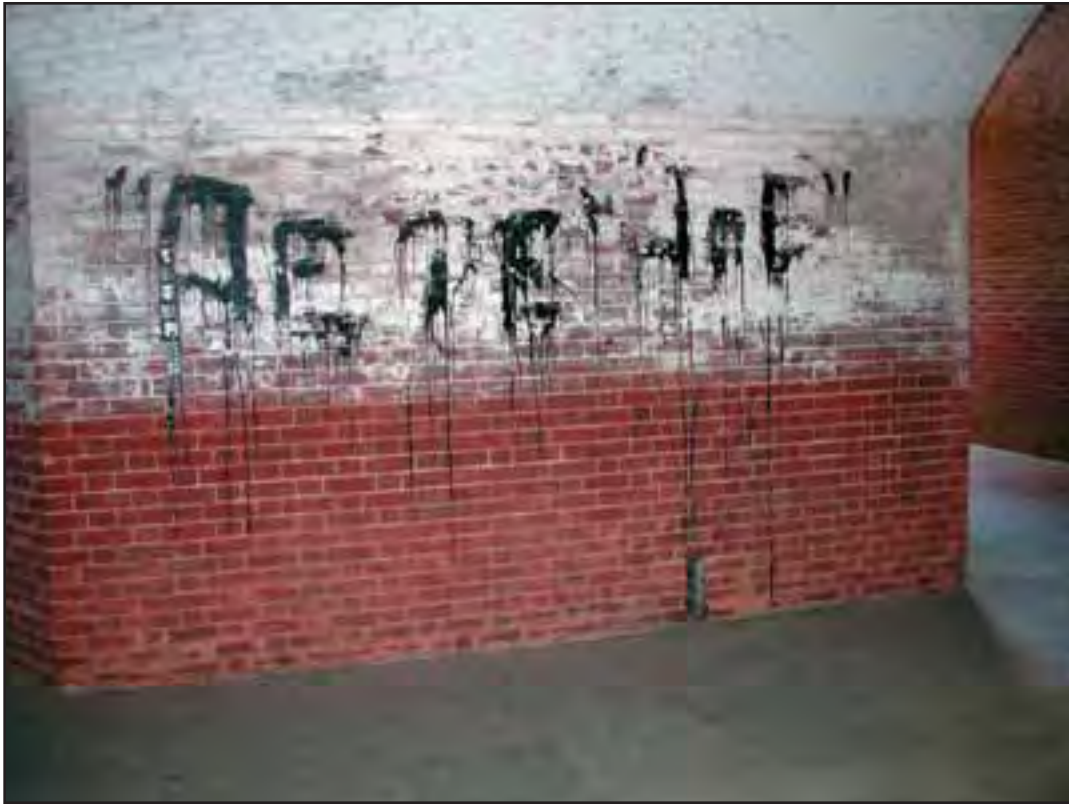
Condition Photo 18:
Casemate 68A—Second Tier; Graffiti
noted on masonry wall.
(Courtesy of ARG, 2003)

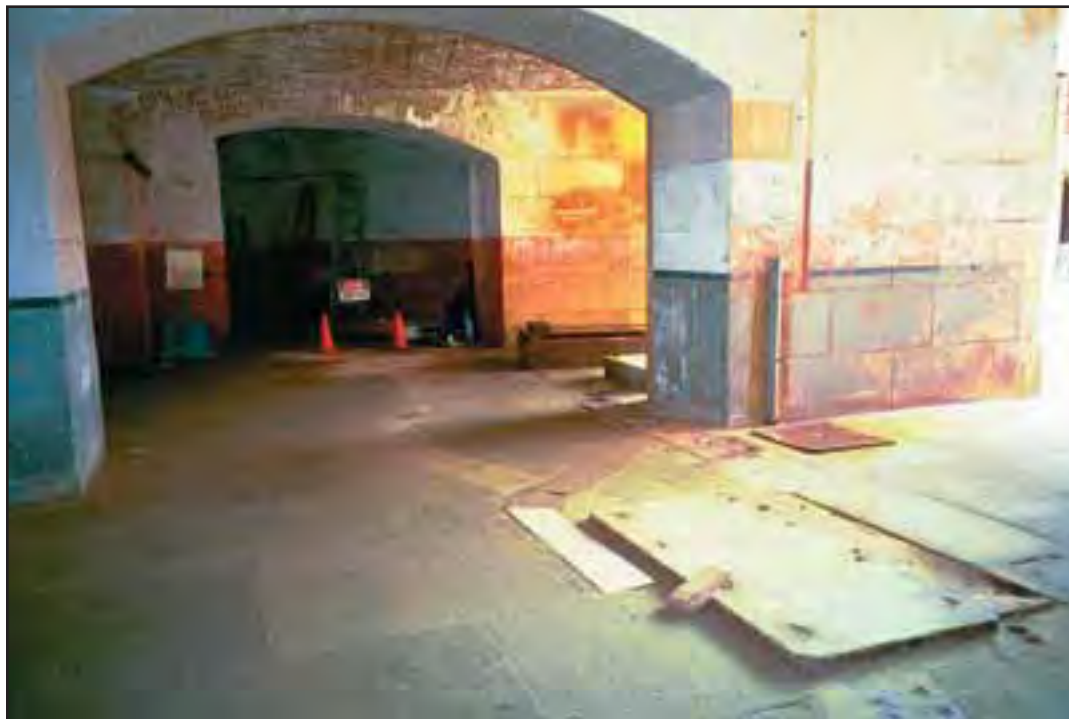
Condition Photo 19:
Casemate 34; Uneven surfaces, open
holes and potential tripping hazards.
(Courtesy of ARG, 2003)

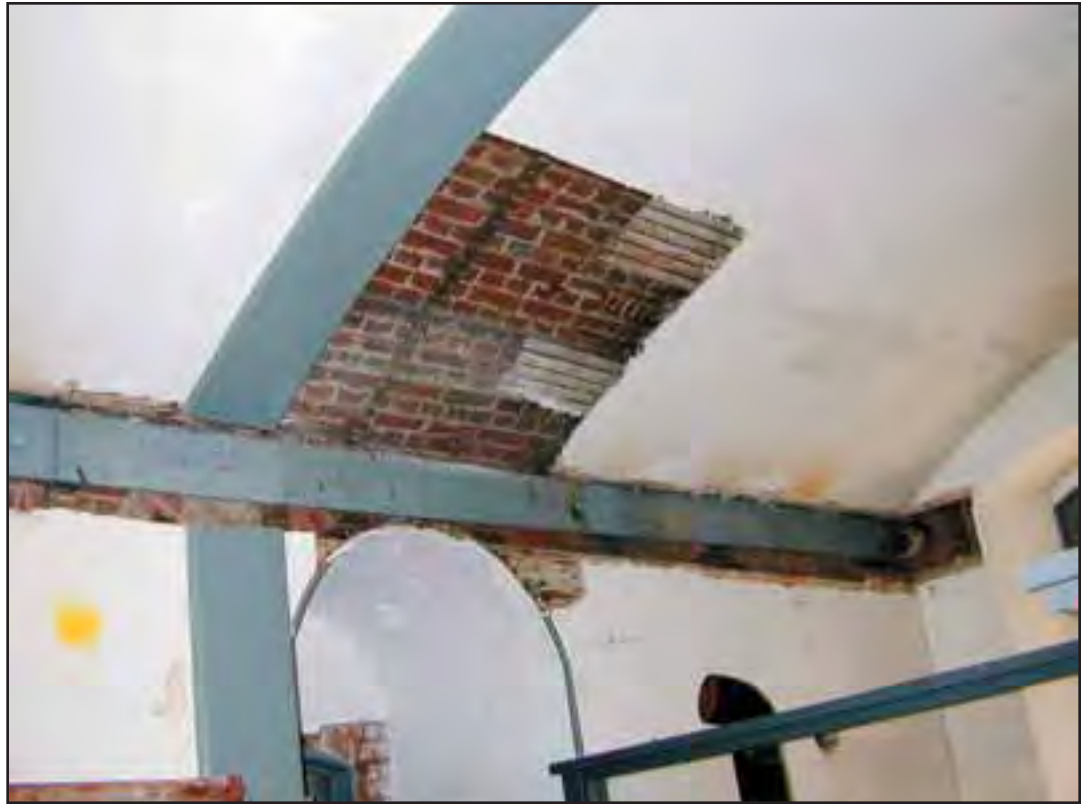
Condition Photo 21:
Detail of brick lath, wire mesh, and
plaster layers. (Courtesy of ARG,
2003)

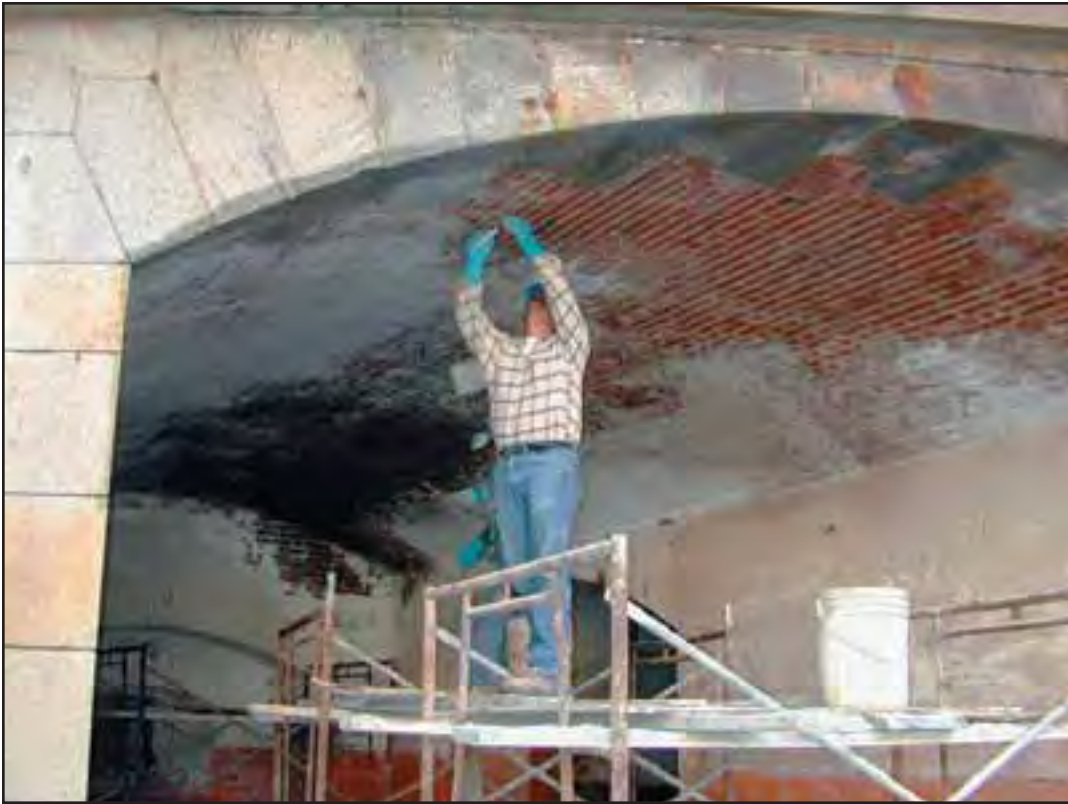
Condition Photo 22:
Masonry repointing project at 1st
tier. (Courtesy of ARG, 2003)
