National Park Service
U.S. Department of the Interior

Fort Point National Historic Site
Golden Gate National Recreation Area

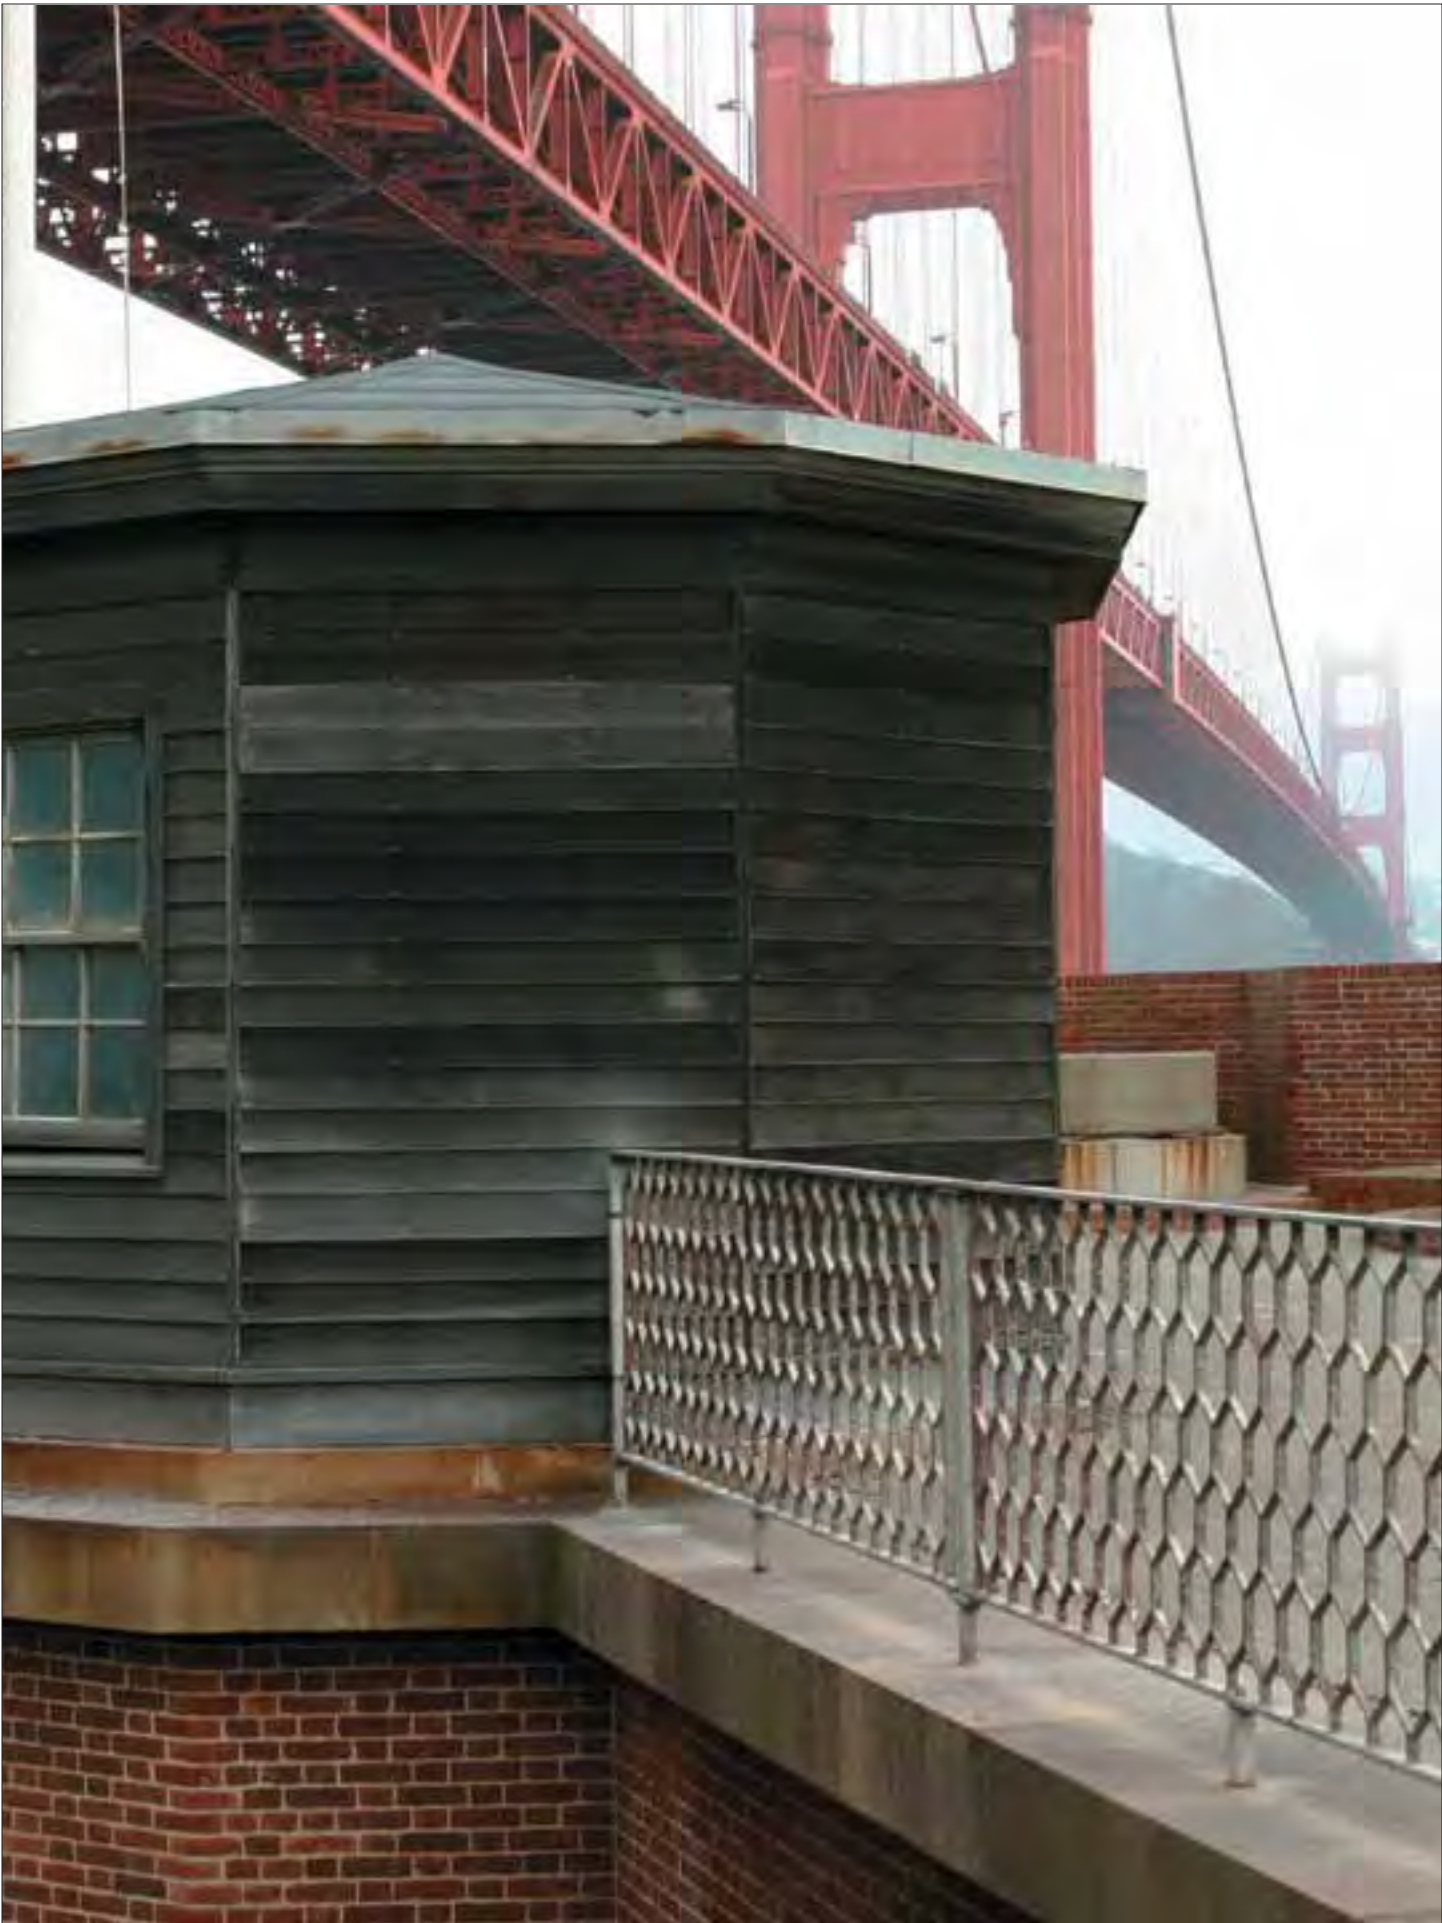
Treatment & Work Recommendations

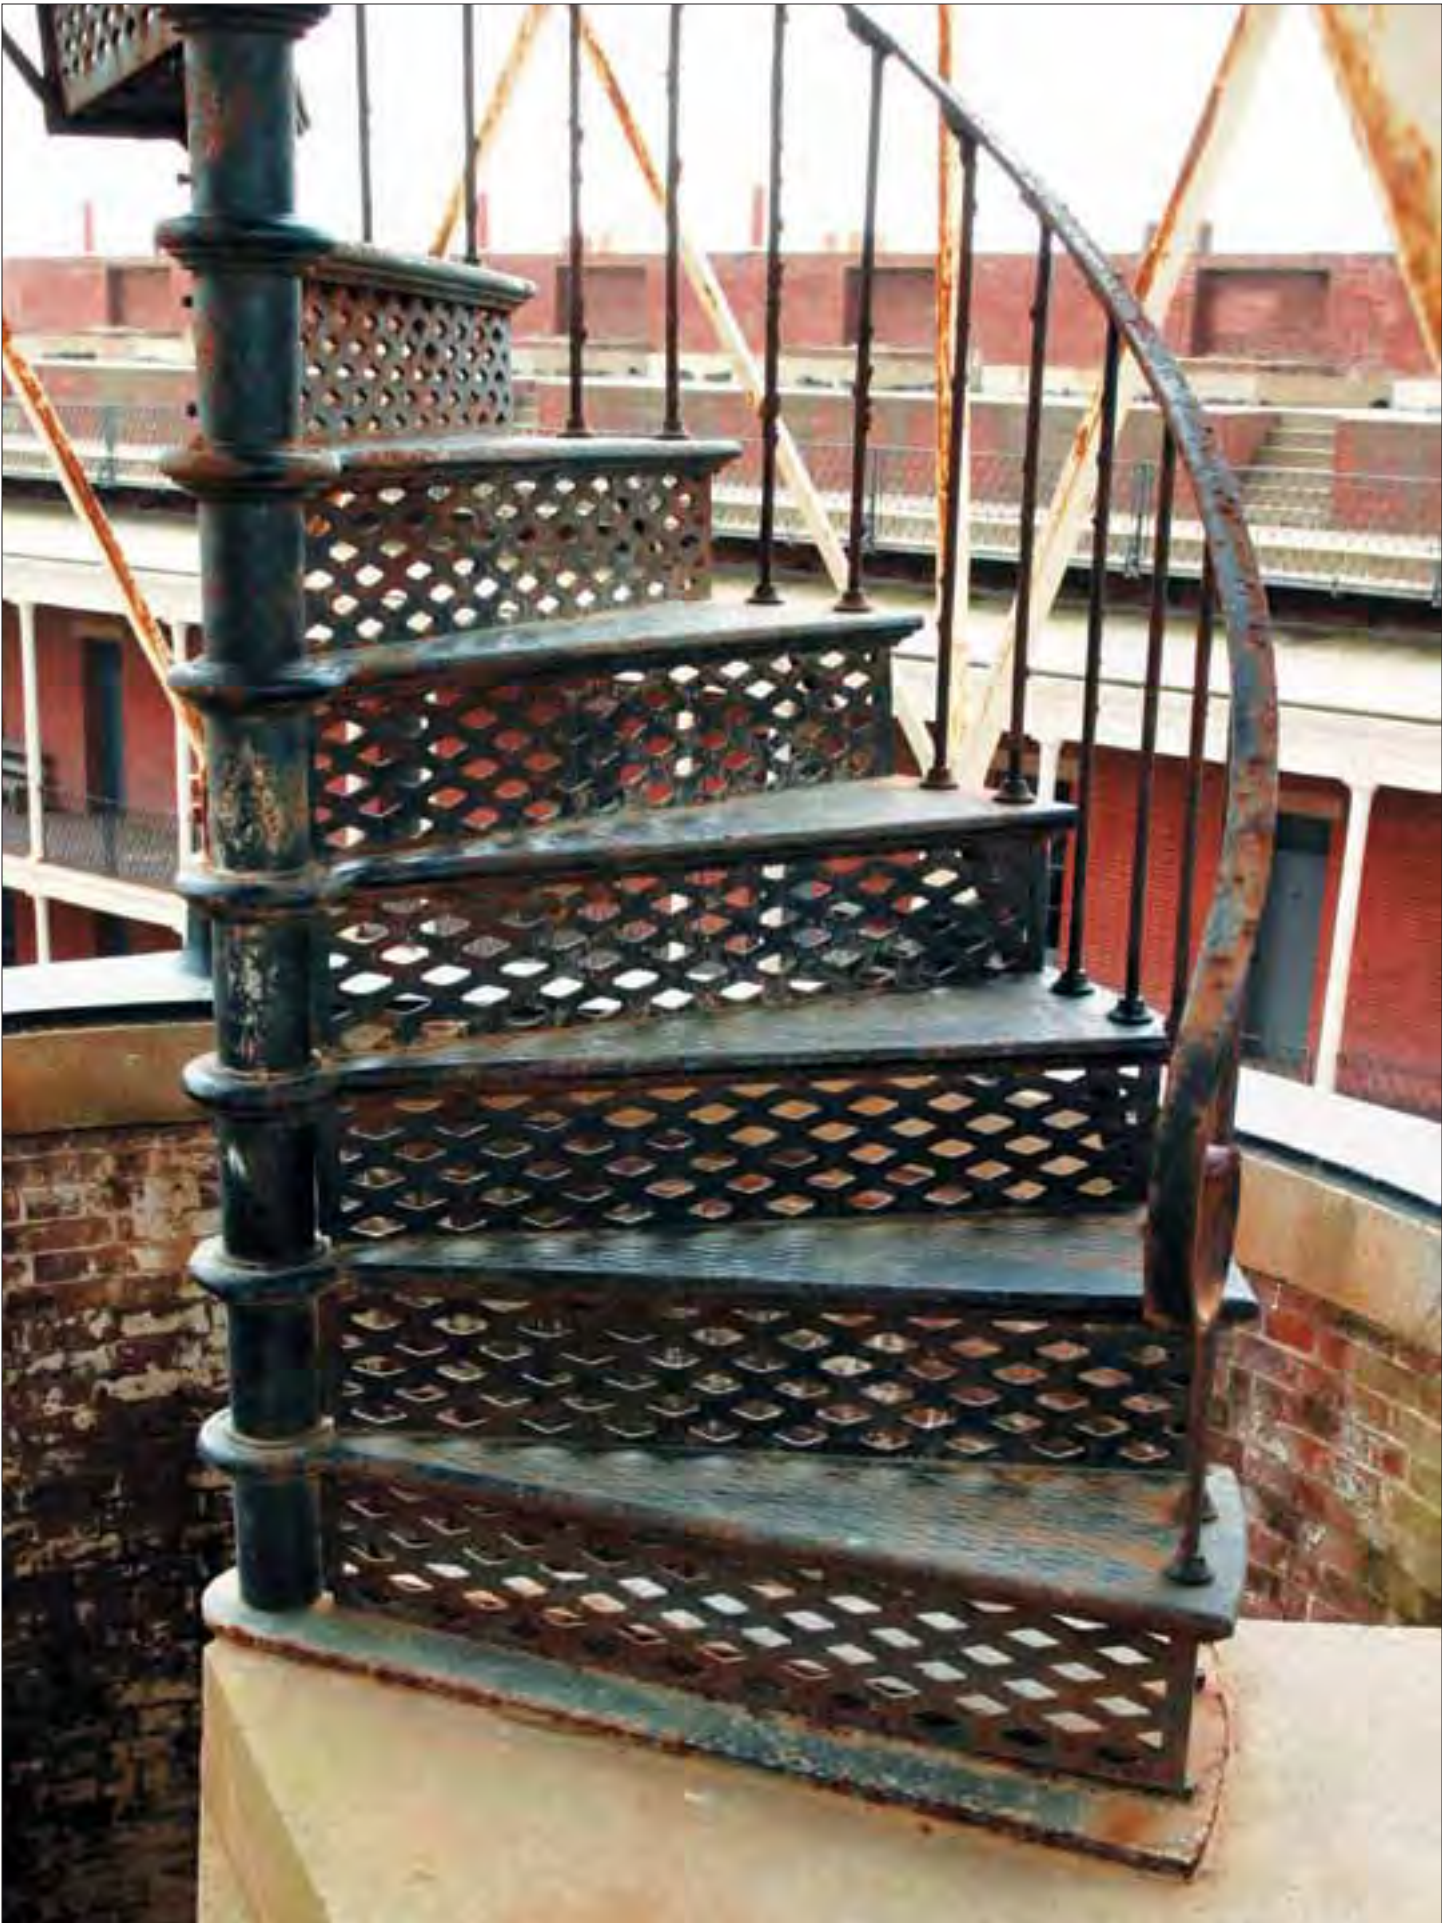
United States Department of the Interior Requisition; July 30, 1985; R.B. McNair Sons.
