# Tech Notes

## **"OLE JIM" GALLAUDET COLLEGE Washington, D.C.**

## **EXTERIOR WOODWORK**

### **Proper Painting And Surface Preparation**

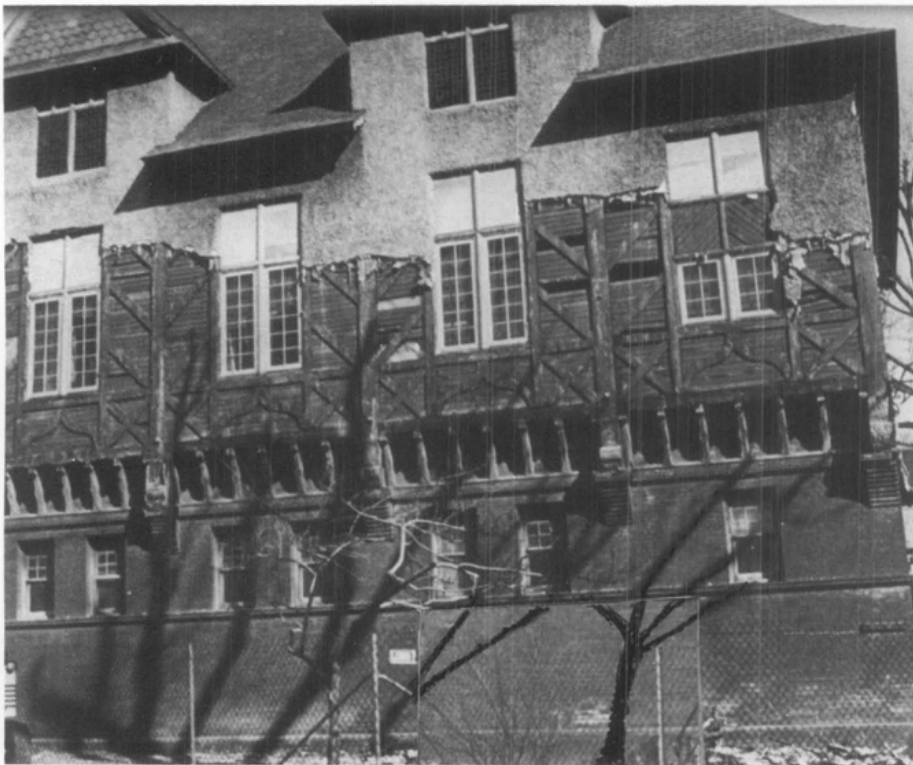
As early as 1910, the second floor wall surfaces were covered with stucco in an attempt to reduce water damage. The most dramatic aspect of the 1980 rehabilitation was the removal of the applied stucco and restoration of the painted half-timbered wooden exterior, much of it still intact (see figure 1). Old paint was removed down to bare wood and a new primer and two topcoats were applied. However, the newly applied paint on the wooden surfaces started failing within a year. By 1984, with the paint blistering and peeling, the college realized that the entire exterior wooden surface once again needed major work.

Figure 1. The stucco, applied circa 1910, is shown here being removed as part of the 1980 restoration. The wooden siding and "half-timbering" was largely intact underneath. Photo: Courtesy of Gallaudet College

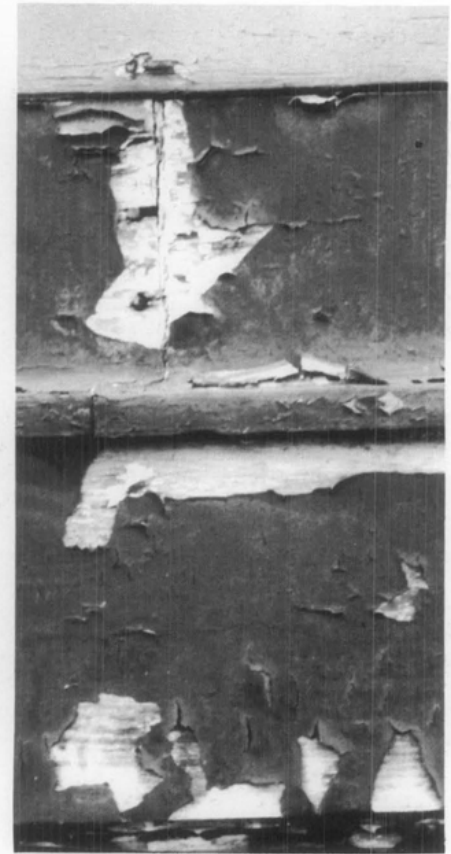
Figure 2. Paint applied in 1980 started to peel within a year, and by 1984 extensive failure had occurred. Photo: Sharon Park, AIA

Paint peeling off the wooden surface indicated that the prime coat had not adequately bonded to the wood (see figure 2). A close inspection using a "cherry picker" revealed three areas of serious deterioration. First it was apparent that moisture was getting behind the "half-timbering" where it covered the tongue and groove siding, and was rotting the wood. Secondly, the joint where the recessed tongue and groove siding abutted the heavy timber posts and lintels was equally difficult to keep sealed once the paint had failed. And finally, extensive dry rot had occurred at the intersection of the structural column and sill plate (see figure 3). The extensive paint failure, together with the deteriorated wood, indicated a serious moisture problem.

The only way to solve the problem was to remove all the paint, properly prepare the wood surface, and repaint.

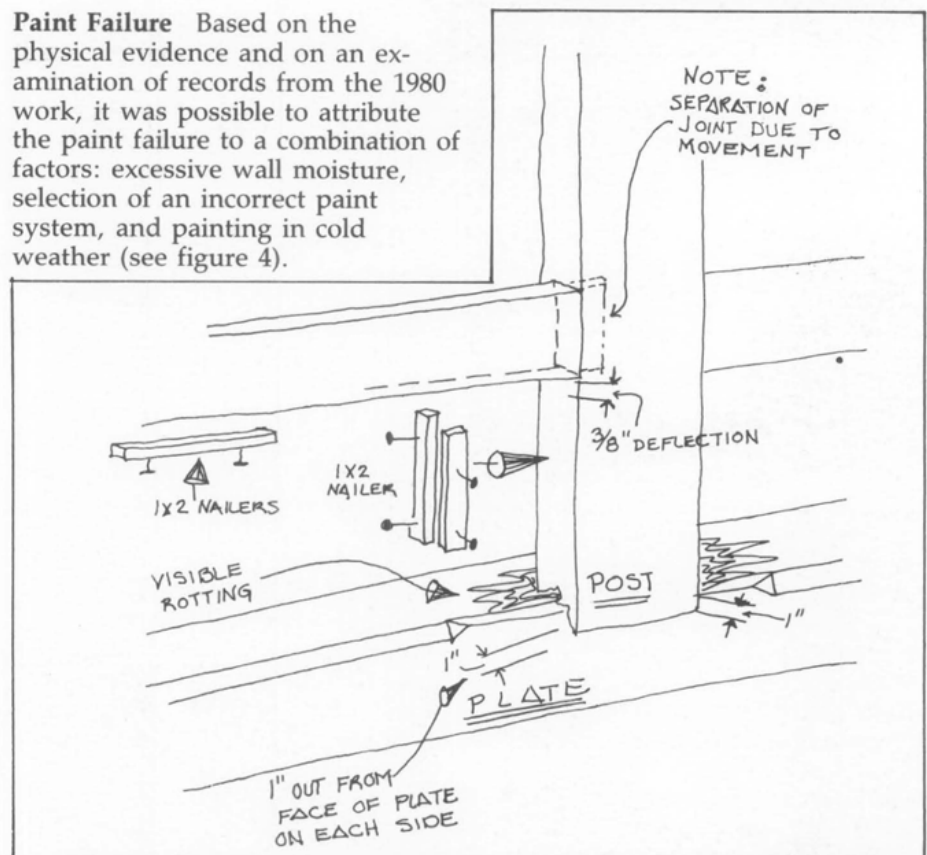
Figure 3. Areas of wood deterioration included the horizontal sill plate at the structural post connection as shown in this sketch made on site in 1985. Drawing: Dell Corporation.

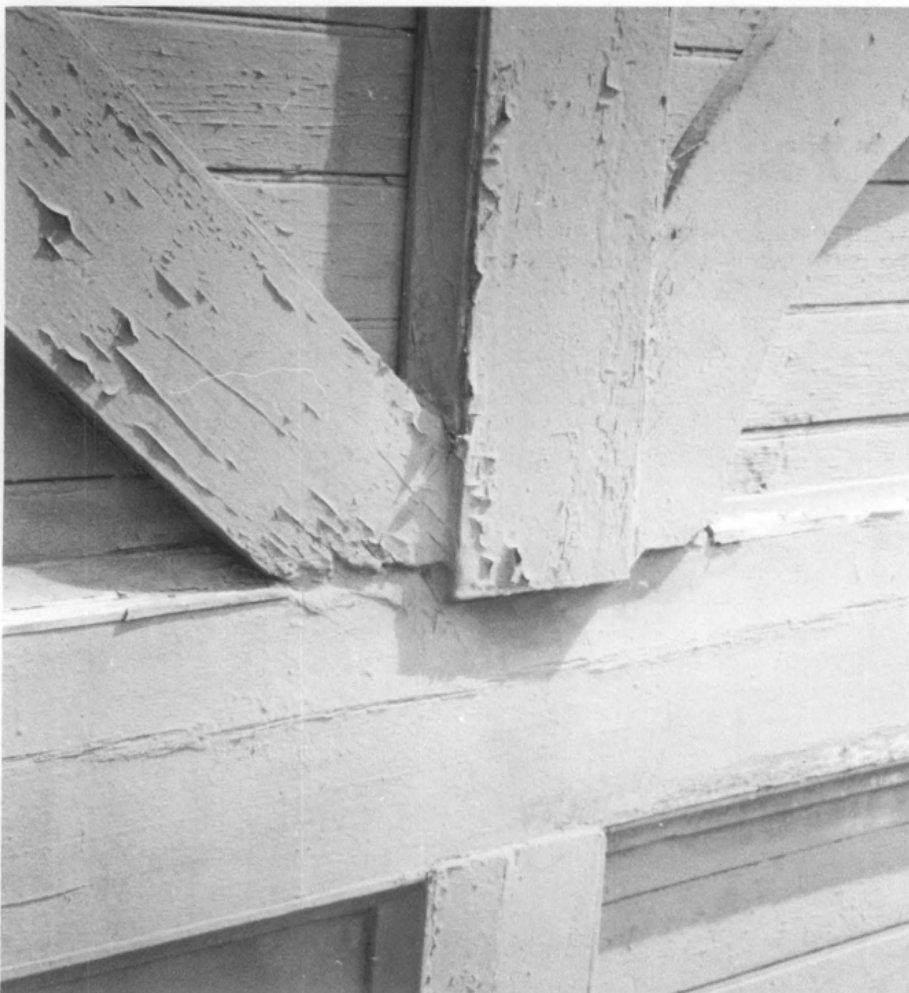
**Paint Failure** Based on the physical evidence and on an examination of records from the 1980 work, it was possible to attribute the paint failure to a combination of factors: excessive wall moisture, selection of an incorrect paint system, and painting in cold weather (see figure 4).

During the 1980 restoration, a steam pipe had burst, saturating a large section of the exterior wooden wall in the gymnasium. Readings taken after the accident showed a moisture level in the wood as high as 43%. Apparently, the walls were not adequately dried out before batt insulation was installed and the wall surfaces painted, thereby contributing to the paint failure.

This impervious paint only compounded the problem. Residual moisture trapped in the walls from the broken steam line could not easily escape once the epoxy paint was applied. Furthermore, the paint turned out to be hygroscopic, or moisture absorbing, because of the salts used in the fire-retardant formulation. Once exposed to moisture, the paint swelled and, due to poor surface bonding, blistered off. Records also showed that the painting occurred during weather below 40°F, creating the possibility that the paint had frozen before drying or, at a minimum, that the prime coat had not properly bonded to the wood. As a result of all these factors, there was widespread paint failure, exposing bare wood to further water damage and ultra-violet degradation.

Figure 4. Flaking paint was the result of painting moisture-laden wood, using an inappropriate paint system, and undertaking the work during cold weather. Photo: Baird Smith, AIA

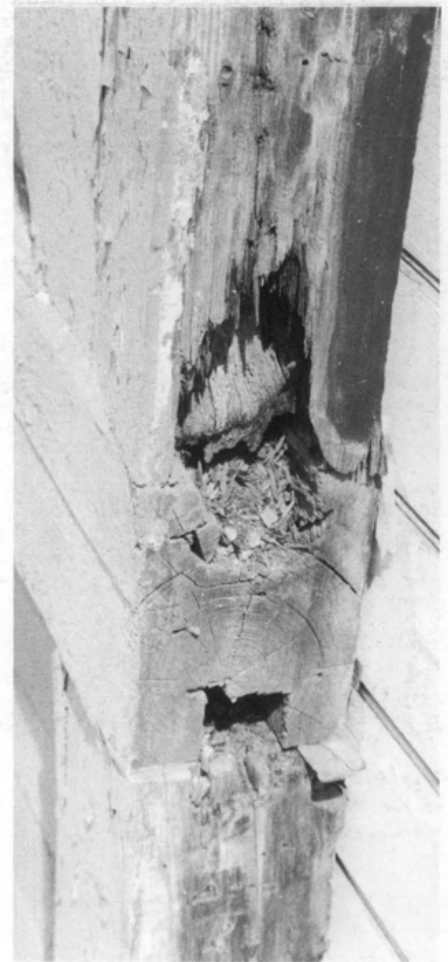
Figure 5. Some internal core deterioration was masked by sound surface wood. Water entering the connection of the post and beam framing rotted out the mortise and tenon pockets. These areas were consolidated and filled with epoxy. Photo: Baird Smith, AIA

**Wood Deterioration** The architect determined that prior to repainting, the deteriorated wood would have to be replaced or consolidated in order to provide a sound painting surface. While surface deterioration was readily evident in areas, further investigation revealed the rotting of the timbers at the tenon pockets (see figure 5).

The deterioration of the timber joints was from long-term decay probably dating back to the turn of the century. Fortunately, the surfaces of the structural timbers were in good condition; the rotted tenon pockets in the structural members could be consolidated and filled with epoxy resins rather than be replaced. About 10% of these timber joints were in need of such repair.

When wood was consolidated and filled with epoxy resins, the strength of the epoxy fill was formulated to match the strength of the wood as closely as possible. The major areas of deterioration were mortise and tenon pockets of the vertical and horizontal structural members. With the surface wood of these members in generally good condition, only the punky areas of the beam or post had to be dug out. The remaining shell forming the tenon pocket was consolidated as a precaution to stop any future deterioration. The hollow was filled with epoxy resins

to stabilize the joint.

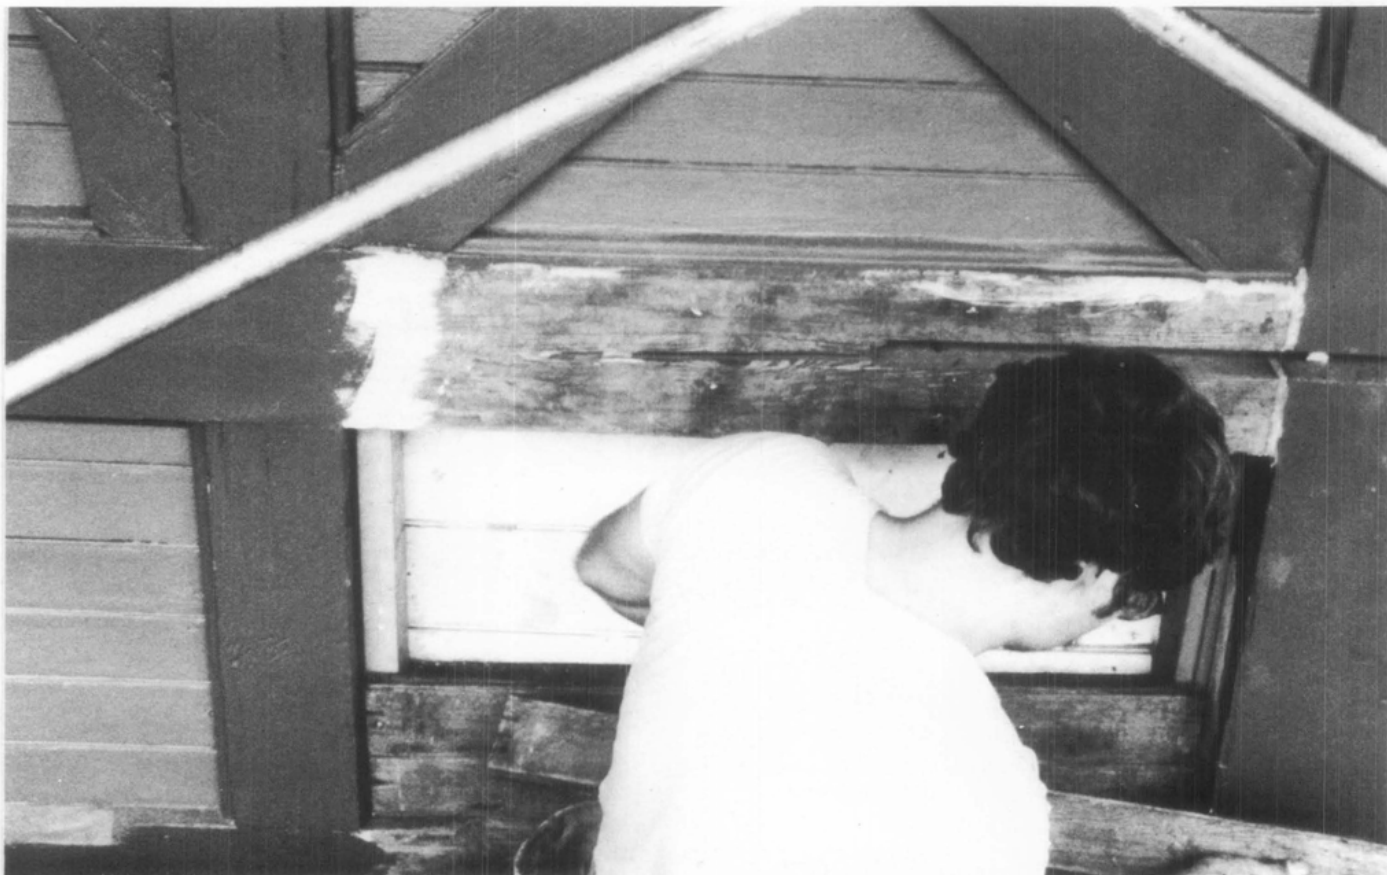
Figure 6. Sound pieces of wood salvaged from elsewhere on the building are being used to replace this deteriorated tongue and groove panel. In most cases, deteriorated wood trim, sills, and paneling were replaced with redwood that was back primed. Photo: Bryan Blundell

Repair or replacement of damaged wood was the next step. This phase involved epoxy consolidation and epoxy infill of damaged structural members and the selective replacement of moderately deteriorated trim and sills. When wood was replaced, primed redwood was used since today's yellow pine is less durable than the heartwood yellow pine originally used on the building. Approximately 20% of the applied decorative trim (diagonals and ogee boards) were replaced along with five panels of tongue and groove paneling (see figure 6). Good sections salvaged from the wood panels were reused for small repairs elsewhere on the building.

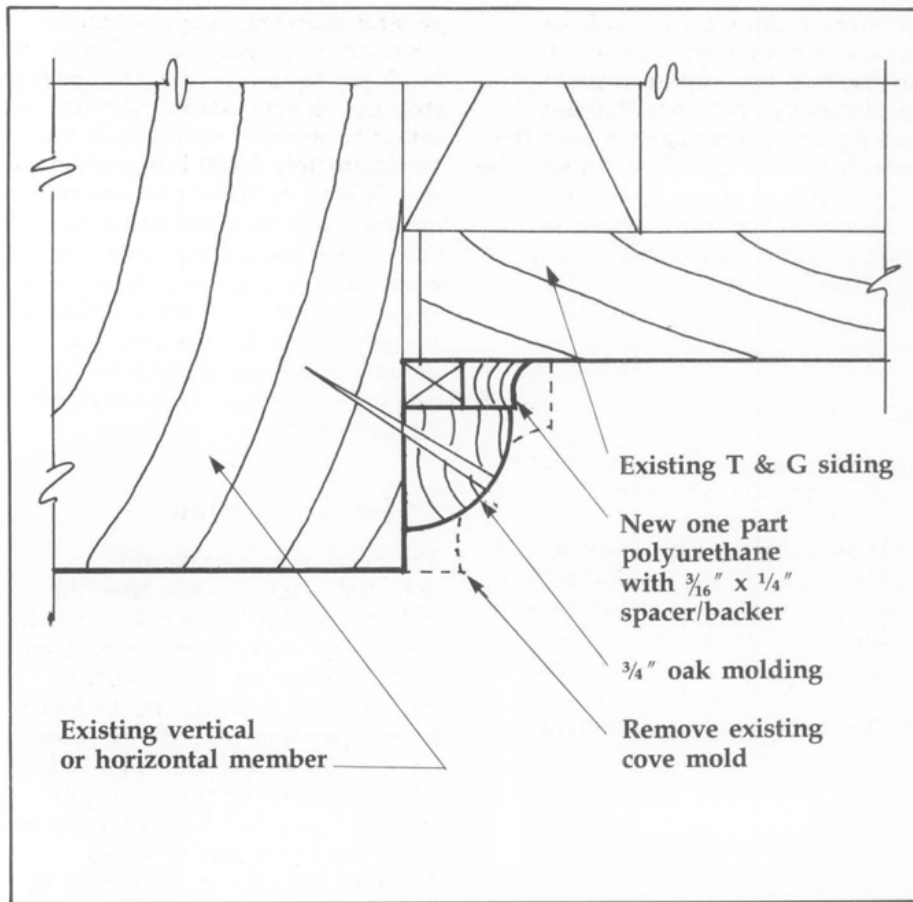
Figure 7. A molding detail was developed to seal the vertical and horizontal reveals. The additional backing strip for the molding provided a channel for a caulking or sealant bead. Drawing: Geier Brown Renfrow, Architects

In the 1980 restoration, a cove molding had been added where the recessed panels abutted the structural posts and beams. The joints, however, were not caulked and water penetrated behind the molding once the paint began to fail. The architect for the remedial work developed a new detail using a combination of a 3/4" quarter-round piece of oak with a 1/4" x 3/16" pine backing (see figure 7). The new wood was back-primed and edge-grain primed prior to installation. The reason for the backing piece was to create a channel to receive a 1/4" bead of caulking/sealant. Without this channel, there was no guarantee that the sealant would hold firm. This detail should allow for an effective seal at the joint—a chronic source of water penetration over the years (see figure 8).

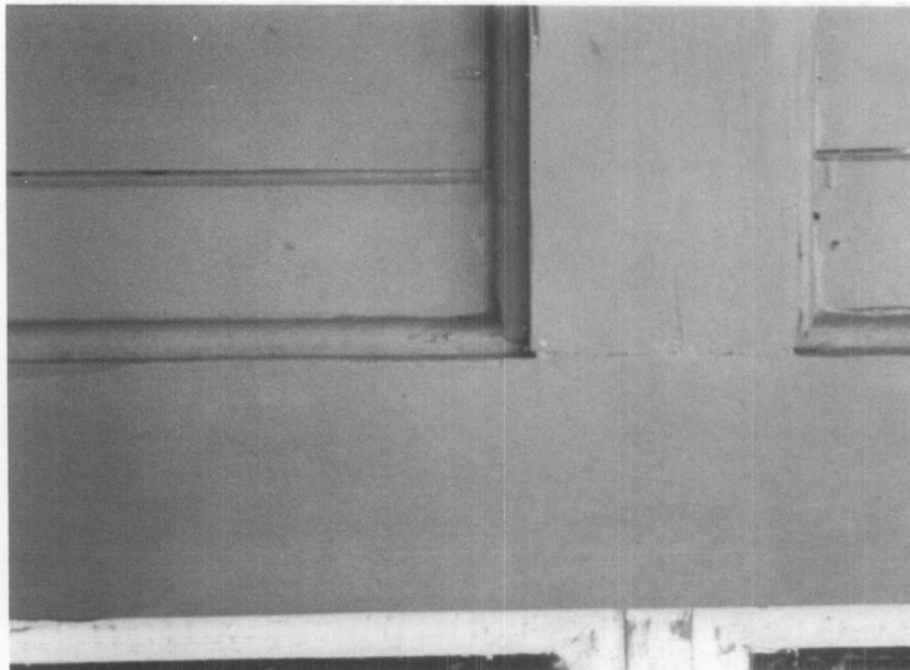
Figure 8. The molding strips blended with the horizontal and vertical boards and in combination with caulking should effectively keep moisture from penetrating behind the recessed paneling. Photos: Sharon Park, AIA

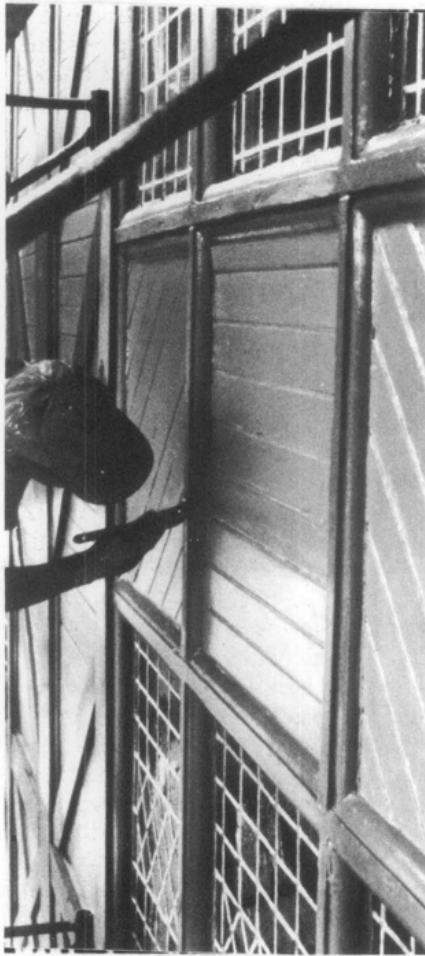
Figure 9. The building was painted with two coats of oil-alkyd primer and two top coats of acrylic latex. Photo: Bryan Blundell

Acrylic latex paint, with its good color stability, was selected for the two top coats primarily for its durability and "breathability" (see figure 9). Compatible with the manufacturer's oil-alkyd primer, the acrylic latex also has flexibility of movement. This is an important quality since wood naturally expands and contracts.

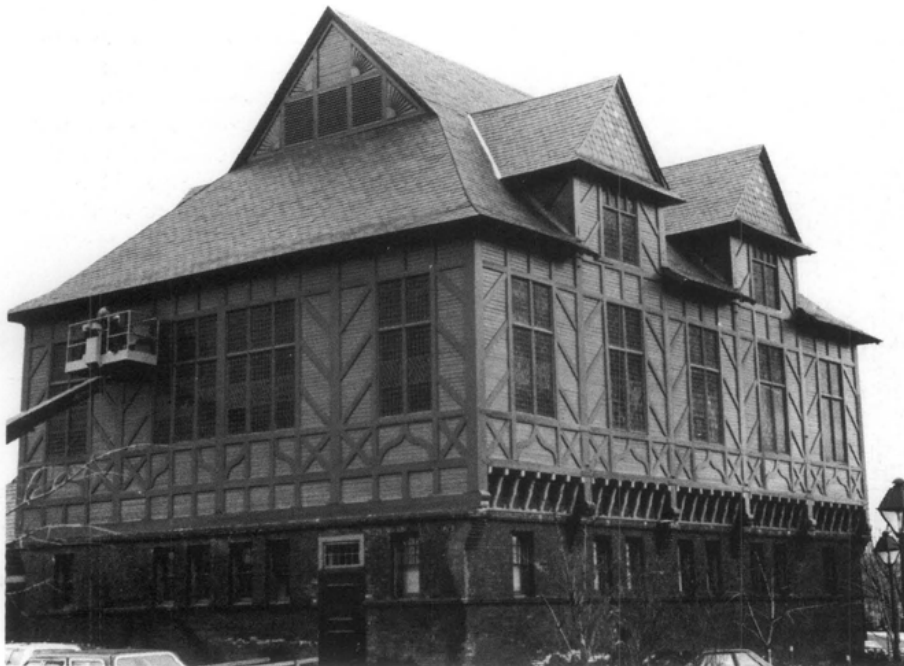
Figure 10. The college will inspect the building on a regular basis to ensure that any problems are immediately corrected. Photo: Charles Fisher

For "Ole Jim," a 7-year life is expected from the new paint job before repainting will be necessary. Under normal conditions, 7 years is the commonly recognized life span for paint applied to bare wood which has been properly prepared. Future repainting should be much easier and cheaper due to the addition of trim pieces and thorough caulking to eliminate pockets where water collected. The owner is committed to regular inspection of the building and the correction of any problems as soon as they are apparent (see figure 10).
