THE HEXAGON (Ephraim Shay House) Harbor Springs, Michigan

Tech Notes

NUMBER 3

In-Kind Replacement of Historic Stamped Metal Exterior Siding

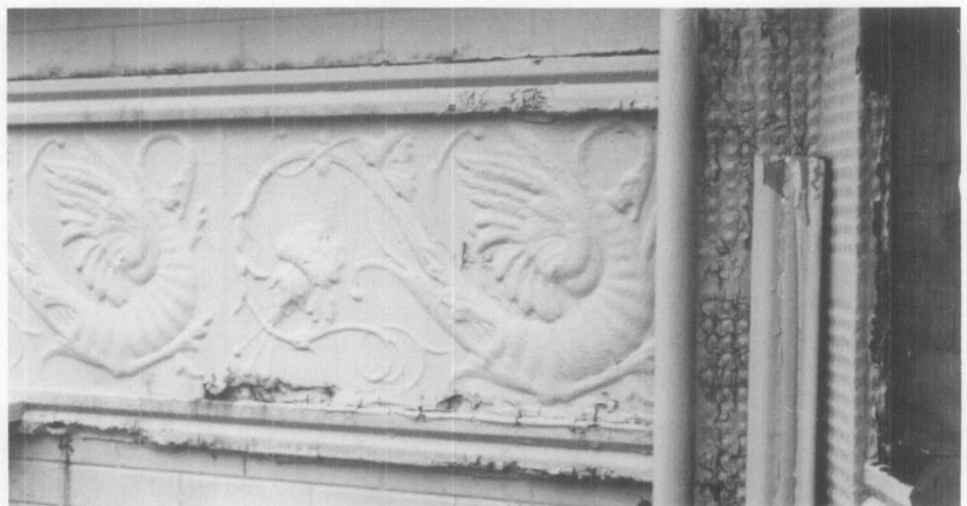
The house had been poorly maintained for several decades and, more recently, had been unoccupied. The asphalt shingle roof that replaced the original standing seam metal roof leaked badly, allowing water to penetrate into the wall cavities behind the stamped metal siding. Due to neglected repairs and cleaning, the original drainspout system failed to divert rainwater away from the house (*see figure 3*). In some places, rainwater

3. Stamped metal siding simulating brickwork covered most of the exterior of the house. Pebbled corner pieces and several ornamental bands added decorative details. Deteriorated drainspout and original plank wall sheathing are at right. Photo: Richard Hiler.

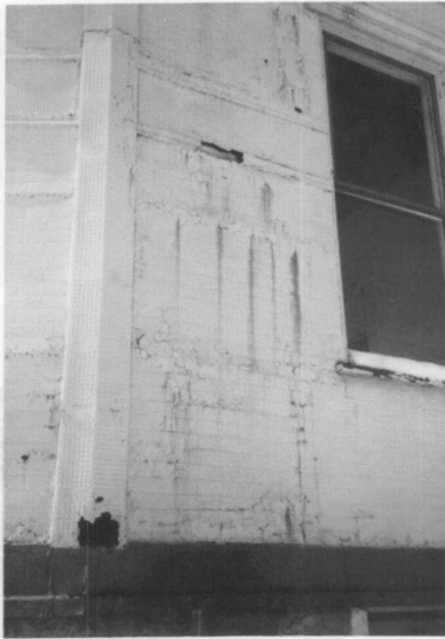
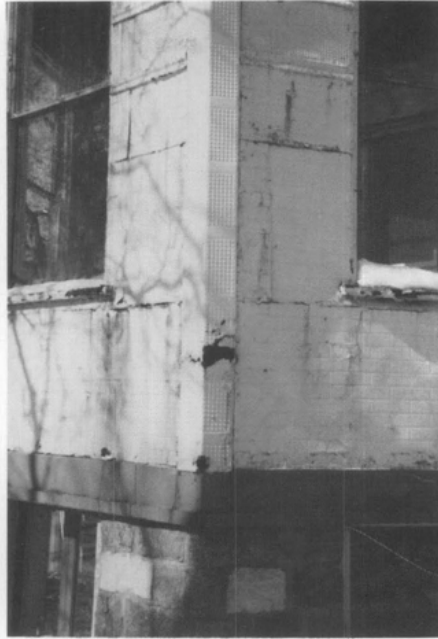
Although the original galvanized (zinc-coated) steel and zinc siding had been back-primed, long-term water infiltration caused the siding to corrode from the inside toward the face. The location of the building at Little Traverse Bay also contributed to the slow deterioration of the siding. In extremely deteriorated areas, the metal had been reduced to an easily breakable, crusty mass. An assessment of the exterior revealed that nearly 90% of the stamped siding had moderately or severely deteriorated to the point that replacement was required (see figure 4). Since only a small percentage of the siding was salvageable and all needed to be removed to facilitate other project work, the decision was made to replace all of the metal siding.

4. Rust stains indicate where corrosion, caused by water infiltration, are breaking through the metal from the rear. Rust and separation are also evident at seams between sheets of stamped metal. Inspection determined that nearly 90% of the stamped metal siding had to be replaced. Photo: Richard Hiler.

Five exterior sheet metal patterns required replacement: the brick pattern that covered more than half of the exterior, two ornamental band patterns, the wall corner pattern, and the molding that separated the ornamental bands from the brick pattern (see figure 5).

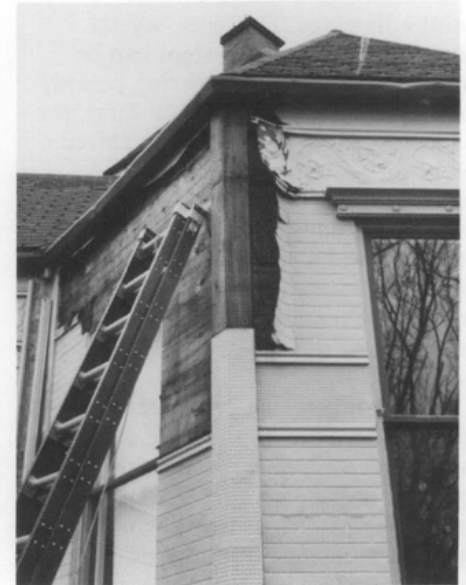
9. Original exterior siding was removed, revealing the exterior plank wall sheathing, which was also removed in order to install additional insulation and a vapor barrier. Photo: Mary Cay Bartush Jones.

After ordering the replacement metal siding, the contractor waited approximately three months for its arrival at the job site. During this time, a new metal roof was installed and the walls were prepared to receive the new siding. The total replacement of the siding provided an opportunity to add wall insulation for enhanced energy efficiency. Insulation was installed from the exterior to avoid damage to the stamped sheet metal covering the interior walls and to permit installation of a vapor barrier. This required removal of all the exterior plank sheathing, some of which was also deteriorated (see figure 9).

Removal of the plank sheathing also permitted repair and replacement of some deteriorated original framing, primarily on the south side of the house and at the lower portions of the walls. A vapor barrier was installed against the back of the interior plank sheathing. Sheets of 3-1/2" fiberglass

insulation were placed in front of the vapor barrier, and 3/4" plywood was installed as an exterior sheathing in place of the original planks.

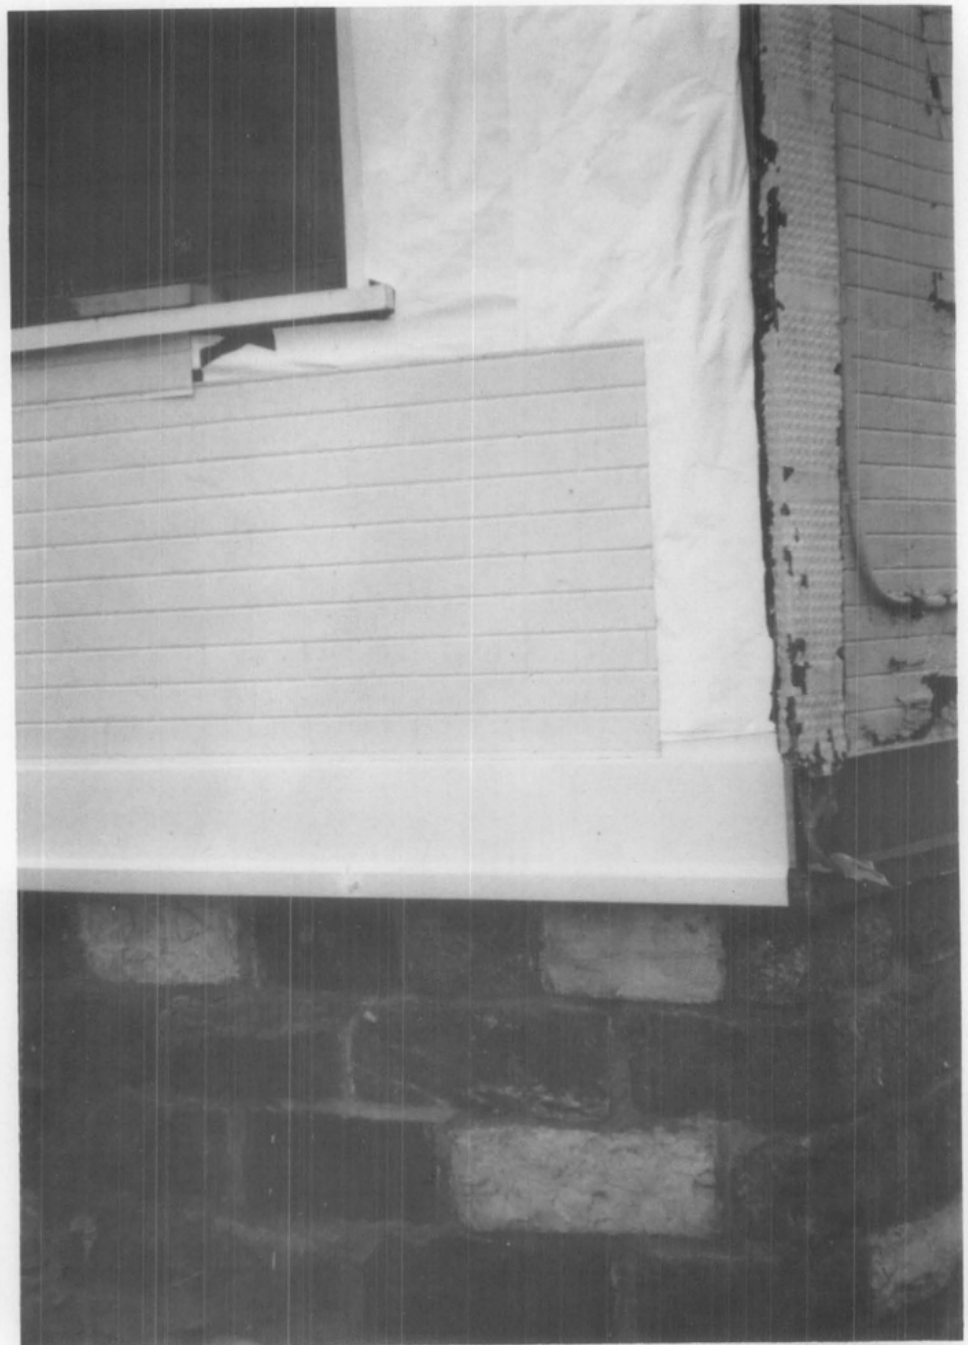
10. Installation of siding began at the base of each story of the building. Corner pieces were installed first, followed by the base flashing, and the stamped brick siding. Care was taken to match the patterns from one elevation to the next around the building. Photo: Mary Cay Bartush Jones.

On each story, installation began at the bottom and proceeded upward toward the roofline (see figure 10).

Each piece of siding lapped over the piece of siding below it and was face-nailed to the house's wood frame. The siding also lapped over the already installed corner pieces. Since the new sheets and bands of siding were identical in size to the originals, only minor trimming was required.

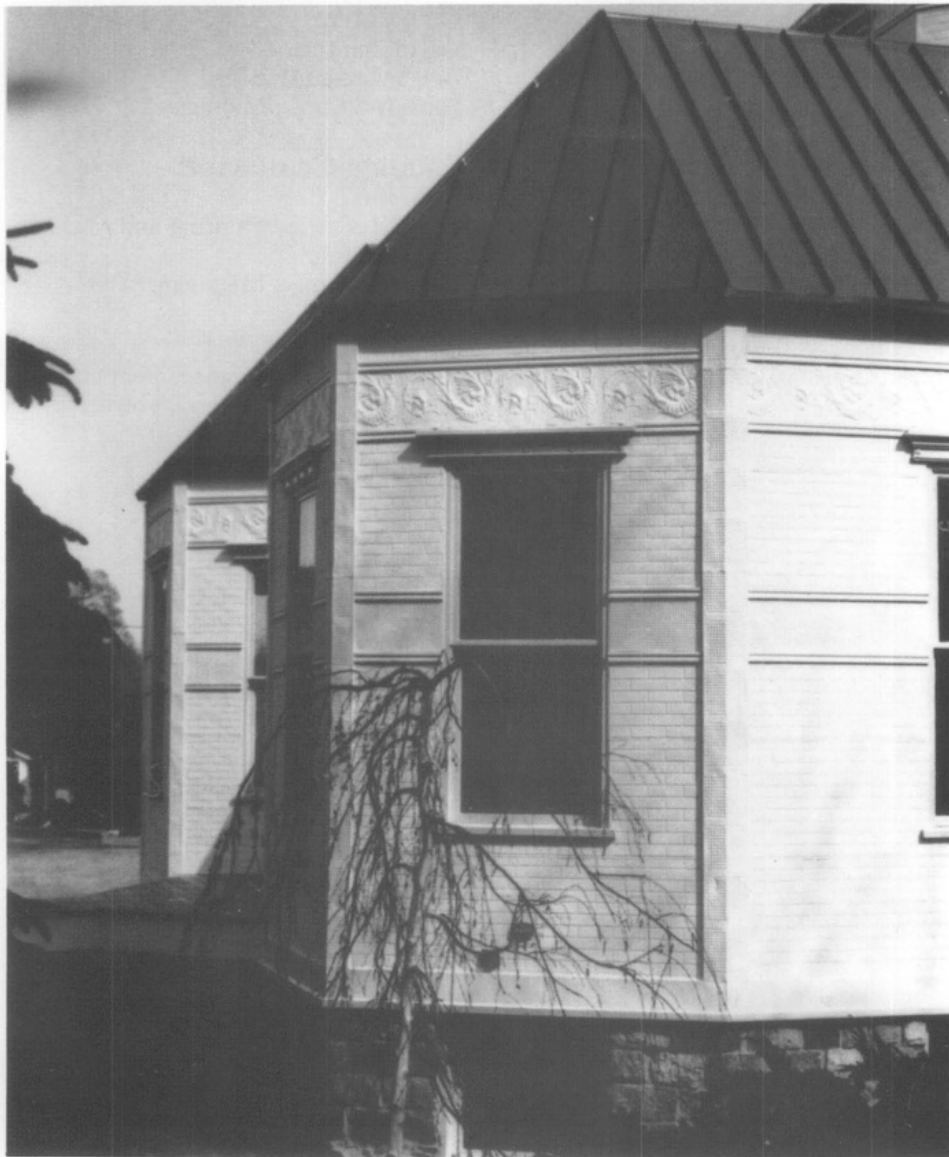
11. Finished appearance of several elevations. Siding has been face nailed to underlying materials and second coat of paint has been applied. Each piece of siding laps over the piece below it, and all overlap the corner pieces. Photo: Richard Neumann.

In the original construction of the Hexagon, the siding had been installed before the windows had been set into the walls. During this project, the window frames were retained in place, so the new siding was bent around and tucked back alongside them. A quarter-round molding was then installed and the edges sealed with a silicone-based caulk. The window hoods were reinstalled after the siding was in place (see figure 11).

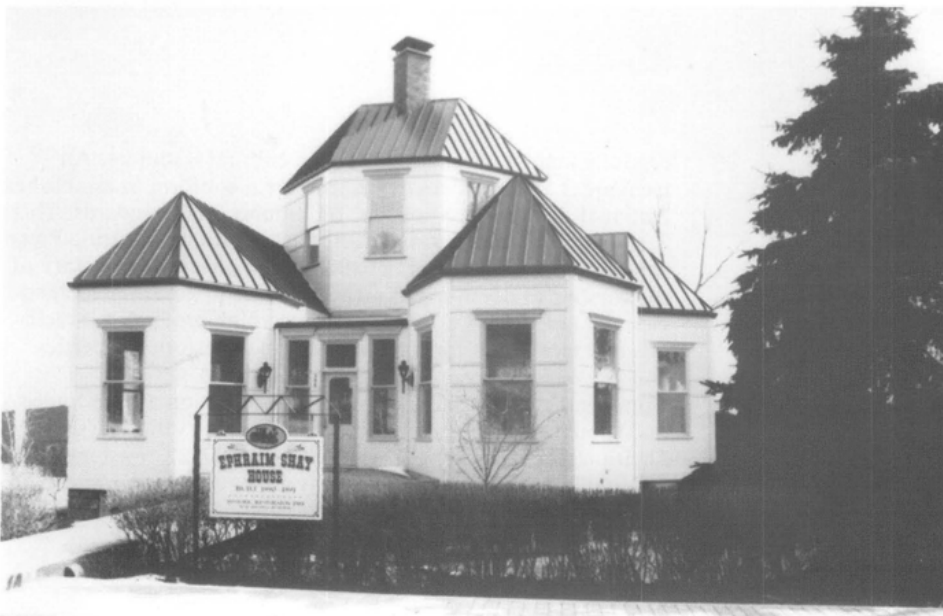
12. The replication of the stamped metal siding has restored the Hexagon to its historic appearance. A new metal panel roof system that duplicates the appearance of the original standing seam roof also contributes to the restoration. Photo: Richard Neumann.

The work on the Hexagon also demonstrates that custom pressed metal work can be both the practical and the appropriate preservation solution for even small projects where historic stamped metal siding is an important feature of the building (see figure 12). When special molds are necessary to duplicate a specific pattern, additional planning time may be required. However, stock patterns, such as the simulated brick siding on the Hexagon, may be available, allowing for quicker delivery and cost savings. Properly prepared, finished, and maintained, galvanized and zinc pressed metal can have a long useful life.
