## BOOTT COTTON MILLS (The Boott Mills) Lowell, Massachusetts

# Tech Notes

### NUMBER 18

## Aluminum Replacement Windows With True Divided Lights, Interior Piggyback Storm Panels, and Exposed Historic Wooden Frames

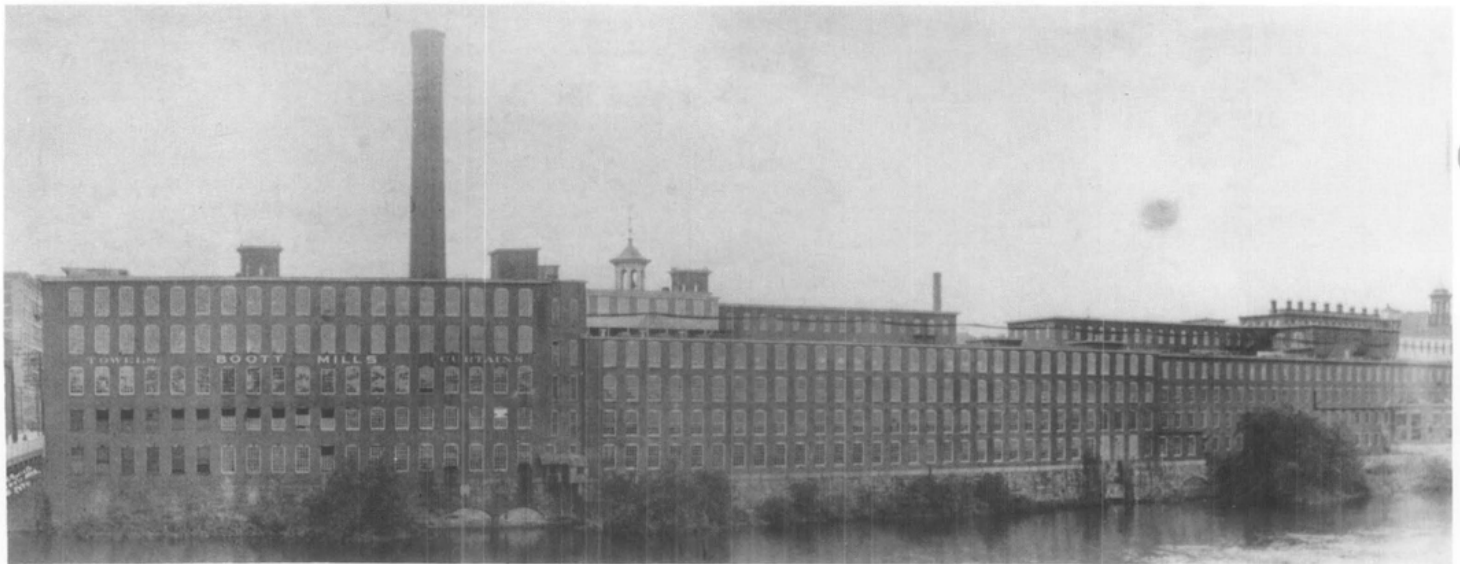
Figure 1. The windows are the dominant element of detail and decoration in the Boott Cotton Mills. Photo: Courtesy of the Center for Lowell History

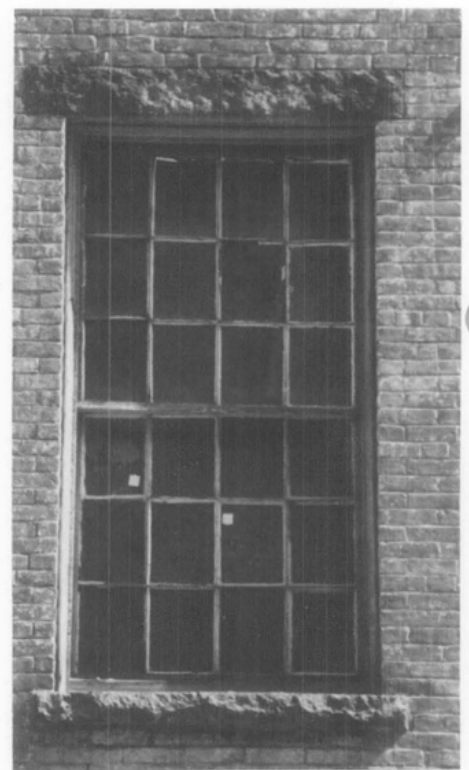
Figure 2. Because of the historic character and significance of the complex, replacement sash needed to have true divided lights and the dimensions and profiles of visible elements needed to be close copies of the originals. Photo: Courtesy of Huygens DiMella Shaffer

The projected three-phase, \$63 million rehabilitation of the Boott Mills involves 700,000 square feet of space. An appropriate window treatment was foremost among several important preservation design problems. The developer and the historic review commission agreed that one-over-one aluminum replacement windows with exterior muntin grids were not desirable. Because of the significance of the complex, it was established that the windows needed to have true divided lights and that the dimensions and profiles of all visible elements would be near copies of the originals (see figure 2).

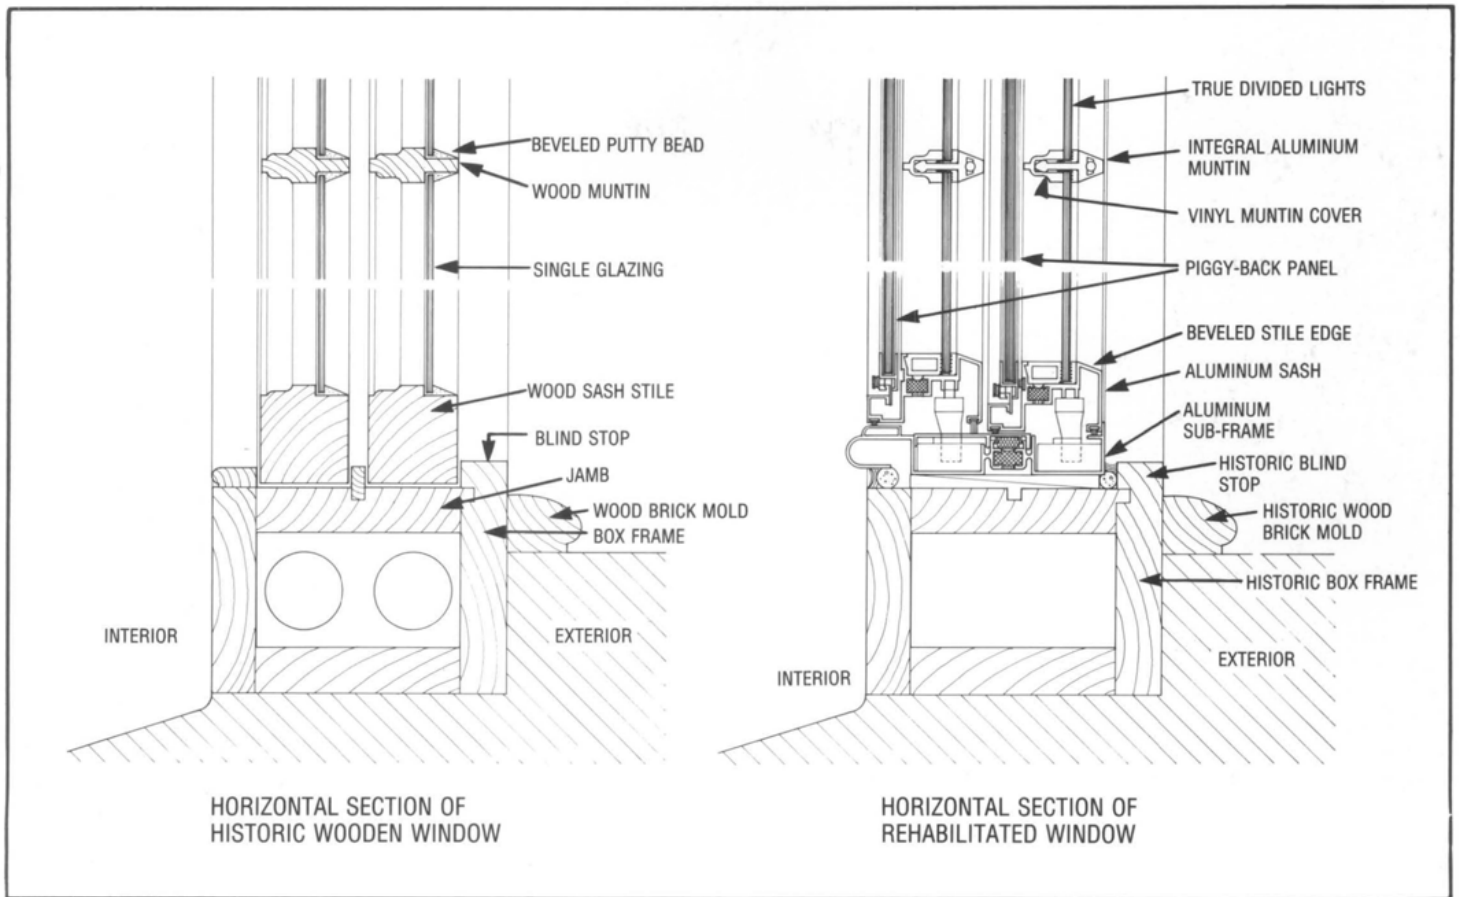
Figure 3. Horizontal section of the window shown with old and new sash. Drawing: Timothy Buehner

Boott Mills, it was necessary to limit the muntin-supported glass panes to single glazing, as in a historic window, and to achieve double glazing with a secondary window system (see figure 3). This secondary window consisted of a "piggy-back" interior glazing panel, which left exposed on the exterior the multiple facets of the true divided lights so characteristic of historic multiple-pane windows. The interior glazing panel was attached to the room side of the sash. It was also decided that the existing wooden frames would be retained and used to receive the aluminum sub-frame for the new window. Finally, new aluminum extrusions were to be made for all members to ensure a very close match to the historic units.

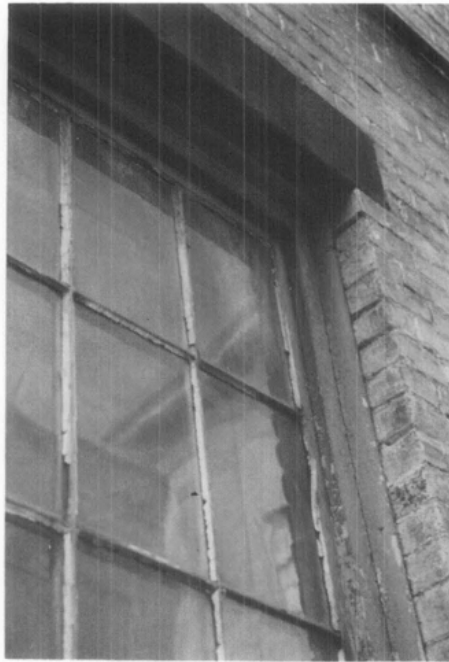
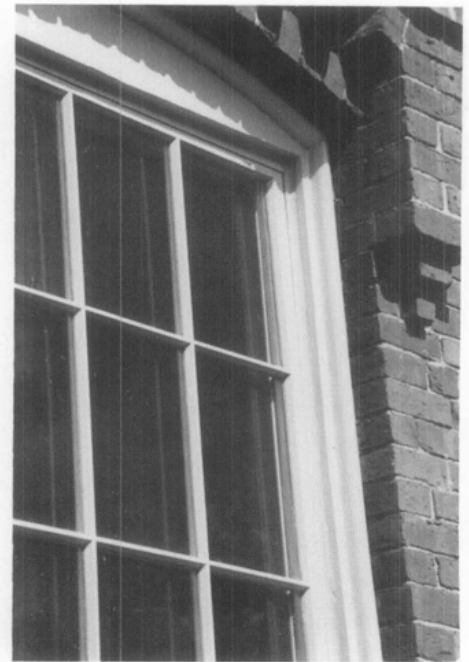
**Figure 4.** The decision to use an integral muntin for the outer glazing and a piggy-back interior glazing panel was an important component of the successful window solution. Sash shown before and after rehabilitation. Photos: Charles Parrott

was narrowed and profiled to approximate the beveled glazing bead and sticking of the historic wooden muntins. However, it was found that the technology of the 1985 three-piece muntin system could be reduced only to about  $\frac{7}{8}$ " in thickness. A new two-piece true muntin was then developed by the manufacturer that met the general dimensions and profile of the putty-glazed historic muntin; it provided the needed strength and proved to be simpler in design and less expensive to fabricate. This muntin consisted of an aluminum tee extrusion with a trapezoidal flange and a web terminating in a triangle-shaped point over which a profiled cover of extruded rigid PVC was snapped to hold the glass panes in place. Plastic was used for this cover to provide the flexibility needed to remove the cover in case of glass breakage and to provide the thermal break to insulate the aluminum tee member. The snap cover extrusion was to be made in the pre-selected custom color chosen for the window (see figure 4).

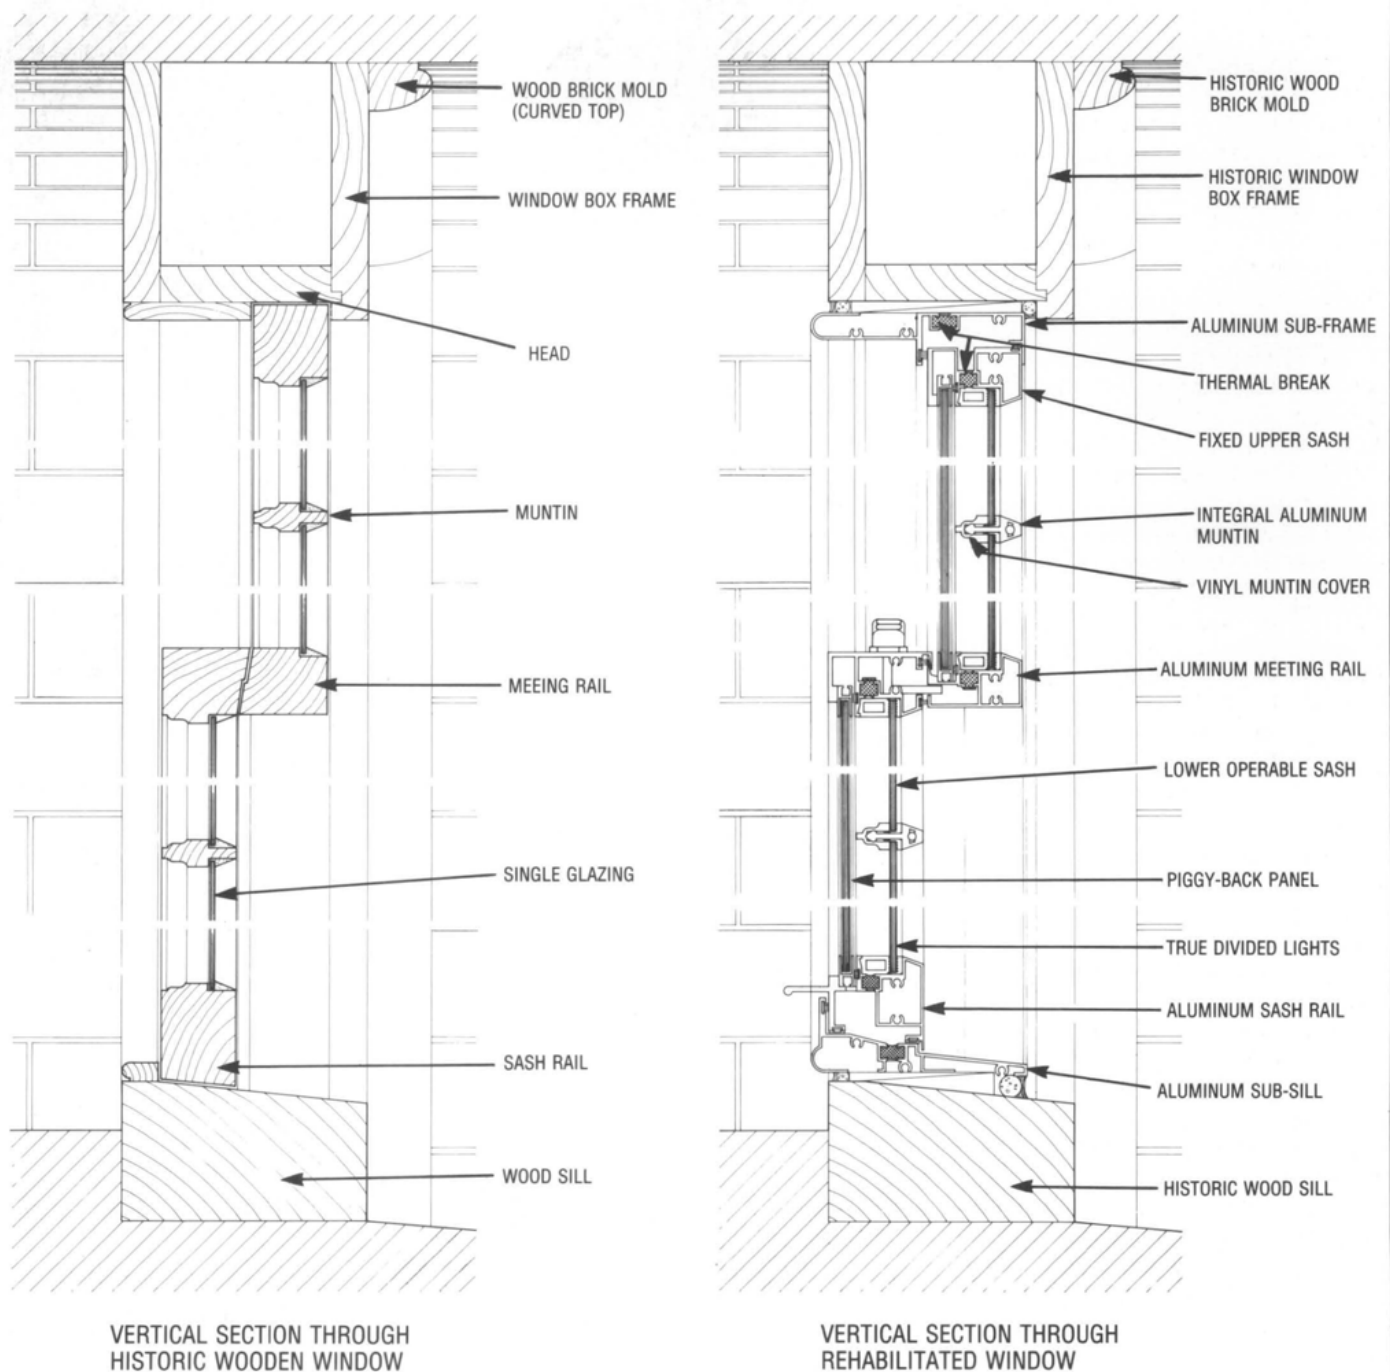
Figure 5. Vertical section of the window shown with old and new sash. Drawing: Timothy Buehner

On the sub-frame, a drip edge that broke the sight line at the head was eliminated as unnecessary. The detailing of the sub-frame was also revised to facilitate installation into the existing frame from the building interior. This resulted in a cleaner interior finish; however, it also increased the height of the sub-sill, making it somewhat more visible on the exterior. The overall depth of the early design was also reduced, resulting in a final depth only about  $\frac{1}{2}$ " larger than the historic window. Because the muntin had to clear the piggy-back panel behind it, the overall muntin depth was to be  $1\frac{1}{16}$ ", just  $\frac{3}{16}$ " less than the historic ones (see figure 5).

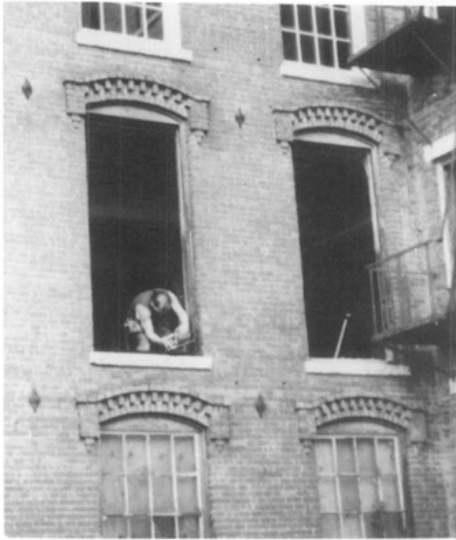
Figure 6. Work on the frames consisted largely of making dutchman repairs to the pulley stiles where required; renailling or replacing brick moldings; replacing some sills; and surface preparation. Photo: Charles Fisher

The exterior of the wooden frames were not to be panned or covered in aluminum. Thus it was important both for aesthetic consideration and good paint performance that the wood frames be repaired and surfaces properly finished. Work on the frames consisted largely of making dutchman repairs to the pulley stiles where required; renailling or replacing brick molding; replacing some sills; and scraping, filling and sanding wood surfaces. Painting consisted of priming and two coats of alkyd oil paint (see figure 6).

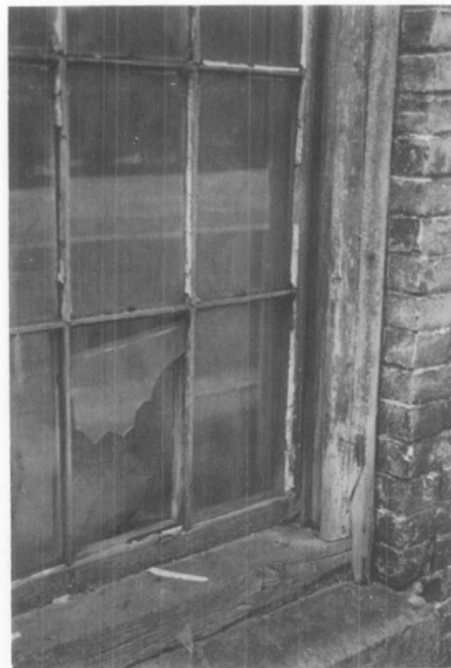
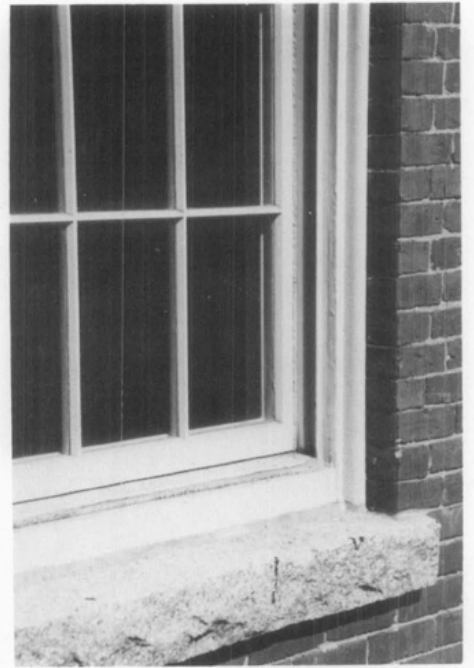
Figure 7. The retention of the exposed outer face of the historic wooden frame and the sill detailing were important qualities of the window treatment. Before and after photos: Charles Parrott

Installation of the new sash went quickly and smoothly. First, the sub-frame was inserted in the prepared opening from the room side, shimming to plumb, line and level before attaching screws through the head and jambs into the old frame. The sash were then installed and the windows were caulked on both the interior and exterior to complete the work (see figure 7).

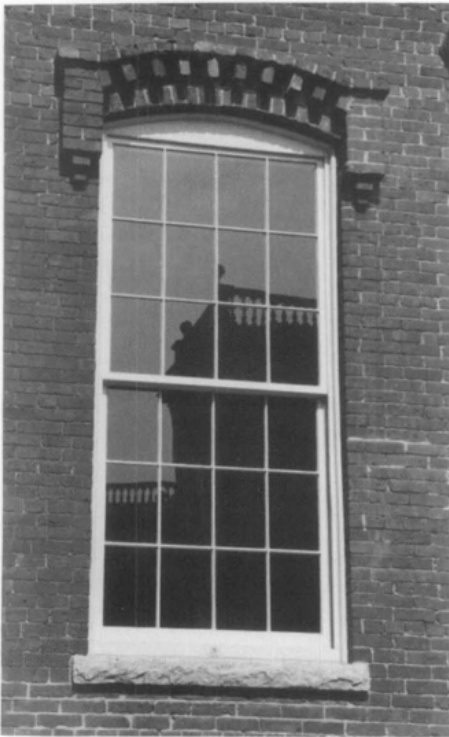
The sash replacement work undertaken to date at the Boott Mills represents an advance in the way in which aluminum windows can be designed to capture more fully the authentic appearance of historic windows in larger buildings while providing good overall performance. The treatment of the muntins and the sash framing elements, the piggy-back glazing panel, and the retention of the exposed historic wooden frame all combined to create a window that was

aesthetically pleasing and that retained many of the important historic qualities of the original windows (see figure 8).

Figure 8. Replacement window sash after installation. Photo: Charles Parrott

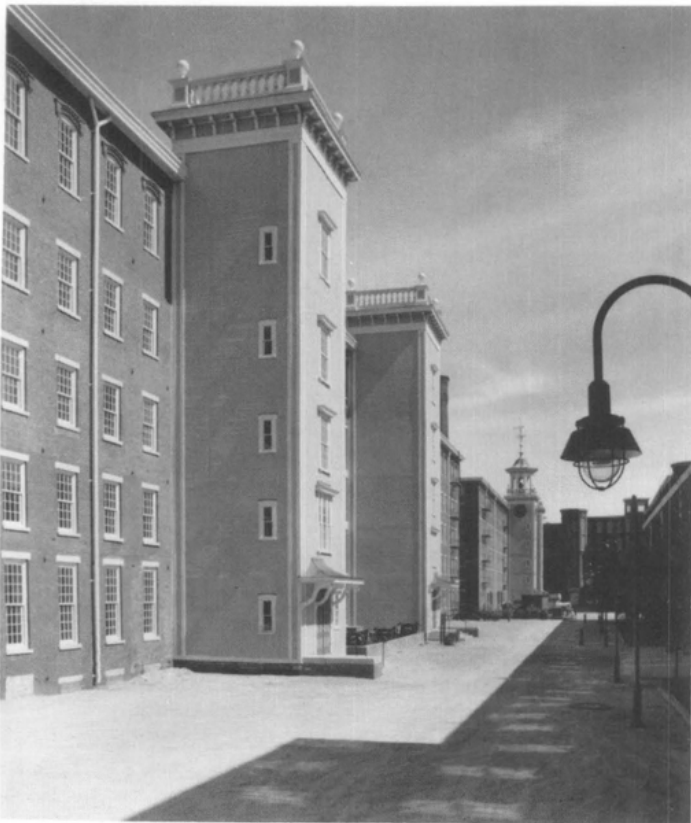
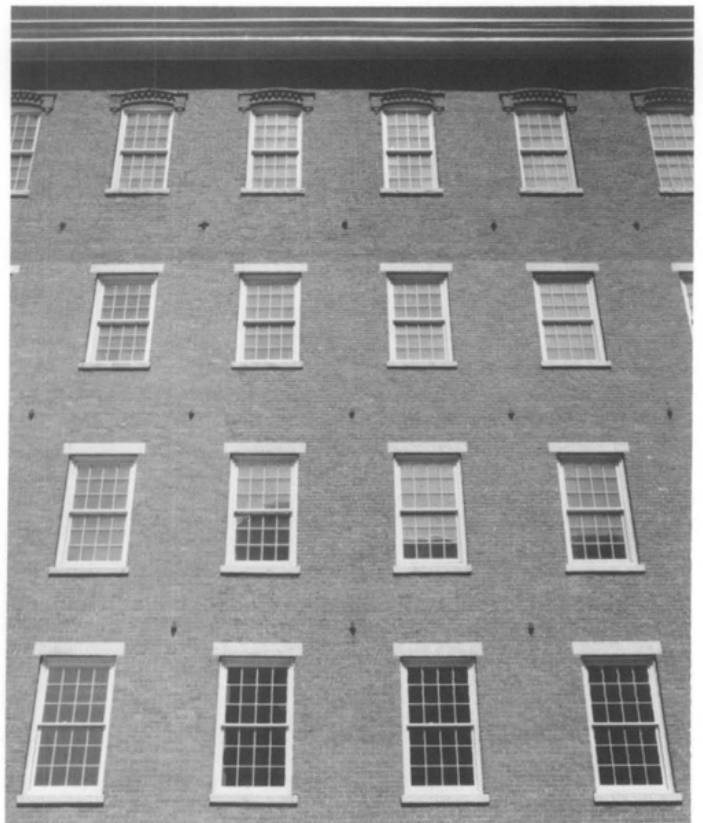
Figure 9. The window solution represents an important advance in the way in which aluminum windows can be designed to capture more fully the appearance of historic windows in larger buildings. Right photo shows wood sash in bottom row and aluminum in the upper three rows. Photos: Jim Higgins ©
