Preservation Tech Notes

NUMBER 21

Replacement Wood Sash Utilizing True Divided Lights and An Interior Piggyback Energy Panel

BEATTY'S MILL (CORAL STREET ARTS HOUSE) Philadelphia, Pennsylvania

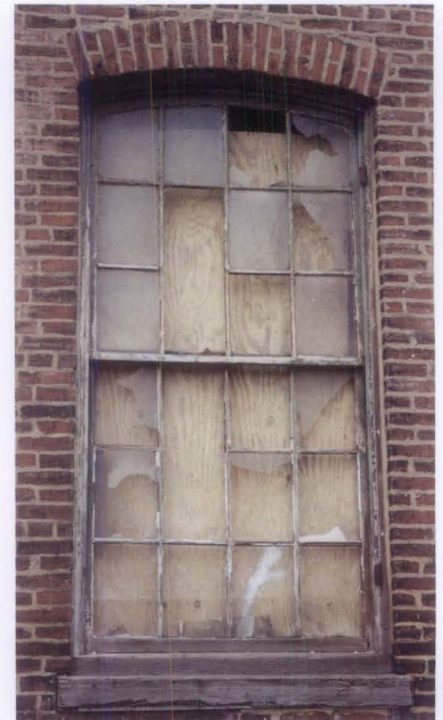
The large double-hung wood windows were one of the most prominent features of the mill. Each measured 48" by 96" with 12 lights of glass in both the upper and lower sash. Characteristic of many mill windows of the time, the sash frames were set in the masonry walls so as to minimize frame exposure on the outside. This provided for more light on the interior. It also enhanced fire safety through minimizing exposed wood on the outside, thus reducing the risk of flames spreading from an adjacent building fire (see figure 2). The outer face of the meeting rail was quite narrow.

Figure 2. The historic double-hung wood windows had narrow sash and frame members that contributed to the distinctive qualities of the windows.

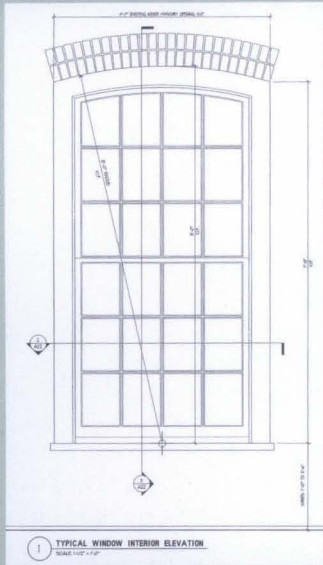
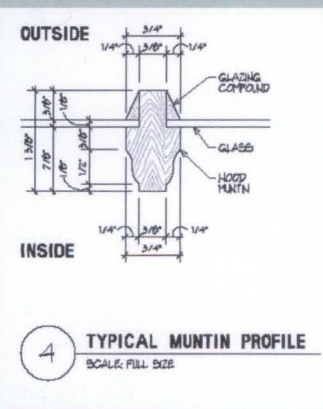
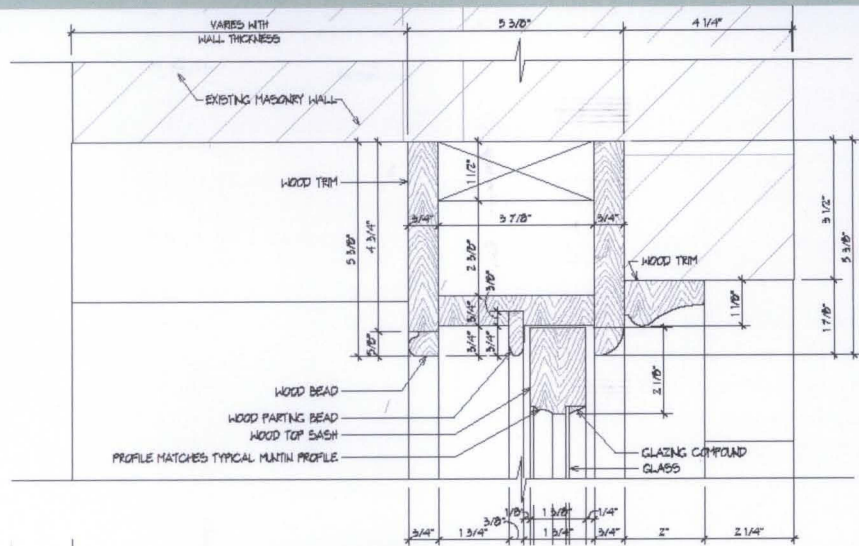
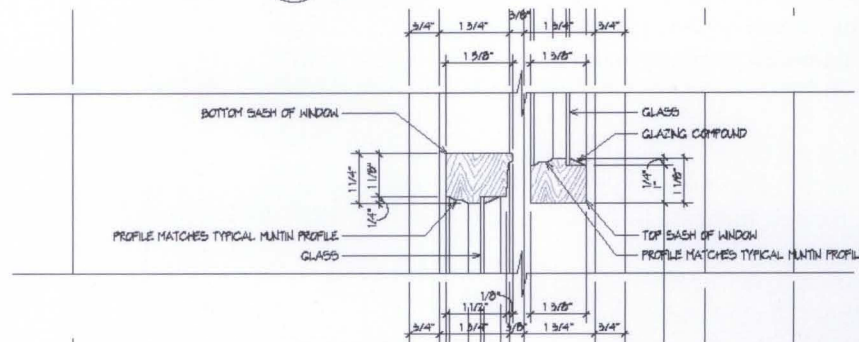
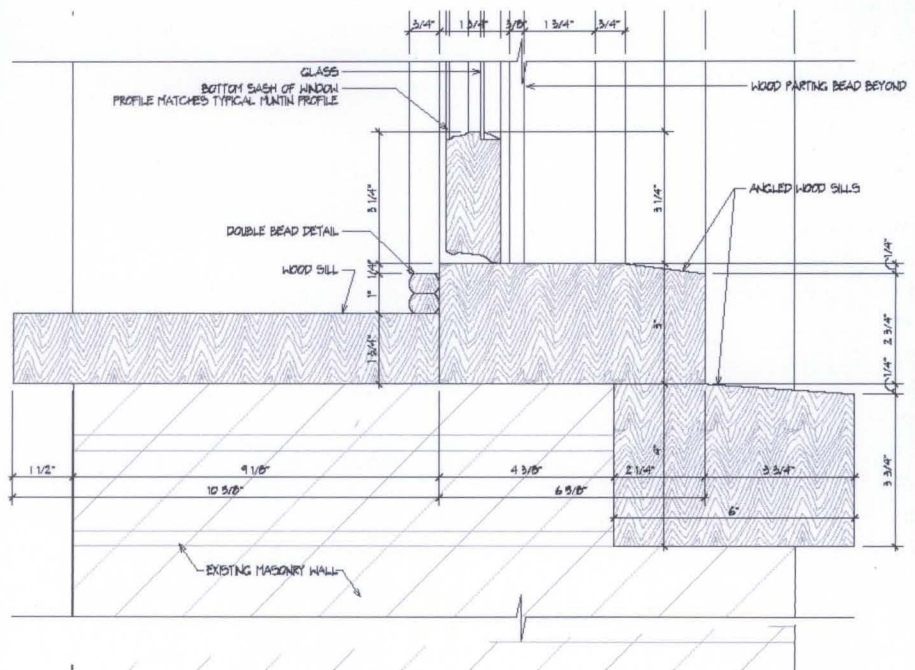
Figure 3. Drawings of the historic windows were prepared by the architectural firm based on field measurements to assist in devising an appropriate replacement window. Drawings: Courtesy of Kitchen & Associates Architectural Services.

The location of this building right on a street corner and the importance of the windows to the historic character of the building led the project team to select a window solution that closely matched both the detail and appearance of the historic windows. By selecting a new custom wood window, the narrow site lines of the historic windows could be closely replicated, the historic glass to wood ratio readily maintained, and other historic details easily reproduced (see figure 3).

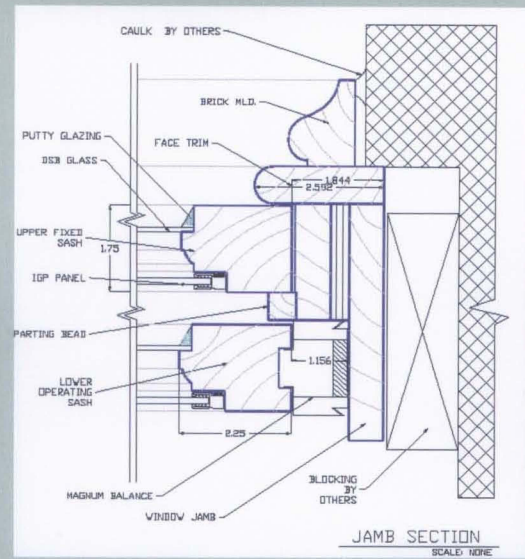
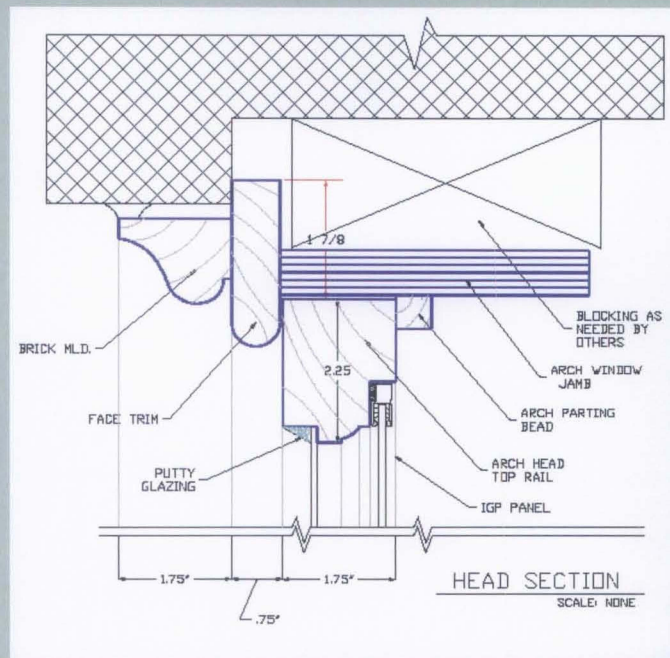
Figure 4. While using contemporary sash balances, the wood replacement windows had many traditional features such as putty glazing for the true wood muntins. Note the sash is rabbeted on the room side to a depth that permits the glazing panel to be set flush. Drawings: Courtesy of Seaquay Architectural Millwork.

To help retain the historic sightlines, the deteriorated frames were removed, permitting the new frames to be set close to the masonry (see figure 4). The alternate approach of retaining the existing frames, abutting new frames to them, and covering the outer face of the exposed portion of the older frames would have resulted in reduced glass exposure and a beefier frame appearance to the finished windows.

Several features of the new window were different than the historic windows in order to accommodate the dual glazing. The inside of the rails and stiles of the sash were rabbeted on the room side to a depth that permits the glazing panel to be set flush. To retain the depth of the original muntin and to accommodate the glazing panel on the inside, the thickness of the sash was increased to 1 3/4". In the bottom rail, weep holes were provided between the glazing panel and the outer glass, to allow water to drain from condensation that might on occasion develop between the two layers of glass.

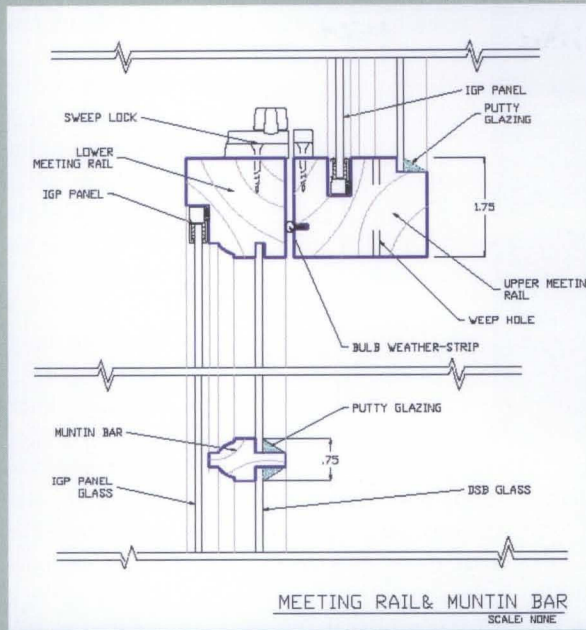
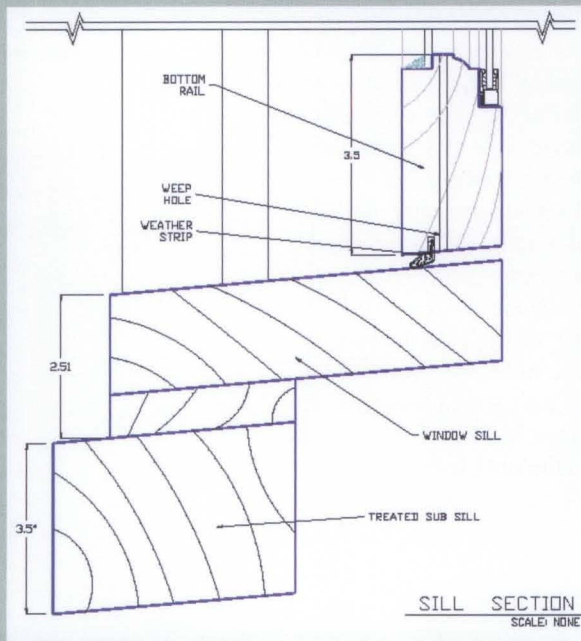
Figure 5. For the new windows to meet ASTM Standards, the face width of the meeting rail was increased 1/2 inch. To both accommodate the piggyback energy panel and match the historic muntins, the thickness of the wood sash was increased from 1 3/8" to 1 3/4". These two changes had minimal visual impact, considering the size of the windows. Drawings: Courtesy of Seaquay Architectural Millwork.

Somewhat more problematic was how close the bottom rail (meeting rail) of the new upper sash could match the narrow width of the existing window. Specifications for the project required that the replacement window meet three ASTM Standards: ASTM E283, the standard test for determining the rate of air leakage through an exterior window; ASTM E331, the test of water penetration; and ASTM E330, the standard test for structural performance of an exterior window. To meet ASTM E330 with the design pressure rating for the window set by the architect, a 1 3/4" wide meeting rail was needed (see figure 5). This was an increase of 1/2 inch over the historic sash. Fortunately because of the size of the window, this increase was considered acceptable, as the meeting rail still appeared relatively narrow even with the 1/2 inch increase.

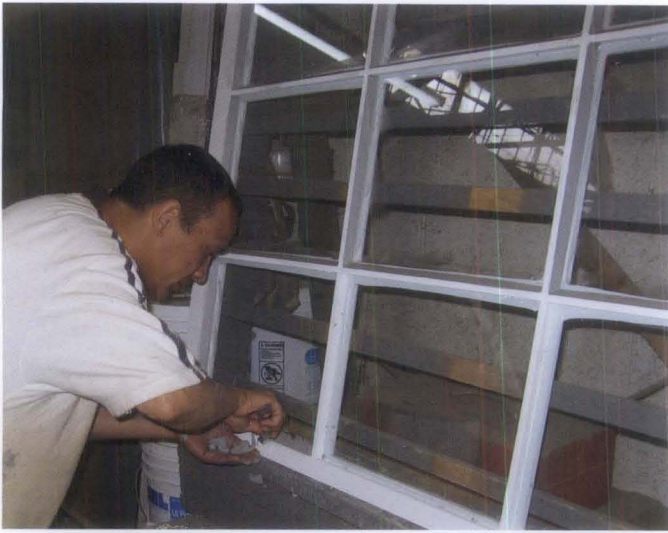
Figure 6. The outer glass was installed in the traditional manner, using exterior glazing putty. Photo: Charles Fisher.

The windows were then assembled and sanded. The outer glass was installed in the factory after the assembled sash were primed. Exterior glazing putty manufactured by C.R. Lawrence was applied in the traditional manner (see figure 6). Since the upper sash were to be fixed in the operable windows, weatherstripping and block and tackle balances were provided only for the lower sash. Each window was provided with two sweep locks and two sash lifts for the operable lower sash. Of the 188 replacement windows, 111 were single hung and 77 were fixed (see figure 7).

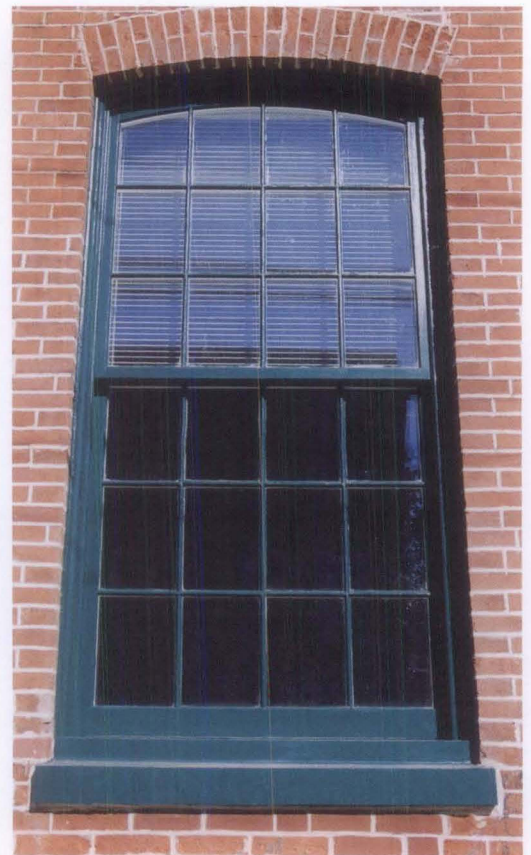
Figure 7. The new window's joinery, individual glass lights, reflective qualities, and painted wood finish all help to capture the appearance of the original units.

The new windows in Beatty's Mill successfully matched the historic units while providing enhanced energy conservation. There is little difference between the new and historic windows in terms of the characteristic features (see figures 2 and 7). The integral wood muntins, individual panes of glass, reflective qualities of the glass, glazing putty, and painted wood surfaces, along with the benefits of using a custom-wood window manufacturer that could duplicate

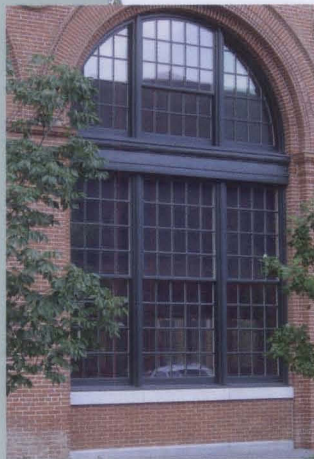
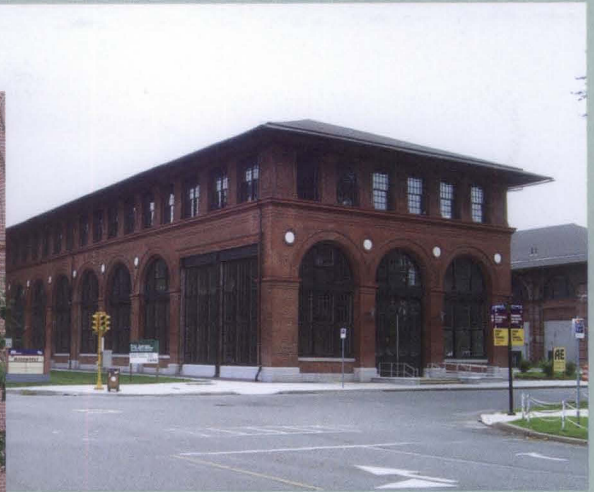
Figure A. Building 10 (headquarters of Urban Outfitters), former Philadelphia Naval Shipyard. New wood windows were made to match the original units, including true divided-lights, while incorporating a piggyback interior energy panel. Photos: Seaquay Architectural Millwork.

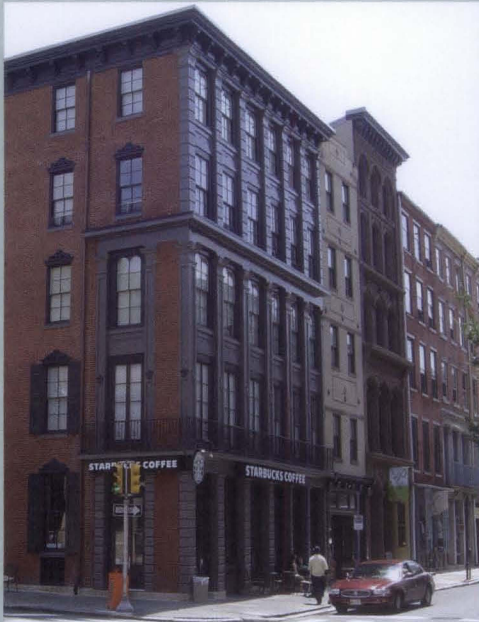
Figure B. 61-63 North Arch Street, Philadelphia (commercial and residential). Most of the historic windows were missing or severely deteriorated prior to the rehabilitation of this corner building. Based on surviving units, new non-clad wood windows were milled with matching true divided lights and piggyback energy panels. Photo: NPS file.

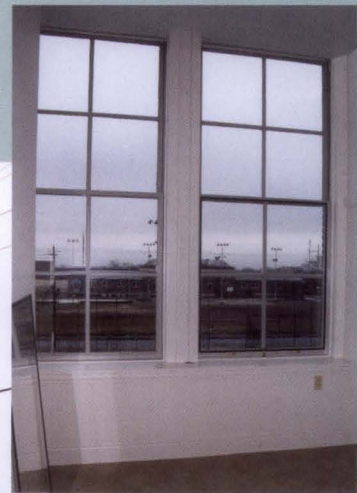
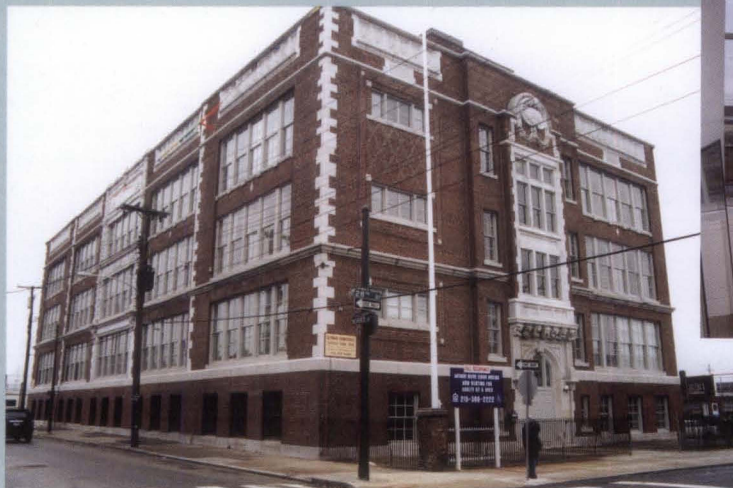
Figure C. Anthony Wayne School (affordable senior housing), former Philadelphia school. The predominant window type is a wood unit with four-over-four glass lights as shown in the lower right-hand photograph. The replicated wood window on the right is shown with the energy panels installed, while both sash in the left window have yet to receive the panels shown in the left forefront.

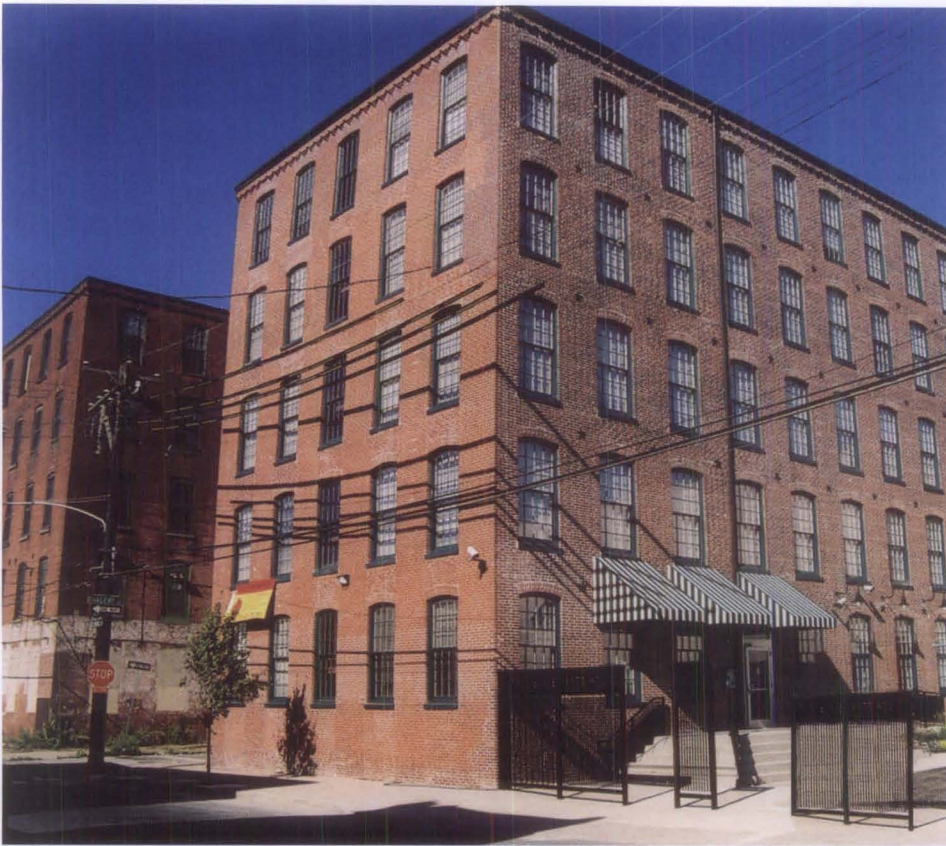
Figure 8. Upon completion of the work, the former mill now serves as low-income housing and artist live/work space. The new wood windows provide improved energy performance and enhance the visual qualities of the historic building.
