# Preservation Tech Notes

## WINDOWS NUMBER 22

### Maintenance and Repair of Historic Aluminum Windows

**Kaaren R. Staveteig**  
Technical Preservation Services  
National Park Service

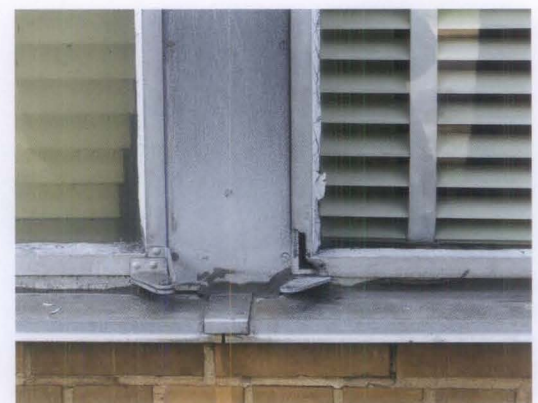
Figure 6. Deferred maintenance can result in a series of problems, such as broken hardware, cracked or missing glazing putty, and missing perimeter caulk (all shown above). All of these problems can be corrected. Note the uneven nature of the surface deposits of pollutants and grime on the mullion and sill of this window due to weathering and lack of cyclical cleaning.

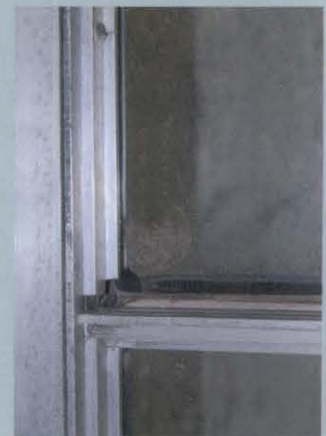
*Figure b. The panes of glass were secured into the frame with aluminum glazing stops, each individually cut, drilled, and fixed in place from the inside. Here the vertical stop is in place while the horizontal is missing.*

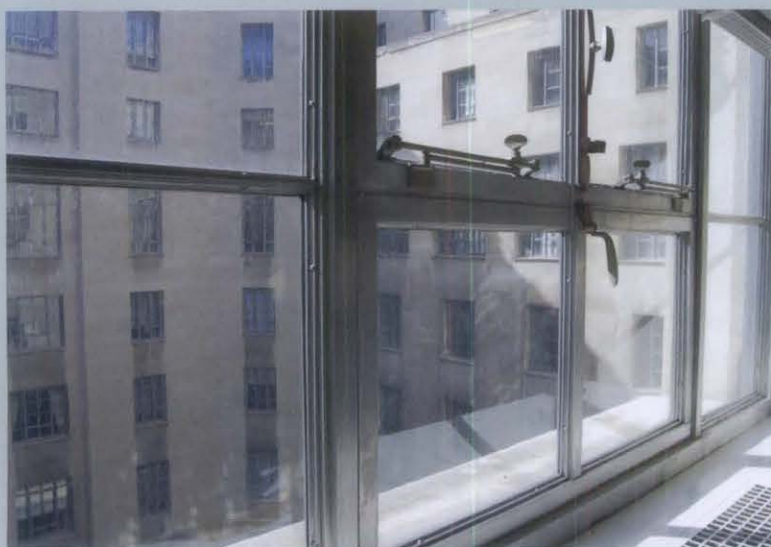
*Figure c. In cleaning historic aluminum windows, the gentlest means possible should be used. More aggressive cleaners should be used only where necessary. The interior surface of this window was cleaned ten years ago with an aluminum jelly cleaner, rinsed and then dried thoroughly. The original mill finish still retains its luster.*

needed. The aluminum was then rinsed to remove the cleaner residue (Figure c). For the exterior surfaces of windows that were more heavily corroded, the aluminum restoration company proposed a more aggressive chemical cleaner be used. This necessitated that the surrounding limestone surfaces around each window be well protected. During a mockup cleaning exercise, this chemical cleaner proved too acidic, difficult to control, and damaging to the adjacent stone. After testing some alternate products, the team found that a diamond abrasive pad used in combination with the Duro Aluminum Cleaner in jell form, worked the best. Special care was still necessary to protect the surrounding limestone.

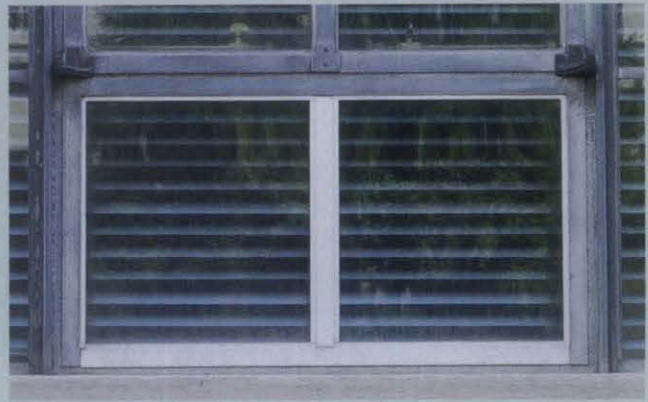
*Figure d. Numerous hopper units have been removed over time to accommodate air conditioning units. Replacement hopper units were manufactured, as needed, to match the original hoppers elsewhere in the building.*

An aluminum company reproduced the vertical muntin that historically existed in the hopper unit but was missing from numerous units. After the muntins were cut to size, each was slotted at the end and fitted into the hopper frame, and then welded at the tip. The same company also made custom extrusions for the rails and stiles of the hopper units for use in fabricating entire hoppers where missing (Figure d).

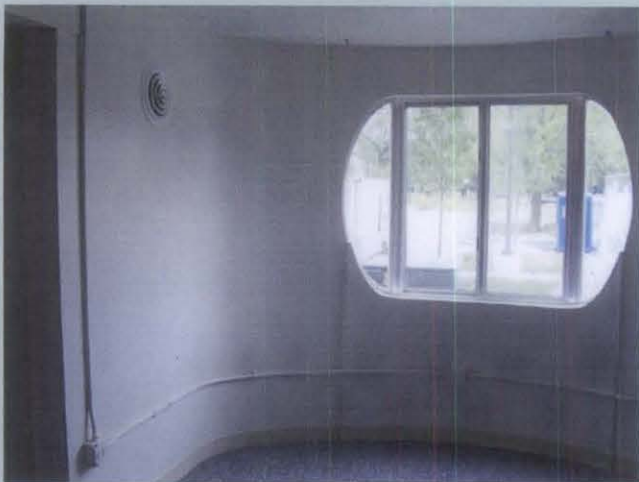
*Figure e. Both interior and exterior aluminum surfaces had become dull, soiled, and oxidized as a result of traffic exhaust and air pollution. Cleaning the aluminum stabilized any further deterioration and brought back the luster of the original mill finish. (Photo: Holsten Real Estate Development Corp.)*

denatured alcohol were used to remove the general residue on the aluminum. Wearing rubber gloves, the crew wiped on the cleaner with a damp cloth, allowed it to stand for 3-5 minutes, and then wiped it off with a clean damp cloth. Scouring pads and scrapers were sometimes used on more encrusted areas, as needed. The removable sash units were cleaned in the basement shop, while any frames that remained in situ were cleaned in place (Figure e).

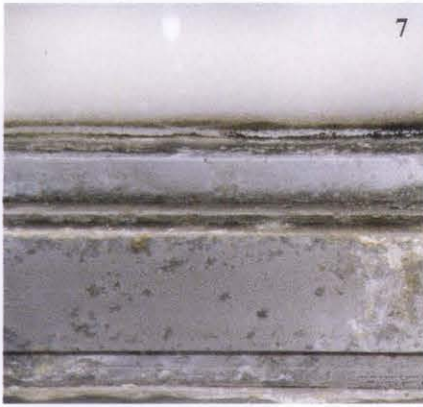
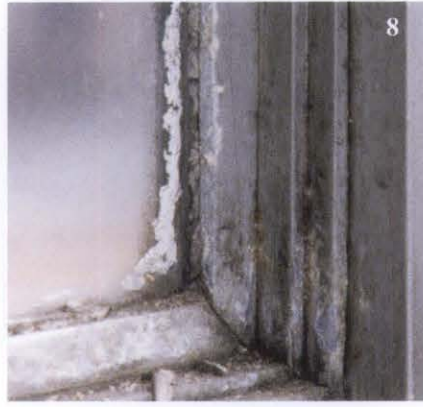
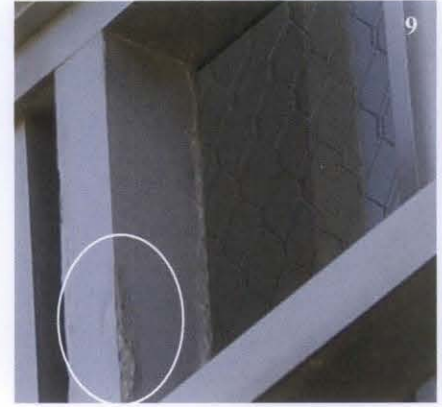
Figures 7 and 8. Aluminum corrosion can appear as a white discoloration and forms on the surface as the protective oxide film breaks down, as seen in these 60 year old windows in the PSFS Building, Philadelphia, before they were replaced. The small dark bumps are where surface dirt, grime, and pollution particles collect. Over time, pits form beneath these dark areas as the surface continues to corrode. This corrosive action is further encouraged by foreign particles, such as dirt and chlorides, which hold moisture next to the surface. (Photo: Powers & Company Inc.) Figure 9. Some aluminum alloys are less corrosion resistant than others. Delamination, as seen on this aluminum railing in front of a window at the Folger Shakespeare Library, can occur when an aluminum-copper alloy is introduced and used in an outdoor setting. The original specifications called for aluminum and chromium, but were not followed.
