**Repair and Upgrade Washington Monument Elevator –
Washington, DC**

NAMA-224923

**Pre-Design Report
Final Submission**

CH2M HILL, Inc.

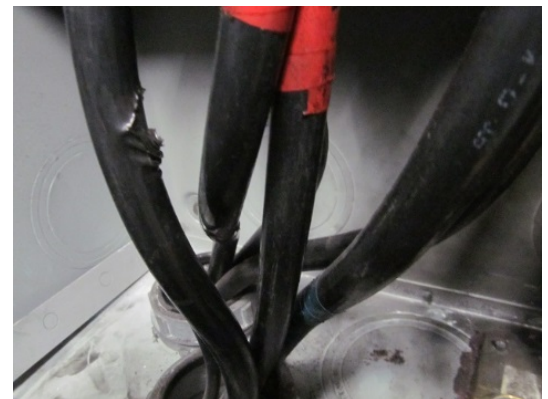
Figure 7: Peeling Skin on Cable (Left Conductor) in Siemens Circuit Breaker Panel

- The outer skin of one of the cables on the load side of the Siemens breaker in the circuit breaker panel is peeling (**Figure 7**) and may need maintenance if it is more than just a cosmetic issue. This may or may not be affecting the integrity of the cable. The electrical testing shall evaluate the integrity of the cable.

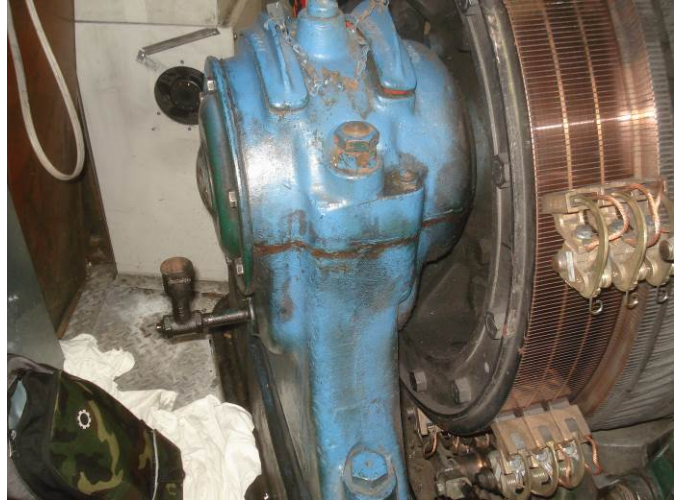
2. Clean hoist machine of accumulation of dirt

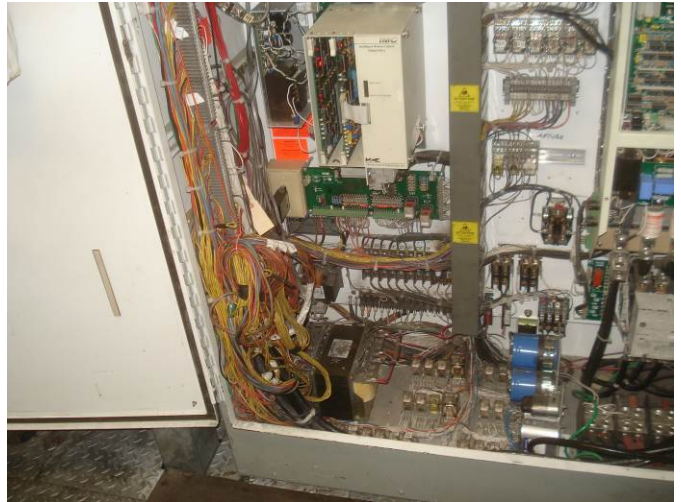
4. Clean out controller

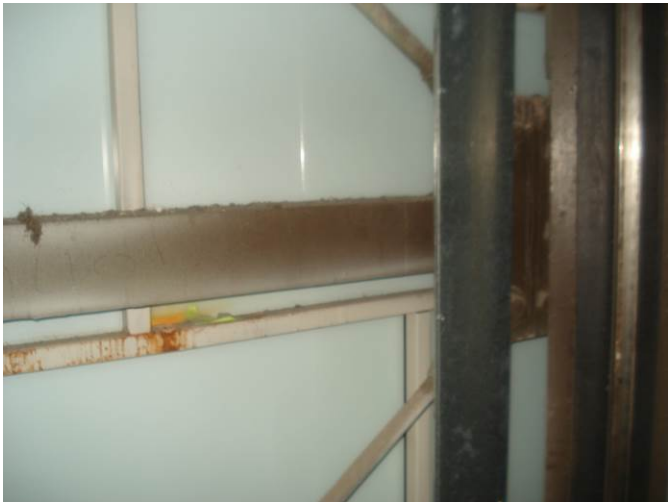
5. Clean down hoistway

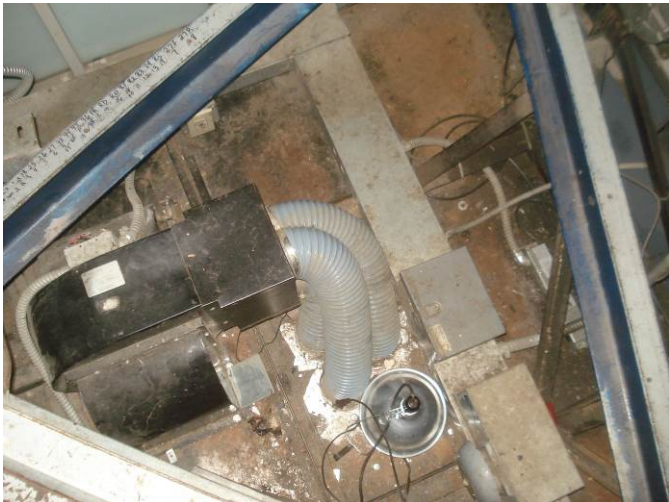
6. Clean cartop

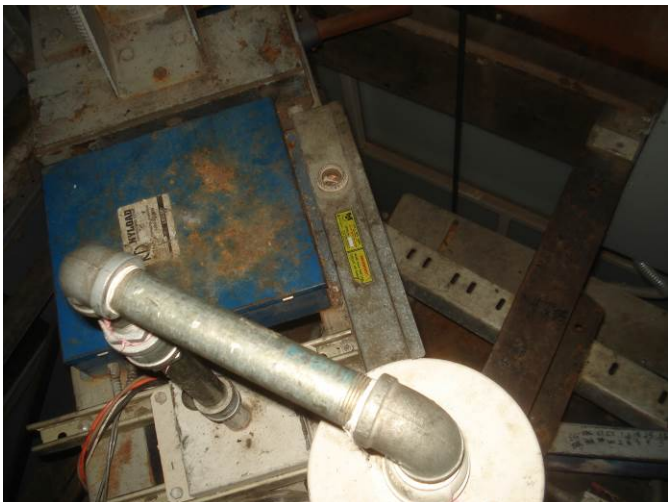
7. Cartop light needs to be operational

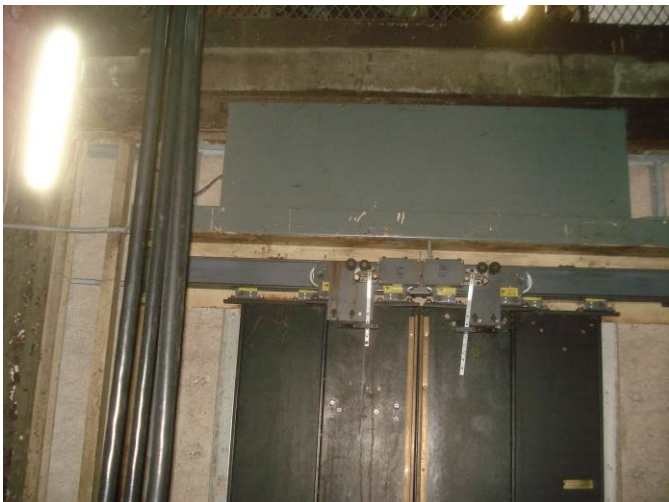
8. Replace missing dust covers

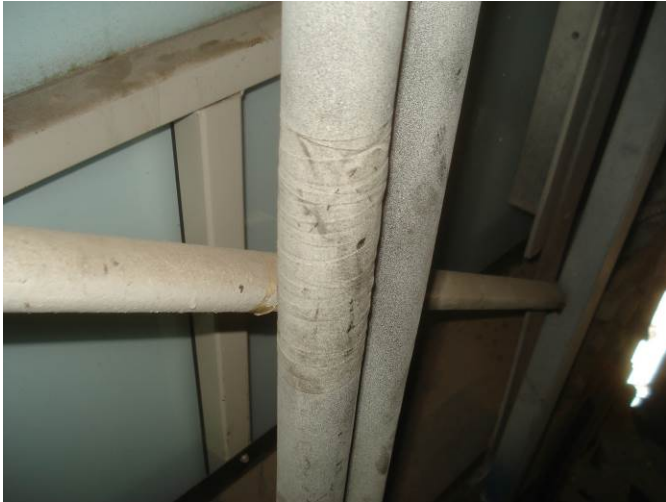
9. Confirm the traveling cables do not have shorts in the wires as there is tape on the traveling cable at the top and bottom of the hoistway

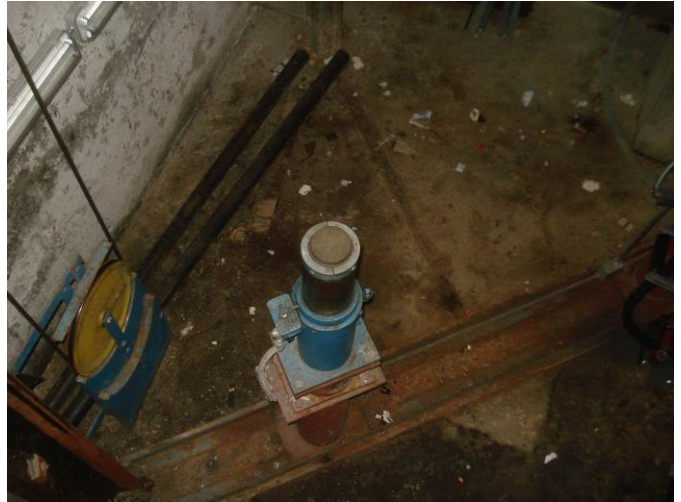
10. Clean pit

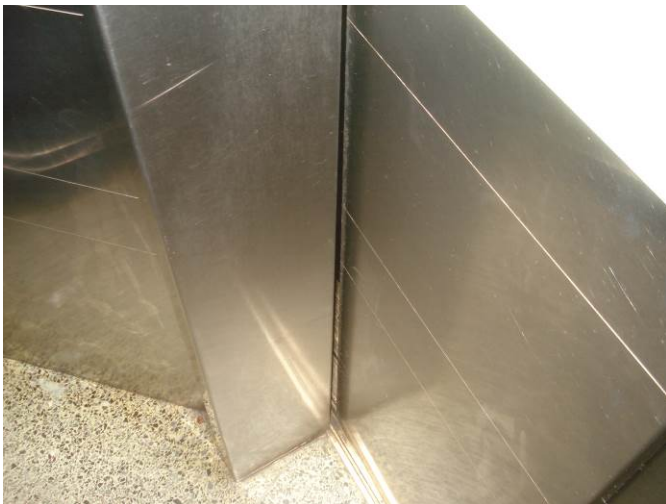
11. Reduce gap between rear door and return panel

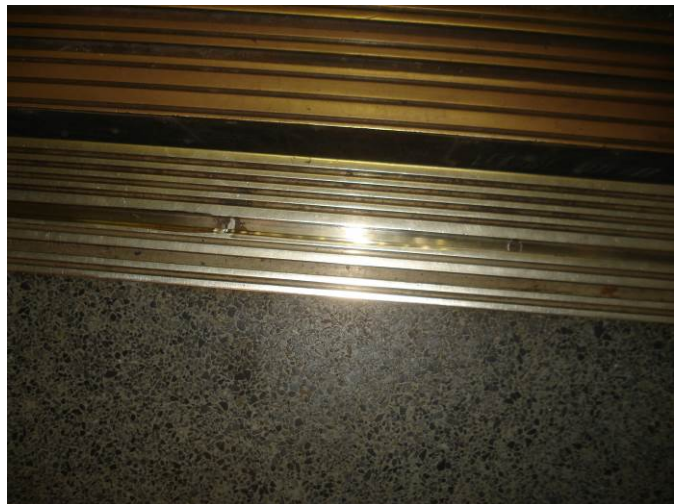
12. Car sill is worn and requires replacement

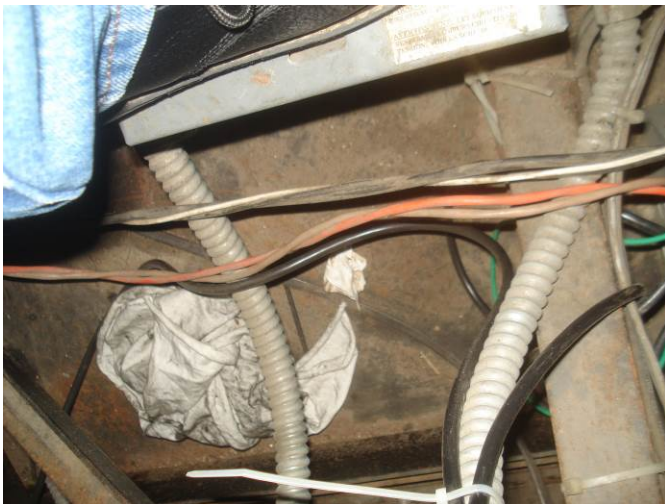
15. It is recommended that during the modernization, all CCTV wiring be placed in conduit.

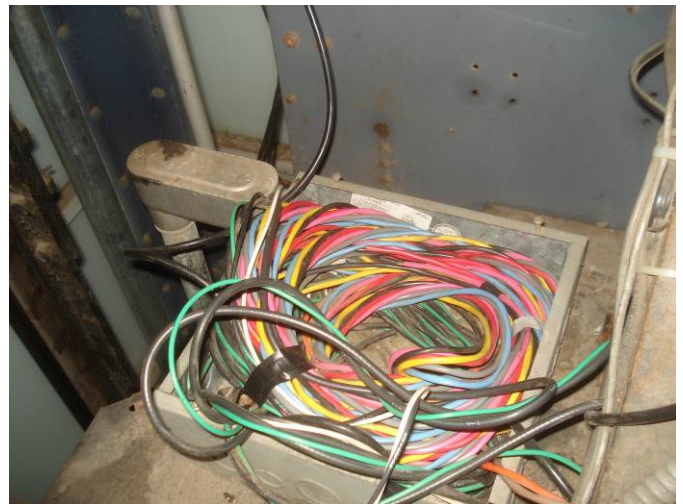
16. Replace missing electrical cover on junction box for CCTV camera at cartop

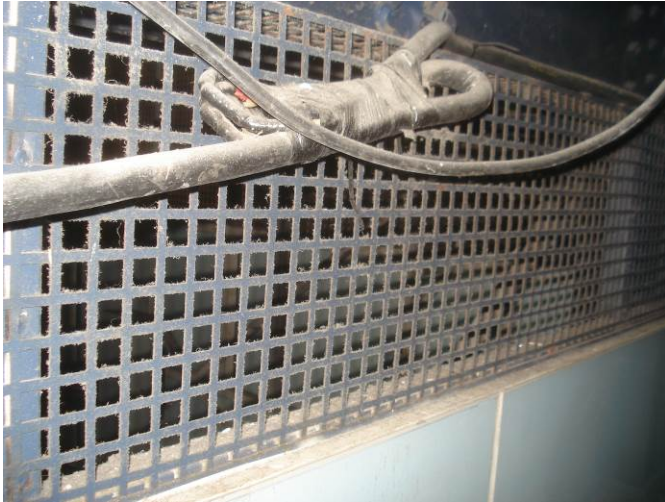
21. Clean hoistway outside of dust, dirt and debris

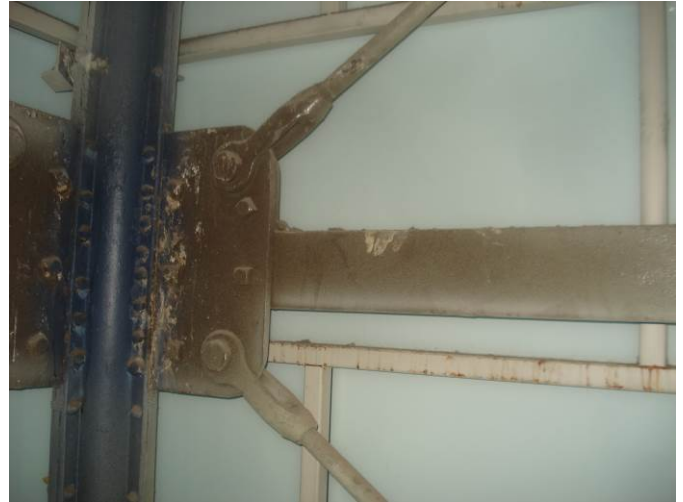
22. Clean inside hoistway of dust, dirt and debris

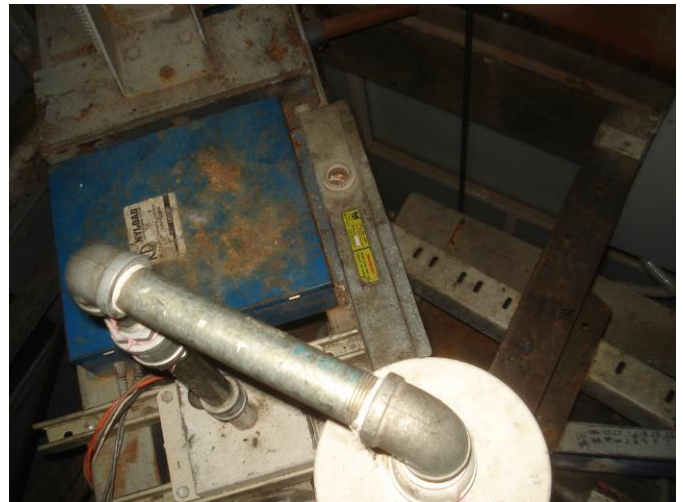
24. All wiring on car top should be protected

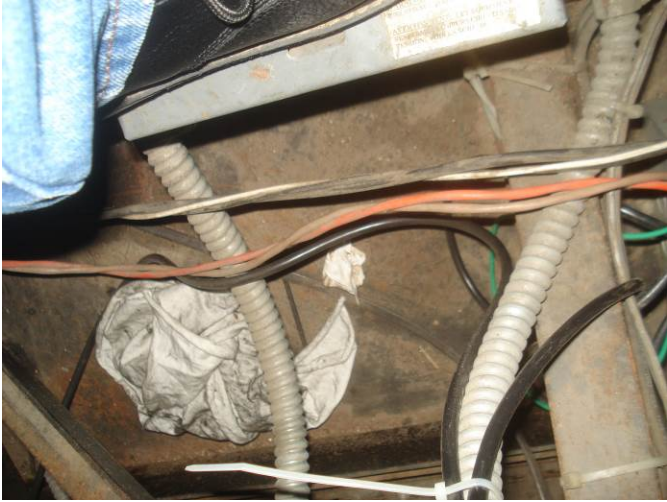
25. All wiring on car top should be protected.

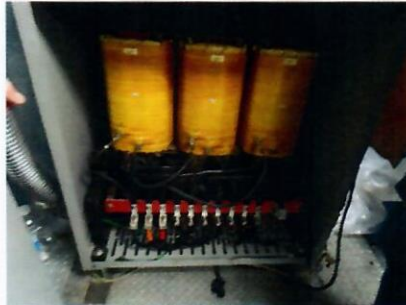
Testing was also done on the isolation transformer. The primary and secondary of the transformer are in excellent condition with balanced values in both windings.(See picture)

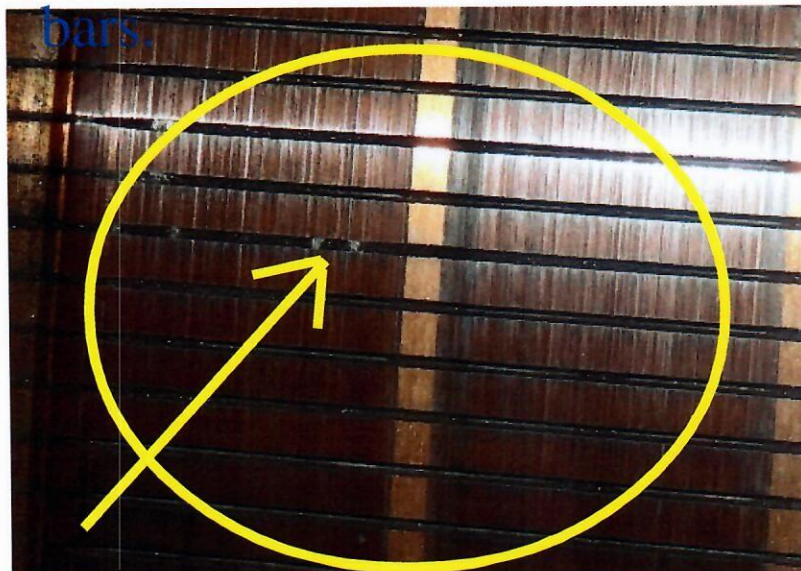
Capacitance between commutator bars
that need to be removed by undercutting.

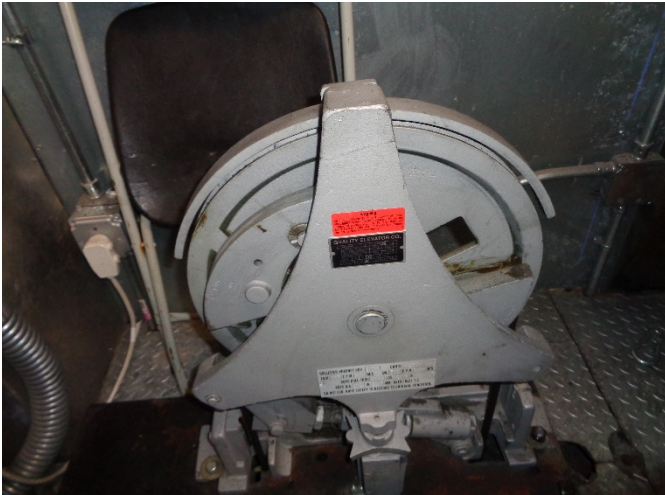
7. Dover Governor should be replaced.

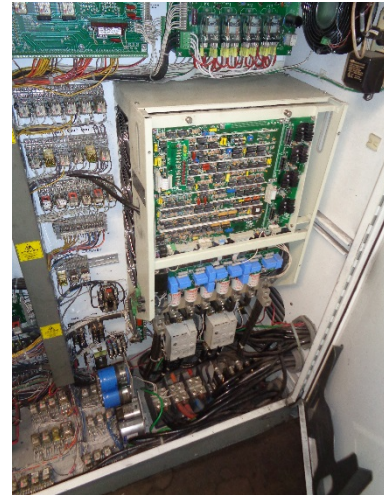
8. MCE controls need to be replaced.

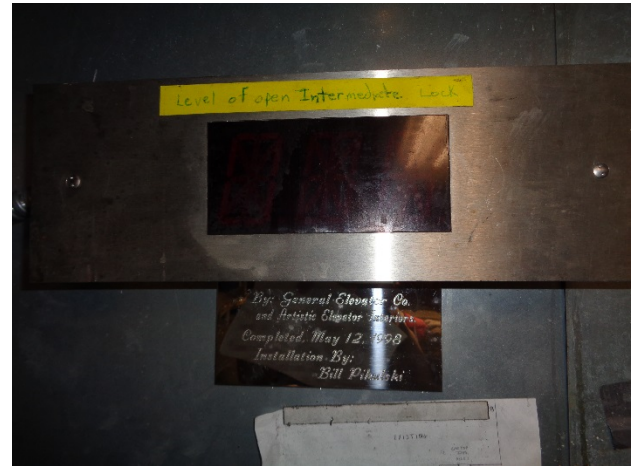
10. Existing car position indicator in machine room and security room does not operate. This will be replaced.

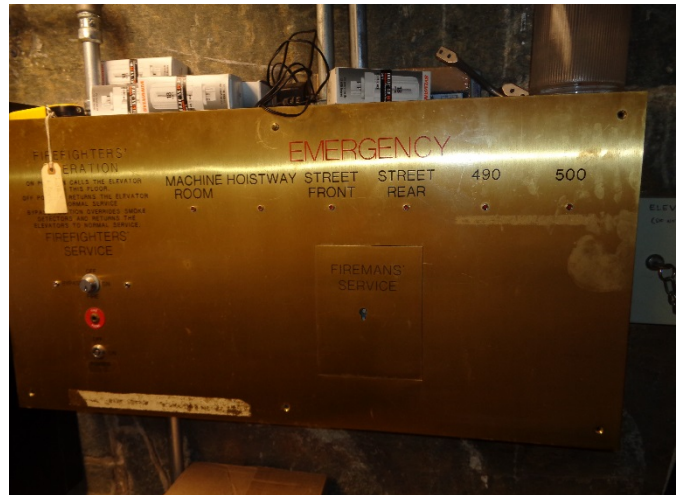
12. Existing fire control panel to be replaced.
