# CULTURAL LANDSCAPE REPORT • HISTORIC STRUCTURE REPORT

*Apostle Islands National Lakeshore – Bayfield, Wisconsin*

## **VOLUME II OF VI: MICHIGAN ISLAND CLR/HSR**

**JULY 2011**

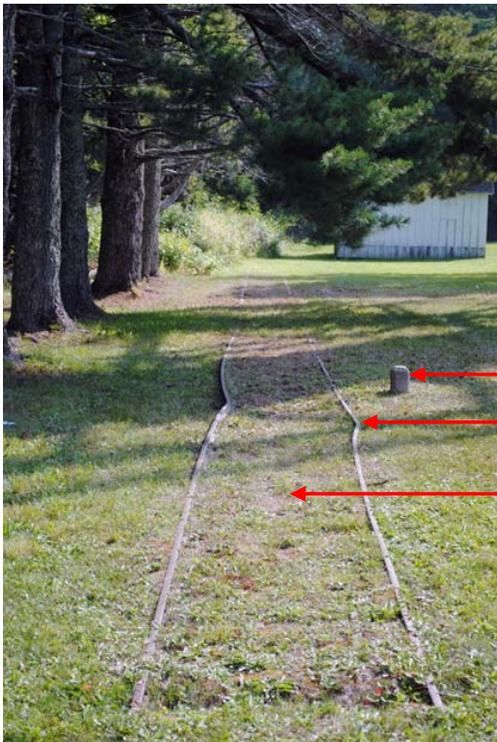
- ← USGS Marker
- ← Area of Damaged Rail
- ← Encroaching Vegetation

Site Image MI-43: Tram tracks, 2009 (Source: MBD DSC\_0054.jpg)

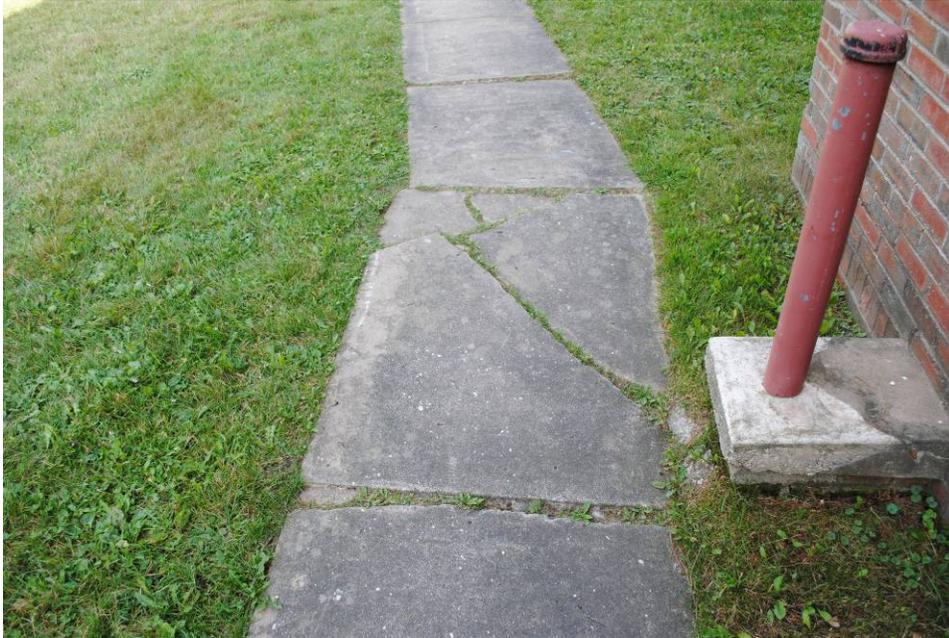
*Site Image MI-48: Broken section of concrete walk north of Power House, 2009 (Source: MBD DSC\_0108.JPG)*

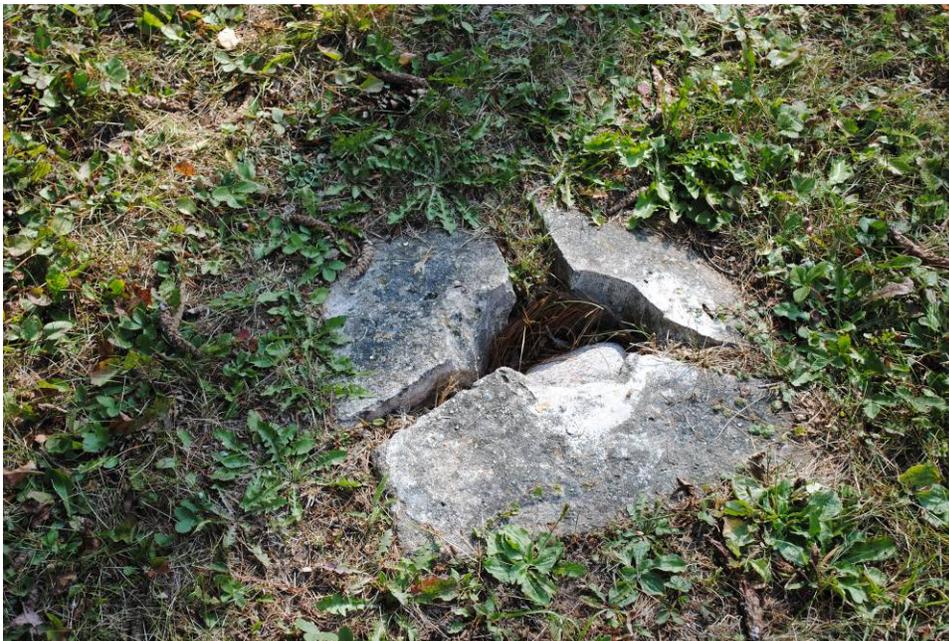
*Site Image MI-63: Broken concrete footing, 2009 (Source: MBD DSC\_057.JPG).*

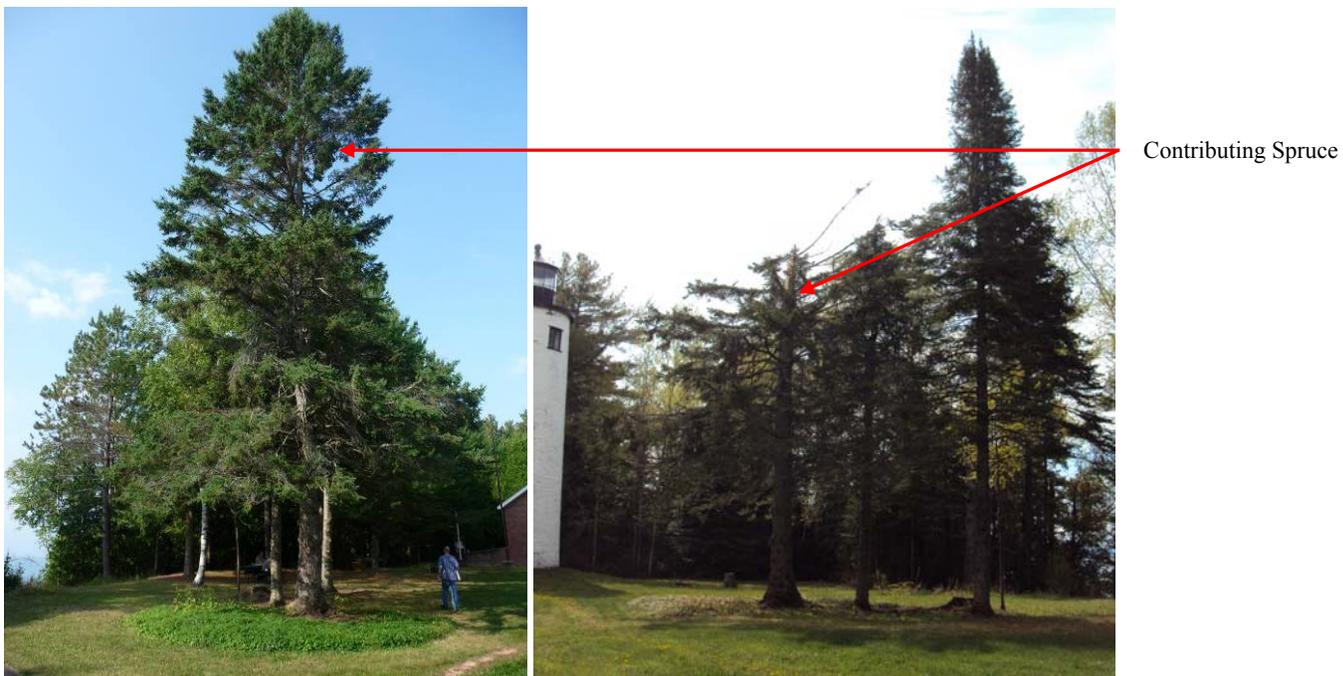
Site Image MI-78: White spruce tree west of Old Michigan Island Lighthouse before and after recent damage: left, 2009 (Source: MBD P1010758.JPG); right, 2011 (Source MBD DSC00882.JPG)

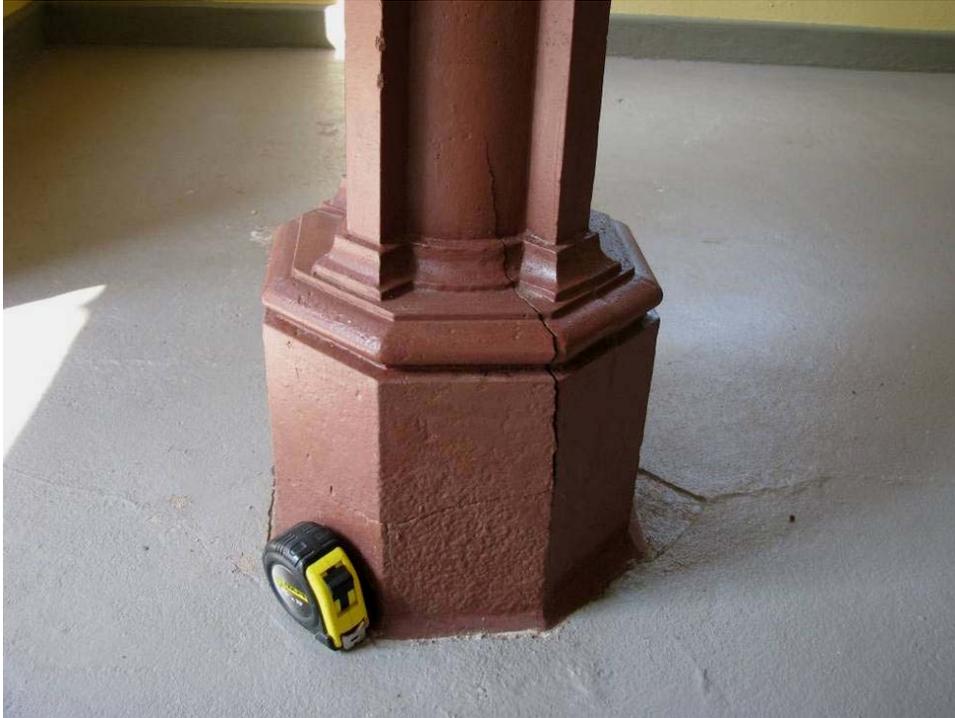
*MI-ST-26: Crack in column base (Source: Martin/Martin)*

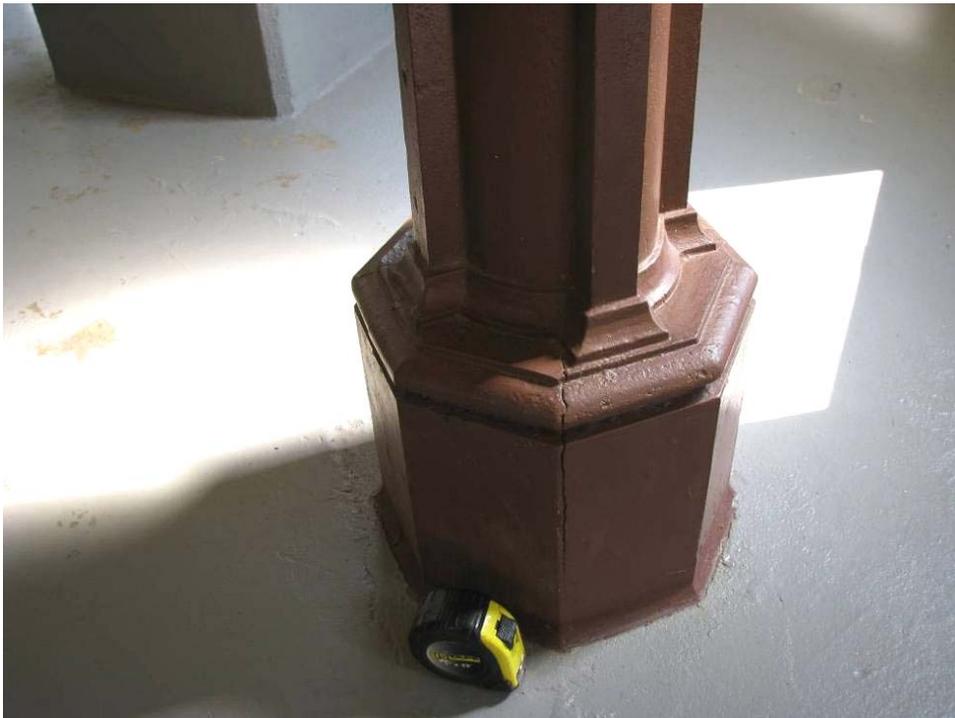
*MI-ST-27: Crack in column base (Source: Martin/Martin)*

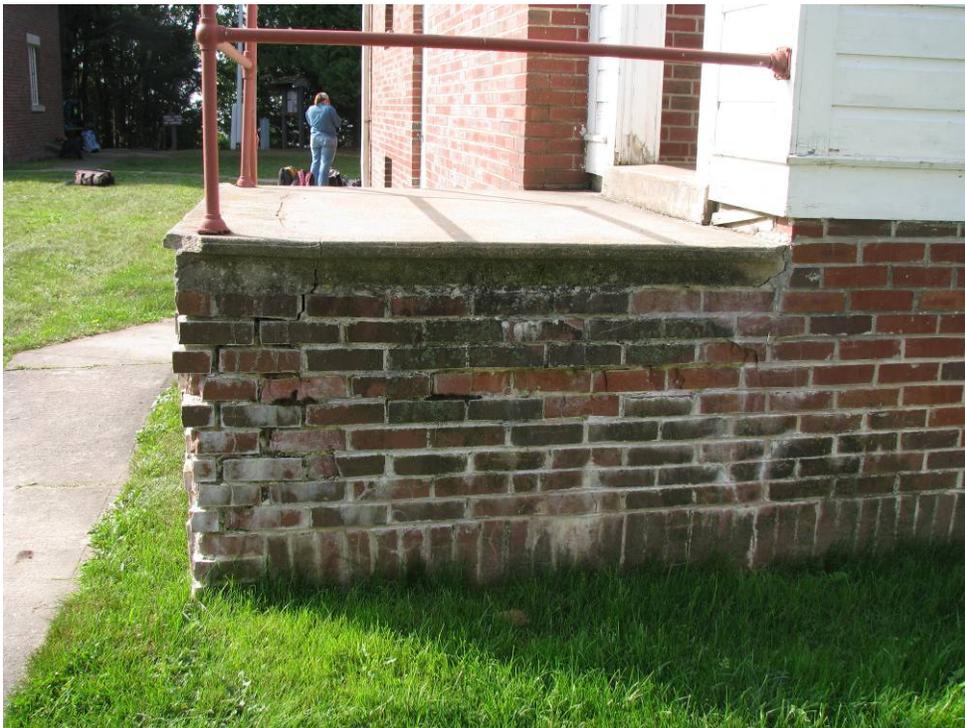
MI-KQ-51: Masonry wall deterioration (Source: Martin/Martin)

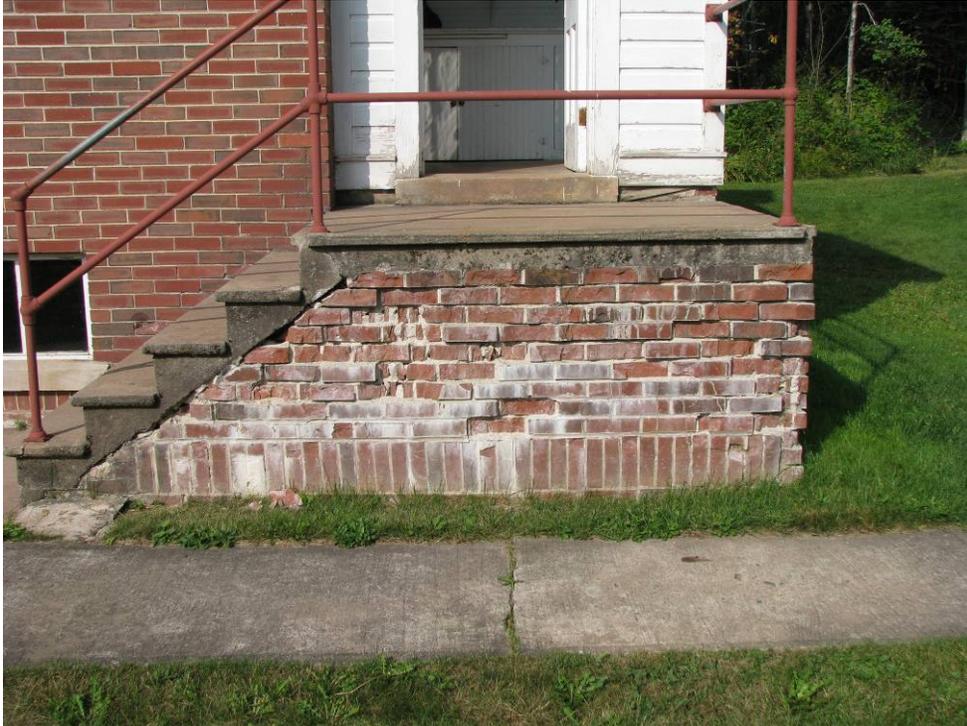
*MI-KQ-52: Masonry wall deterioration (Source: Martin/Martin)*

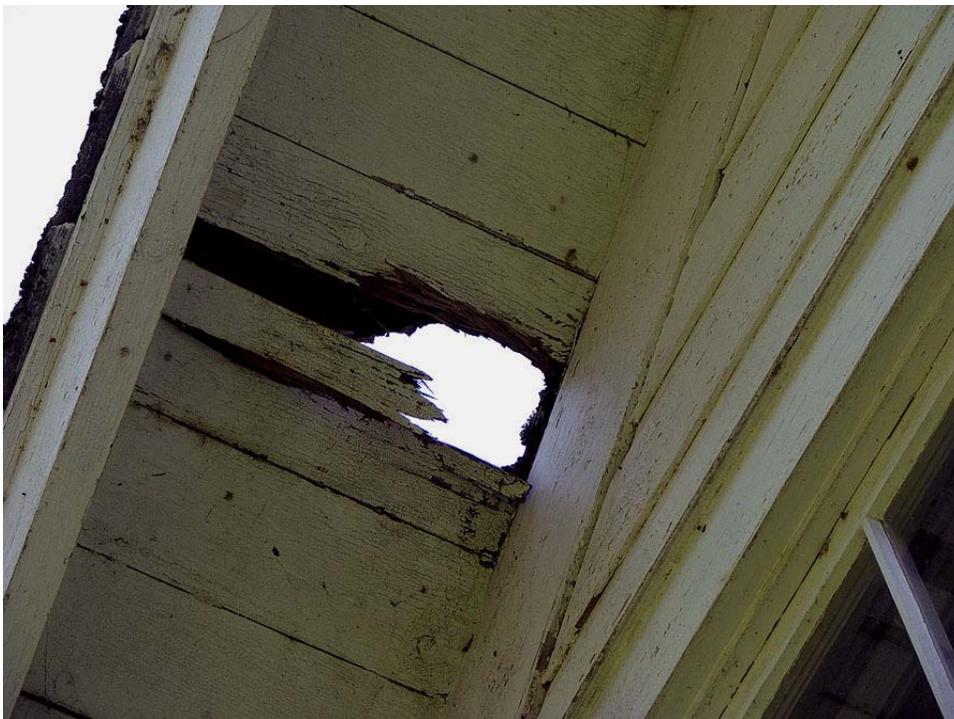
*MI-AKQ-28: Roof damage detail (Source: Martin/Martin)*

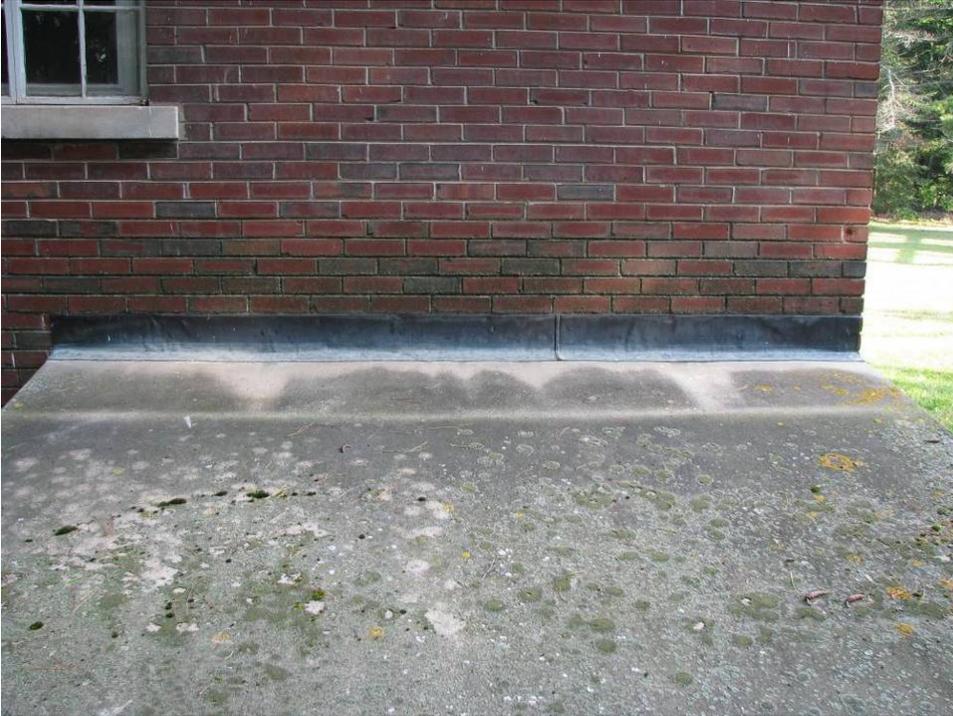
*MI-PH-22: Roof damage (Source: Martin/Martin)*

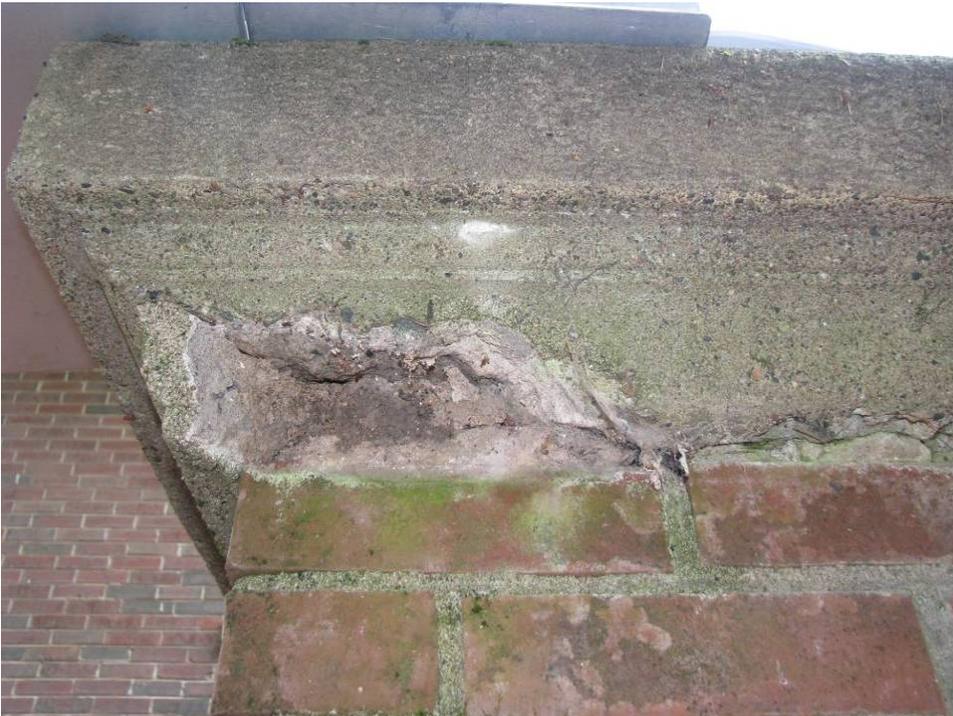
*MI-PH-23: Roof damage (Source: Martin/Martin)*

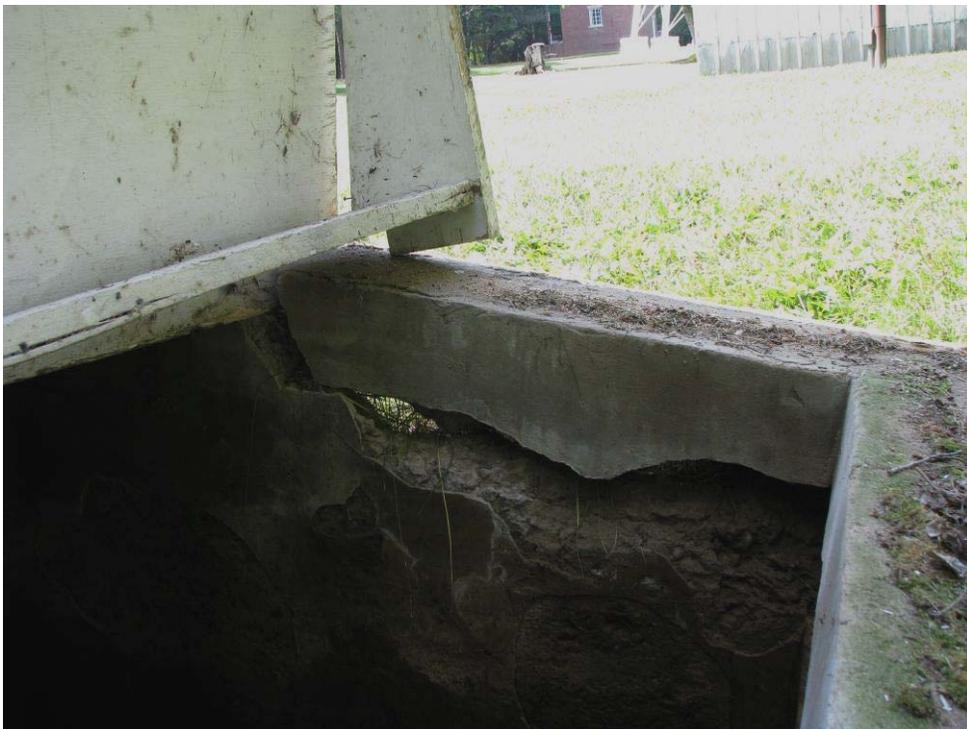
*MI-P-11: Concrete wall deterioration (Source: Martin/Martin)*

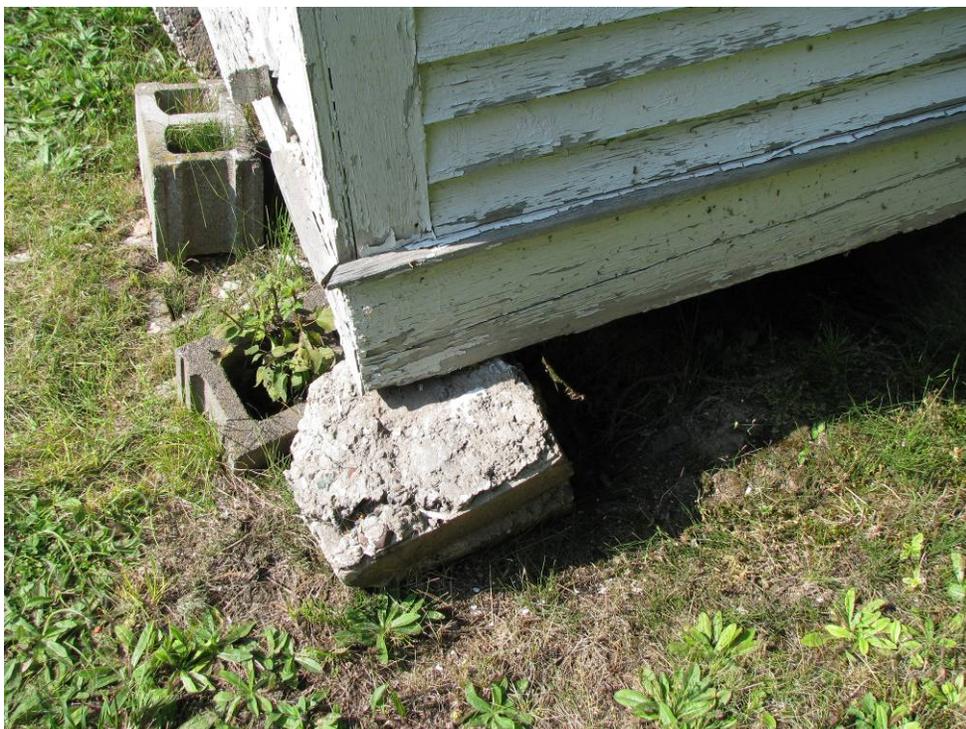
*MI-P-12: Footing rotation (Source: Martin/Martin)*
