REHABILITATE THE HISTORIC STRUCTURE AT MONROE STATION

BIG CYPRESS NATIONAL PRESERVE
EAST OCHOPEE, FLORIDA

HISTORIC STRUCTURE ASSESSMENT REPORT

AUGUST 2007
FY07

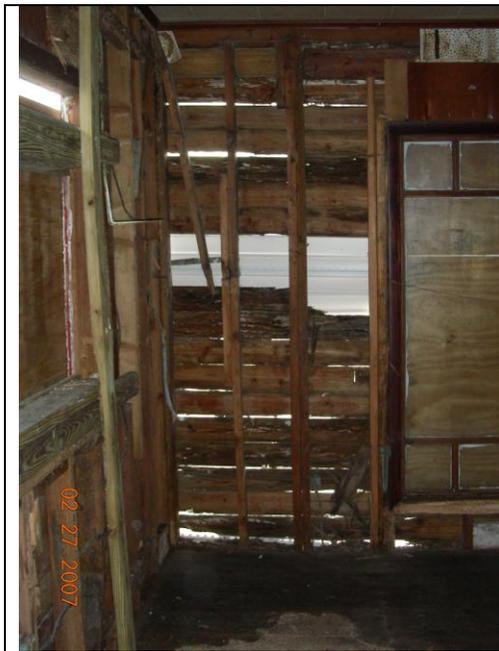
Framing - Original block north elevation – Diagonal brace and studs deteriorated by termites

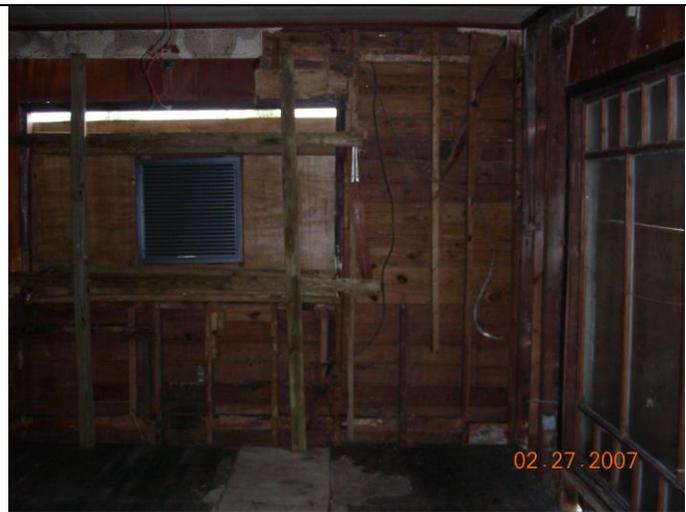
Original West elevation – Mix of original and replacement studs

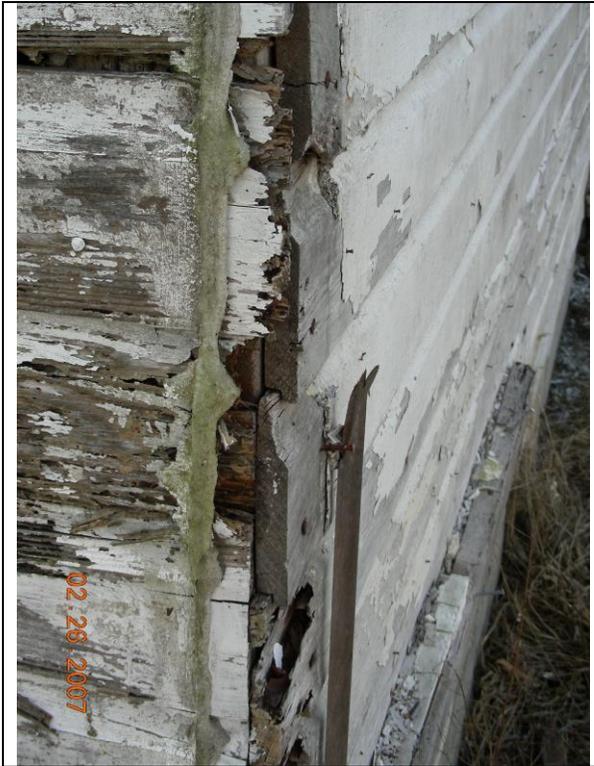
Feature	Material Type	Joinery/Tool Marks	Condition Rating	Priority Rating
Wall Surface Covering	Southern Yellow Pine	Circular Sawn	Poor to Fair	Critical to Serious
<p>Feature Description - The remaining portions of the original exterior walls (north and portion of west elevation) are clad in 5 ¼” x ¾” horizontal lap siding. The drop siding is painted white and fastened with wire nails.</p>				
<p>Feature Condition - The bottom half of the north elevation has significant termite damage. In areas where boards are missing and/or severely deteriorated, modern vinyl siding has been installed.</p> <p>On the west elevation the bottom 2 feet of boards appear to have sustained termite damage.</p> <p>On both elevations, the paint system has failed.</p>

North west corner of original block

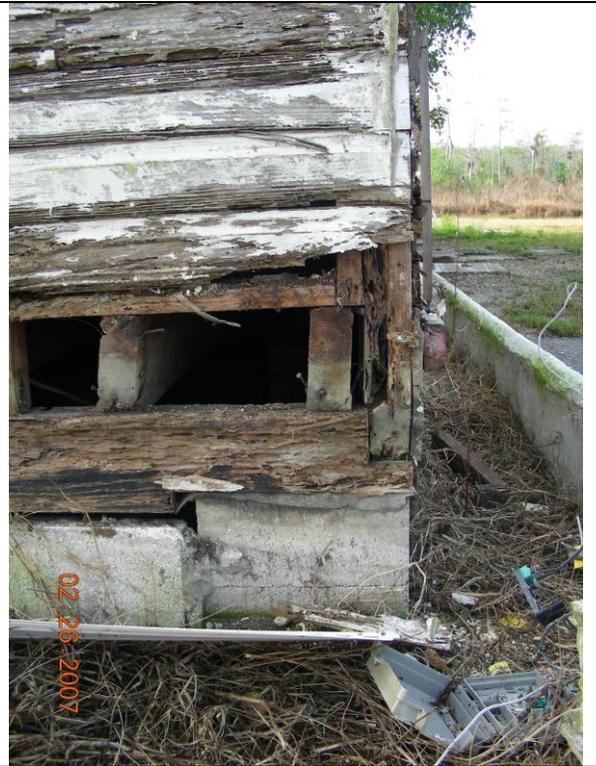
Deteriorated siding – north elevation

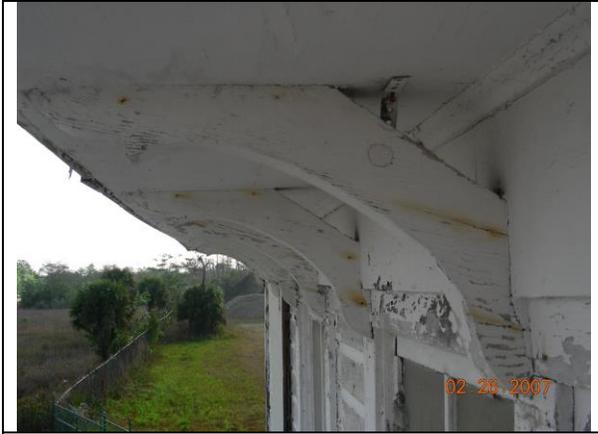
Feature	Material Type	Joinery/Tool Marks	Condition Rating	Priority Rating
Cornice	Southern Yellow Pine		Fair	Serious
<p>Feature Description - The box cornice along the north elevation consists of several elements. First, the plain-faced fascia board measures approximately 5 3/8" x 3/4" and is painted white. The soffit extends out approximately 22" and is constructed of 3 1/2" x 3/4" tongue and groove bead boards. At some point a layer of plywood was installed over the tongue and groove boards. The frieze consists of two boards, the upper measuring 9 5/8" x 7/8". The lower board extends under the upper board. The visible portion is approximately 3 1/2" x 7/8". Immediately under the soffit, fastened to the upper frieze board is a 1 1/2" piece of cove molding. All of the elements are painted white but remnants of green and red paint are visible.</p> <p>On the west and east elevations, the original cornice appears to have been removed and replaced with a plain-faced frieze boards approximately 3" to 4" in width.</p> <p>Feature Condition - The cornice appears to be in fair condition however evidence of termite infestation and moisture infiltration are apparent. A layer of plywood was installed over the tongue and groove soffit boards. Portions of the plywood are sagging and show evidence of moisture infiltration.</p> <p>The paint system on all of the elements has failed.</p>

View of cornice – North Elevation

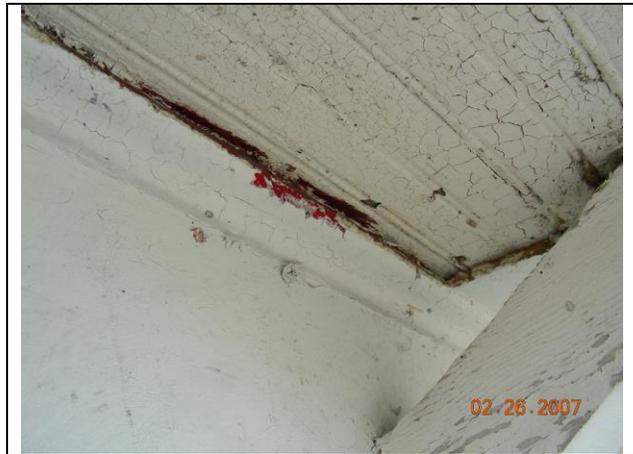
Detail soffit boards – paint failed – original soffit boards covered with plywood

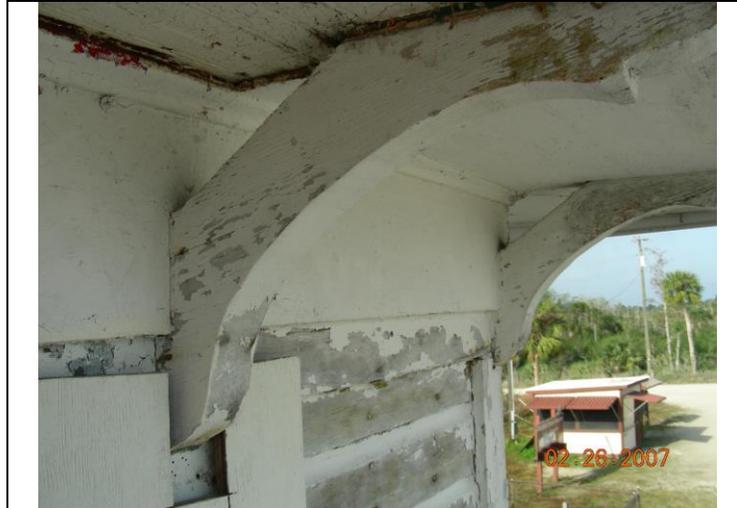
Detail decorative bracket – paint failed

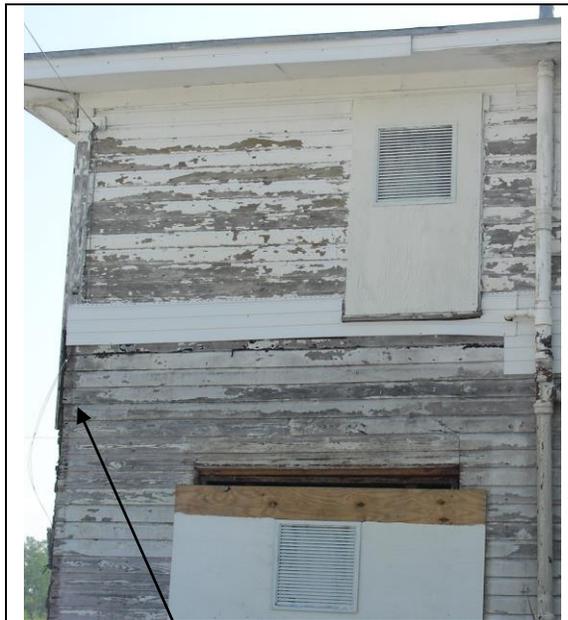
Large section of corner board missing –
north corner of west elevation

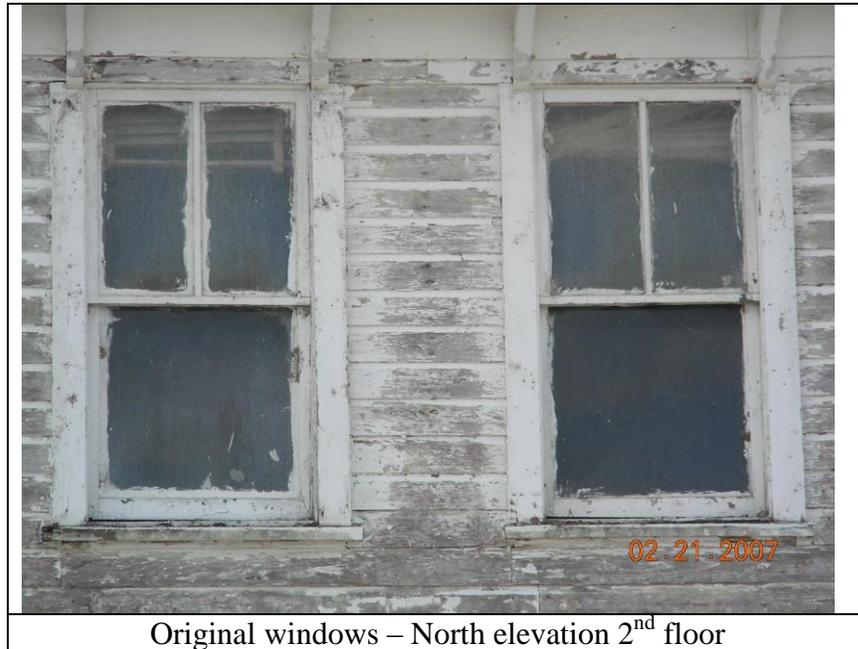
Feature	Material Type	Joinery/Tool Marks	Condition Rating	Priority Rating
Windows	Indigenous hardwoods		Fair to Poor	Serious
<p>Feature Description - The windows in the original structure vary. On the second floor in the north and west elevations, the windows are two over one double hung sash. In the east elevation, the original window was removed and replaced with more modern aluminum awning style window.</p> <p>On the first floor, the original double hung sash window in the west window was removed and a large fixed picture window installed.</p> <p>The sash are painted white but remnants of both red and green paint are visible.</p> <p><i>See Window and Door Schedule</i></p>				
<p>Feature Condition - The double hung sash are in varying degrees of failure. The majority of the sash are sound, but the glazing is deteriorated and panes of glass are broken or missing. Numerous sections of trim are missing and the sills are rotted. Also, hardware components are missing or non-functioning and the paint system has failed.</p> <p><i>See Window and Door Schedule</i></p>

Original windows – North elevation 2nd floor

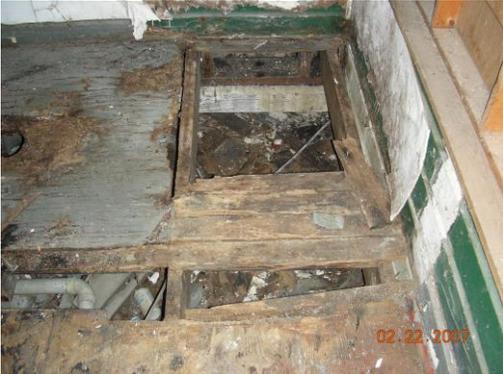
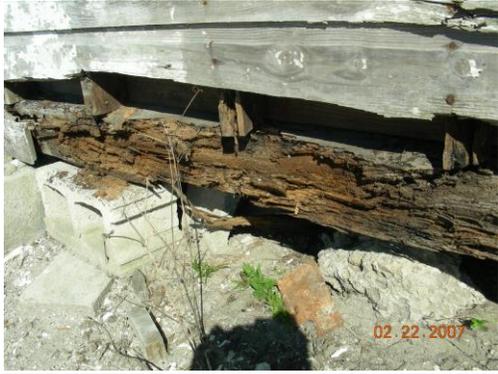
<p>Rotted Joists & Floorboards – Room 203 (2nd floor Addition)</p>	<p>Rotted west elevation sill plate</p>

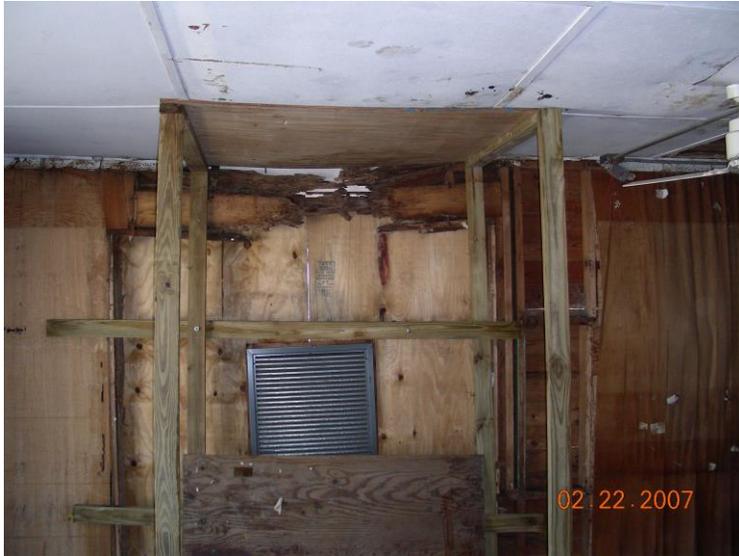
East wall of Addition #2 –
Large opening in wall
enclosed with plywood –
Significant water damage
to structural members

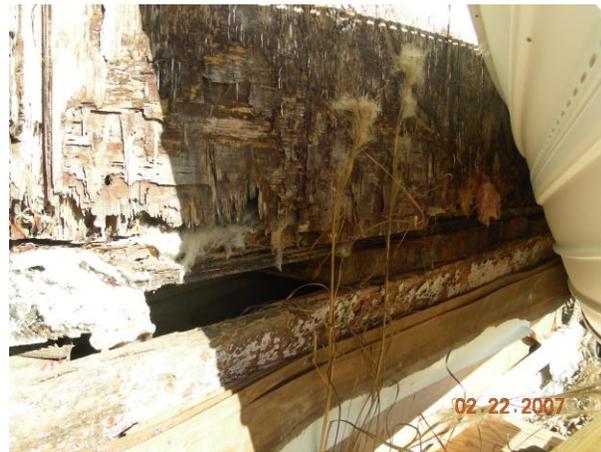
Evidence of
moisture infiltration
east wall of Addition
#2

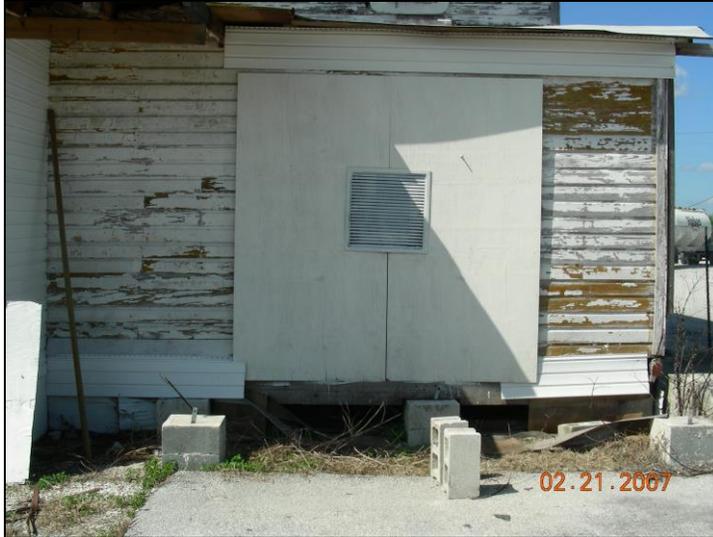
East Wall Addition #1 – Paint deteriorated; bottom boards rotted – covered with vinyl siding; large area missing; Evidence of termite infestation

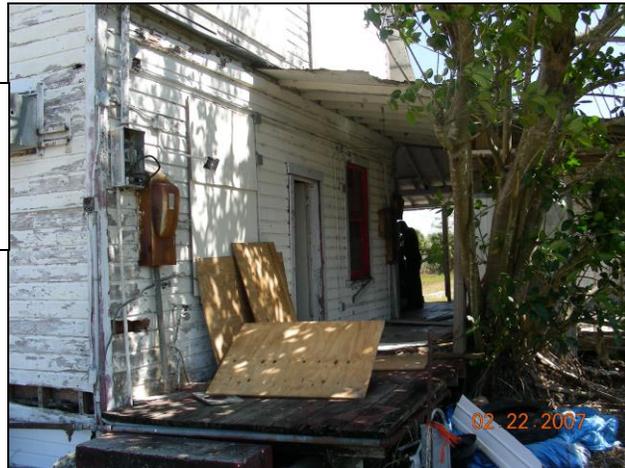
South wall – paint deteriorated; evidence of termite infestation

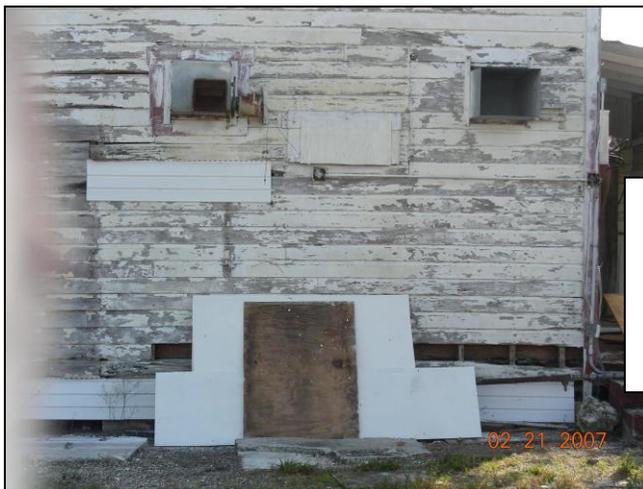
West wall – Boards missing/rotted – covered with vinyl siding; Paint deteriorated; Evidence of termite infestation

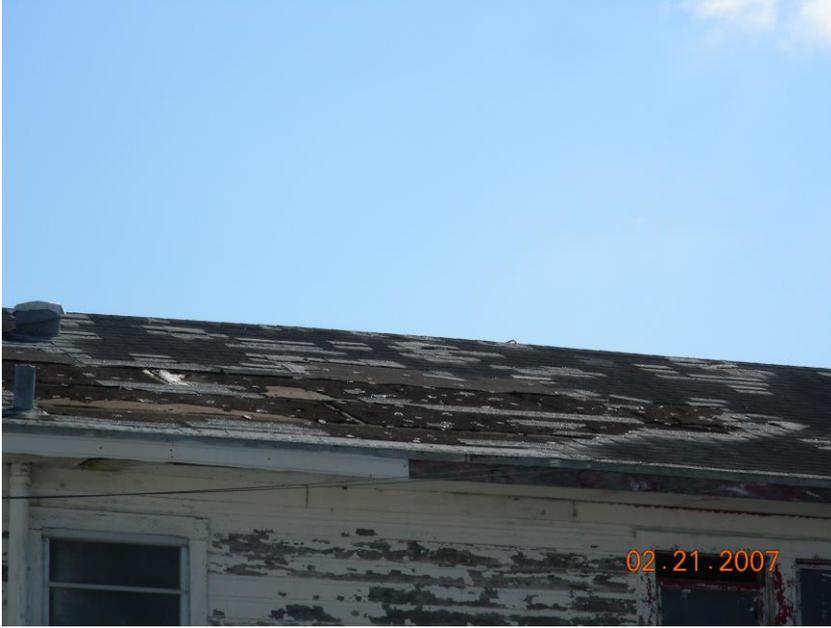
Deteriorated Shingle –
West elevation roof

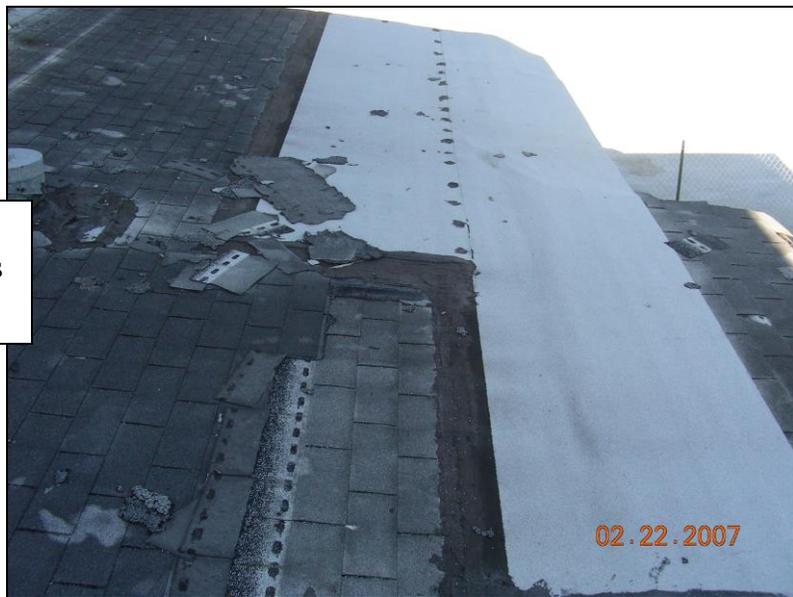
Deteriorated shingles – large
patch – East elevation additions

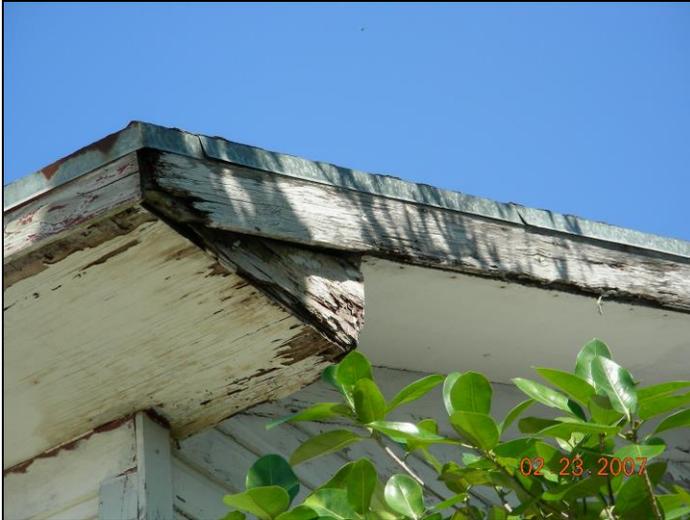
Plywood gable returns – moisture damage; Rake boards deteriorated

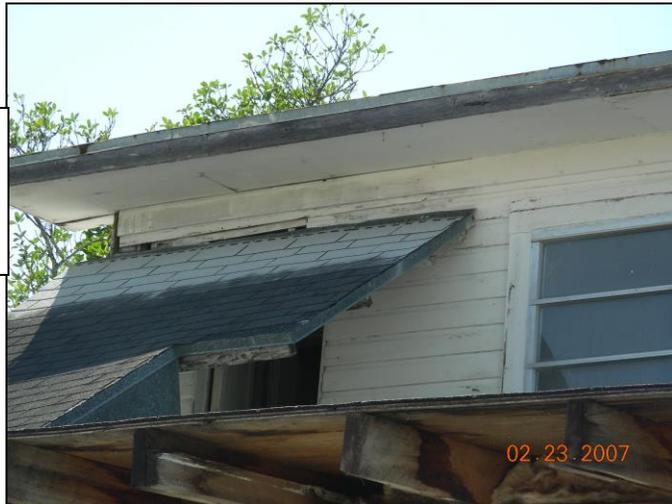
East elevation fascia board extremely weathered; paint failed

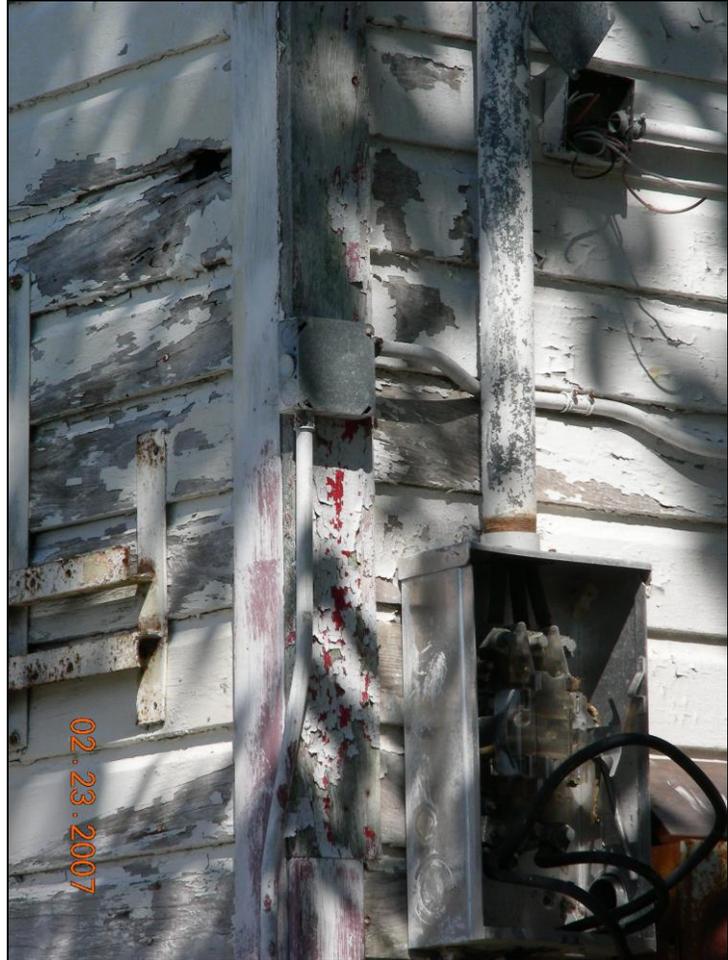
Corner boards south
west corner – Sections
pieced together – termite
infested

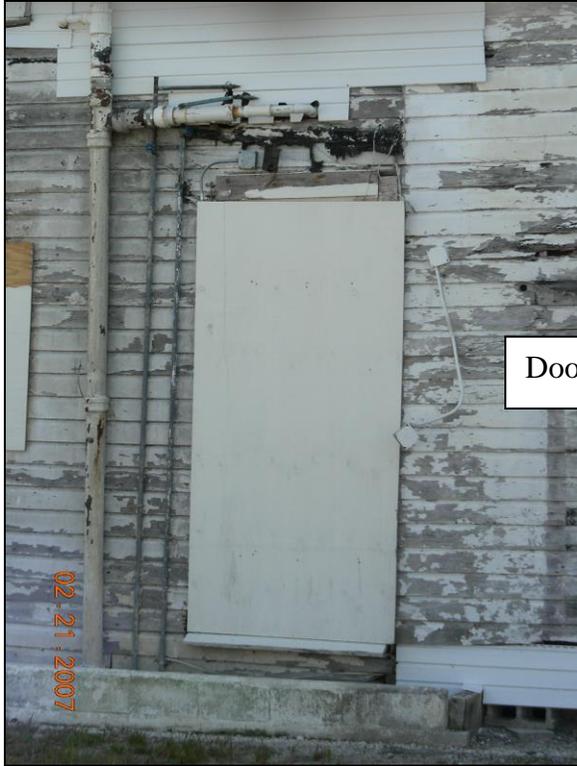
Door missing – west elevation

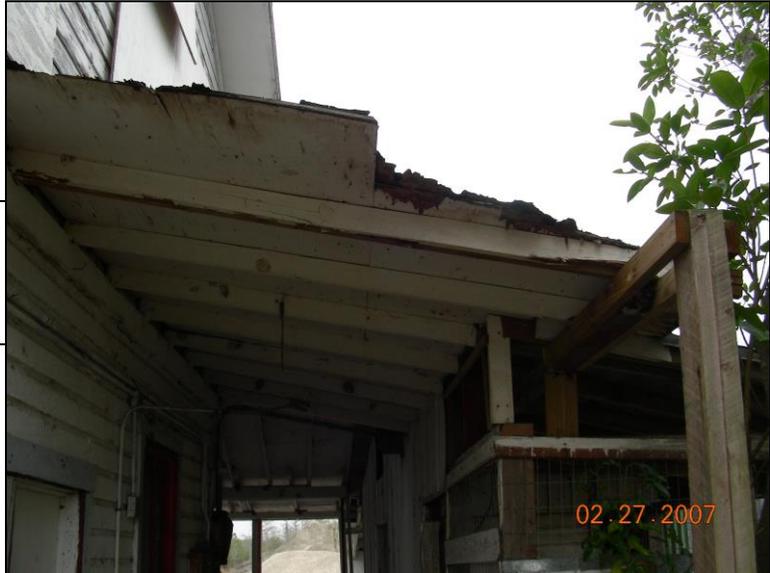
Deteriorated roof structure

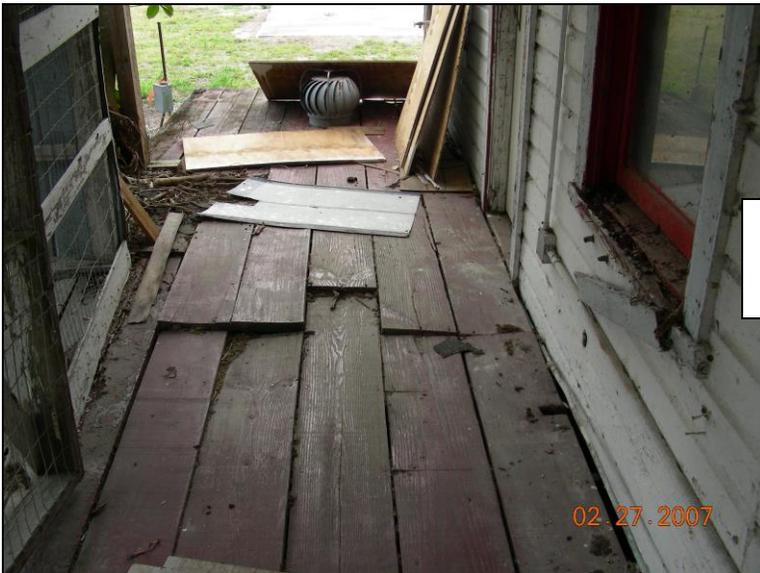
Plank floorboards lifting
– areas patched

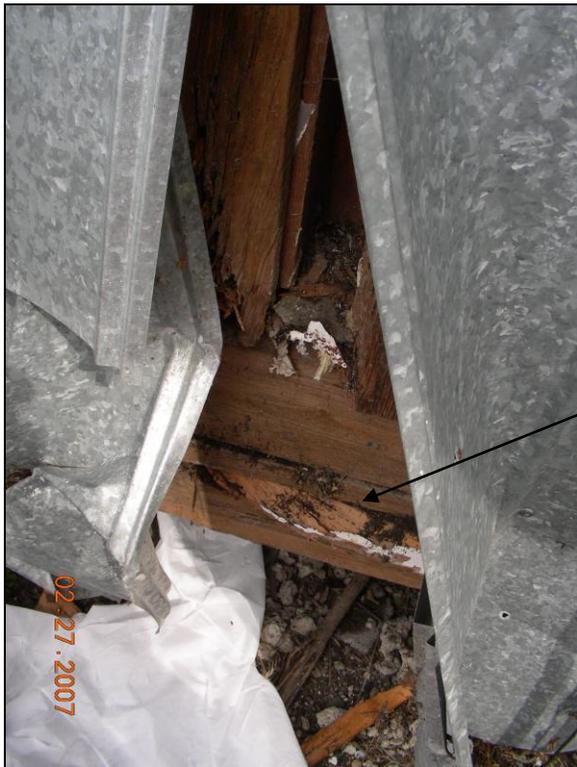
Sill plate rotted south elevation

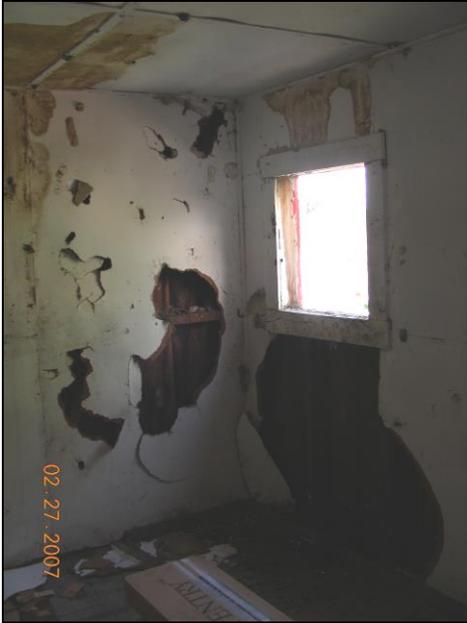
South and west wall –
evidence of moisture
infiltration

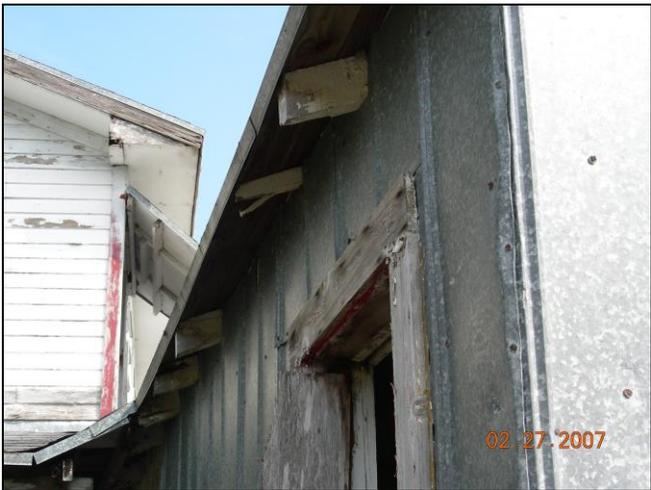
Missing and
deteriorated rafter tails
