CAPE LOOKOUT NATIONAL SEASHORE
Coca-Cola House

HISTORIC STRUCTURE REPORT

**Historical Architecture, Cultural Resources Division
Southeast Regional
Office
National Park Service**

2004

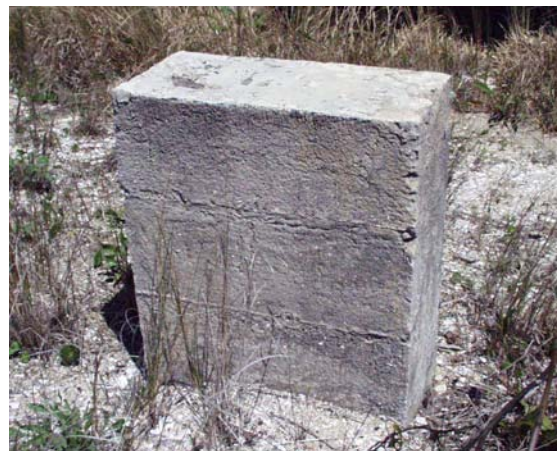
Figure 20 View of typical concrete pier. (NPS-SERO-CR, 2002)

Except for some of the buildings at the old Coast Guard and Lighthouse stations, which were built on brick piers, most of the residences at Cape Lookout were built on wood pilings. The wood frame of the Coca-Cola House, however, was built on poured concrete piers, spaced about six feet apart, and probably set on some sort of spread footing. Piers are about 8" by 15" in plan and 15" high. All of the piers remain in relatively good condition, except where the original porch was removed along the south sides of the house, allowing some of the piers to be overturned or destabilized.

- Eliminate wood- to- ground contact at all locations, repairing damaged beams as necessary.
- Install metal termite shields at all piers.

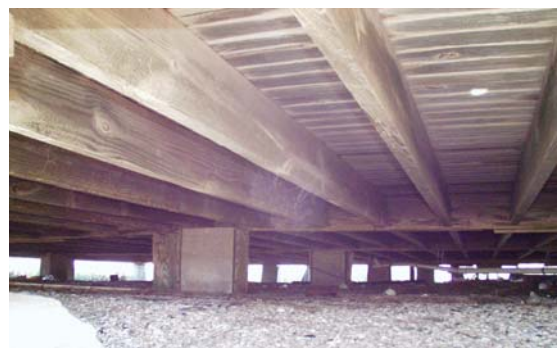
Figure 21 View of typical floor framing. (NPS-SERO-CR, 2002)

A number of the rafters, especially on the south side of the house, have been repaired by sistering new material to the old. The repairs, which are fully visible from the interior, resulted in the removal of small sections of the interior partition walls on the southwest side of the building, but this does not appear to have destabilized the structure. Perimeter sills have also been extensively replaced.

- Rework repaired connections between rafters and wall framing to improve appearance from the interior.
- Reconstruct missing wall framing and paneling at southwest ends of walls on either side of southwest wing of hall.
- Repair termite damage as necessary.

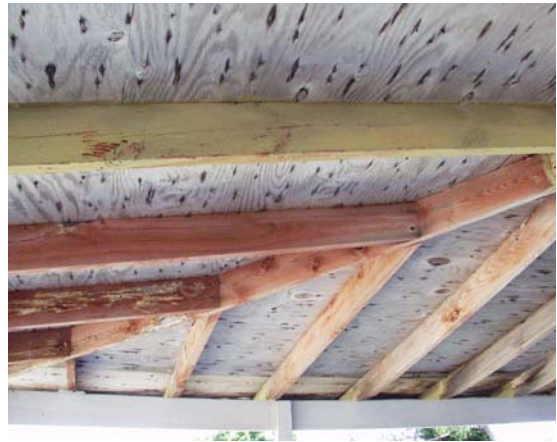
According to tradition, the house was painted red through much of its existence. Traces of this red paint are still visible in the framing of the porch roof around the north corner of the building, and red is also visible on window casing along with white window sash in one of the 1976 photographs. Except for white window sash and an unpainted porch floor, it is

Figure 22 View of original porch roof framing at north corner of house. (NPS-SERO-CR, 2003)

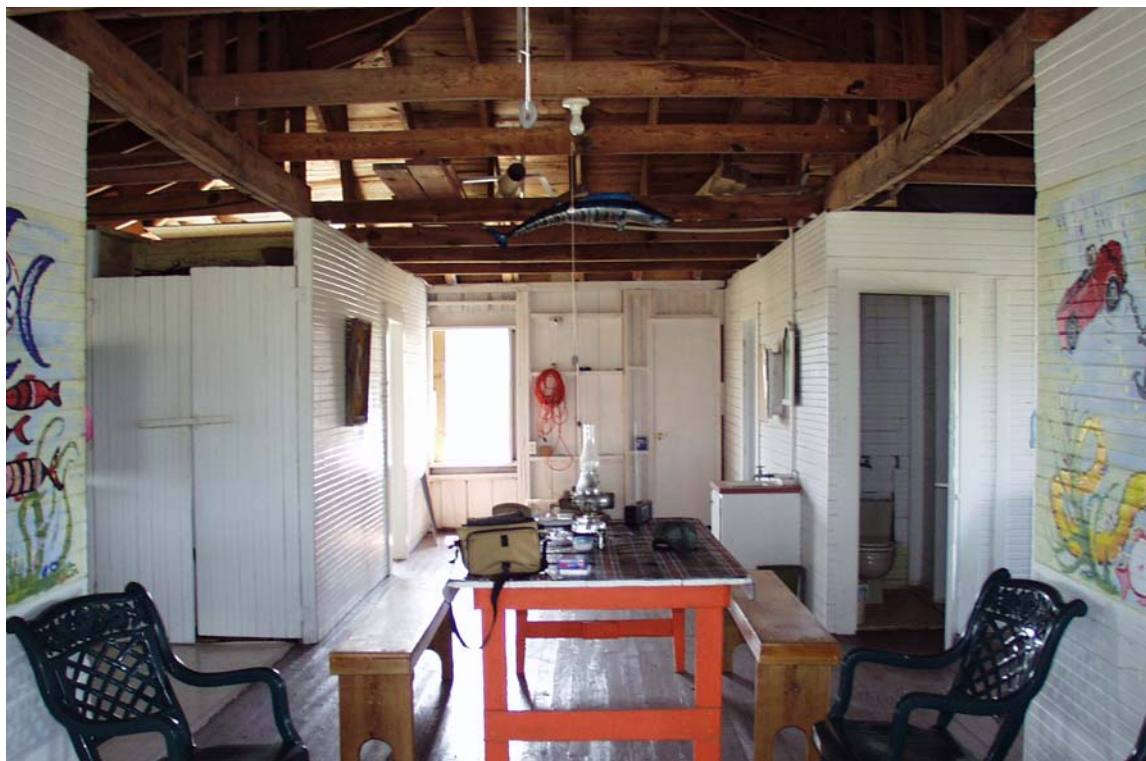
The most significant addition to the house was the garage that was constructed on the southeast side of the house after 1976. Other changes to the building after 1976 were the removal of the exterior battens (but not the boards) and installation of T- III plywood panels over all the exterior walls. At the same time, the window in Room 105 was closed completely, and fourteen of the remaining twenty- two wooden windows were replaced with metal, triple- track storm windows.

Figure 24 View to southeast showing back door now opening to the garage. (NPS-SERO-CR, 2003)

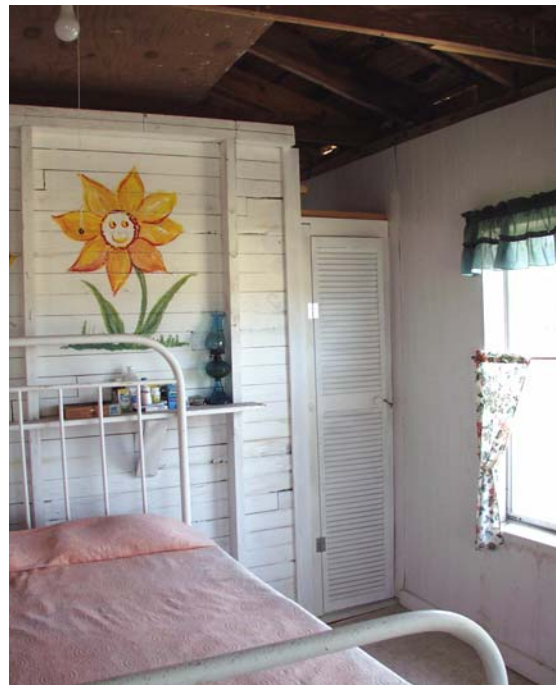
Located in the west corner of the house, this room also measures 12' by 12'. The walls in this room are open to the framing except on the southwest wall which has been finished with sheets of plywood paneling. A small closet, which is apparently contemporaneous with the built- in cabinets in the cross hall, has been created in the south corner of the room by removing part of the southwest end of the southeast wall and installing a 14" louvered shutter as a door. The top plate and wall paneling above this shutter door was also removed, apparently in conjunction with repairs to the roof framing in that area. The floor is covered with a sheet- vinyl floor covering.

Figure 31 View south in Room 102, showing altered wall and added closet door. (NPS-SERO-CR, 2003)
