ENGINEERING STUDY of CAPE LOOKOUT LIGHTHOUSE

May 12, 2005

Project No. 0508-01-00-04

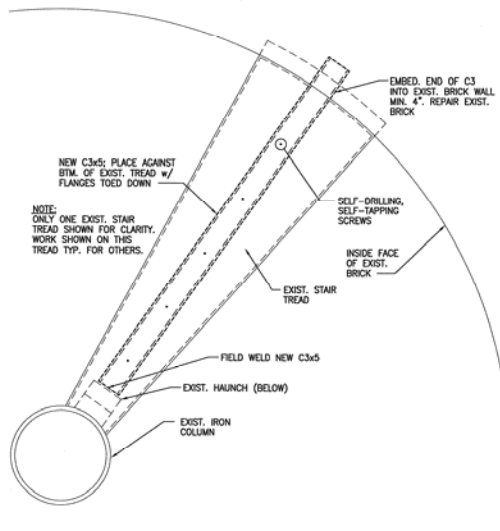
Repair and Stiffen Existing Cast Iron Stair Treads

The existing stair treads span approximately 4'-6" between the inside face of the lighthouse wall and a cast iron column located in the center of the lighthouse shaft. They vary in width from approximately 4" at the column, where they bear on a cast iron haunch attached to the column, to approximately 17" at the wall, where their top plates extend into and bear on the wall. The treads have turned-down edges on three sides, which give them the ability to support light foot traffic over the existing span. However, excessive mid-span deflection of the treads is a concern, as is the long-term serviceability of the treads under repeated foot traffic.

One way to reduce mid-span deflection and provide greater resistance to repeated impact loads would be to reinforce the treads with a structural steel member fastened to the bottom of each one. One end of the new member could be welded to the existing haunch and the other embedded into the brick wall. Preliminary analyses indicate that a channel shape, such as a C3x5, could be used as the reinforcing member, as shown in the following figure:

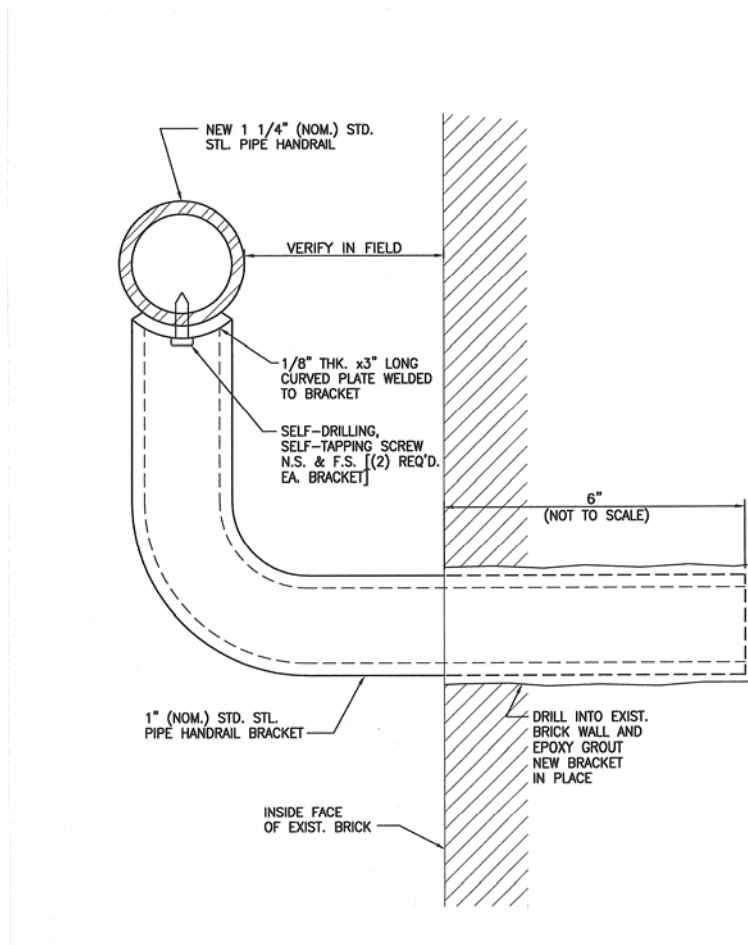
Existing Outer Handrail

The existing outer handrail is constructed of approximately 1" diameter wrought iron solid bar, supported by wrought iron L-shaped anchors inserted in the tower's brick wall. There are two problems with the existing handrail. First, the diameter is much smaller than required by most building codes (1-1/4" minimum). Second, the distance between existing handrail anchors is such that excessive deflection of the handrail can occur under normal use. There are also some anchors that no longer adequately support the handrail because they have worked loose from the masonry into which they are embedded or have corroded away at their base.

Option 2: We recommend that the handrail be replaced with a 1-1/4" diameter pipe rail with wall anchors as shown in the following figure:

The open ends of the new rail will be closed and turned down so that, visually, the old and new handrails would appear similar.

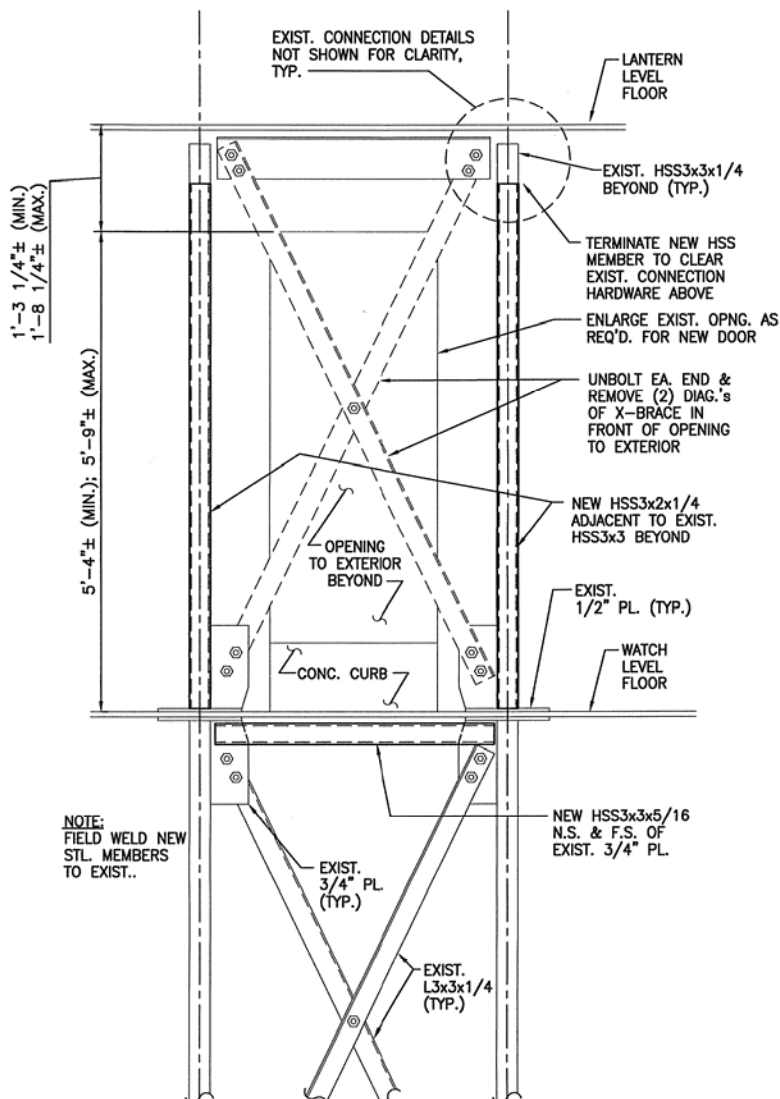
Modify Structural X-Bracing at Door to Outdoor Gallery

Access to the outdoor gallery from the Watch Level is severely impeded by the X-bracing installed in front of the door opening in the late 1980's.

Our analysis of the X-bracing system around the inside of the upper levels of the lighthouse finds it to be redundant enough to allow removal of the section of bracing at the door opening. The two diagonal angles that block the door opening can simply be unbolted and removed. The vertical members on each side of the opening should then be reinforced and a new horizontal strut constructed just below the Watch Level deck, as shown by the following figure:

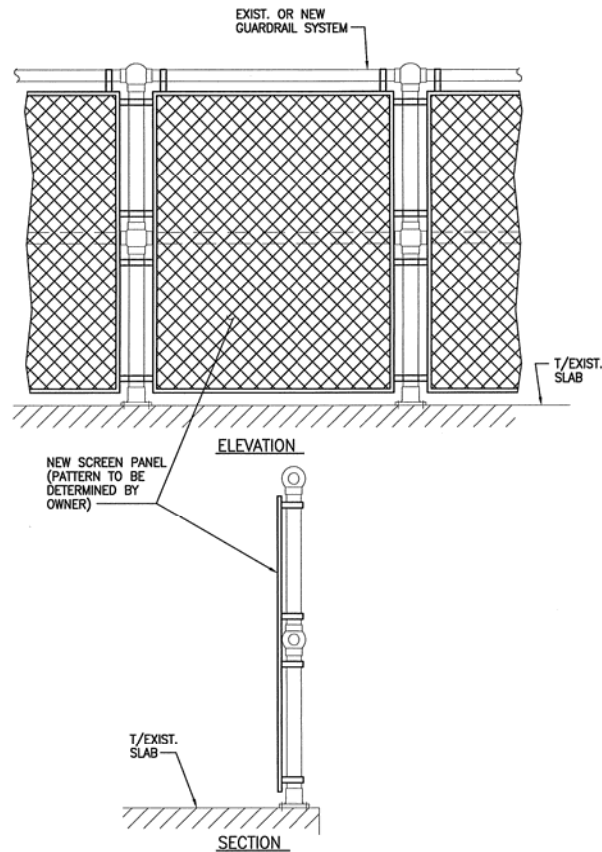
Existing Outdoor Gallery Guardrail Modifications

Some of the cast iron posts and rails of the existing guardrail around the outdoor gallery deck are deteriorated to the point of needing replacement. The rest could be cleaned and repainted and remain in use. Any repair of existing guardrail components should be performed in accordance with the "Iron" section of the *Historic Lighthouse Preservation Handbook*, created through cooperative partnership between the National Park Service, the U.S. Coast Guard, and the Department of Defense.

The primary structural concern with the existing guardrail is that each post must be properly anchored to the concrete gallery deck. This concern could be addressed by providing additional anchors at the base of each post.

New post and rail construction should replicate the existing guardrail system. However, in order to meet building code requirements for guardrails in public spaces, modifications to the guardrail will be required. The open spaces between guardrail components must be reduced to less than four inches. This can be accomplished in a number of ways, including installing perforated stainless steel screen panels, expanded stainless steel screen panels or "extruded" anodized aluminum screen panels along the inside of the existing guardrail. The following drawing shows one potential solution to the guardrail problems:
