CAPE LOOKOUT NATIONAL SEASHORE  
Cape Lookout Village  
FISHING COTTAGE #2

# HISTORIC STRUCTURE REPORT

**2004**

2004  
Historic Structure Report  
Fishing Cottage #2  
Cape Lookout National Seashore  
Cape Lookout Village  
LCS#: 091833

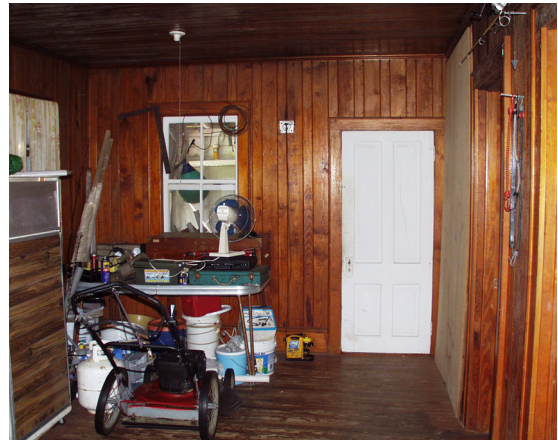
**Figure 15** View to southwest in Room 100. (NPS-SERO-CR, 2002)

At the northeast end of the main room is a pine counter 6’- 11” long and 25” deep with a porcelain- enameled sink. Although the formica counter top is modern, the base cabinet, which is constructed of the same tongue- and- groove boards used on the walls and ceilings, appears to be original.

The existing kitchen arrangement should be rehabilitated. Cabinet, sink, and pump can be preserved, but the formica counter top, which is a modern replacement of the original can be replaced. The wall-mounted shelves and cabinet should be preserved.

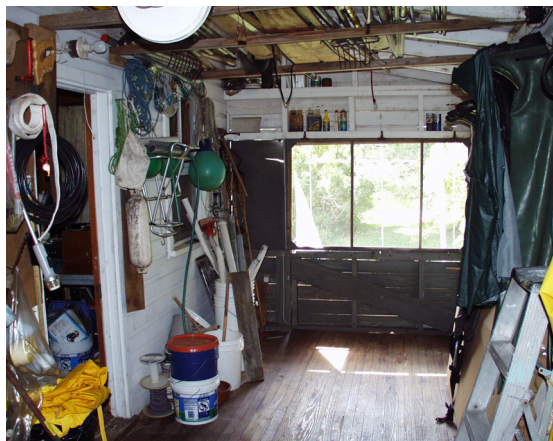
**Figure 18** View to southeast on porch. (NPS-SERO-CR, 2002)

The northwest end of the porch has been partially enclosed in recent years to allow installation of a shower and toilet. At the southeast end, the knee wall has been cut and hinged to swing open and part of the wall above the screening has been removed to increase vertical clearance. These alterations are associated with the ramp that allows small vehicles to be stored on the porch.

- Reconstruct missing portions of southeast porch wall
- Remove plywood shutter at southeast end and replicate board- and- batten shutters to match original shutters elsewhere on the building
