Cape Lookout National Seashore  
O'BOYLE - BRYANT HOUSE  
**HISTORIC STRUCTURE  
REPORT**

2004  
Historic Structure Report  
O'Boyle- Bryant House  
CAPE LOOKOUT NATIONAL SEASHORE  
Cape Lookout Village  
LCS#: 271581

## Historic Structure Report

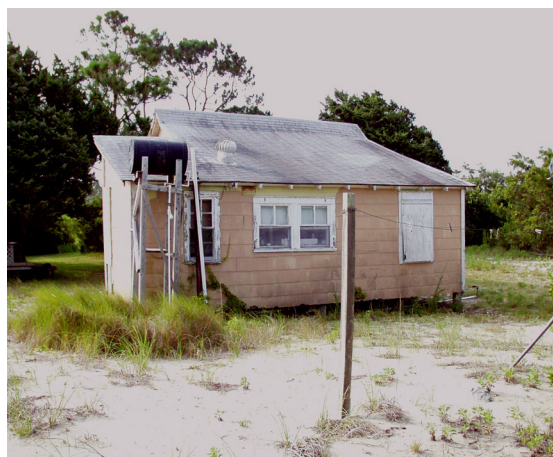
**Figure 25** View to south of O'Boyle-Bryant House, showing elevated water tank. (NPS-SERO-CRS, 2002)

Against the northern end of the rear wall of the house is a wooden structure on which a small elevated metal water tank is mounted. Too high to function as a cistern, this tank is used to provide water for an outdoor shower and for flushing the broken toilet inside the house.

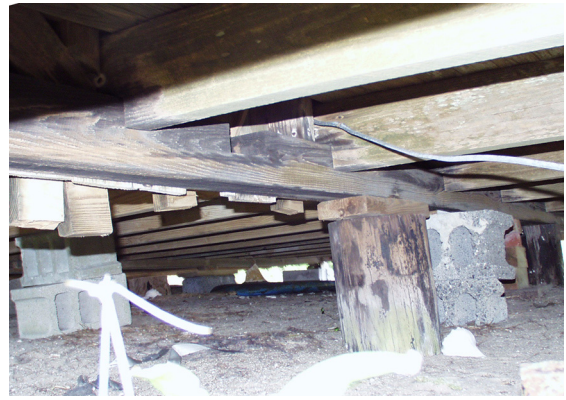
**Figure 27** View of front sill of original house. Original siding extends below the bottom of the sill to left of center in this image. (NPS-SERO-CRS, 2002)

at the rear of the house has been severely damaged by termite infestation. Floor joists for this historic addition are around 1- 3/4" by 5- 5/8" as are those in the post- WWII bathroom extension.

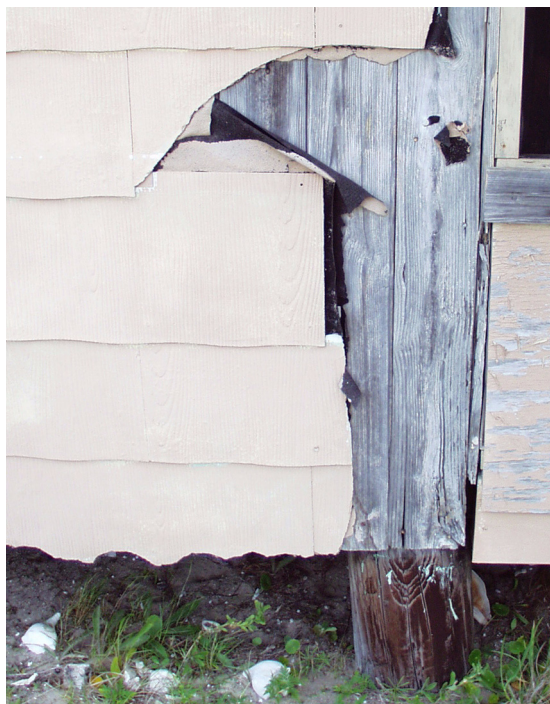
**Figure 28** View of south corner of house showing original siding at center, asbestos siding at left, and modern plywood at right. (NPS-SERO-CRS, 2002)

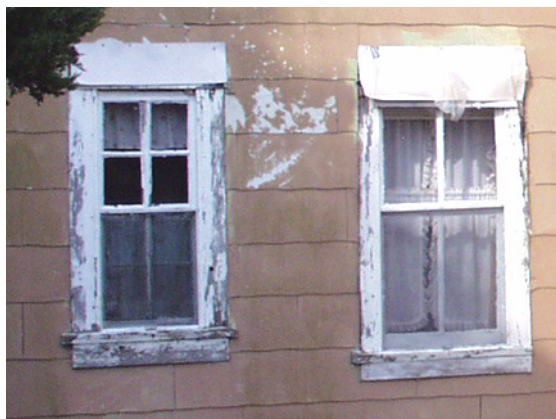
**Figure 31** View of Windows 8 and 9 on northeast side of house. (NPS-SERO-CRS, 2002)
