Cape Lookout National Seashore

Portsmouth Life- Saving Station

Historic Structure Report

2006

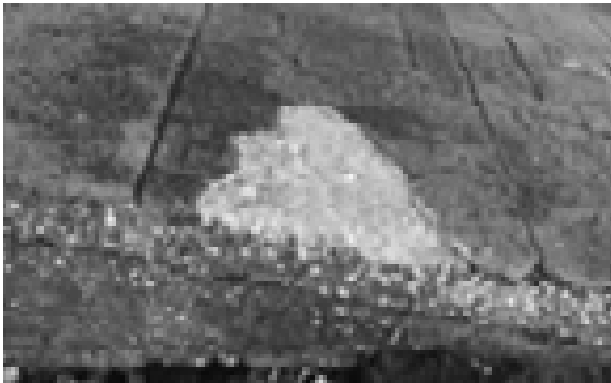
FIGURE 56. View of deterioration on ramp to small boat-room door. (T. Jones, NPS, 2005)

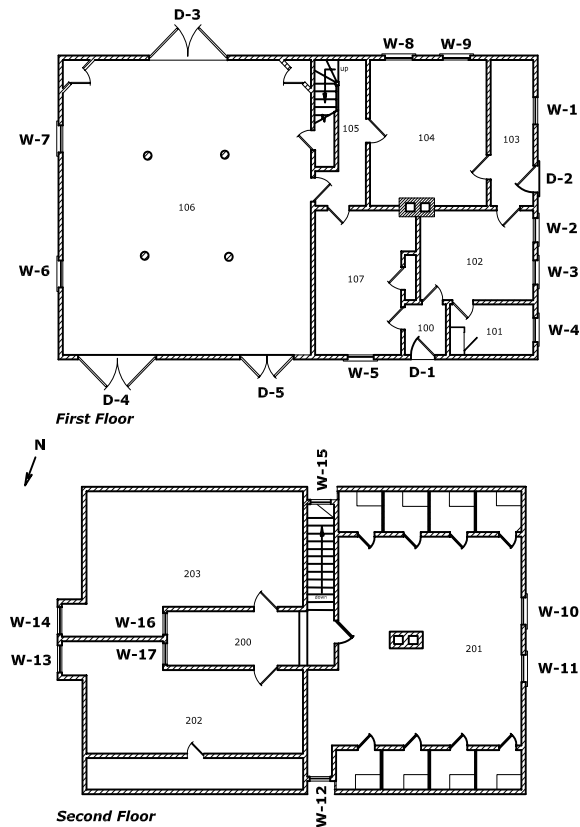
FIGURE 73. Plan showing numbering of windows and doors. (T. Jones, NPS, 2005)

W-1	3'-4" by 2'-9", single sash, nine lights, originally top hinged
W-2	2'-10" by 5'-8", nine over two, double hung, one light broken
W-3	2'-10" by 5'-8", nine over two, double hung, one light broken
W-4	2'-10" by 5'-8", nine over two, double hung, two lights broken
W-5	3'-4" by 5'-10", nine over two, double hung
W-6	3'-4" by 5'-10", nine over two, double hung, sash and frame out of opening
W-7	3'-4" by 5'-10", nine over two, double hung
W-8	3'-4" by 5'-8", nine over two, double hung, ropes broken
W-9	3'-4" by 5'-8", nine over two, double hung, ropes broken
W-10	3'-0" by 4'-4", six over two, double hung
W-11	3'-0" by 4'-4", six over two, double hung
W-12	2'-10" by 4'-4", six over two, double hung
W-13	3'-0" by 4'-4", six over two, double hung, ropes broken
W-14	3'-0" by 4'-4", six over two, double hung, ropes broken
W-15	2'-10" by 4'-4", six over two, double hung
W-16	2'-6" by 2'-7", single sash, four light, top hinged, all glass missing

Condition: Some of the sash may have been replaced, and most are in good condition, although many of the counterweight ropes are broken and there are several panes of broken glass. The sash in the attic window, which are almost certainly original, are badly weathered, primarily because the interior side of the sash has not been maintained. At the northeast end of the boat room (Room 107), recent storms badly damaged both windows (w- 6 &

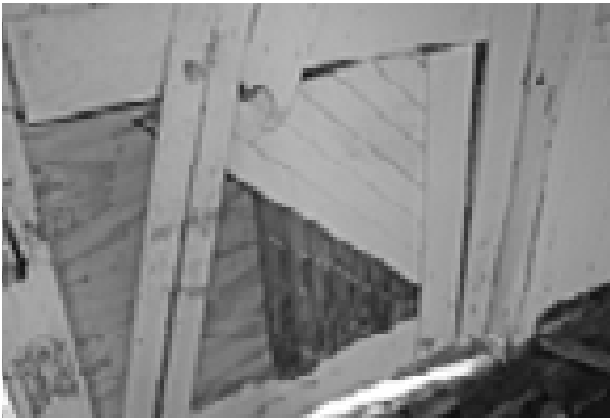
FIGURE 84. View of damage to lower panel of leaf of Boat Room door D-5. (T. Jones, NPS, 2005)

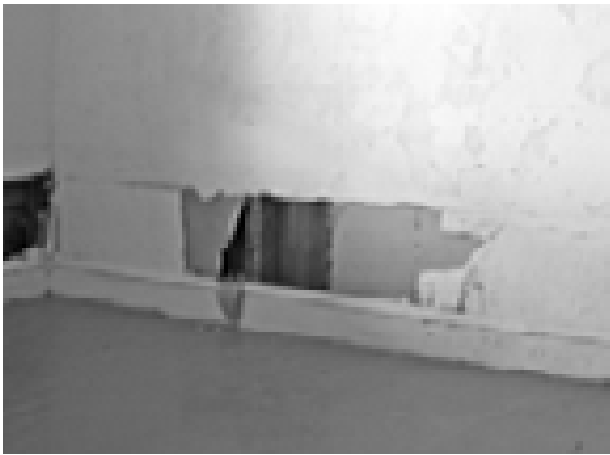
FIGURE 89. View of water-damaged plaster on rock lath in Room 106. (T. Jones, NPS, 2005)
