# HISTORIC STRUCTURE REPORT The Wright Cycle Company Building

(HS - 01)

Dayton Aviation Heritage National Historical Park  
Dayton, Ohio

March 31, 1999  
Final Submission

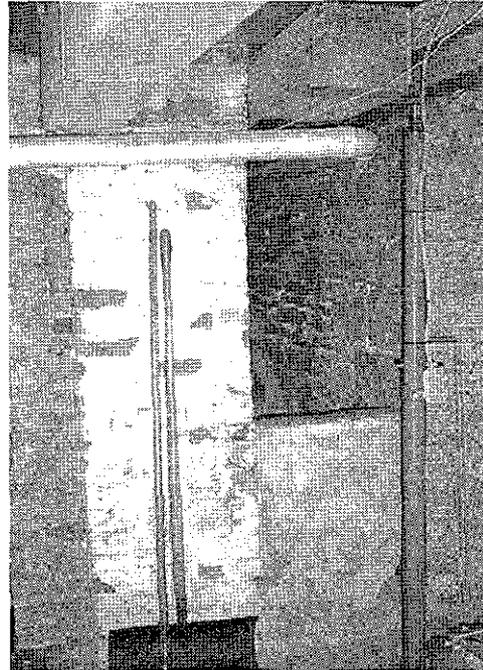
Figure 2: The chimney was constructed at the time of the addition. The brick infill at the left of the chimney indicates that it was not part of the original wall.

Two chimney chases are currently located at the basement level: one at the western half of the north wall, the other near the center of the east wall. The east chimney is not original, as indicated by the brick infill used on the north side and the former stairwell behind it (Figure 2). This chimney was probably added as part of the addition construction. One interior wood stair at the east end of the south wall leads up to the first floor. There is one small window over the stair, high in the south wall. An original window in the east wall, south end, was bricked up, probably when the addition was built.

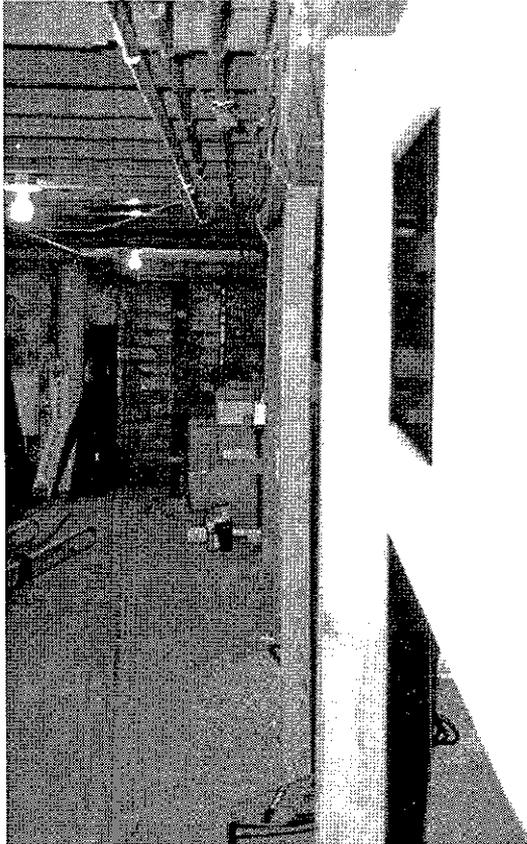
Figure 2 View of columns E (in the foreground) and D (in the background), 1996 (Fitzpatrick Structural Engineering).

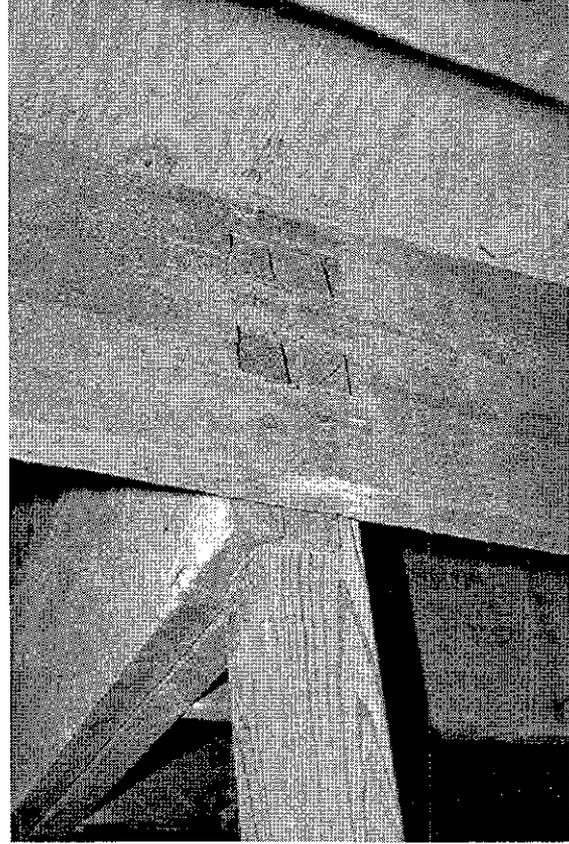
Figure 3 View of the eastern connection between the stair header, joist and wood post, 1996 (Fitzpatrick Structural Engineering).

In general, the joists are in good condition with few splits, shakes, checks, or knots. A double header is used to frame the stairway. Double mortise and tenon connections are used and can be observed in the single joists picking up the header load. In addition to the single joists, two newer wood posts are supporting the double header.

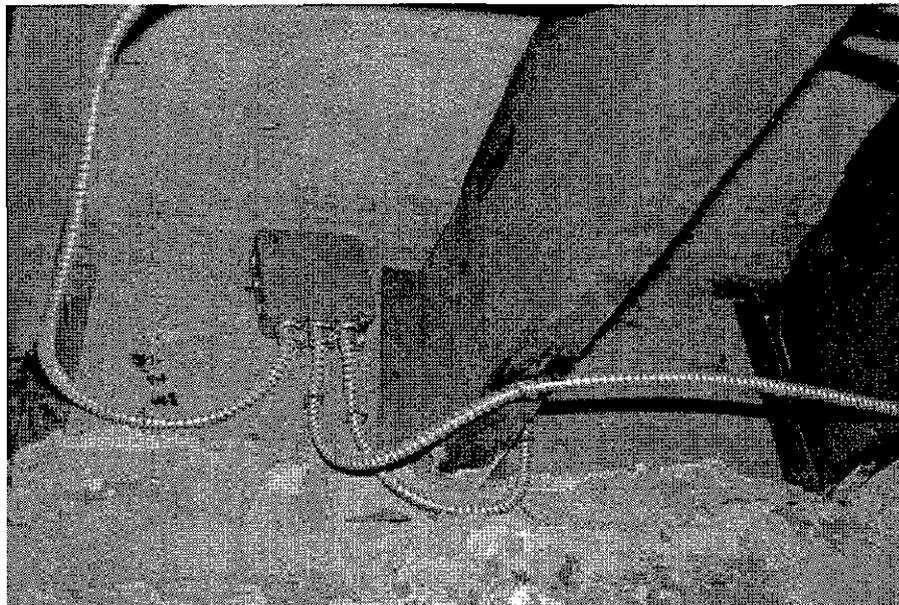
Figure 4 View of the joists rolled on the south bearings and new metal joist hangers, 1996 (Fitzpatrick Structural Engineering).

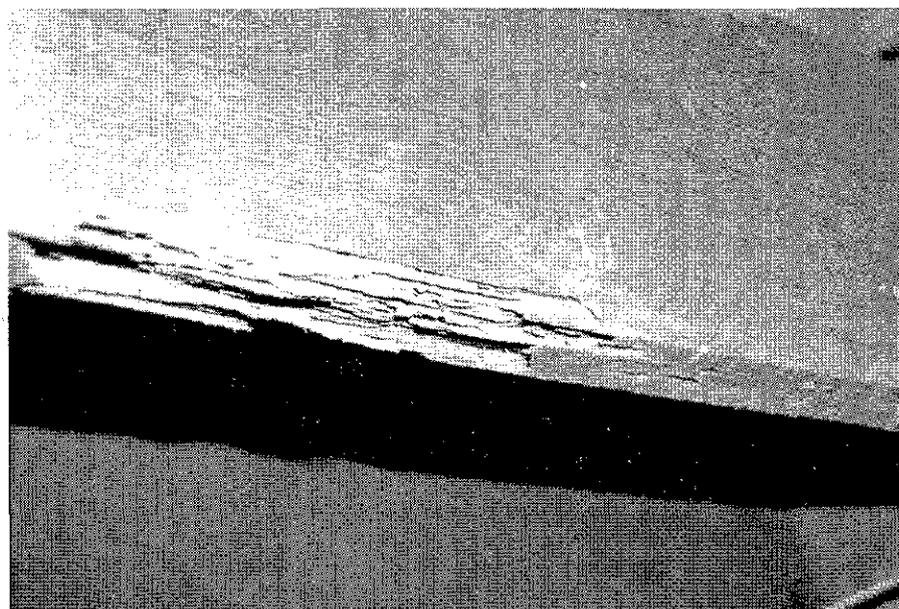
This insect damage appears to have ceased and the new members have reinforced this western end of the first floor. The four western-most members have been replaced with newer 2x12s (nominal). The fifth western-most

Figure 5 View of the insect damaged joist, 1996 (Fitzpatrick Structural Engineering).

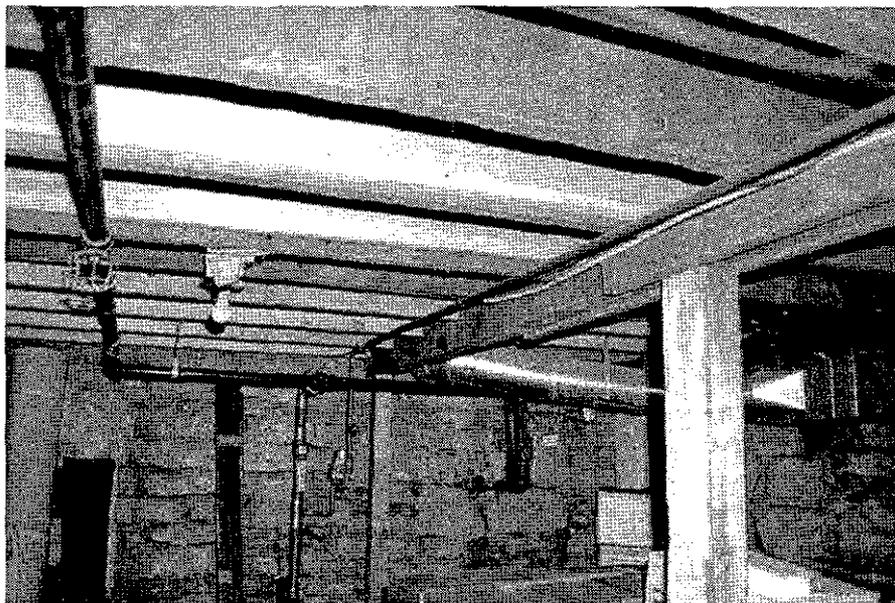
joist is an original joist that has not been reinforced. The sixth and seventh western-most joists have been sistered on their south halves with newer 2x12s (nominal).

Figure 6 View of the western end of the first floor framing, 1996 (Fitzpatrick Structural Engineering).
