Tortugas Harbor Light

Current Status and Treatment Recommendations

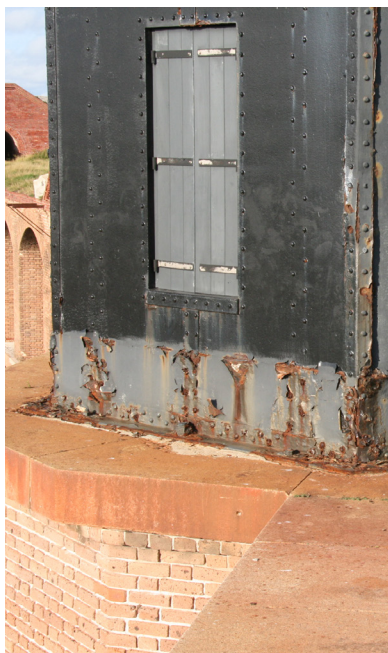
The condition and stability of the Harbor Lighthouse structure is likely to decline rapidly without immediate treatment. General maintenance and intermittent repairs performed in the 1930s, 1970s, 1990s, and 2000s have performed reasonably well and have allowed preservation of the structure for 140 years. However, continuing deterioration and shortening maintenance cycles indicate that the structure is on a downward course.

The Harbor Lighthouse has been temporarily shored to remove load from the most critical and heavily deteriorated components. Exterior scaffolding has been installed up to the third floor and balcony to provide protection from falling debris and sufficient closure. The scaffolding and shoring have been designed to facilitate future disassembly and removal of the Harbor Lighthouse and rehabilitation.

Currently, the NPS is working with Lord Aeck Sargent Architecture (Ann Arbor, MI) on the full design package for a complete rehabilitation of the Tortugas Harbor Light. The proposed, and recommended treatment, involves dismantling the structure and moving it to an

off-site facility for repair and rehabilitation. The level of work currently warranted cannot be adequately performed in-situ. While previous in-situ work has helped sustain the structure to date, those past repairs were completed with potentially incompatible materials and are now deteriorating faster than the original components. Dismantling the structure will allow a thorough evaluation of the material conditions and compatibility issues, and will result in a more durable and long-lasting repairs.
