FORT MATANZAS

HISTORIC STRUCTURE REPORT

FORT MATANZAS NATIONAL MONUMENT
ST. JOHN'S COUNTY, FLORIDA

THE FORT MATANZAS STABILIZATION TEAM

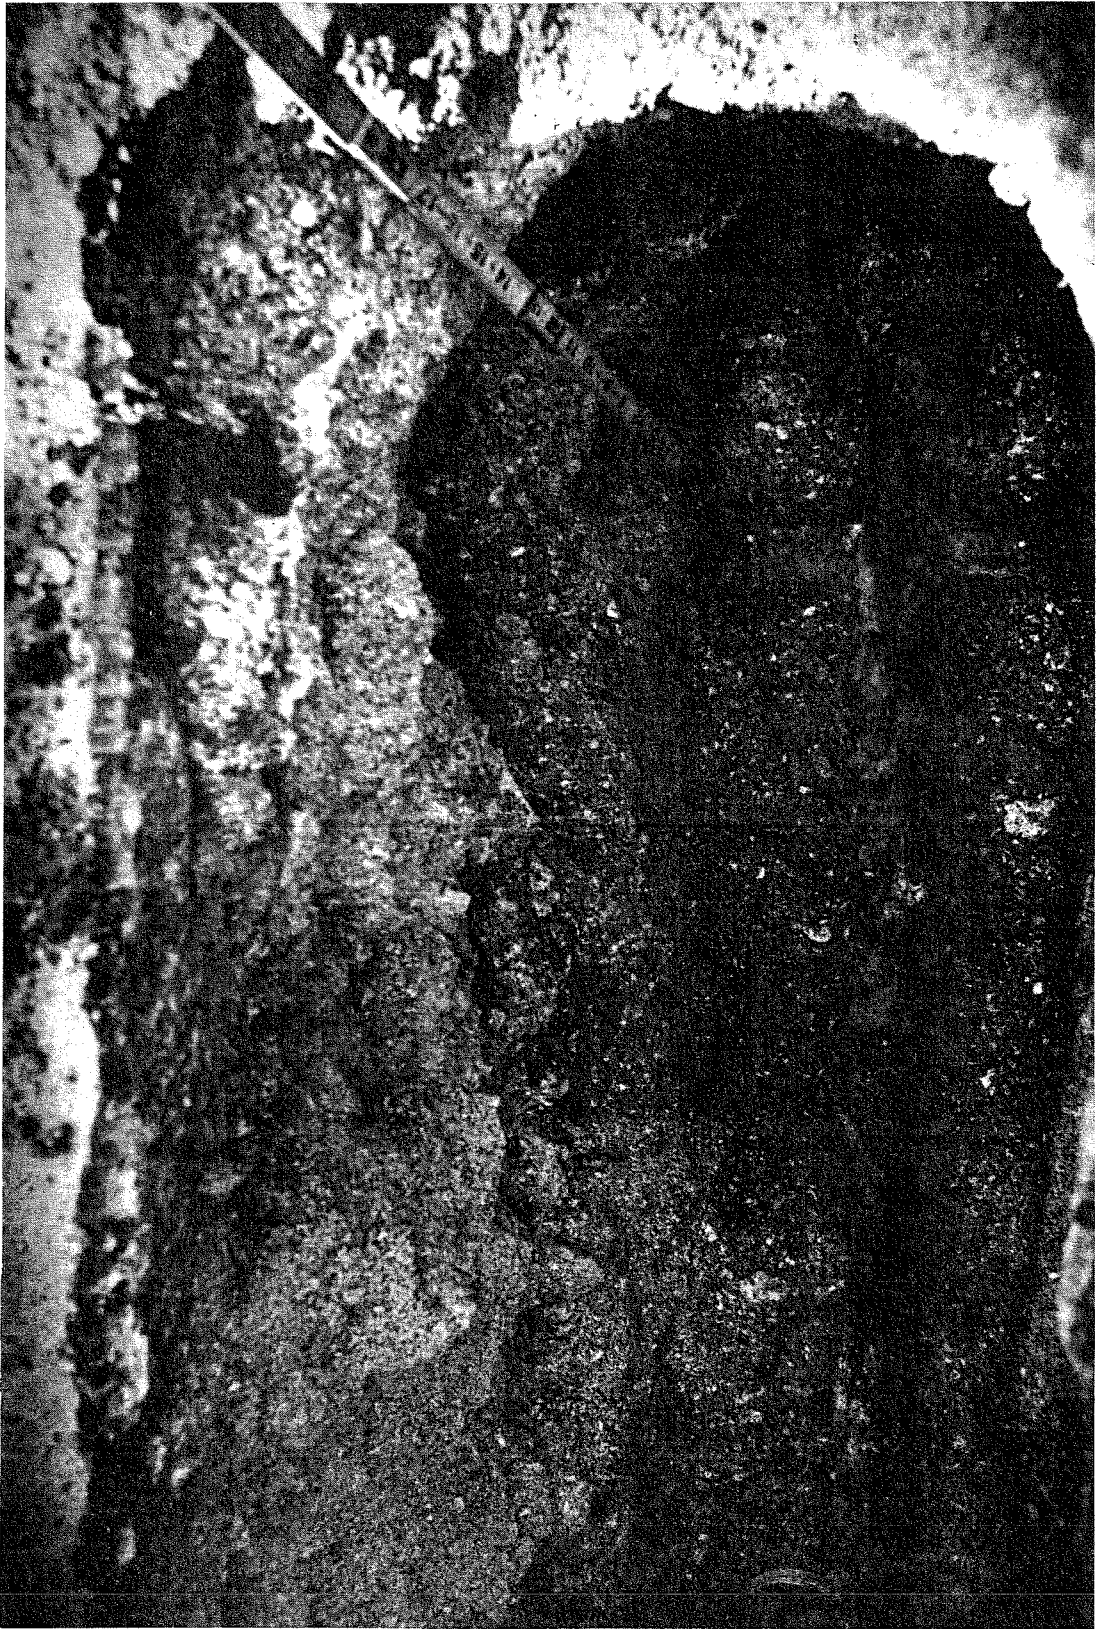
Illustration 25

Notice the courses of the face stones covering the tie rod and plates, particularly the lower which is being dislodged due to the plate exfoliation. The upper course appears intact although the same forces that caused the lower steel plate to exfoliate are at work on the upper set as well as the east face, and in time could cause similar problems.

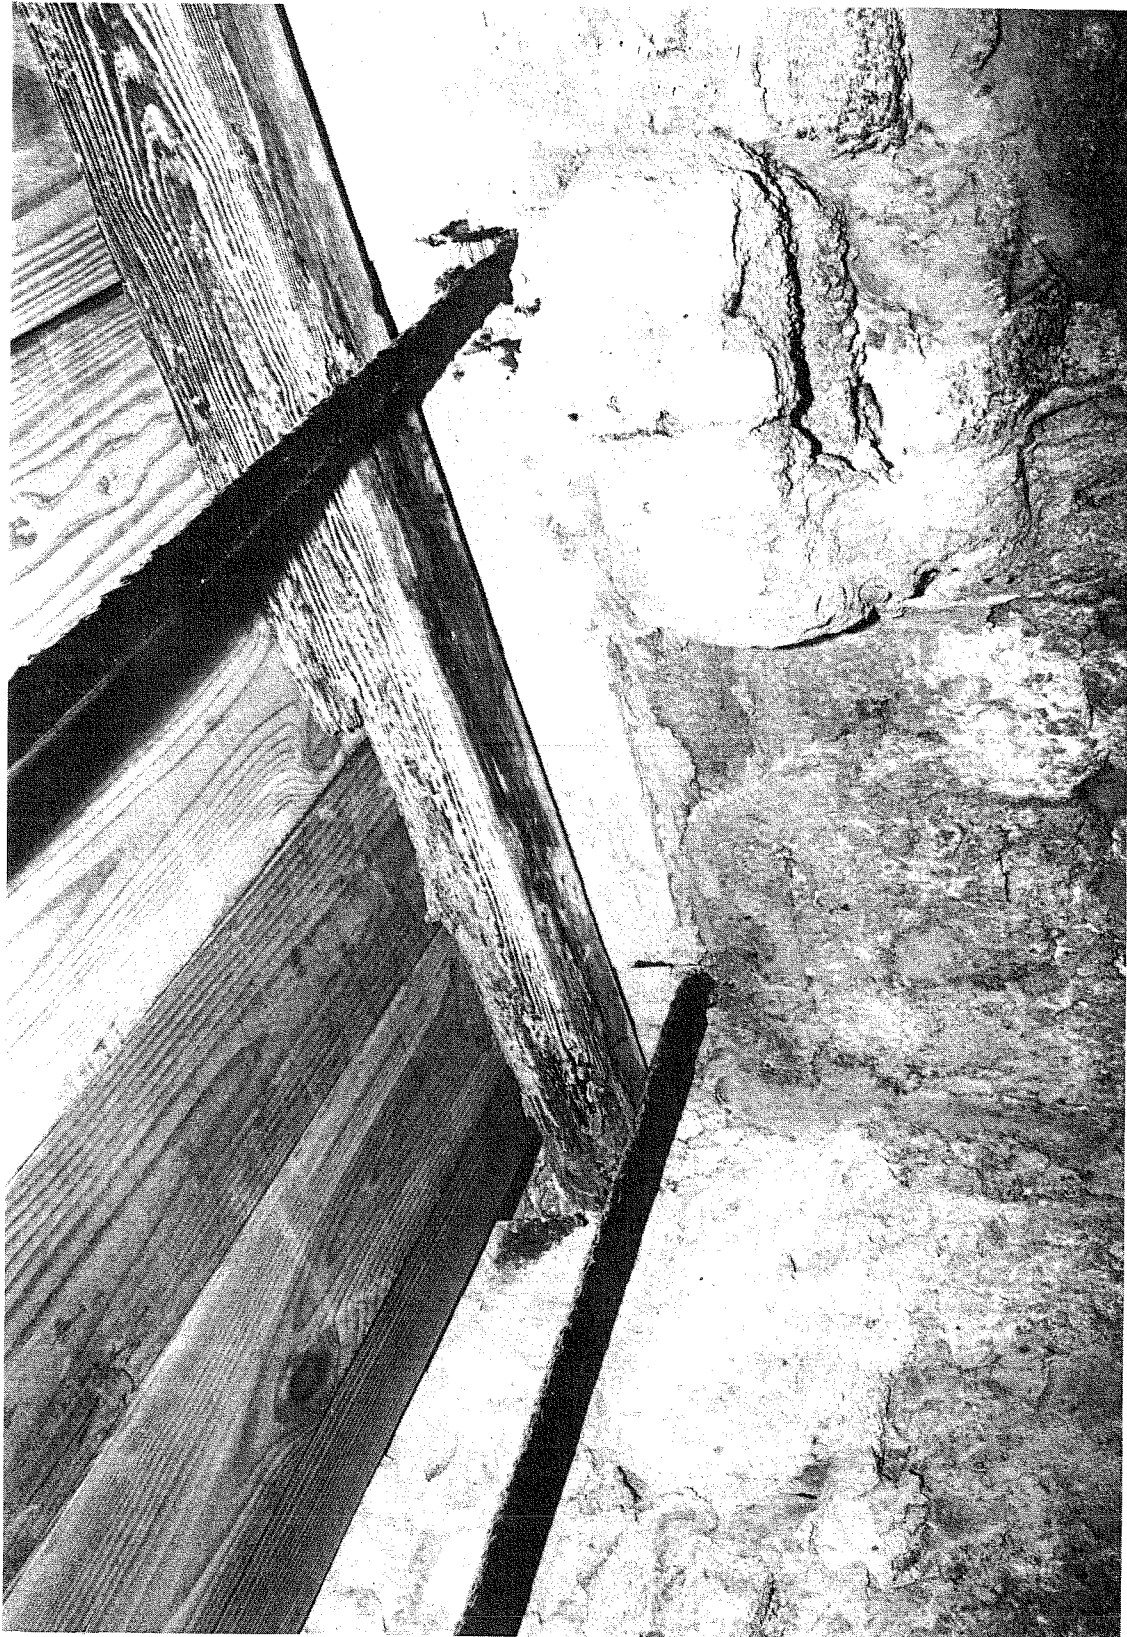
Illustration 27

Notice exfoliated iron.

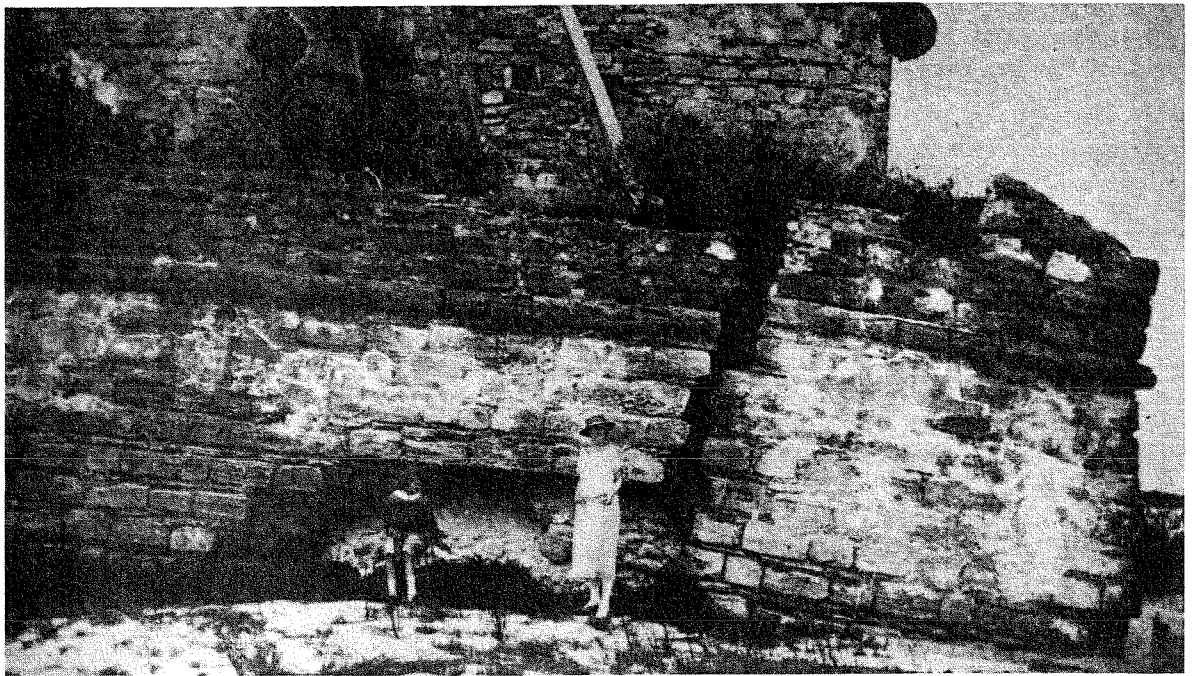
Illustration D-11

The condition of Fort Matanzas was documented by War Department personnel in April 1923. In this view we can see the irregular masonry of the 1916 repair to the south parapet (left). Much vegetation is still present. The scuttle curb wall is intact and like parapet walls, plastered. It also appears to have a special shape along its north and south edges--perhaps to accommodate the once existing hatch or hatch "house."

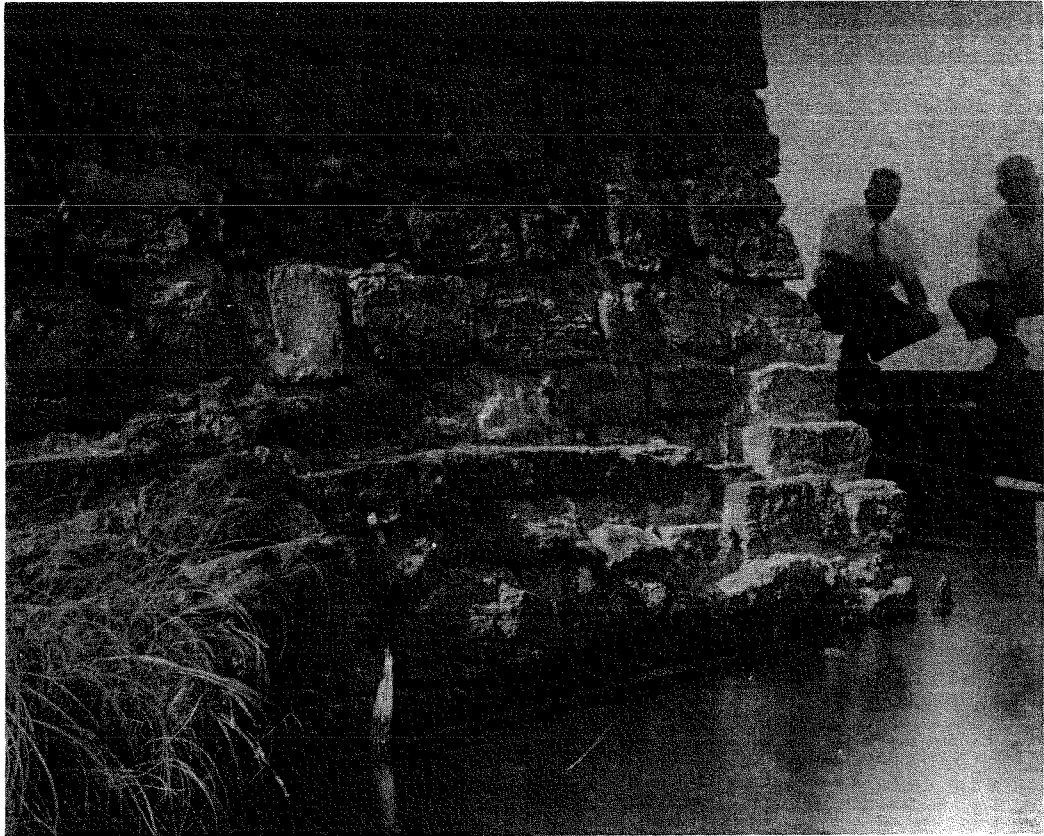
Illustration D-37

Taken in October 1947, this view shows that the southeast corner of the coquina sea wall and fill behind the wall has been removed by the storms of 1944 and 1947.

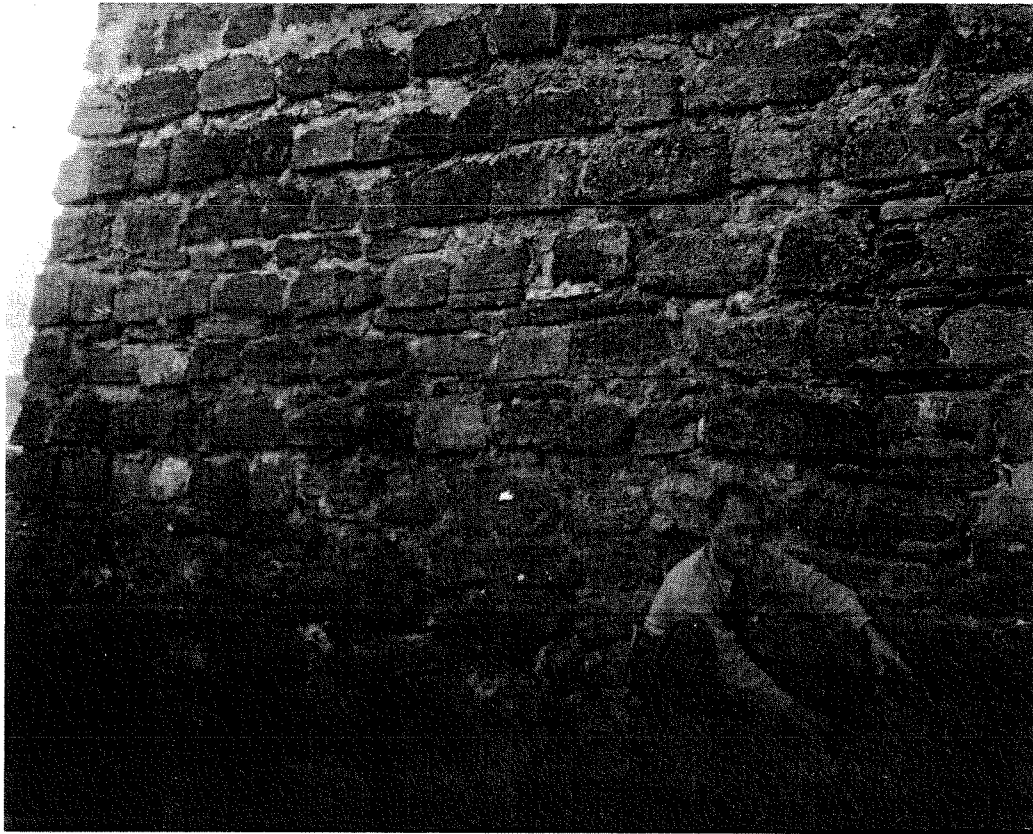
Illustration D-38

The storms of 1944 and 1947 removed a great deal of fill adjacent to the fort and as illustrated here, once again exposed the remains of the wooden foundation at the east salient. Notice that water is trapped between the steel sheet bulkhead and the base of the fort.

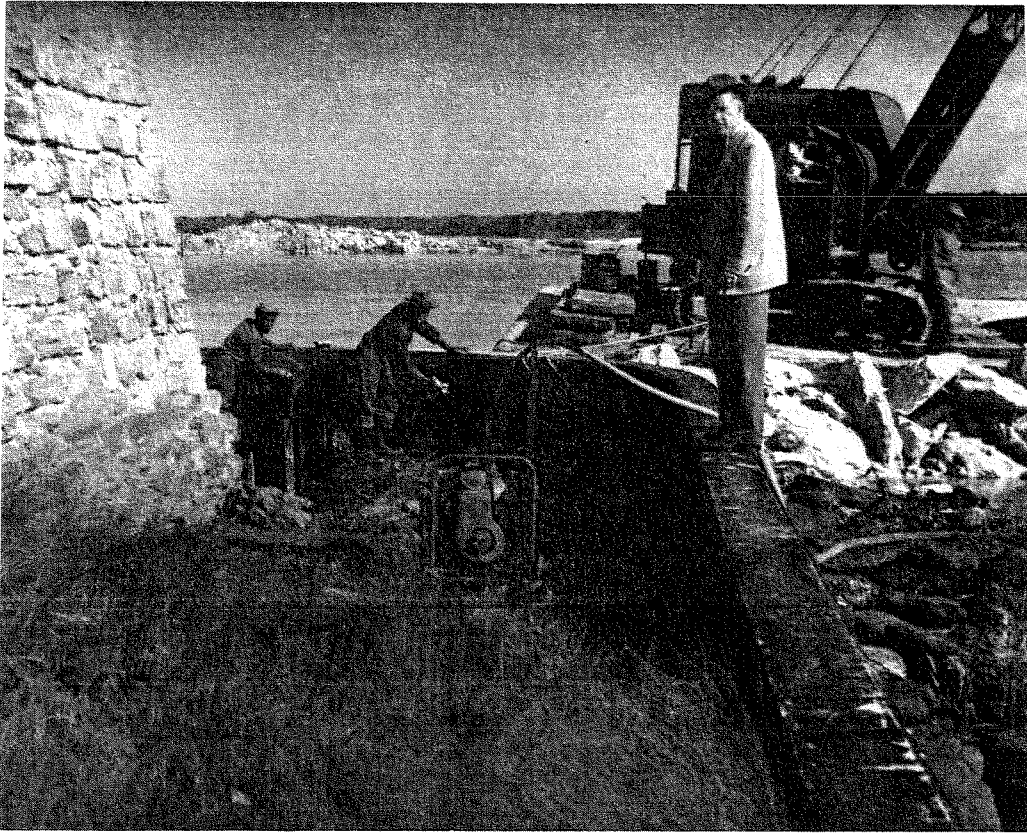
Illustration D-40

Massive riprap was used to repair the southeast corner of the fort site after the storms of 1944 and 1947 removed the coquina sea wall.

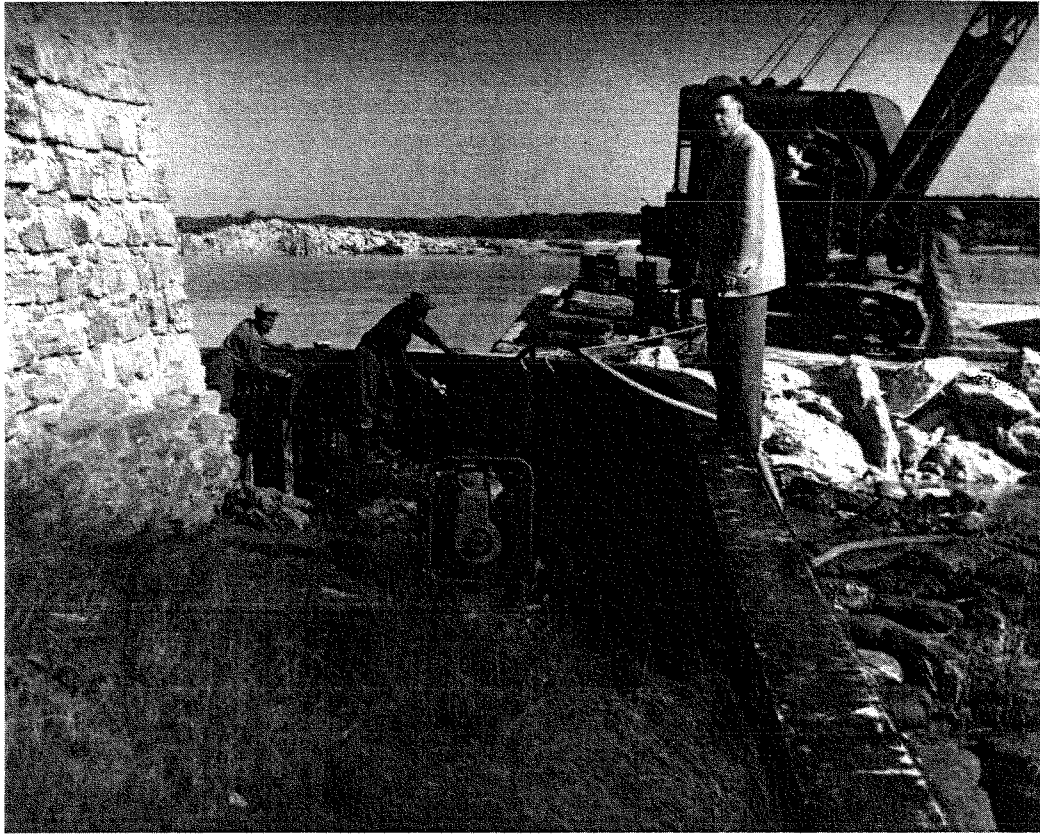
Illustration D-41

This massive riprap groin created an unsightly condition, but probably performed its protective function for fifteen years.

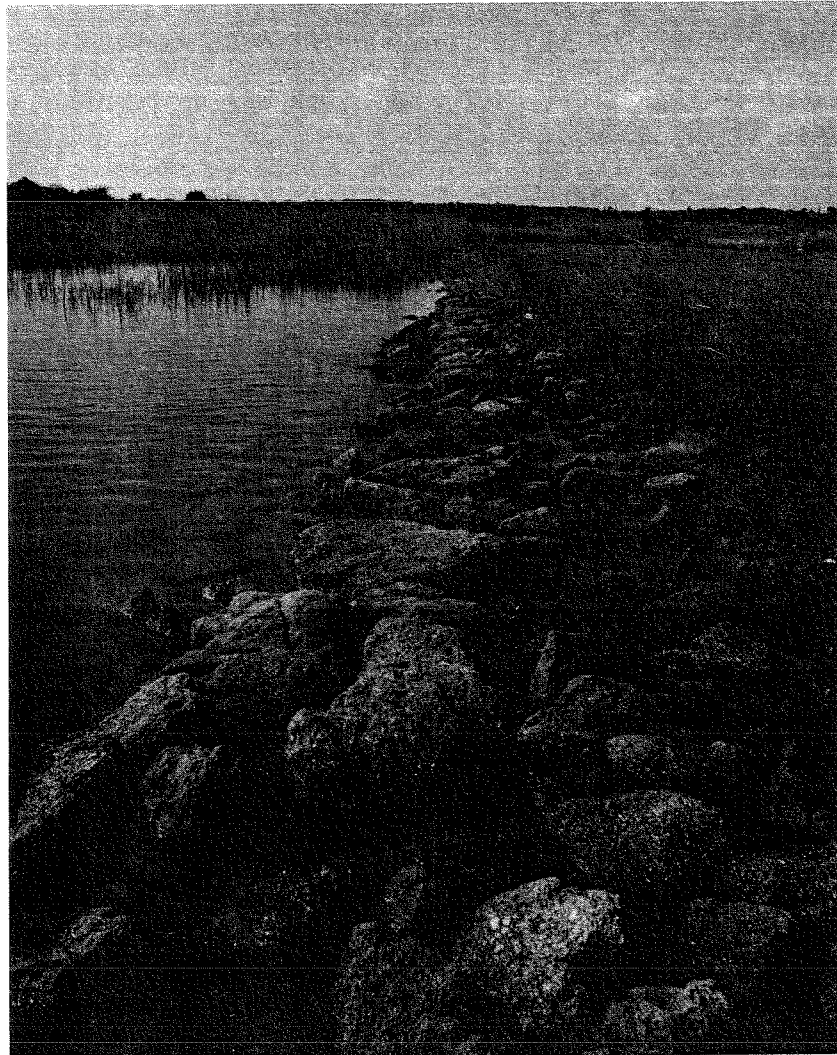
Illustration E-2

This seawall segment presently is covered by coquina riprap (Illus. E-2). Erosion on this side is minimal due to protection by the small island and the wall appears to be in stable condition.

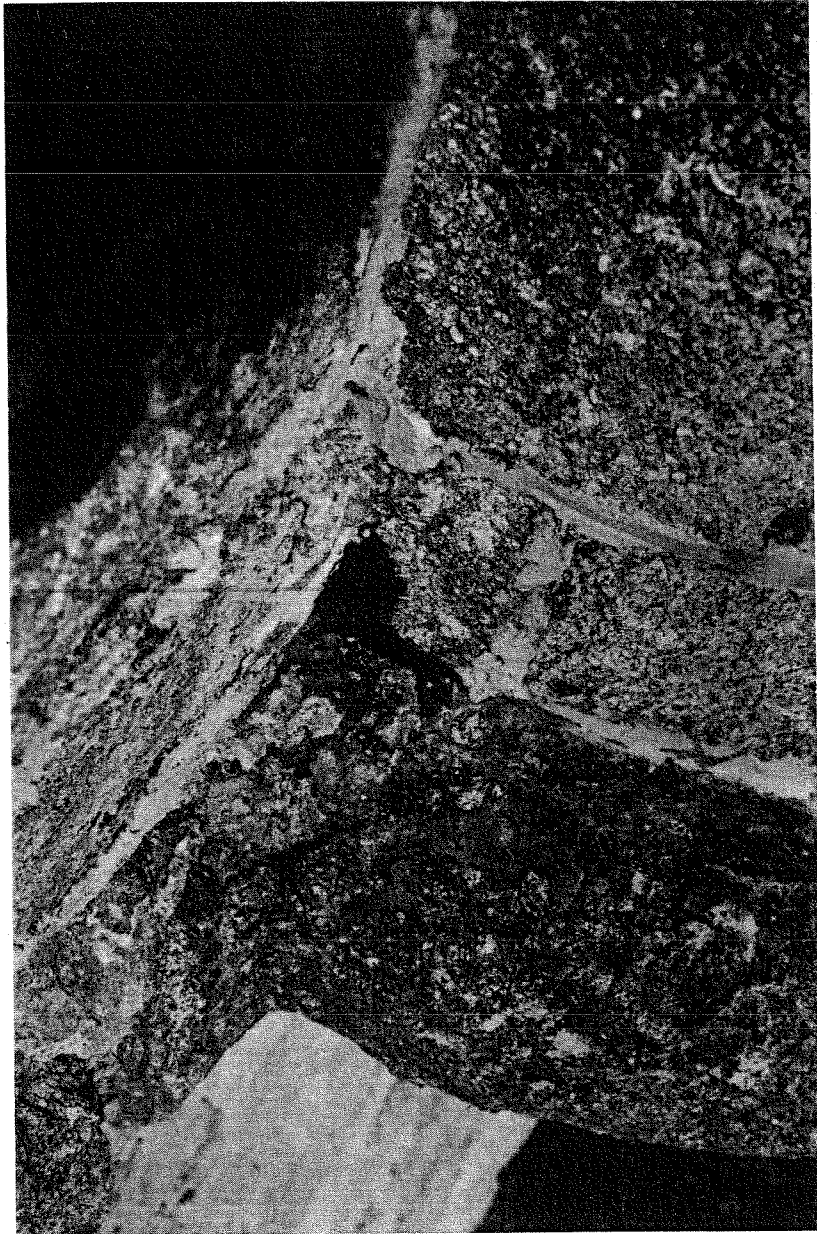
Illustration E-16

Detail of Steel Deterioration of Sentry Box Cordon

Will involve an intensive maintenance/repair effort in which visible iron brackets are cut out of the corbeled masonry base; new reinforcement will be installed and corbeled base stones replaced. Architectural details of the masonry base will thus be restored. Other metal elements above the base and at the dome level will not be treated, but will require observation and maintenance as required at a later date.

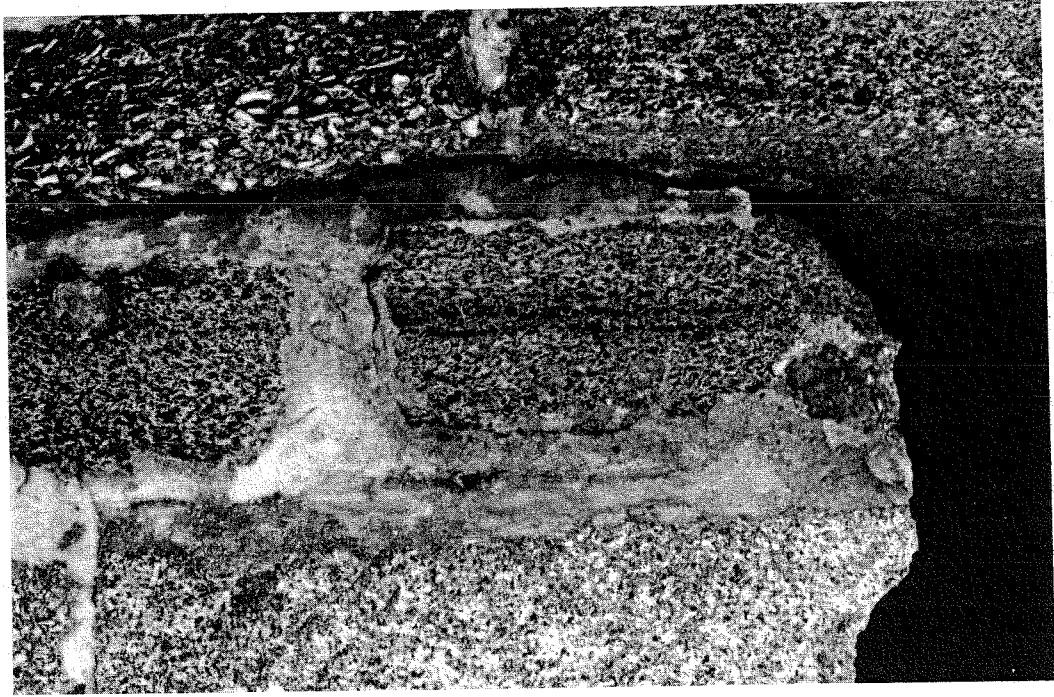
Illustration E-17
Detail of Steel Deterioration at Sentry Box Dome

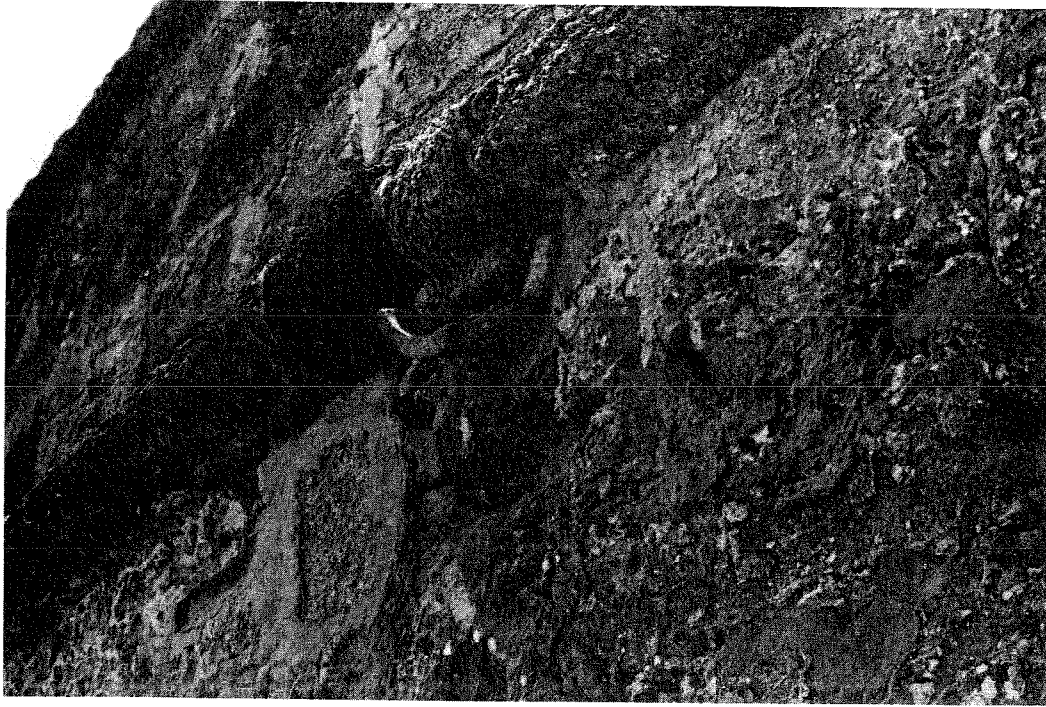
Illustration E-34

Expansion cracks such as the ones shown here allow rainwater seepage into the vault and rooms below.
