# SPERMACETI COVE LIFE-SAVING STATION

Fort Hancock, New Jersey  
Sandy Hook Unit, Gateway National Recreation Area

## **HISTORIC STRUCTURE REPORT**

**Sandy Hook Unit  
Gateway National Recreation Area  
Fort Hancock, New Jersey**

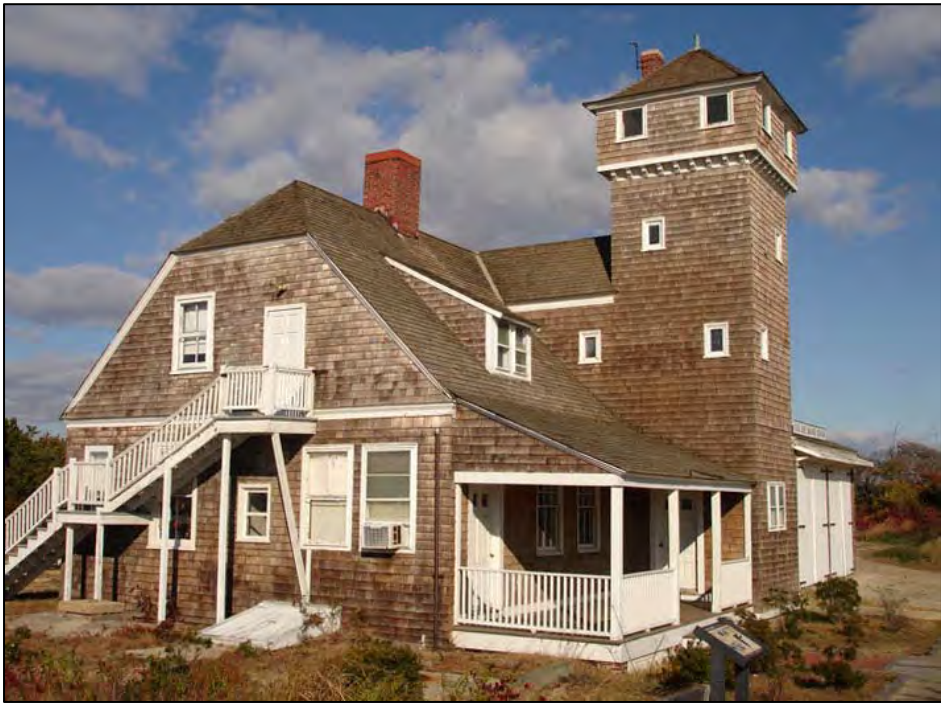
The exterior trim elements are currently finished with white paint that is degraded on some surfaces. This includes all cornice trim, window trim, and window sashes, as well as porch elements. Historic photographs indicate that these elements were historically painted but were probably finished in a different color. It appears as though the trim was painted with a light color and the sashes were painted with a darker color. Analysis of the exterior paint samples supports the documentary evidence.

**Figure 41.** Spermaceti Cove Life-Saving Station, south and east elevations.

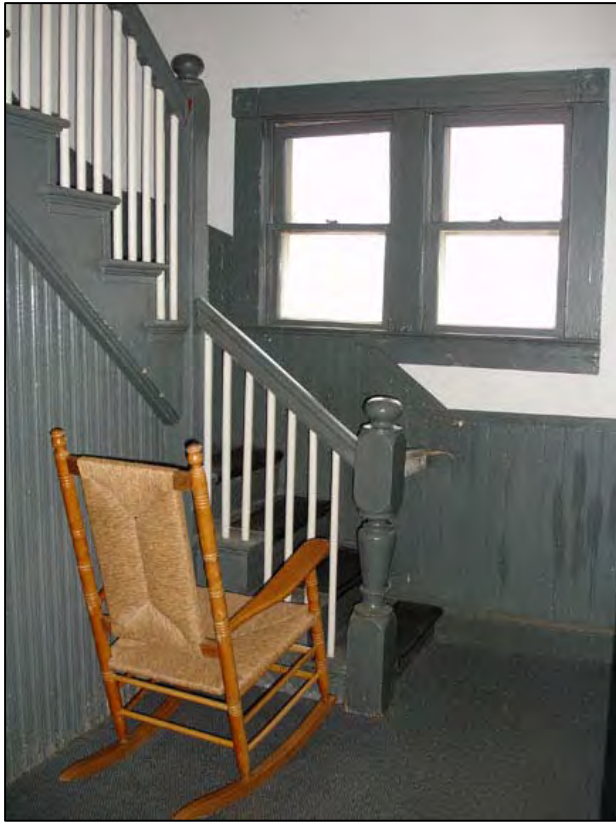
**Figure 49.** Spermaceti Cove Life-Saving Station, Room 101 looking east, W101.

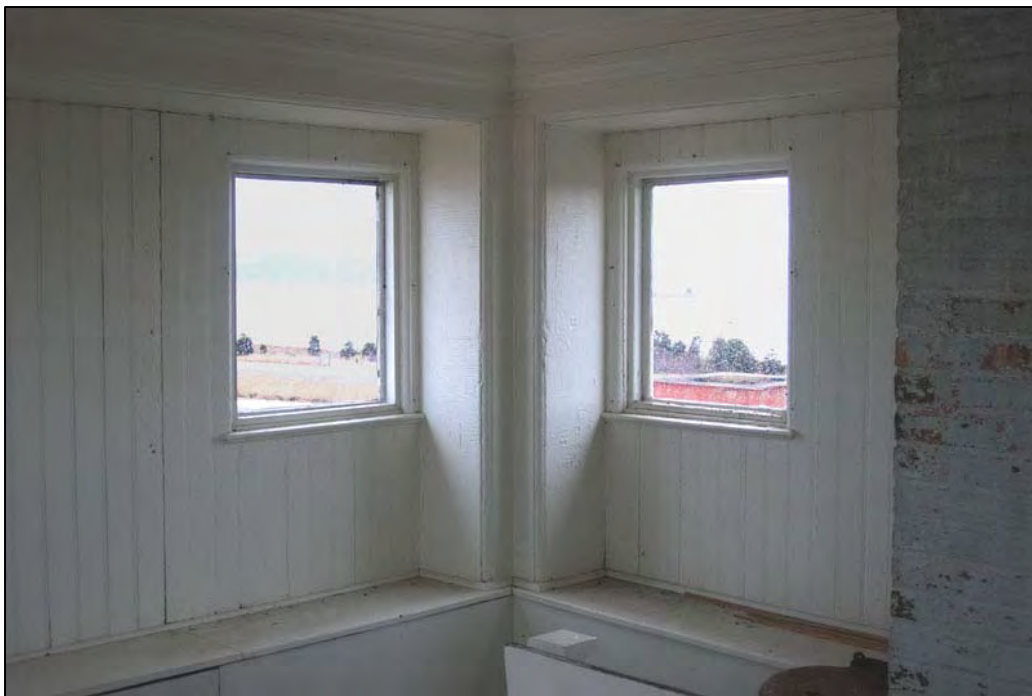
**Figure 64.** Spermaceti Cove Life-Saving Station, Watch Room/Room 401 looking southwest depicting cantilevered window section and typical woodwork for the fourth story.

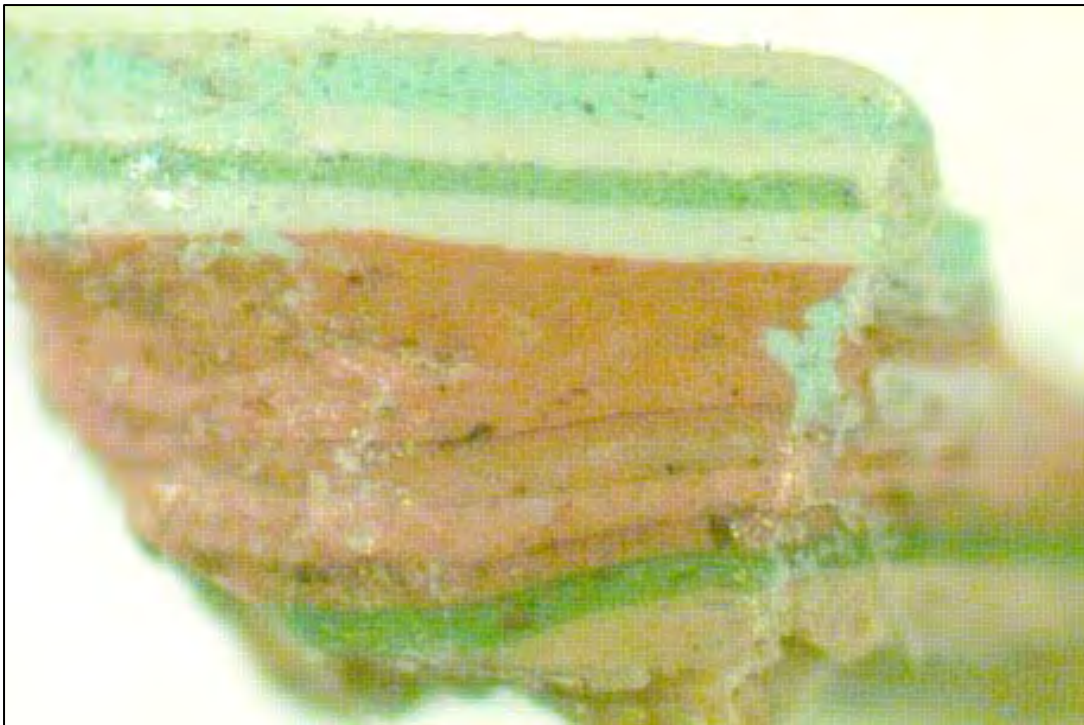
**Figure 70.** Spermaceti Cove Life-Saving Station, sample P039 taken from Room 106 north plaster wall.
