Structures - Industries

Historic structures of the Industries landscape character area include the North Caponier and fortification walls and magazines of Batteries Halleck and Rosecrans; buttresses supporting the Model Industries Building; oil tanks and other structures associated with the Powerhouse; Cross Island Tunnel; and the Metal Detector Shed.

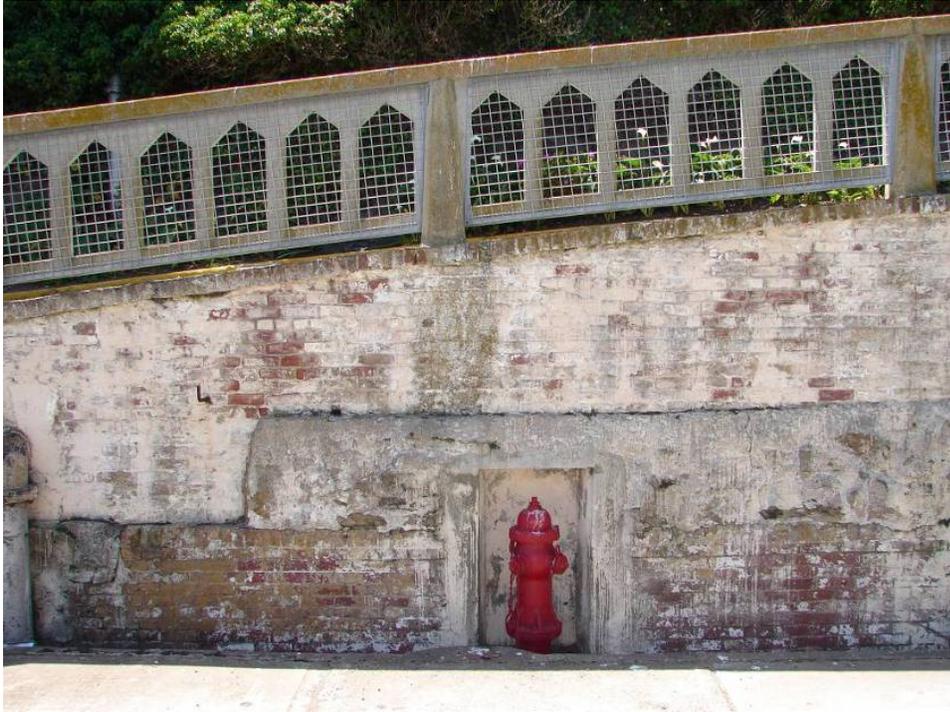
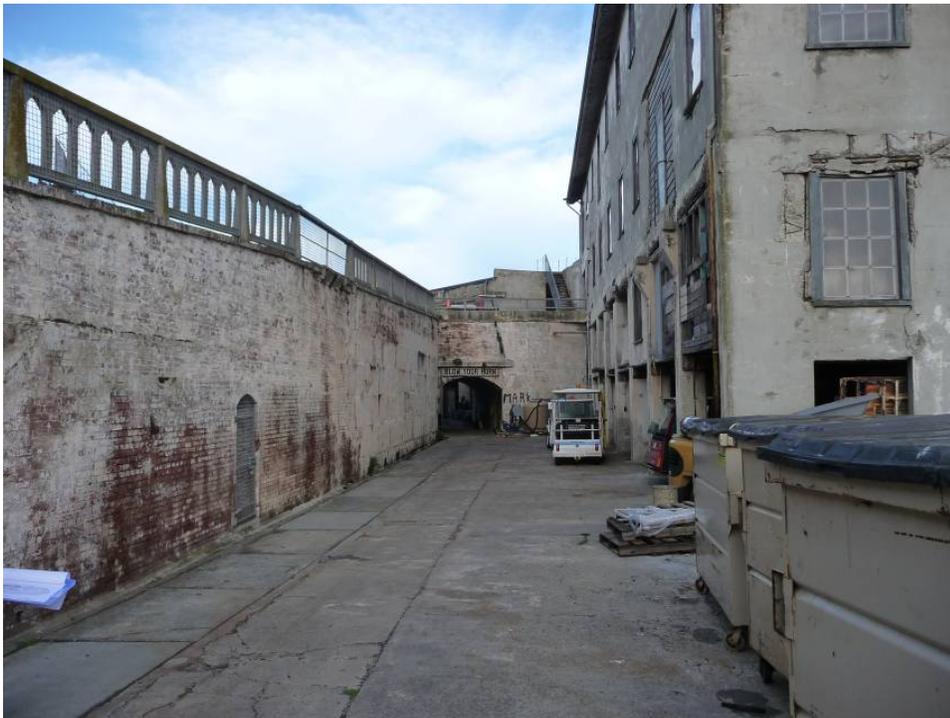
<i>Feature (Type)</i>	<i>Bldg #</i>	<i>Figure #</i>	<i>Description</i>	<i>Condition</i>
Fortification Wall and Magazines- Powerhouse/Stores/ QM Warehouse (1867) <ul style="list-style-type: none"> • MBSR4 • MBSR5 • MBSR6 • MBSF3 		3 - 249	Fortification wall near Stores/QM Warehouse with three visible layers of construction: brick wall at bottom, mortared stone in middle, and brick at top. 1872 Traverse walls intact – two brick archways formed tunnels on covered way through earthen traverses between where pairs of cannon were emplaced – Quartermaster Storehouse, Powerhouse, Garage built in 1921 – electric Powerhouse and heating furnaces (1985 NHL) <ul style="list-style-type: none"> • Bombproof rooms: • MBSR4: Decorative concrete railing at top of wall, NPS 2000 • MBSR5: Steel pipe and safety mesh at top of wall at location of bridge to Stores/QM Warehouse, NPS 2000 • MBSR6: Decorative concrete railing at top of wall, NPS 2000 • MBSF3: NPS cyclone fence, 2003 	Good

Figure 3 - 249. Fortification Wall - Stores/QM Warehouse with MBSR4 above, viewed from south of Stores/QM Warehouse. Note four layers of construction: brick wall at bottom, mortared stone in middle, brick at top and concrete railing above. (MBD DSC02665.JPG, MBD P1020585.JPG)

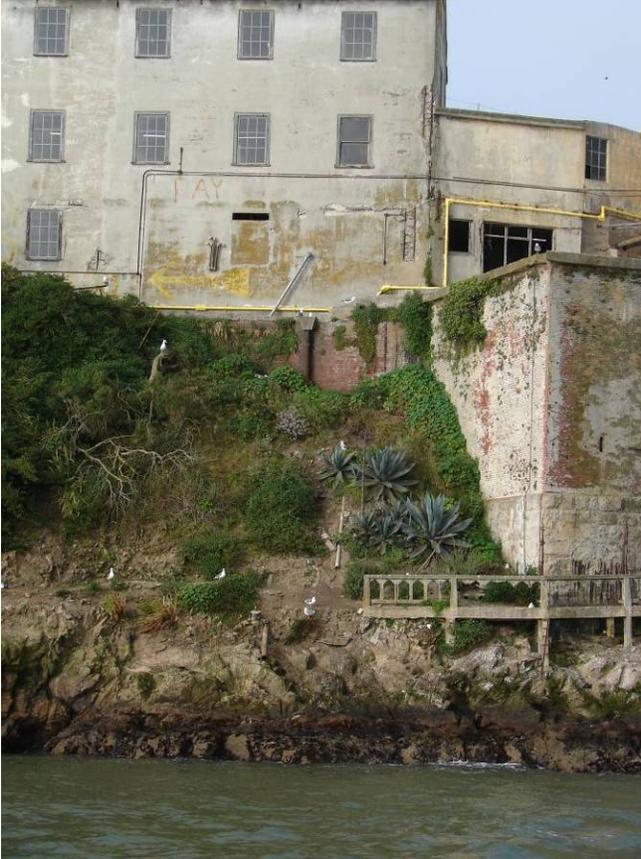
Fortification Wall - Battery Halleck		3 -250 3- 251	Brick scarp walls flanking both sides of North Caponier <ul style="list-style-type: none"> • Stairs and Sentry Walk 	Good
Cross Island Tunnel		3-252 3-253	Connects Powerhouse with New Industries Building	Good

Figure 3 - 250. Fortification Wall - Battery Halleck at North Caponier in mid ground (MBD: DSC02988.JPG)

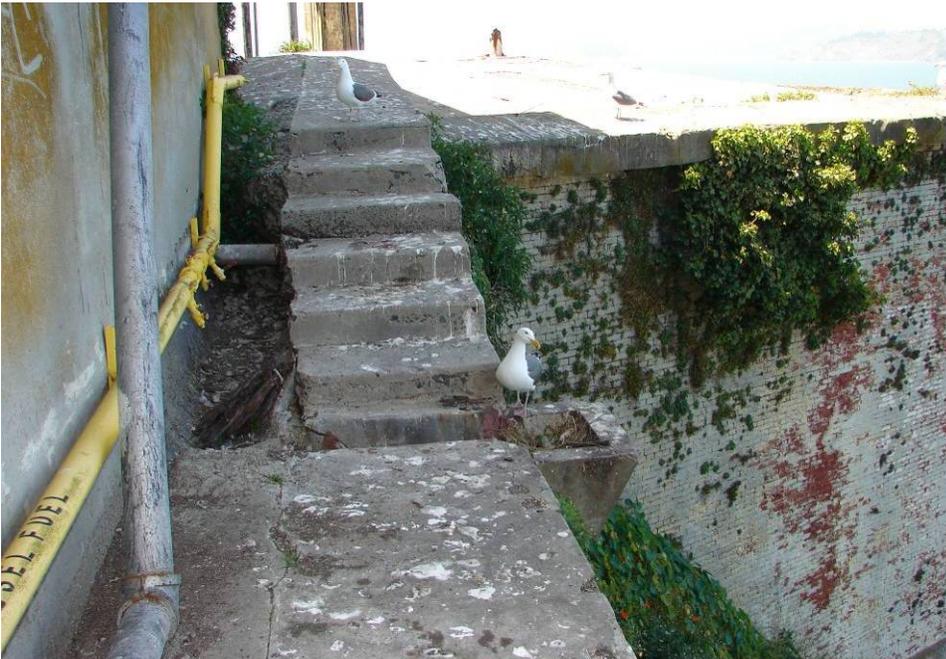
Figure 3 - 251. Battery Halleck - Stairs and Sentry Walk on Fortification Wall (MBD: DSC02795.JPG)

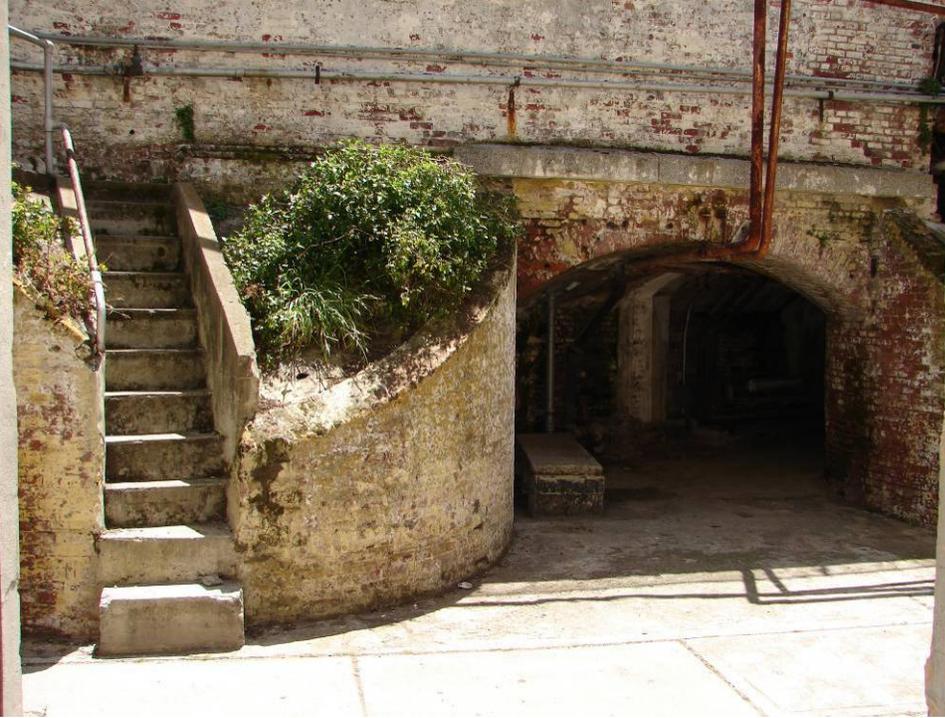
Figure 3 - 252. Fortification Tunnel portal (right) with Stairs to Stores/QM Warehouse (left) as viewed from Powerhouse (MBD DSC02703.JPG)

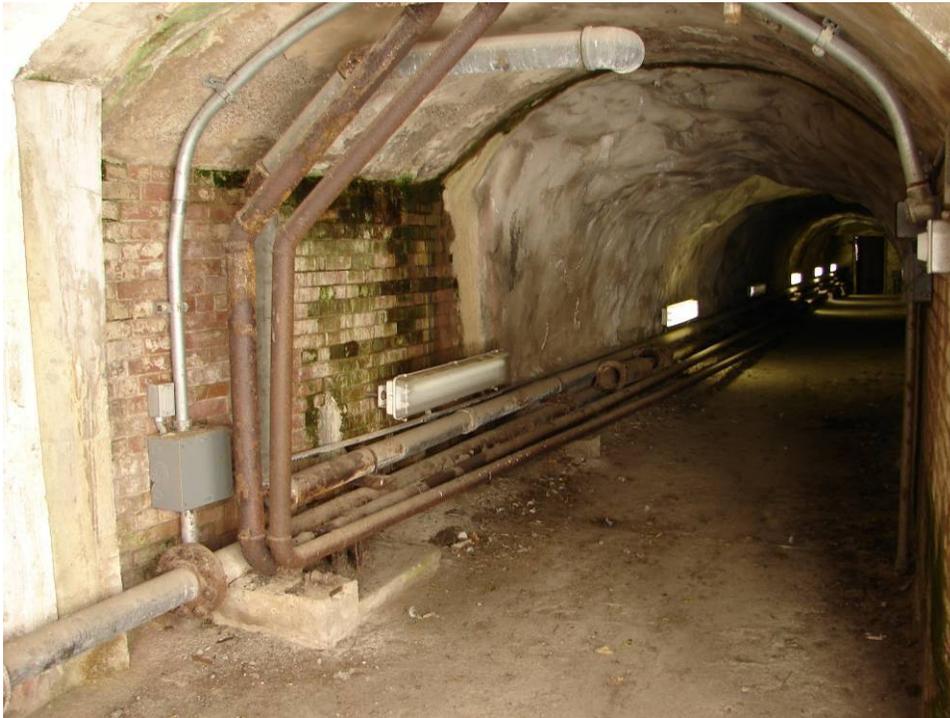
Figure 3 - 253. Interior of Fortification Tunnel, view is west towards New Industries Building (MBD DSC02726.JPG)

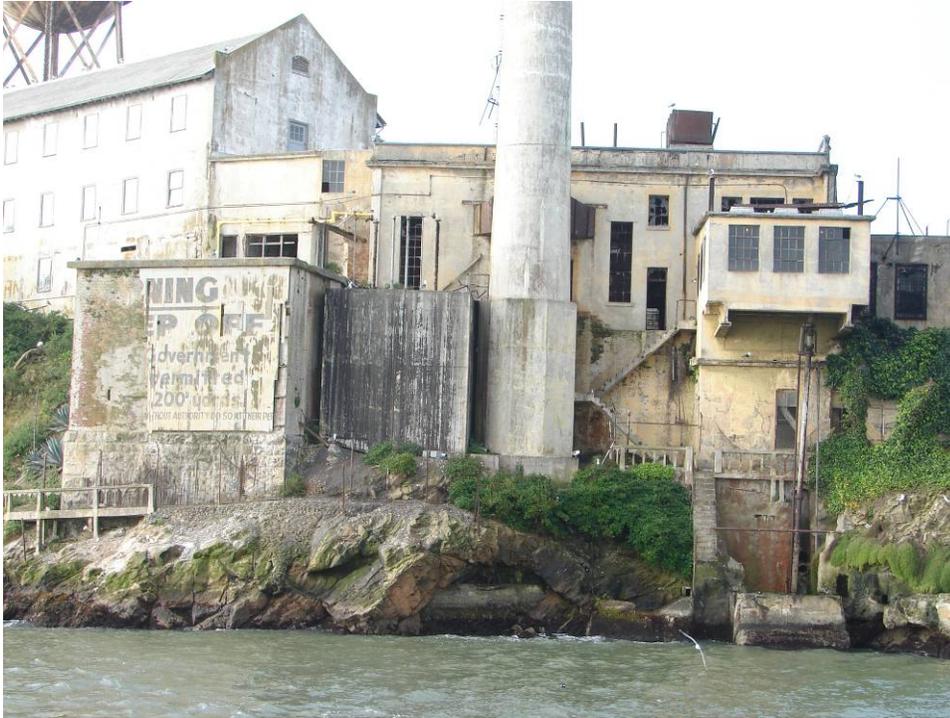
<i>Feature (Type)</i>	<i>Bldg #</i>	<i>Figure #</i>	<i>Description</i>	<i>Condition</i>
North Caponier		3-254	Built of concrete and brick - Oil Tank #1 - lower floor was powder magazine - 8 24-pound howitzers mounted on second floor to defend adjacent batteries - 8" Columbiad on top with infantry parapet - 1872 demolition of gunroom second floor and drawbridge during island wide battery rehabs - magazine remains today (Thompson 1979: Map 3) - Bunker Oil (B.O.) Tank (1963) - adjacent tank called "Hot Well" (1928) - buildings around it came in part in 1910-1912 - electric Powerhouse and heating furnaces (1985 NHL) (Barker, 2009:34)	Fair
Oil Tank No. 1 in North Caponier magazine	2	3-255	Large metal tank in North Caponier magazine	Fair
Oil Tanks No. 2		3-256	Large metal tank exposed northwest of Powerhouse	Good
Saltwater Intake Port and Stairs		3-257	Concrete wet well, piping, and access stairs (Barker 2009; 104)	Fair

Figure 3 - 254. Left to right: North Caponier, hot well, smoke stack, and saltwater intake port. (MBD DSC02981.JPG)

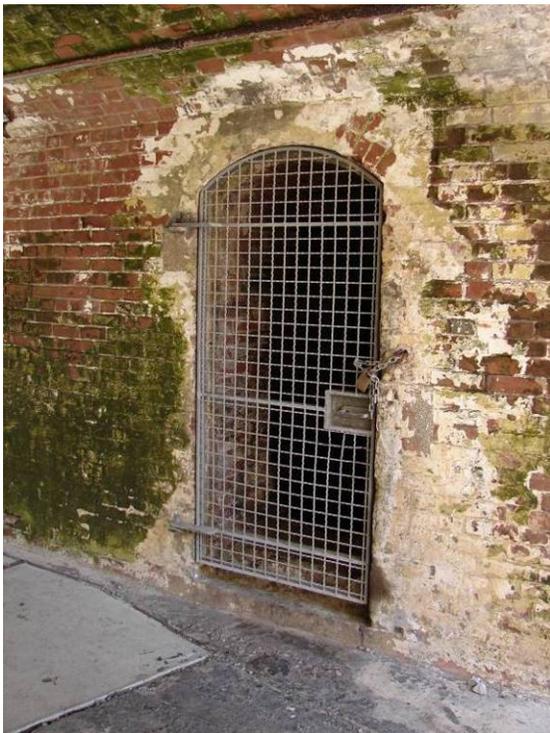
Figure 3 - 255. Oil Tank No. 1 (in North Caponier magazine) (MBD DSC02688.JPG)

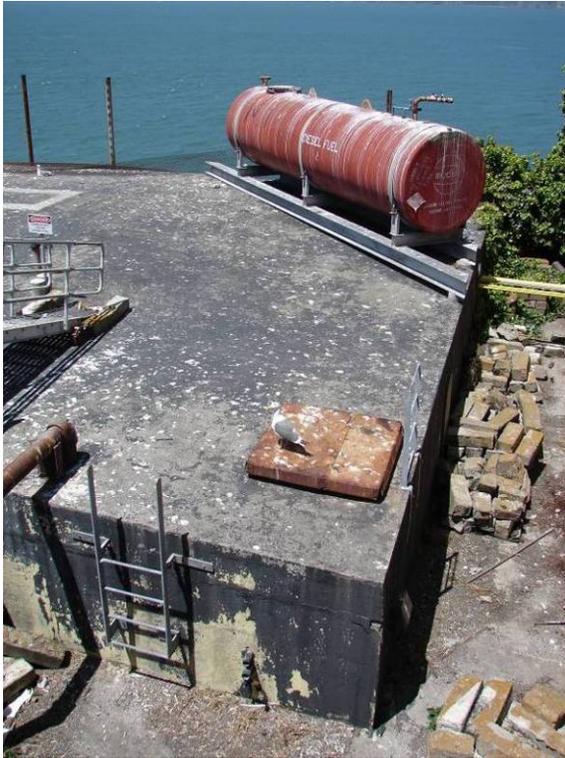
Figure 3 - 256. Oil Tank No. 2 (MBD DSC02735.JPG)

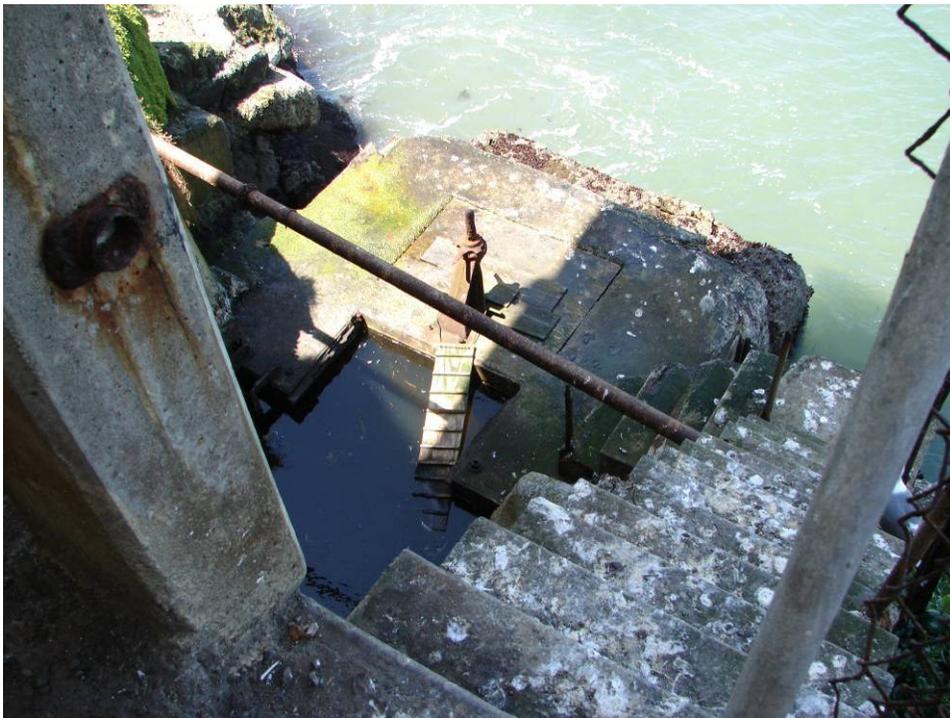
Figure 3 - 257. Saltwater Intake Port and Stairs (MBD DSC02767.JPG)

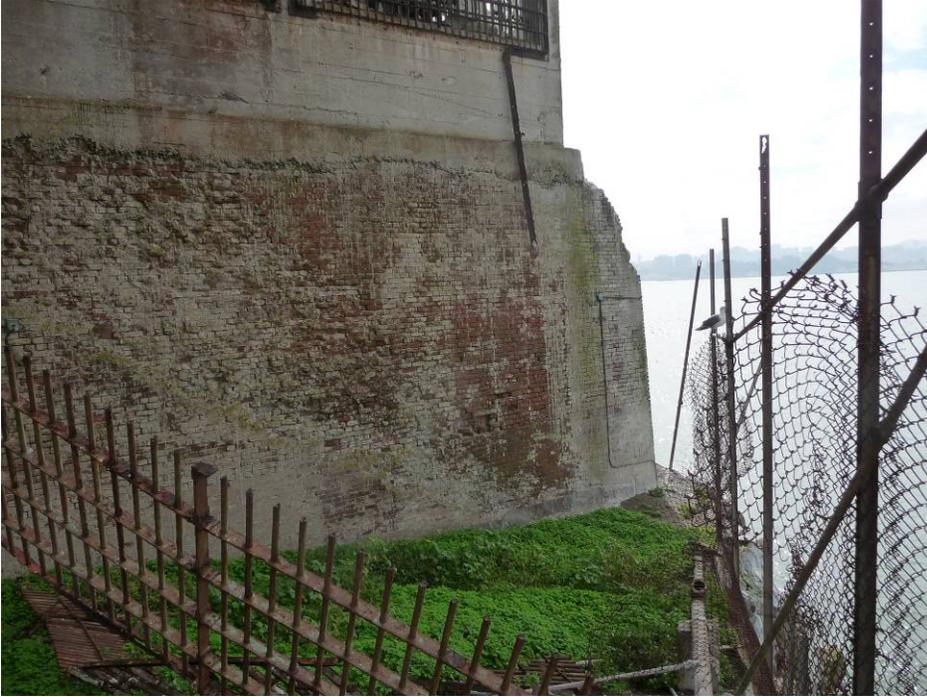
Fortification Wall - Battery Rosecrans (Part of North Battery, Battery III, Battery IV) with MBSF15		3-258 3-259	Brick wall underneath the Model Industries Building - partially visible inside basement (Thompson 1979: Map 9 and Historical Base Map 1 (1867); Kelly 1981:1-4, Category 1; Delgado et al. 1992:42; Chappell 1993) MBSF15 is a Prison Cyclone fence	Wall: Good MBSF15: Poor
Buttress 1 and Buttress 2		3-260	Fortification walls perpendicular to batteries	Good
Metal Detector Shed		3-261	Wooden Building west of Stockade/Recreation Yard	Good
Firebox #4		3-262	Concrete shed south of New Industries Building	Good
Incinerator	85	3-263	Includes dump chute to bay	Poor
Greenhouse		3-264	Remnant reinforced concrete foundation	Poor

Figure 3 - 258. Northwest corner of Fortification Wall - Battery Rosecrans; serving as foundation for a portion of Model Industries Building (above). Remnant fencing is MBSF15; Sentry Walk was located between building and fence. (MBD: DSC02743.JPG)

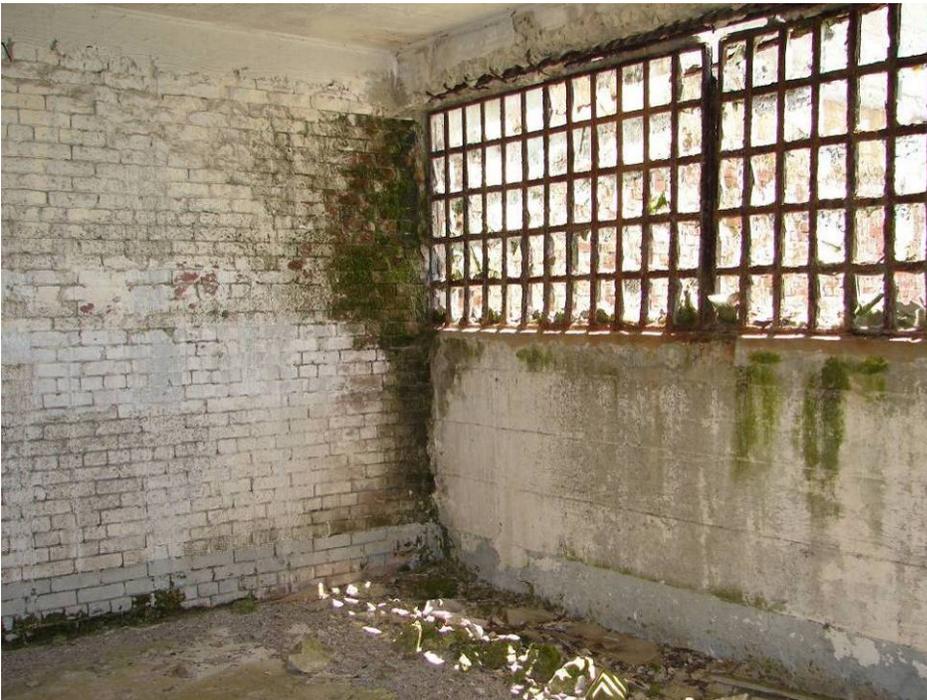
Figure 3 - 259. Fortification Wall - Battery Rosecrans in interior of Model Industries Building lower level (MBD: DSC02740.JPG)

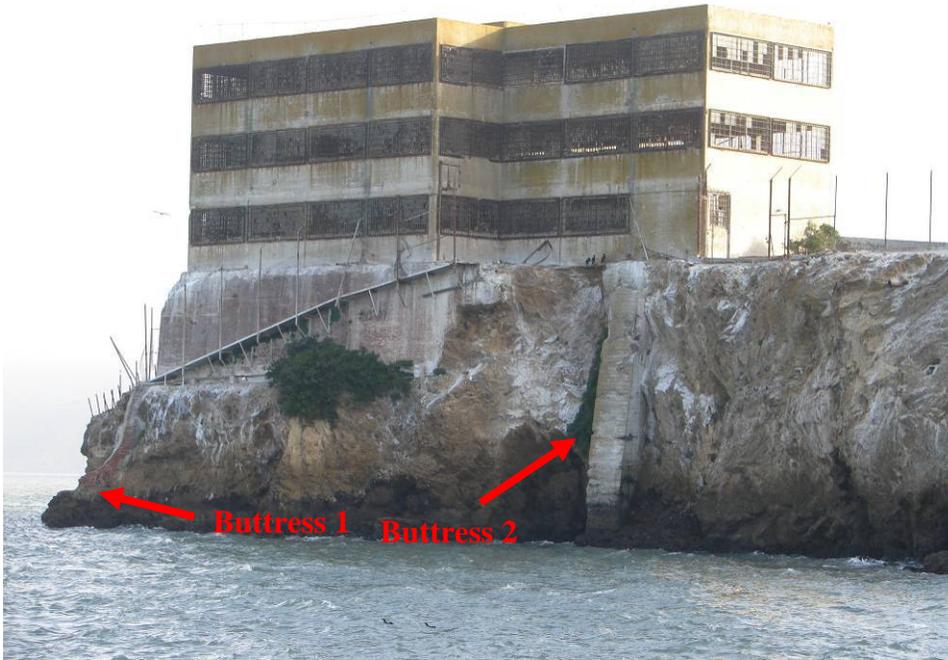
Figure 3 - 260. Buttresses and steel catwalk on southwest side of Model Industries Building (MBD DSC02957.JPG)

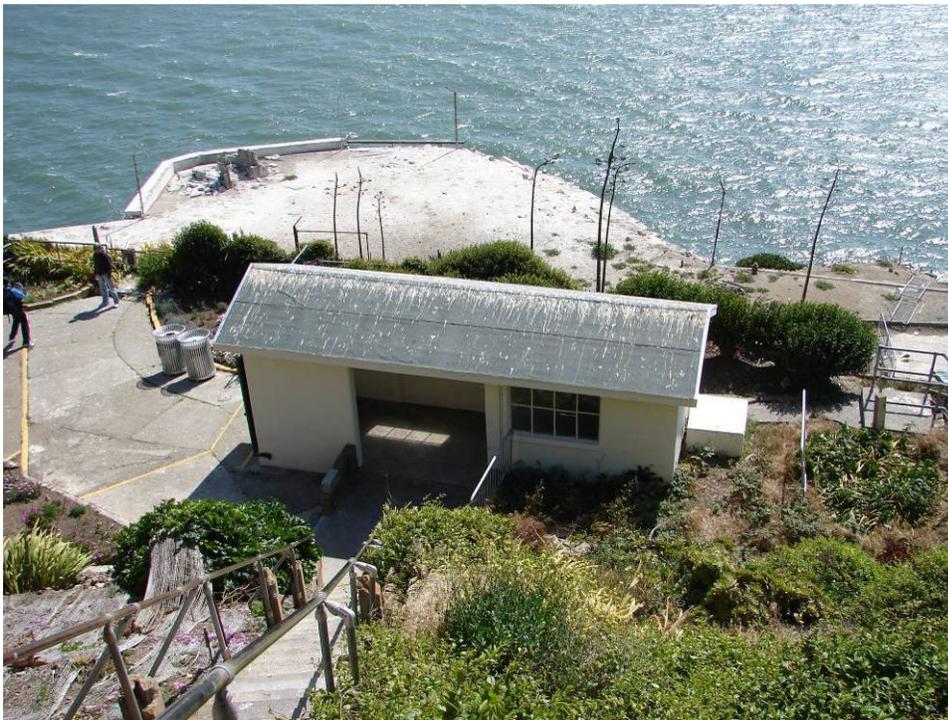
Figure 3 - 261. Metal Detector Shed (MBD DSC02799.JPG)

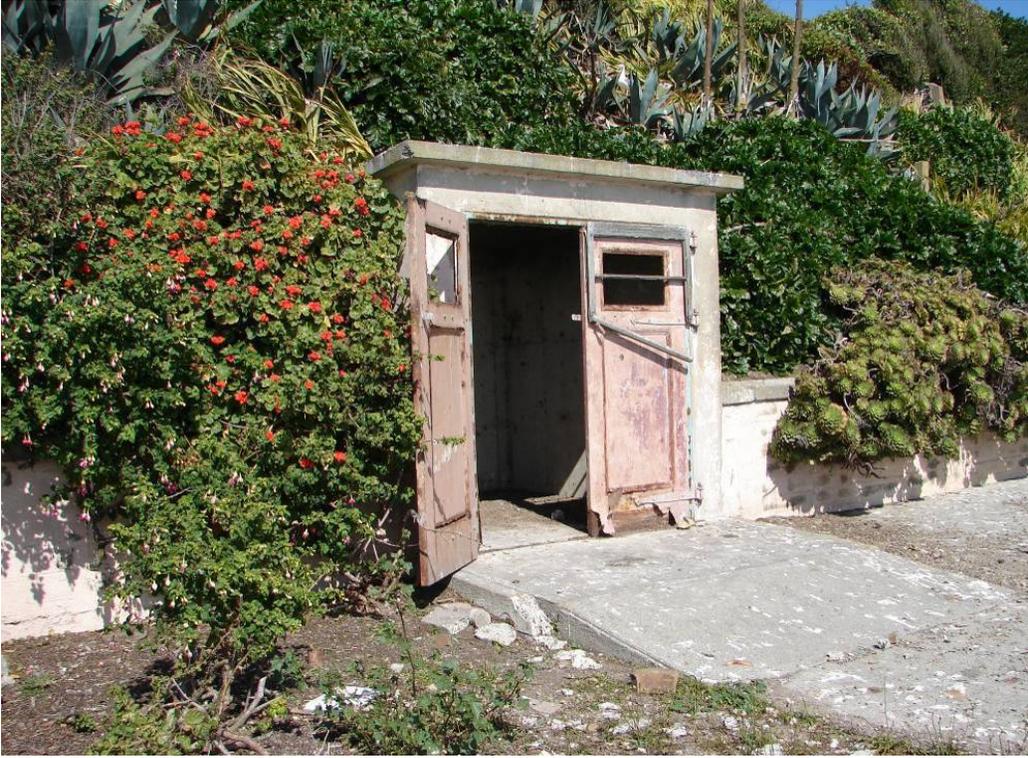
Figure 3 - 262. Firebox #4, located near Incinerator (MBD DSC02846.JPG)

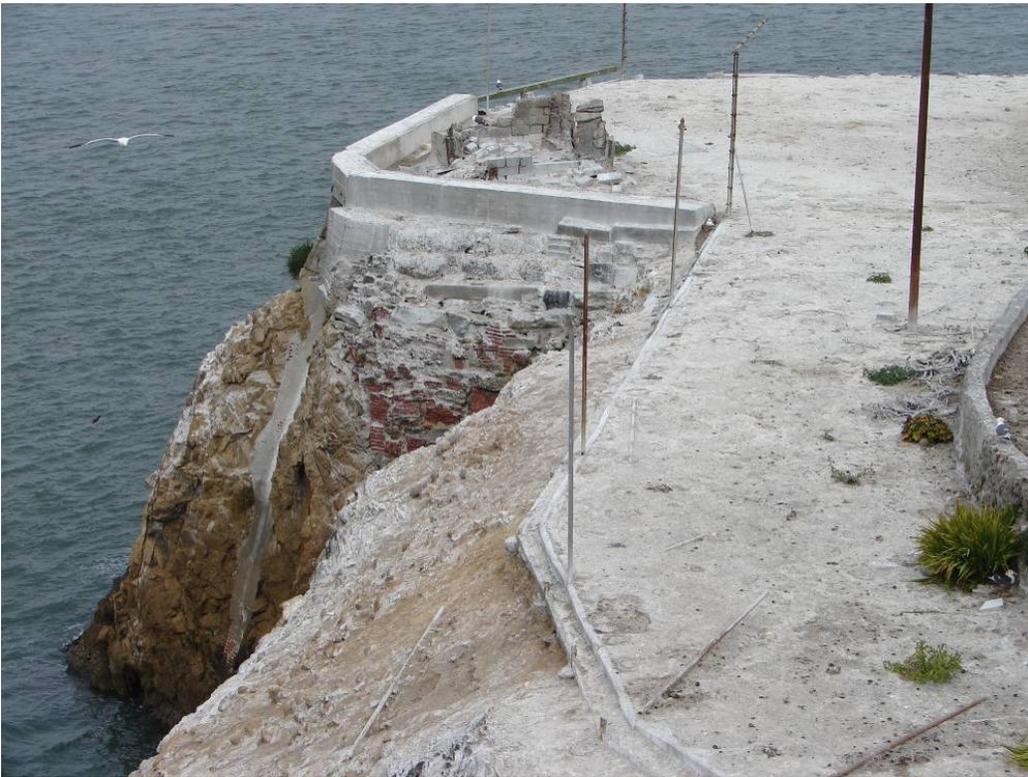
Figure 3 - 263. Incinerator ruins and dump chute, as seen from Lower West Road; poles are remnants of Federal Penitentiary period security fences (MBD DSC03269.JPG)

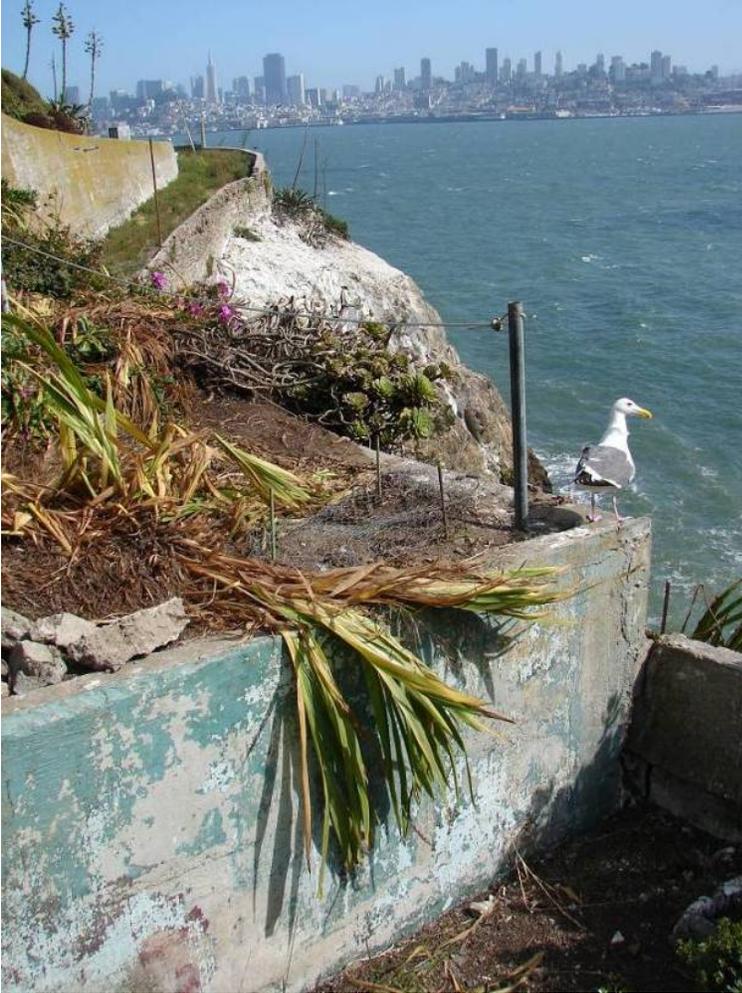
Figure 3 - 264. Greenhouse foundation and view to San Francisco (MBD DSC03248.JPG)

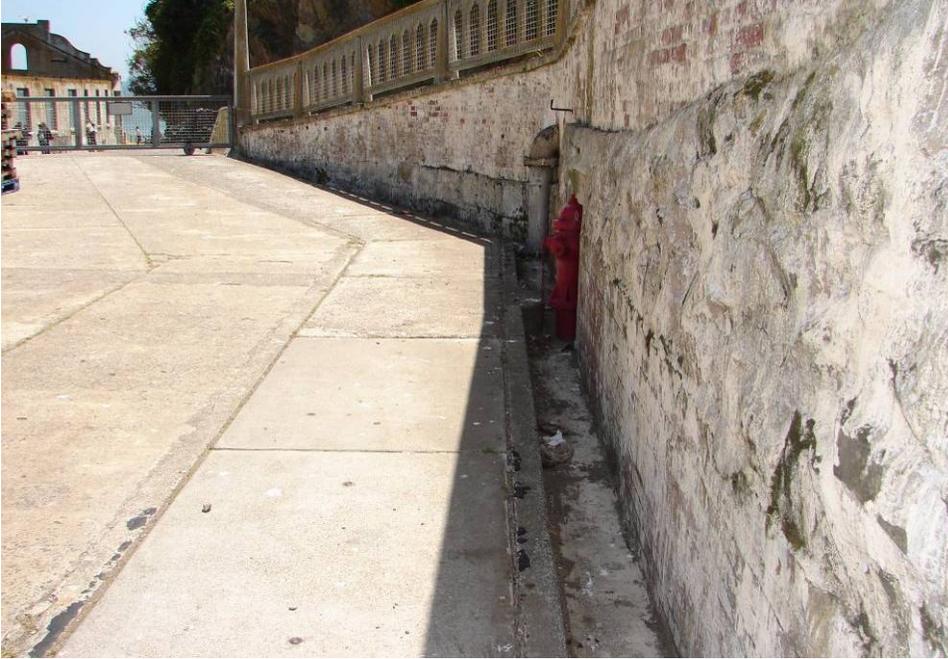
<i>Feature (Type)</i>	<i>Bldg #</i>	<i>Figure #</i>	<i>Description</i>	<i>Condition</i>
Utility Chase with adjacent drain		3-265	Concrete-covered utility trench with adjacent concrete drain pan	Good
West Seawall/Concrete Pilings		3-266	Seawall of quarry dock – recent stabilization with concrete pilings	Fair
Staircases to West Seawall		3-267	Concrete stairs on west slope above Northwest Seawall	Poor
Staircase to Foghorn North		3-268	Wood stairs from Model Industries Yard to Foghorn North	Good
Staircase to New Industries • SR59		3-269	Concrete stairs with concrete handrail • SR59: Concrete post with wood cap	Stairs: Fair SR59: Poor
Gardener's Stairs		3-269	Concrete stairs south of Stairs to New Industries	Stairs: Fair
Incinerator Rubble Wall		3-270	Wall below Incinerator, composed of salvaged concrete blocks and portions of brick walls	Poor
Staircase to Stores/QM Warehouse 2 • MBSR12 • MBSR13		3-271	Cast in place concrete stairs with steel pipe railings	Stairs: Good Railings: Poor

Figure 3 - 265. Utility Chase with adjacent drain pan and Fortification Wall - Quartermaster, on Road to Industries looking south towards Post Exchange (MBD DSC02668.JPG)

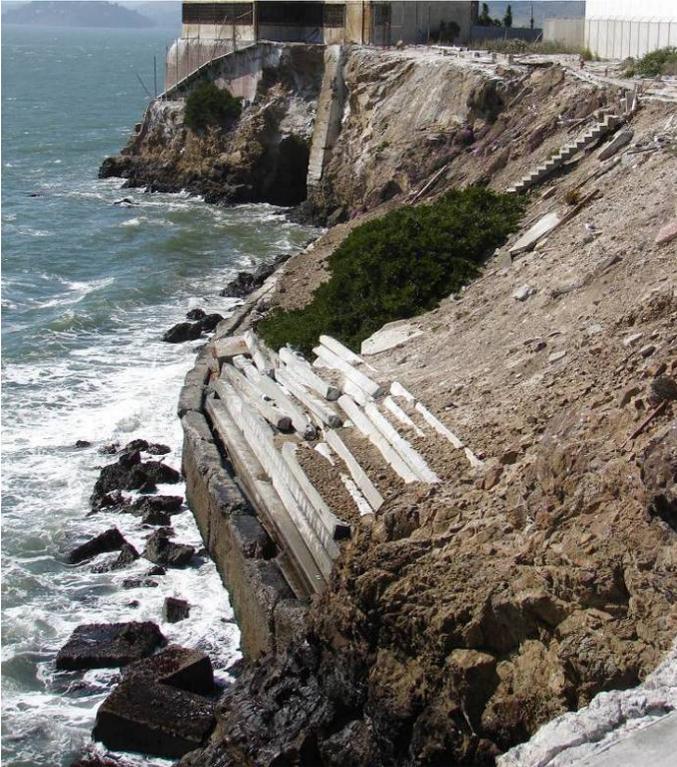
Figure 3 - 266. Northwest Seawall, pilings and stairs - Pirate's Cove fill slope as viewed from Incinerator area (MBD DSC02868.JPG)

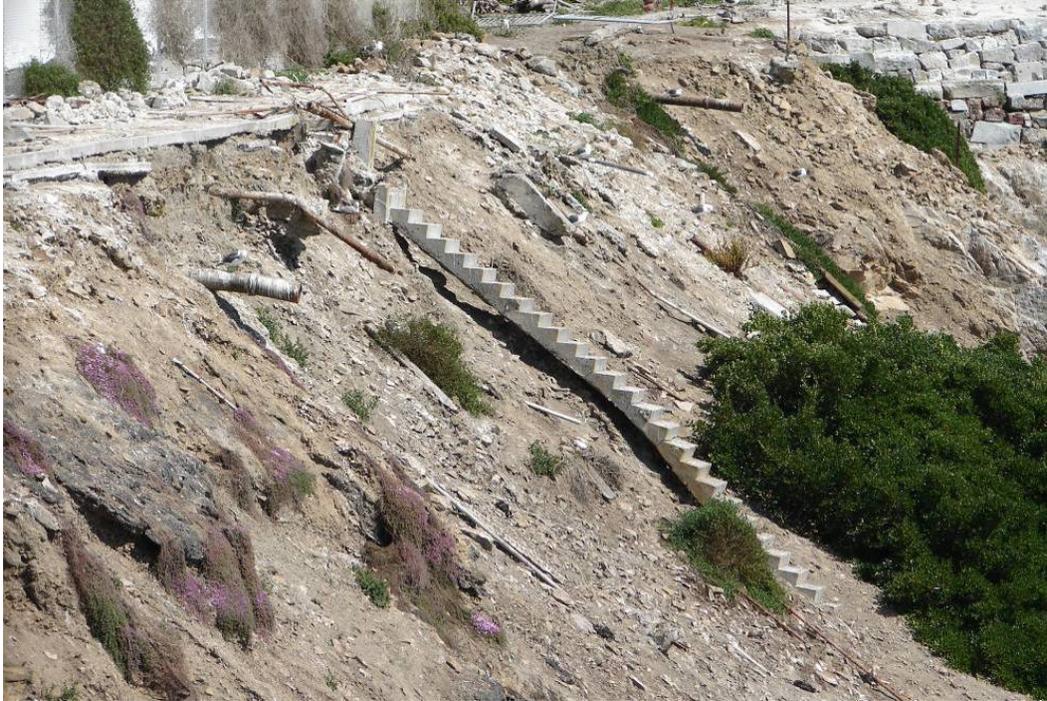
Figure 3 - 267. Concrete staircase to West Seawall (MBD DSC02583.JPG)

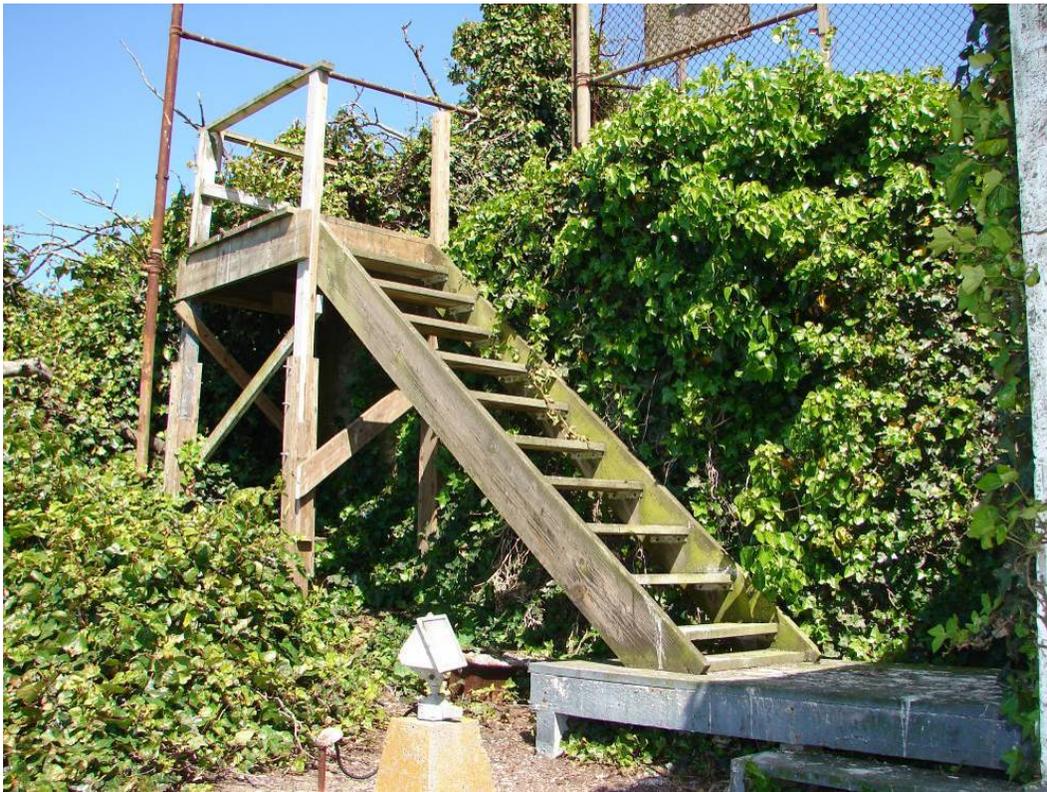
Figure 3 - 268. Wood staircase and platform to Foghorn North (MBD: DSC02558.JPG)

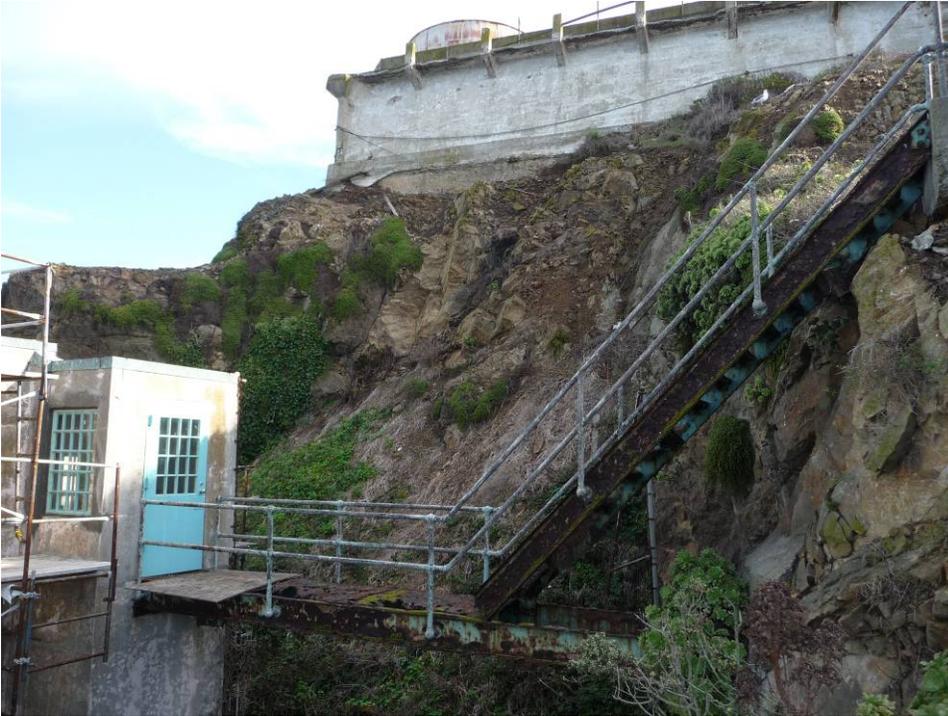
Figure 3 - 283. Catwalk #1 with MBSR32 and MBSR33 as viewed from Catwalk #2; Stockade/Recreation Yard wall and Water Tower in background (MBD: P1020634.JPG)

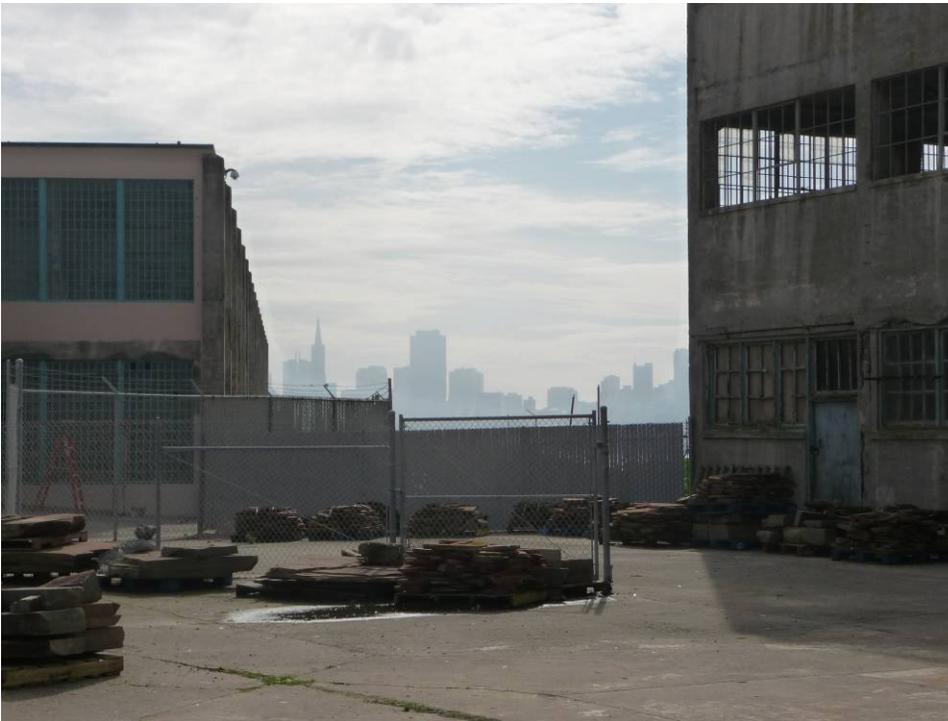
Catwalk #2 • MBSR34 • MBSR35 • MBSR38		3-282	Catwalk to New Industries upper floor • MBSR34: Steel pipe rail, circa 1940 • MBSR35: Steel pipe rail, circa 1940 • MBSR38: Steel pipe panel, NPS 1990	Good MBSR34: Good MBSR35: Good MBSR38: Good
MBSF17, and MBSF18 in Model Industries Yard		3-284	MBSF17 and MBSF18 are both NPS Cyclone security fences	Good
Security Fence and Foundation • MBSF5		3-285 3-286	Modern concrete foundation with embedded steel pipes for security fence MBSF5 (NPS cyclone, 2003) on top of original concrete foundation	Foundation: Poor MBSF5: Good
West Road – North Side along New Industries Building		3-286	Concrete roadway between New Industries Building and MBSF5	Road: Fair Fence: Good

Figure 3 - 284. NPS Cyclone security fencing MBSF17 at Model Industries Yard, looking south towards San Francisco (MBD P1030565.JPG)

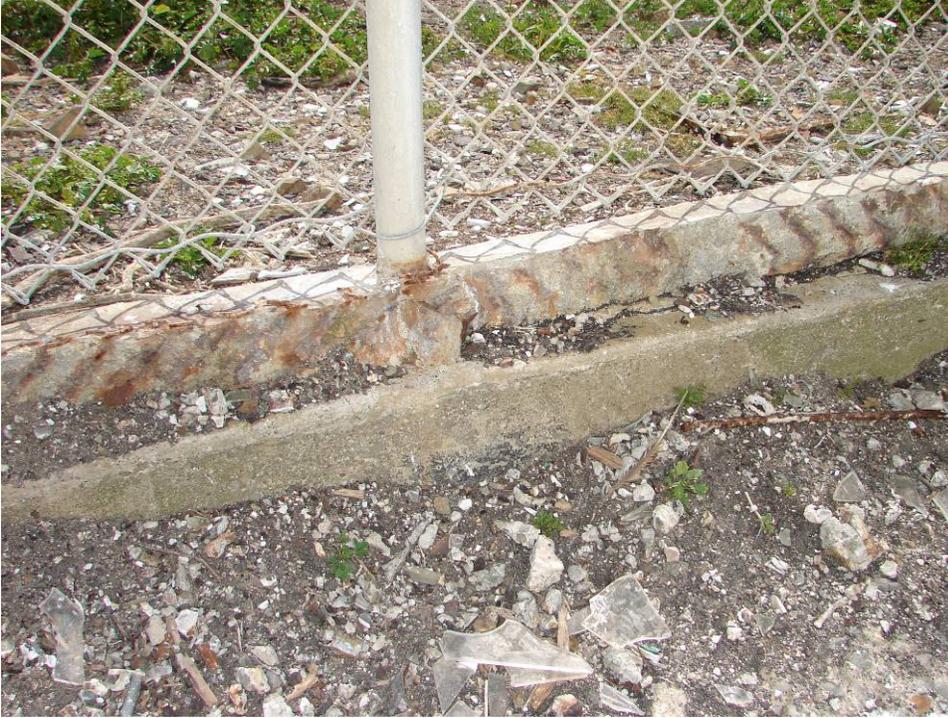
Figure 3 - 285. Security Fence Foundation with MBSF5; note construction of new curb for modern fence on top of original curb. (MBD DSC02604.JPG)

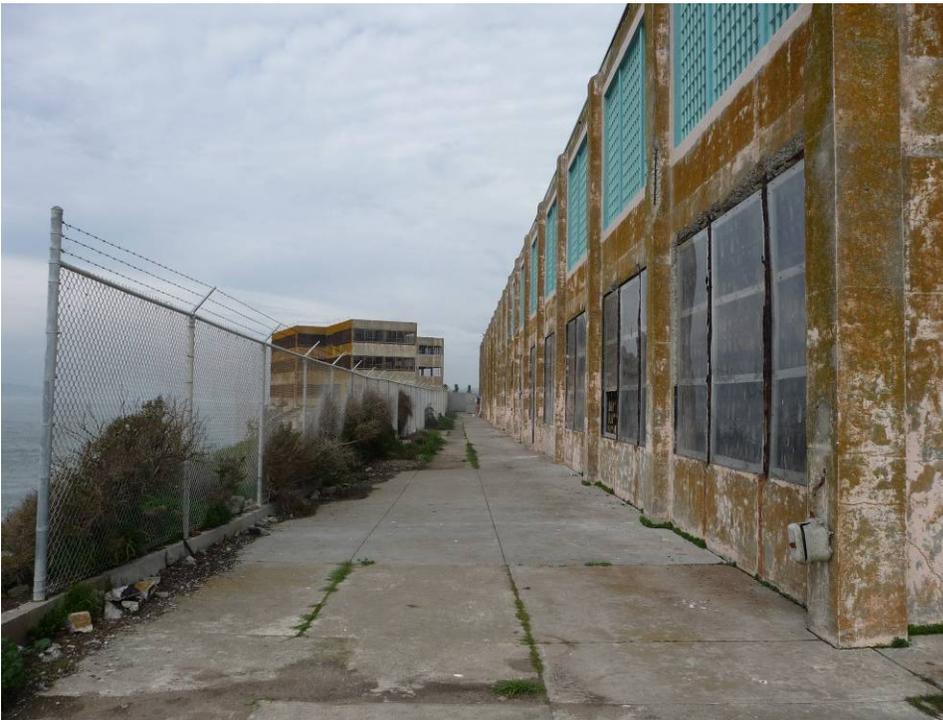
Figure 3 - 286. West Road - North Side along New Industries Building, viewed from south end towards Model Industries Building. New Industries Building at right, MBSF5 at left. (MBD P1030609.JPG)
