Historic Structures Report

Fort Point US Coast Guard Station
Gulf of the Farallones National Marine Sanctuary

April 1, 2008

by
Carey & Co. Inc.

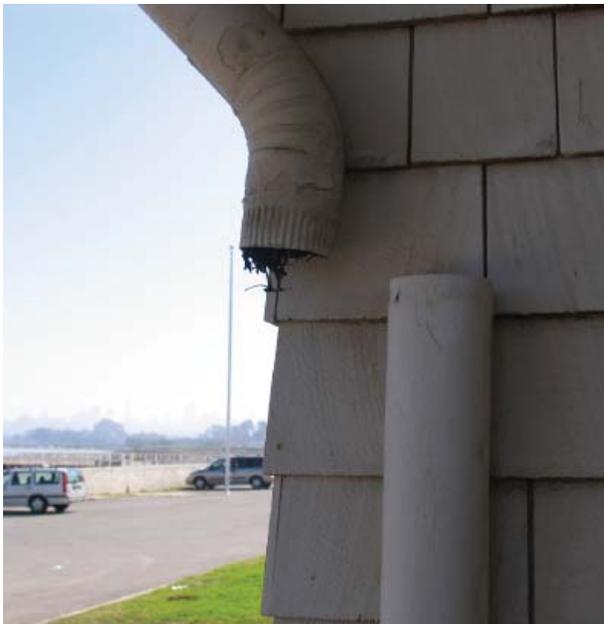
Fig. 27 : Clogged drain at the 1890 Boathouse.

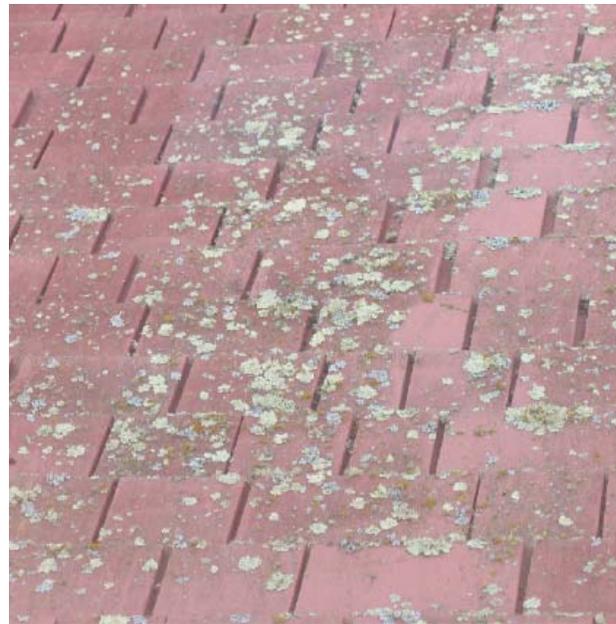
Fig. 28 : Biological growth on the roof at the Main Boathouse.

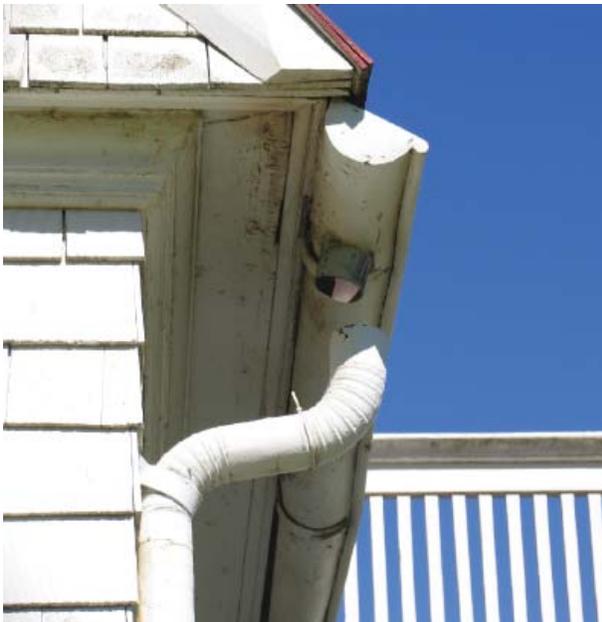
Fig. 29 : Disconnected drain spout at the Officer in Charge Quarters.

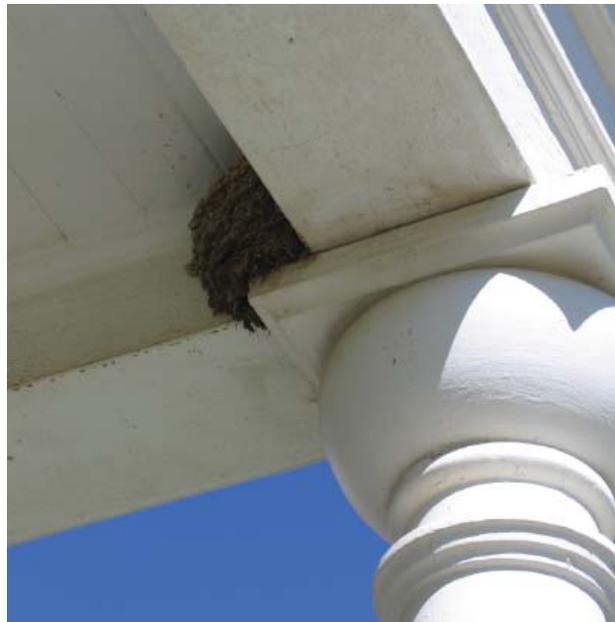
Fig. 30 : Mud Swallows nesting in the eaves of the porch at the Officer in Charge Quarters.

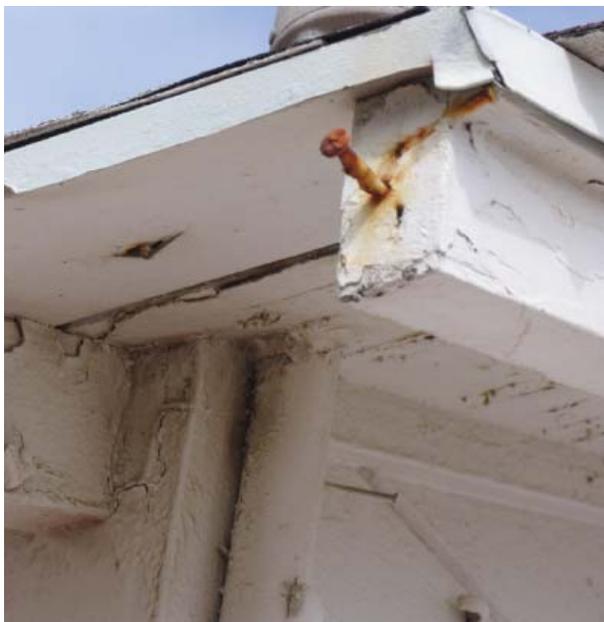
- Figure 31. Photograph: Buoy Shack, 2007. Corroded ferrous metal attachments in rafter tails. Carey & Co., Inc.
- Figure 32. Photograph: Buoy Shack, 2007. Deteriorated substrate below paint layer. Carey & Co., Inc.

Fig. 31 : Corroded ferrous metal hardware at the Buoy Shack.

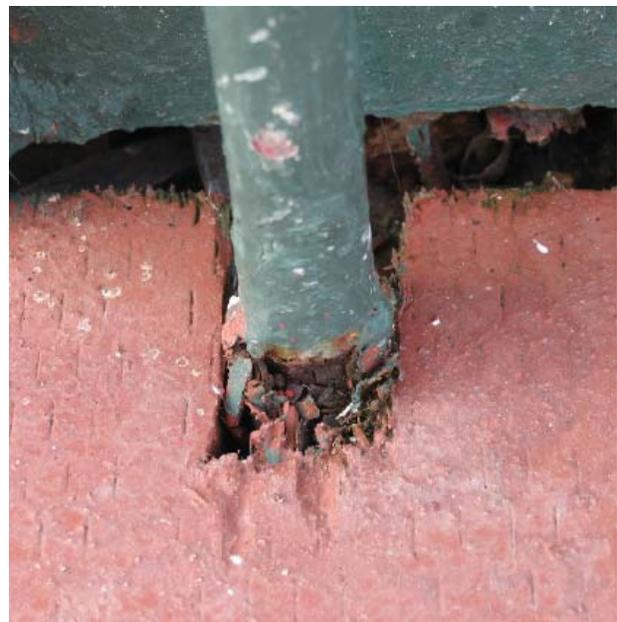
Fig. 32 :Substrate underneath deteriorated paint is deteriorating from rot.

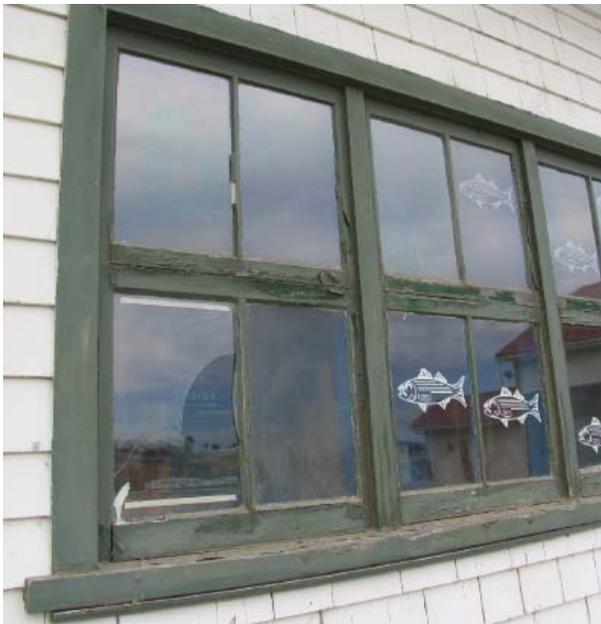
- Figure 33. Photograph: Main Boathouse, 2007. Exterior paint and glazing compound deterioration at the windows of the east enclosed porch. Carey & Co., Inc.

Fig. 33 : The exterior paint is deteriorating on the windows, as is the glazing compound.

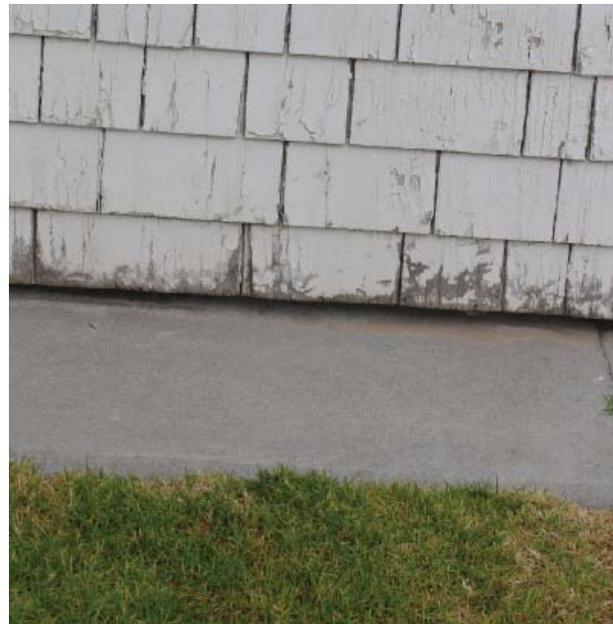
- Figure 34. Photograph: Main Boathouse, 2007. Improper drainage at grade leading to shingle deterioration. Carey & Co., Inc.
- Figure 35. Photograph: Main Boathouse, 2007. Biological growth developing in shaded areas near the water table. Carey & Co., Inc.

Fig. 34: Improper drainage at grade has lead to shingle deterioration.

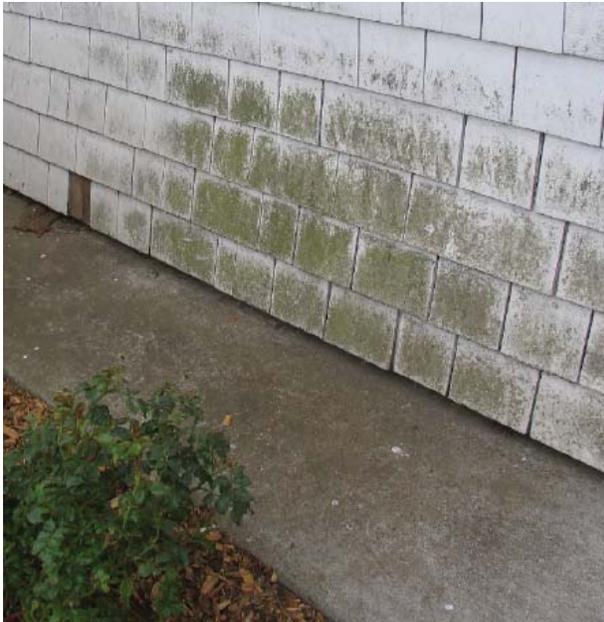
Fig. 35 : Biological growth has developed in moist, shaded areas

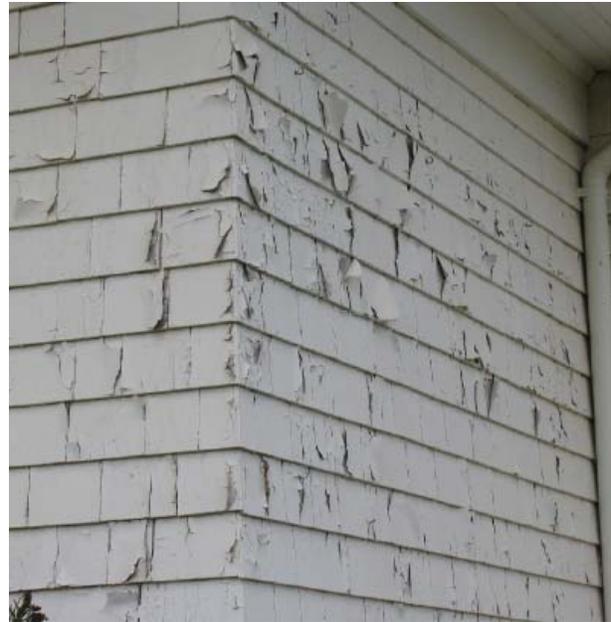
- Figure 36. Photograph: Main Boathouse, 2007. Paint failure on the shingle siding in close proximity with vegetation. Carey & Co., Inc.

Fig. 36 : Much of the paint has detached from the shingle siding.

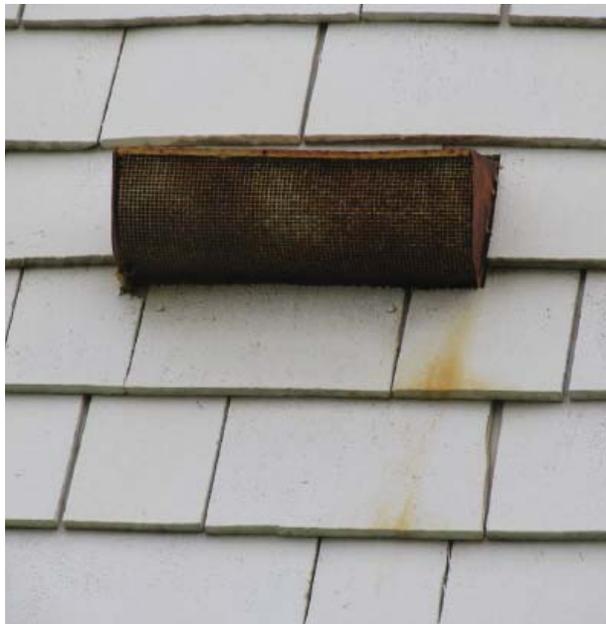
Fig. 39 : Rust stains are evident in the shingled areas.

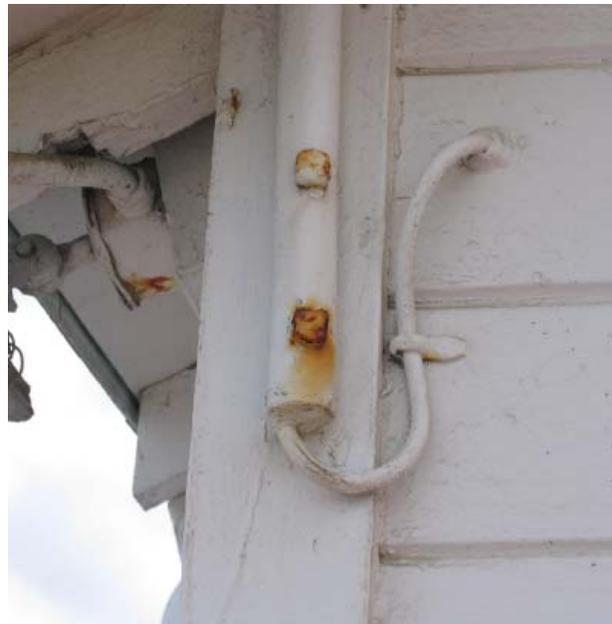
Fig. 40 : Corroded ferrous metal hardware is embedded in the shingles

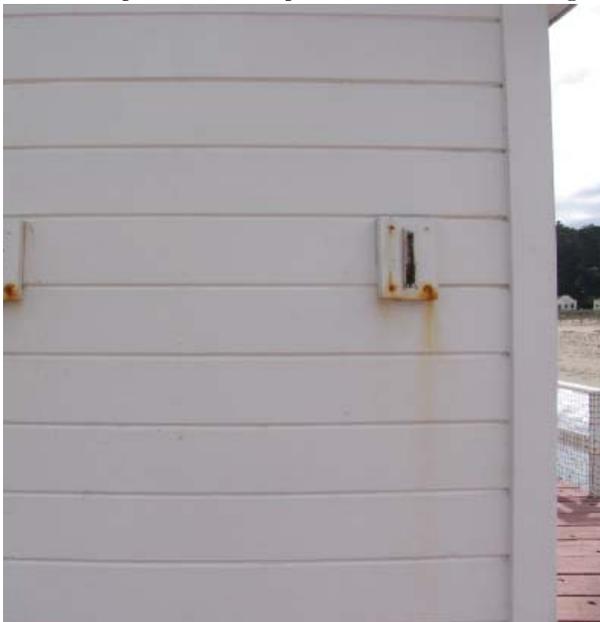
Fig. 43: Corrosion staining from embedded hardware at the Buoy Shack

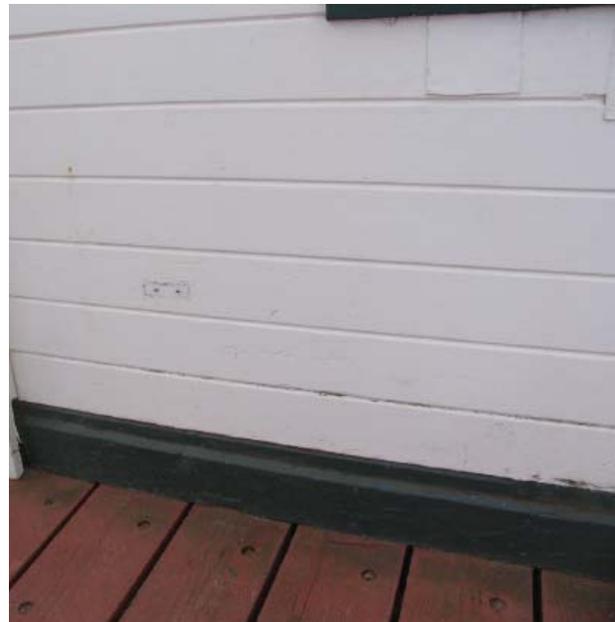
Fig. 44: Inappropriate patching on clapboard wall at the Buoy Shack..

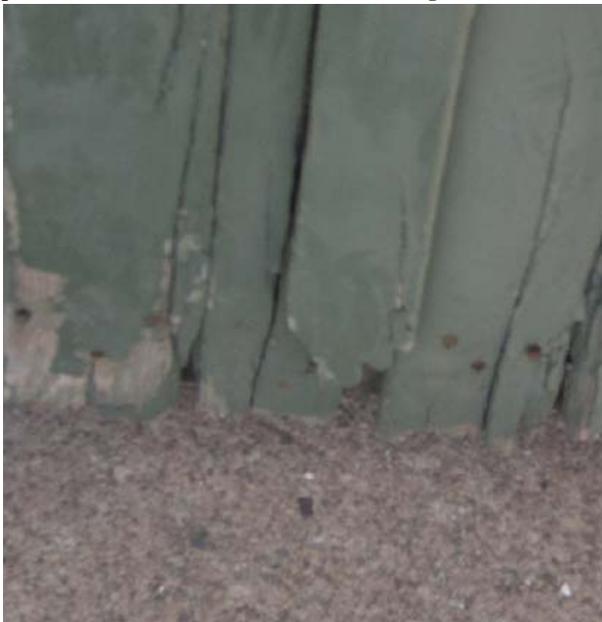
- Figure 44. Photograph: Buoy Shack, 2007. Inappropriate patching on clapboard wall. Carey & Co., Inc.
- Figure 45. Photograph: Shop & Garage, 2007. South garage doors exhibiting the mechanical deterioration associated with cross-grain dragging and water infiltration. Carey & Co., Inc.

Fig. 45: Mechanical deterioration of doors of the Shop & Garage associated with cross-grain dragging.

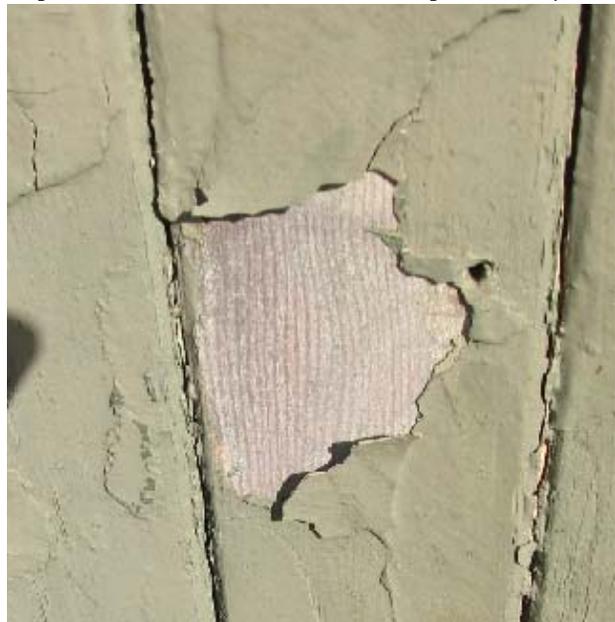
Fig. 46: Paint failure on the doors of the Shop & Garage.

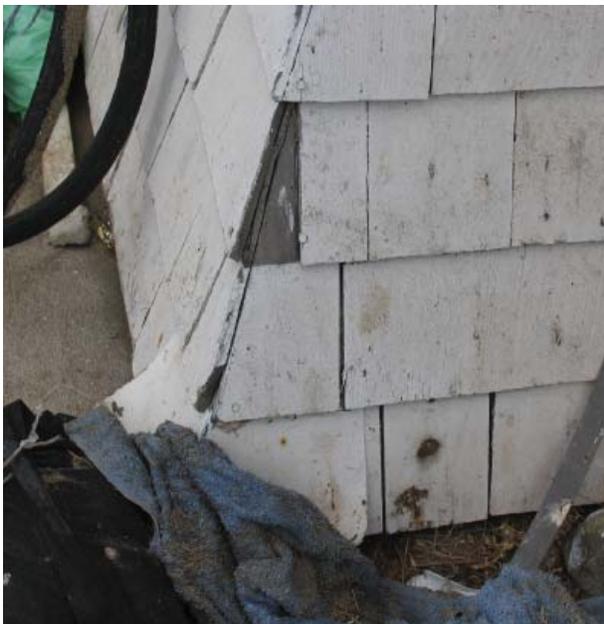
Fig. 49: Loss of shingles at the sloped corner of the Main Boathouse

Recommendation: The existing wall shingles are not severely deteriorated; however, there some are missing and should be replaced. These appear to be holding up well, however shingles have a finite life span, and will someday need to be replaced.

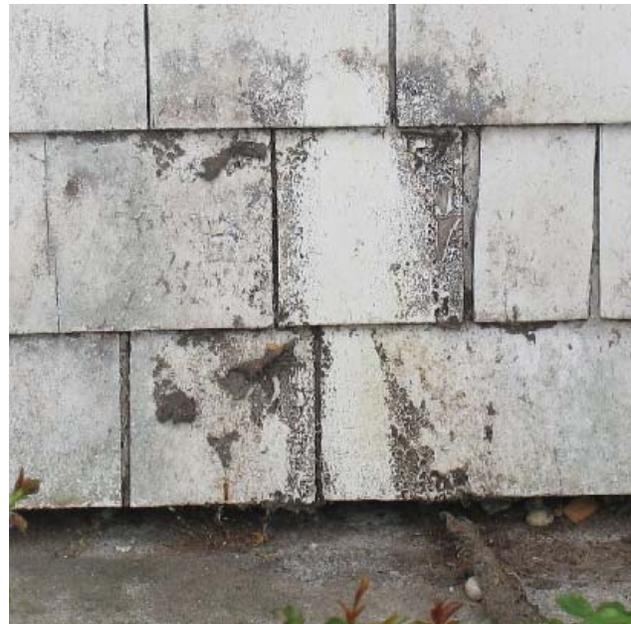
Fig. 50: Shingle soiling and deterioration at the Main Boathouse.

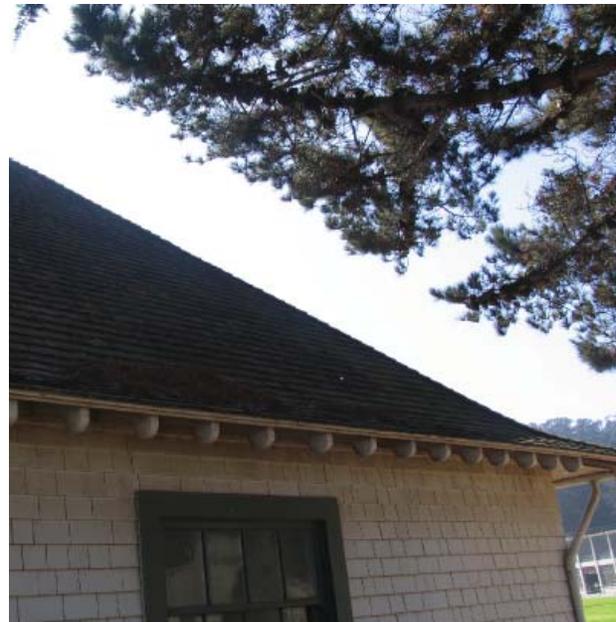
Fig. 56: Overhanging tree limb at the 1890 Boathouse.

Condition: Generally, the vegetation is well-kept. The trees could potentially cause damage in the event of strong winds. The trees to the west of the 1890 Boathouse and south of the Officer in Charge Quarters are close enough to hold moisture against the buildings and support biological growth (see figure 56).

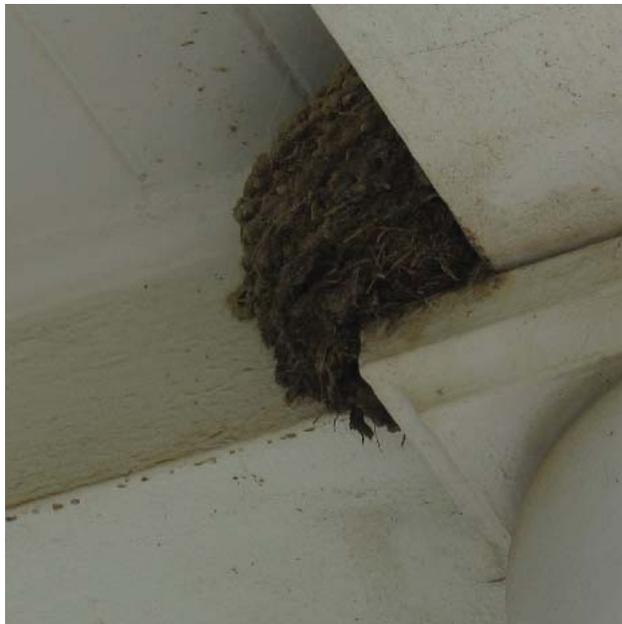
Fig. 57: Mud Swallow nests at the front porch of the Officer in Charge Quarters.

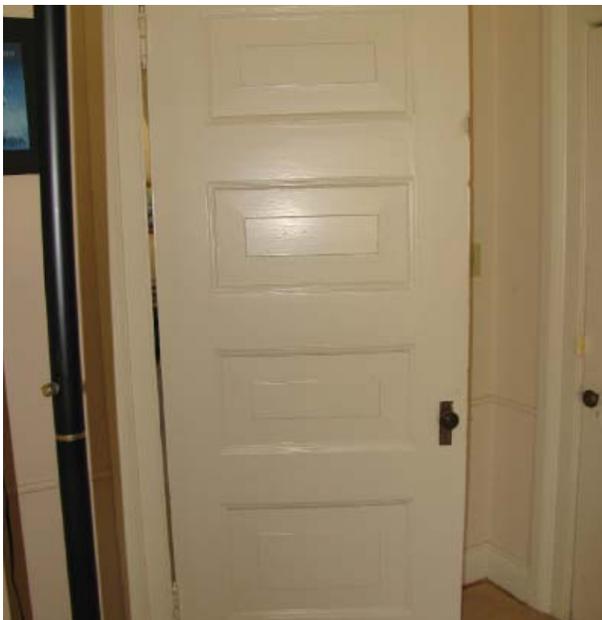
Fig. 67 : Most of the doors appear to be in good condition, with only minor repairs needed.

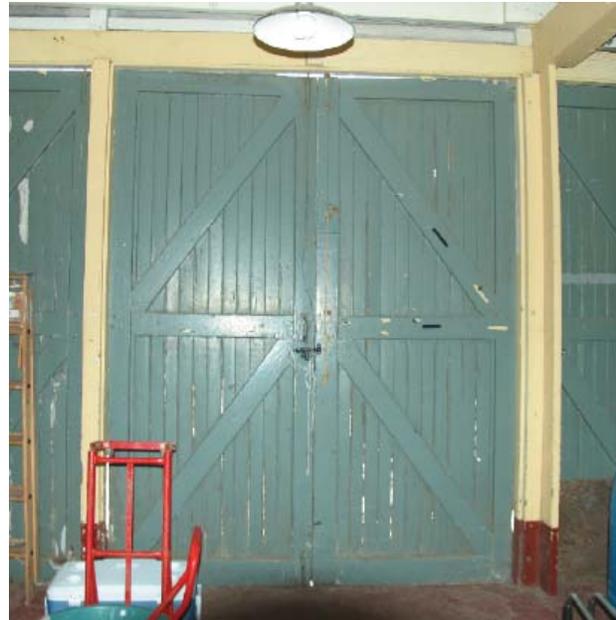
Fig. 68 : The doors at the Shop & Garage appear to be in fair condition.
