Golden Gate Dairy (Lopes Brothers Dairy, Ranch M)

Cultural Resource Reports and Site Treatments: Cultural Landscape Report Historic Structure Reports Archeological Assessment and Treatment Report

June 10, 2013
United States National Park Service,
Golden Gate National Recreation Area
Division of Cultural Resources

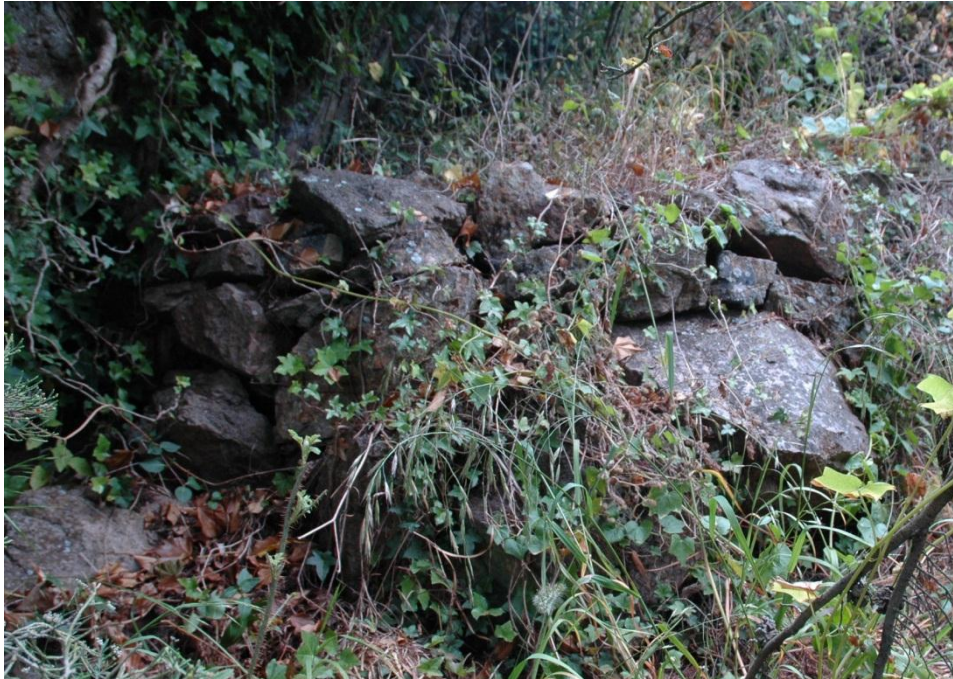
constructed, though the walls are somewhat distinguishable in a 1942 aerial. Although vegetation has largely obscured the walls, they still exist in good condition.

Detail of one the garden terrace stone walls, located east of the Main House.

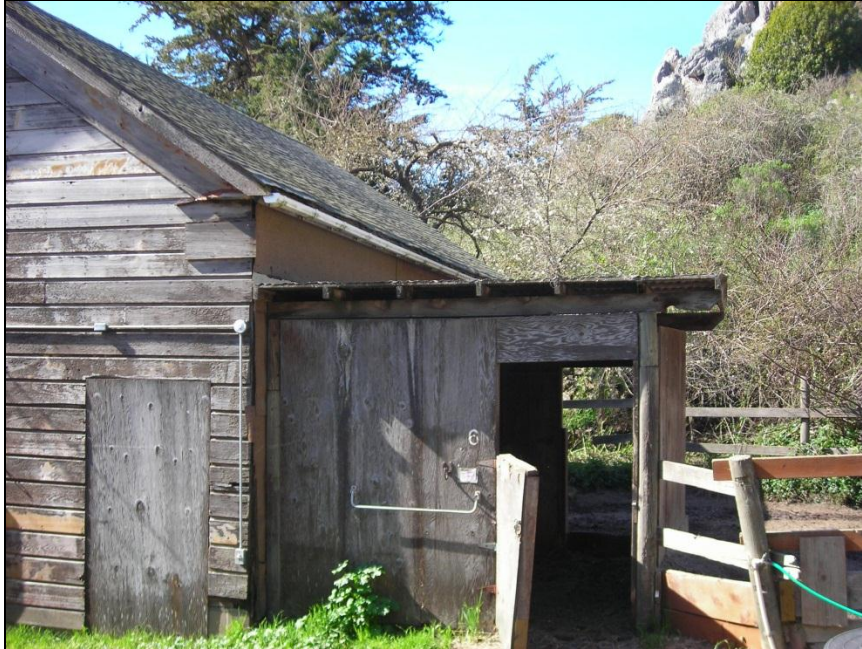
Recommendations include removal of non-historic attachments to historic buildings, such as this plywood stall behind the Creamery.

- Remove all non-historic additions to the historic buildings, including the outhouse on the south side of the Sanitary Barn.
 - Plywood stalls in the will be removed. Stalls outside of the historic core maybe replaced in the same general location, with an emphasis on organization of the space available. This may result in a less than one for one replacement.

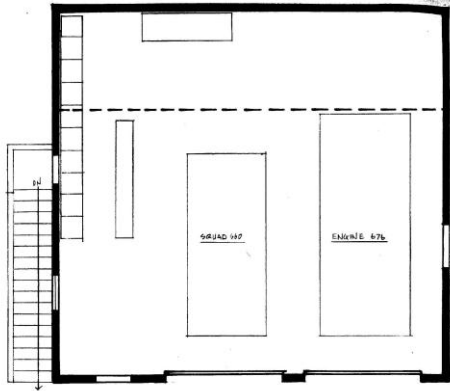
MBVFD Barn Remodel Concept Floor Plan

Not Recommended: Changing the building form and shape by adding a stair on the west where there was not one historically; altering the original footprint with an addition along the whole of the north wall, modifying the roofline.

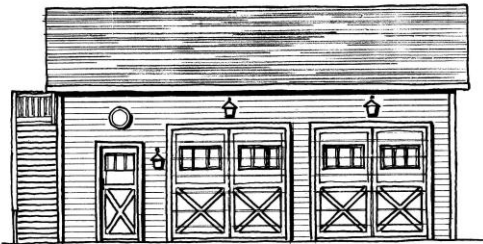
MBVFD Barn Remodel Concept Front (South) Elevation

Not Recommended: Changing the building form and shape by adding a stair on the west where there was not one historically; changing the character of the main façade by the addition of contrasting stylistic treatments and appurtenances; altering important elements of the building style (rake boards and corner returns).

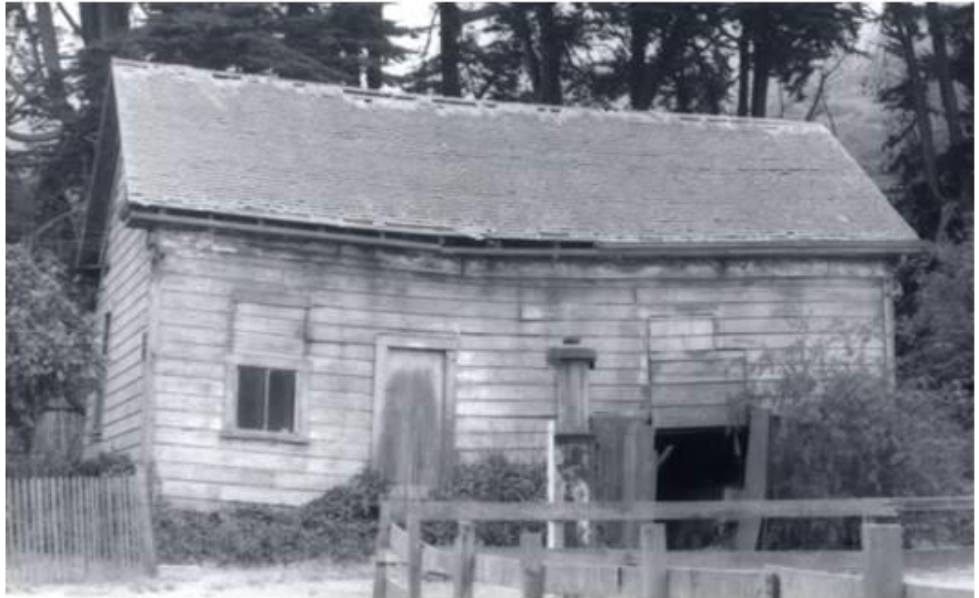
Golden Gate Dairy Creamery Building South Façade ca. 1970

Note the window penetration on the west, the in-filled window penetrations on the south, and the door penetrations. There is no exterior porch. The window at photo left matches windows extant on the Main House. Object in foreground is believed to be a gasoline pump.

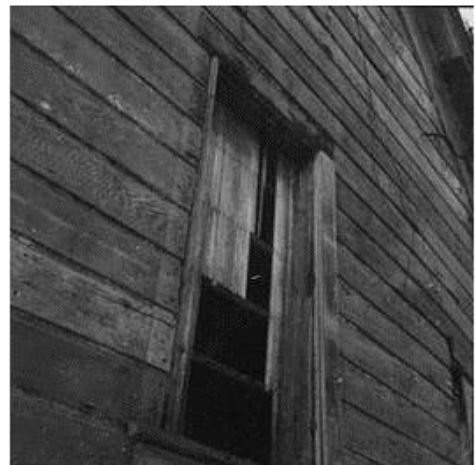
Two Views of the Golden Gate Dairy Creamery Building East Façade 1970

Note the window that appears to have been closed off but has shelves on the interior. Note also the lack of (or extreme foreshortening) of the door penetration in this location.

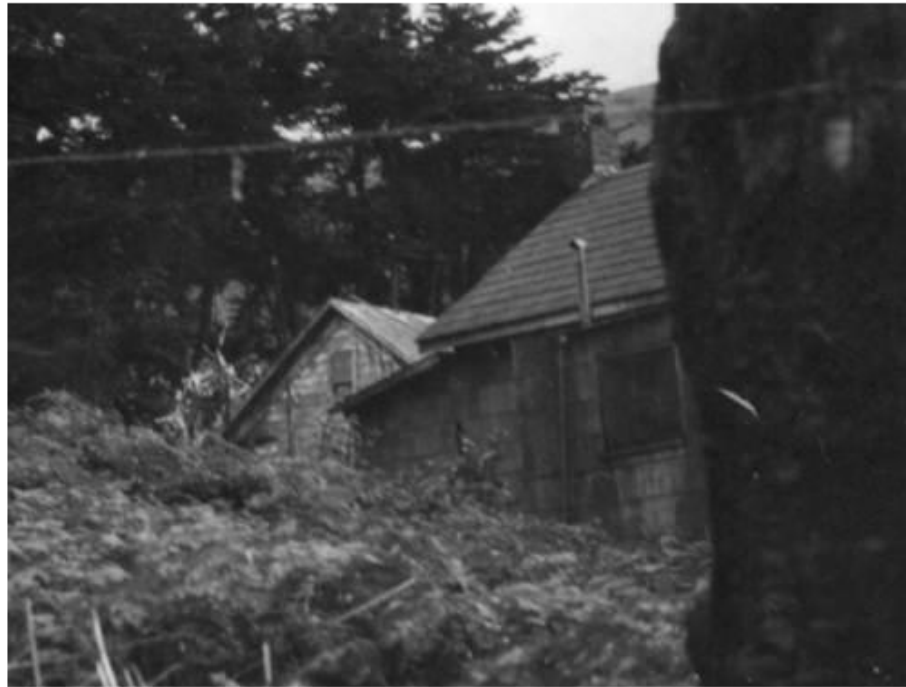
View of the Golden Gate Dairy 1970

Windows on the ground level are covered in wood lattice, making them difficult to distinguish in this photo.

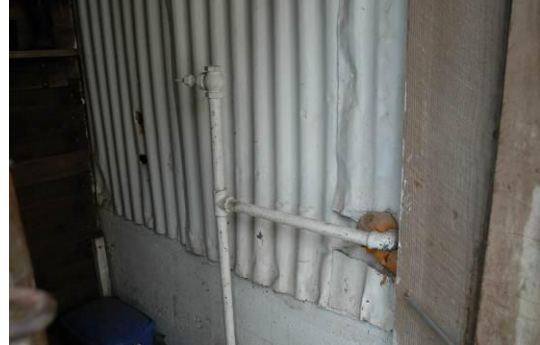
<p>Northeast corner inside outhouse; abandoned water piping possibly from boiler or heater on opposite side; north room (NPS Photo, 2012)</p>		<p>Capped ridge vent detail (NPS Photo, 2012)</p>
