PART I: DEVELOPMENTAL HISTORY

HISTORICAL BACKGROUND & CONTEXT

CONDITIONS ASSESSMENT

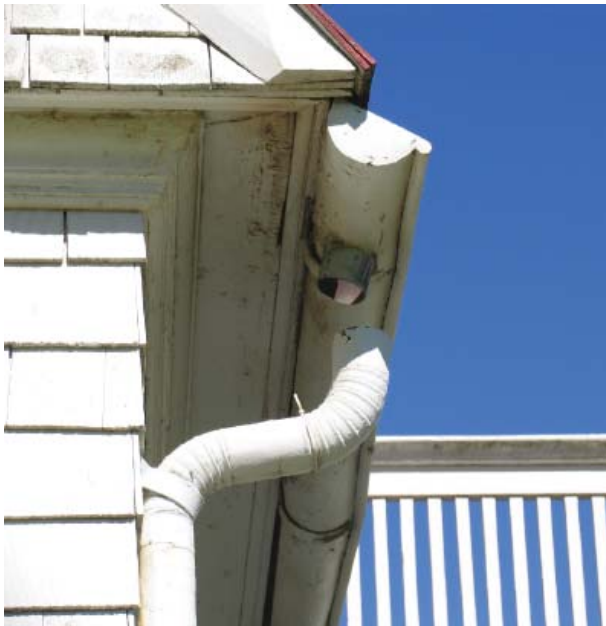
Fig. 29 : Disconnected drain spout at the Officer in Charge Quarters.

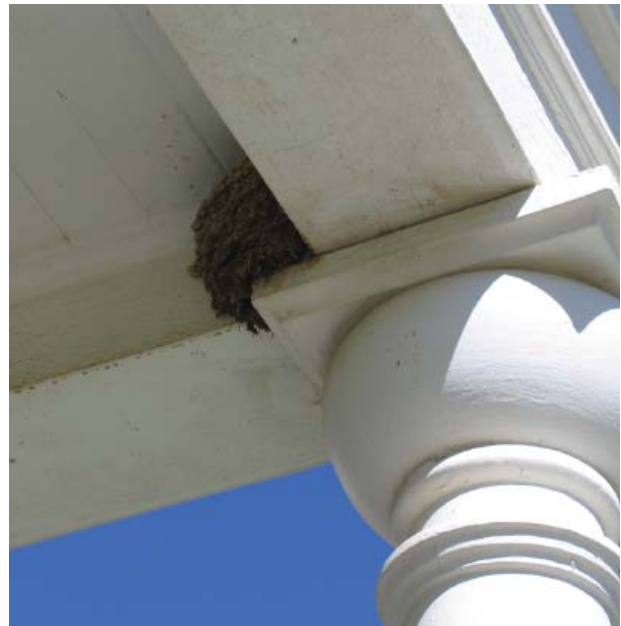
surface, indicating a problem with water infiltration, but the condition of the paint suggests that the water infiltration is not yet severe. In general the windows appear to need only mild repair for full functionality. Mud swallows are nesting in the entryway porch.

Fig. 30 : Mud Swallows nesting in the eaves of the porch at the Officer in Charge Quarters.

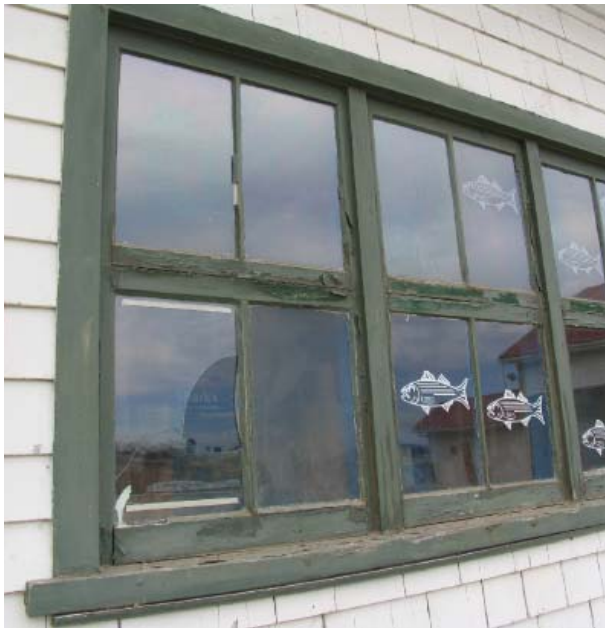
Fig. 33 : The exterior paint is deteriorating on the windows, as is the glazing compound.

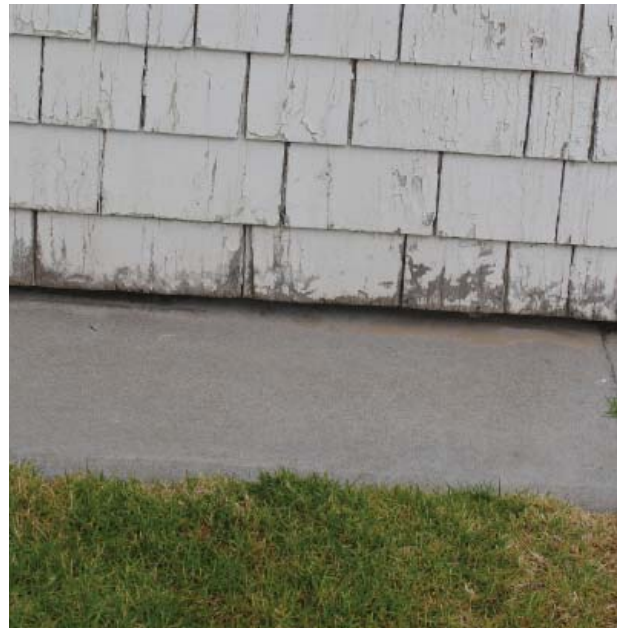
Fig. 34: Improper drainage at grade has lead to shingle deterioration.

This structure is in fair condition. The exterior shingle cladding appears sound but has biological growth and severe painted finish failure. It is possible that some of the shingles will require consolidation or replacement; however, the majority of the singles will simply need to be repainted. All of the hardware has corroded and is staining the finish of the structure, in some cases causing mechanical damage to the wooden elements. The hip roof appears to be in good condition; however, it hosts some biological growth that should be addressed. The wooden windows vary in condition. The windows on the lower level of the eastern exposure appear to be in the poorest condition. Most of the remaining windows are protected with aluminum exterior storms and are in fair to good condition. The windows on the fourth floor are not protected by exterior storm windows. The windows of the south and west exposures are in fair to poor condition and are exhibiting evidence of salt efflorescence. Much of the poured concrete appears to be in generally good shape, though some cracking has occurred, possibly due to settling or seismic activity. All of the hardware is corroded and there is evidence of biological growth on the painted concrete and the painted steel emergency stair.

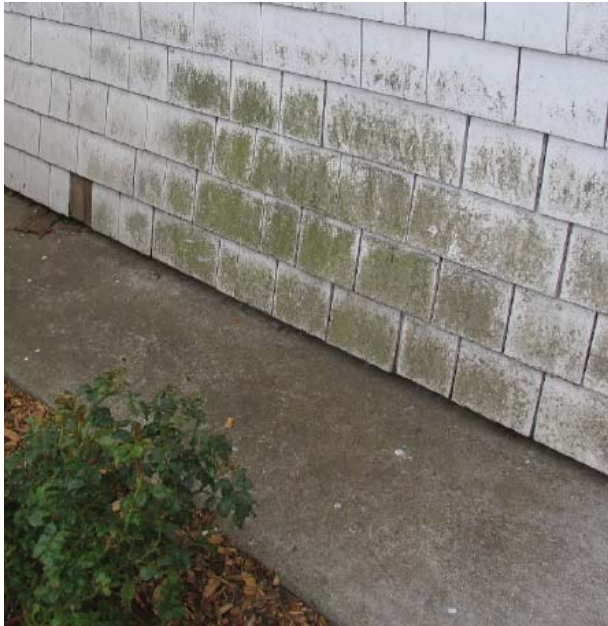
Fig. 35 : Biological growth has developed in moist, shaded areas

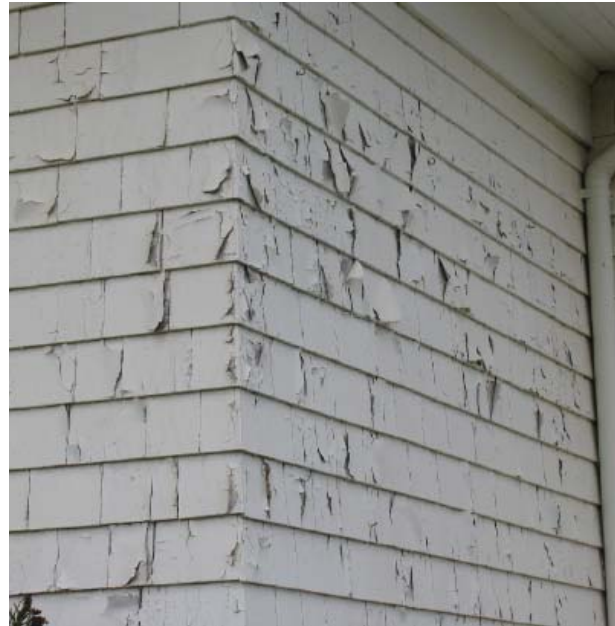
Fig. 36 : Much of the paint has detached from the shingle siding.
