## **PART II: TREATMENT AND WORK RECOMMENDATIONS**

#### **GULF OF THE FARALLONES NATIONAL MARINE SANCTUARY, FORT POINT COAST GUARD STATION REHABILITATION OF THE MAIN BOATHOUSE/LIFE SAVING STATION (PE1903)**

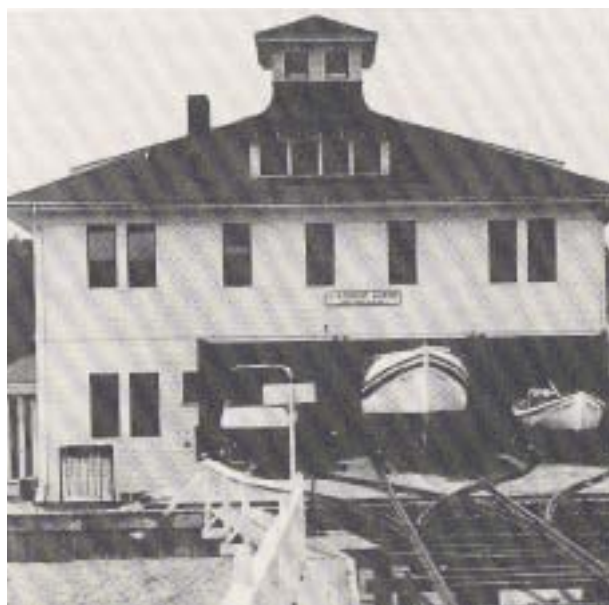
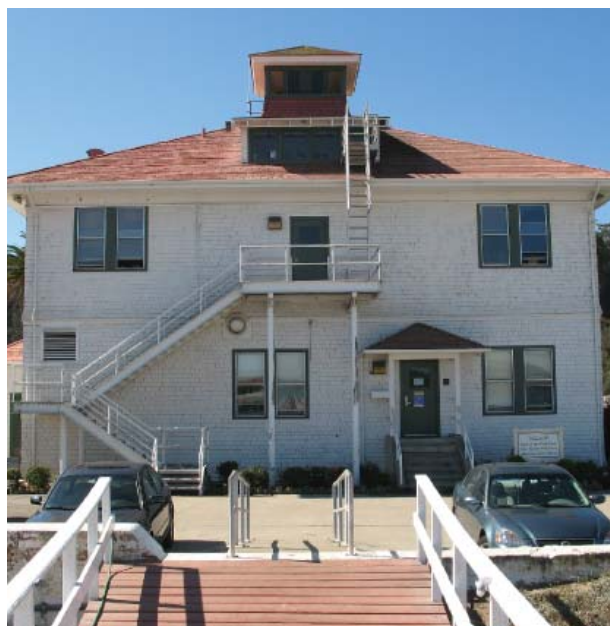
and exhibiting a full size life saving boat in front of the building could be a core element of cultural interpretation (see figures 37 & 38).

*Fig. 37 : North elevation, the original window configuration of the Life Safety Station, 1919.*

*Fig. 38 :North elevation, the current window configuration of the Life Safety Station.*

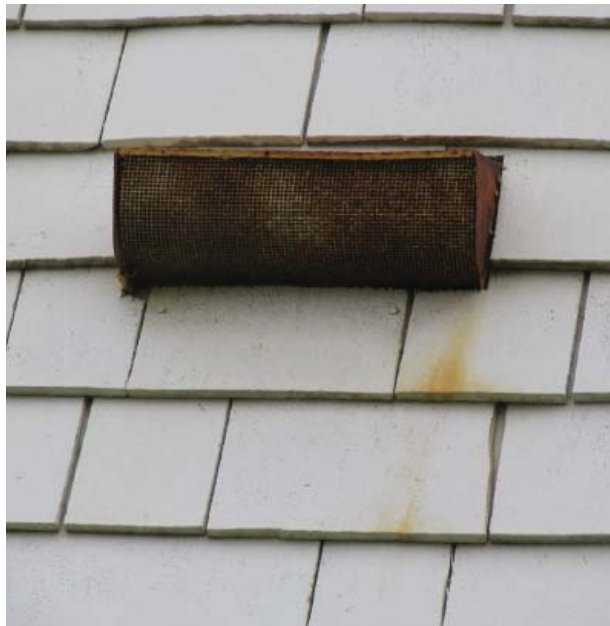
*Fig. 39 : Rust stains are evident in the shingled areas.*

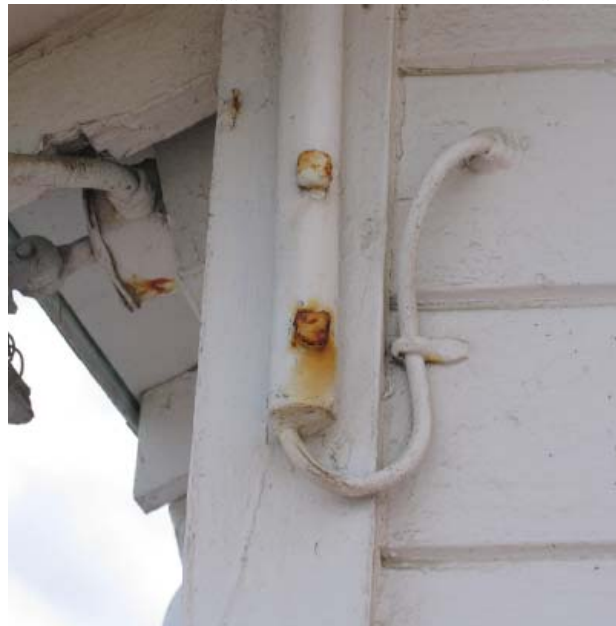
*Fig. 40 : Corroded ferrous metal hardware is embedded in the shingles*

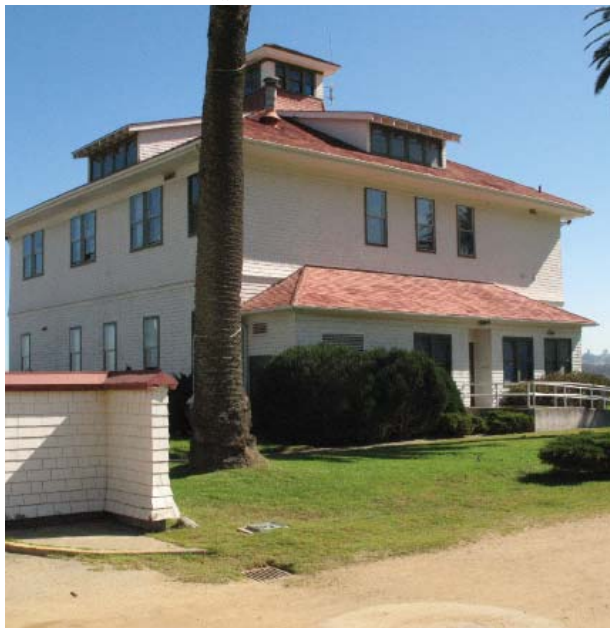
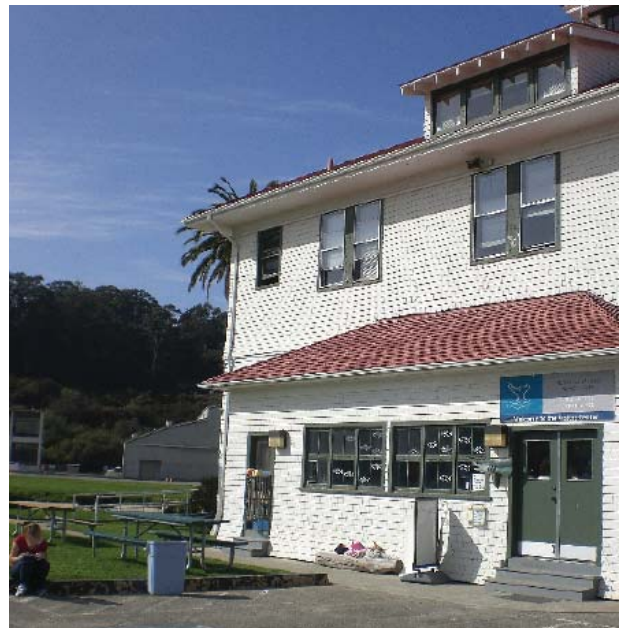
Condition: At the Main Boathouse, the enclosed area of the south porch has been completely reconfigured. The enclosed area of the eastern porch is in fair condition; however, the exterior windows are in relatively poor condition. Water has infiltrated the interiors, around the window sash and on the floors. The open front porch of the Officer in Charge Quarters is in poor condition, the platforms and stairs are deteriorated and unsafe, mud swallows are nesting in the eaves, and the painted finishes are severely deteriorated.

Fig. 41 : South elevation, enclosed porch of the Main Boat-house

Fig. 42 : East elevation, enclosed porch of the Main Boat-house

Recommendations: Reopen the eastern porch at the Main Boathouse. Repair wooden elements at the Officer in Charge Quarters porch. Refinish all porches with historically appropriate colors.

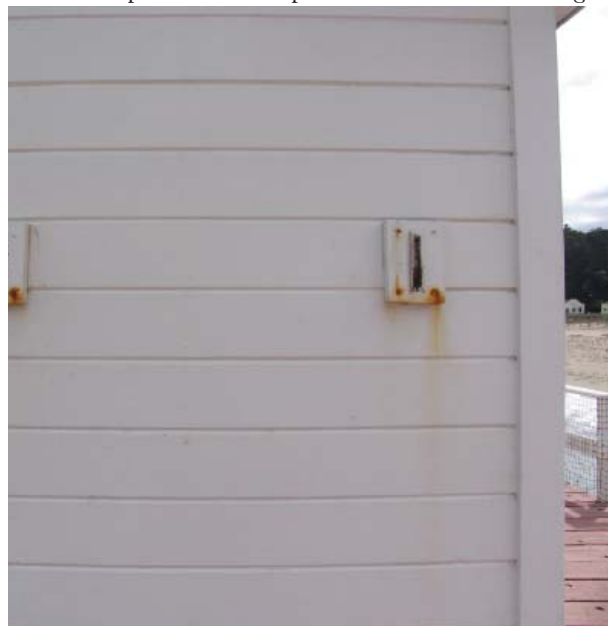
Fig. 43: Corrosion staining from embedded hardware at the Buoy Shack

Condition: The cladding is in fair condition. Deterioration includes delamination and general deterioration of the paint, water damage, dirt build-up, and biological growth. Rust staining occurs at metal attachments (see figure 43).

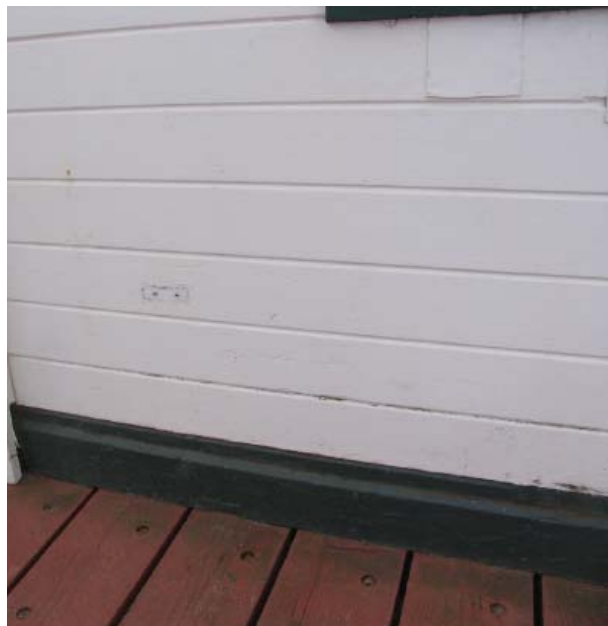
Fig. 44: Inappropriate patching on clapboard wall at the Buoy Shack..

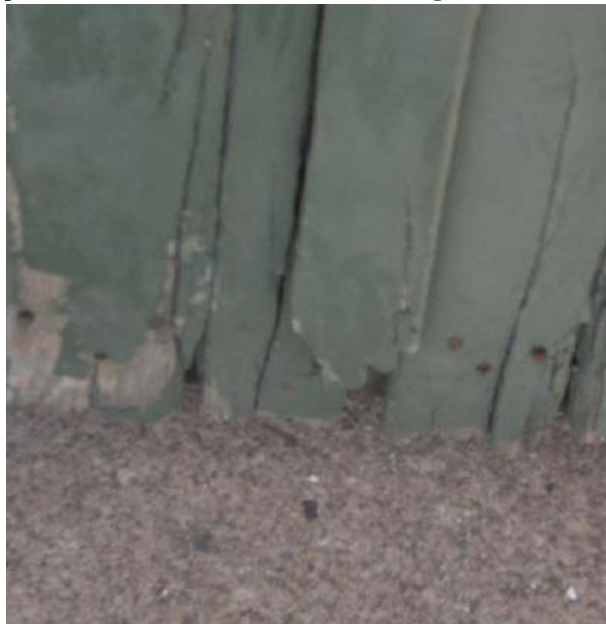
*Fig. 45: Mechanical deterioration of doors of the Shop & Garage associated with cross-grain dragging.*

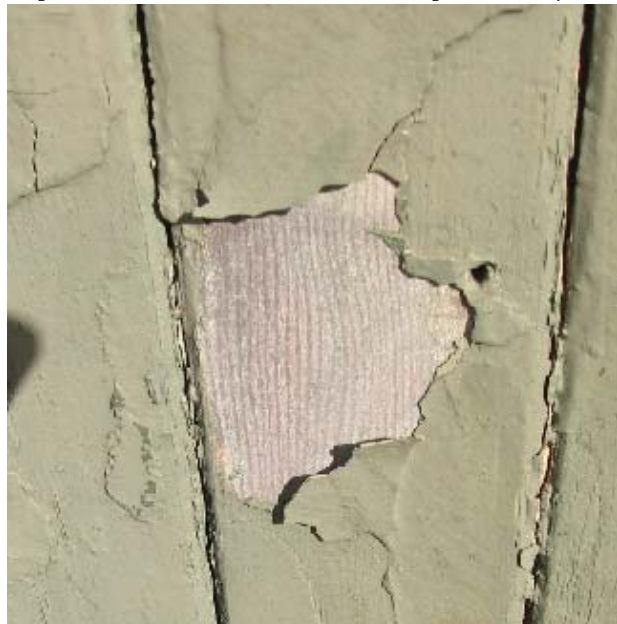
*Fig. 46: Paint failure on the doors of the Shop & Garage.*

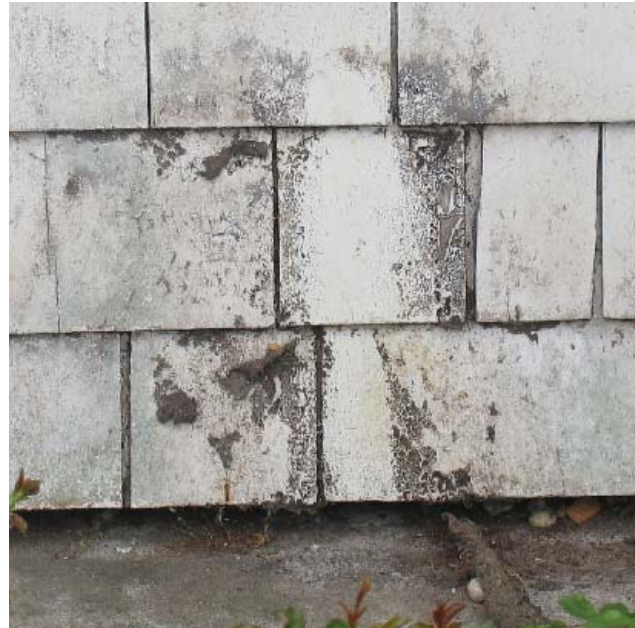
*Fig. 50: Shingle soiling and deterioration at the Main Boathouse.*

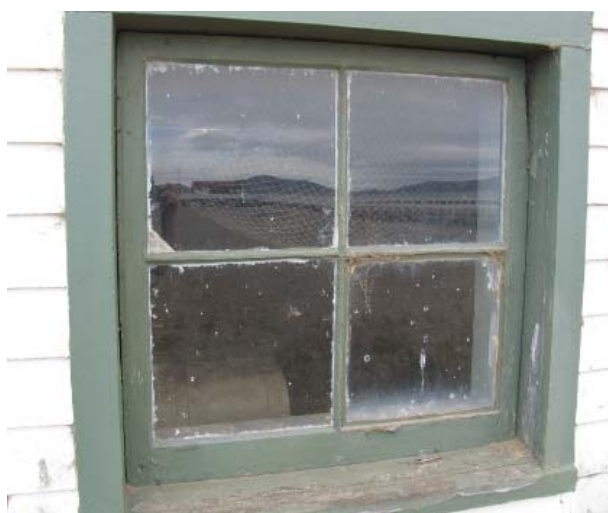
Condition: The paint has deteriorated, and is alligatored, peeling, or missing over the majority of all five structures primarily on the window elements (see figure 52).

*Fig. 52: Four-lite awning window at the Shop & Garage.*

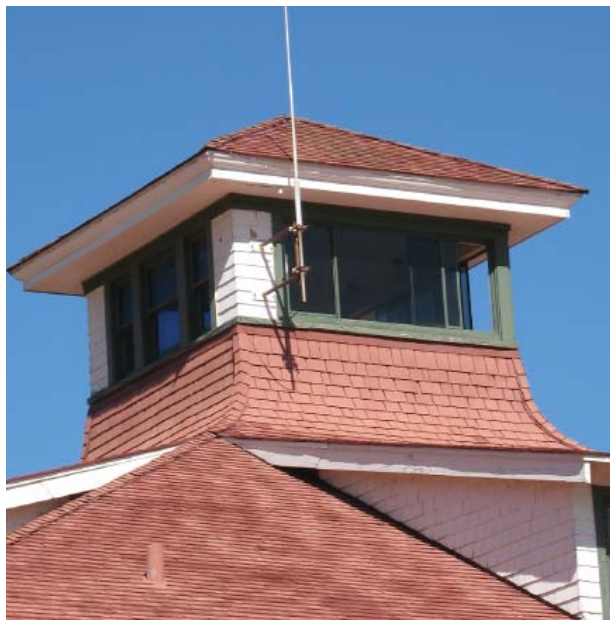
*Fig. 53: Aluminum sliding window at the Main Boathouse*

**Recommendations:** Replace non-contributing windows, particular aluminum sliders, with replica wood windows to match those shown in early drawings and photographs. A number of replacement windows fall within the period of significance, therefore restoration would not necessarily warrant their removal or restoration to their pre-renovation condition. While it would be possible to restore the windows to the pre-renovation/replacement condition, it may be argued that these 60 year old replacements have acquired significance over time, and that they may help to tell the full story of the buildings. Finally, their removal may constitute intrusions to the historic fabric that would result in a net loss of historic fabric. Therefore, careful consideration of all of these factors is recommended prior to a decisions regarding the dispensation

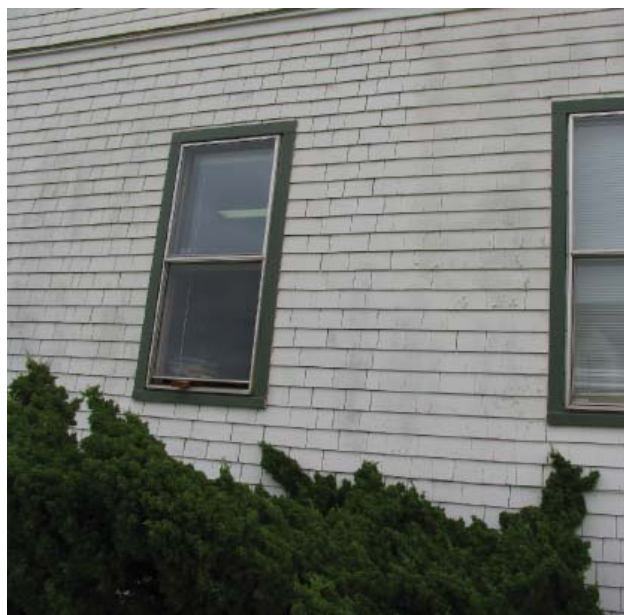
Fig. 55: Vegetation at the south wall of the Main Boathouse.

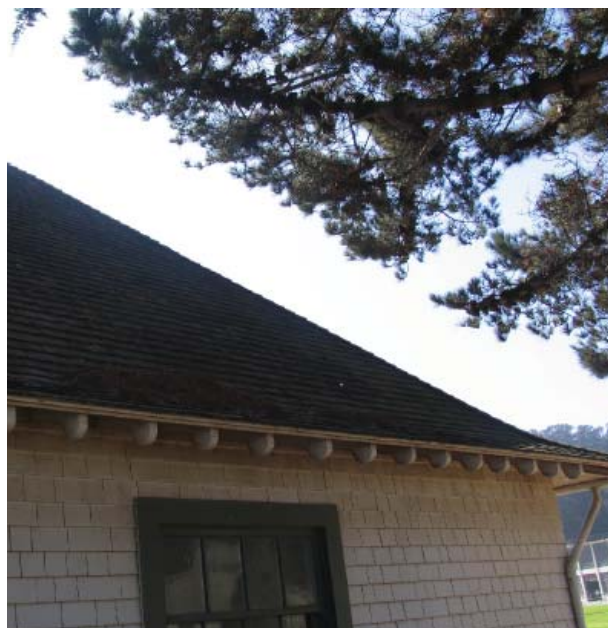
Fig. 56: Overhanging tree limb at the 1890 Boathouse.

Condition: Generally, the vegetation is well-kept. The trees could potentially cause damage in the event of strong winds. The trees to the west of the 1890 Boathouse and south of the Officer in Charge Quarters are close enough to hold moisture against the buildings and support biological growth (see figure 56).

Recommendations: Cut back trees and bushes in contact with the buildings. Swinging tree branches could cause impact damage. Roots can damage building foundations, underground building services and drainage systems. Additionally, vegetation can hold moisture against the buildings, providing an ideal climate for biological growth. Proposed landscape plans should use historic landscaping as a guide.

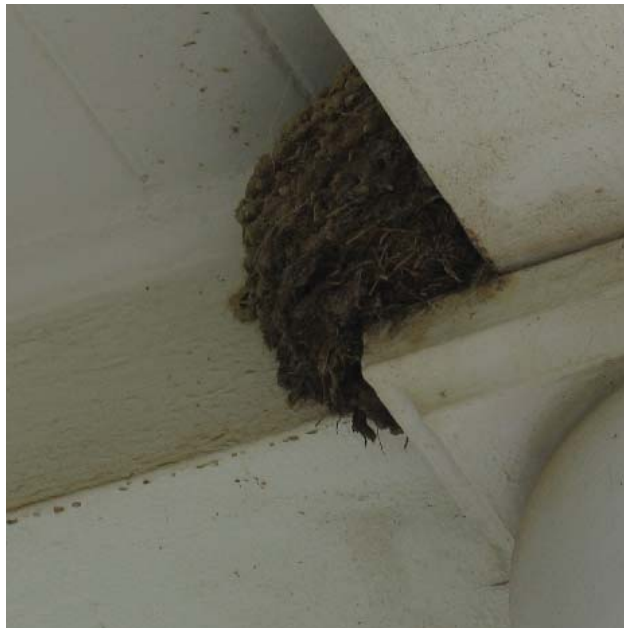
*Fig. 57: Mud Swallow nests at the front porch of the Officer in Charge Quarters.*

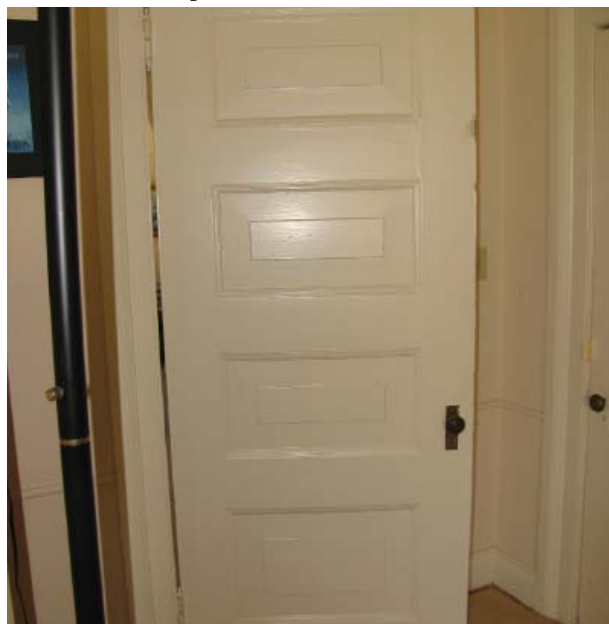
Fig. 67 : Most of the doors appear to be in good condition, with only minor repairs needed.

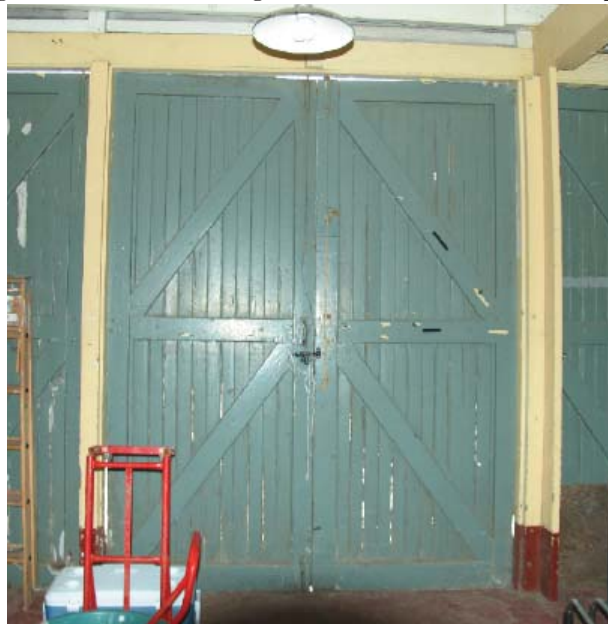
Fig. 68 : The doors at the Shop & Garage appear to be in fair condition.

Description: In general, nearly all doors appear to be original, and hardware also is, for the most part, intact and original. The historic doors are five-panel wood (see figure 67) and tongue-and-groove with diagonal battens and iron hinges (see figure 68). All of the doors have been painted.
