**Golden Gate National Recreation Area
Redwood Creek Watershed, Muir Woods
Road and Trail Re-evaluation and Assessment
Marin County, California**

Report No. 171024403
August 2017

Prepared for:
Golden Gate National Recreation Area
Building 201, Fort Mason
San Francisco, CA 94123

Prepared by:
Clay Allison, Project Geologist
Tara Zuroweste, Professional Geologist #8418
Danny Hagans, Principal Earth Scientist
Pacific Watershed Associates Inc.
PO Box 2070, Petaluma, CA 94953 / (707) 773-1385
taraz@pacificwatershed.com

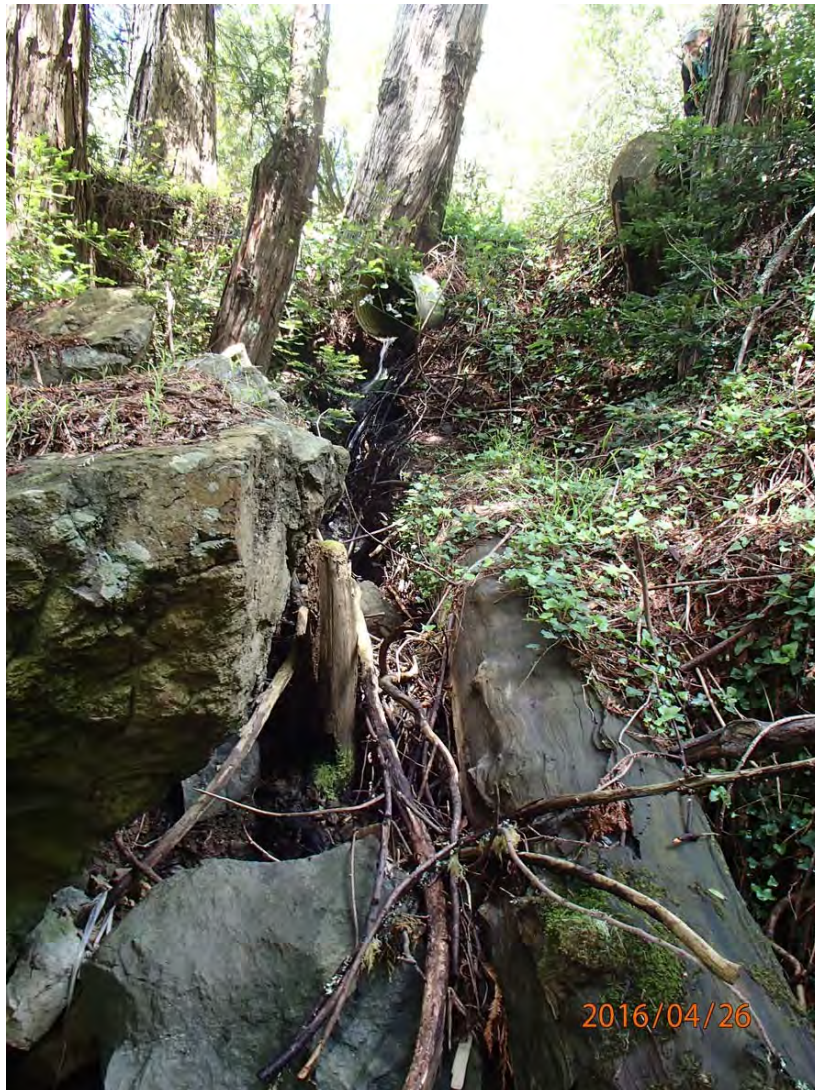
Photo 1. Photo taken from the trail looking upslope at the outlet of Site #78. We recommend installing a full round downspout to connect the outlet of this DRC to the armored trail crossing.

Description of Recommended Treatment: Install 20’-30’ of full-round downspouts at the DRC outlets to the trail and/or stream at DRC Sites #77, 78, and 80.

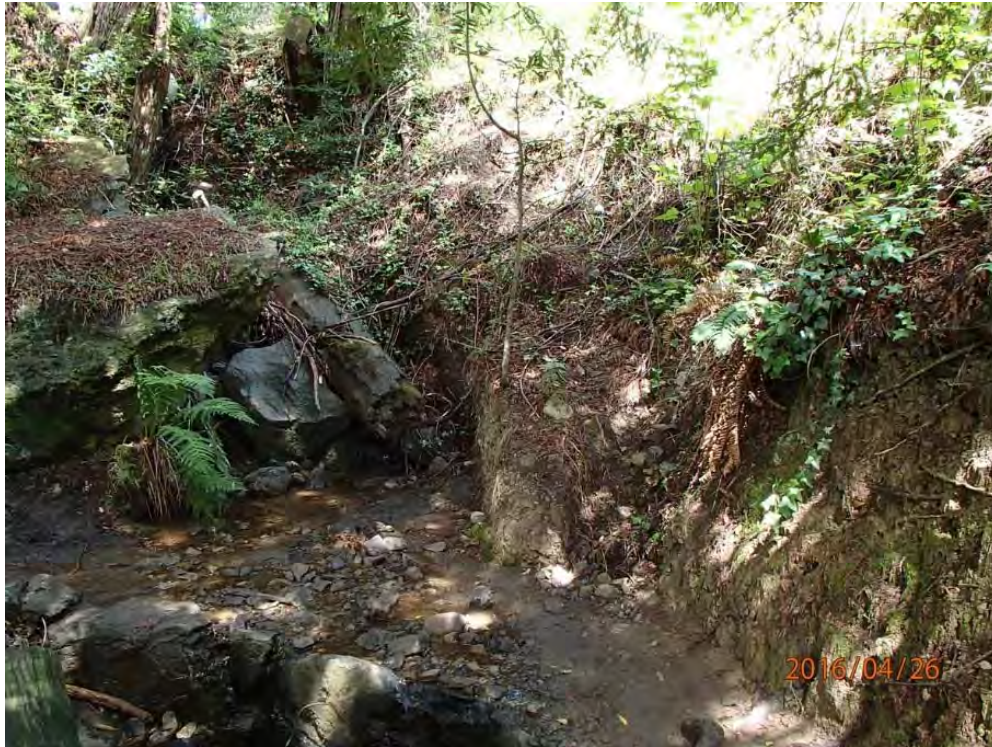
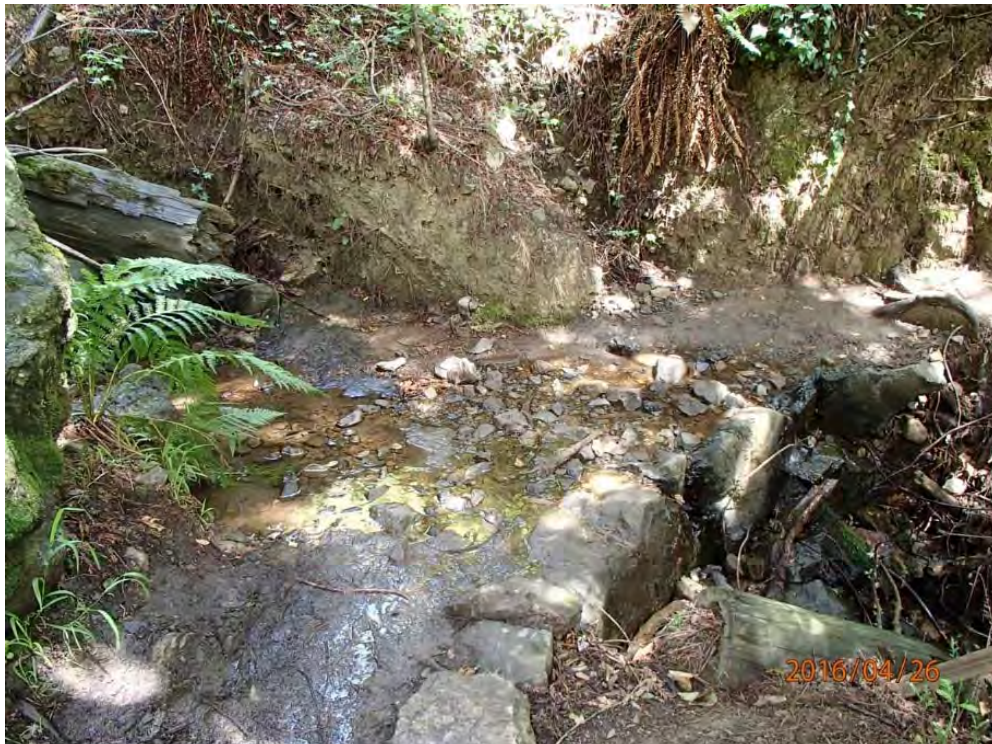
Photos 2 and 3. Photos taken from the left and right road approaches⁵ (top and bottom photos, respectively) looking at where Site #78 hits the armored trail crossing. Note the outlet of DRC Sites #77, 78, and 80 all deliver to stream crossing Site #79.

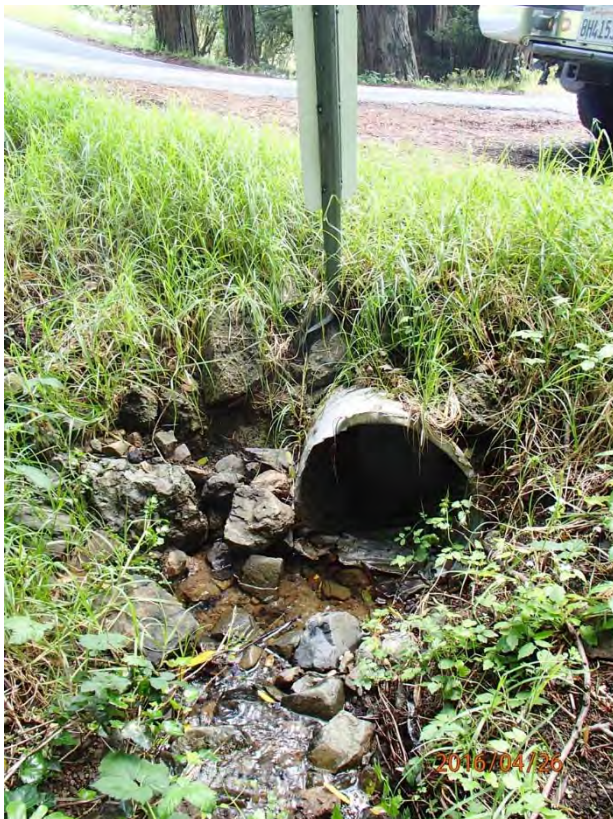
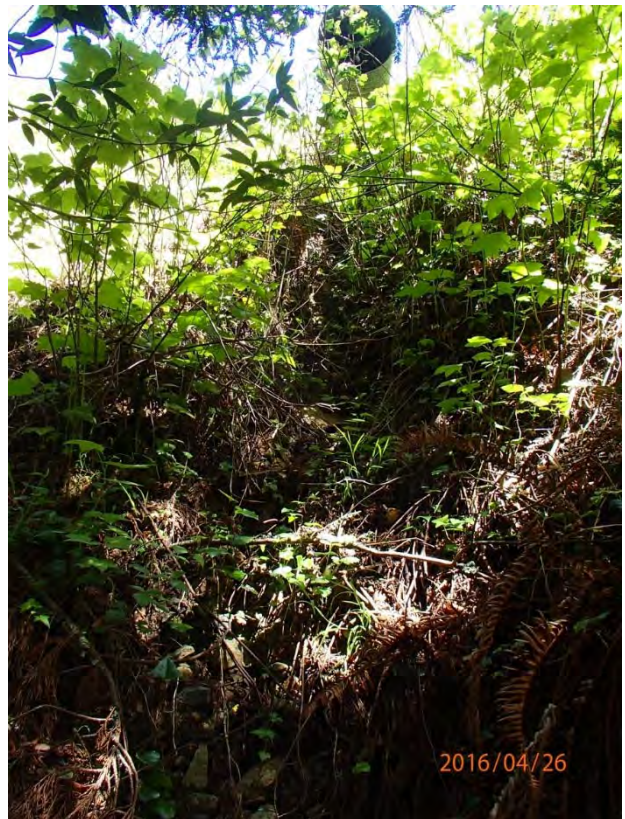
Photos 4 and 5. Photos taken of stream crossing Site #79. Photo 4 (left) taken upstream of the 20” diameter CMP inlet. Photo 5 (right) taken downstream of the CMP outlet. This 5’ x 1.5’ class 2 stream flows through an undersized culvert set shallow in the fill with a high plug potential. PWA recommends replacing this culvert with a properly sized and installed culvert.

Description of Recommended Treatment: Replace the existing culvert with a properly sized 42” diameter culvert, set at natural stream grade and at the base of the fill. Install a flared inlet and a trash rack 42” above the culvert inlet to decrease plug potential.

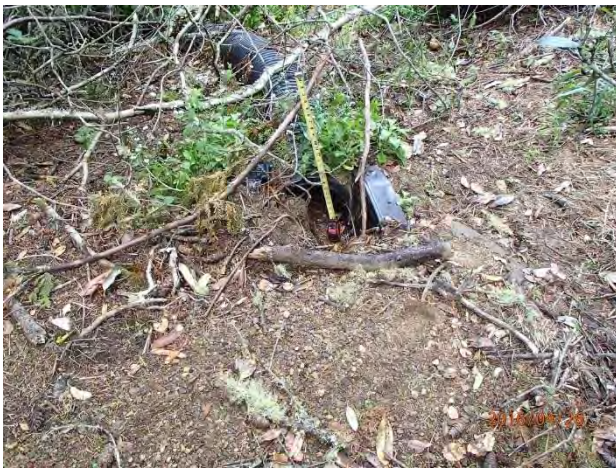
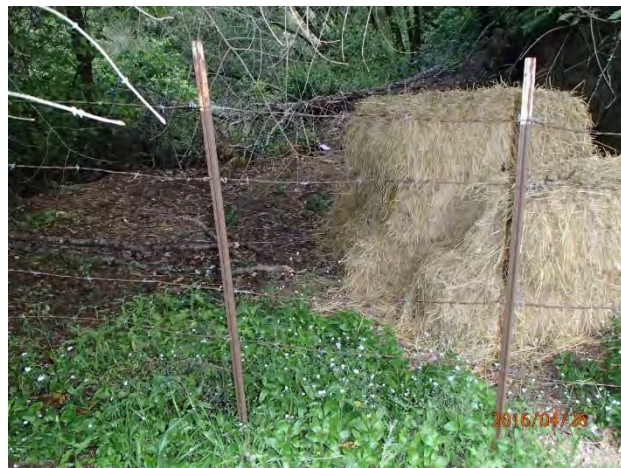
Photos 6 and 7. Photos taken at road surface discharge point Site #90. Photo 6 (left) taken at newly installed 12" DRC collecting flow from 730' of ditch along Muir Woods Road. DRC has a flared inlet and flex pipe for >100' down the hillslope. Photo 7 (right) is taken from Muir Woods Road looking at newly installed fence and stack of straw bales. We recommend that straw bales are moved to the outboard edge of the road so as not to impede flow onto abandoned road and to clean the inlet of the DRC.

Description of Recommended Treatment: Move or spread the straw bales as erosion control material. Clean the inlet of the DRC and use spoils to create a berm to direct flow from inboard ditch (IBD) of Muir Woods Road to DRC flared inlet and prevent future diversion down the abandoned road.

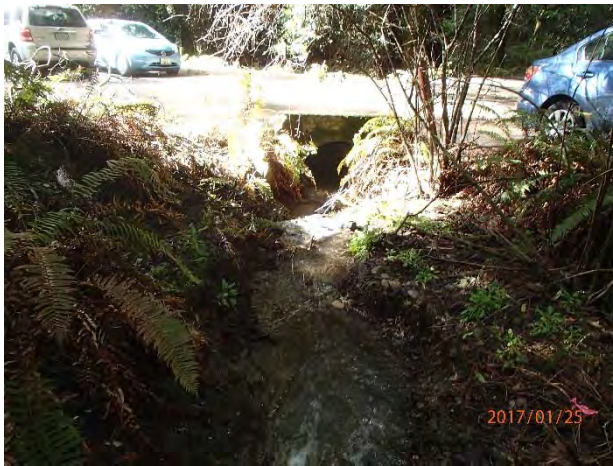
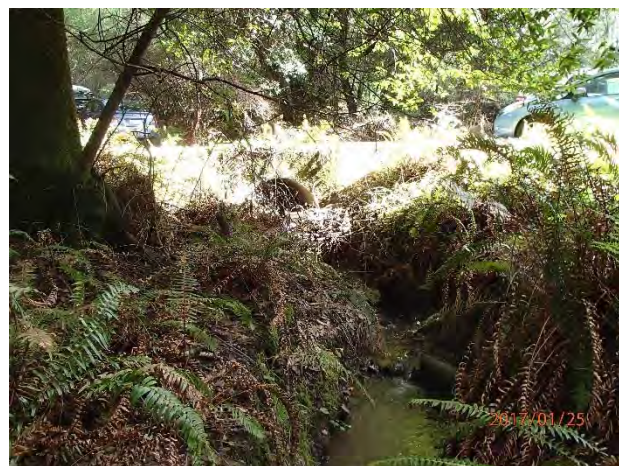
Photos 8 and 9. Photos taken at stream crossing Site #92. The stream is carried through an oval 41" wide by 30" tall culvert. Photo 8 (left) is taken from above the inlet of the culvert looking downstream. Photo on the left is view looking upstream at the outlet.

Description of Recommended Treatment: Clean out the stream channel downstream of the culvert outlet for 5' to the step in the channel and install a rock grade control structure at the culvert outlet to act as energy dissipation. Maintain the DRC up the right road approach and clean the plugged DRC to the left of the site and remove 60' of bermed road. If you are concerned about road-related pollutants, consider installing a filter above the inlets of contributing DRCs.

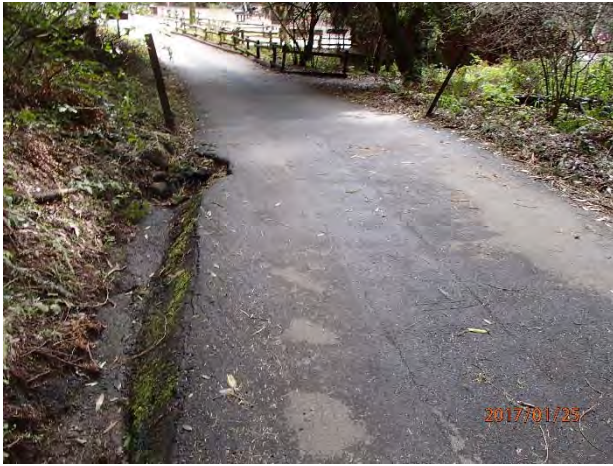
Photos 10 and 11. Photos taken at DRC Site #93. Photo above on left is taken from above the inlet of the 12" DRC. Photo to the right is taken below the outlet of the 12" culvert showing half plugged culvert.

Description of Recommended Treatment: Define the channel by removing accumulated stored sediment prior to entering the culvert inlet to prevent plugging. Clean accumulated sediment at the culvert outlet for 15' long x 2' wide x 1' deep. Note that this is not a stream site, but a ditch relief culvert that carries flow only in response to immediate rainfall.

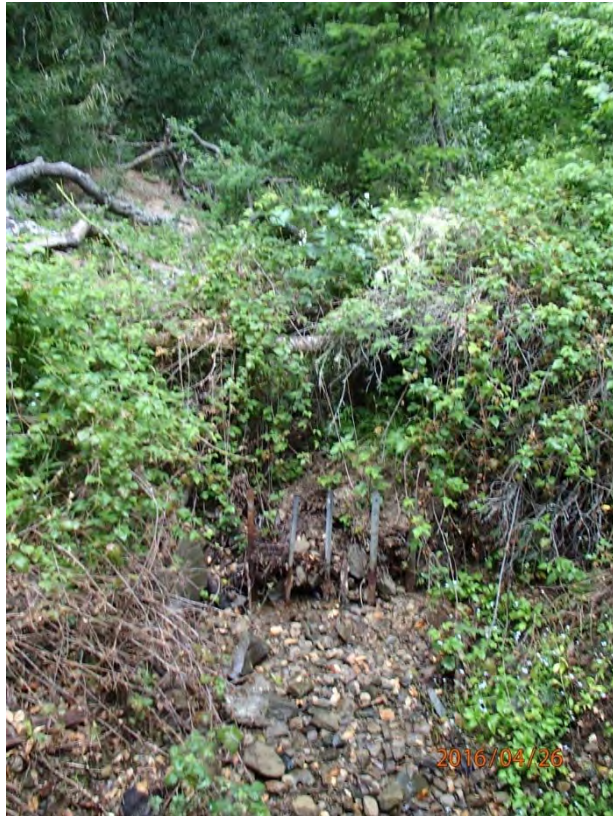
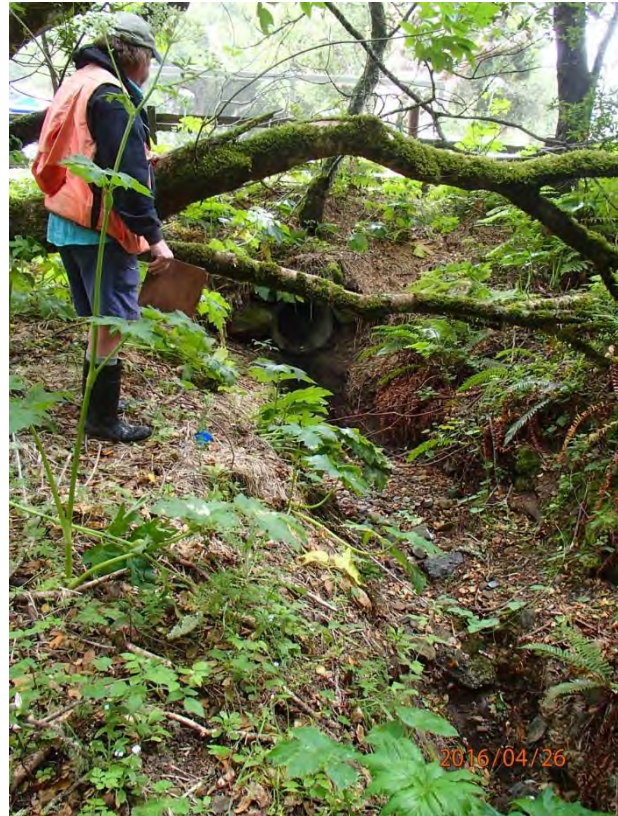
Photos 12 and 13. Photos taken at complicated stream crossing Site #94. Photo 12 (left) is taken from the inlet of the uppermost culvert looking upstream. The stream is carried through an undersized 24” diameter culvert from this point where the stream valley becomes buried by buildings, parking lot, and Muir Woods Road. The 24” culvert regularly plugs and flows across pavement and through a DRC. Flows from the 24” culvert are plumbed into an 18” culvert which outlets into Redwood Creek. Photo 13 (right) is taken below the outlet of the undersized 18” culvert delivering to Redwood Creek.

Long-term recommendation: If the road and parking lots are being redesigned, we recommend that a permanent solution be designed. PWA is available for consultation and/or review of any proposed plans. The existing culverts should be located and evaluated for structural integrity. Based on location and condition, drainage structures should be replaced, decommissioned, and/or removed. In addition, based on the location and extent of the improvements, we recommend that a new, properly sized culvert section(s), designed to accommodate the 100-year design flood flow along with organic debris that will be in transport, should connect the class 2 stream to Redwood Creek. Finally, any lengths of culvert that will be located under paved road/parking lot(s) greater than 60 ft in length and/or that may include elbows should have risers installed with cleanouts for future maintenance and trouble shooting.

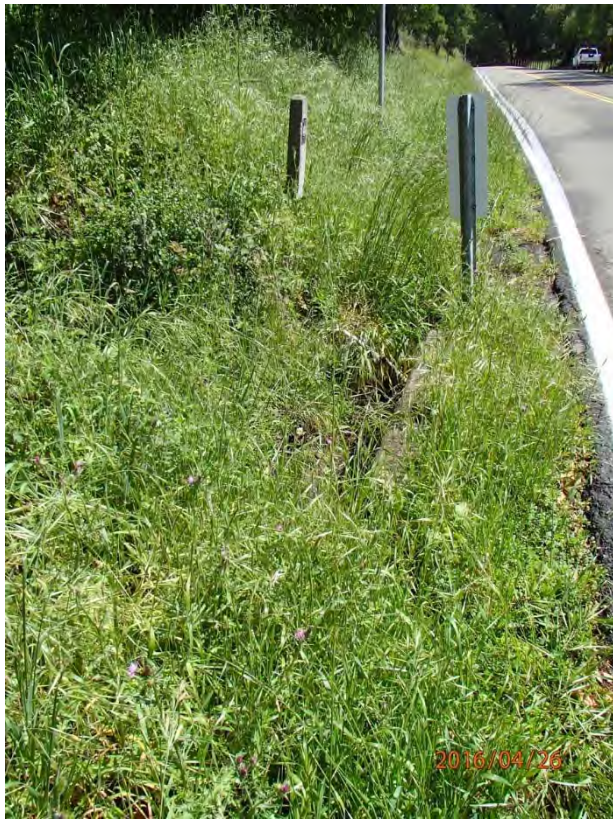
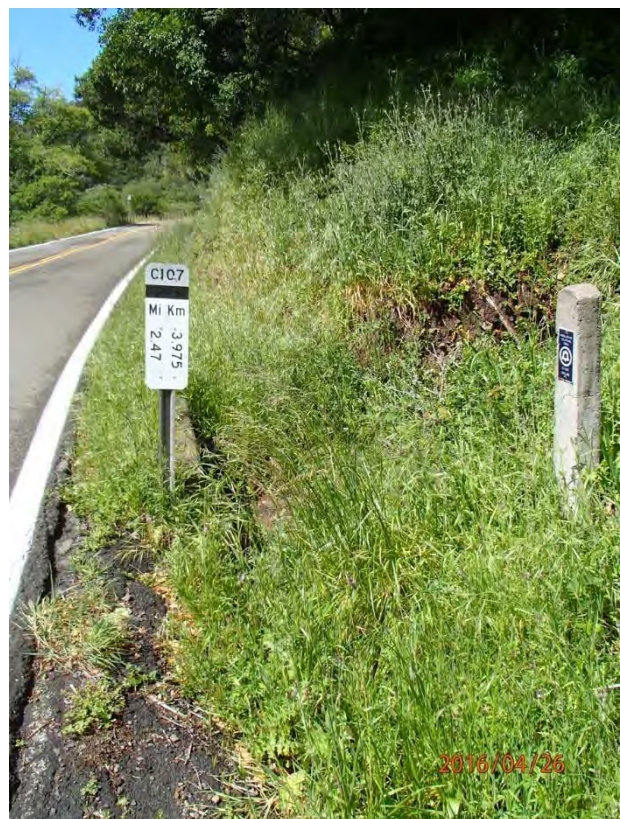
Photos 14 and 15. Photos taken of the hydrologically connected road and inboard ditch draining to stream crossing inlet at Site #159. Note that ditches are well vegetated, which promotes filtration of road surface runoff (sediment and pollutants).

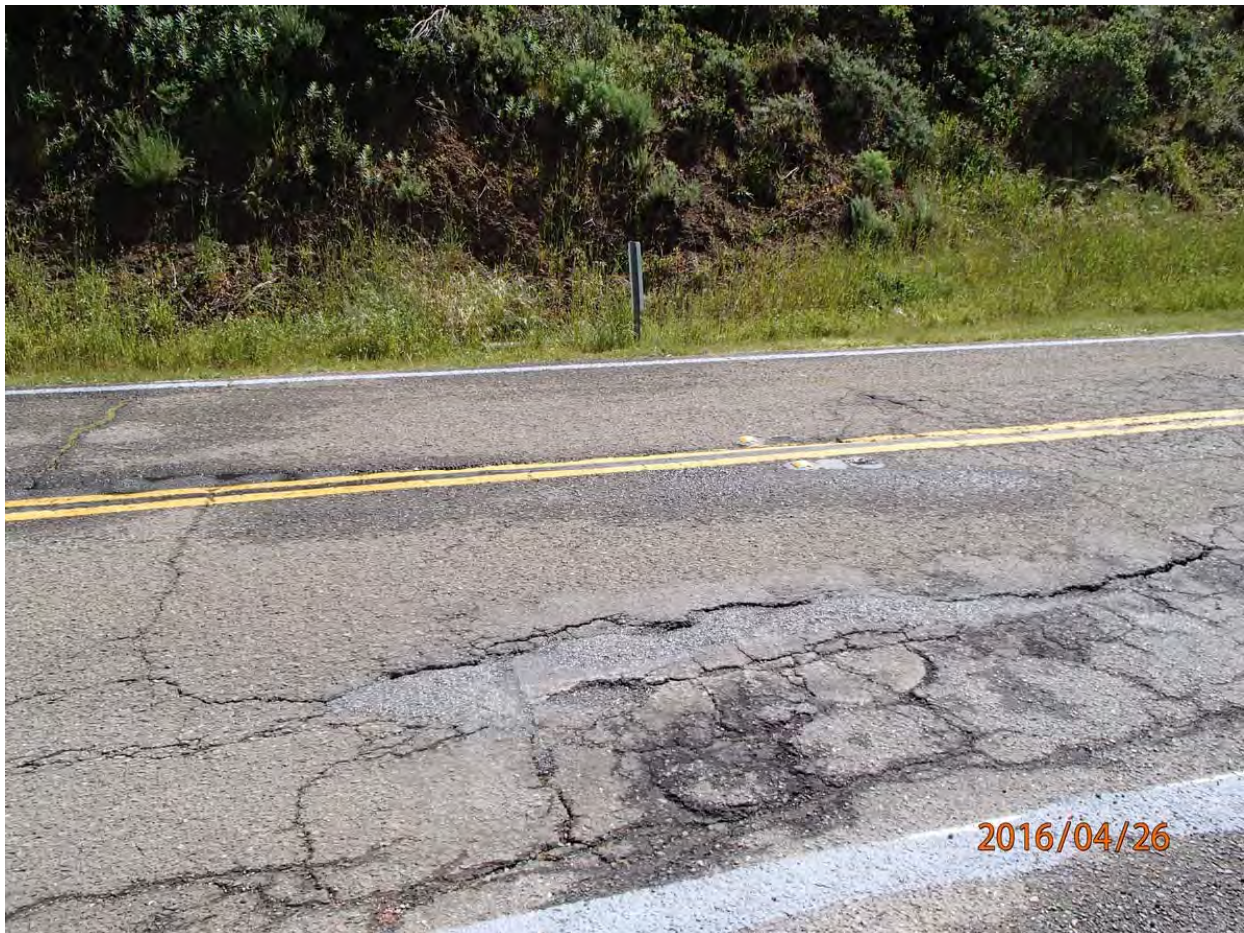
Photo 16. Photo taken along the outboard edge of the road across at the inlet of DRC Site #216 and the well vegetated inboard ditch.

Description of Treatment Recommendation Pack armor around the existing culvert outlet to offer additional support and protect the OBR against further erosion.

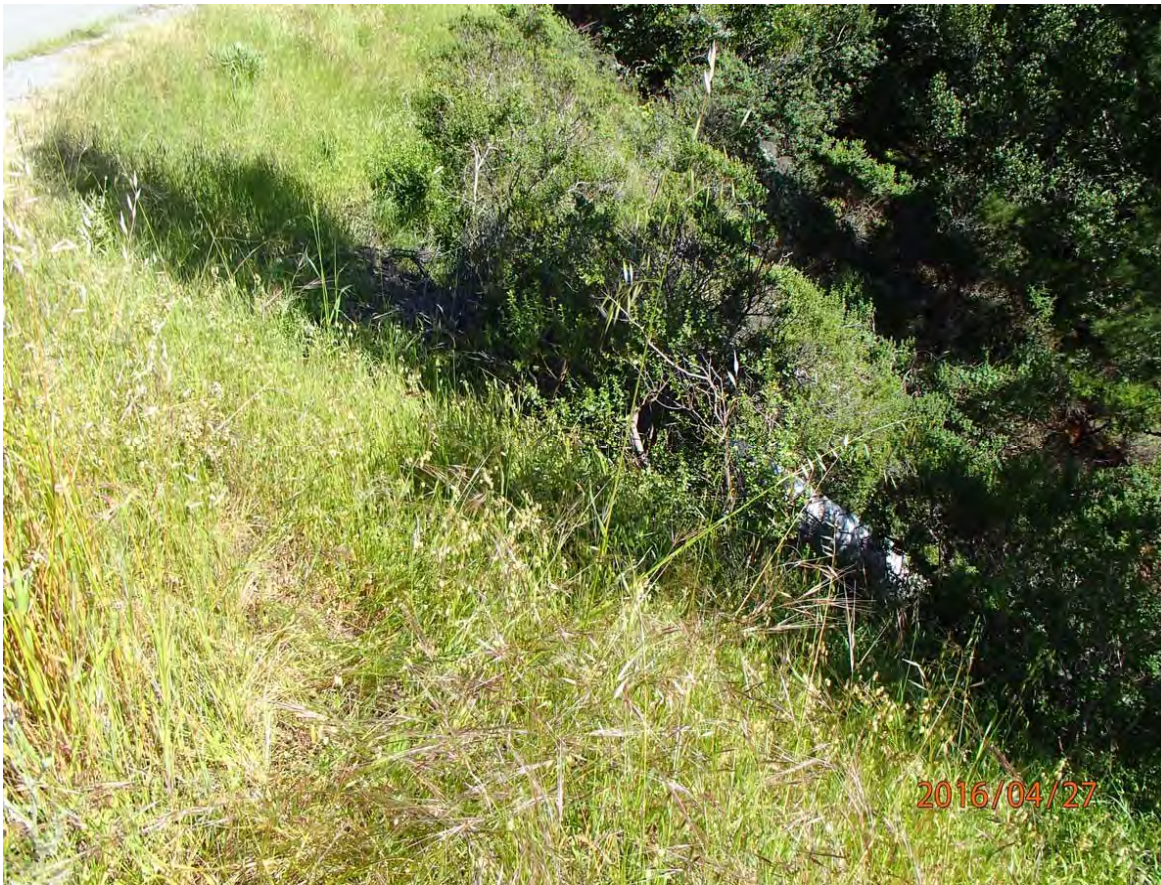
Photo 17. Photo taken of DRC Site #118 view of recently installed full round downspout attached to outlet to protect the fillslopes from further gullyng.

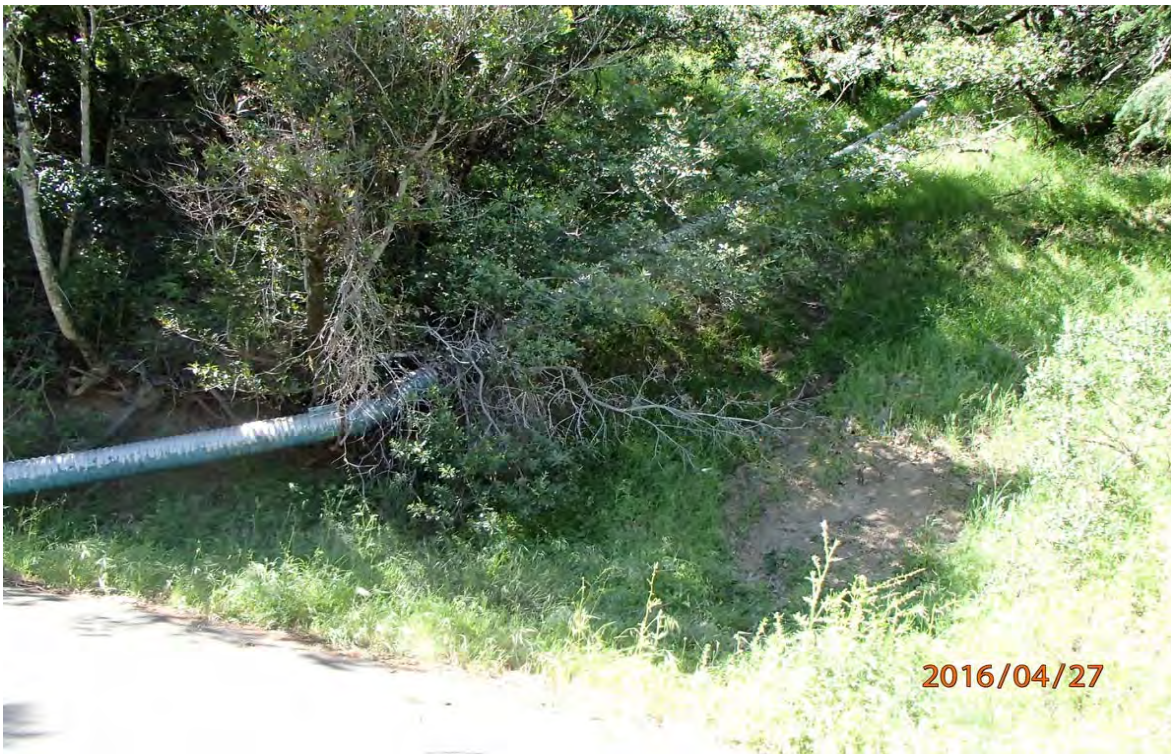
Photo 18. Photo taken of DRC Site #119 view of recently installed full round downspout attached to outlet to protect the fillslopes from further gullyng.

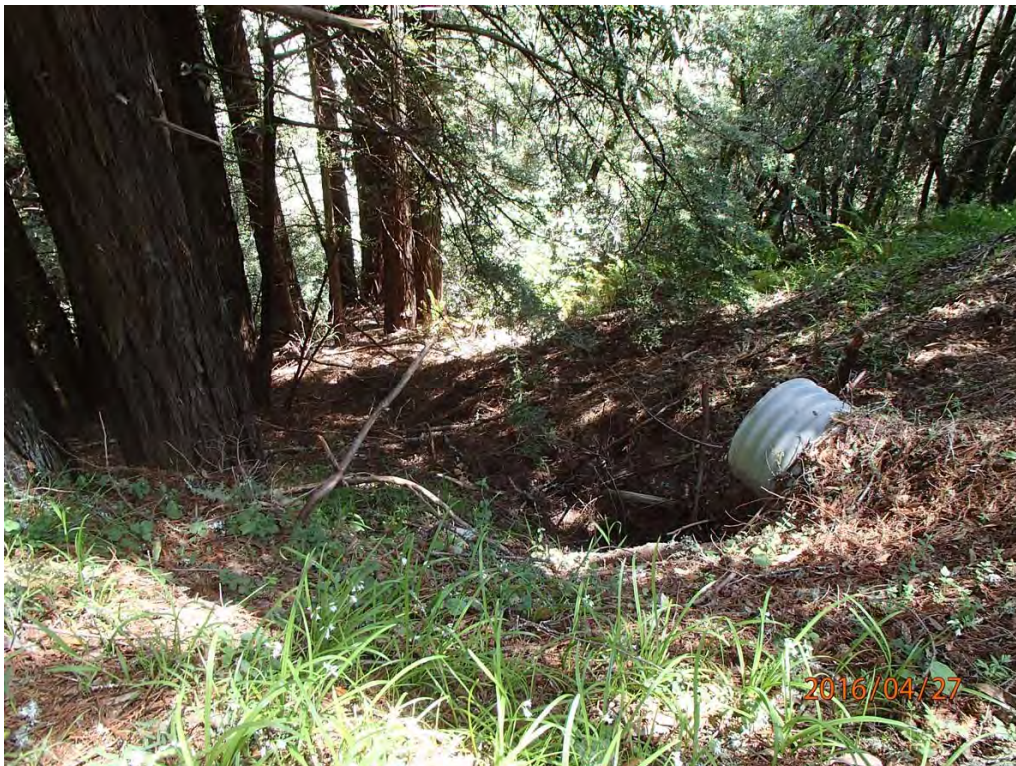
Photo 19. Photo taken from outboard edge of road looking downslope at the outlet of DRC Site #127. Note that the existing gully below the DRC outlet is stable and covered with duff.

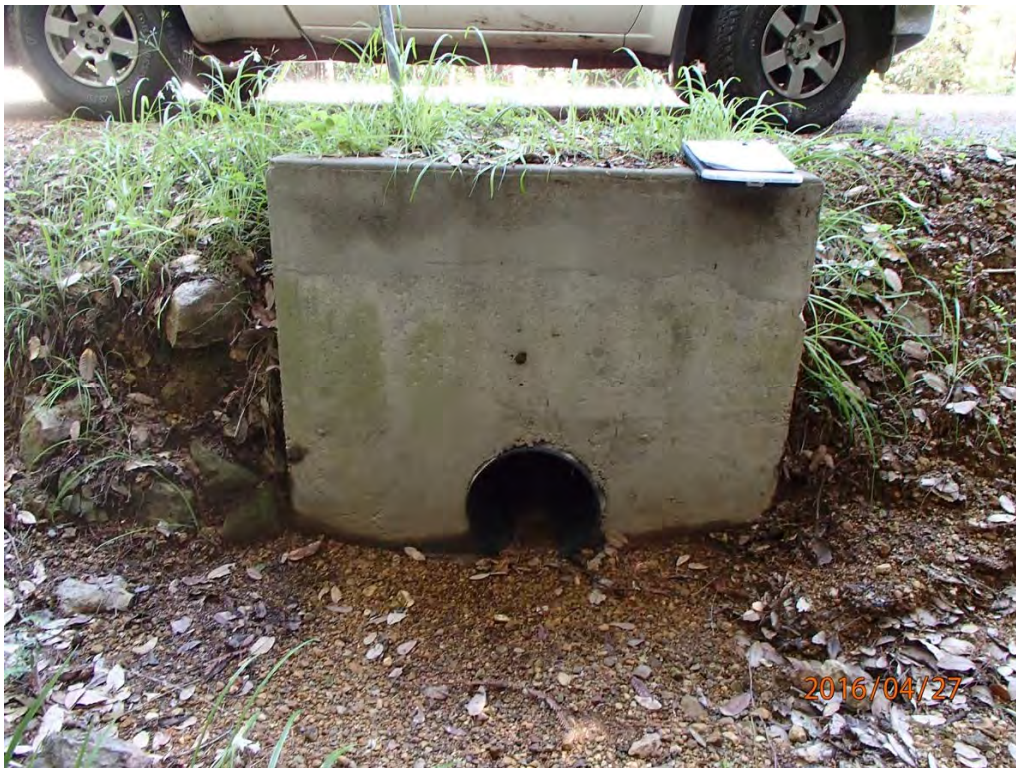
Photo 20. Photo taken from above the inlet of stream crossing Site #129. Note that the pipe has been recently upgraded with an 18” diameter culvert and 57” wide x 43” high concrete headwall. This site will require ongoing maintenance.

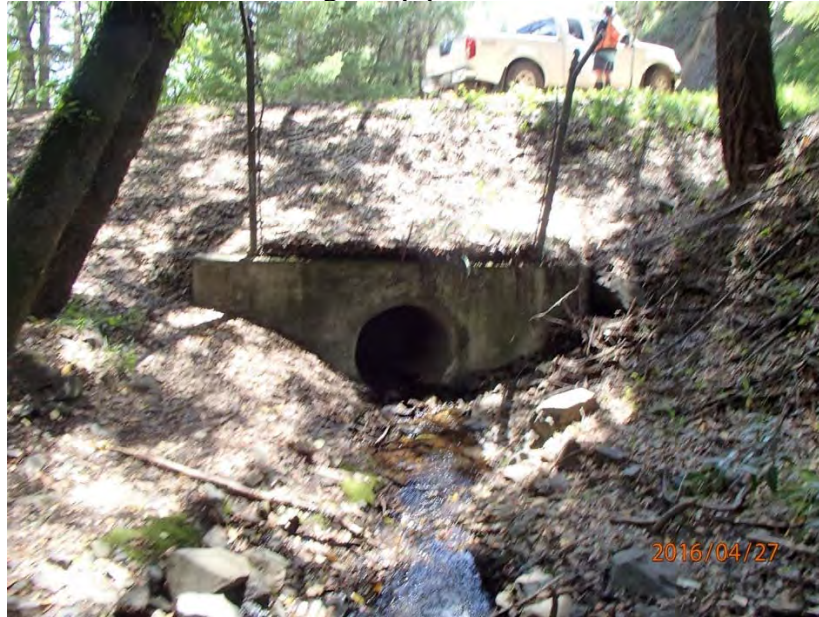
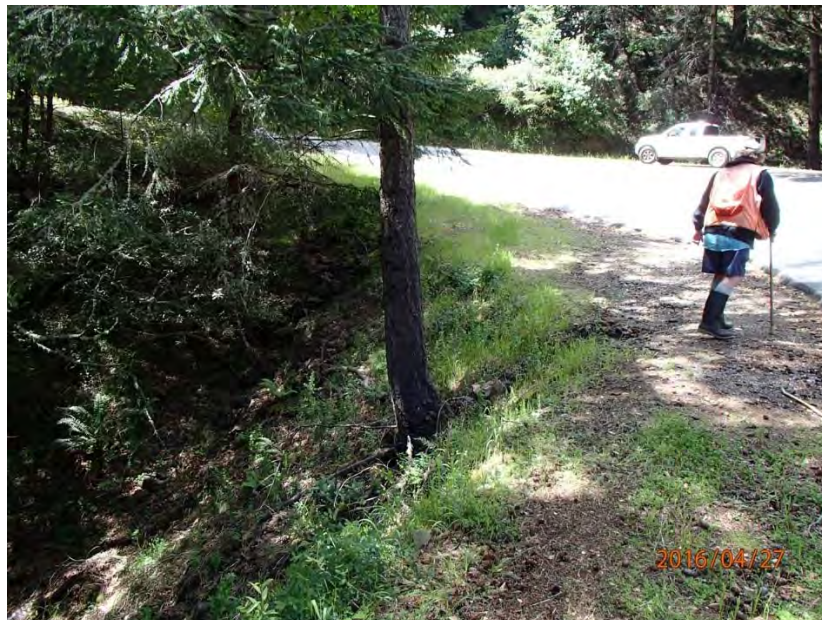
Photos 21 and 22. Photos taken from above the inlet (top) and from the left road approach (bottom) looking at the stream crossing Site #137. Based on the orientation, we presume there is an elbow within the fillslope. We recommend installing an overflow pipe with a downspout and a riser for cleanout.

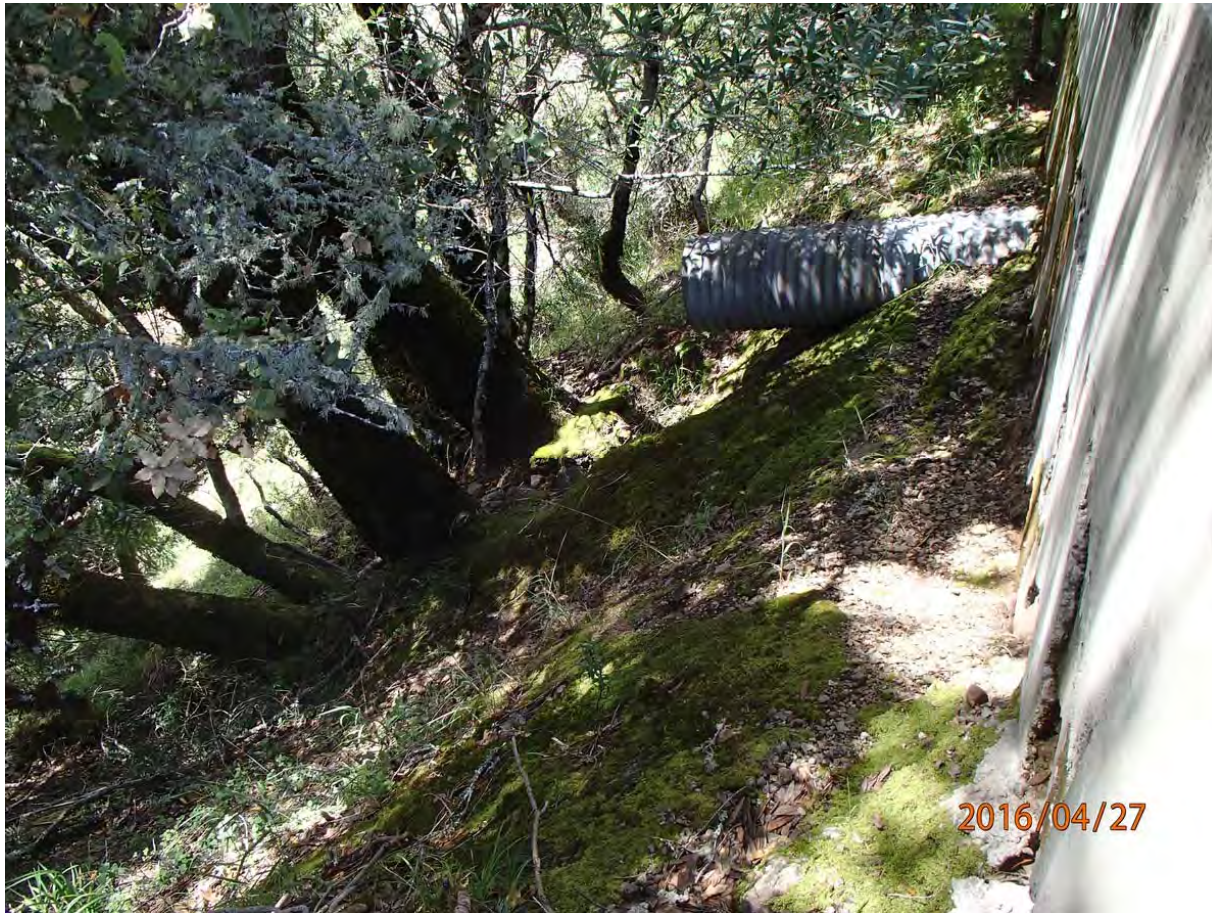
Photo 23. Photo taken from the outboard edge of the road looking downslope at the DRC outlet at Site #139. We recommend installing a downspout to the culvert outlet to protect the fillslope from future erosion.

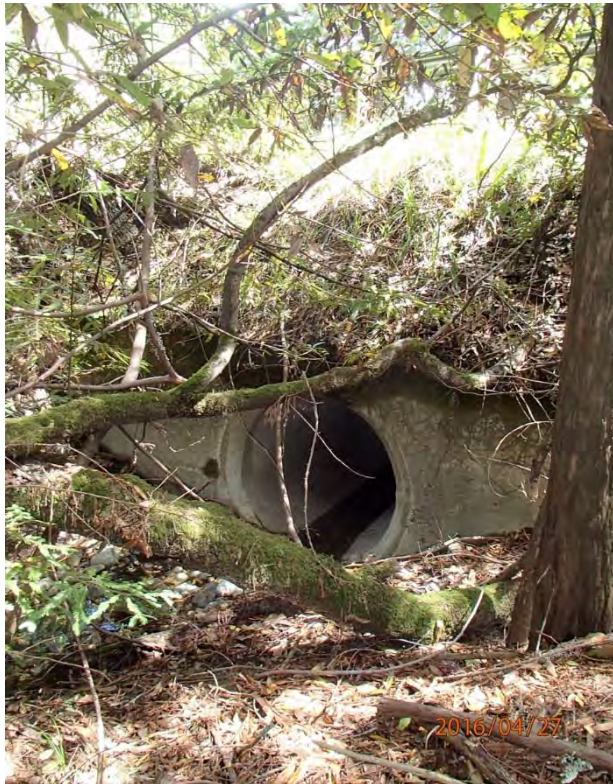
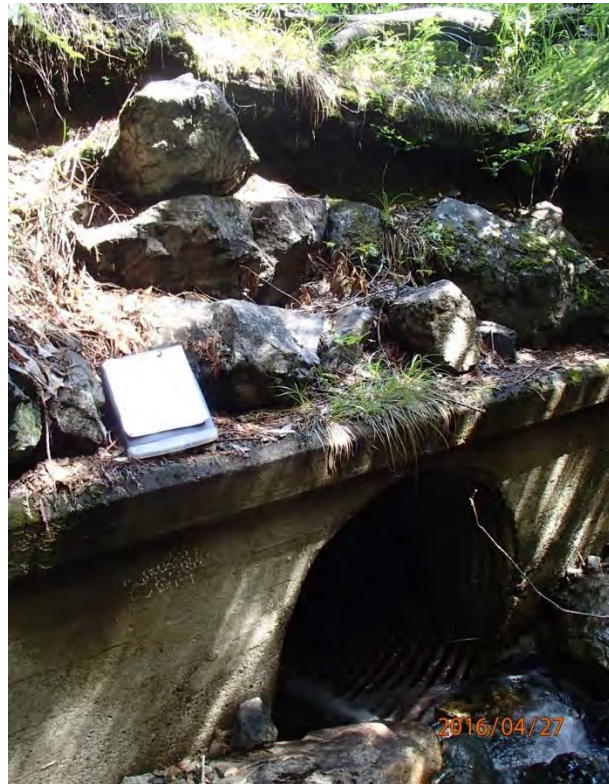
Photos 24 and 25. Photos taken from upstream looking at the stream crossing inlets at Site #140 (left) and #141 (right). The culvert at Site #141 is undersized; therefore, we recommend installing an overflow pipe and excavating material between Sites #140 and #141 for additional protection against diversion.

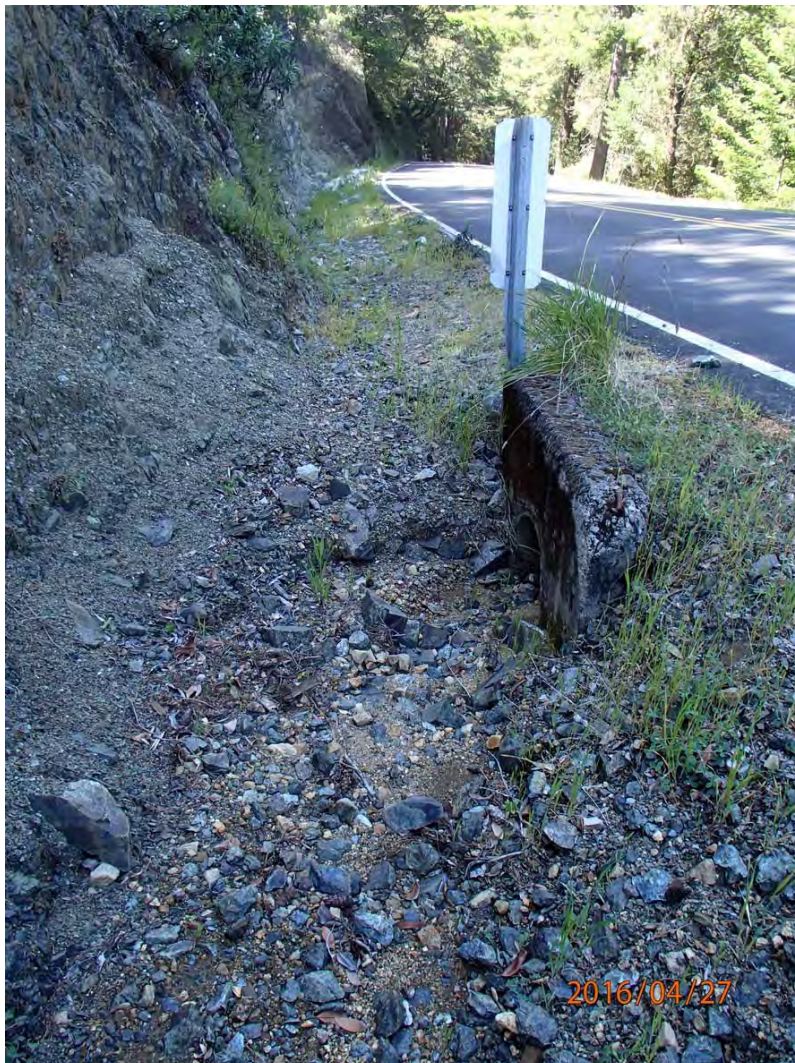
Photo 26. Photo taken along the inboard ditch looking down road at the inlet of DRC Site #143.

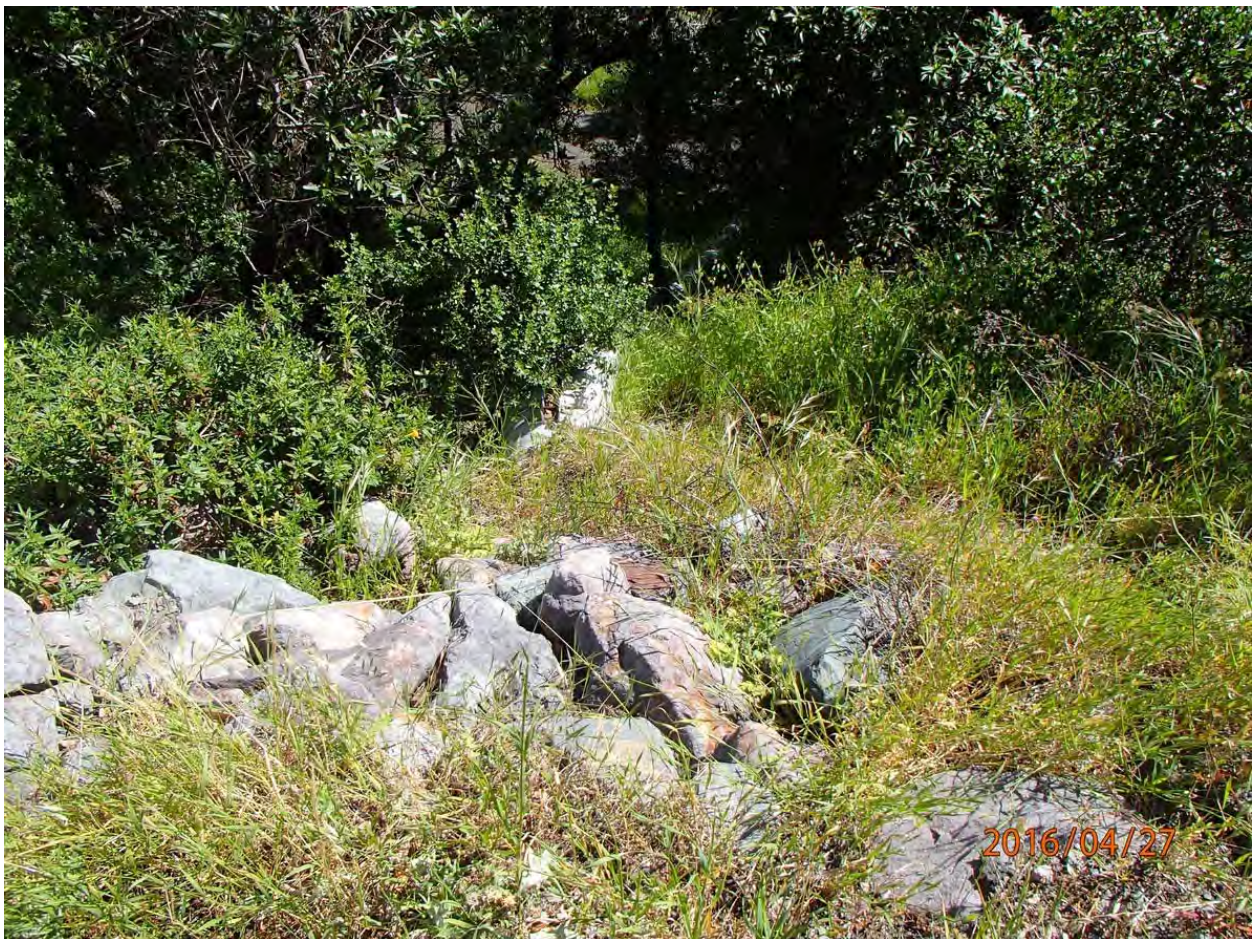
Photo 27. Photo taken of the armored outlet at stream crossing Site #152. The culvert is undersized, but at time of re-evaluation, the inlet was open and the pre-existing sediment fan above inlet had been cleared.

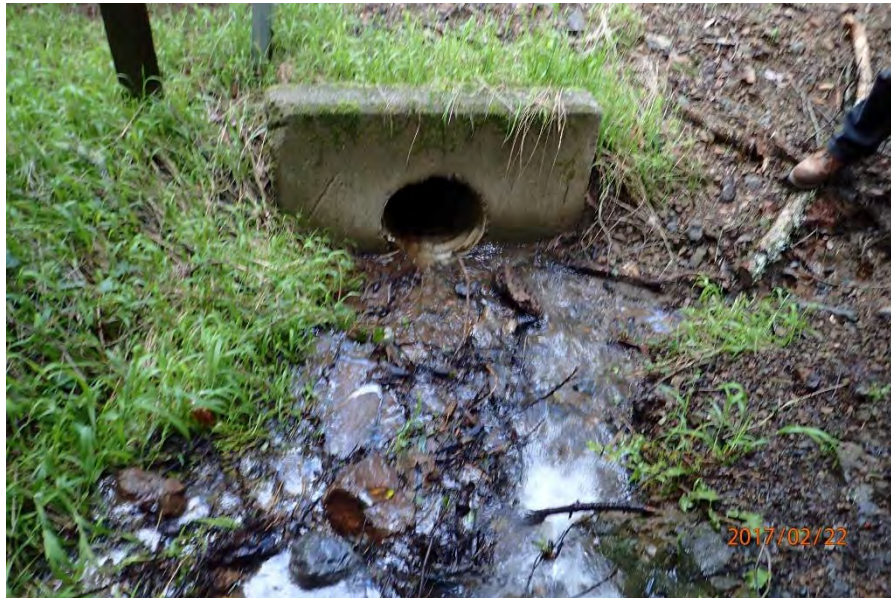
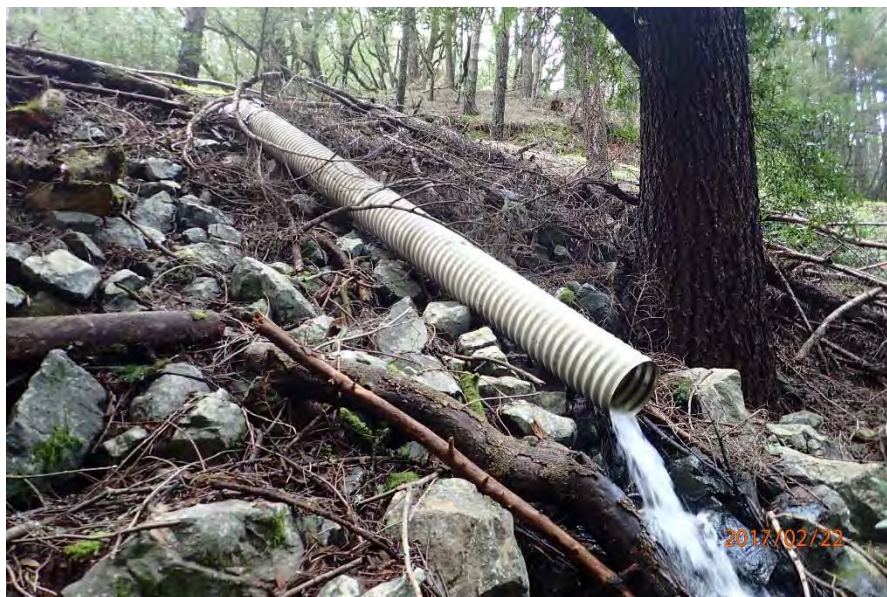
Photos 28 and 29. Photos taken of stream crossing Site #154. The small class 3 stream is conveyed through an 18" diameter culvert with an open inlet (top) and outlet with downspout onto an armored fillslope (bottom). Existing pipe is functioning well as installed. But, hydrologically connected road needs to be addressed with improved road drainage.

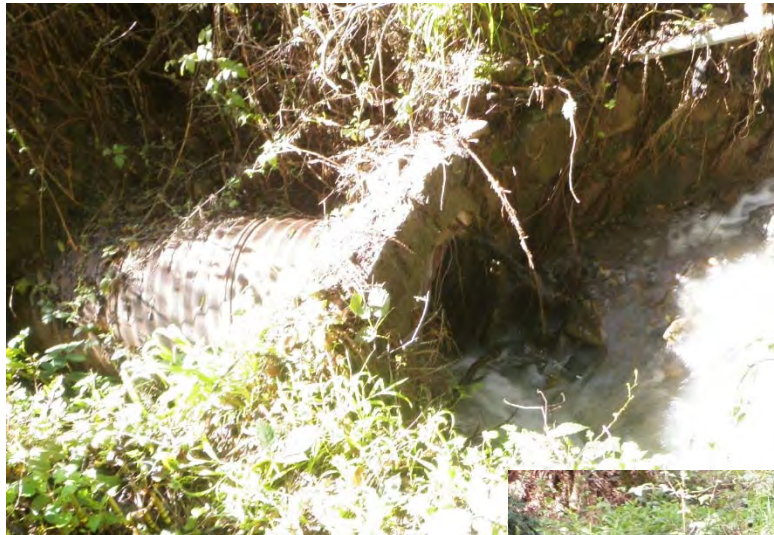
Photos 30 and 31. Photos taken of stream crossing Site #199. A Class 2 stream crossing with a poorly installed 36” CMP with fill near the inlet (above, left) showing active erosion to and its’ capacity being exceeded. The outlet is placed well (right); but there is an active overflow channel along the axis of the crossing. Stream valley was filled to create building space for home to the left of the site.

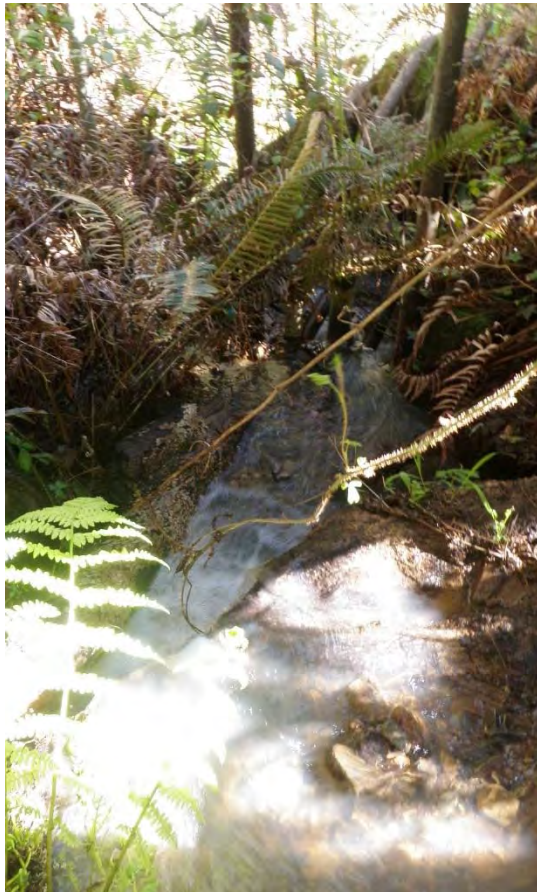
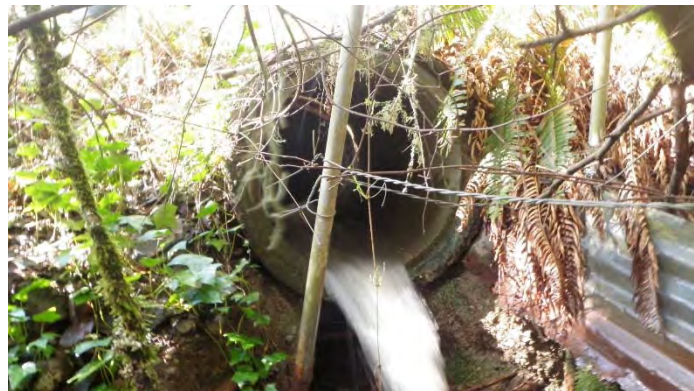
Site #200

Photos 32 and 33. Photos taken of stream crossing Site #200. Stream valley has been filled and altered by both ancient debris fan deposits as well as mechanical disturbance. A debris trash rack has been installed above the 30” concrete culvert inlet (left) in an attempt to reduce plugging potential. Outlet seen in the photo above.

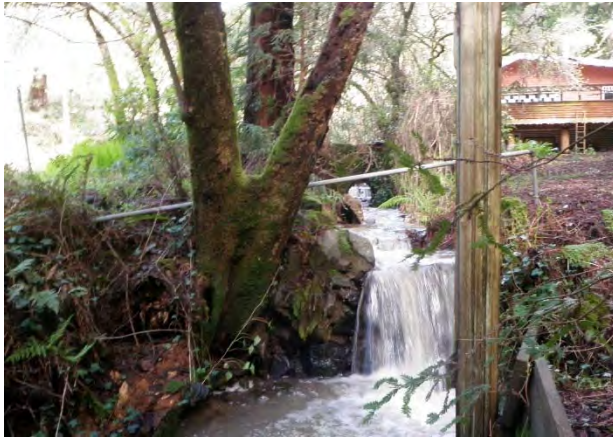
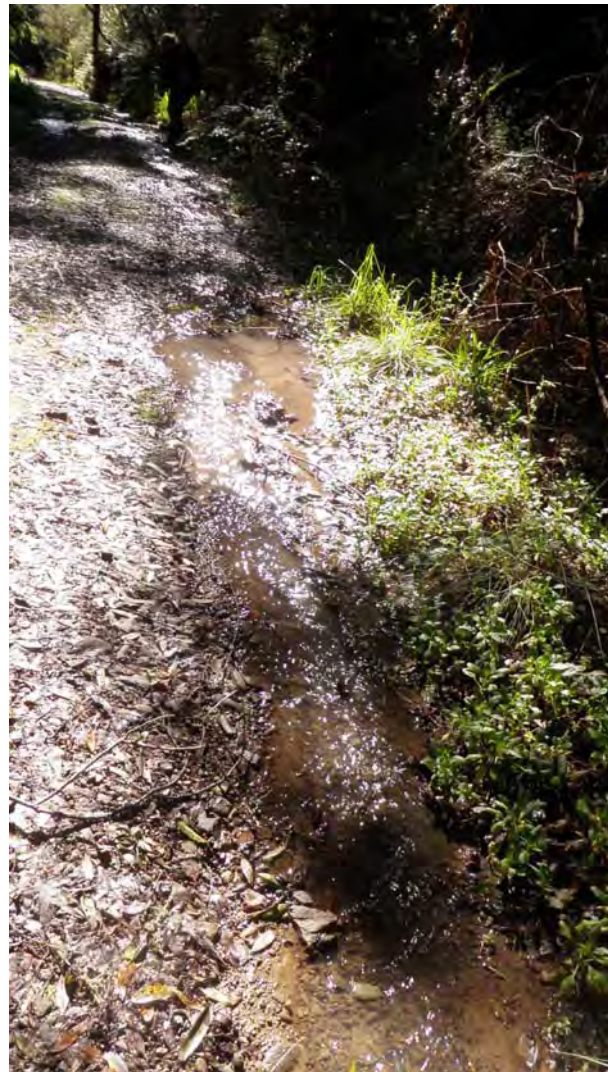
Photos 34 and 35. Photos taken of stream crossing Site #201. Flow is conveyed via an undersized 36” concrete culvert under the driveway to house (above, left). Representative photo of right and left road contribution (right) as well as diversion potential down road to right.
