**Golden Gate National Recreation Area
Redwood Creek Watershed, Muir Woods
Road and Trail Re-evaluation and Assessment
Marin County, California**

Report No. 171024403
August 2017

Prepared for:
Golden Gate National Recreation Area
Building 201, Fort Mason
San Francisco, CA 94123

Prepared by:
Clay Allison, Project Geologist
Tara Zuroweste, Professional Geologist #8418
Danny Hagans, Principal Earth Scientist
Pacific Watershed Associates Inc.
PO Box 2070, Petaluma, CA 94953 / (707) 773-1385
taraz@pacificwatershed.com

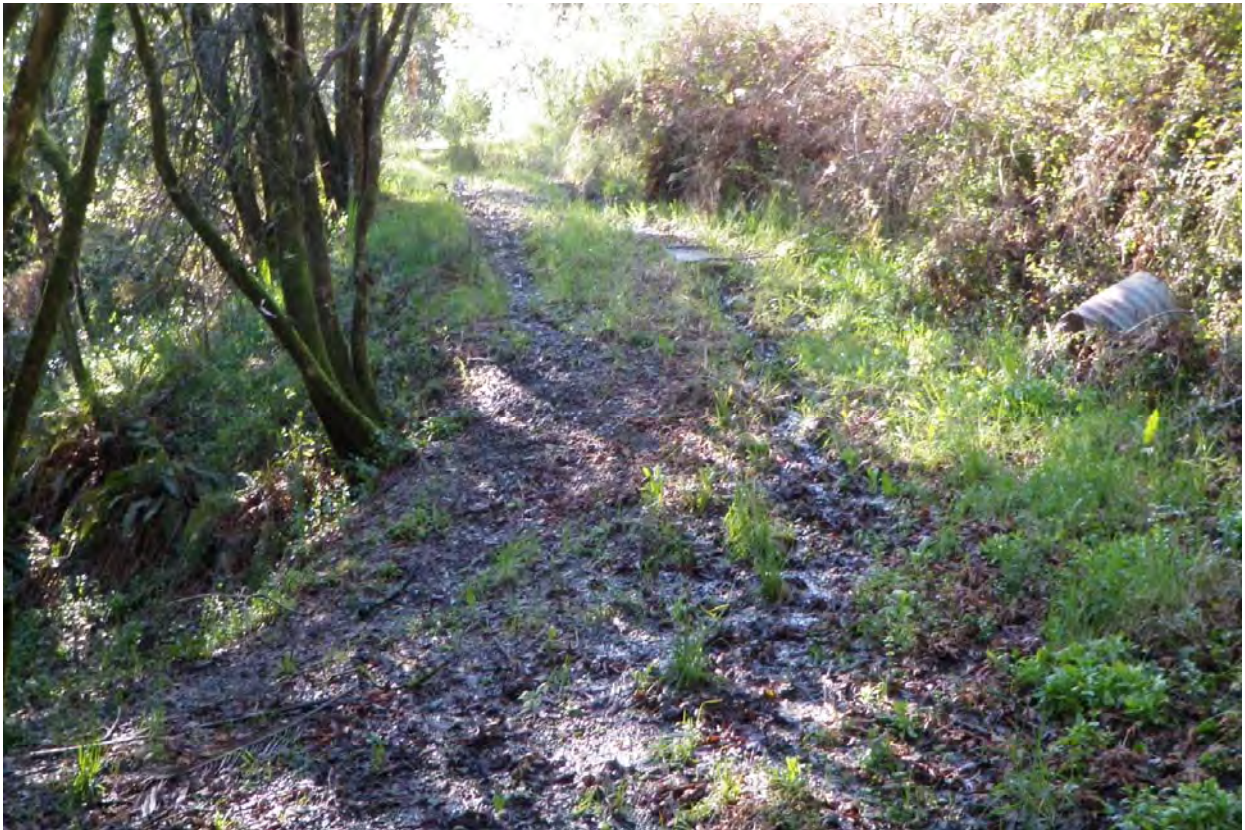
Photo 36. Photo taken of DRC Site #202. A 400' streamside road with an incised IBD drains to 10" rusted DRC. This delivers directly to the nearby channel.

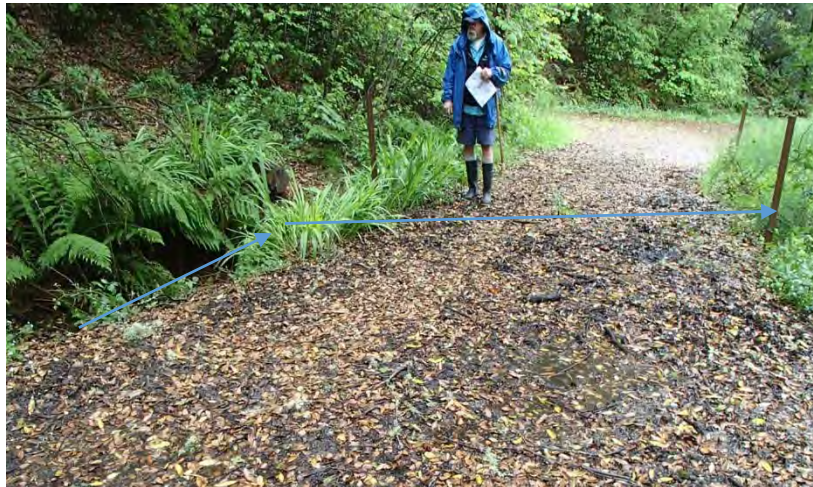
Photos 37 and 38. Photos taken of undersized, 30" culvert installed within failing 36" culvert at stream crossing Site #203. Photo 37 (left) is taken from the right road approach, note the blue arrow denotes the direction of flow. Photo 38 (right) shows the concrete crib wall protecting the road above the inlet at the bend in the channel.

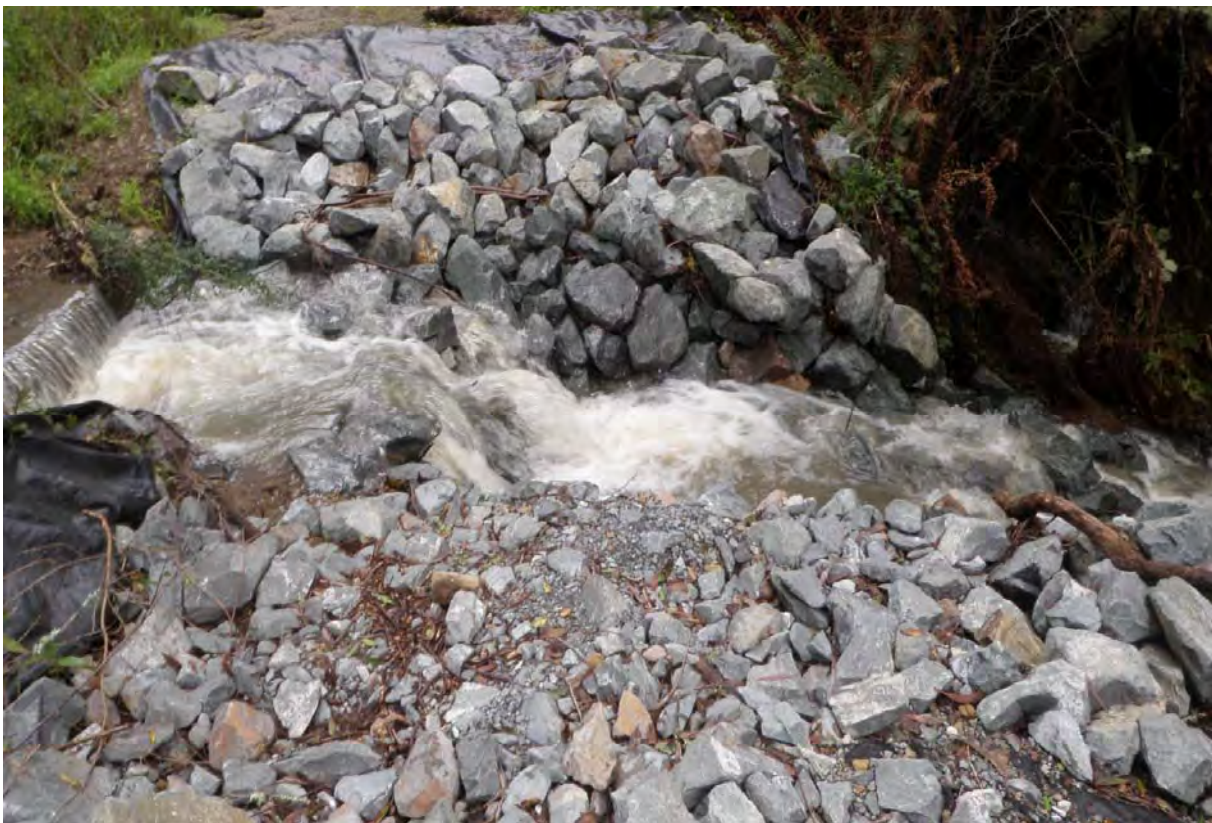
Site #204

Photo 39. Photo taken from the right road approach in 2017 of failed stream crossing with subsequent adequate emergency repaired measures installed at Site #204.

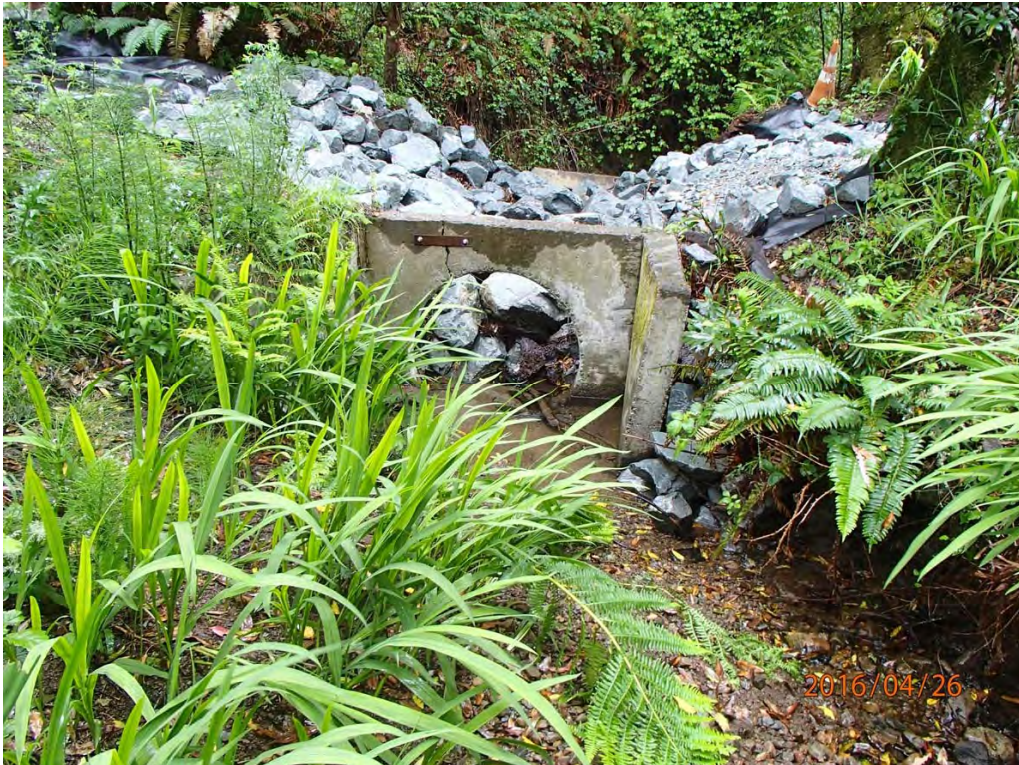
Photo 40. Photo taken looking downstream of failed and emergency repaired stream crossing at Site #204 at the remaining concrete headwall of the inlet and the installation of a temporary rock armored crossing.

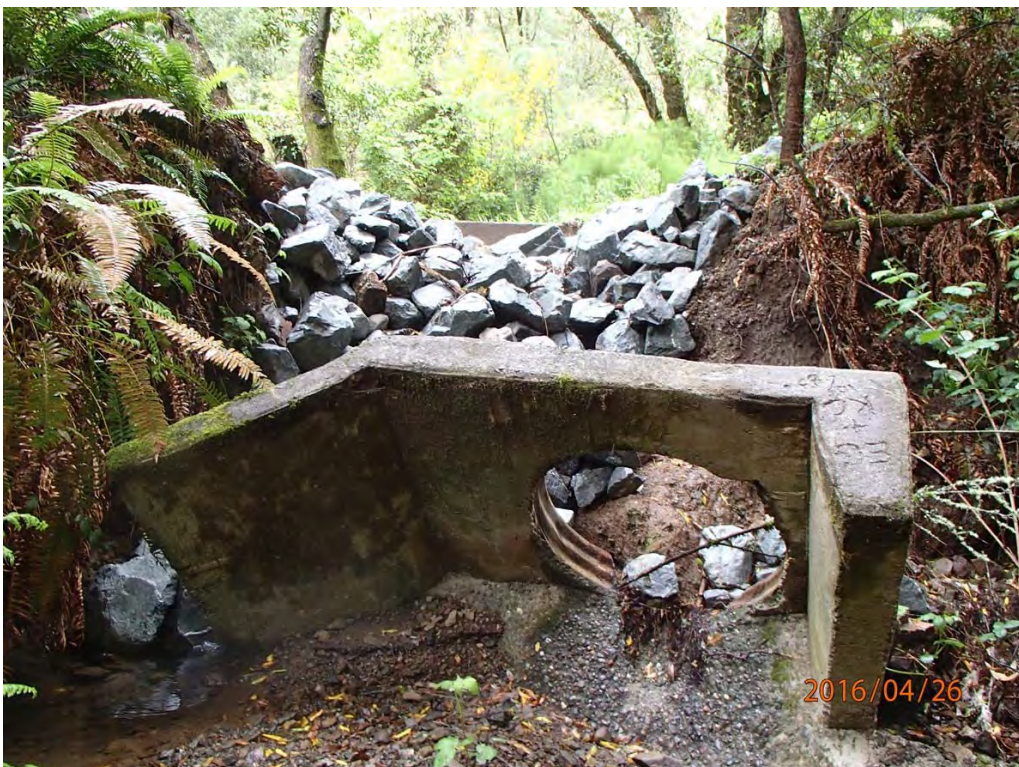
Photo 41. Photo taken looking upstream at failed and emergency repair at stream crossing Site #204 looking at the remaining concrete headwall at the outlet and the installation of a temporary rock armored crossing.

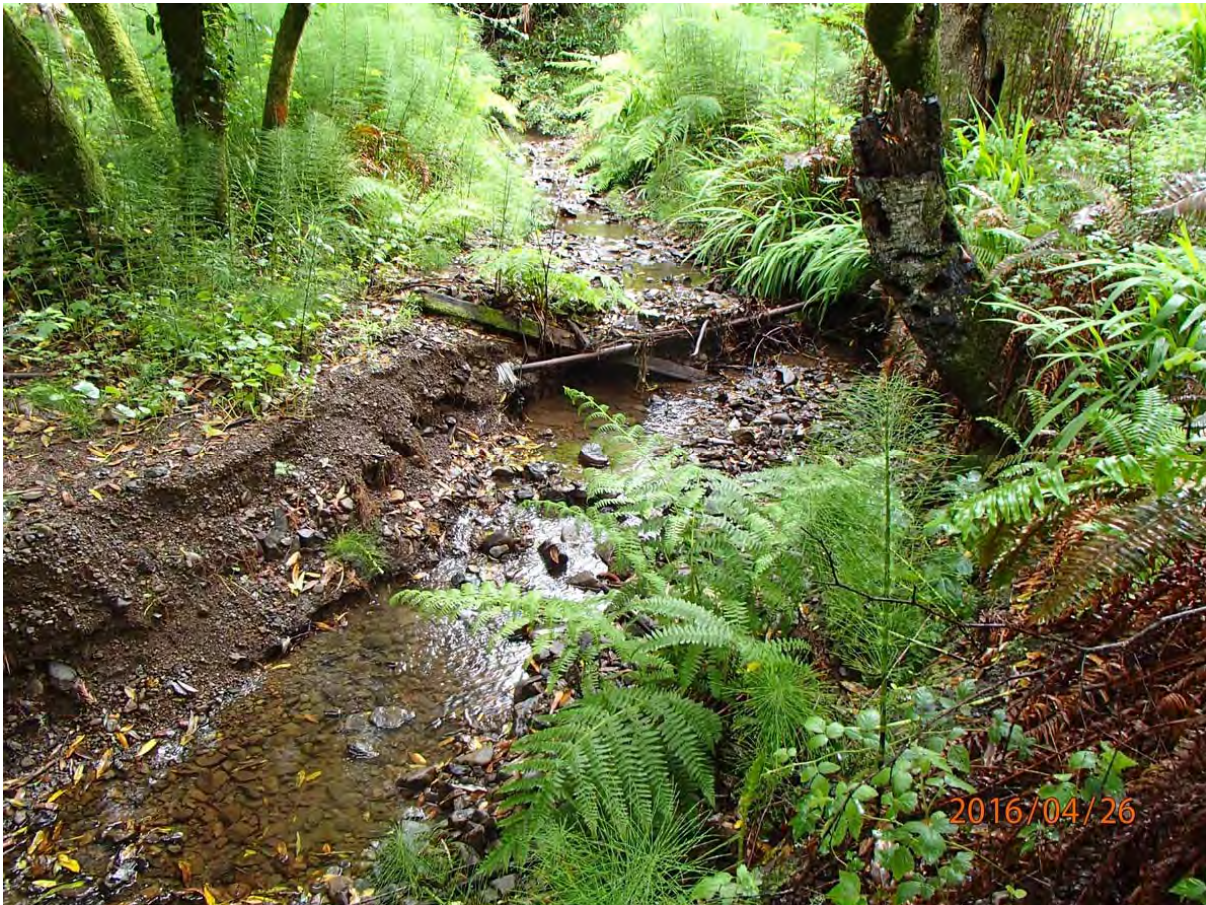
Photo 42. Photo taken looking upstream at the presumed location of the decommissioned or blown out stream crossing site #205. No future treatments at this site.

Description of Treatment Recommendation: None. Crossing no longer exists.

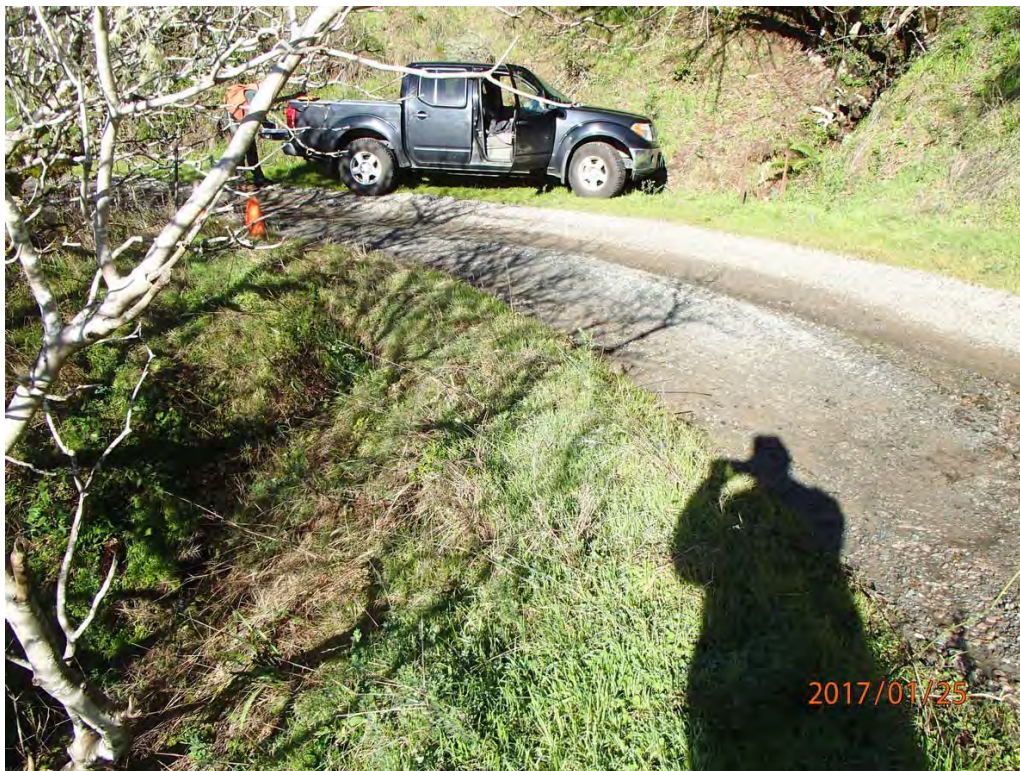
Photo 43. Photo taken of stream crossing Site #180. An undersized, 12" culvert is currently 100% plugged and not conveying flow through the pipe but underneath and through the fill. The site also receives significant runoff from the connected road reaches as well as Panoramic Rd. and Dipsea Trail above.

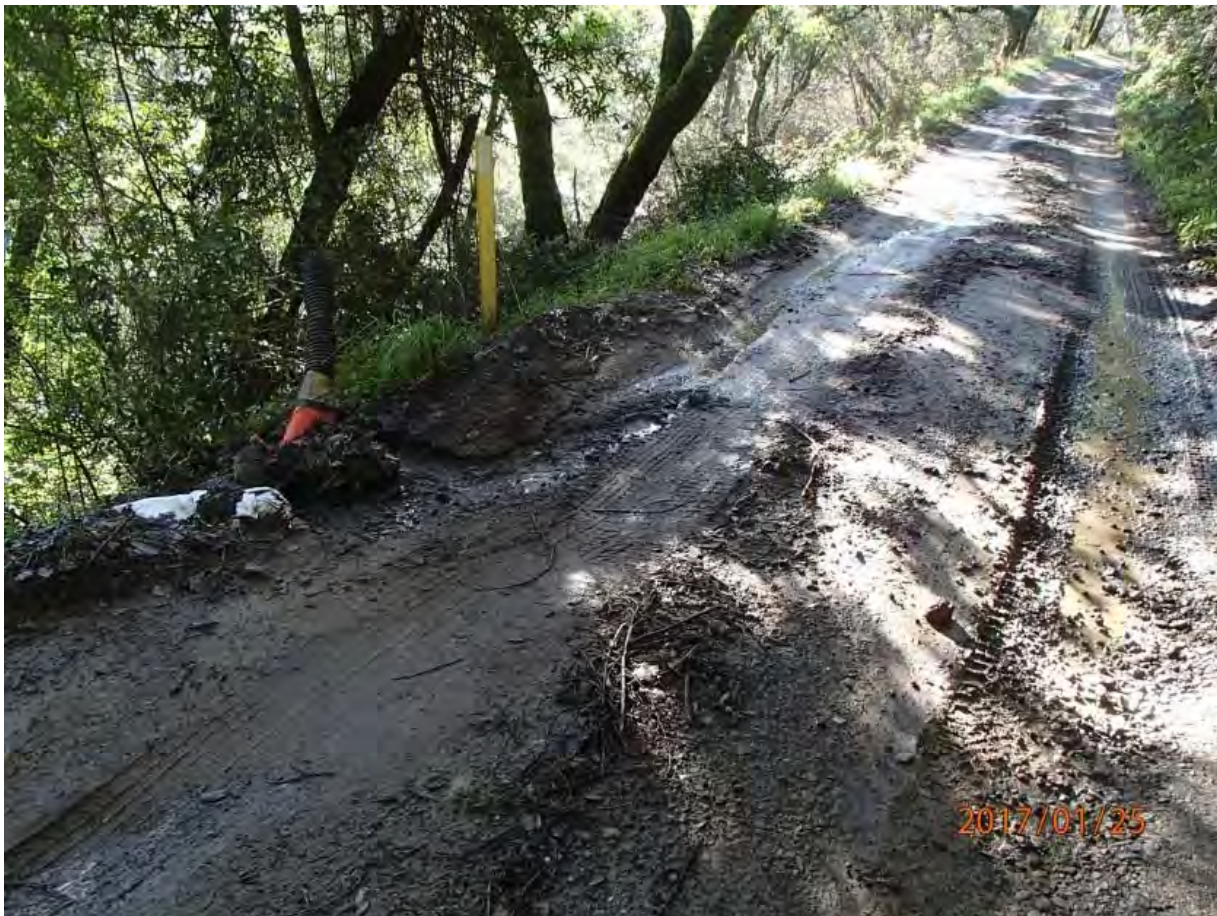
Photo 44. Photo taken of road surface discharge point Site #181. 700' of concentrated road runoff exits road at a low point in the road. Concentrated road run off has eroded a gully that delivers to Class II stream channel below.

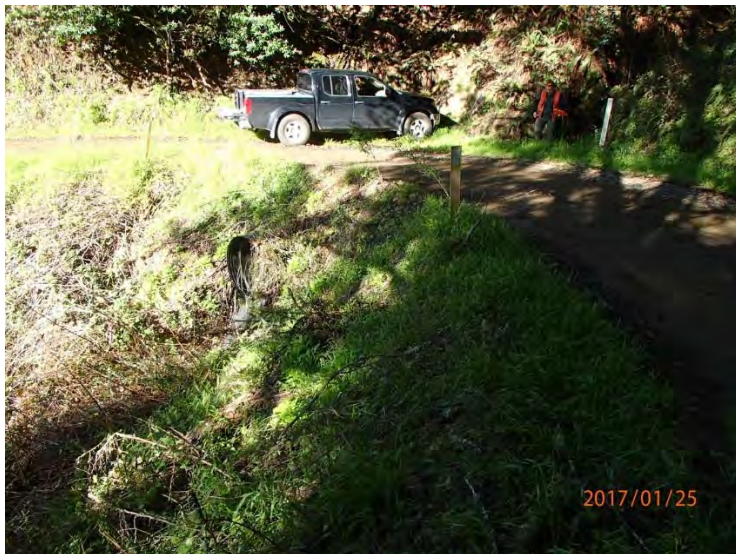
Photos 45 and 46. Photos taken of stream crossing Site #182. The culvert is set high in the fill with a 3' drop at the outlet (above, left). An active spring along the right inboard ditch is being effectively conveyed into a recently installed 42" diameter culvert.

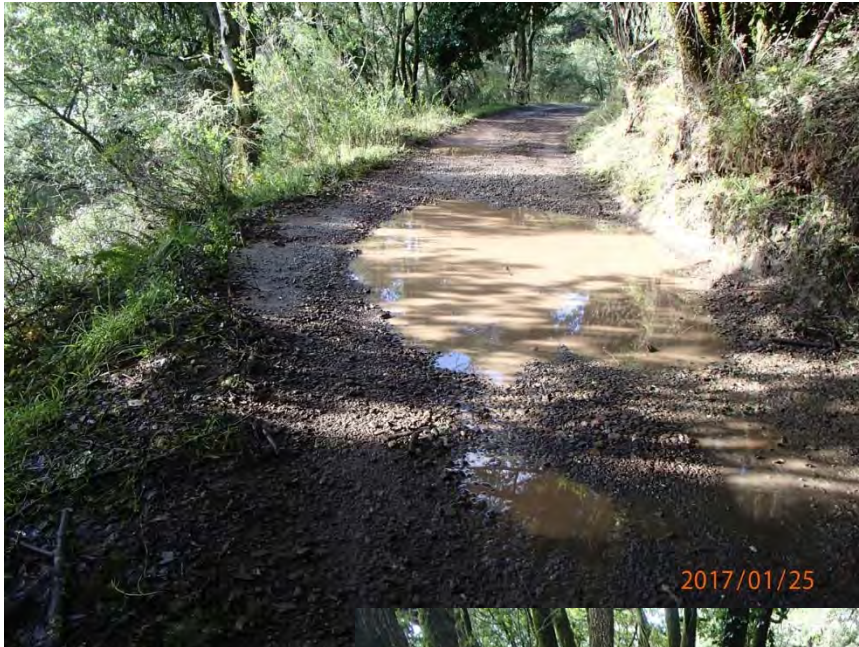
Photos 47 and 48. Photos taken of road surface discharge point Site #183. A section of insloped and bermed road accumulates water at 2 low spots 165' apart. At both sites ponded water exits road at OBF and is actively gullying the OBF slope.

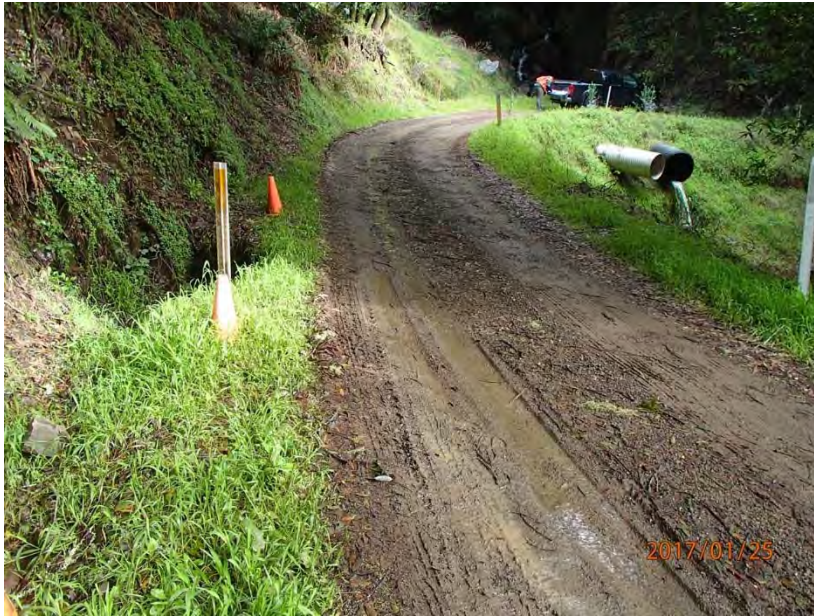
Photos 49 and 50. Photos taken of DRC Site #184. An 18” diameter DRC drains the connected right road approach and springy cutbank (left). The DRC is 30% plugged and is installed at a shallow grade, and the outlet is shot-gunned with a 5’ drop at the outlet (below).

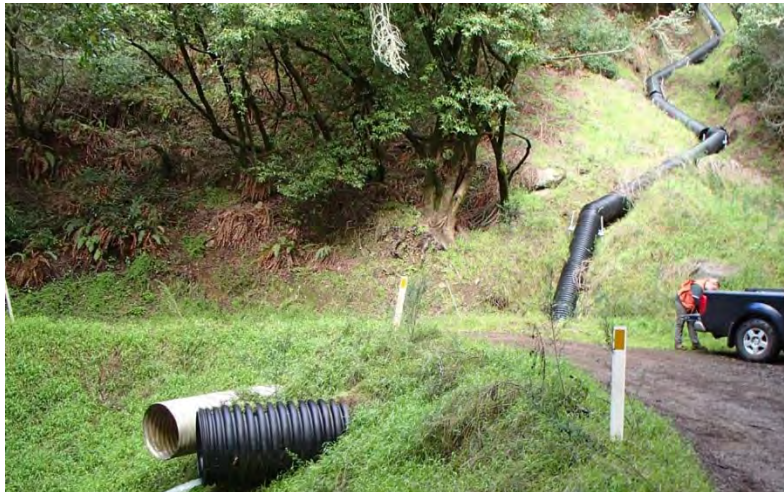
Site #185

Photos 51 and 52. Photos taken of stream crossing Site #185. A rowdy Class 2 stream is conveyed through this crossing via an undersized 36" diameter HDPE plastic culvert with an aluminum flared inlet (left). There is a 24" diameter CMP ~26' to the right of the stream crossing that conveys flow from a failing downspout network upslope (right).

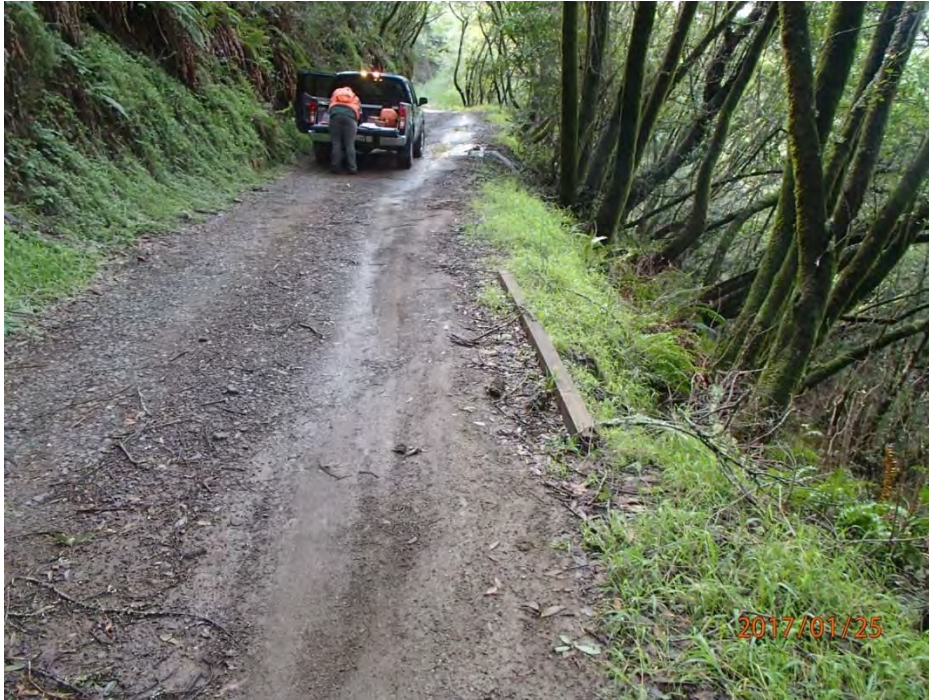
Site #186

Photos 53 and 54. Photos taken of road surface discharge point Site #186. The concentrated RSDP run off is actively eroding a gully that delivers to Class 2 stream 100' downslope.

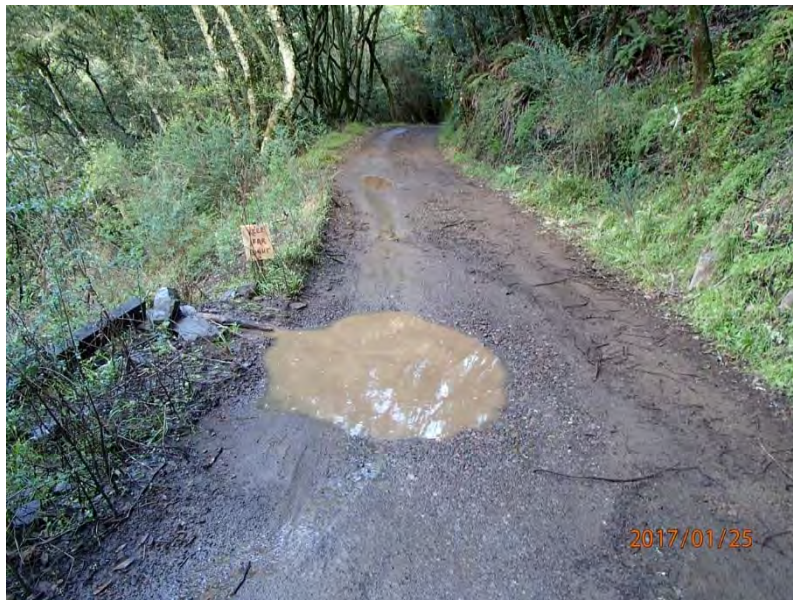
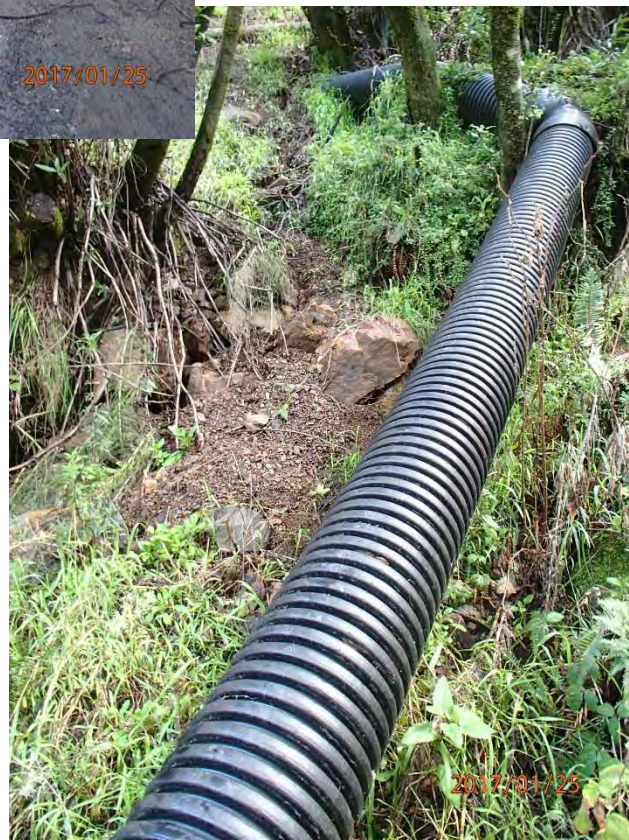
Photos 55 and 56. Photos taken of stream crossing Site #187. A plugged 12" diameter CMP conveys Class 2 stream flow through this crossing. A downspout was installed at the lower cutbank (right), but it is not functioning. Water is ponding on road and evacuating the RSDP via an OBF gully (above, left).

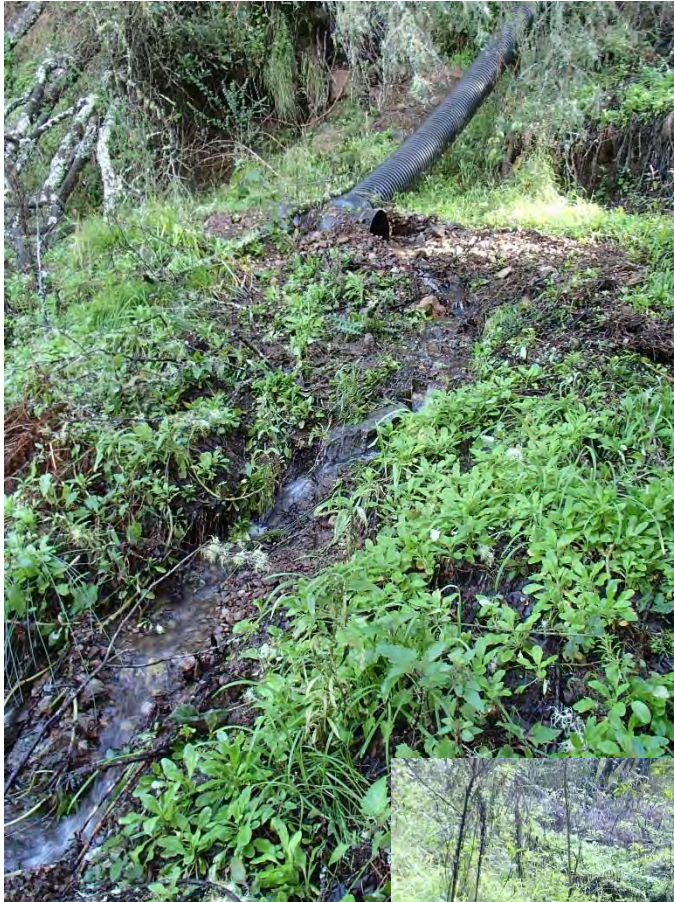
Photos 57 and 58. Photos taken of stream crossing Site #187.1. Stream flow from site #187 on Camino Canyon Road outlets onto this relict road prism (left). Stream flow is actively eroding through the fill and delivering sediment to the Class 2 stream downslope (below).

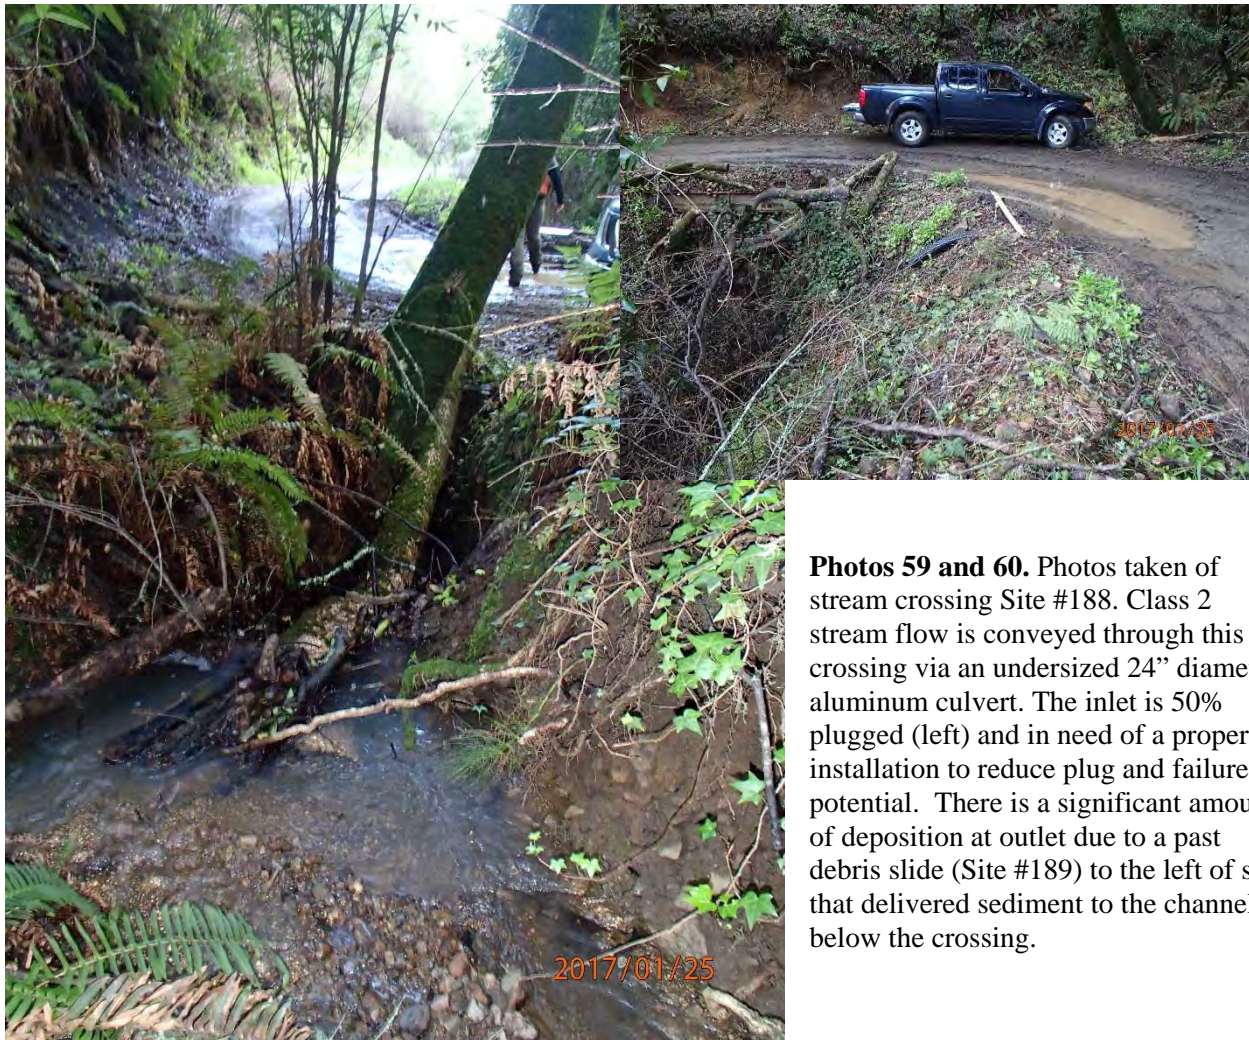
Photos 59 and 60. Photos taken of stream crossing Site #188. Class 2 stream flow is conveyed through this crossing via an undersized 24" diameter aluminum culvert. The inlet is 50% plugged (left) and in need of a proper installation to reduce plug and failure potential. There is a significant amount of deposition at outlet due to a past debris slide (Site #189) to the left of site that delivered sediment to the channel below the crossing.

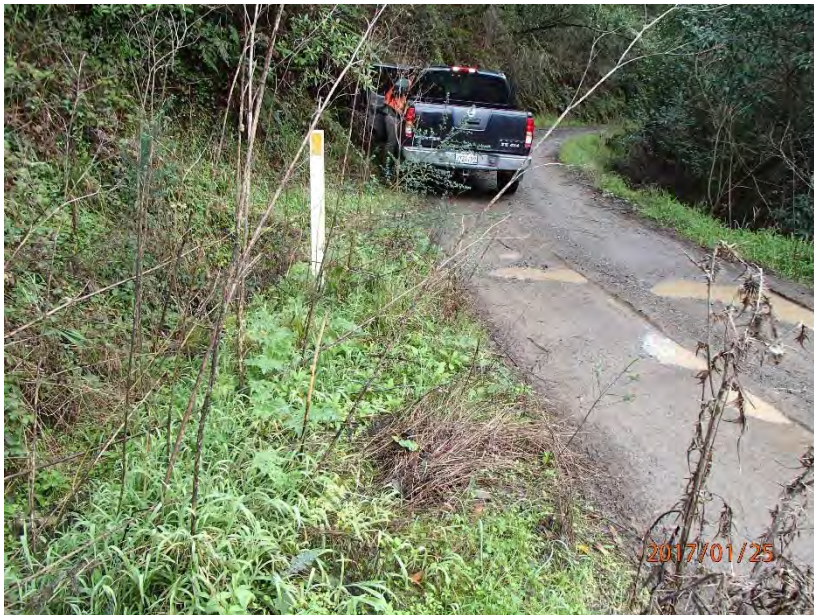
Photos 61 and 62. Photos taken of road beneath landslide Site #189. A large debris slide has deposited into channel below stream crossing site #188. Since failure, road has been rebuilt thru deposit with a maintained inboard ditch and DRC draining hillslope and feature seepage as well as road surface runoff.

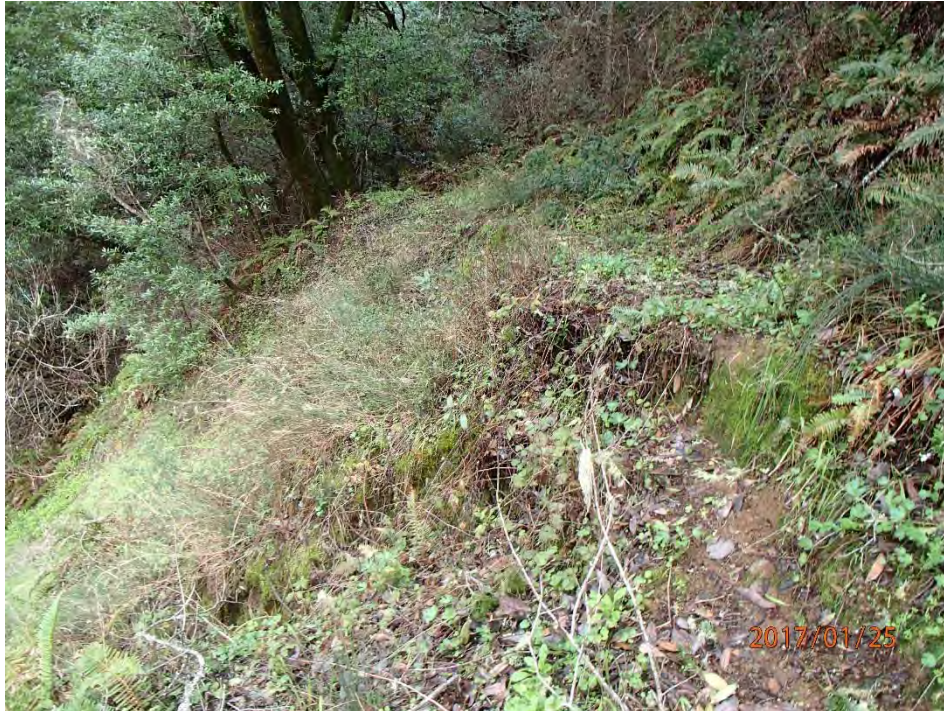
Photos 65 and 66. Photos taken of landslide Site #193. The road was decommissioned by NPS in 2003 when remaining perched fill was excavated. Currently, road and feature appear to be stable.

Description of Treatment Recommendation: No treatment recommended.

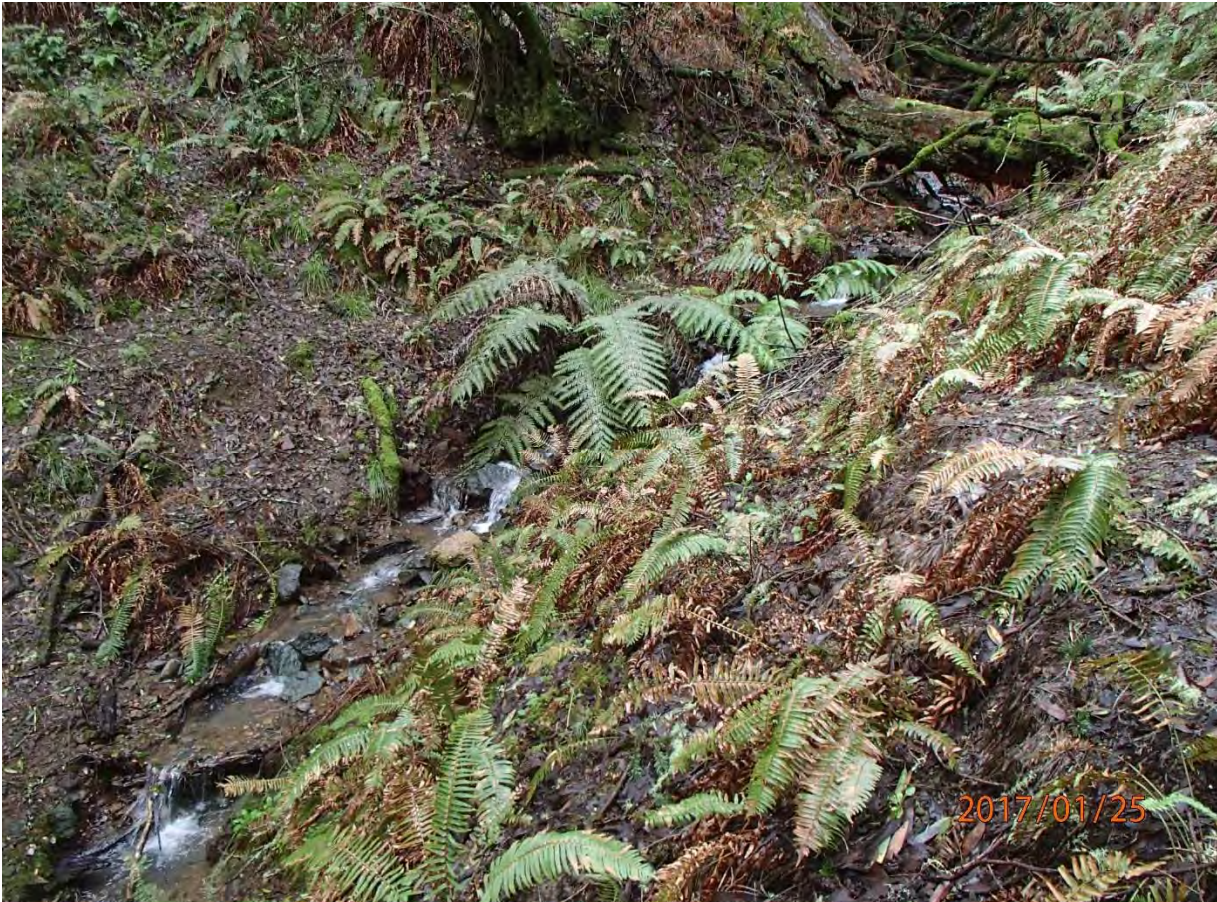
Photo 67. Photo taken of stream crossing Site #194. The road and stream crossing was decommissioned by NPS in 2003 when remaining fill was excavated from the crossing. Currently, stream appears to be stable.

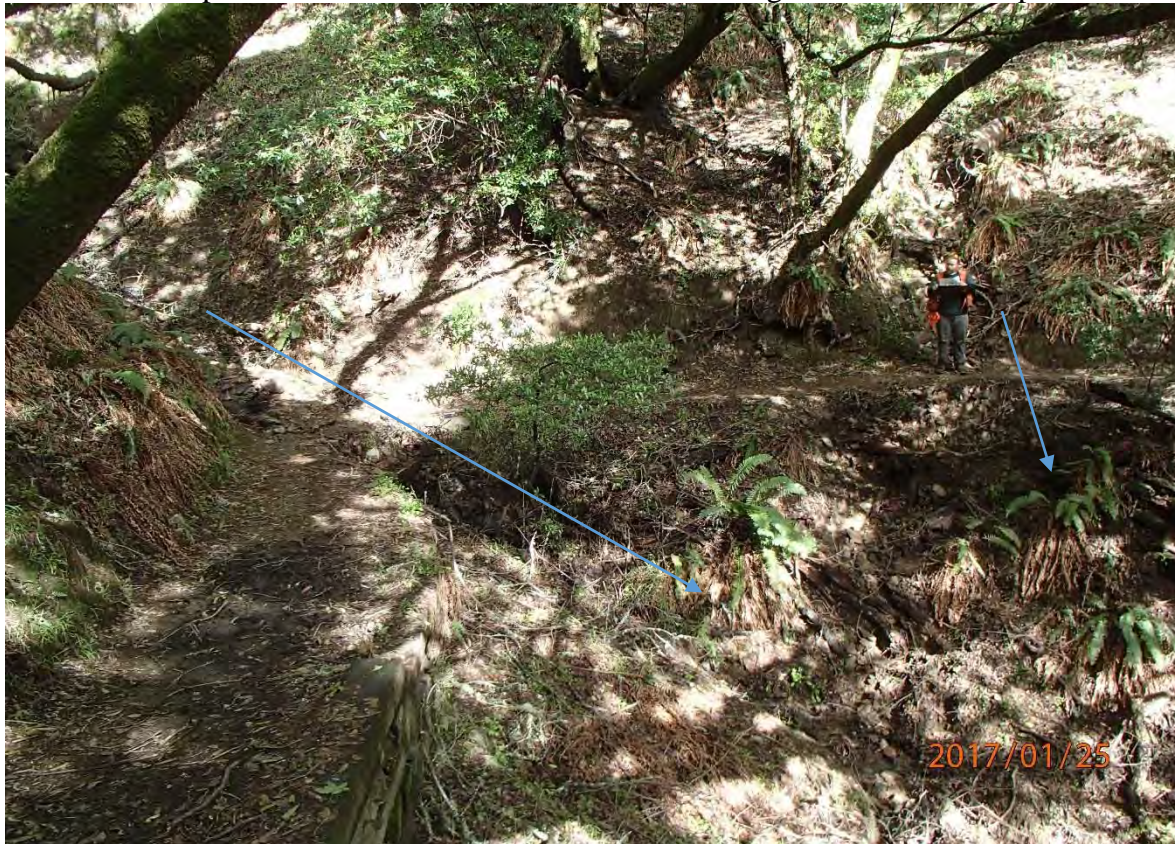
Photo 68. Photo taken of poorly installed and inadequately sized armored fill stream crossings at Site #517 (left) and Site #518 (right). Note the two blue arrows indicating flow at each crossing.

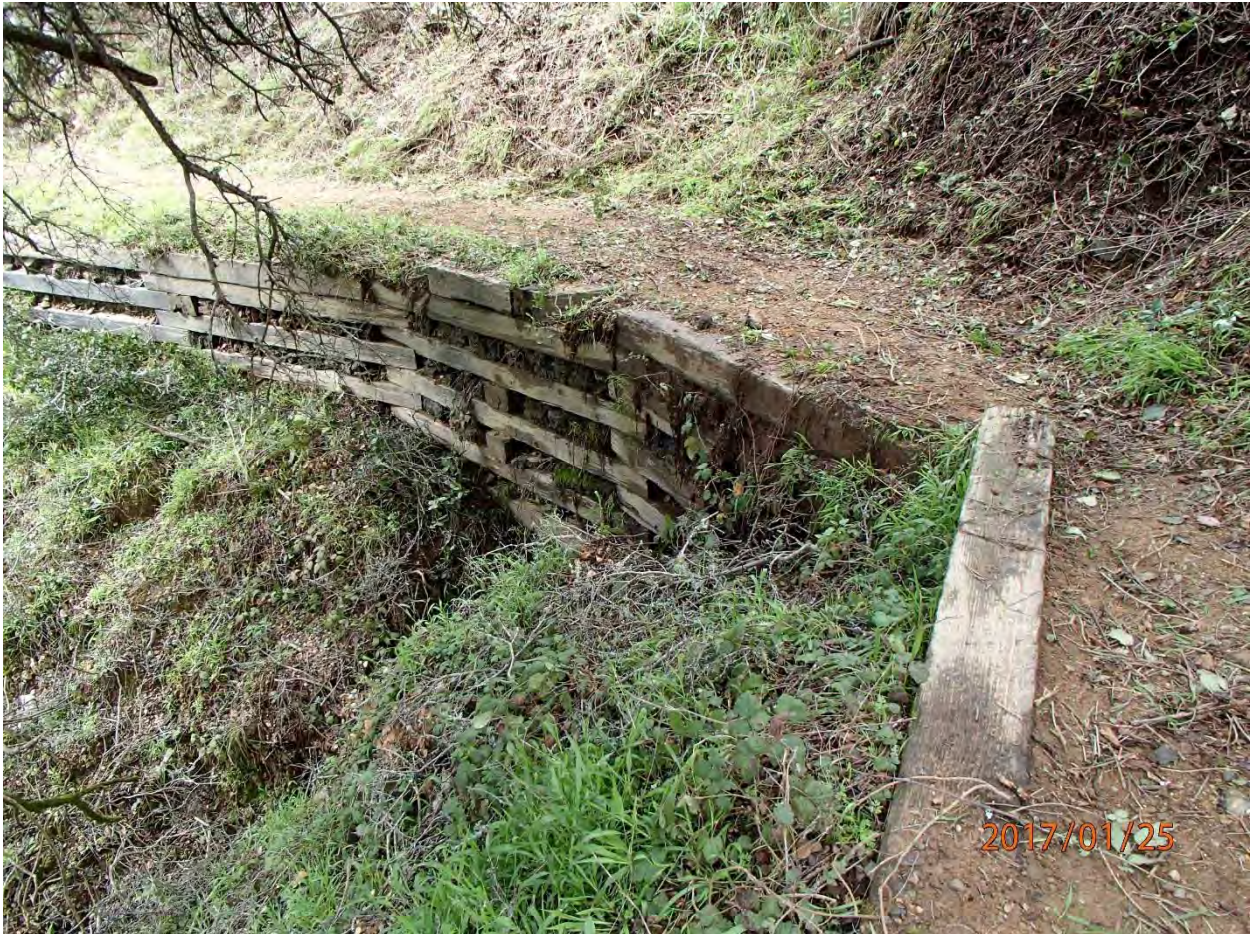
Photo 69. Photo of stream crossing Site #520. This near origin class 3 stream needs a properly sized and installed armored fill.

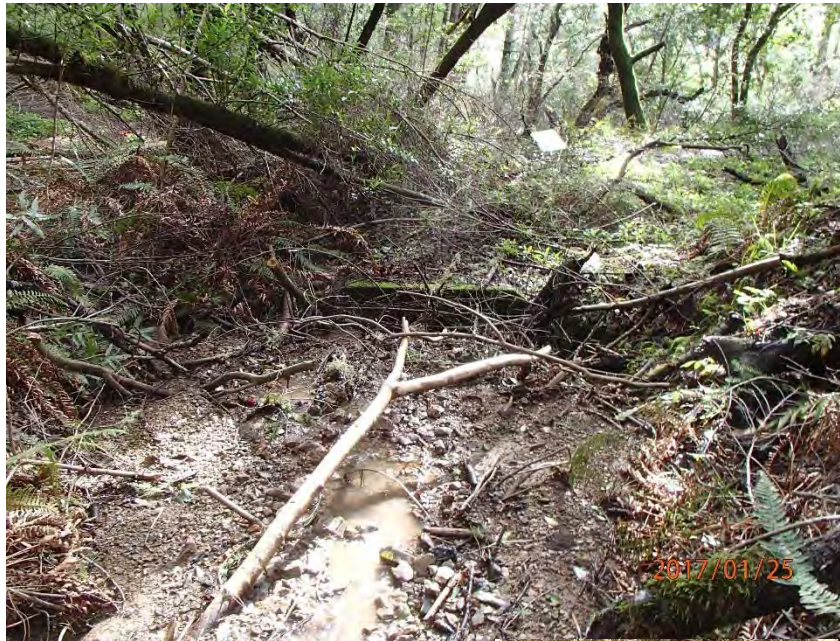
Photos 70 and 71. Photos of stream crossing Site #521.1. Culvert inlet is buried by sediment fan (left) and outlet of very undersized and poorly installed clay pipe is visible below the road (below).

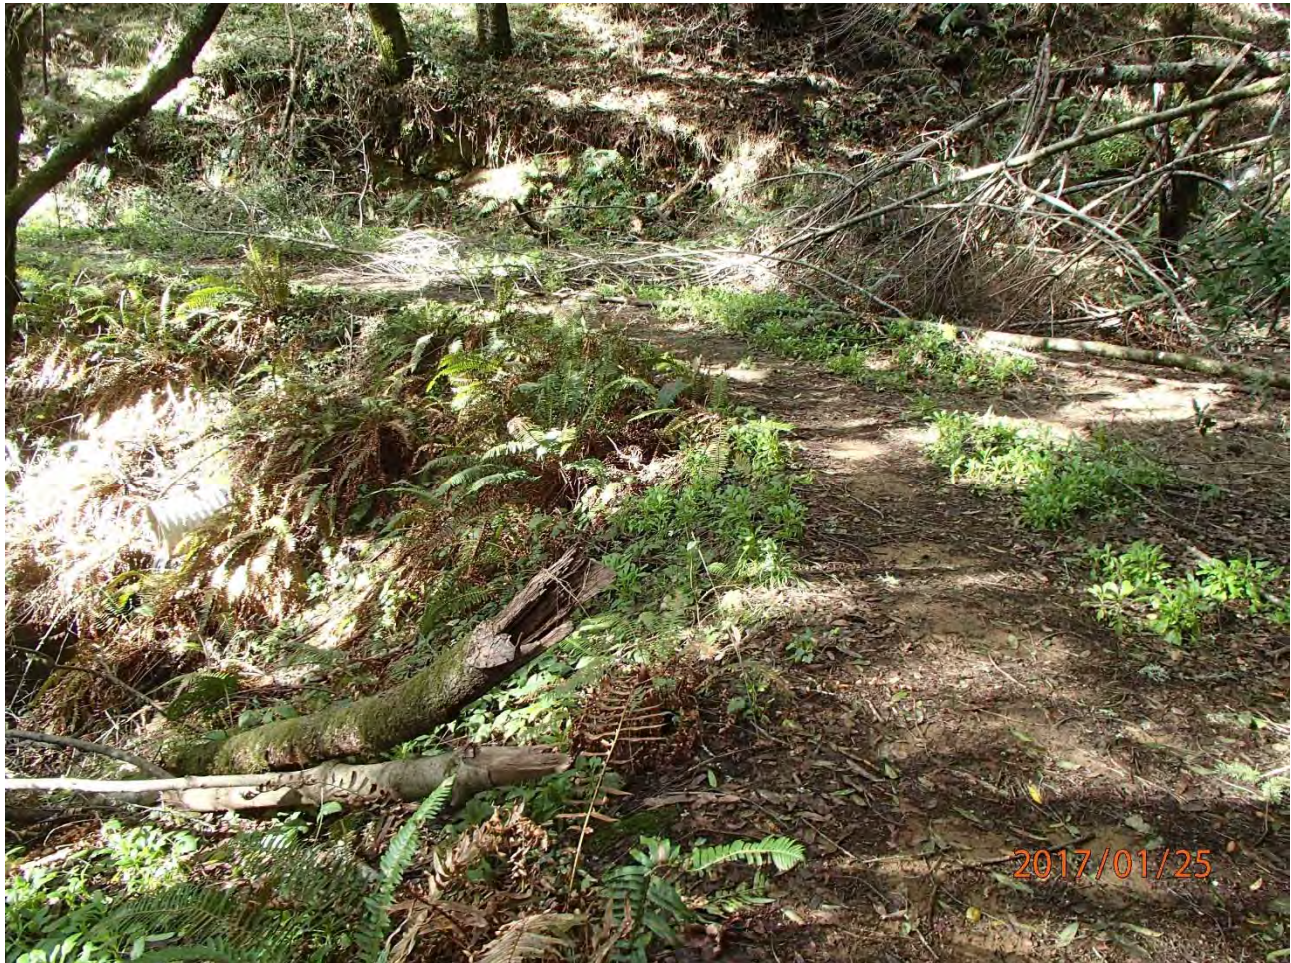
Photo 72. Photo of stream crossing site #522.1. Stream flow is being conveyed through a poorly installed, undersized and high plug potential 12" clay pipe at inlet and 18" aluminum pipe at outlet.
