# Beaver Creek No. 10

## Grand Teton National Park Wyoming

### Historic Structure Report

*Prepared by*  
Colorado State University  
Architectural Preservation Institute  
Christopher Koziol, Principal Investigator

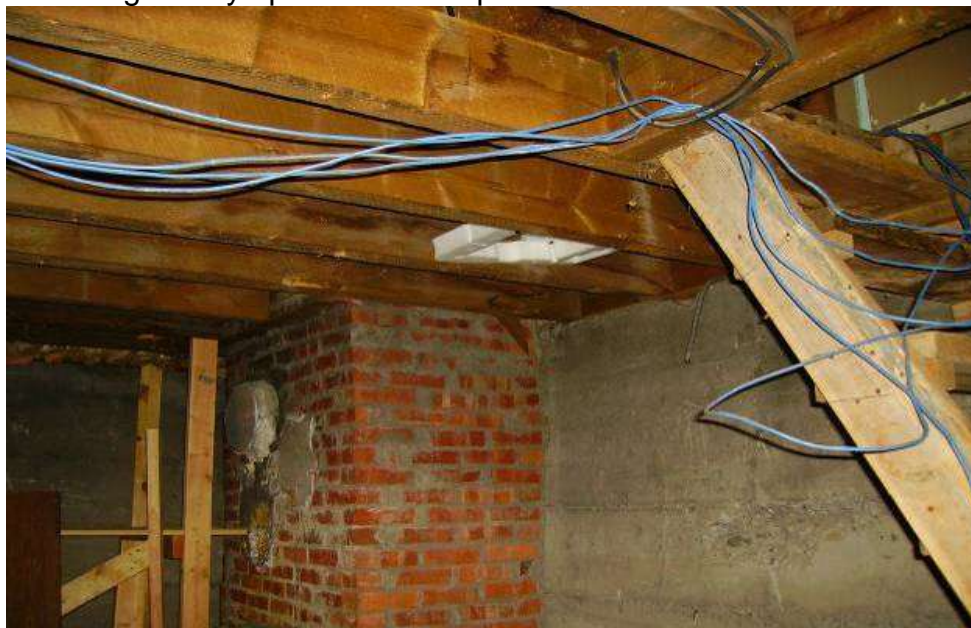
Figure 13 Basement under Rm. #5 showing chimney

- Foundations were added prior to all of the additions, and on the CCC-constructed west wing a basement foundation was constructed, including a new chimney. The basement has two large windows on the west side, which show signs of wear on the lower concrete sill,

possibly from being used as a coal chute. In the basement the chimney shows signs that it was used as a flue for a burner of some kind. The chimney was not inspected during this report to determine if it served a fireplace on the first floor.

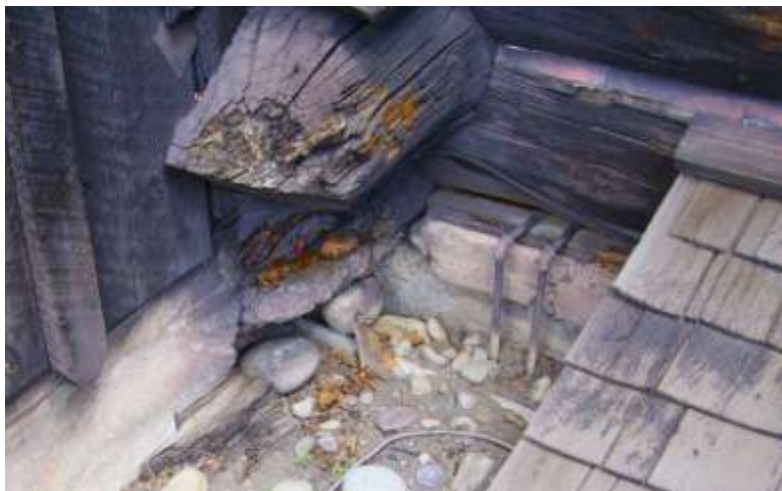
The lower north corner (where this addition connects to the west elevation of the CCC log addition) reveals the only visible sign of foundation decay on the entire building.

**Figure 24 Log decay at corner of addition**

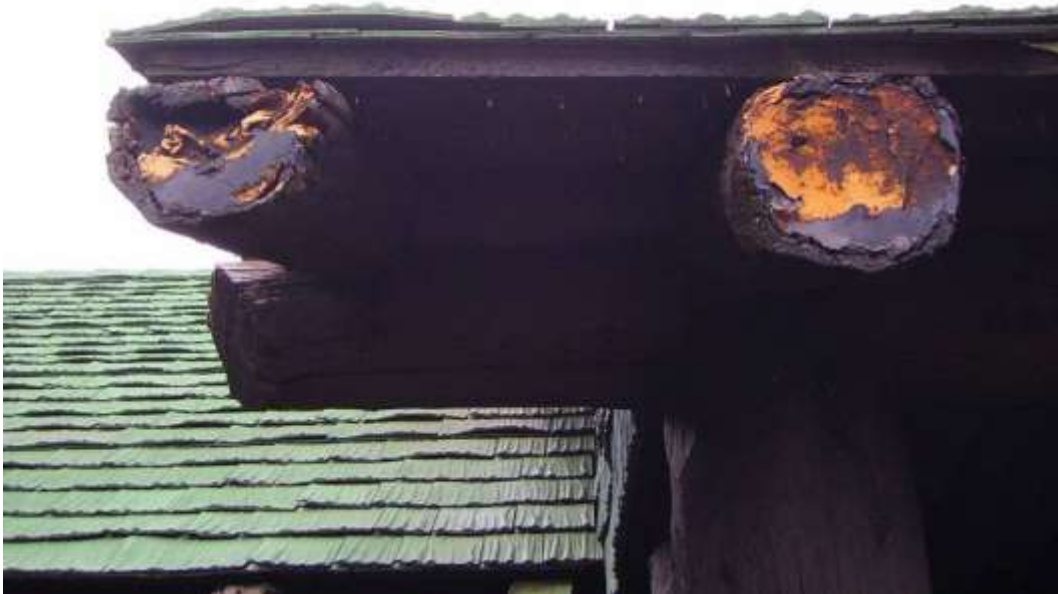
The roof appears in **good** condition. Watermarks under the roof sheathing indicate previous water intrusion, apparently rectified with the recent installation of an eco-shake® roof by the NPS. The fascia at the north elevation, unprotected by either gutters or drip edge, is weathered and shows signs of distress due to water/snow. Exposed rafter (south & north elevations) and purlin (east elevation) tails, as mentioned above, are beginning to show indications of wood rot, and while in **fair** condition, will require significant treatment.

Figure 38 Wood decay at exposed porch rafters

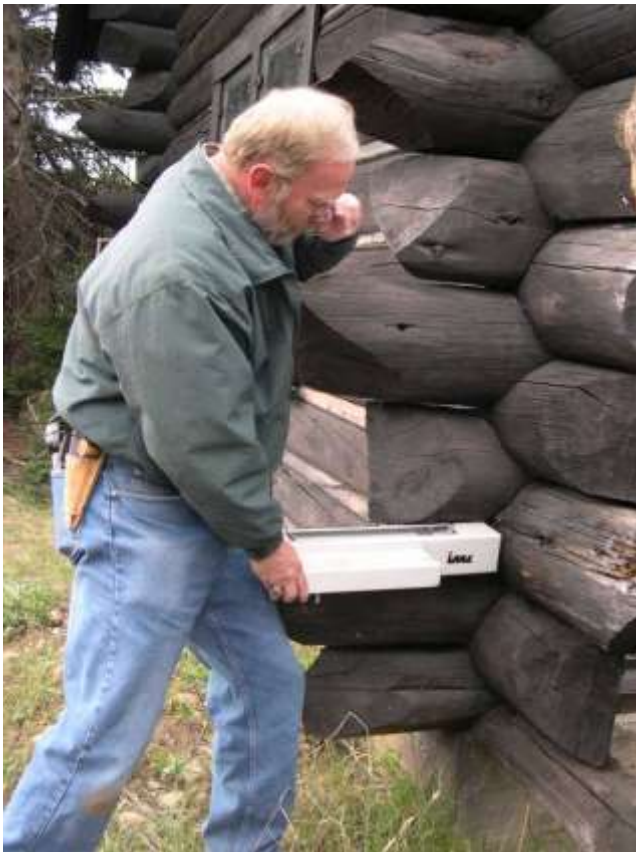
Resistance drill testing indicates log fiber integrity the entire diameter of the rafter at the top wall log (see Drill Test Chart, Appendix C).

Figure 39 Resistance drill testing at east elevation 'beaver tail'

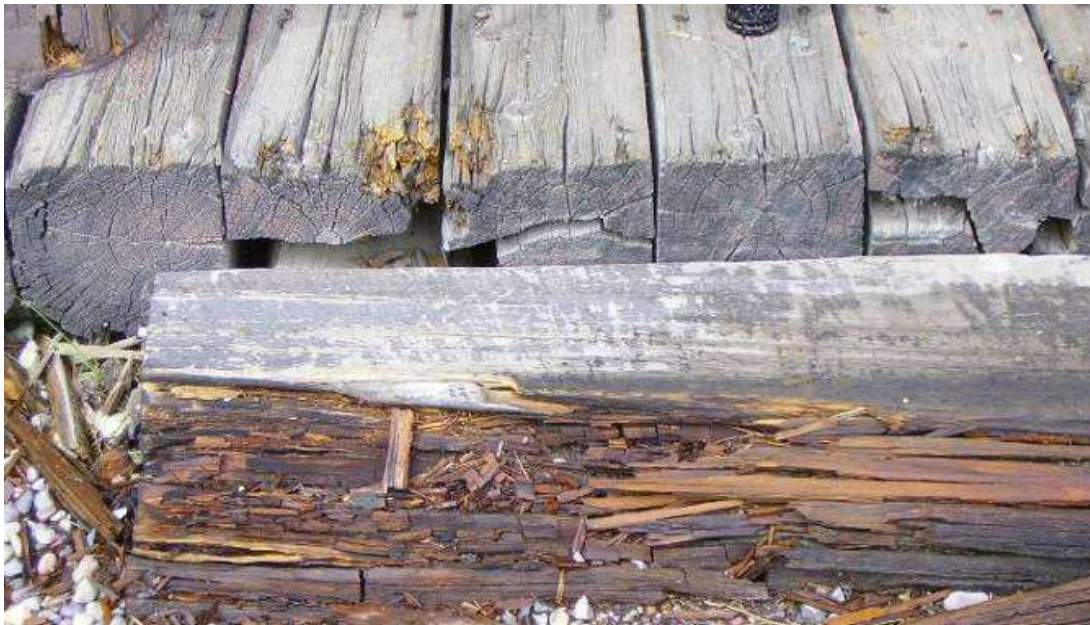
The covered porch on the south elevation is in **fair** condition. The log columns, having seen minor repairs in the past, are structurally sound. The porch deck is being affected by the prevailing weather patterns (from the south), as evidenced by several logs having damaged tails. The step to the porch from the ground is significantly deteriorated (see Figure 40).

Figure 40 Decay of porch timber

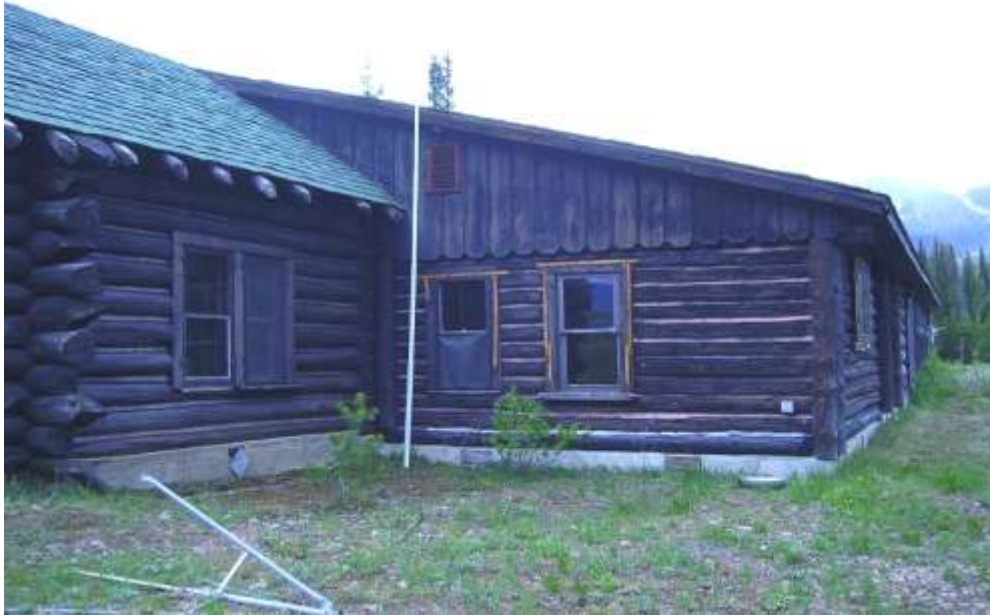
The issue of snow accumulation on the north elevation is best illustrated by the deterioration of the daubing on this wall and the east elevation log wall. These are the areas of the most significant daubing distress.

Figure 41 Shed roof as seen from the east. Note missing log rafter tail

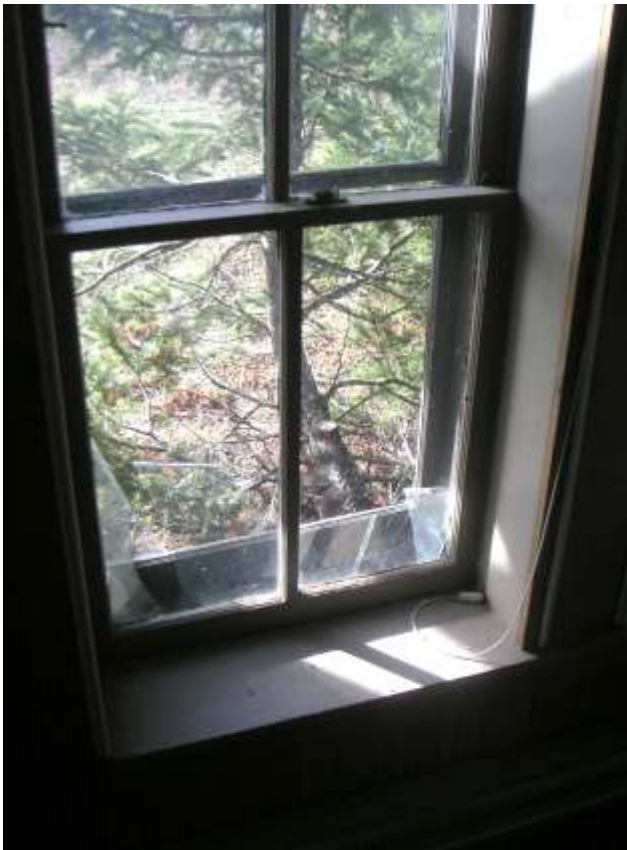
The windows are in **fair** condition. Lack of regular building maintenance has obviously adversely affected the exterior of most windows. However, no degradation appears irreversible at this time. Several windows panes are broken and some storm sashes are missing or have broken panes. All windows and trim lack paint or any other protective finish. While individual window parts may be damaged and in need of replacement or repairs, overall, the windows appear in **fair** condition. We recommend a more thorough assessment by a skilled wood preservationist.

Figure 43 Double hung window with broken panes in storm sash

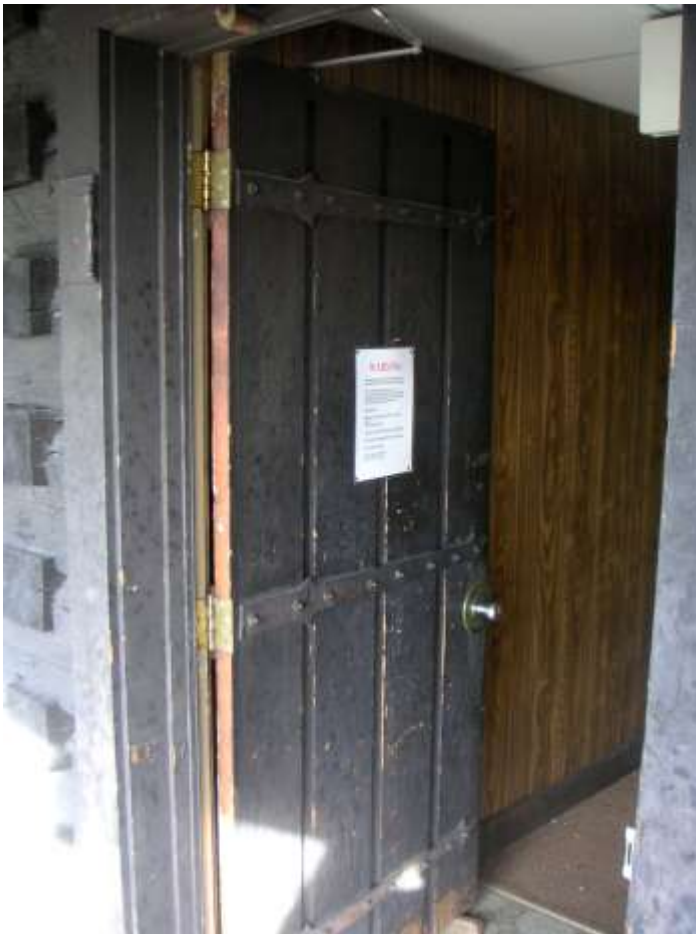
Beaver Creek #10 has three exterior doors, only one of which contributes to the historic character of the building (front entrance). The front door is in **good** condition, although somewhat worn at the bottom. The exterior door at the west elevation lacks a step to grade level and presents a safety issue. The exterior doors at the west and north elevations both are historically incompatible.

Figure 44 Front (south) door

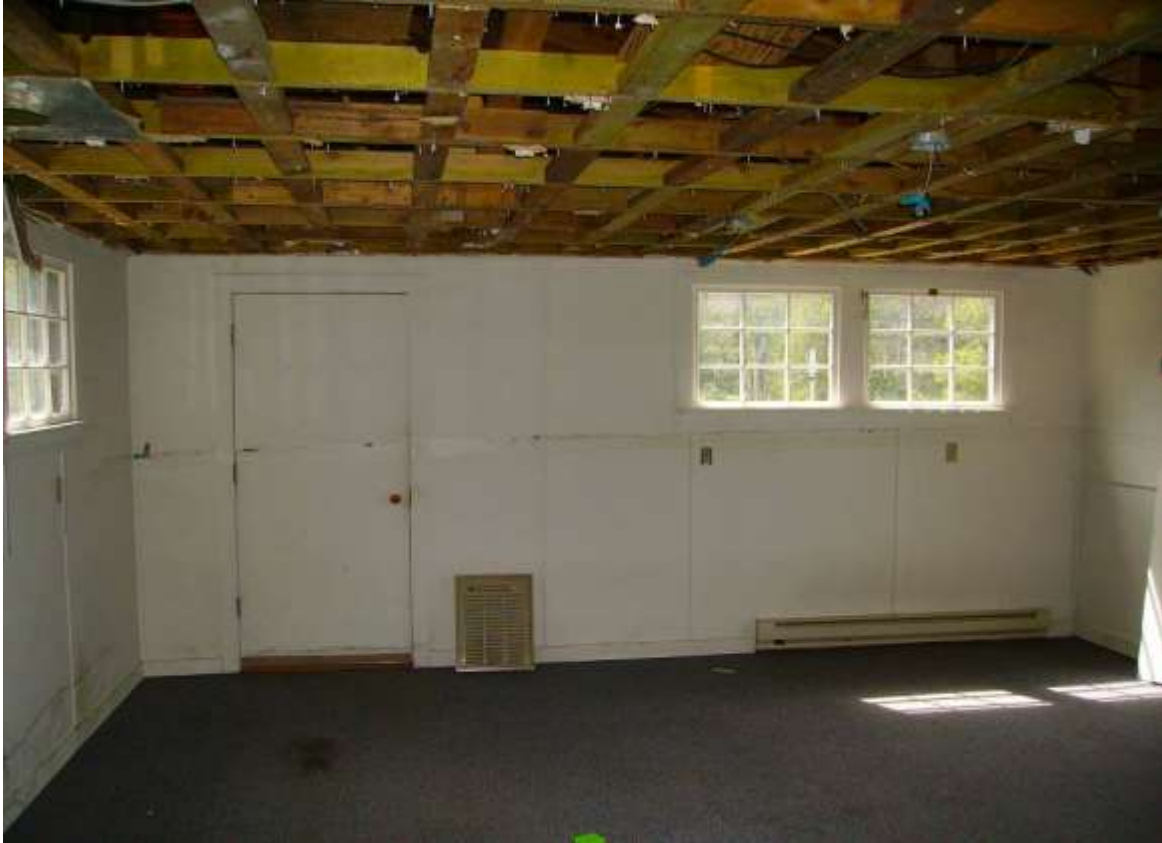
Figure 46 Interior of Rm. #9. Note interior use of pressure treated lumber in ceiling joists

Removal of the ceiling panels has revealed that the framing consists of Wolmanized® 2 x 4's. This material, designed for exterior use, has been proven to be a human health hazard.

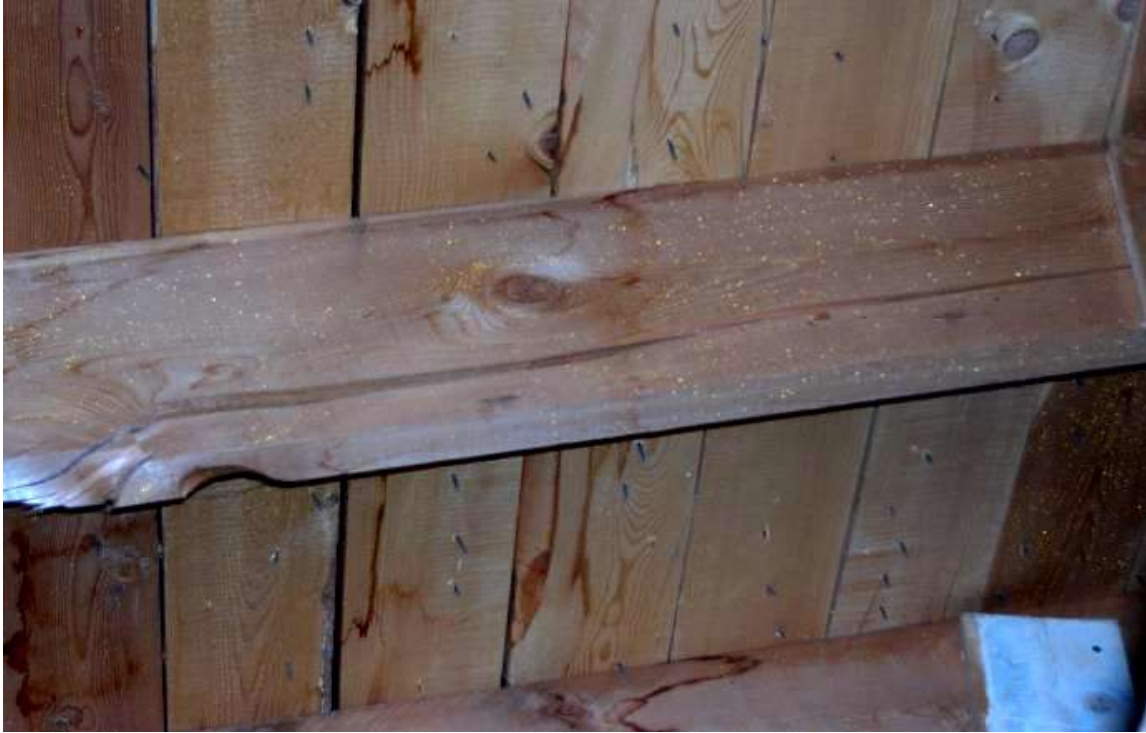
Roof rafters appear in **good** condition with the exception of the dimensional 2 x 10 rafters for the shed roof over rooms 9 and 10. These rooms are 17' wide (North – South) and there is no intermediate support, resulting in the failure of two rafters. (see photo below)

Figure 47 Cracked rafter in Rm. #9

Most significantly, the west 1956 addition may require the services of a structural engineer as the roof system may be undersized and structurally compromised. Snow loads in the Grand Tetons are extreme and this roof has two rafters that have already failed. Safety concerns require this structural problem be addressed. Also of concern is the south elevation 1956 board/batten wall. Many large checks expose the interior framing to the elements and increases shear concerns for this wall.

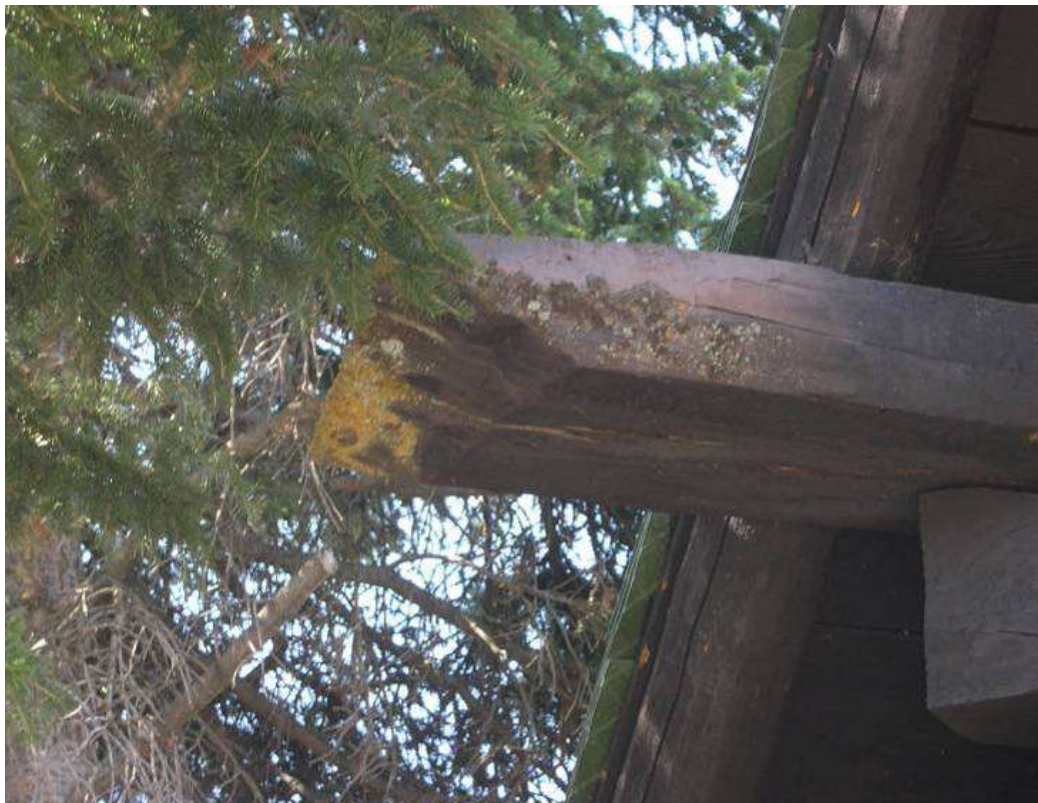
Figure 51 Exposed log tail deteriorating due to moist conditions related to tree as southeast corner of building

The Spruce trees at the southwest and southeast corners should be removed. Photographic records prove that they are not historically significant. If left alone, the relatively small wood decay problems at these locations will become much more significant. Removal of the two trees will make managing the associated log decay issues more feasible.

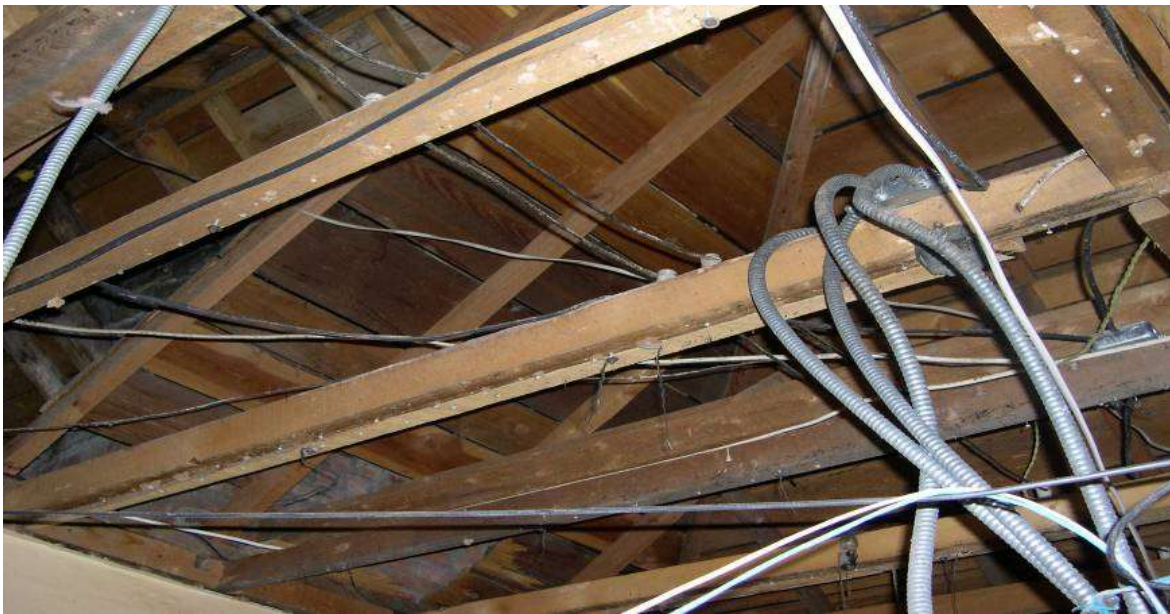
Figure 52 Various types of exposed electrical wiring

Interior spaces also require sympathetic treatment, and should be compliant with standards established by the Secretary of the Interior. Removal of wall coverings will enable a more thorough assessment of the log condition underneath. Any remaining electrical wiring or plumbing (pipes) should be removed, as it is unsafe. New plumbing and electrical requirements should be detailed in new architectural drawings, or specified by a qualified plumber or electrician. Mechanical heat and insulation are necessary if the building is to be utilized year-round.

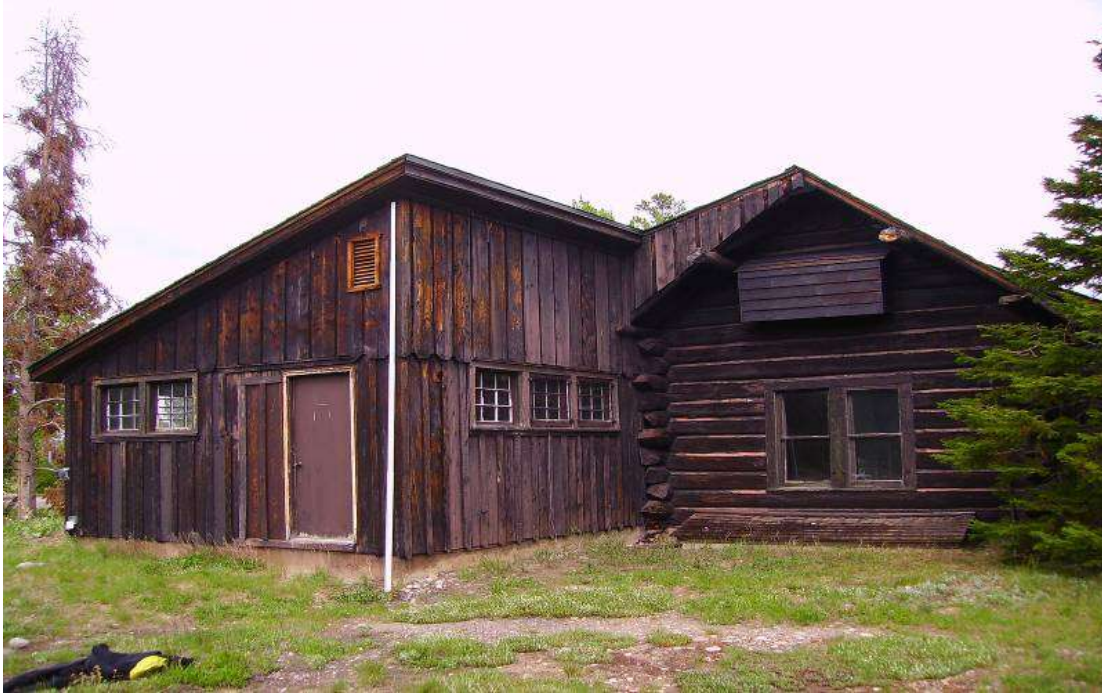
Figure 53 1956 addition at west elevation. Note bat habitat on gable end

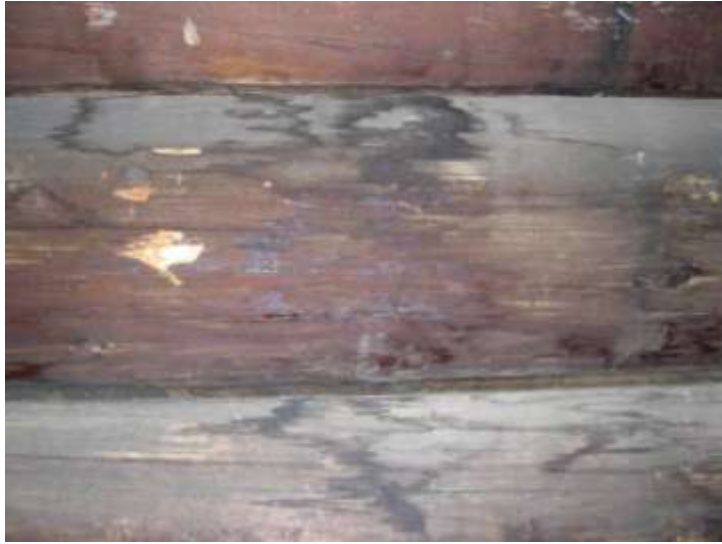
Typical evidence of exterior water damage

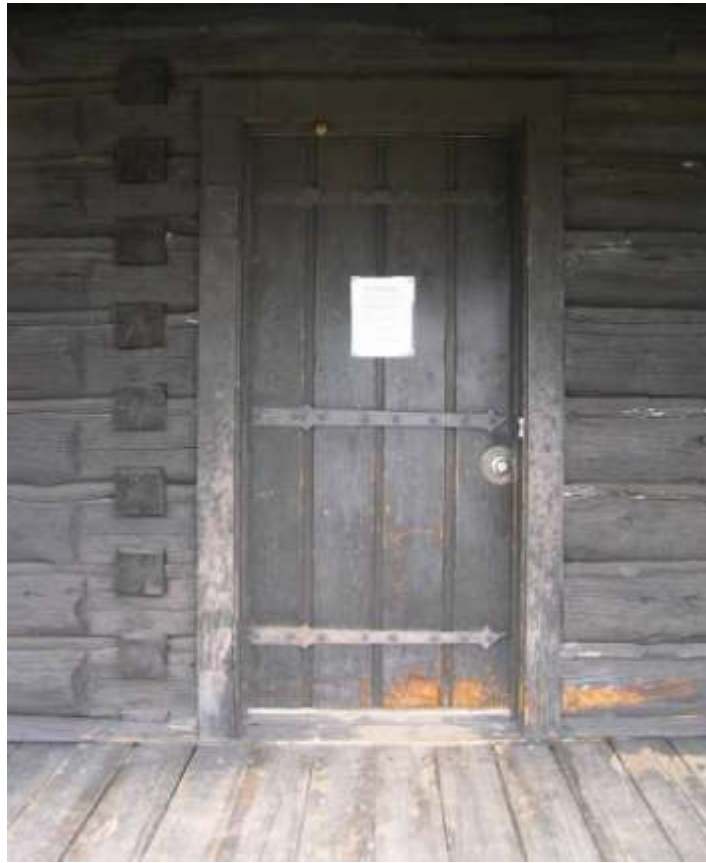
Front entry with wear on bottom right corner, otherwise in good condition, especially decorative hardware

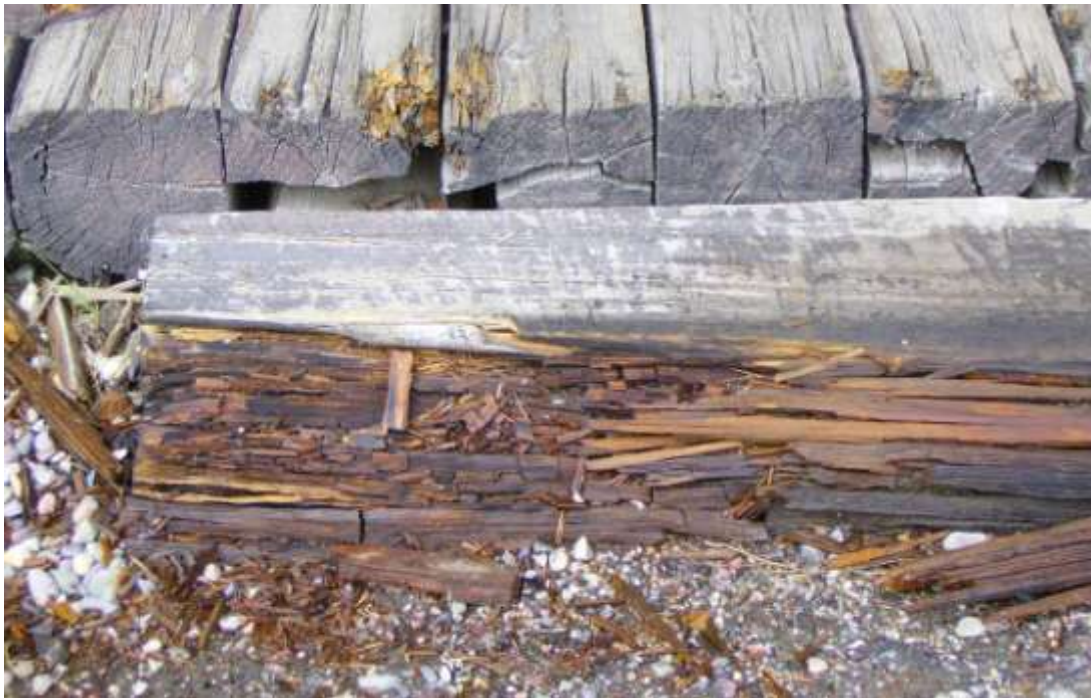
Entry step showing deterioration

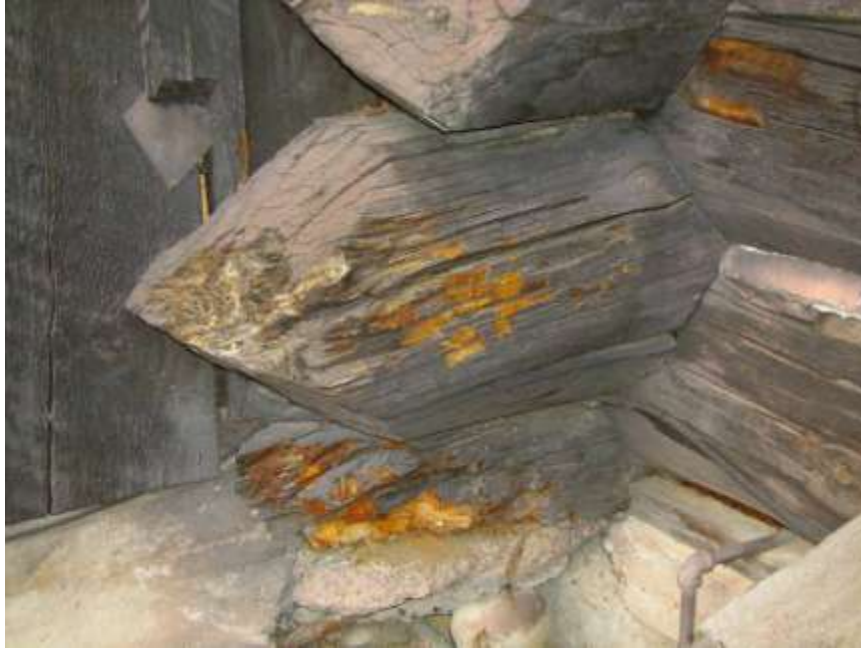
'Beaver tails' at junction of 1956 addition with CCC west addition showing foundation and tail decay; note metal patch blocking rodent entry

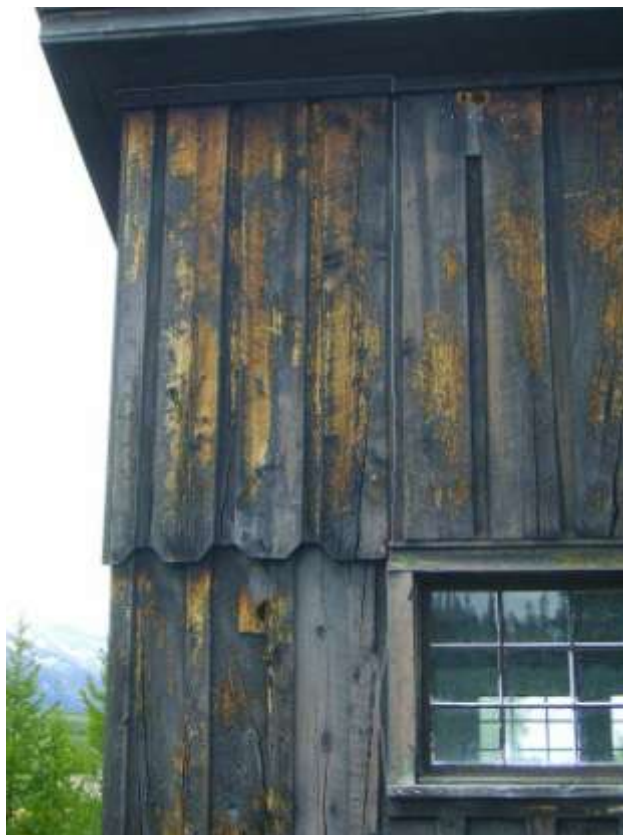
Southwest corner of 1956 addition showing deterioration likely due to weather

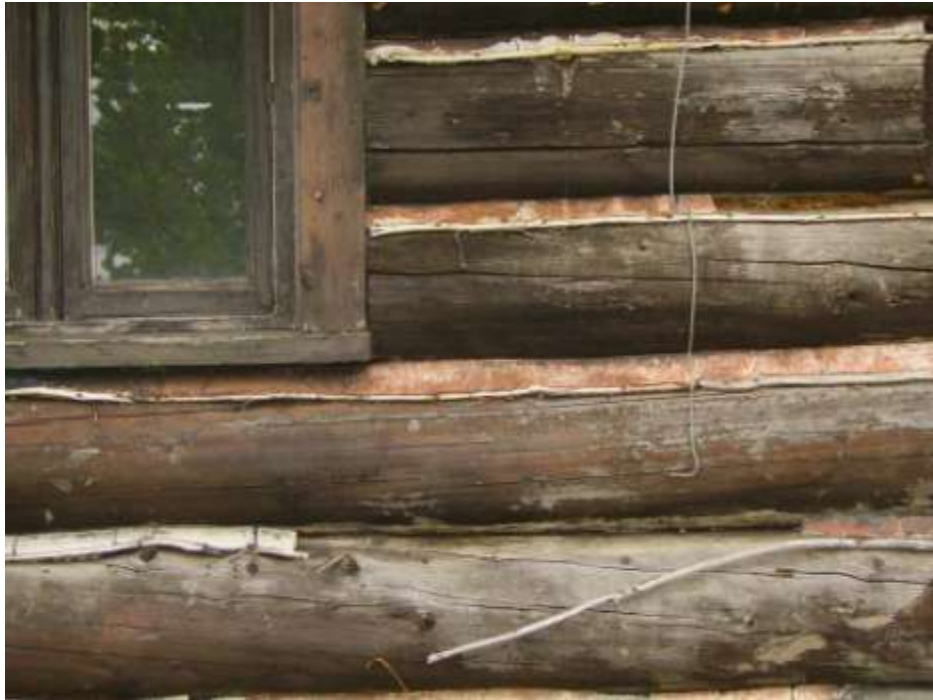
Chinking and daubing on north elevation showing need for replacement

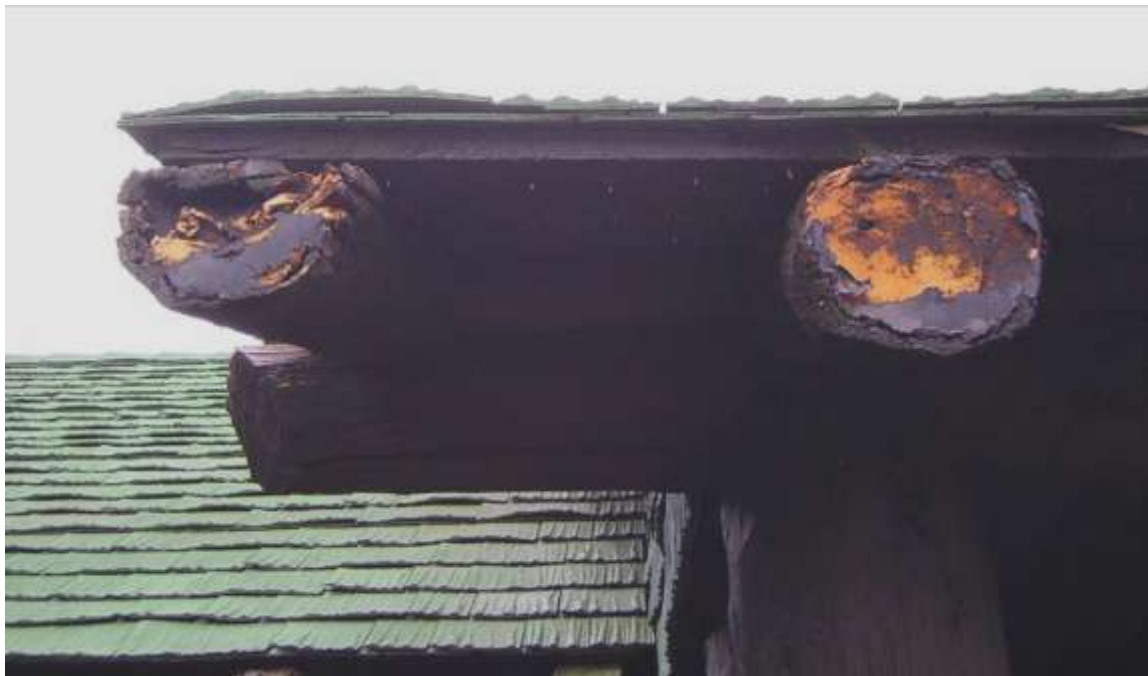
South elevation, wood decay on porch roof rafter tails

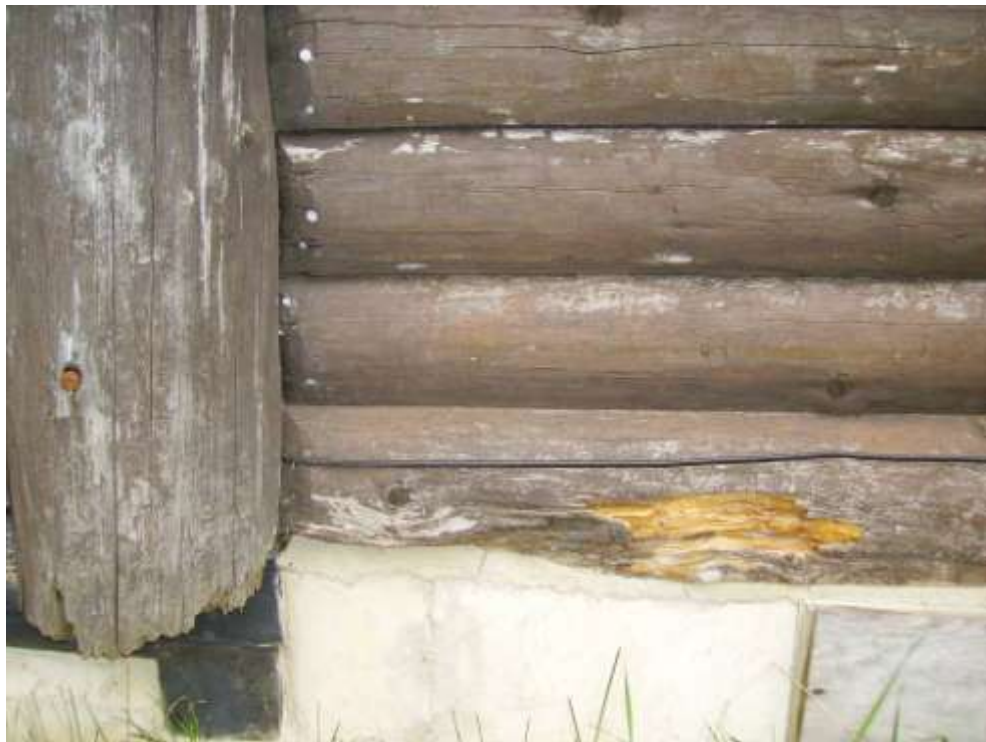
North elevation, sill log of middle enclosure used as darkroom and storage showing possible adverse animal activity

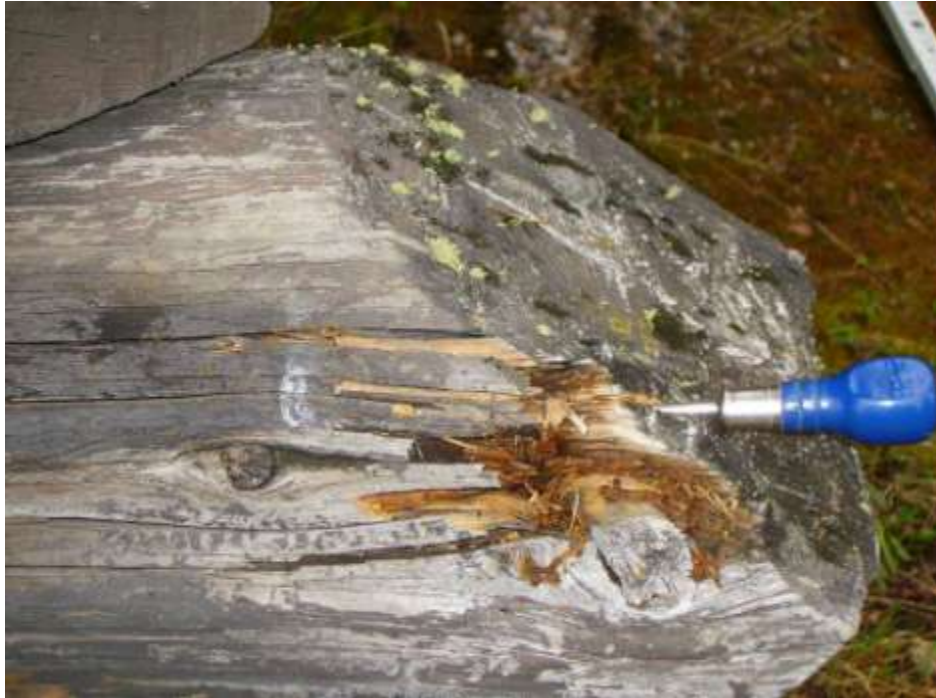
Decay on 'beaver tail'

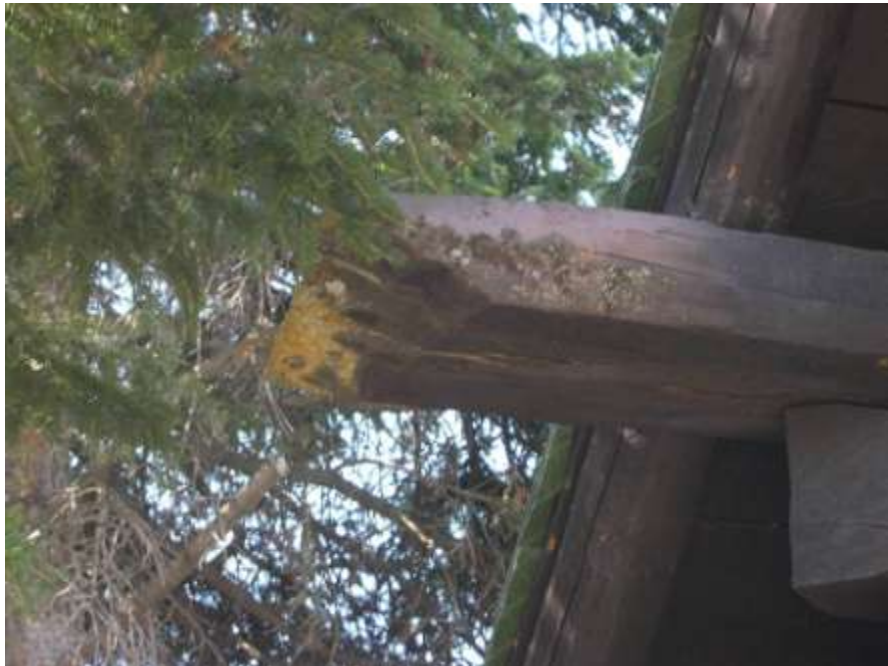
East elevation, decayed purlin on CCC addition

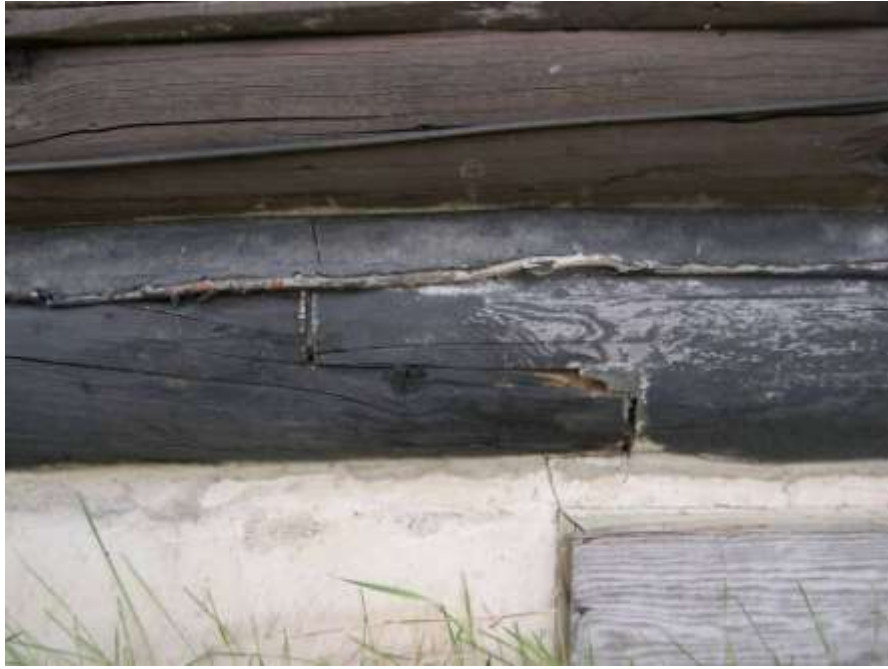
North elevation, splice on earliest addition at foundation level,  
note covered vent on bottom right

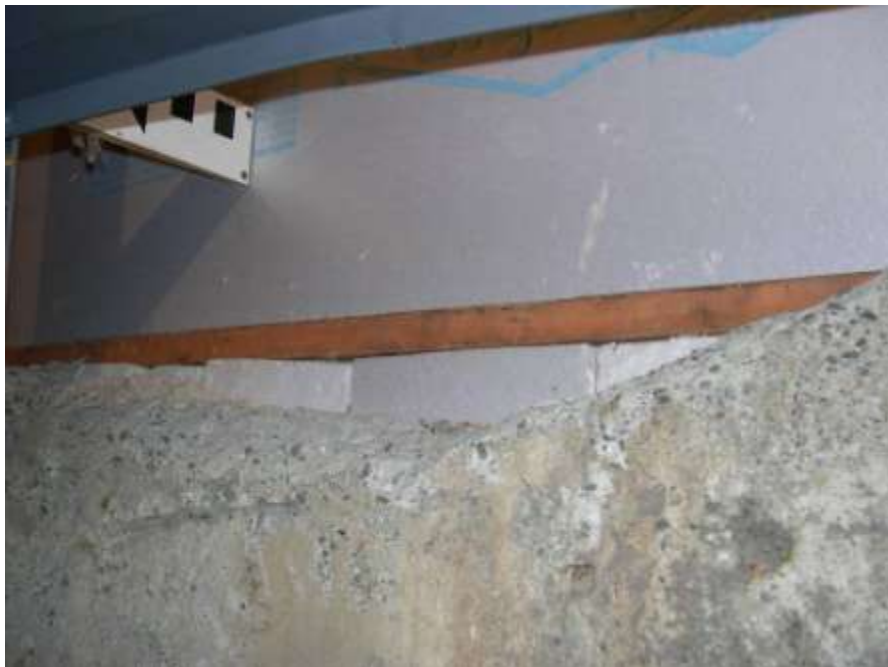
West interior basement access/egress, concrete sill showing wear;  
note sheet insulation at top of photo

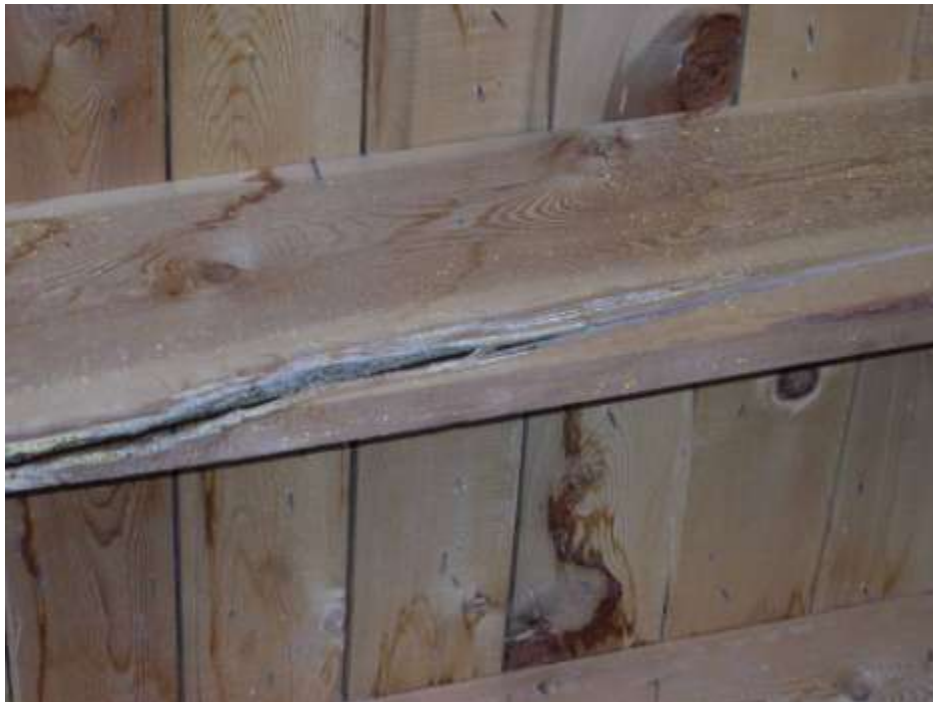
Ceiling of 1956 addition, showing major crack in rafter
