East Courtroom,
Old Courthouse
Jefferson National Expansion Memorial
St. Louis Missouri

Paint & Finish Analysis
November 2011

prepared for
National Park Service
Jefferson National Expansion Memorial
St. Louis Missouri

prepared by
Richbrook Conservation
New York New York

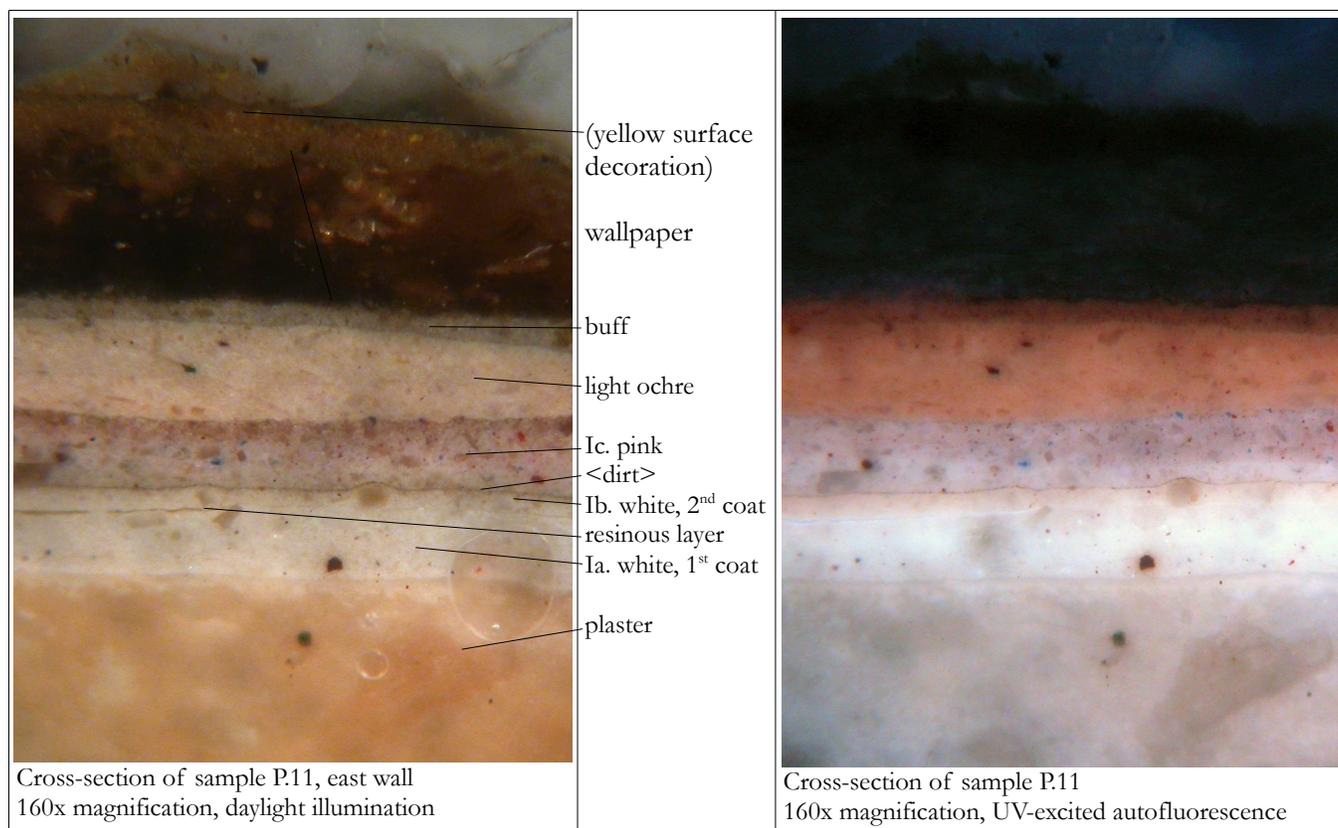
One paint sample on plaster recovered *in-situ* from the east wall against the door header for the bailiff’s door shows 4 early paint layers prior to a remnant wallpaper (paint layers in white, pink, light ochre, then grey-buff). The white layer, applied in two coats, was judged to be a base on which a decorative painting scheme was executed, in which case the pink layer which follows is believed to have been the intended finish, potentially decoratively applied. The first coat of white appears to be an emulsion type paint (adding casein to an oil bound paint), which would have facilitated faster drying. A thin varnish or glaze applied over it may have been used to create a smooth and nonporous surface for the second coat, which was executed in oil. These base layers were left to dry for a period of time, as demonstrated by the accumulation of light surface dirt. In this sample, the paint layer that follows, in pink, is interpreted to be the original decorative finish.

This rare surviving sample of the original plaster wall surface reveals the campaigns of paint finishes applied prior to the first wallpaper. The generation of the wallpaper evidence in this sample is unknown. The sample shows the original execution of the original finish, with a first coat in white, followed by a thin and inconsistent resinous layer. The visible breaks and inconsistency in this thin resinous glaze may be due to quick brush-strokes. A fine layer of accumulated surface dirt on the second paint coat is testament to the time this base-coat system was allowed to dry prior to the installation of the decorative treatment. The pink layer which follows is the suspected intended decorative finish for the walls, and is remarkably coarse in texture, with prominent pigment particles in red and blue. A thin penetrating sealer at the surface may be part of the original application, or may be a sealer applied prior to repainting in the later light ochre paint. The two subsequent paint layers may not necessarily correlate with the repainting sequence on the trim in the room; the “frescoed” walls may have been valued enough not to have been immediately overpainted along with the trim elements.

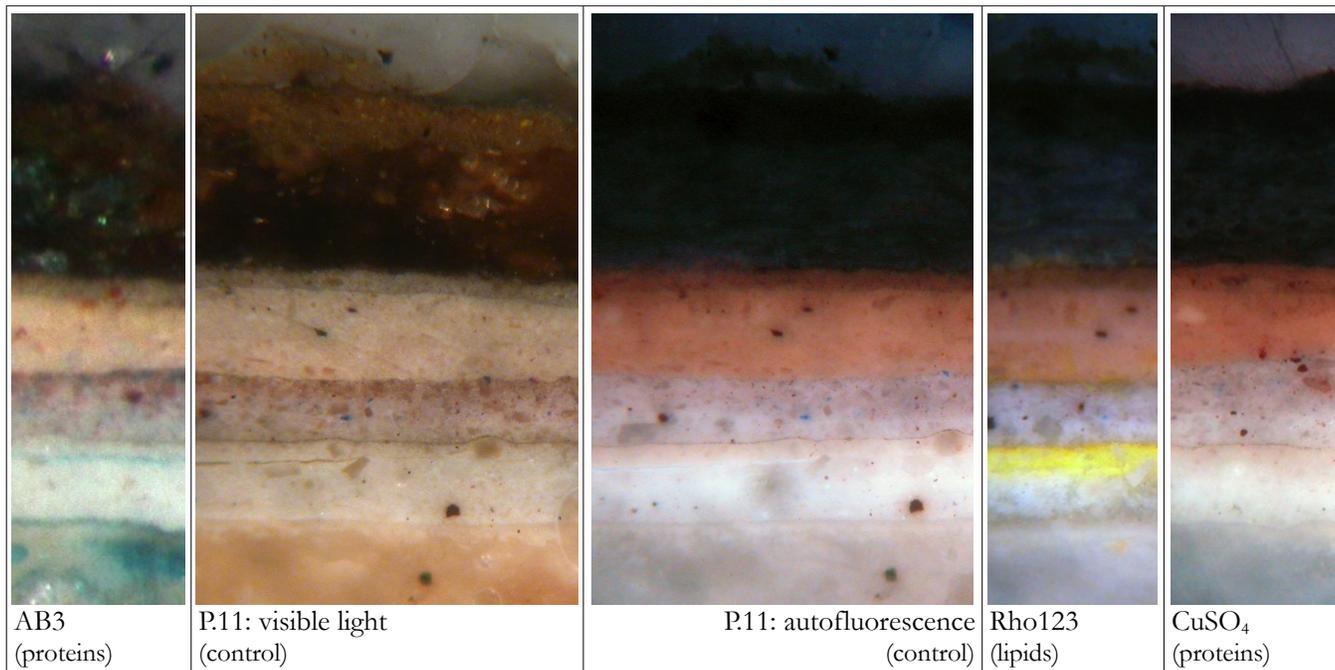
This series of staining tests was used to preliminarily test the early pink decorative layer for typical binding media based on lipids (i.e. linseed oil) or proteins (i.e. hide glue or casein). The layer did not yield strong positive reactions for either of these classes of media. Based on visual characteristics of the layer and the lack of a significant oil or protein binder, the paint might be interpreted to be an alternative medium such as a limewash, which could have been integrally pigmented, and/or used as a base for execution of a “limewash fresco” technique, involving decorative application of penetrating watercolor wash over a fresh limewash coating.

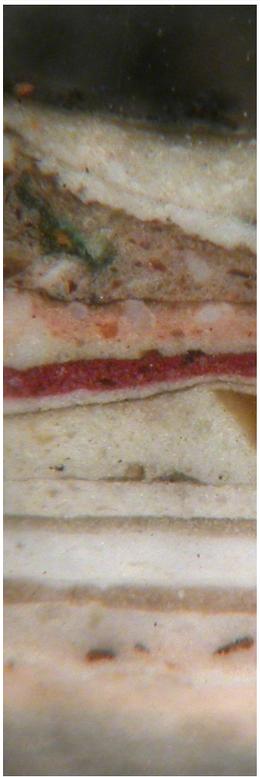
A01 filled flute, typical	A.01f 'dutchman' at column East	A.01g filled flute below 'dutchman' East	A.01e filled flute, beneath judge's platform	
white	white

The paint sequence on the 'dutchman' repair marks when the judge's platform was moved from the East wall, requiring fills to these joins in the columns prior to repainting. The sample from directly below the dutchman reveals that this area of the column was obscured for a period of time, after the initial white paint sequence until the 1903 renovation, presumably because it was below a riser platform in place for the judge's bench along that wall. Similarly, the sample taken from the column below the current judge's platform was not painted originally, as it may have been obscured in 1856 as well, but was then painted consistently up until just before the 1903 re-encapsulation.

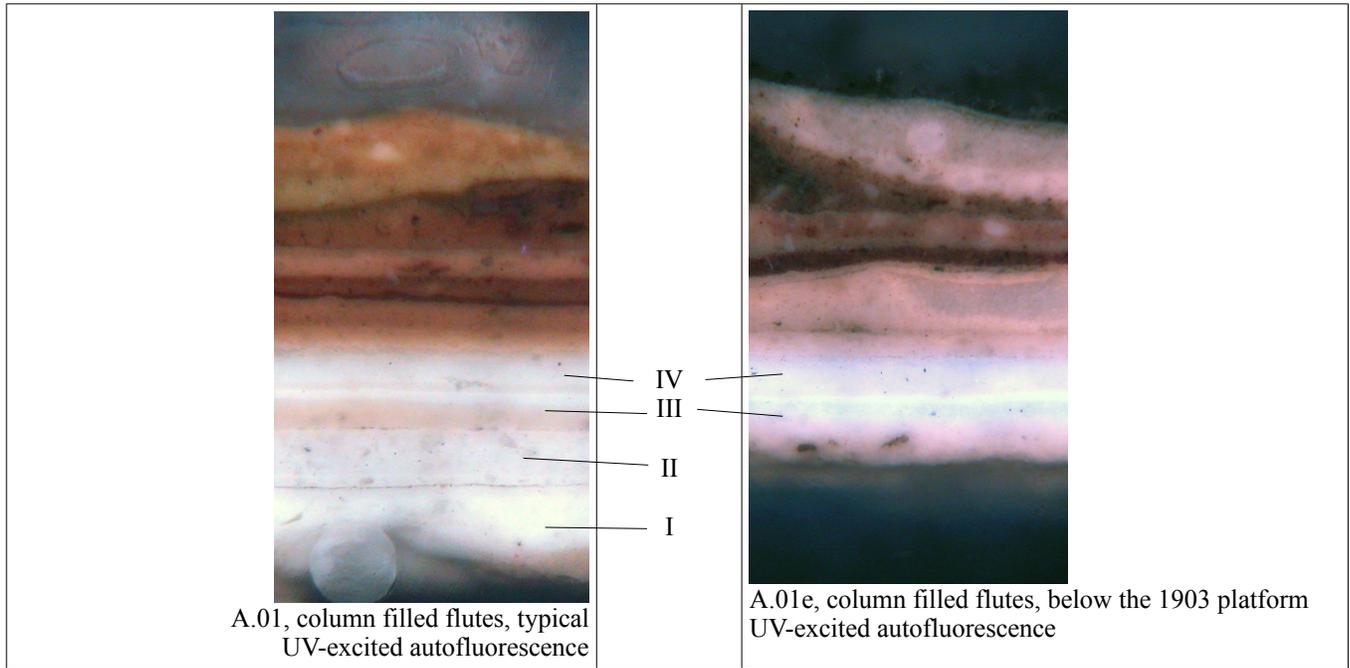
The comparative fluorescence response of the earliest white paint treatments on the column shaft samples shows that the first white paint applied to the column where it was sampled below the judge's platform matches the characteristics of the third white paint application on the control sample, representative of typical columns in the room. Accordingly, this area of the column was not painted along with the other columns at original construction, nor during the subsequent repainting. It may therefore be deduced that it was first painted white in 1870, when the original judge's bench was relocated. This third scheme may be used as one benchmark for identifying the 1870 treatment throughout the room.

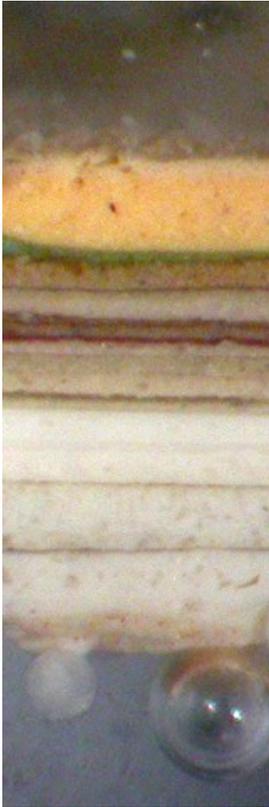
These two samples, taken from either side of a vertical paint-edge line on a west wall column, reveal that the difference between them is in the earliest two paint layers. The sample closest to the wall is missing the first two layers, potentially due to a built-in fixture or molding in this location in 1856 which may have been removed in 1870. Evidence to support the partition wall shown in the 1903-1909 floorplan was not specifically noted in these sequences.

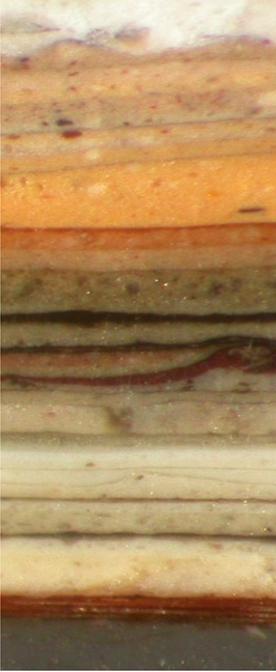
A.02 typical, at filled flutes	A.02a dutchman repair at North column	A.02b typical, above filled flutes	A.02c behind paint-edge line at west wall

The paint sequence on the 'dutchman' repair provides a benchmark in the paint history for the circa 1903 re-arrangement of the room which would have required the removal of a bailiff's stand or similar structure in this north wall location and repair of the associated wood join. The sample from the shaft above the filled flutes shows that for three consecutive periods during the later 19th century, the upper part of the column shaft was painted in contrast to the lower part of the shaft.

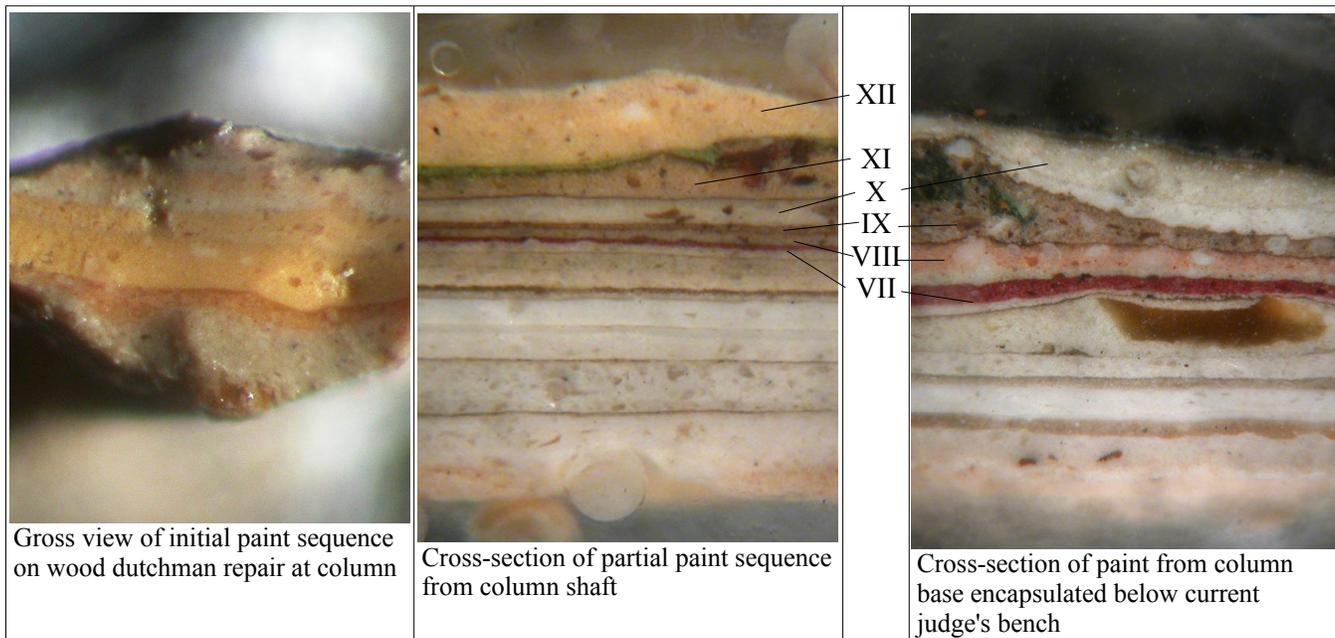
To establish the benchmark for the 1903 construction, three paint samples have been selected for comparison, all representing the wood column shaft. The sample shown below on the left is from a dutchman repair to a column along the north wall adjacent to the bench structure. The center sample is a typical sequence of early paints on the column shaft and is being used as the standard, and the sample on the right is from the column shaft below the platform which was conceivably not painted in 1903 or any period thereafter.

The earliest sequences on the two samples to the right are generally in line, through and including the dark red (VII), salmon (VIII), brown (IX), and light buff (X). Per this stratigraphy comparison, the light buff was the last finish applied to the columns before being encapsulated below the judge's bench in 1903. The ochre-buff paint which appears subsequently on the center sample would then correlate with refinishing work of 1903. It may be assumed that the relocation of this substantial feature created enough of a disturbance on especially the east wall to warrant a full refinishing of the space.

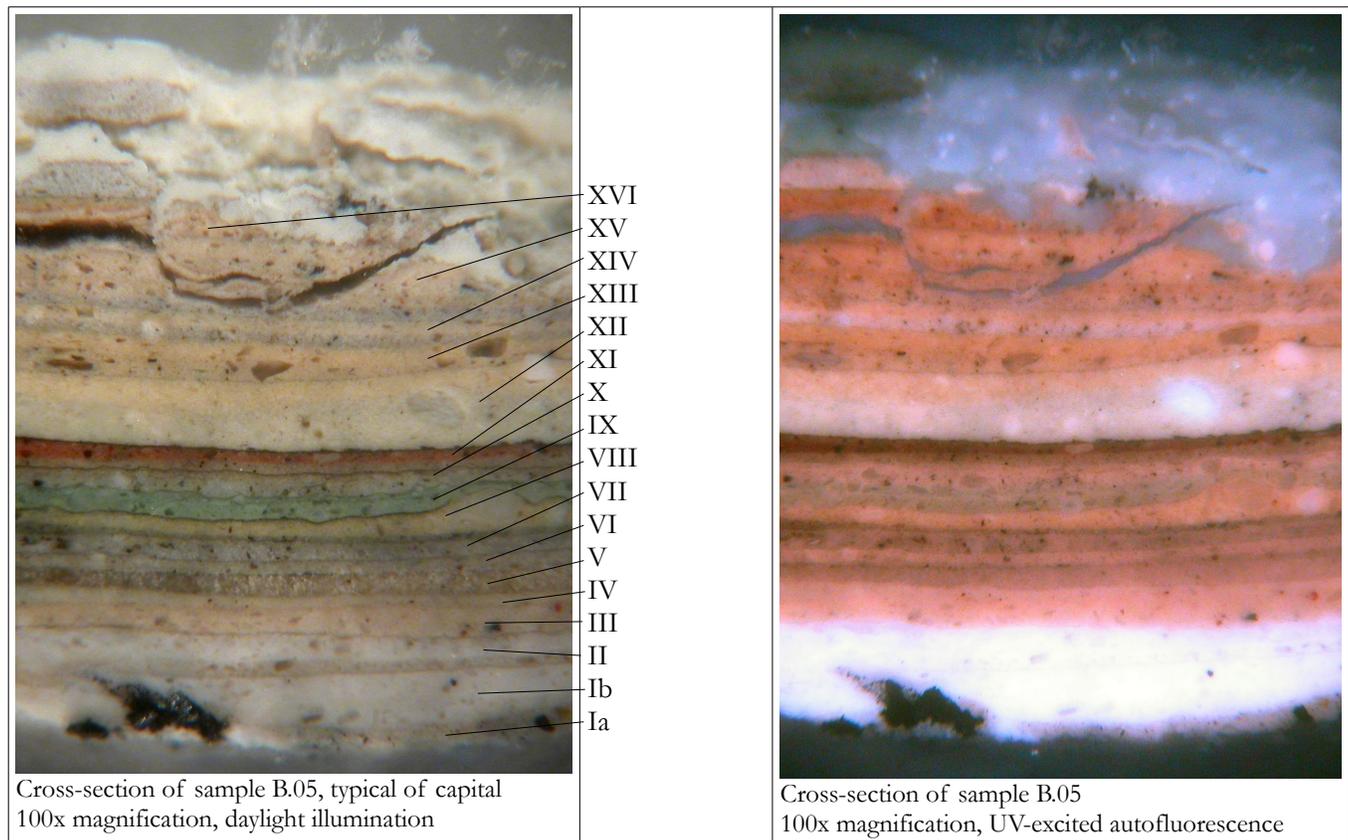
The upper shafts of the columns, where the flutes are hollow rather than filled, were finished in contrast to the lower, filled-flute part of the shaft during the late 19th century.

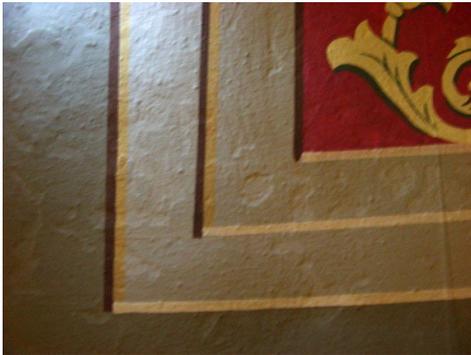
Raking light observation of the frieze area, which currently has canvas applied over the painted wood, reveals a repeating pattern of what appears to be a classical wave motif. It was established in the field that this decoration was not applied to the canvas, but telegraphs through the canvas from an applied layer below. Notably, this telegraphing pattern is evident in the historic photo from the 1910s as well.

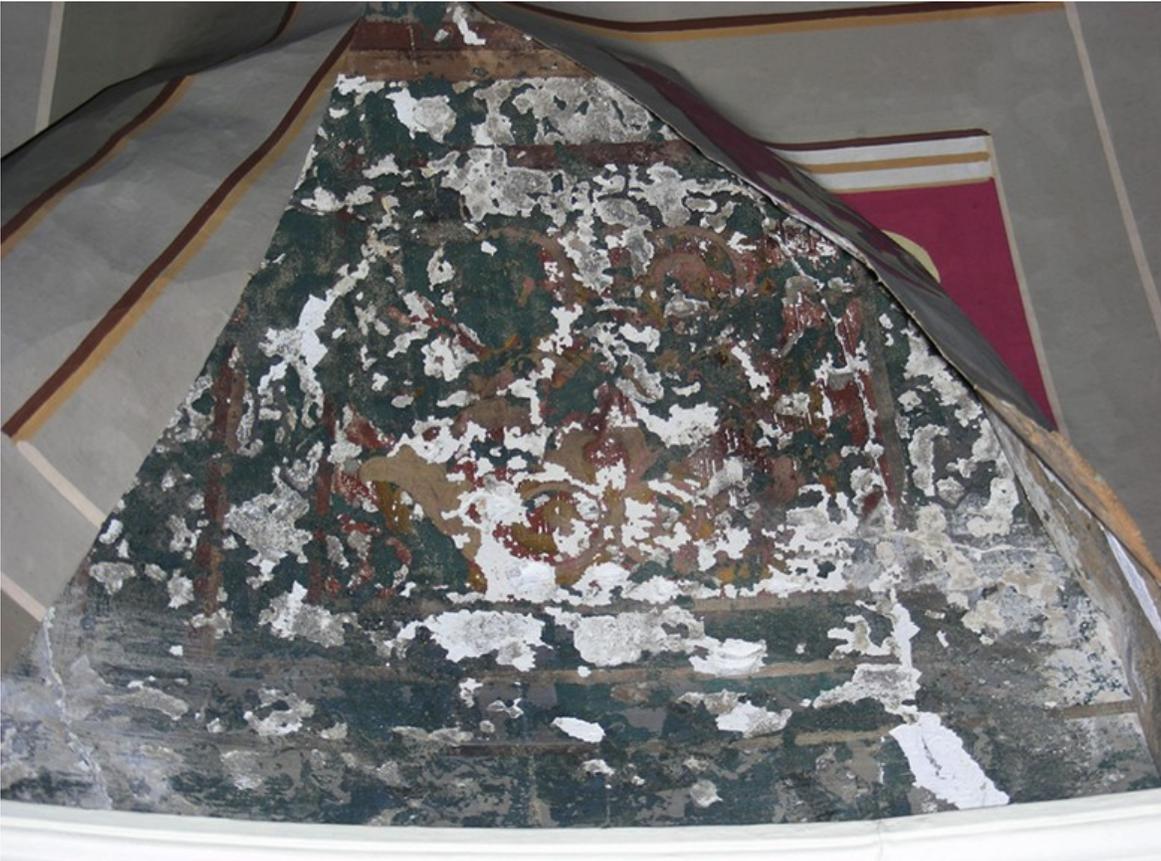
Overall panel design; the historic panel is wider than the re-interpretation, resulting in 10 panels instead of the current 12

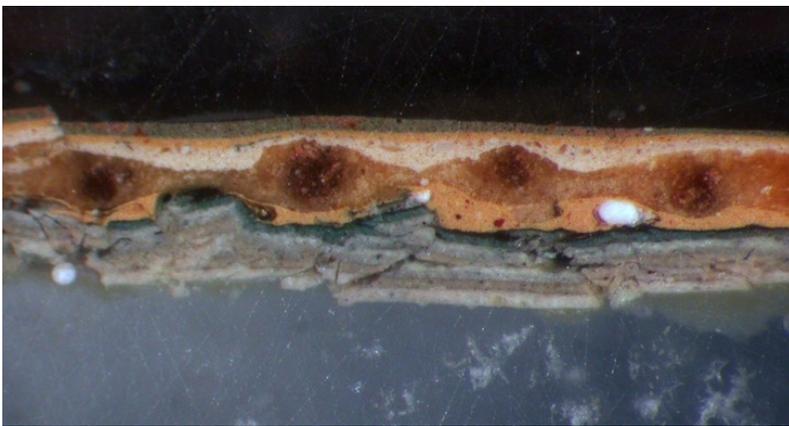
This wider view of cross-section E.01 illustrates the mechanical stress and disruption that the early paint layers suffered through the action of removing Lincrusta, which may have been applied with a high-strength adhesive.

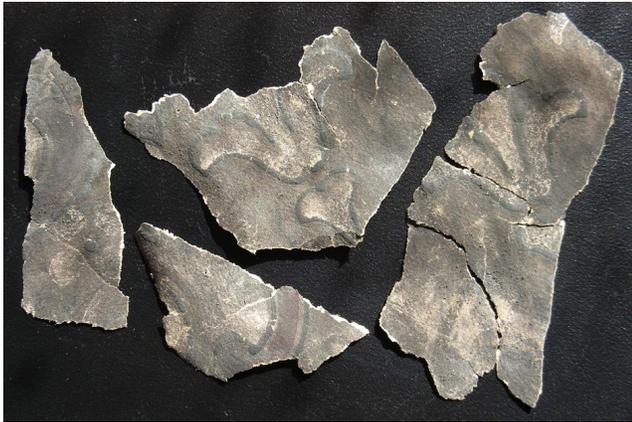
Scraps of wallpaper were recovered with a *fleur-di-lis* pattern matching the extant paper on the encapsulated north wall (WP04).

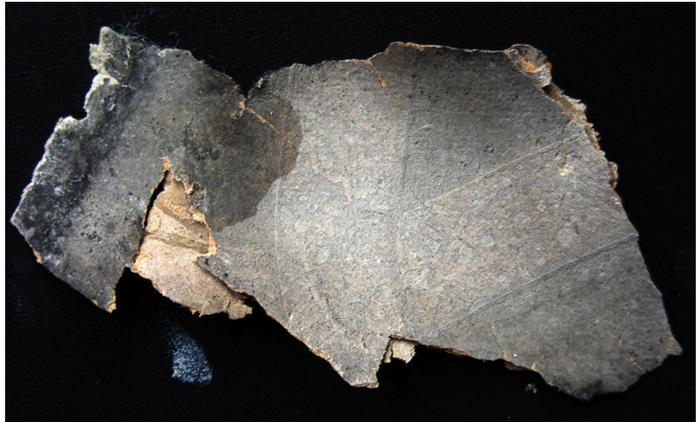
Two sequential scraps of wallpaper were recovered, one (WP05) with a partial design (as of ribbons). This paper has an earlier paper (WP05a) adhered below it.

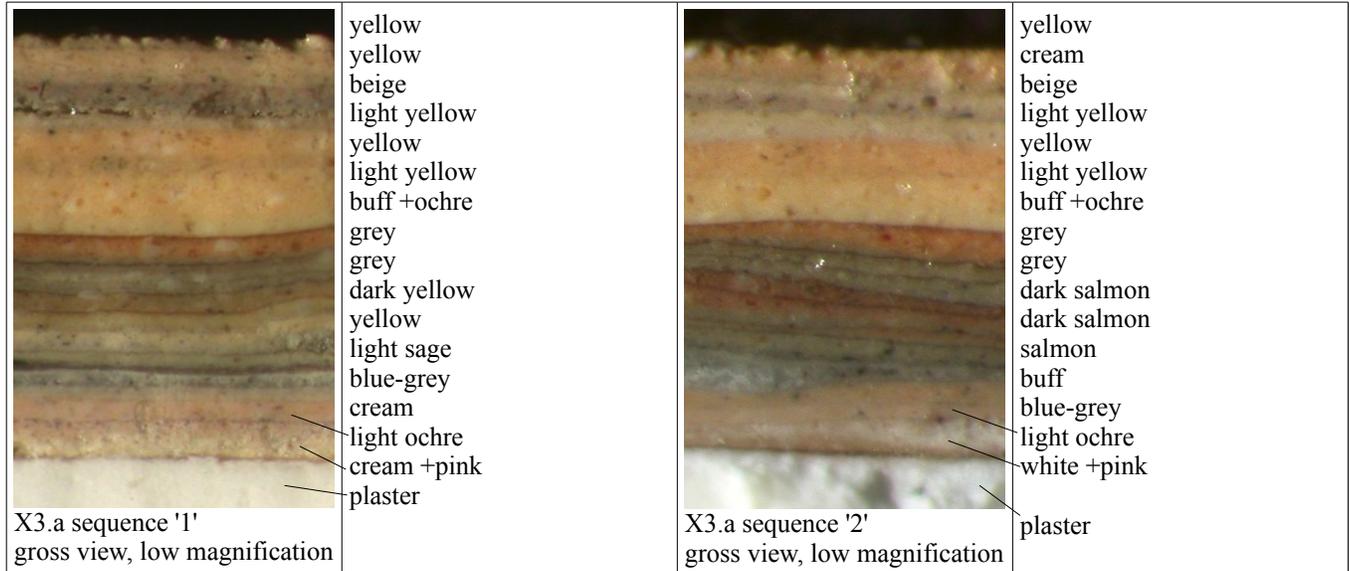
The two alternate paint sequences as shown at low magnification, viewed on edge. They reveal slight variations in the color scheme through the paint history. The last, buff color paint, provides a contextual reference for the paint finish immediately prior to 1954. These fragments may represent elements of the entablature. The visual characteristics of the earliest layers applied to plaster match those of the early “fresco” paints identified on the dentil molding of the entablature. The color of this layer on sequence '1' is a yellow-cream color, not observed on wall or dentil samples. The color applied to the sequence '2' fragment is cream-white, possibly in keeping with the color identified on the dentil molding. The slightly curved profile of this chip further suggests that this may have come from a running molding of the cornice. Both chips reveal a highly decorative historic treatment during the late 19th century.
