April 19, 2019

RE: Final Report – Water Intrusion Issue Evaluation
Klipsch Heritage Museum, Hope Arkansas
Cromwell project number: 2018-238

The following is our report on the water intrusion study for the basement of the Klipsch Museum in Hope, Arkansas. The work was done under order number 140P5118P0121 dated 8/28/2018 from the National Park Service, MWY, Pres. Wm J. Clinton.

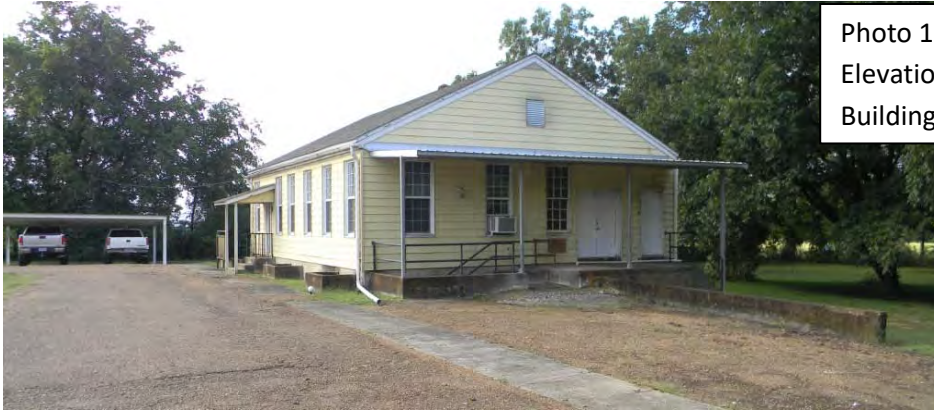
Photo 1 – Exterior
Elevation of North Side of
Building

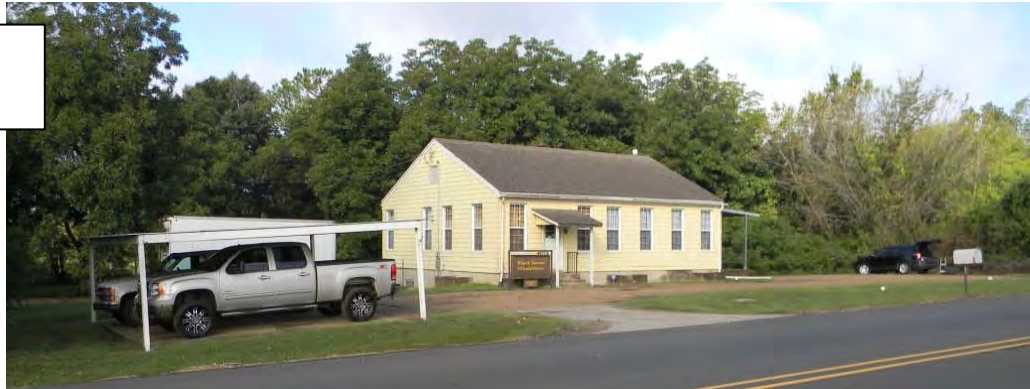
Photo 2 – East and south
side of Building

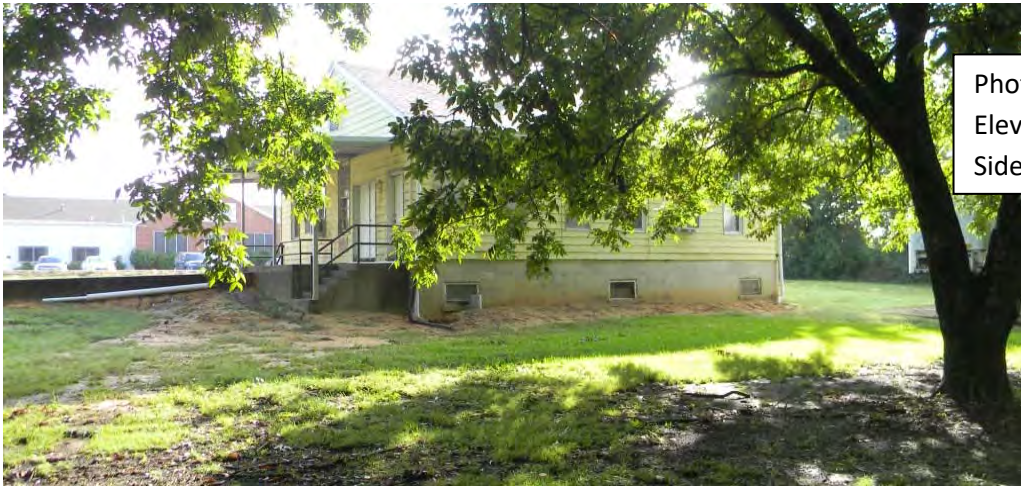
Photo 3 – Exterior
Elevation of West / Back
Side of Building

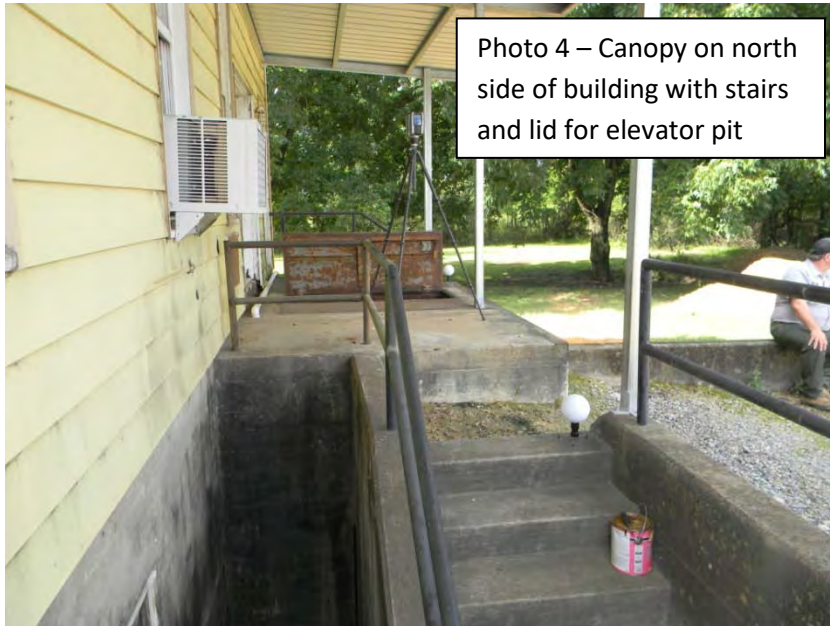
Photo 4 – Canopy on north side of building with stairs and lid for elevator pit

- a. Canopy of north end of building: Need a roof gutter on that canopy due to erosion from water falling off the canopy and getting water away from the building.
- b. Need to pipe water from the front gutter to the back side of the property to replace the existing stopped up storm drain system that the downspouts in front of the building tie into.
- c. Need to drain water from the window wells on the south side of the building.

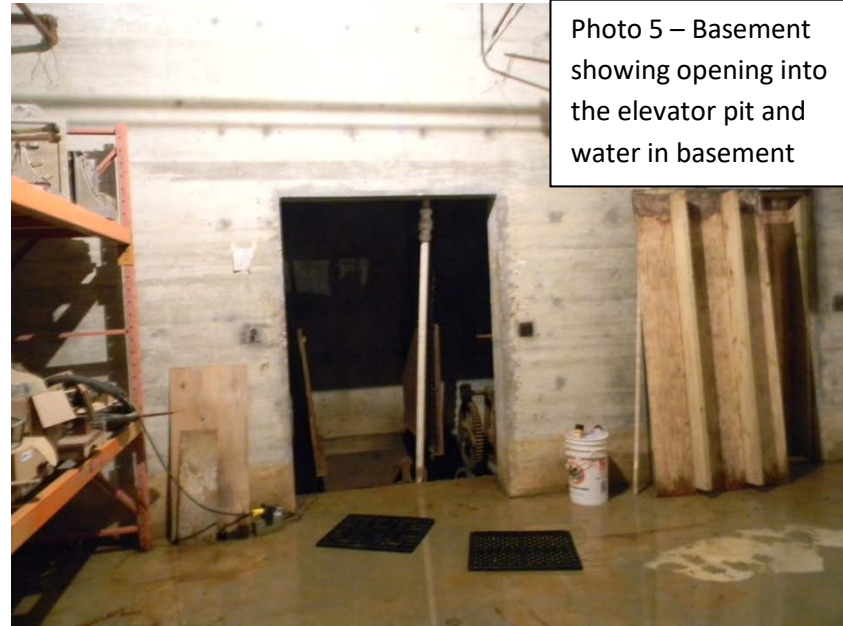
- d. Elevator / Lift Pit: The building has a lift pit on the north side of the building which was used to move equipment in and out of the basement. The pit for the lift is approximately 4-feet below the bottom of the basement floor. This pit had water in it of varying depths from 1-foot to 1½ foot at each visit.

Photo 5 – Basement showing opening into the elevator pit and water in basement

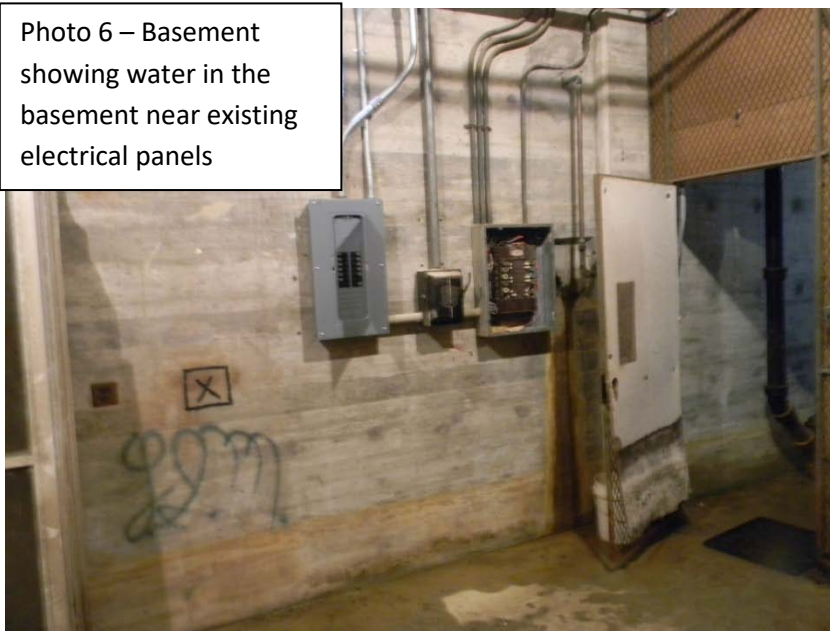
- c. Basement walls and slab on grade: The basement walls and slab on grade appear to be in good condition. The water on the basement floor varied based on the site visit. Typical there were some dry areas in the higher elevation of the slab and lower areas holding water around the edges of the slab. The difference in the depth is expected to be due to the slab not being level when poured and possible uplift of the slab due to pressure from ground water.

Photo 6 – Basement showing water in the basement near existing electrical panels

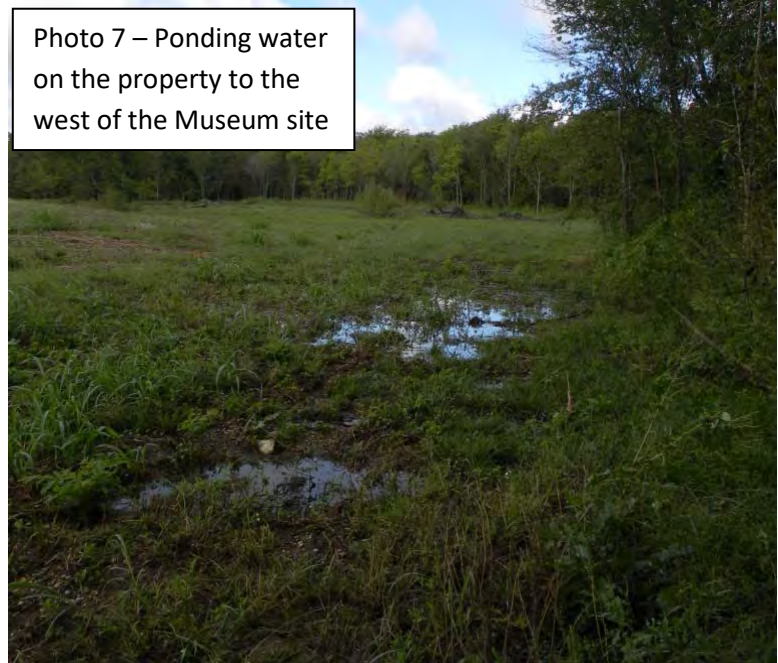
3. The land to the west of the building does not drain well. There is water standing in the field where the drainage from the site occurs. According to Jim Hunter, the museum curator, the adjacent land owner brought in a significant amount of fill which impeded the flow of water from the site. A Google image from November 28th, 2013 shows that the drainage from the southwest corner of the site at that time appears to be relatively continuous sheet flow across the property. Per Jim Hunter, the land owner has brought in fill. Our site observations are that the fill impedes water leaving the site with some standing water near the southwest corner of the property. See Image 2 for the image from Google Earth.

Photo 7 – Ponding water on the property to the west of the Museum site

- b. Get the landowner to the south and west of the museum to cut a ditch across their property to the drainage ditch to the west to reduce standing water and improve the drainage from the area. Image 2 at the end of this report shows the approximate flow direction of water from the site prior to fill being placed from a Google Earth image dated 11/28/13.
- B. On-Site Improvements - Option 1: Attack the problem from the exterior. The theory behind this fix is that waterproofing the walls below the exterior grade, fixing the existing foundation drainage system, installing exterior sumps below the water level of the basement floor, and pumping the water to the back of the property will lower the water table around the building allowing the basement to stay dry.
