CASE STUDY: Rehabilitation of Anacapa Island Lighthouse

by CWO3 Wayne Truax
(formerly with CEU
Oakland)

Anacapa Lighthouse is located on Anacapa Island, 11 miles off the coast of Port Hueneme, California. It was built in 1932 and was the last lighthouse built by the U.S. Lighthouse Service. Until the 1995-1996 Coast Guard rehabilitation, Anacapa Lighthouse had never undergone any major repairs.

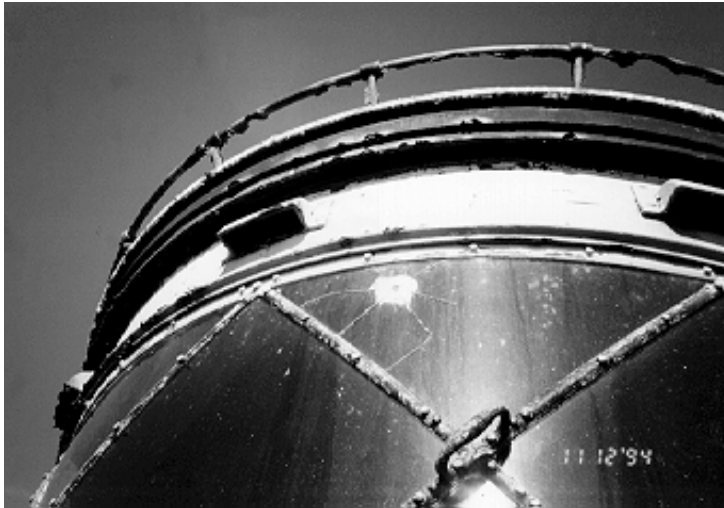
Figure 18. Close-up of the deteriorated conditions of the Anacapa Island Lighthouse before rehabilitation.

Civil Engineering Unit Oakland's Facility Inspection Team originally identified the need for this rehabilitation during an inspection of the lighthouse in 1992. The entire lighthouse was in such poor condition that it was labeled the worst lighthouse on the West Coast (see Figure 18). The inspection team initiated the paperwork that identified both the need for the rehabilitation and funds. Although most large Coast Guard projects normally take five years before being funded, Anacapa was in such poor condition that it was given a high priority; design work started within two years. In late 1994 the architect assigned to the project made his first site visit. The architect determined that the best way to repair the badly deteriorated cast-iron lantern house was to remove it from the concrete tower via heavy-lift helicopter and transport it to the mainland for overhaul. Further investigation, however, disclosed several insurmountable obstacles; he was forced to consider a more conventional but far from easy onsite rehabilitation of the entire lighthouse. The following scope of work was identified and budgeted for \$325,000:

- (a) Replace all broken lantern room glass.
- (b) Replace the missing vent ball with a new fully functional replica cast 304 stainless steel (S/S) vent ball.
- (c) Replace the severely deteriorated ladder rails on the lantern room roof with 304 S/S replicas.
- (d) Restore the solid bronze lantern room door and lock to a fully operational condition.
- (e) Abate all lead and asbestos coatings.
- (f) Restore all vents to an operational condition.
- (g) Repair all decorative concrete details and structural concrete.
- (h) Replace all missing ventilation hoods and covers with historically accurate replacement parts fabricated from 304 S/S.

- (i) Replace the severely deteriorated galvanized iron windows with new galvanized steel windows.
- (j) Install new coatings that require minimal maintenance by Coast Guard personnel.

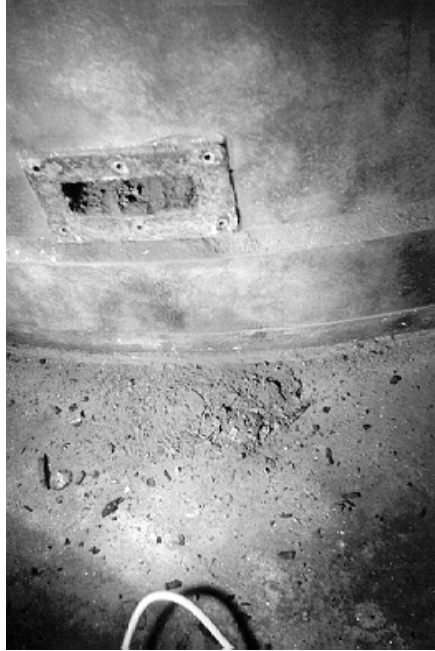
Figure 19 (left). Buildup of rust in parapet wall vents.

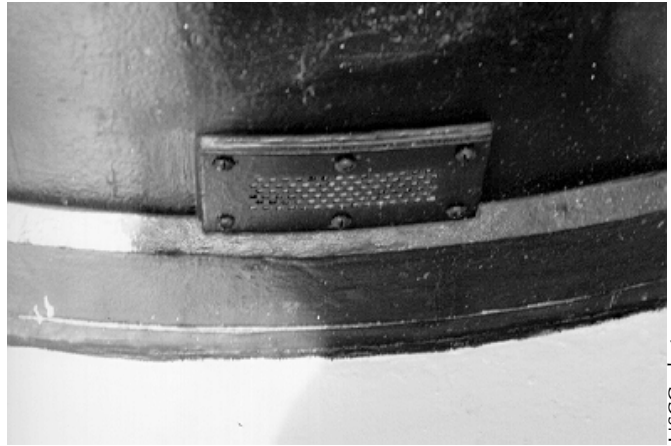
Figure 20 (above). The finished vent installation: 15-lb. roofing felt was placed between the bronze vent grill and the cast-iron parapet wall.

Anacapa Lighthouse did not have damage caused by dissimilar metals; however, a lot of new stainless steel (S/S) replacement parts were introduced and care taken to prevent any future problems. A barrier was applied in all cases where S/S was attached to the cast-iron or bronze areas of the lantern. S/S fasteners were coated with a modern anti-seize compound to prevent galvanic reaction and to take the place of the original white lead. A thick gasket made of roofing felt and coated with a silicone caulk was installed between the new S/S vents, vent hoods, and cast-iron lanternhouse walls (see Figures 19 and 20). The gasket was made from 15 lb. roofing felt which was inexpensive, easy to apply, and did not crush when the vents were bolted in place. Installing the new S/S ladder rail ring stanchions required a two-step process. First a coat of primer was applied and allowed to dry. Then a heavy coat of primer was applied and the stanchions were installed while the primer was still wet creating a watertight seal. This last step was needed because when the original stanchions were removed, a heavy coat of red lead was found sealing the joint.

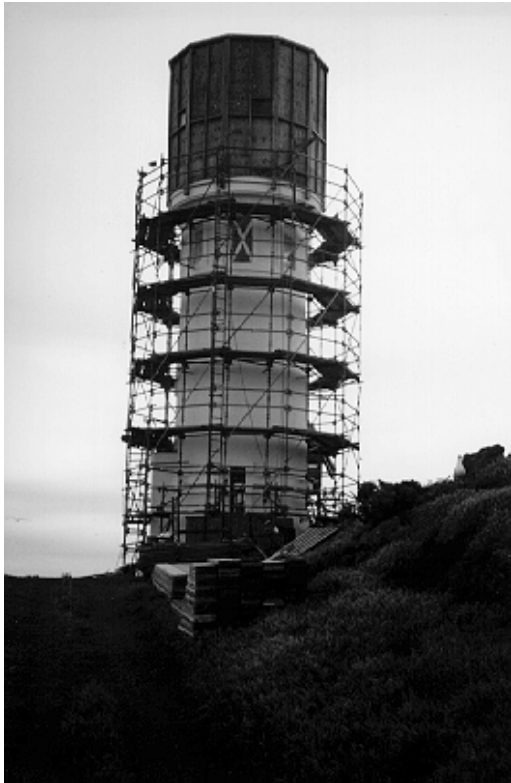
Figure 21. View of the plywood lantern enclosure and scaffolding.

The rehabilitation took place during the winter months, so no repair work could begin until the contractor completed an enclosure around the lighthouse. The enclosure served several purposes: containment of hazardous materials; protection of workers from severe weather; and a dry environment for the repair, prepping, and painting of the lighthouse. The first step in building the enclosure was the erecting of a scaffolding completely around the 30-foot concrete tower. Next was a weathertight plywood enclosure for the cast-iron lantern, complete with pitched roof to shed heavy rain. The final step was sealing the scaffolding in heavy shrink wrap to provide weather protection and containment of any hazardous materials (see Figures 21 and 22). The entire enclosure phase of the project took two weeks because of difficulties in handling the plywood and applying the shrink wrap in high winds. After the enclosure was complete, all deteriorated metal pieces that were scheduled to be replaced and did not require abrasive blasting were removed.

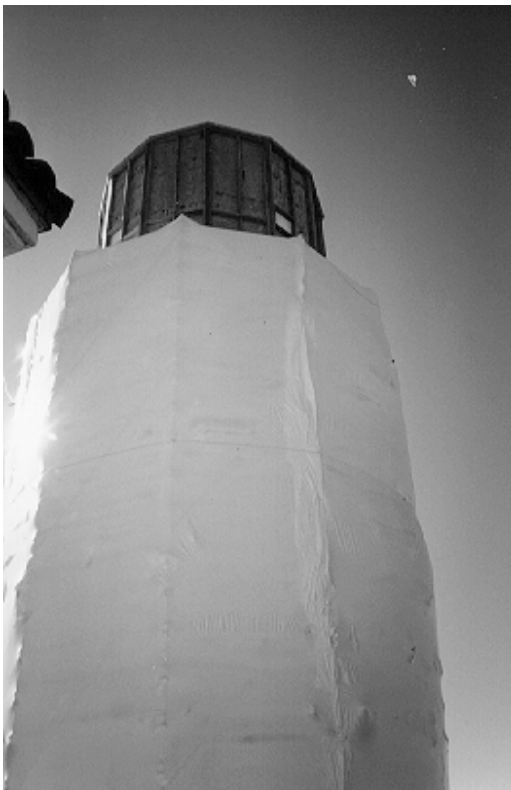
Figure 22. View of the lighthouse scaffolding covered with shrink wrap to contain all hazardous materials and protect workers from severe weather.

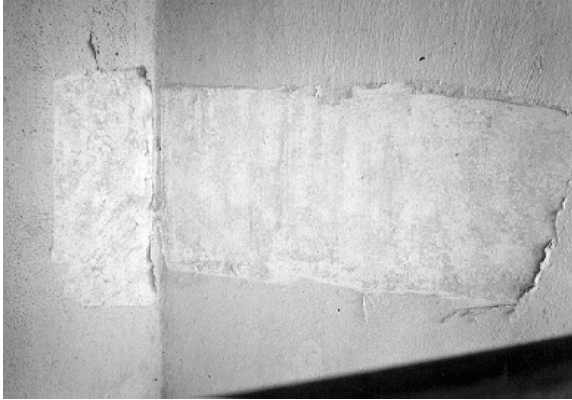
Figure 23. The water-based paint stripper was very effective in removing the many layers of paint from the exterior of the tower.

windows. The stripper was water-based and applied by brush and airless sprayer. After soaking for at least 1 1/2 hours, it was scraped off (see Figure 23). The stripped area was then neutralized with water and finished with power sanding where necessary. The interior lead-painted walls which were originally only to be lightly scraped and painted were causing problems. The paint was so old and brittle it continually flaked off. The abatement contractor asked for a change order to completely remove the paint because the current finished product was proving to be unacceptable. Chemical stripping of the interior walls had been selected over light blasting to save on the costs of transporting more blasting media to the island. Air-driven needle gun scalers using low pressure air, however, proved to be a more cost-effective method. The paint was so brittle, it shattered when struck by the needles, leaving the concrete virtually paint free (see Figure 24). There was no damage to the concrete and only lead-paint chips were left to be swept up and disposed of. This method could not be used on the exterior concrete because of the 3/8-inch white mortar skim coat that had been applied as a finish coat when the light was built in 1932.

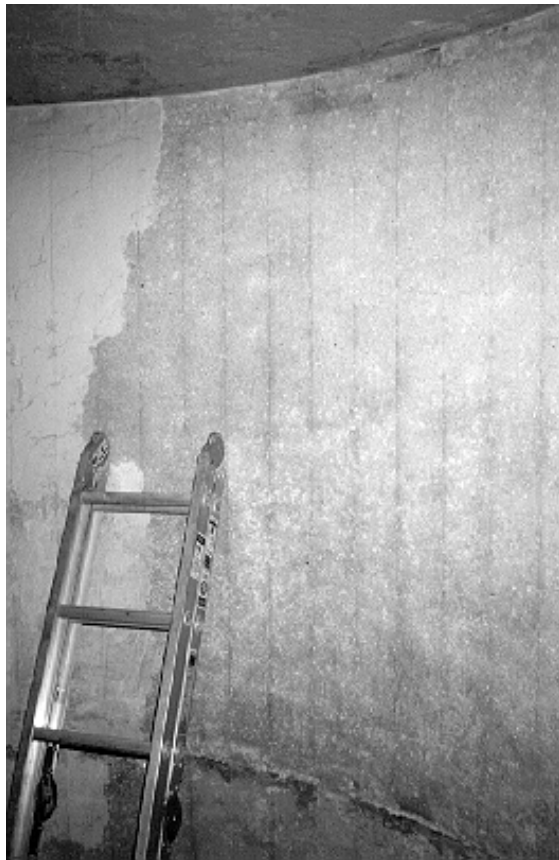
Figure 24. The interior paint was effectively removed using needle gun scalers, without damaging the concrete as evidenced by the visible impressions of the formwork boards.

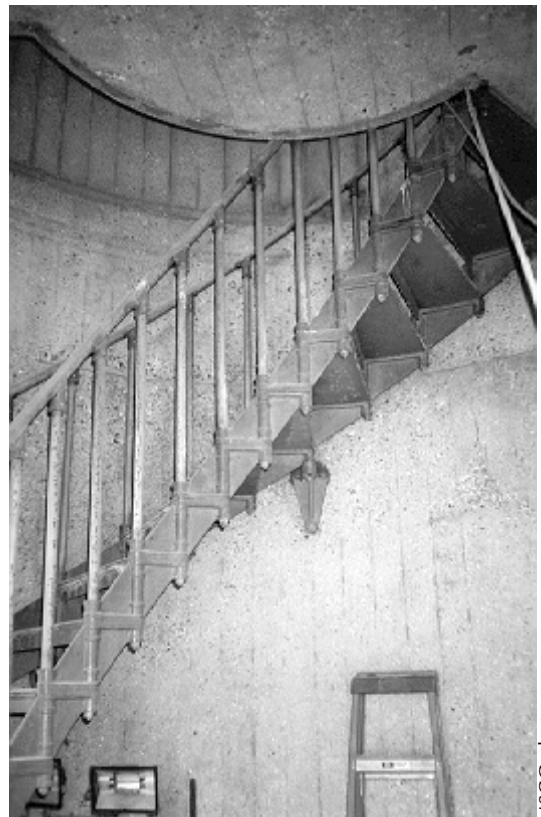
After the interior walls were complete, the cast-iron spiral staircase was the last item to be abated. The blaster started at the top floor of the lantern and backed his way to the front doors. This process took three days and prevented any other interior work from taking place because of the dust. After the blasting was complete, the entire structure was swept and vacuumed before being rinsed down to remove the remaining dust. The water did cause flash rusting on the newly blasted cast-iron staircase but that was

expected and did not pose a problem (see Figure 25). All surfaces were then wire brushed, prepped, and primed by a three-man team who only prepped what they could prime within an hour. Although the primer used was designed for use over flash-rust, we did not want to chance a coating failure.

Figure 25. After the cast-iron stairs were blast-cleaned, they were rinsed to remove all traces of lead dust; flash rust immediately formed (as seen in this photo). Before painting, this light rust was removed with wire brushes.

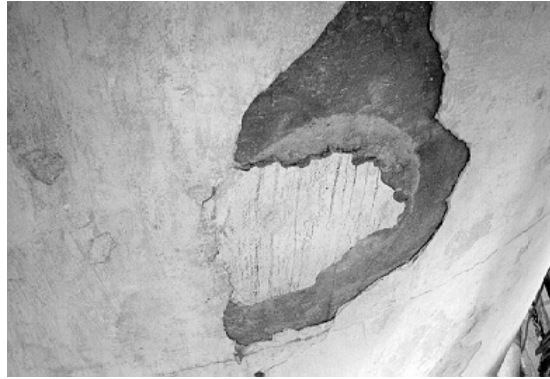
The 3/8-inch white mortar finish coat that had been applied over the exterior concrete when the light was built in 1932 was not identified in any of the original drawings. As a result, no one looked during the work site visit for signs of delamination. After the scaffolding was in place, however, several areas were found to be loose between the 10- and 30-foot elevations. The foreman became concerned that other unidentified delaminated areas would fall out after the job was complete and ruin his work. The foreman inspected the entire tower and found an additional 100 square feet of delaminated mortar. After receiving approval to repair any bad mortar, he personally chipped away all the loose mortar and applied a two-part masonry patch material. The repair work was of such high quality that the patches were unnoticeable when the tower was repainted (see Figures 26 and 27).

Figure 26. Once the scaffolding was erected, areas of the delaminated white mortar finish coat were removed.

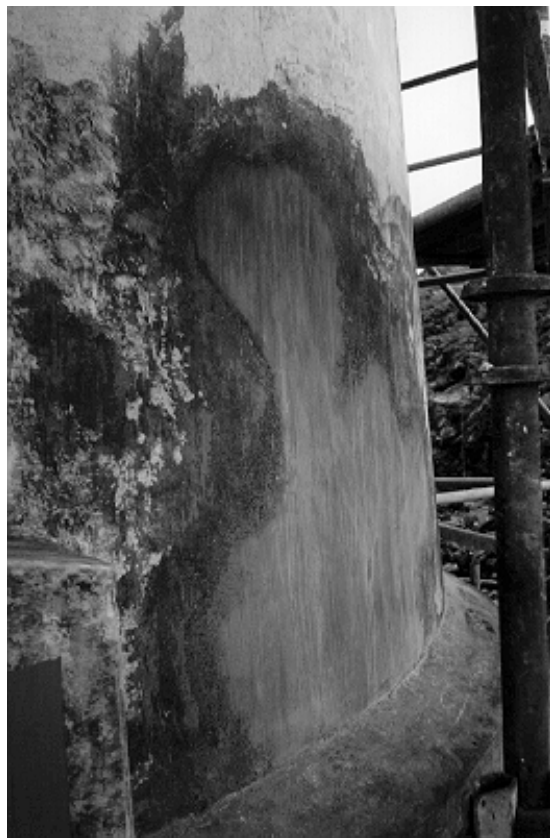
Figure 27. The areas where the loose mortar finish coat was removed were repaired with a two-part mortar patch. The final texture on the patch was tooled to match the historic wall surface. The patch was completely invisible after the tower was painted.

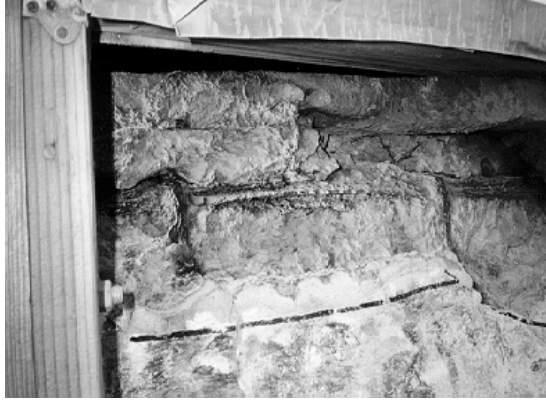
One major area of concern was the concrete gallery deck located outside the lantern. This deck had considerable damage in two areas without any evidence of the cause. The outer rebar showed signs of corrosion but the damage went 18 to 24 inches deeper into the concrete. Since freezing was not an issue, the cause of the damage was at first unknown. Closer examination revealed signs of an explosion inside the concrete, and we noticed bolt patterns for two old antenna mounts directly above the area. We determined lightning to be the cause. There was no practical way to dig out the

Figure 28. Close-up of the damaged concrete gallery deck after the loose concrete has been removed and before the damaged concrete was repaired using pressure-injected epoxy grout.

broken concrete; the project was already over budget. We decided to do a pressurized epoxy injection and fill all the voids. The area was prepped and pumped full. The outer three inches were left unfilled so the two-part mortar patching compound could be used to restore the damaged area (see Figures 29 and 30).

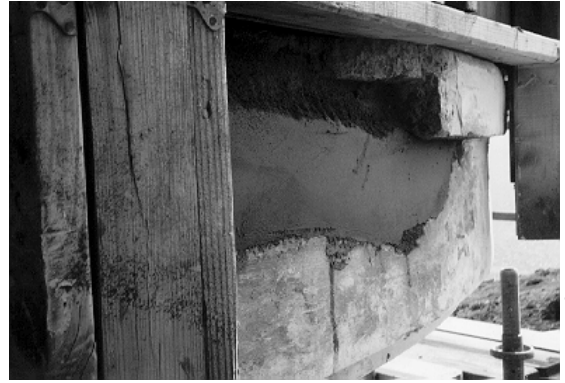
Figure 29. The first application of the mortar patch material to the damaged concrete.

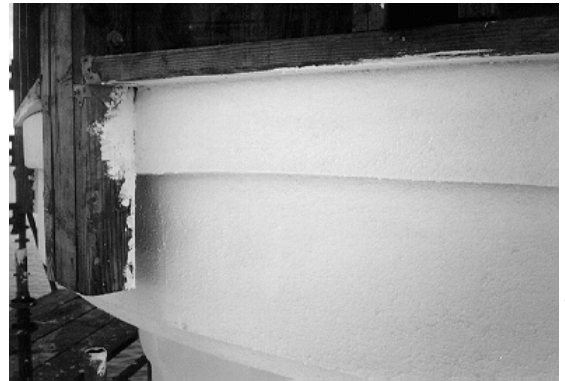
Figure 30. The finished concrete repair is virtually invisible after the surface has been painted.

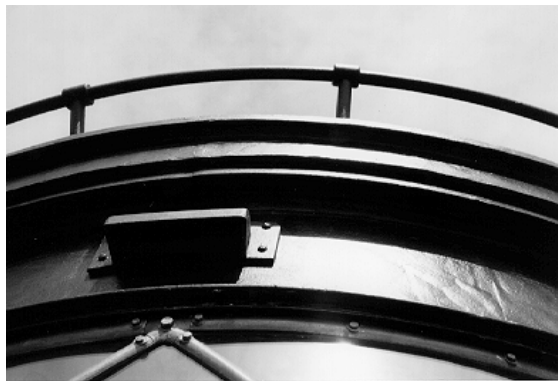
Figure 31. Close-up of the finished metal work on the lantern.

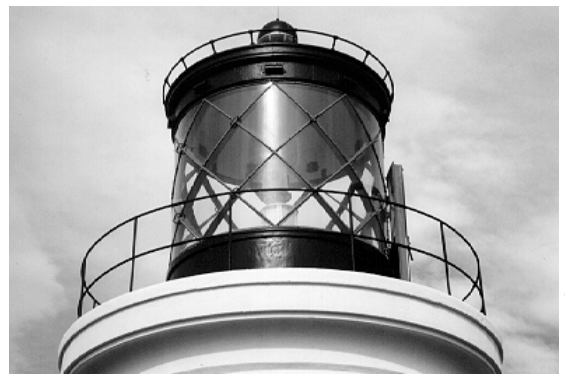
Figure 32. View of the finished lantern
