## **CASE STUDY: Rehabilitation of Point Bonita Light Station**

## **CASE STUDY: Rehabilitation of Point Conception Light Station**

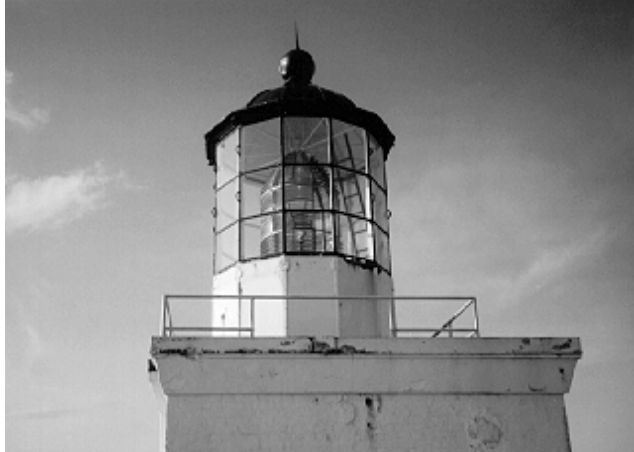
**Figure 33.** Point Bonita Lighthouse before rehabilitation; note missing gallery deck and holes below between the bottom of the lantern glass and top of the service room wall.

The poor condition of Point Bonita was first noted by the Officer in Charge of the San Francisco Aids to Navigation Team (ANT). His request prompted a site visit to Point Bonita in January 1993 to conduct a facility assessment and provide advice on how to repair the structure (see Figure 33). The original plan was to stop the water from entering the lighthouse and let Civil Engineering Unit (CEU) Oakland do the overall renovation in a couple years. But further investigation indicated the need for more immediate repairs, using self help-funding and the ANT personnel. The project soon grew into a full renovation that took six months and \$75,000 to complete.

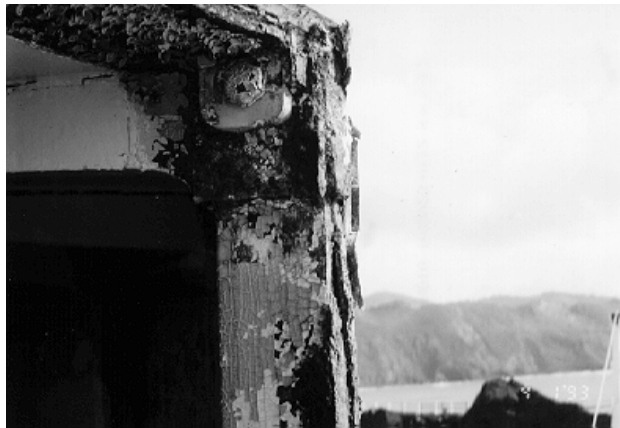
**Figure 34.** Close-up showing what remained after the gallery deck brackets were cut off with a torch. Note the heavy rust and paint failure caused by exposure.

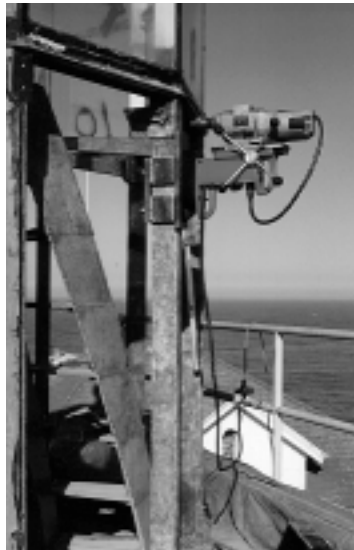
**Figure 35.** Jig used to bore holes in the gallery bracket tenons.

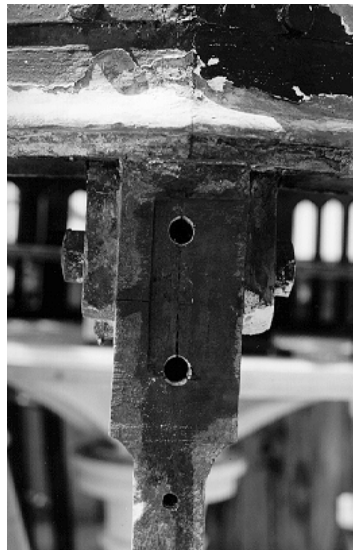
**Figure 36.** View of the gallery bracket tenons after the holes have been drilled. The tenon on the right connected to the exterior gallery; the tenon on the left is part of the interior gallery deck bracket. The 'v' that has been stamped in the end of the left tenon is an assembly identification mark.

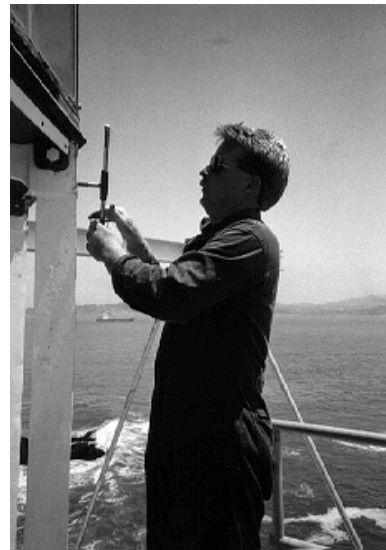
**Figure 37.** After drilling, threads were cut into each hole using a hand-operated tap.

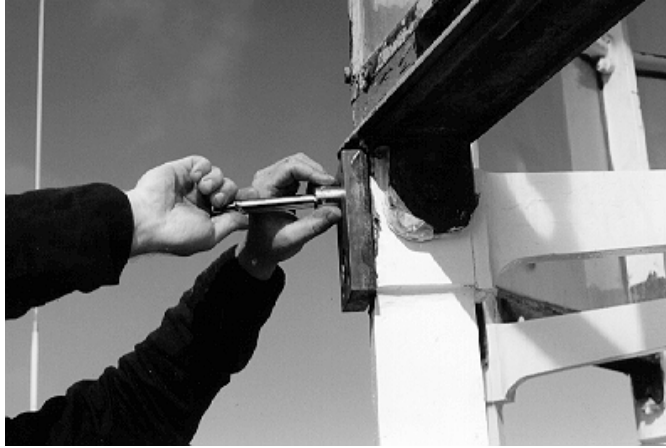
**Figure 38.** To provide a plumb mounting surface for the gallery deck, each mounting surface was covered with Belzona (a two-part metal paste); then the mounting plates were installed and tightened until they were plumb. The excess Belzona can be seen oozing near the middle of the plate.

Investigative demolition followed. The original gallery deck had been removed in the 1960s, but no details were available on how it was performed. First removed was the fiberglass cloth that sealed the watchroom panels to the lantern room and covered the areas of the original gallery deck brackets. Fortunately, the old brackets had been cut off above the wide base flange with a torch, leaving the tenons from the original brackets intact inside the cast-iron lantern frame (see Figures 34 and 36). Removal of the remaining tenons from the frame and fabrication of new gallery deck brackets duplicating the originals proved impractical because the tenons were rusted tight and pinned in place. The tenon was therefore used as an anchor. The old base flange flush with the frame was cut using a portable metal-cutting bandsaw and the area ground flush. A special jig was designed for the magnetic drill press; two holes were then drilled and tapped directly between each set of tenons (see Figures 35, 36, and 37). A one-inch-thick mild steel mounting plate consisting of two recessed bolt holes and four tapped holes was then put in place. (304 S/S might have been an even better choice; the mild steel is holding up well, but may become a maintenance problem if the lighthouse isn't properly maintained.) The two recessed holes allowed the plate to be bolted to the lantern frame and the new bracket bolted directly over the two base bolts. The area beneath the plate was covered with a 1/8-inch layer of Belzona Metal filler to ensure there would be no voids and to act as a leveling compound (see Figure 38). The bolts as well as the plate were covered with a releasing compound (Vaseline)

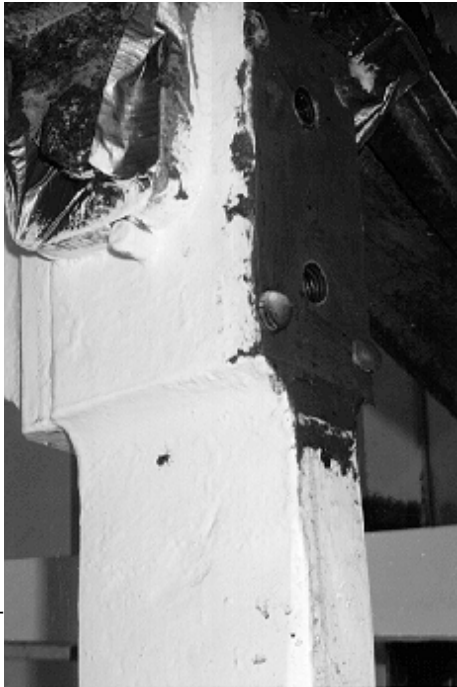
**Figure 39 (left).** View of the mounting surface after the Belzona had cured and the mounting plate had been removed. The 'knobs' or protrusions on the surface are where the Belzona was squeezed through the holes in the mounting plate. These were ground off along with the excess Belzona that squeezed out around the plate.

and then slowly tightened until the plate was plumb. The Belzona was then allowed to dry before all excess Belzona was ground off (see Figure 39). This procedure worked very well and took no more than three days to accomplish. The base plates were then primed, painted, and caulked before being torqued in place.

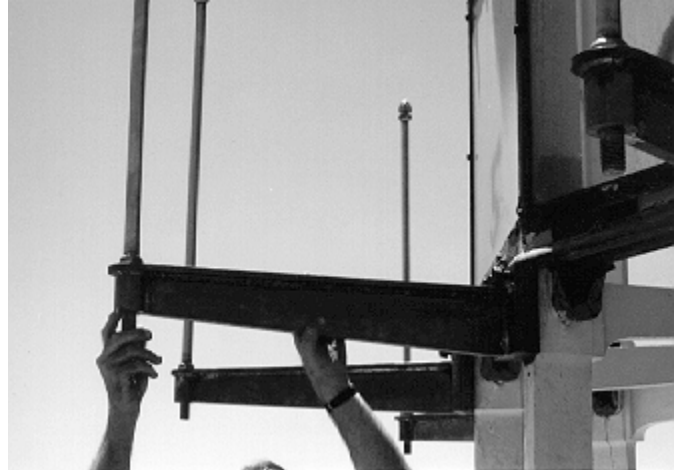
**Figure 40 (above).** The new gallery deck brackets after installation.

fabricated to match the original cast-iron brackets details. (This is another area where 304 S/S might have been better.) The stanchions were made of 1-inch 304 S/S round stock and 1-inch 316 S/S bolts. The bolts had a 1-inch diameter and 1/4-inch-deep recess machined in the head to ensure the bolts were properly aligned during welding. Custom 1-inch 316 S/S acorn nuts were then purchased to secure the stanchion to the brackets and the handrails. With the brackets and stanchions in place, the 3/8-inch flat bar handrails were then drilled, scribed, and fitted (see Figure 40).

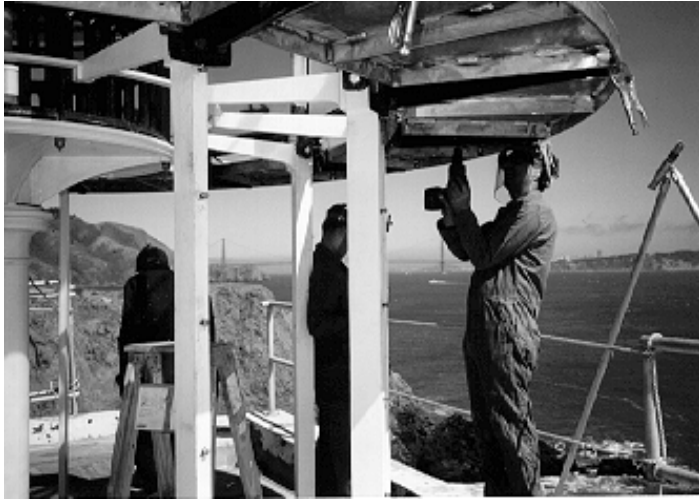
**Figure 41.** Final fitting and installation of the new aluminum deck plate.

The hard part was laying out the new gallery deck. One 3-foot section of 1/4-inch-thick hard board was laid out at a time. Each section was different and had to be custom fitted. The completed templates were then taken to the Coast Guard Industrial Metal Fabrication Shop and used to lay out the new 3/8-inch 6061 aluminum diamond-plate gallery deck. Once completed, the new gallery deck sections were brought back to the lighthouse for final drilling, fitting, and painting. (The aluminum is working well here,

with no signs of dissimilar metals reacting. S/S diamond plate, might however, avoid any future problems (see Figure 41).)

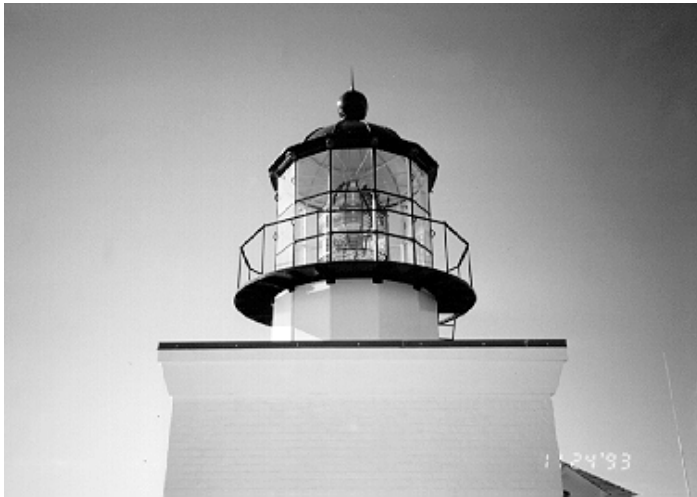
**Figure 42.** View of the Point Bonita Lighthouse after the gallery deck replacement.

on lighthouses understands dissimilar metals or even how to ensure that materials are properly reinstalled (see Figure 42).

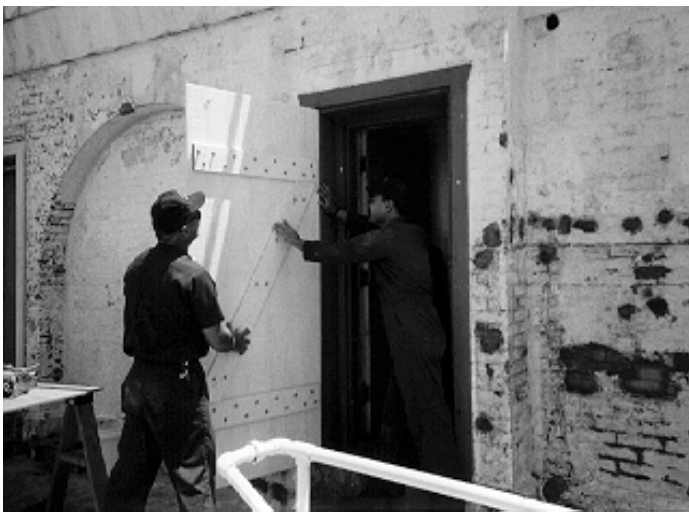
**Figure 43.** Installation of the new exterior wood storm door.

The exterior storm doors were also easy to duplicate. The pictures were clear and showed one door open and one closed. Both exterior doors were made of 1- by 6-inch tongue-and-groove redwood and fastened together using S/S carriage bolts, nuts, and washers. After the doors were test fitted, they were disassembled, primed, painted, and reassembled. These doors have held up extremely well and have given no trouble (see Figure 43).

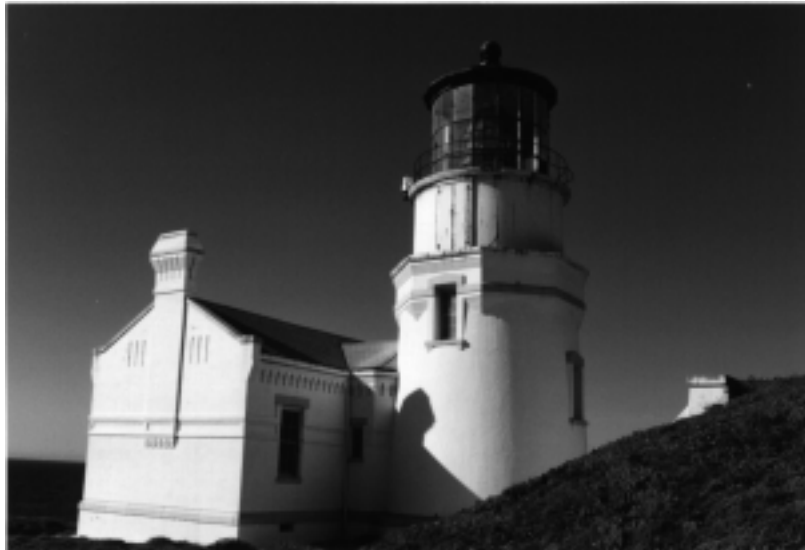
**Figure 44.** *Before the rehabilitation.* Note the doors at the watch room. A new louvered panel will be installed for added ventilation.

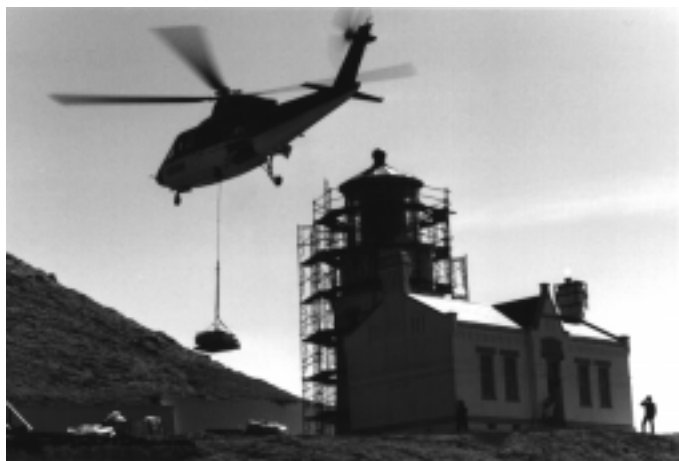
**Figure 45.** *Staging the work.* Note the temporary location of the auxiliary light on the fog signal building chimney.

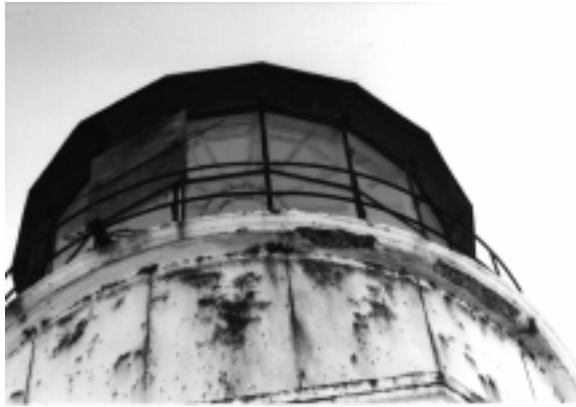
**Figure 46.** *Lighthouse lantern before rehabilitation.* Note the missing ladder rails and the severe rust on the lantern cornice and lower watch room panels. The badly spalled concrete gallery deck was installed in 1947 and is not original.

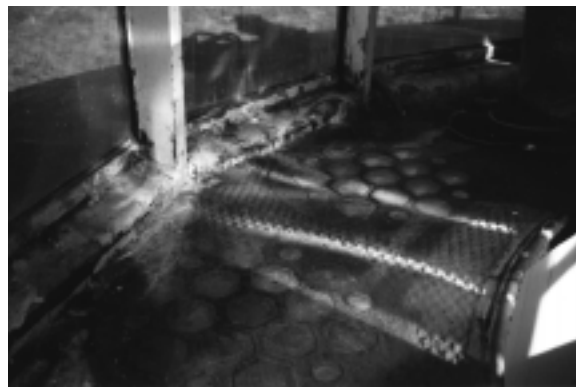
**Figure 47.** *Lantern room before rehabilitation.* Note the lower sill channels filled with concrete. This shortsighted ‘repair’ method blocked the ventilators and caused condensation to spill out on the deck, effecting rust and further damages below.

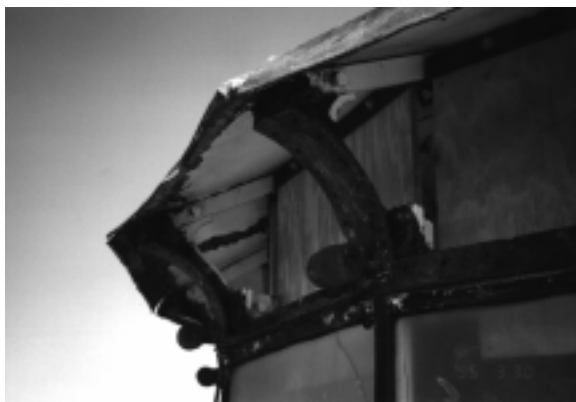
**Figure 48.** *Reconstructing the cornice.* The cornice plates were removed to expose the corroded cast-iron brackets and top channels. New brackets were cast in bronze, and the top sill channels were fabricated in stainless steel. Note the plywood ‘curtain’ erected for weather protection and shoring the lantern roof during reconstruction.

heavy rain washed out portions of the road, which cut off access for over a week. A special plywood ‘curtain’ was erected in the lantern room with clamps to protect the classical lens from the weather and shore up the lantern structure during reconstruction.

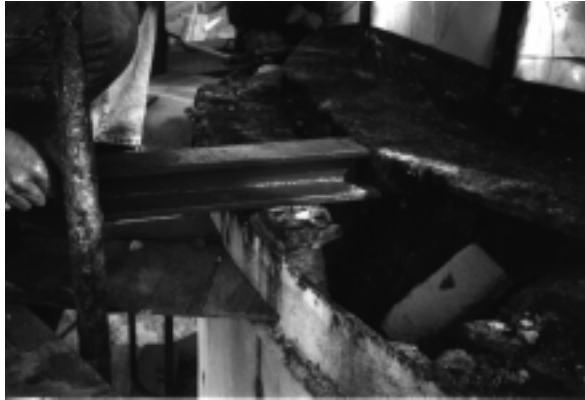
**Figure 49.** *Reconstructing the gallery deck.* After removing the existing concrete, remnants of the original cast-iron deck were found.

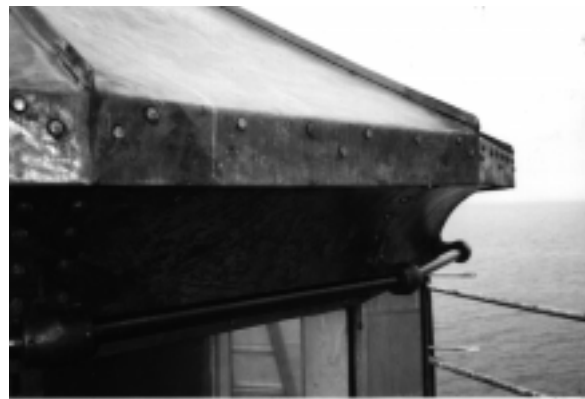
**Figure 50.** *Lantern cornice after rehabilitation.* Replacing the original steel cornice plates with copper eliminated the dissimilar metals problem.

Although surface rusting was the main problem at the lantern, some of the deterioration was caused by galvanic reaction between dissimilar metals. Dissimilar metal problems were eliminated by replacing the original deteriorated cast-iron cornice plates and brackets with copper and bronze. The original copper roof dome was then stripped of its paint and allowed to naturally patina. Besides low maintenance, the other advantages of copper are its flexibility to withstand strong winds, building movement, and wide temperature changes. In other areas, neoprene gaskets, felt or teflon tape, thick epoxy primers, and bituminous paints were used between dissimilar metals to prevent future corrosion.

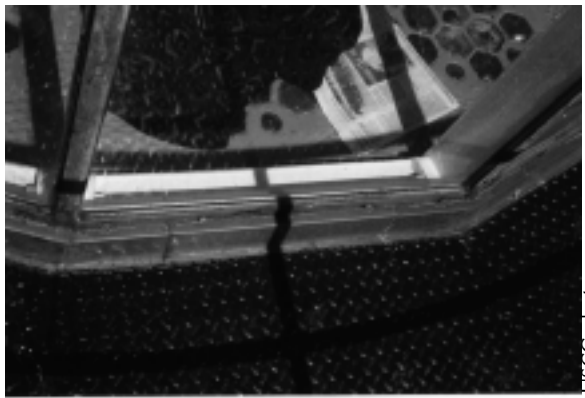
**Figure 51.** *Lantern galley deck after rehabilitation.* The new gallery deck was fabricated with stainless steel diamond plate and carefully flashed with copper at the lantern room. The interior lower sill channels were rebuilt to catch condensation from the glass.

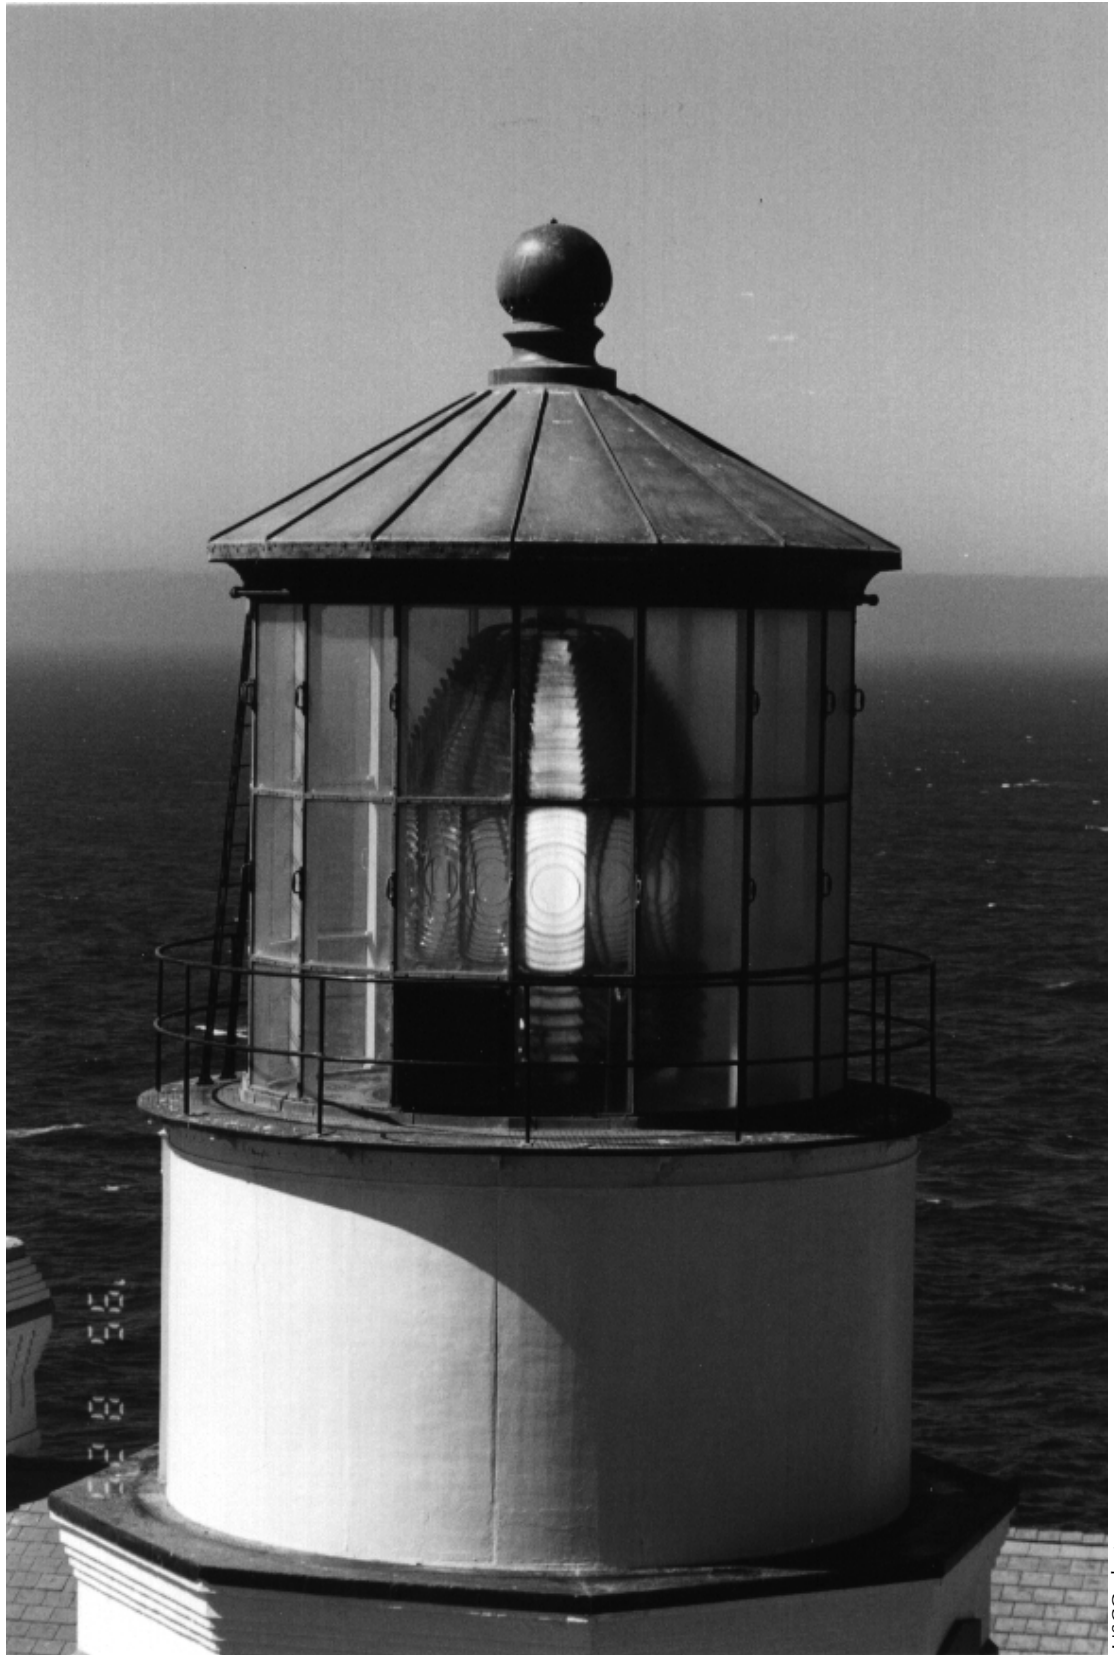
**Figure 52.** *Light tower lantern after rehabilitation.* The nonferrous metalwork at the lantern room is left unpainted and allowed to naturally patina, thus saving maintenance costs.
