# Spruce Tree House Alcove

National Park Service  
U.S. Department of the Interior  
Mesa Verde National Park

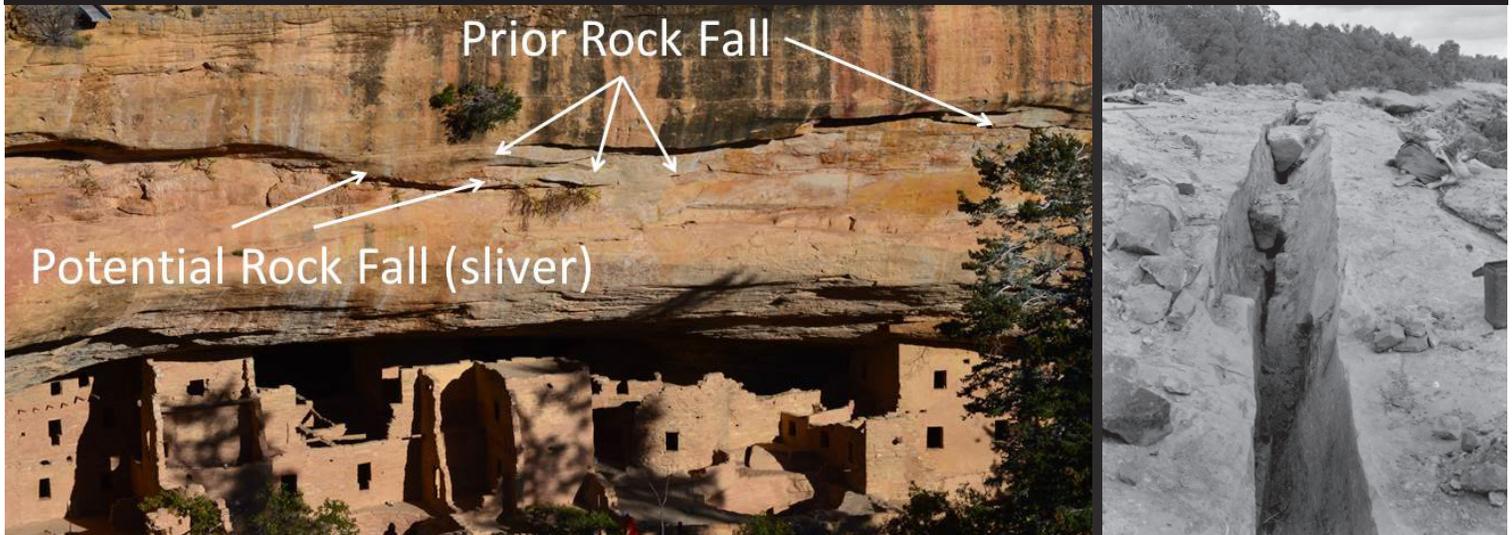
Left: Areas of previous and potential rockfalls. Right: 1940 photo of widest section of crack above Spruce Tree House.

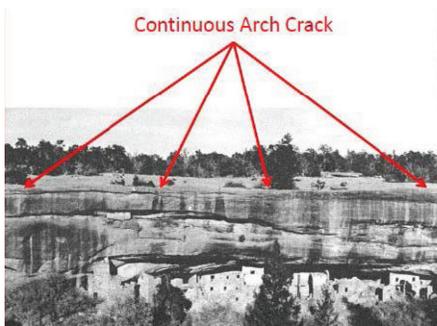
The arch crack spans Spruce Tree House.

The primary concern is a large, naturally forming arch located within one of several cracks that exist in the cliff above Spruce Tree House, nearly parallel to the outer edge (above right). In 1940, an attempt was made to slow the erosional processes by cleaning the crack of plants and rock debris which were acting like wedges, exerting force and widening the crack. Following cleaning, a protective covering was constructed over the crevice in an attempt to make it water proof. In 1960, a large, 10-ton rock fell from a ledge under the lip of the cliff overhanging the south end of Spruce Tree House, impacting the public trail as well as a small portion of the site. This resulted in the 1961-2 anchoring of the natural rock arches. The earlier covering was removed, the arches were pinned to the cliff face, and the crack was filled with aggregate and cement grout. Forty two rock anchor bolts, some 16 feet long, were drilled horizontally into the cliff face to secure the arches.

Before any new stabilization can be done, a thorough geotechnical assessment will need to be conducted. This will include taking a more sophisticated look at the arch-forming mechanism using Light Detection and Ranging (LiDAR, a remote sensing method using laser imaging), and then performing a 3-D computer analyses of the data to compare the sandstone's condition before and after the 1960 stabilization work. Specialists will use the data to plan for additional work, if needed, using more modern engineering techniques to ensure the continued stability of the arch.

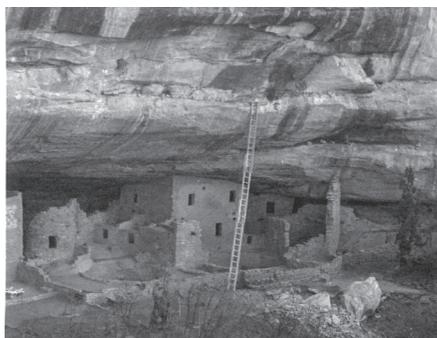
1960 rock fall. Note large debris field on lower right. One 10-ton rock fell, and a second, loose 5-ton slab was pulled down.

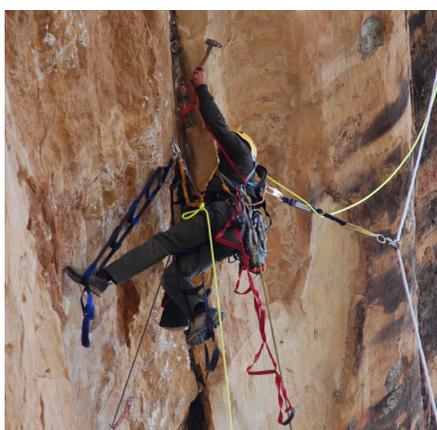
Scaling operation in the fall of 2015. Note the rock anchor (bolt) in the rock along the right side of photo, just above climber.

In the fall of 2015, the arches, specifically the large one in the south end of the site, were again the focus of concern. A number of smaller rock falls, some which fell on public trails, occurred within the alcove in the area of the large arch. The site was closed in order to conduct an assessment and remove loose rock material from the cliff face and ledges. The scaling operation brought down about 60 cubic feet (cf) of material from the alcove edge. Some of the rock removed had a harder, desiccated outer surface with a substantially softer interior, revealing that sections of the sandstone are weakening due to water leaching the calcium carbonate matrix that binds the sand particles within the sandstone.

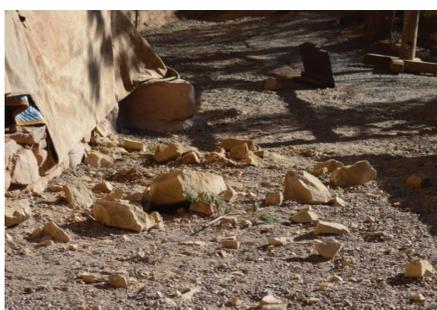
About 60 cubic feet (cf) of loose material fell along the public trail from the alcove edge above during the scaling operation.
