MASONRY

NUMBER 3

Water Soak Cleaning of Limestone

THE WIDENER BUILDING **Philadelphia, Pennsylvania**

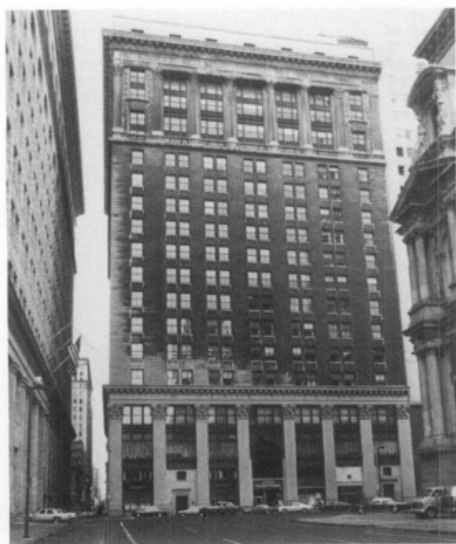
Figure 1. In 1989, just prior to the onset of the rehabilitation project, the Widener Building was showing the effects of 75 years of exposure to an urban environment. Note the lighter color of the left side of the building regularly washed by rain. Photo: John Milner Associates.

to seventy-five years of exposure to an urban/industrial environment and had never been cleaned, the masonry surfaces were heavily coated with typical deposits of air-borne particulates of soot, fly ash, tar and clay matter as well as localized areas of organic matter. These deposits in conjunction with sulfur oxides accelerate the decay process of the calcareous stones such as limestone by forming non-stable, highly soluble and chemically-reactive crusts that increase the stone's surface area and ultimately leave the stone more vulnerable to damage from continuing deposition attack.

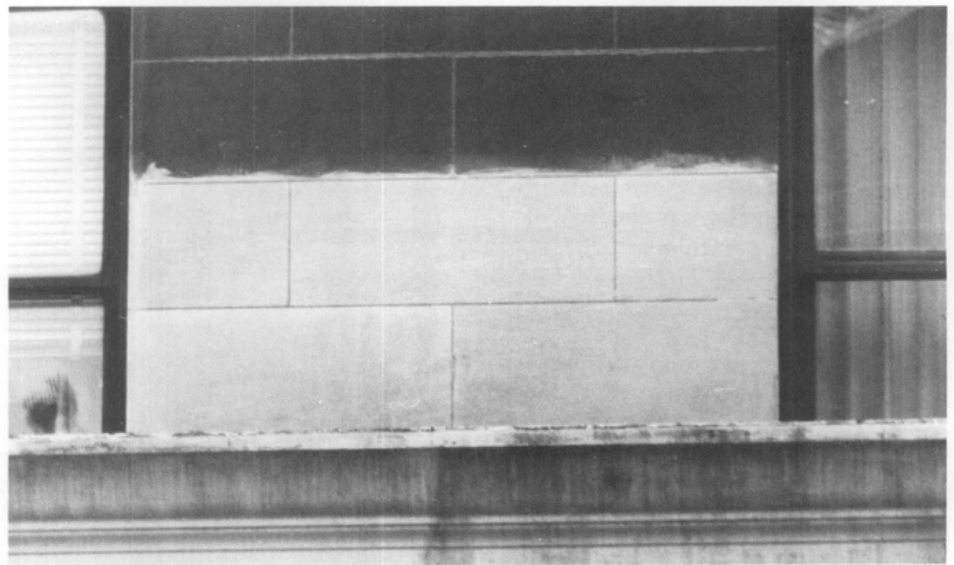
Figure 2. The three test panels were carried out on the right side of the 4th floor of the South Penn Square elevation directly above the cornice that tops the 3-story storefront columns. (a) The completed panel on which the water soak method was tested; (b) the second completed panel after testing with the two-part alkaline chemical cleaner; and (c) the third completed panel after testing with the one-part alkaline chemical cleaner. Photos: John Milner Associates.

For this test, the limestone was soaked for 4 hours with low-pressure water from an oscillating sprinkler in order to dissolve and loosen the pollutant crust. After the 4-hour soak, the loosened crust and remaining particulate matter were rinsed off the stone surface by a pressure washer with a 45 degree fan tip nozzle at 400 pounds per square inch (psi) using approximately 5 gallons of water per minute (gpm) (*see figure 2a*).

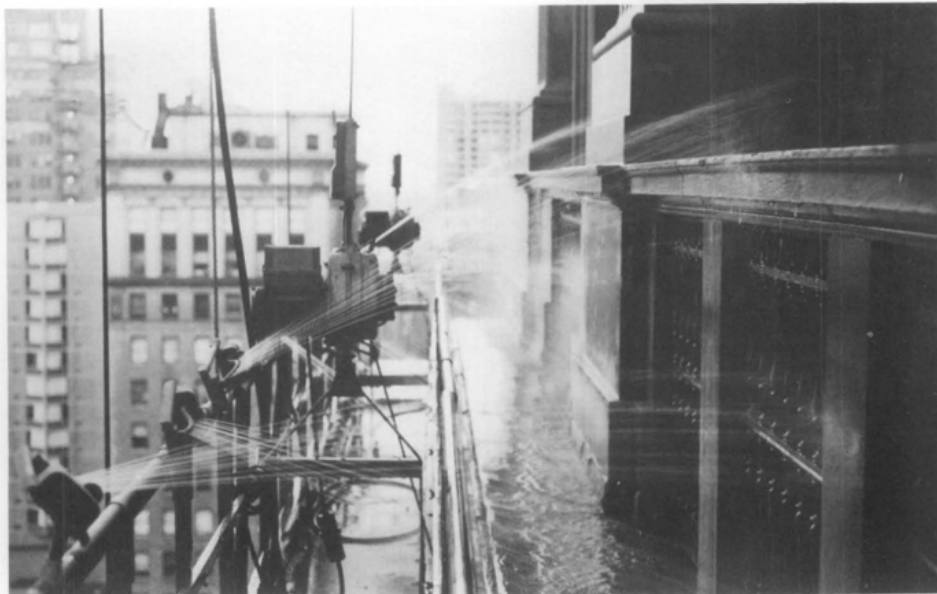
Figure 3. Close-up view of the oscillating sprinklers spaced 3 feet apart and connected to 1/4" PVC piping attached to the rear bar of each scaffold. Photo: P & R Masonry Restoration, Inc.

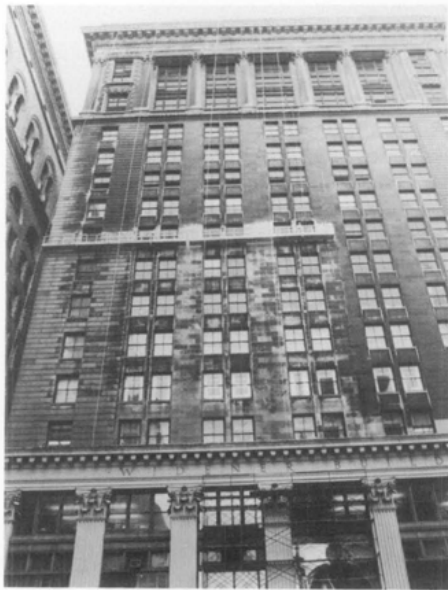
Figure 4. South Penn Square elevation after the completion of two drops from the 9th-4th floors of water soaking only, and prior to beginning the rinse process. Photo: P & R Masonry Restoration, Inc.

soaking had been completed on both drops (a "drop" is the amount of vertical wall surface that can be covered by one scaffold moving vertically up or down a building), the crew began the rinsing process this time moving down the elevation, starting from the 9th floor and proceeding to the 4th (*see figure 4*).

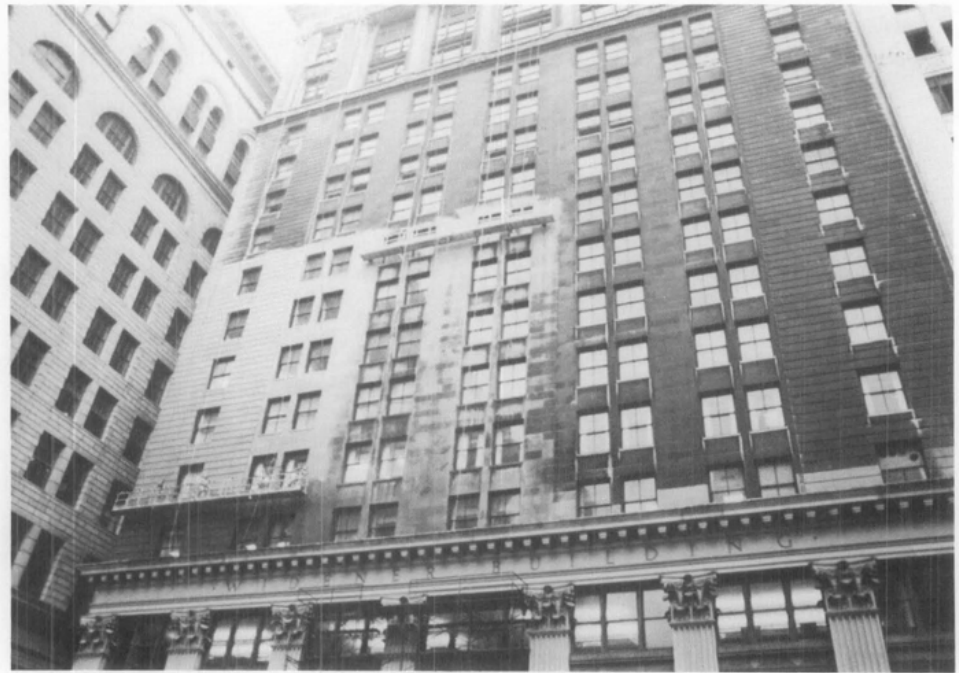
Figure 5. The drop on the left side of the building has been water-soaked and rinsed, while the drop on the right has been soaked only. Note the amount of soil that still remains on the right side before rinsing. Photo: P & R Masonry Restoration, Inc.

For the rinsing process, two pressure washers were placed atop the building with pressure hoses extending to the scaffolds. Each machine generated a pressure of 400 psi and 5 gpm. Throughout the cleaning, one worker per scaffold used a short-handled spray wand with a 30 degree nozzle to rinse away loose material and clean out the pores of the stone. The nozzle was kept a minimum of two feet away from the masonry surface at all times (*see figure 5*).

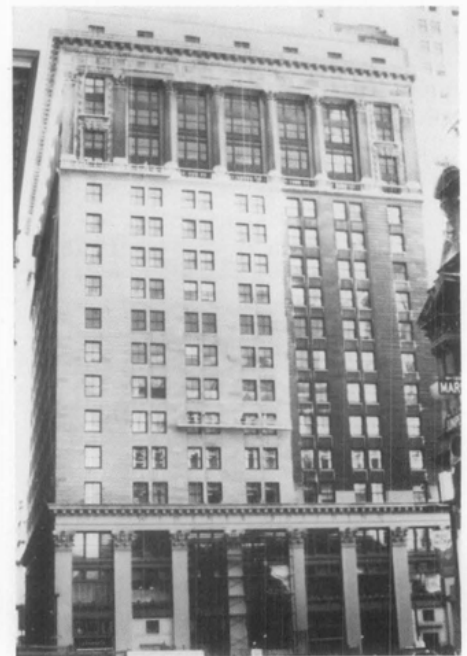
Figure 6. The contrast between the cleaned and the uncleaned portions of the facade after completion of both the water soak and the washdown rinse of these two drops from the 14th-4th floors is dramatic. Photo: Robert M. Powers.

After cleaning (soaking and rinsing) the 4th through the 9th floors, both scaffolds were moved up to the 10th floor where the soaking process was begun again and was continued up through the 13th floor (*see figure 6*). This section was then rinsed, and the soaking process recommenced at the 14th floor and proceeded to the cornice at the top of the building.

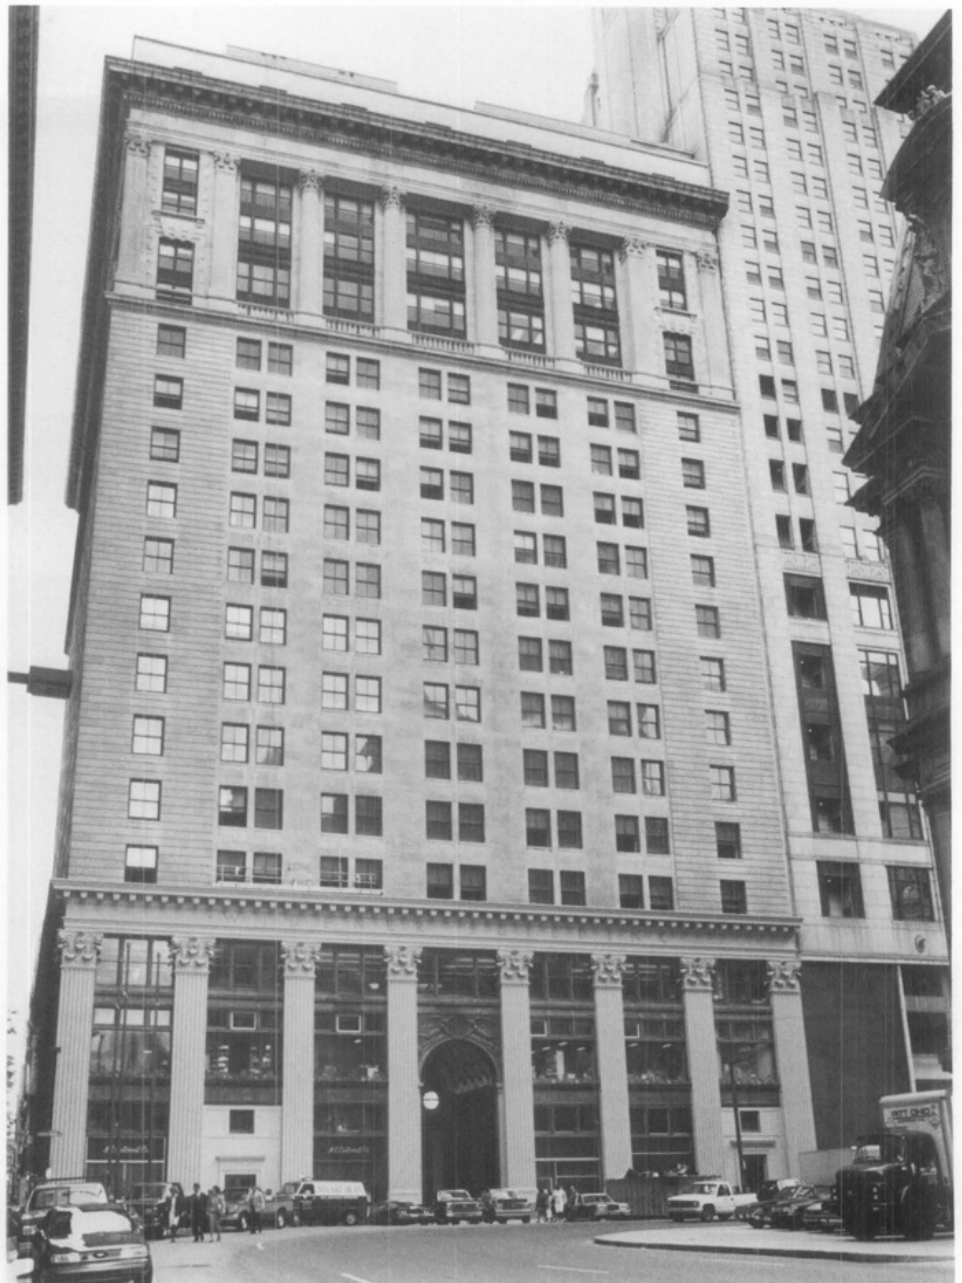
Water soaking is a cost-effective cleaning process for both large and small limestone buildings. The results of the cleaning of the Widener Building are startling, especially when compared to the appearance of the stone prior to the start of the project (*see figure 7*). Although the cleaning team was on the job site for a longer

Figure 7. The South Penn Square elevation after its successful cleaning using the water soak method. Photo: Faherty/Kelter Associates, Inc.
