## DELAWARE BUILDING

# Tech Notes

### NUMBER 11

### Installing Insulating Glass In Existing Wooden Sash Incorporating the Historic Glass

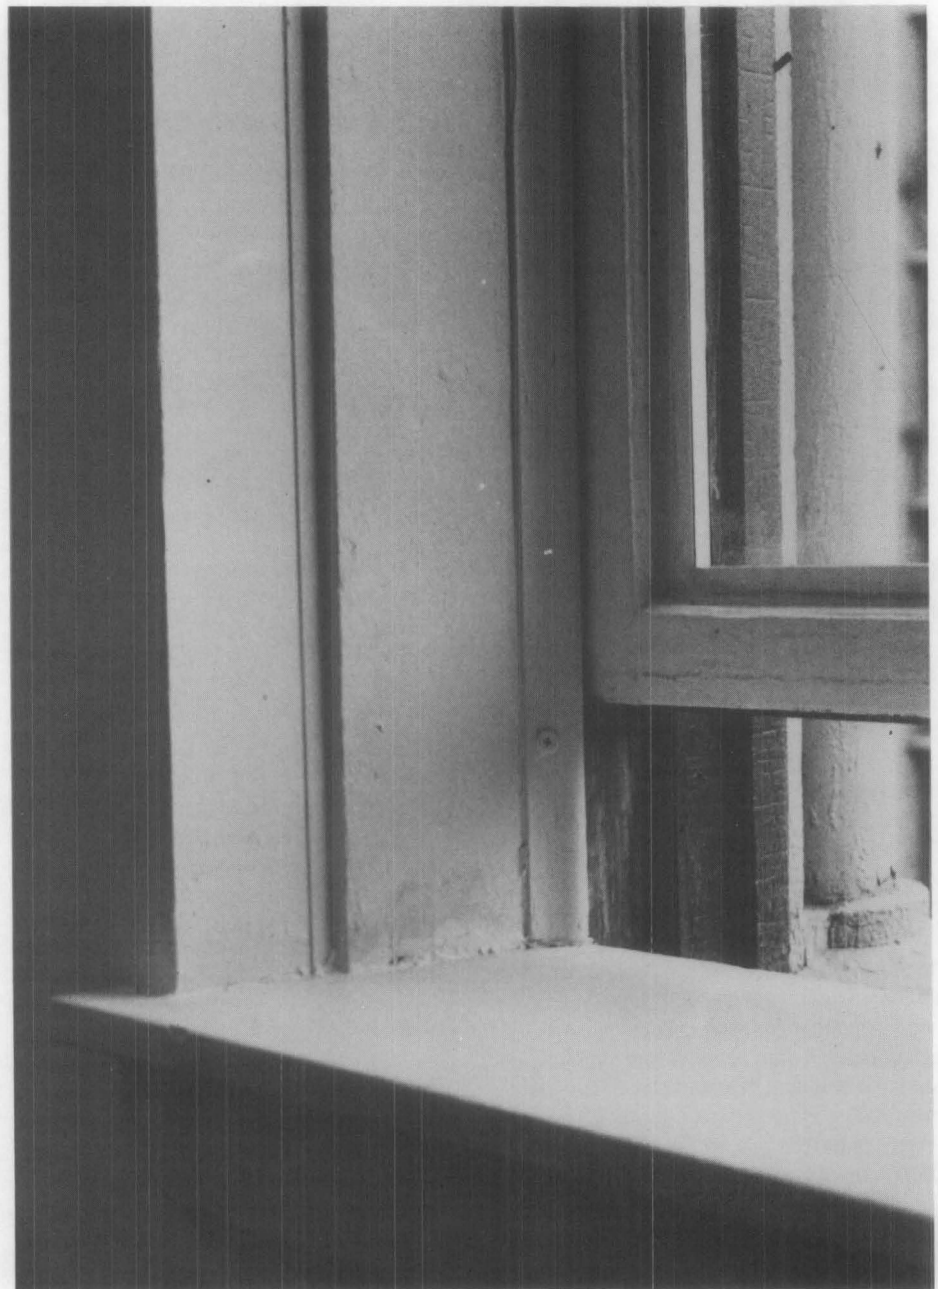
above, the 1/2" encroachment along the edges of the glass on the large sash at the Delaware Building was determined not readily visible from the street. The architect felt that the additional expense to avoid any sight encroachment was not justified for an alternate approach entailing the routing out the 2 1/4" thick sash on the inside putty rabbet to a greater depth in order to accept an all new sealed insulating unit. Such an alternative, however, might have been appropriate had the interior moldings along the inside rail and stile been more decorative, since the added

**Figure 1.** Since the metal spacer placed between the glass sheets is set slightly off the edges of the rails and stiles, the retrofitted insulating unit reduces the historic glass exposure by about 1/2" along all sides. This change on large windows is hardly noticeable particularly once the flat trim piece is glued in place. Photo: Charles E. Fisher.

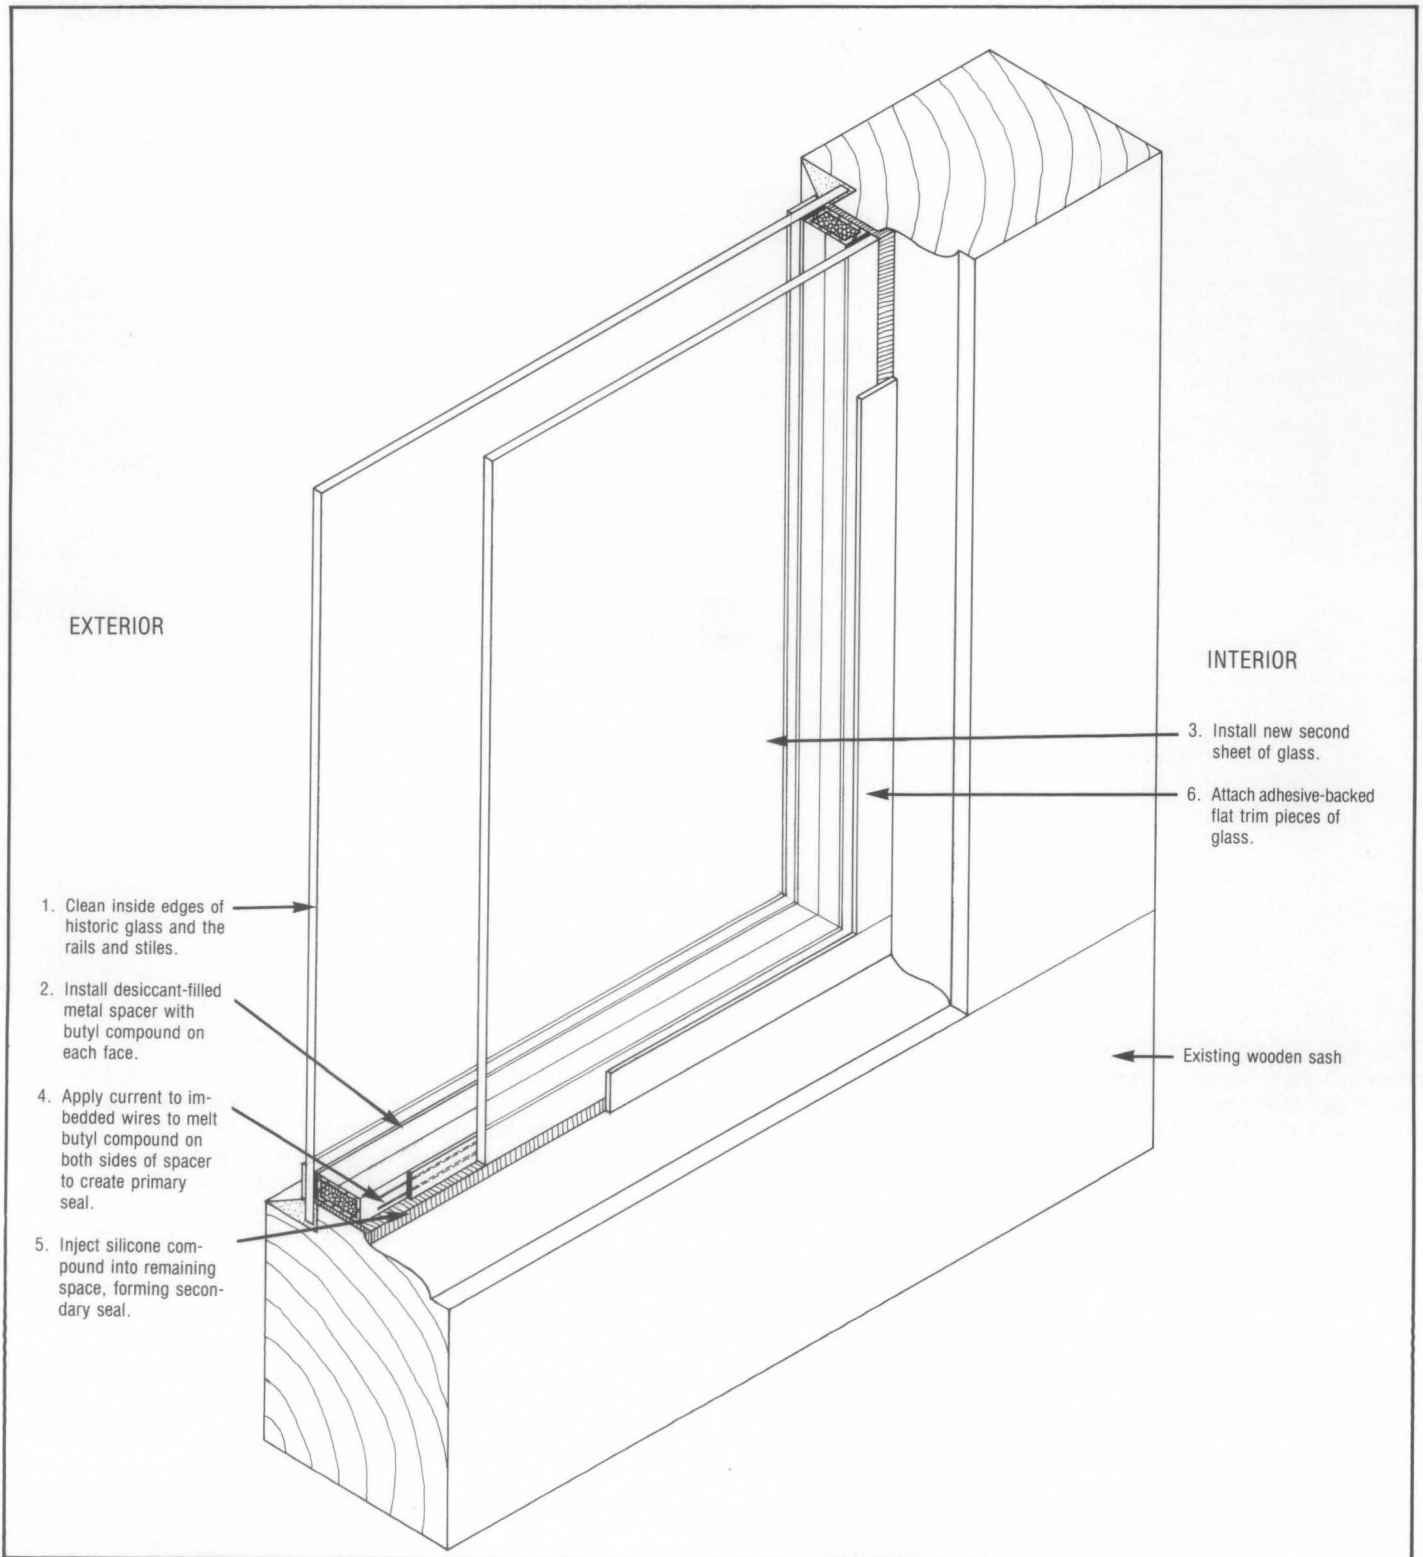
**Figure 2. The isometric drawing of the window shows the manner in which the insulating glass units were created utilizing the existing glass without any damage to the wooden sash. Drawing: Christina Henry.**

lene. The polyisobutylene strip on the room side also had two parallel copper wires running the entire length, terminating through one corner (see figure 2). With the sash lying flat, the spacer was set snugly up against the inner surface of the existing glass, then the sheet of new glass was placed upon it. Small setting blocks

The primary seal for the insulating unit was then created by applying an electrical charge for about 5 to 10 minutes through the two copper wires. The wire-resistant heating melted the butyl compound on both sides of the spacer since the aluminum spacer easily conducted the heat generated by the wires to the polyisobutylene strip on the opposite face. As a secondary seal to retard moisture collection between the glass and help secure the new glass in the sash, a silicone compound was applied in the space between the wood frame, the old glass and the edge of the new glass and the metal spacer (see figure 2).

To complete the glazing work, a flat piece of 5/8" wide painted aluminum trim was adhered with silicone along the inside perimeter of the light as trim to cover the spacer (see figure 2). A similar trim piece, normally applied to the outside, was judged not to be necessary in this instance.

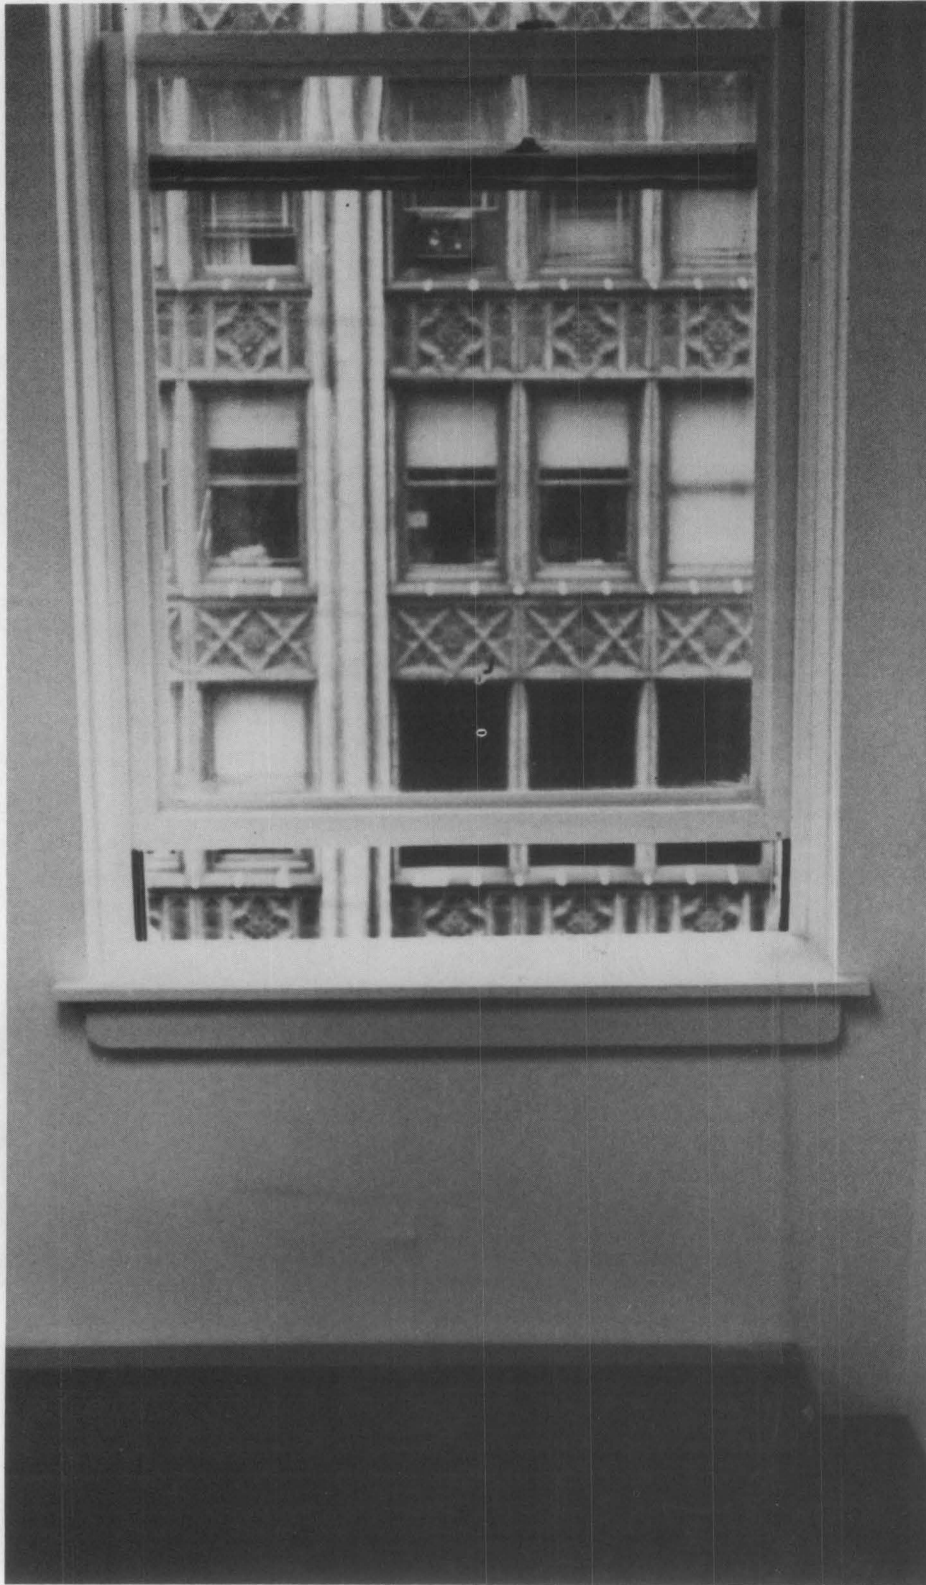
**Figure 3.** View of the window with the lower sash partially raised following completion of the work. Due to the large size of the sash, the small flat aluminum trim piece covering the spacer had little noticeable effect on the appearance of the windows as viewed from the typical office area. Photo: Charles E. Fisher.

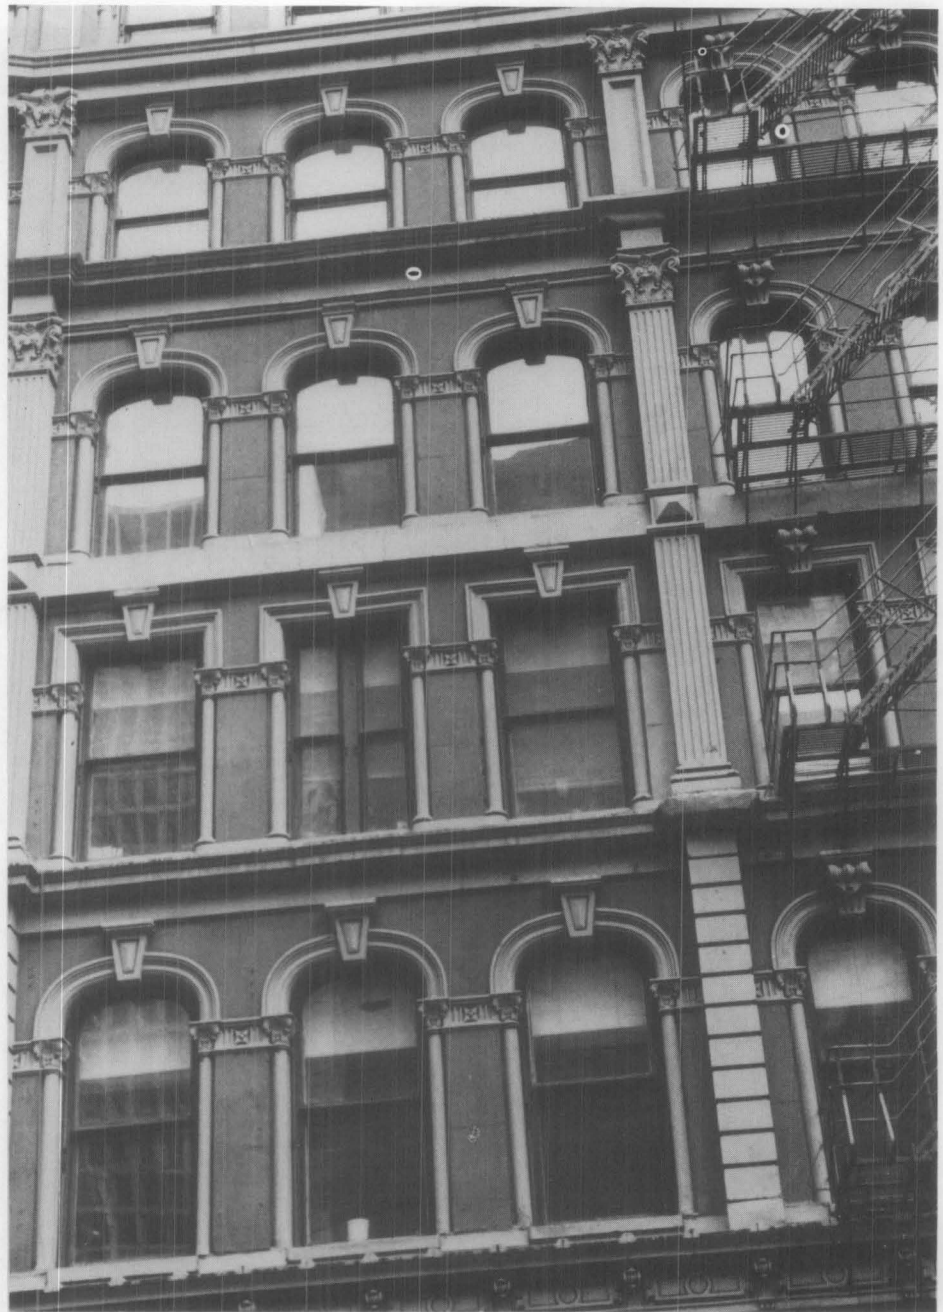
The incorporation of the existing glass into a sealed insulating unit was accomplished in the Delaware Building without any damage to the historic sash and without any loss of historic material (see figure 4). The retrofit work, which is easily reversible, has performed well since its completion in 1982.

Figure 4. View of the windows on floors 3 thru 6 shows that the technique used for creating sealed insulating glass units in the existing wooden sash had no noticeable impact on the historic appearance of the windows as seen from the street below. Photo: Charles E. Fisher.
