Tech Notes

WINDOWS NUMBER 17

Repair and Retrofitting Industrial Steel Windows

LIPPINCOTT PRESS BUILDING Philadelphia, Pennsylvania

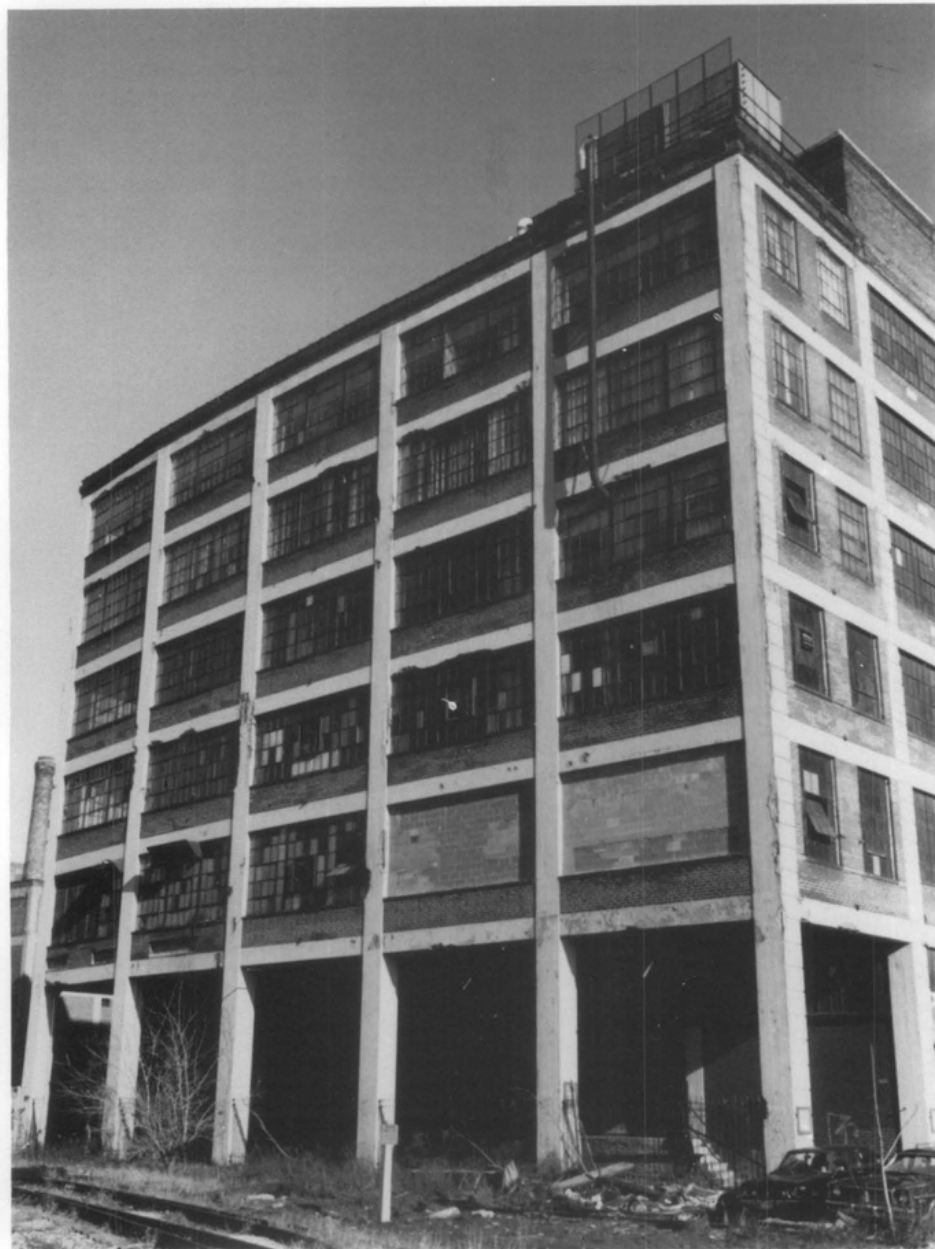
Since the Lippincott Building was used for a long time as a storage facility, the windows had not been painted, oiled, reglazed, or caulked, nor had missing or damaged parts been replaced in well over twenty years (see figure 1). Naturally, many of the windows exhibited problems typically found on inadequately maintained steel windows, including corrosion, bent and bowed metal sections, non-operable ventilators, missing or non-functional hardware and broken glazing. Furthermore, some of the original windows had been removed and replaced with double-hung aluminum windows, and other window openings had been infilled with glass and concrete block, metal louvered air vents, ductwork and other mechanical equipment (see cover photo).

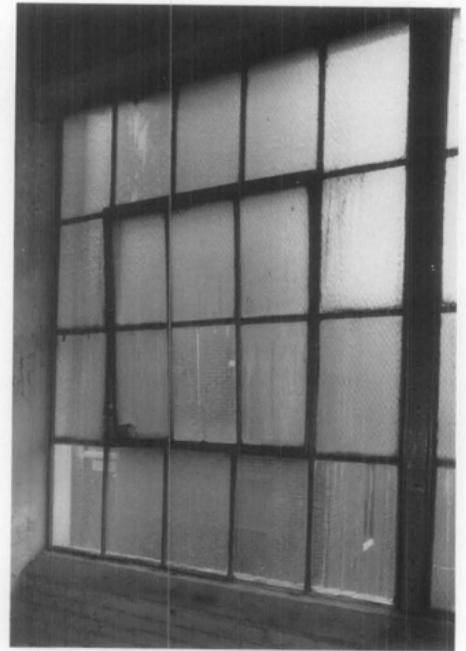
Figure 1. Typical multi-light steel window with ventilator as seen from the interior. This window exhibits typical pre-rehab conditions including sill corrosion, missing hardware and a poorly operating ventilator. Photo: Clio Group.

The rehabilitation included replacing the deteriorated steel sections, particularly in the sill areas, and replacing the missing and nonrepairable windows with new single-glazed steel windows similar in profile and configuration to the existing windows. As part of the repair process, the existing ventilator windows would be modified from center pivoting sash to projecting sash (to meet Philadelphia code for emergency egress), and both the repaired and new steel windows would receive interior storm windows to bring the windows into compliance with the Pennsylvania State Energy Code requirements for heat loss, air infiltration, and other energy/comfort criteria.

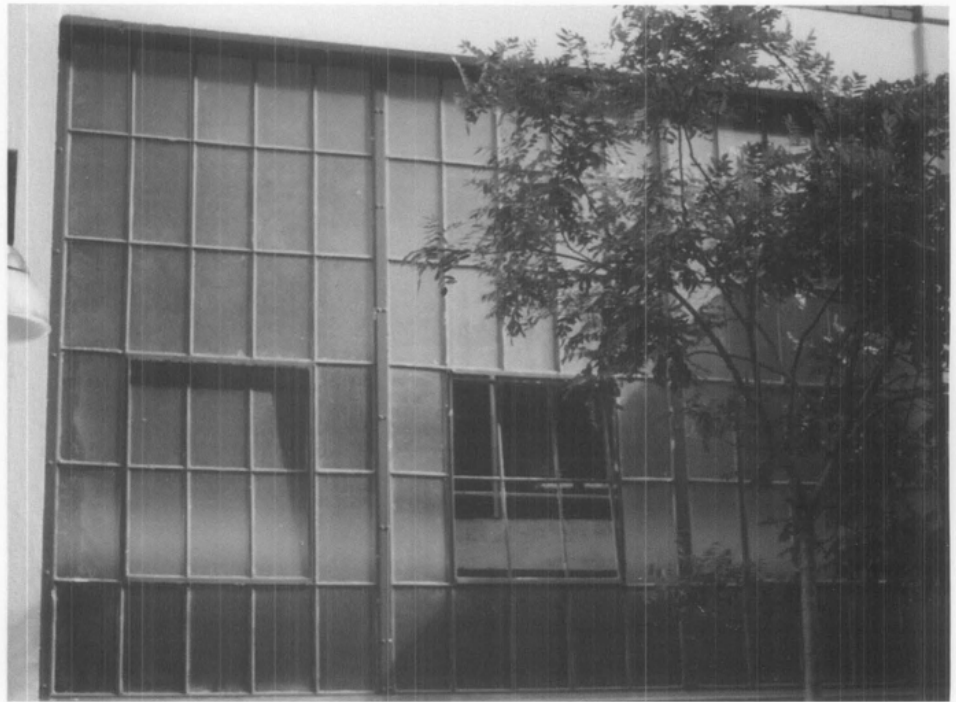
To accommodate the first floor lobby and parking garage, the decision was made to repair and reglaze with frosted glass the existing steel windows in the garage area, and to install new windows in the newly created lobby area where no windows previously existed. The garage windows retained their operable pivoting sash, since compliance with energy requirements was not applicable. To provide for adequate garage ventilation, glazing was omitted from a number of the ventilators (see figure 4).

Figure 4. First floor, garage level showing the frosted glass and the center ventilator without glazing. Photo: Robert Powers.

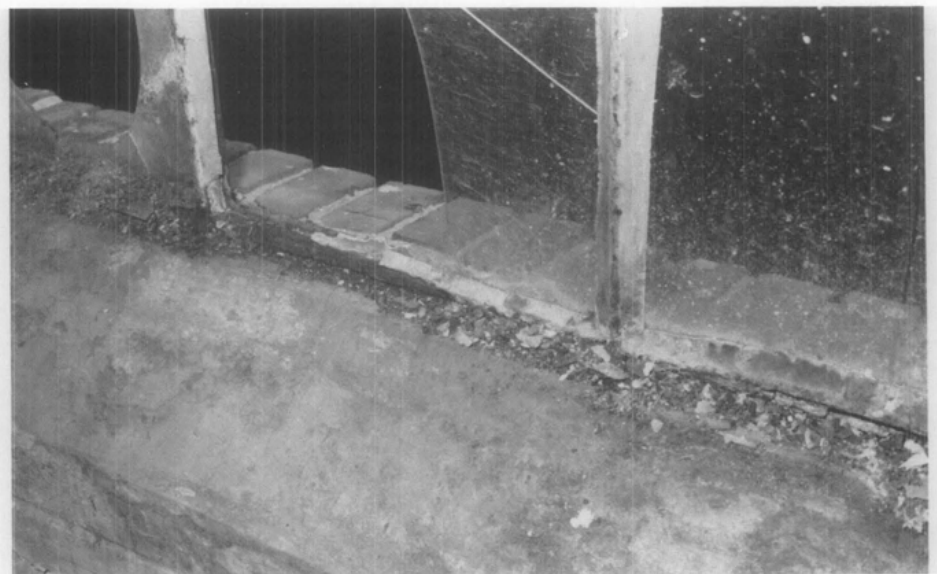
Figure 5. Sill corrosion typically found on 95% of the windows. Photo: Clío Group.

Generally employing three crews of three to four men, each contractor began by cutting out all the severely corroded and/or heavily bent metal sections from each window. Severe corrosion occurred primarily in the sill areas where the original steel sill section was embedded in concrete—a condition existing in approximately 95% of the window sills to be repaired (see figure 5). The spalled concrete and the corroded metal sill sections were chopped out with a portable band saw. In addition to the corrosion in the sill areas, extensive deterioration typically extended up the window muntins approximately three to six inches. These members were cut at a 45 degree angle with a five-inch grinding wheel using a five-inch disk, usually at a point four to seven inches from the sill or where the steel was no longer corroded.

Once the muntins and mullions were set plumb, the final steps in the steel repair process began. In most of the sill areas, lengths of new steel sections were installed to replace the original corroded members. The new cavetto-shaped steel sections did not match exactly the bullnose profile of the historic windows (see figures 9 and 10). However, the original profile was no longer available and the new profile was close enough so that the overall proportions, profile, and shadow lines were compatible with the historic window appearance. The new steel sections at the sill and the lengths

extending up into the muntins were welded together, installed in the appropriate location and then clamped and welded to the remaining original window. All welds were ground smooth and primed immediately with a rust-inhibiting primer. The concrete sills were then patched. Concurrent with the splicing-in of the new members, the ventilator jambs were also retrofitted to accept the new projecting ventilator. Similar to the work on the ventilators, the bullnose trim piece on the upper portion of the exterior side rails was cut off and a new steel angle was installed on the interior of the side and bottom rails and the hinges were attached.

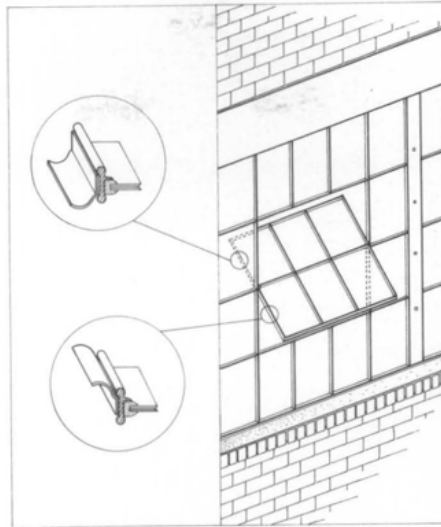
Figure 6. Pivot ventilators prior to retrofitting on the upper floors. Bullnose trim pieces to be modified as part of the retrofitting from pivot to projecting ventilators. Drawing: Martha Raymond.

Concurrent with the cutting out of the window's corroded steel members, each of the existing pivot window ventilators on floors two through six were cut from their jambs, labeled and brought to an on-site work station. At the work station, the pivoting ventilators were modified to operate as projecting windows (see figure 6). This was accomplished by cutting off the bullnose outside face of the side and bottom rails on the sash and riveting a new water-shed steel angle at the same locations. To allow the ventilators to swing out, two 16", heavy duty, 6 bar, zinc chromate plated steel, TRUTH hinges were screwed to each ventilator (see figure 7). New right-hand, cast iron, bronze lacquered, locking handles were installed on the bottom rail by face-mounting and screwing to each ventilator.

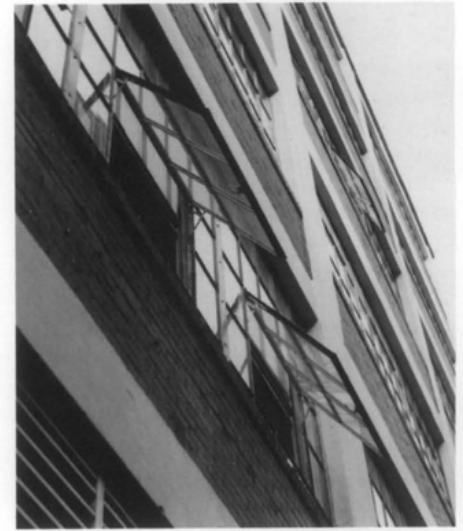
Figure 7. Retrofitting projecting ventilator with the TRUTH hinges. Photo: Robert Powers.

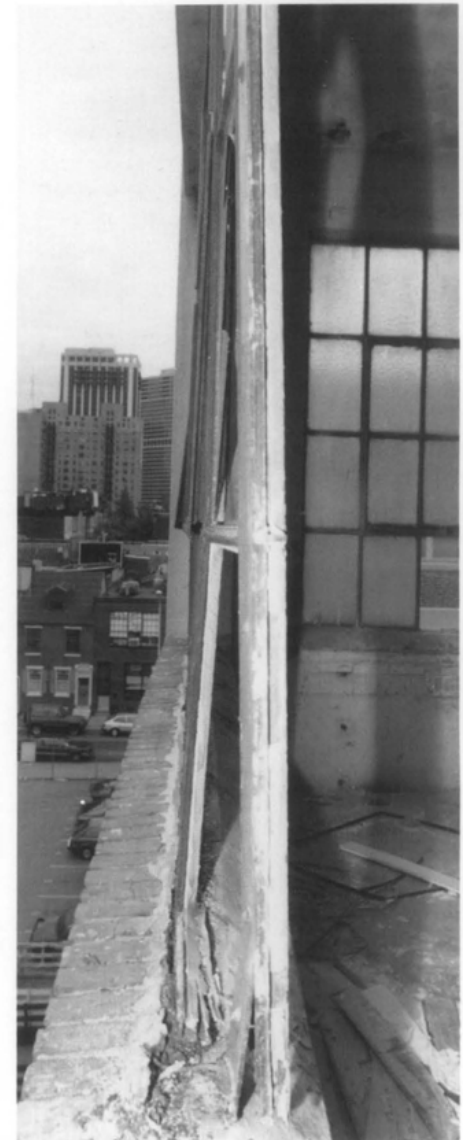
In addition to the retrofitting of the ventilators, many of the window muntins and structural mullions needed to be straightened, patched and repaired (see figure 8). Members that were seriously bowed and could not be adequately straightened were cut off using grinding wheels and salvaged;

Figure 8. Bowed and corroded window during construction. Photo: Clío Group.

replacement members were welded into place. Two relatively simple techniques were used to straighten the less seriously bent and bowed steel members. With mullions, a wooden brace (usually a two-by-four) was attached to the mullion; a wire cable was wrapped around the wooden brace and the mullion; and slowly the cable was pulled with a "come-along" winch hooked to the ceiling of the building. Since the mullions had typically bowed toward the exterior, the member was pulled in the direction opposite its bowing, towards the inside of the building. To straighten out bent and bowed muntins, the contractor applied constant pressure through the use of 14" bar-type clamps on the muntin. All indentations and gouges left in the steel members were filled with an auto-body patching compound containing steel fibers and an epoxy binder, sanded smooth and primed with a rust-inhibiting primer.

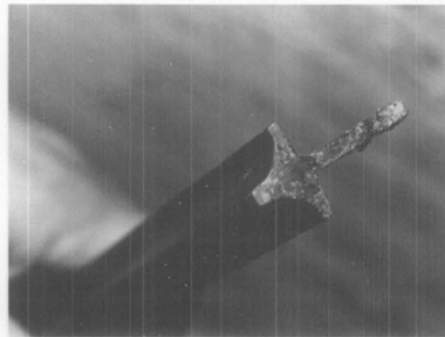
Figure 10. Replacement steel window section used primarily in the sill areas. Photo: Clio Group.

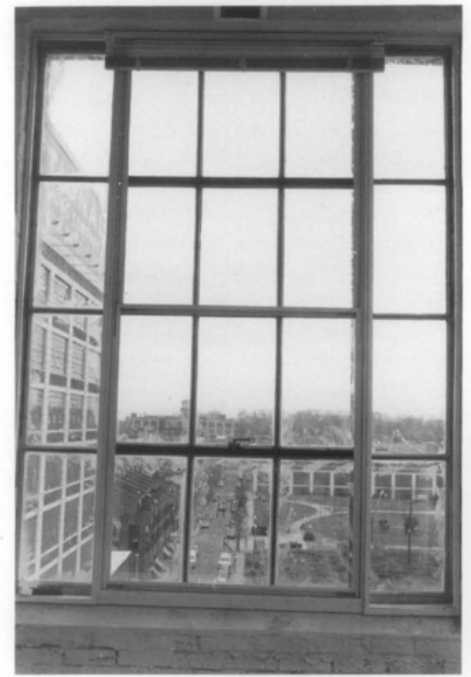
Figure 12. Installed interior triple-track storm window with fixed sidelights. Photo: Clio Group.

the existing steel windows in and of itself was not sufficient in bringing the windows up to code. The development of an interior storm window system provided the additional thermal performance for code compliance. The solution involved an aluminum, triple-track, interior storm unit with flanking, fixed "sidelites" (see figure 11). A major consideration in the development of this storm system was the desire to minimize the outside visibility of the storm unit by aligning as closely as possible the meeting rails and other aluminum members with the steel window members (see figure 12). The exterior face of the storm windows was painted the same color as the steel windows so as to be as inobtrusive as possible (see figure 13). Although, the aluminum members do not match exactly the width of the opposite steel members, the storm windows were not readily visible from the exterior.

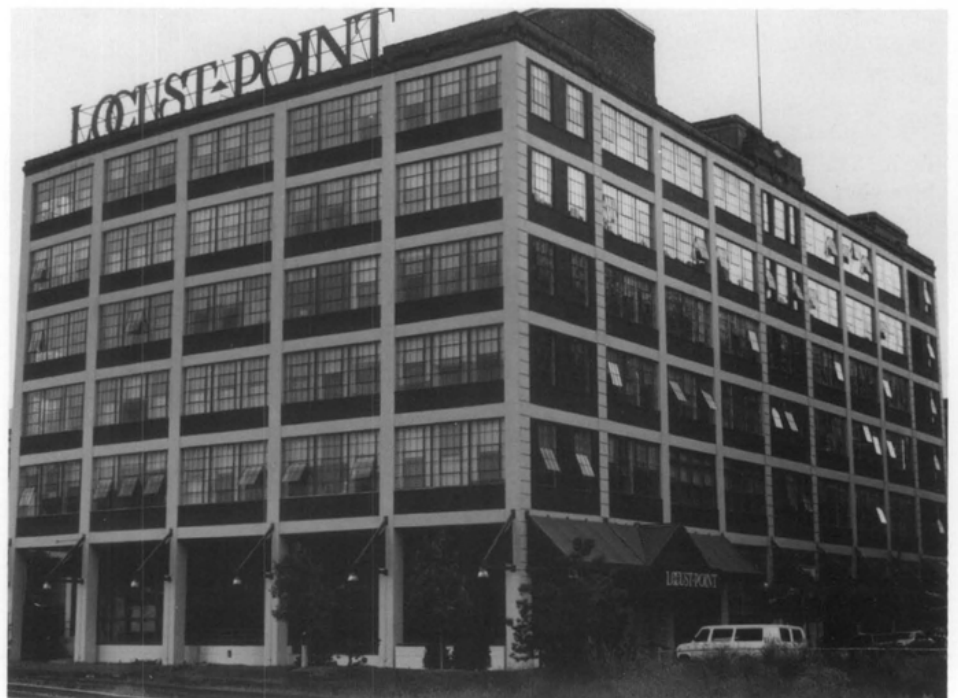
Figure 13. Lippincott Press Building (now Locust Point) after repair of the multi-light steel windows. Photo: Robert Powers.

were explored with the ultimate decision made to repair the significant historic steel windows. This decision was based on the assumption that repair of the windows was both a practical and cost-effective undertaking. The end product was a practical, cost-effective and ultimately successful solution to a difficult rehabilitation problem. The prominence of the thinly profiled, multi-light, industrial steel windows has been retained while current residential and energy code requirements as well as the Secretary of the Interior's Standards for Rehabilitation have been met.
