Emergency Stabilization & Rehabilitation Plan

KNP Complex

Sequoia and Kings Canyon National Parks, CA

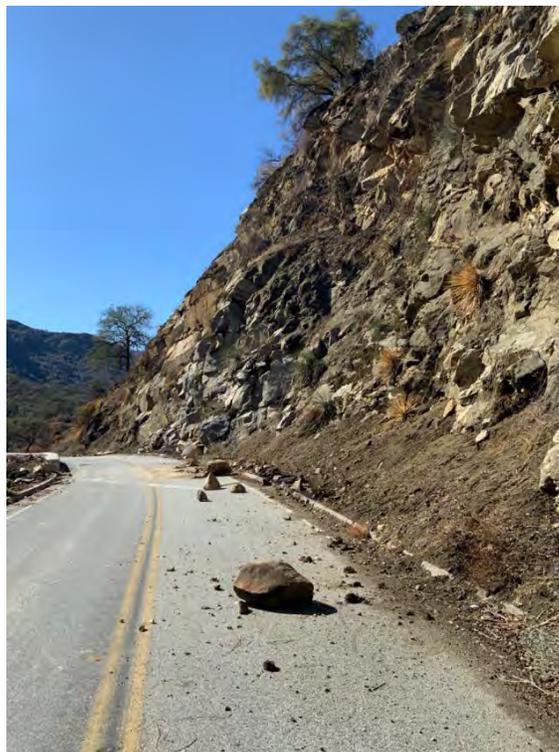
Similar, and perhaps even larger, rock falls are likely to occur throughout the winter as erosion of sediment dislodges loose rocks. Rock falls are most likely to occur during or immediately after storm events but could happen at other times. Over multi-year timescales, additional rockfalls are likely to occur as larger storms impose greater stresses and as the root networks of burned vegetation that are presently stabilizing loose rocks decay.

Rock falls onto the Generals Highway from a roadcut between Ash Mountain and Hospital Rock following a rain event.

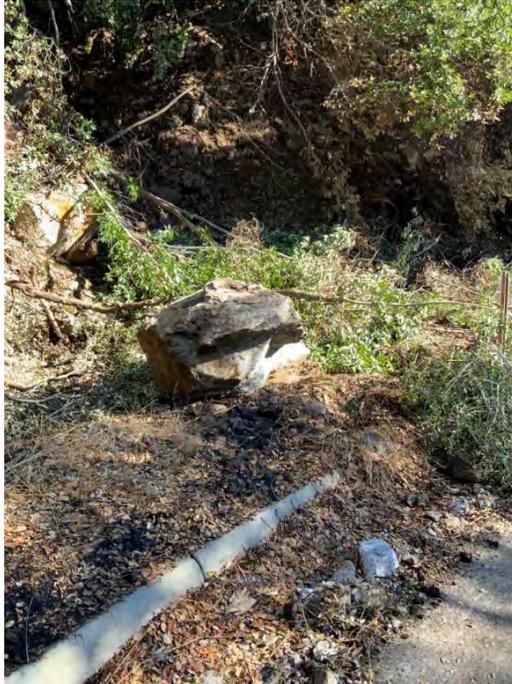
Rock falls of this magnitude and smaller are likely to occur throughout the winter in conjunction with winter storms; the potential for rock falls during clear summer weather is less likely but still possible.

Boulder resulting from a post-fire rock fall from above the General's Highway above Amphitheater Point. A fragment of this boulder continued downward, damaging the asphalt in the uphill lane and traveling across a switchback to the next road segment below.

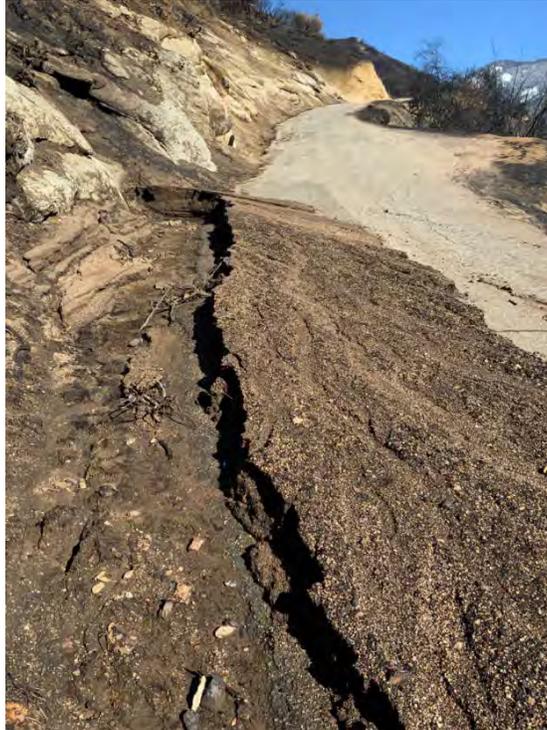
Sediment deposited on the Mineral King Road following a rain event within an area of locally moderate to high soil burn severity.

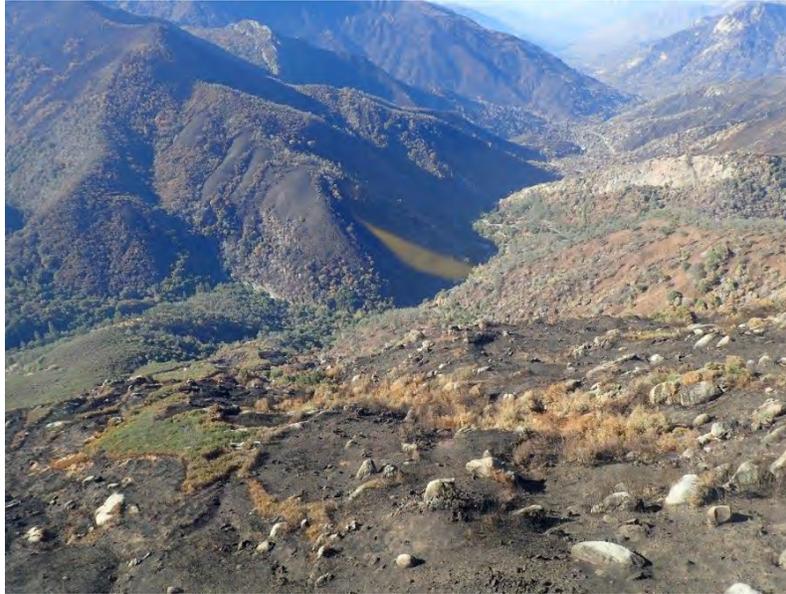
Moderate to high soil burn severity on a hillslope north of the Middle Fork Kaweah River and east of the General's Highway below Moro Rock. Erosion of hillslope sediments could cause granitic boulders on the slope to tumble towards Buckeye Flat Campground, located in the unburned trees adjacent to the river at the toe of the slope.

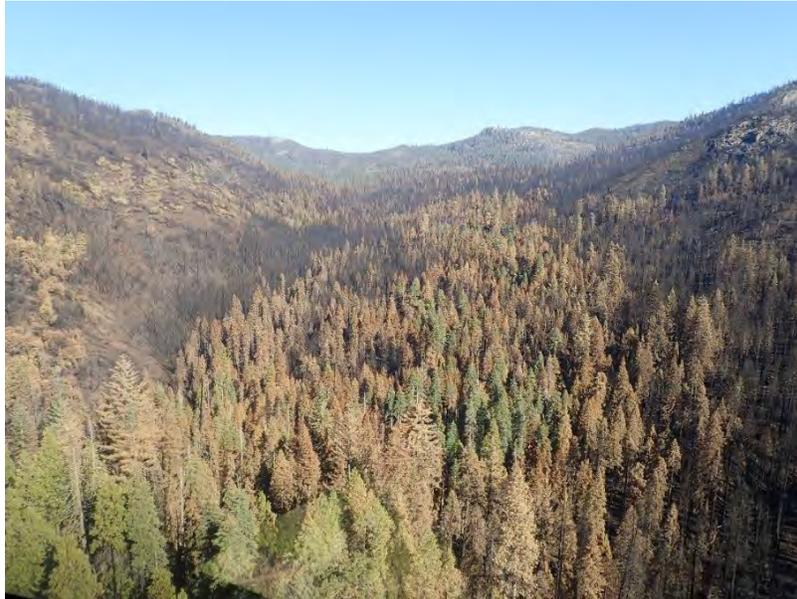
View looking north up Redwood Canyon from a position approximately above Lilburn Cave showing moderate to high soil burn severity above the cave and on the hillslopes adjacent to it. Sediment from burned slopes could enter Lilburn Cave via Redwood Creek, which flows through the cave, or through tributaries that enter the cave through sinkholes.

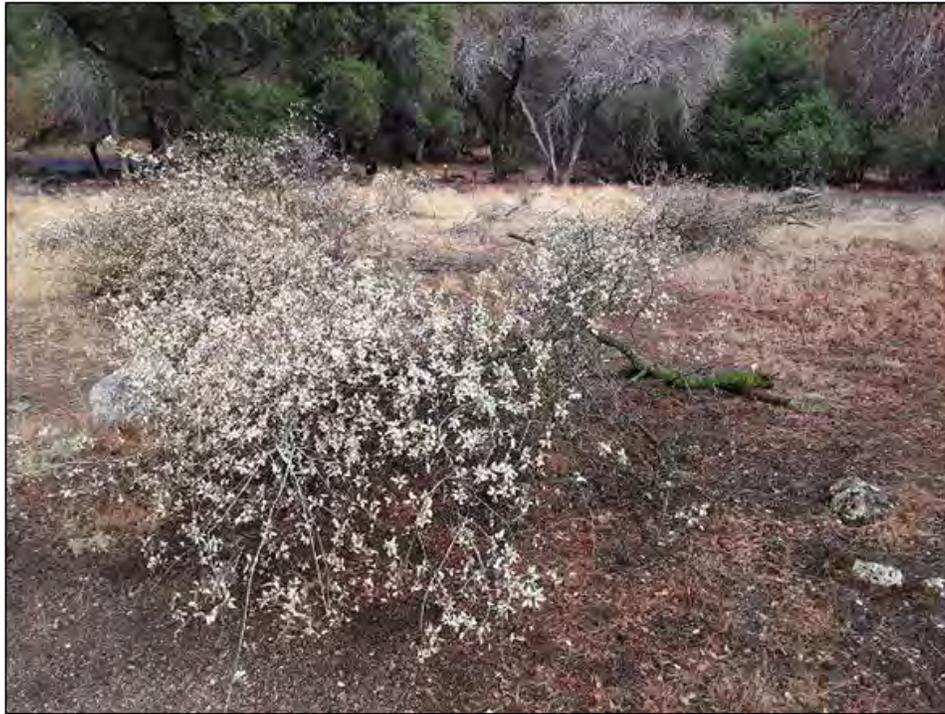
Figure 4. Twenty year-old blue oak that were planted to restore age diversity to the woodland at Potwisha Campground. These trees were cut as part of a fuel break project for the KNP Complex.

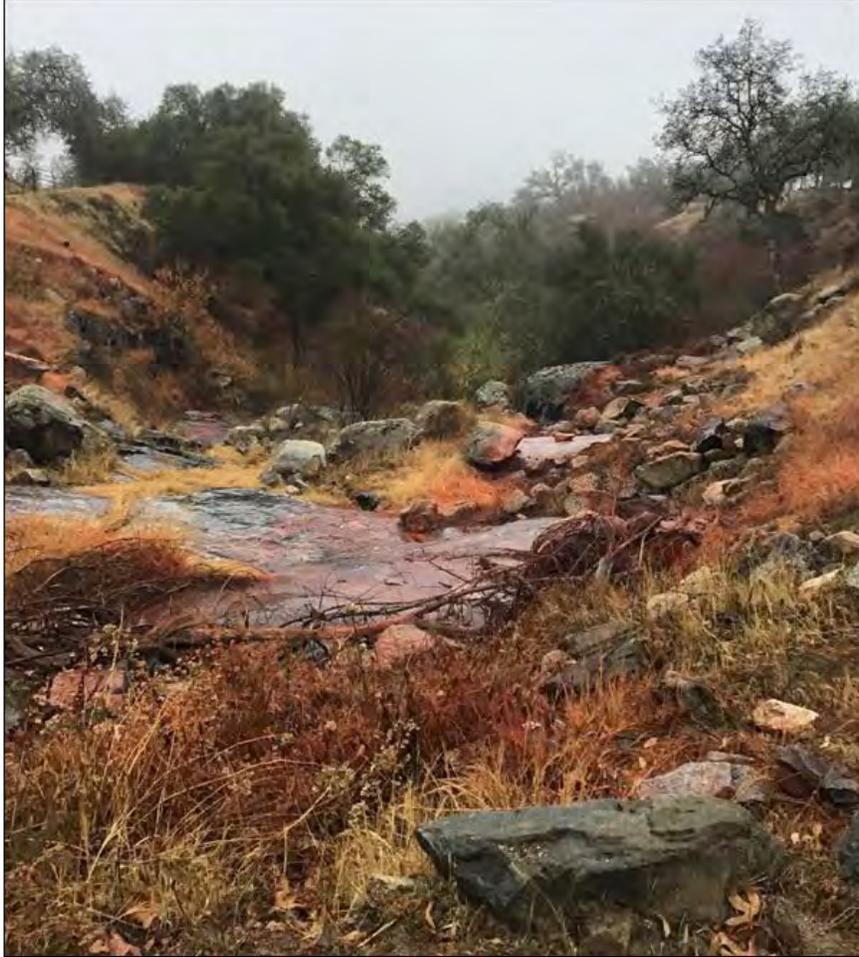
READ and BAER staff noted misapplied retardant in Sycamore Creek (Figure 5). Adjacent populations of *Iris munzii* were not directly affected. Amphibians known to occupy this drainagemay be affected as runoff transfers retardant throughout the stream. The KNP BAER Wildlife Assessment addresses this issue in greater detail. Invasive plants are less of an issue because retardant was applied in areas already heavily infested by invasive annual grasses.

Figure 5. Retardant impacts to Sycamore Creek. Newts and western pond turtle inhabit this drainage.

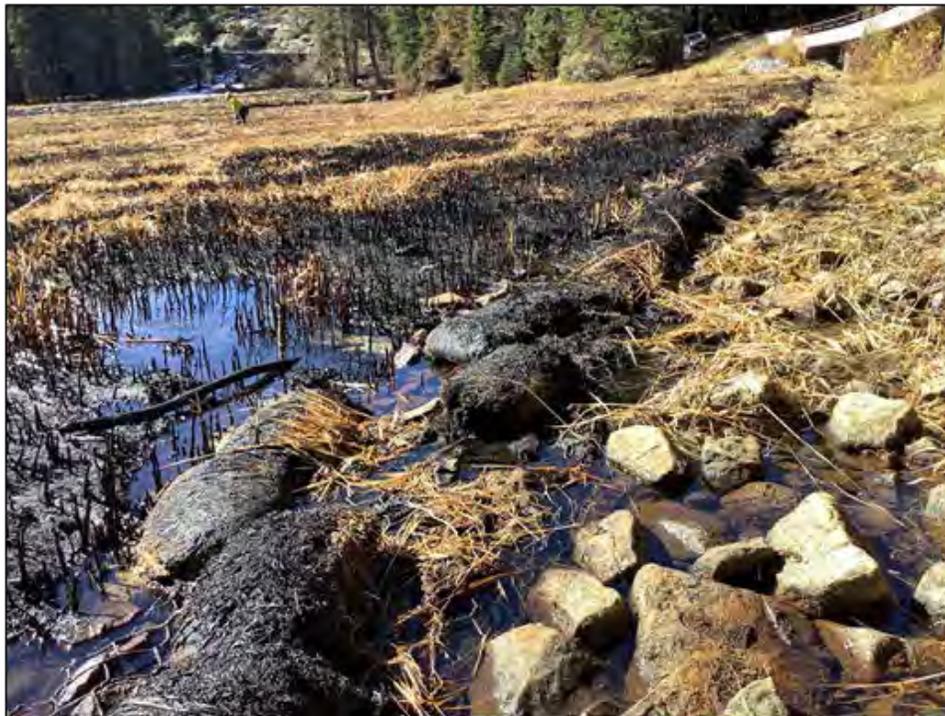
Figure 6. A row of sandbags designed to spread out surface flow in restored Halstead Meadow was damaged in the KNP Complex and started to fail in the October 25 storm.

Resource Protection / Revegetation	Fire-damaged sandbags put Halstead Meadow restoration at risk of new gullyng	ES-14: Reinforce damaged sandbags with a row of new ones laid immediately upstream (not on top). Retain damaged sandbags to allow surviving vegetation to colonize new bags
	Areas revegetated for resource protection but damaged by fire suppression activities	BAR-6: Collect propagules, propagate, and install replacement plants in conservation planting areas damaged by fire or those deliberately cut or burned at Giant Forest, Tunnel Rock, and Potwisha Campground.
Native Plant Communities	Ecological degradation by invasive species	ES-13 & BAR-5: Invasive Plant Management: Survey and treat for new infestations of invasive species in sites disturbed by fire suppression activities as well as around known infestations that may have spread into nearby fire-disturbed areas.
	Loss of community structure and habitat function to severe fire intensity, especially in mixed conifer habitat for Pacific fisher	BAR-11: Replant 500 acres of high severity mixed conifer in areas of maximum benefit to Pacific fisher. See Wildlife Assessment for details.

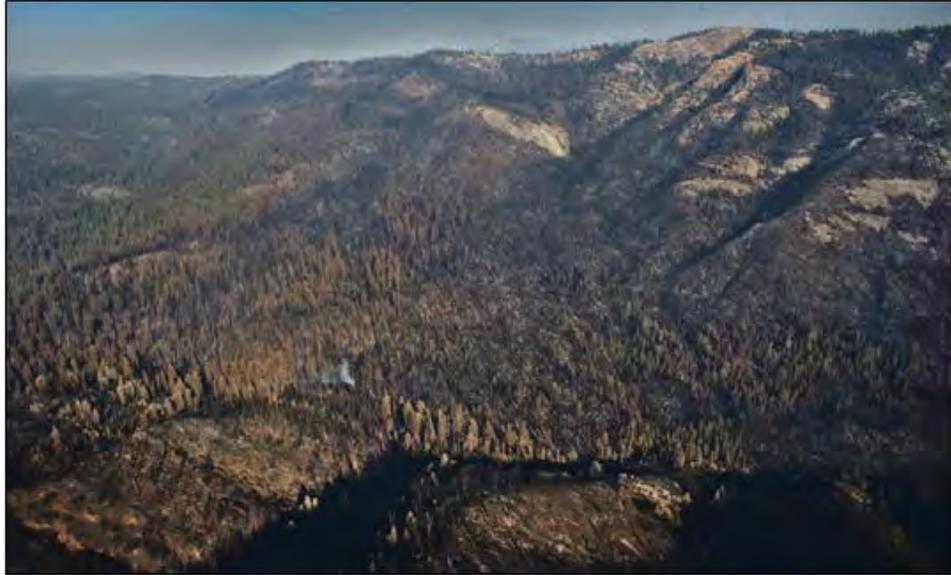
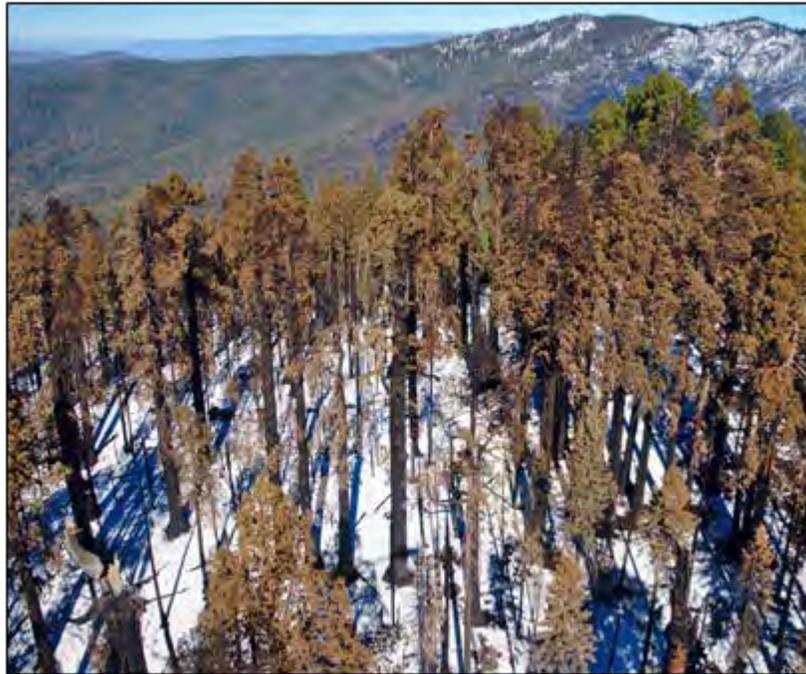
Figure 10. Redwood Mountain Grove. Views of (a) top large high severity patch at the southern end of the grove from 10/12/2021 and (b) bottom a close-up view of dead sequoias from 10/27/2021.

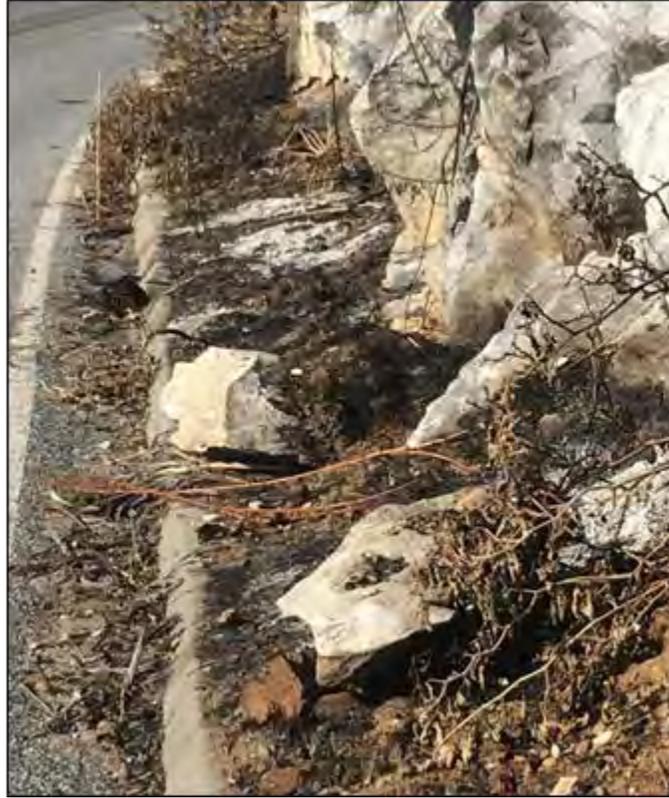
Figure 14. Type locality of mouse buckwheat, showing the impact of fire and rock/soil movement. Approximately 20 plants were lost at this location.

Sensitive Plant Populations	Fire and slope erosion damage to type locality of <i>Eriogonum nudum</i> var. <i>murinum</i>	BAR-8: Propagate and out-plant 50 plugs of this species from seed collected in the type locality, to replace those burnt or buried during the fire.
Vegetation Monitoring Plots	Plot monumentation damaged; potential that plots no longer are valid for monitoring goals	Non-Specification Recommendation: Inspect plots within burn footprint, replace damaged plot stakes and tags, decommission plots and/or select new monitoring plots if needed.

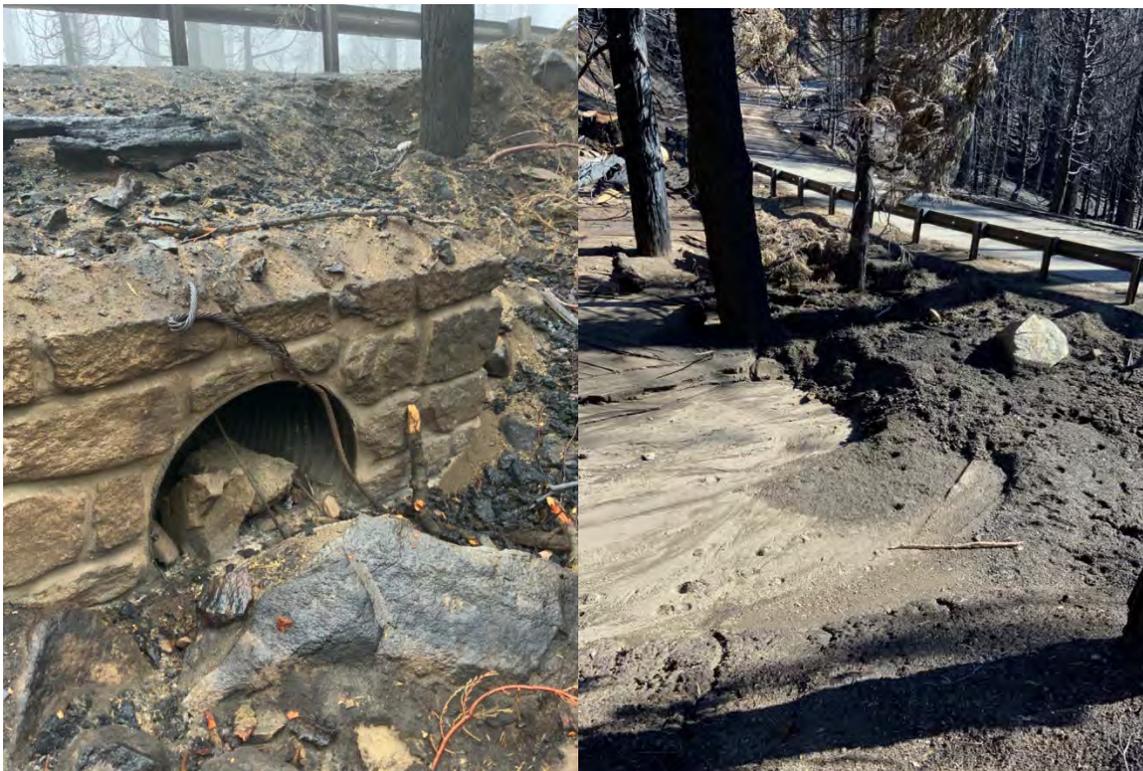
Figure 1. A culvert up the road from Red Fir Maintenance facility before and after the Oct 25 storm

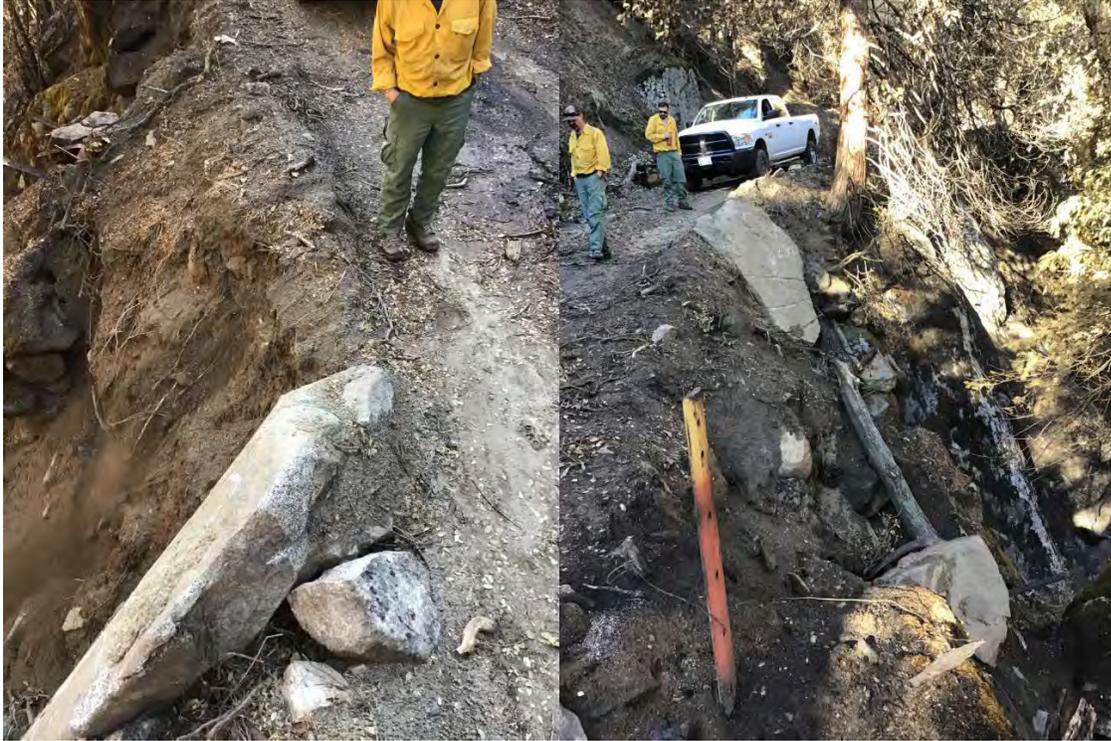
Figure 2. Oriole Lake road retaining structure lost

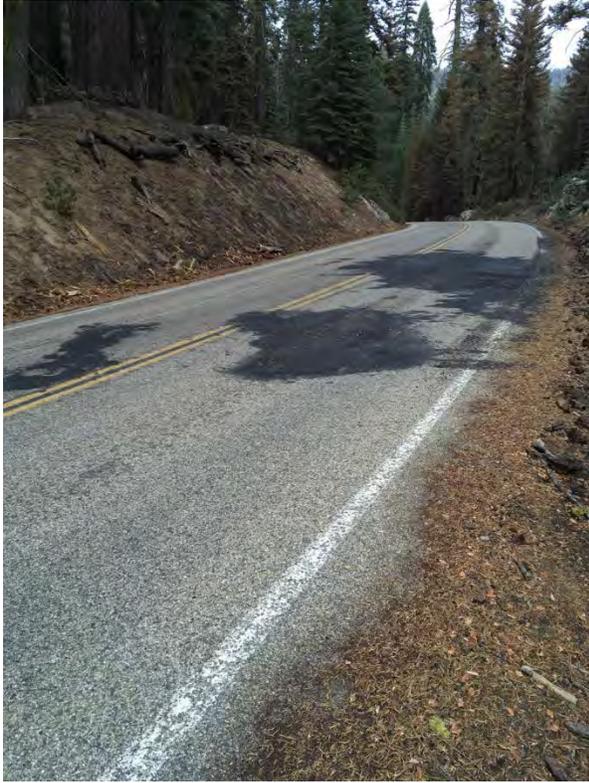
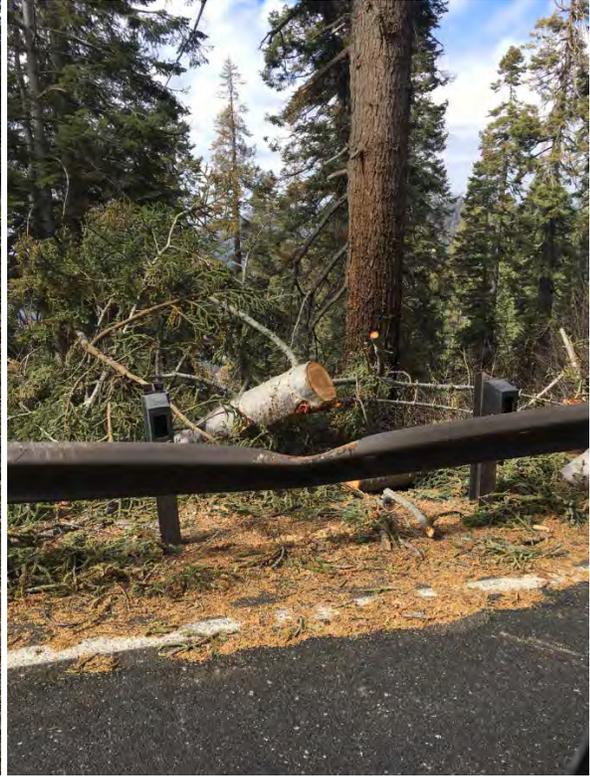
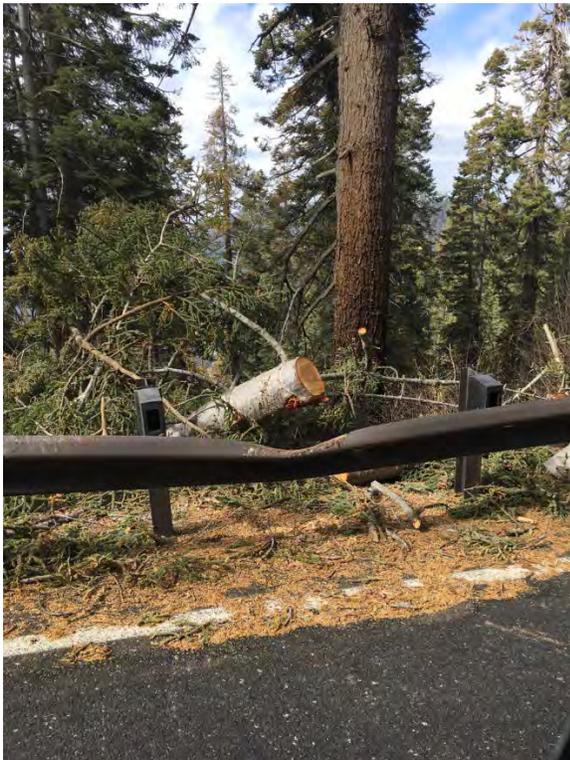
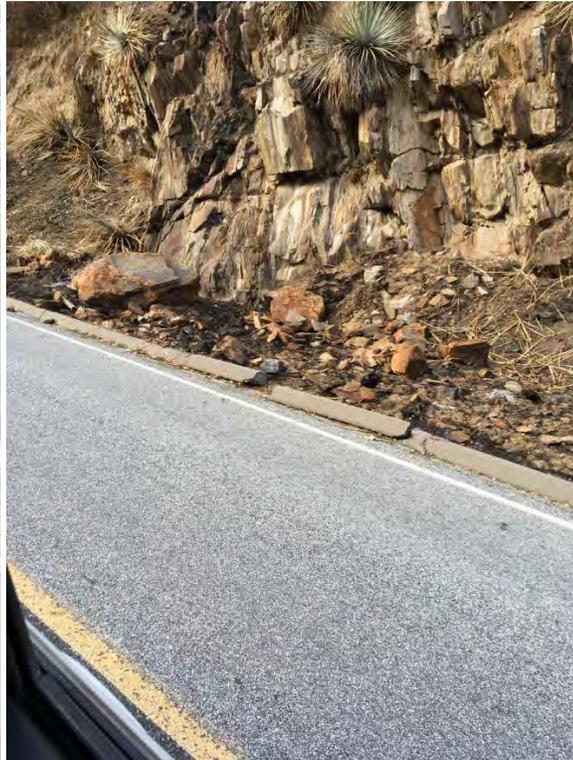
Figure 3. Road damage on Generals Highway

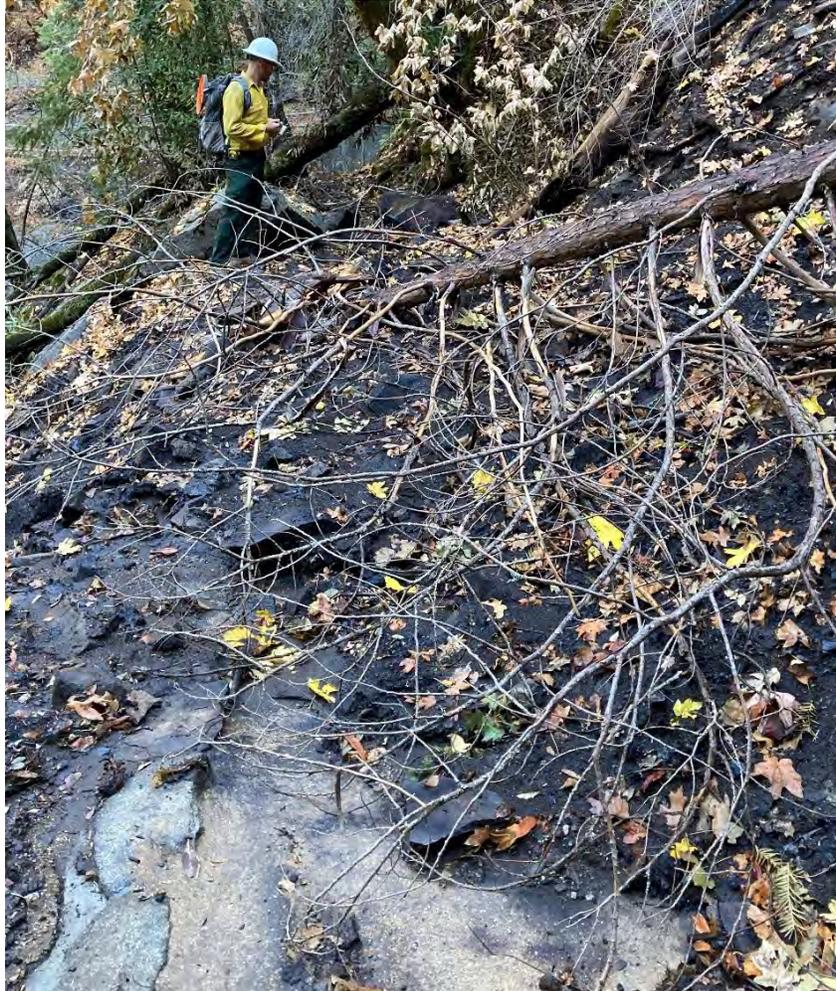
Figure 1. Soil and woody debris on Crystal Cave trail.

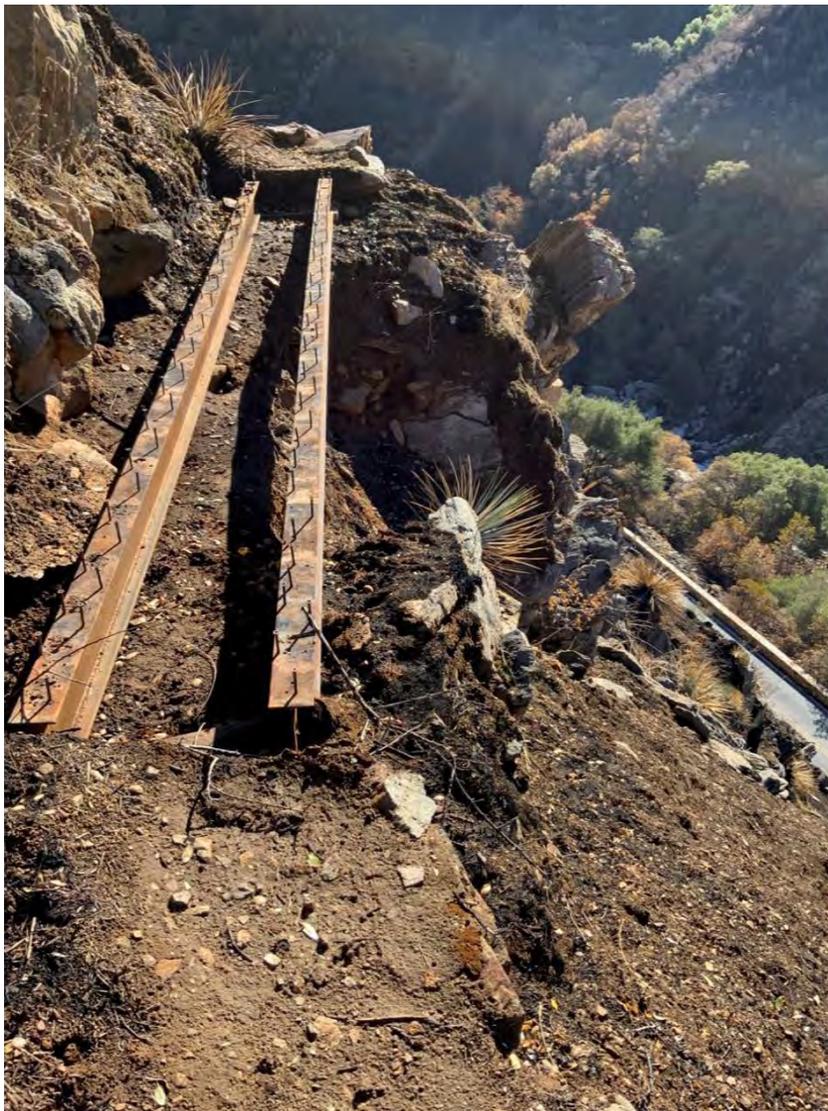
Figure 2. Burned boardwalk, Hospital Rock-Potwisha trail.

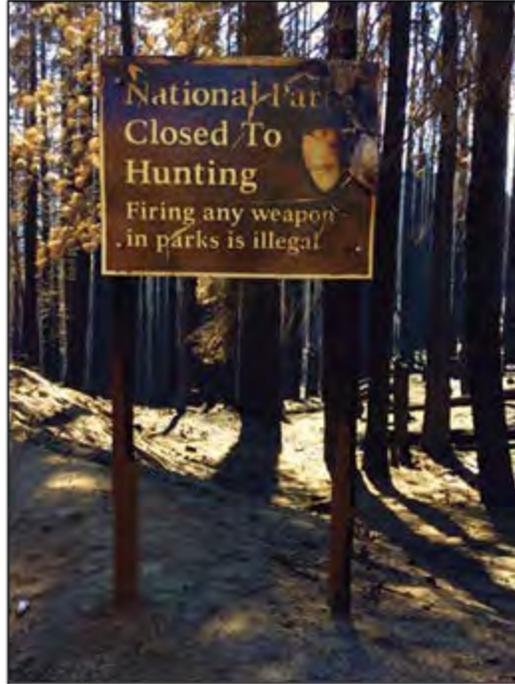
Burned NPS Regulatory Sign

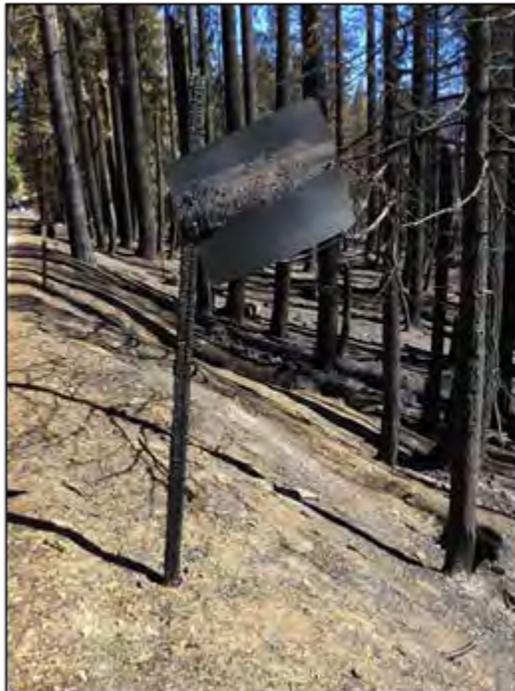
Burned Speed Limit Sign

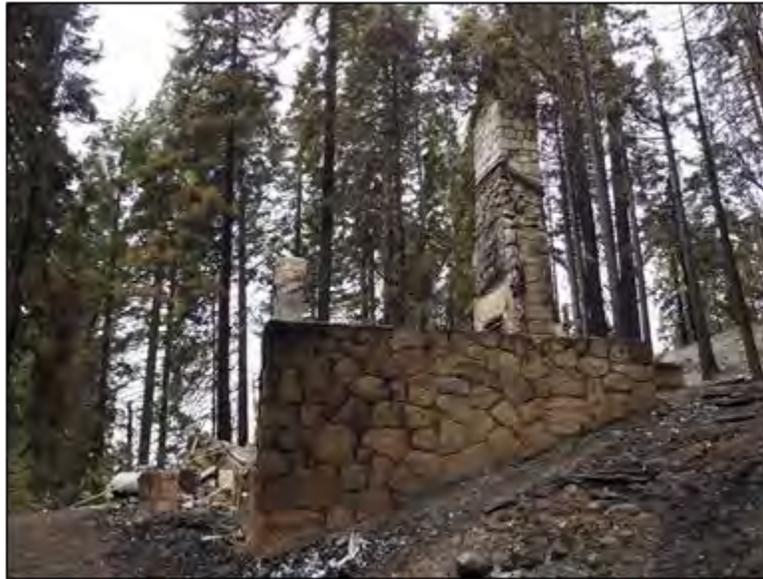
Photo 1 Redwood Mountain Ranger Station masonry remnants. View looking west.

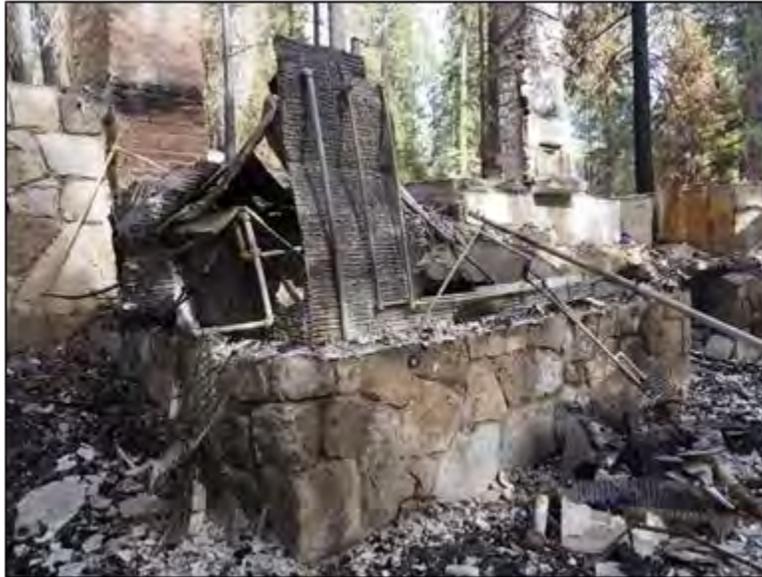
Photo 2 Redwood Mountain Ranger Station masonry remnants. View looking northeast.

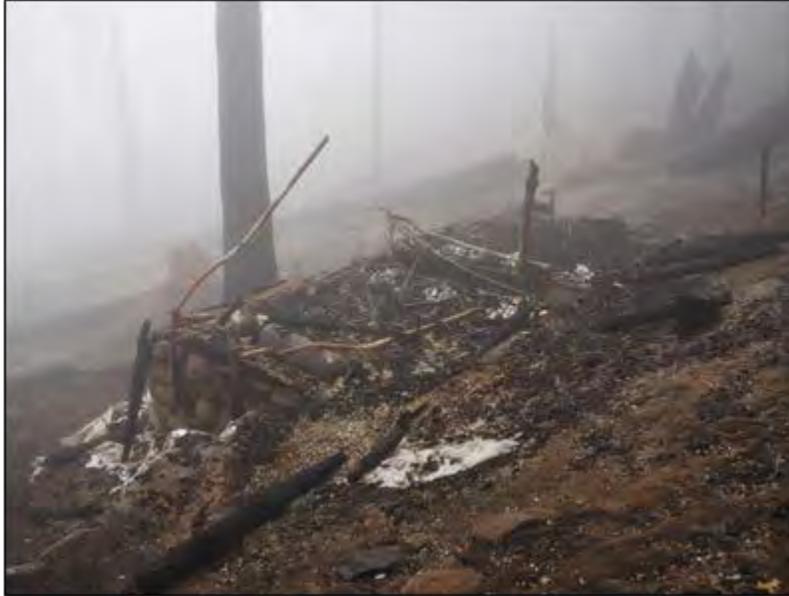
Photo 6 Moro Rock Comfort Station remains. View looking west.

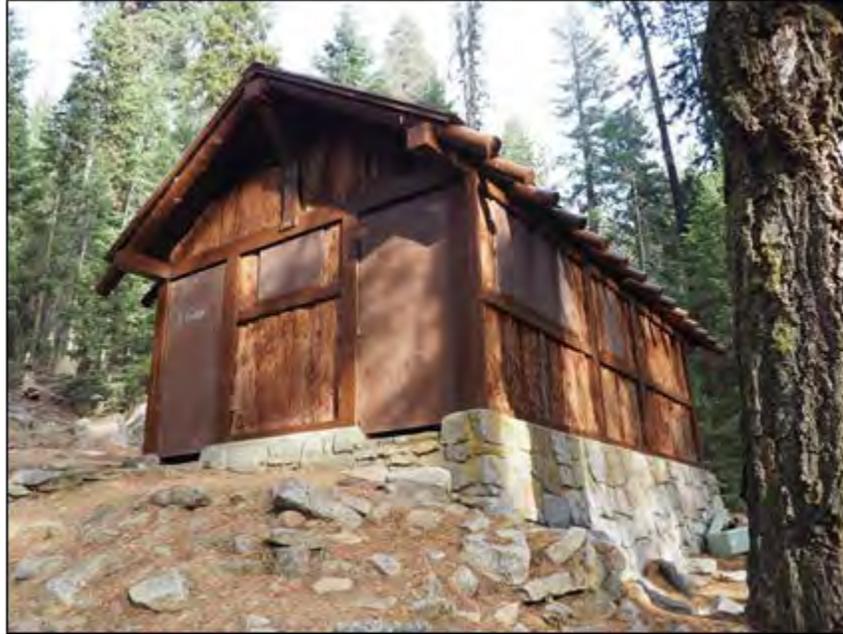
The Lost Grove Comfort Station was not damaged by fire, but hazard trees are a concern.	ES-1: Hazard Tree Assessment & Mitigation Addresses the removal of hazard trees threatening these buildings. Directionally fall hazard trees away
--	---	--

Photo 8 Lost Grove Comfort Station. View looking upslope, east.

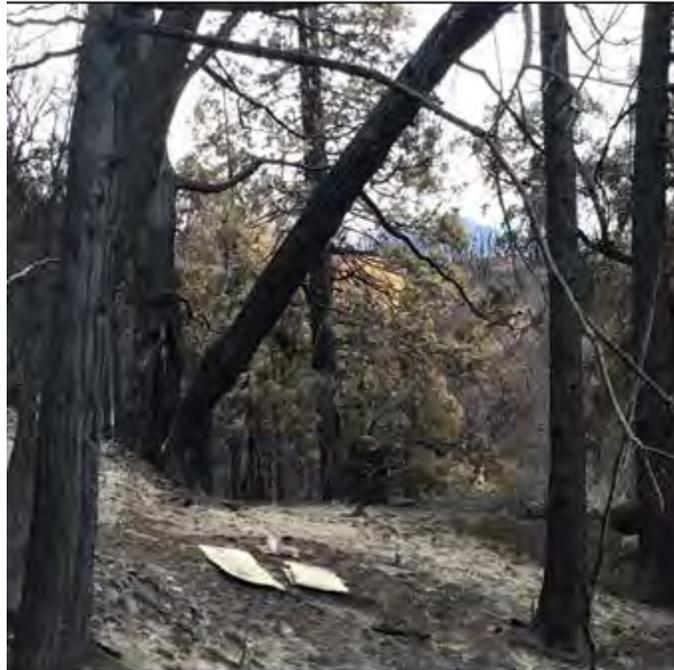
Photo 18. Example of a hazard tree hanging over a historic stone fireplace feature at (CA-TUL-2235H). If the tree is still standing after reassessment in FY22, then it should be removed to prevent potential damage to the feature and surrounding artifacts.

<p>Burn sites have post-fire stability concerns including hazard trees, erosion, burned out stump holes and roots, and exposed artifacts and features.</p>	<p>ES-1: Hazard Tree Assessment & Mitigation. One hazard tree at CA-TUL-2235H should be removed to prevent damage to a historic structural feature.</p> <p>Unassessed sites may have additional hazard trees that require removal.</p> <p>ES-10: Cultural Resource Assessments. A contracted</p>
--	--	--

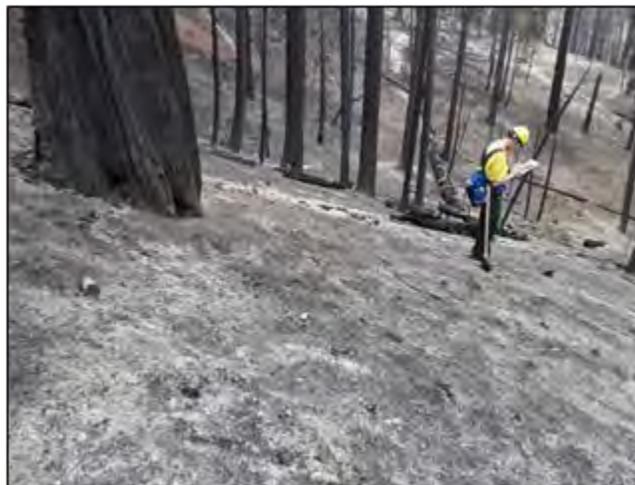
Photo 19. Example of exposed historic artifacts eroding down slope in burn area at CA-TUL-3183H. BAER Archaeologist Weston Bacon-Schulte pictured.

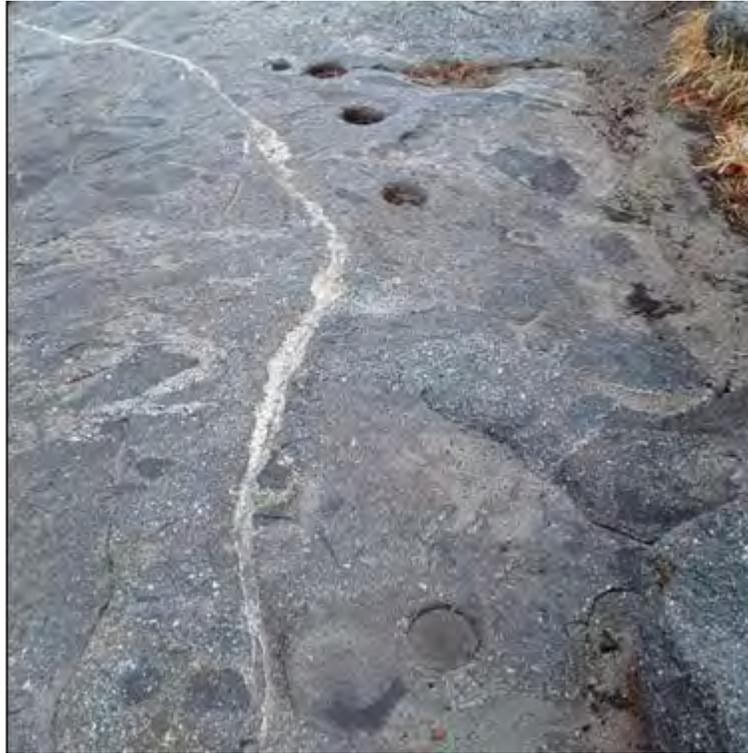
Photo 20. Example of significant cultural and archaeological site near (CA-TUL-0028) within the KNP Complex perimeter in SEKI. Portions of the site burned, but the areas around the pictograph and bedrock mortar features at the site were not directly damaged.
