**SPRINGFIELD ARMORY  
NATIONAL HISTORIC SITE**

**BUILDING 19  
HISTORIC STRUCTURE REPORT**

**Volume I.**

Building Conservation Branch, Cultural Resources Center  
North Atlantic Regional Office, National Park Service  
U.S. Department of Interior  
Boston, Massachusetts  
November 1991

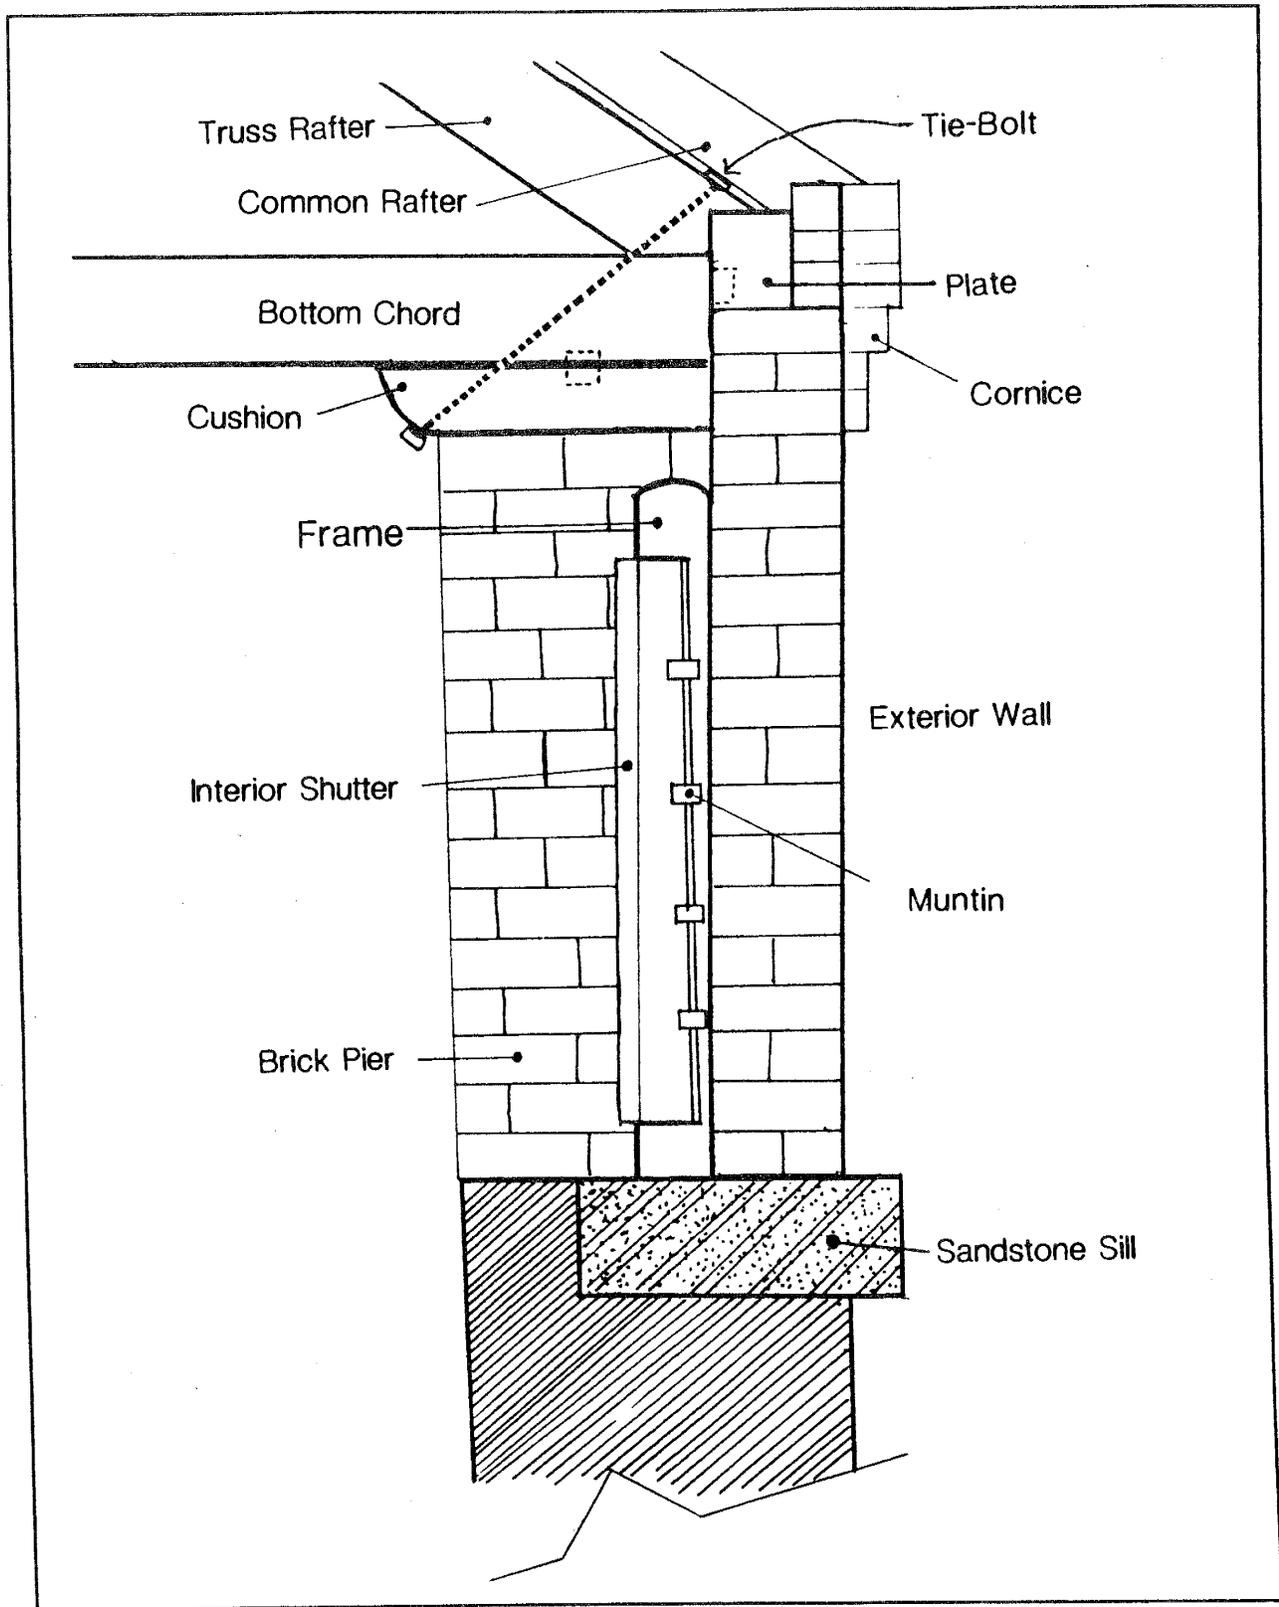
Section looking west, window at bay 21, West Addition. (Schematic drawing by J. Quinn, 1991.)

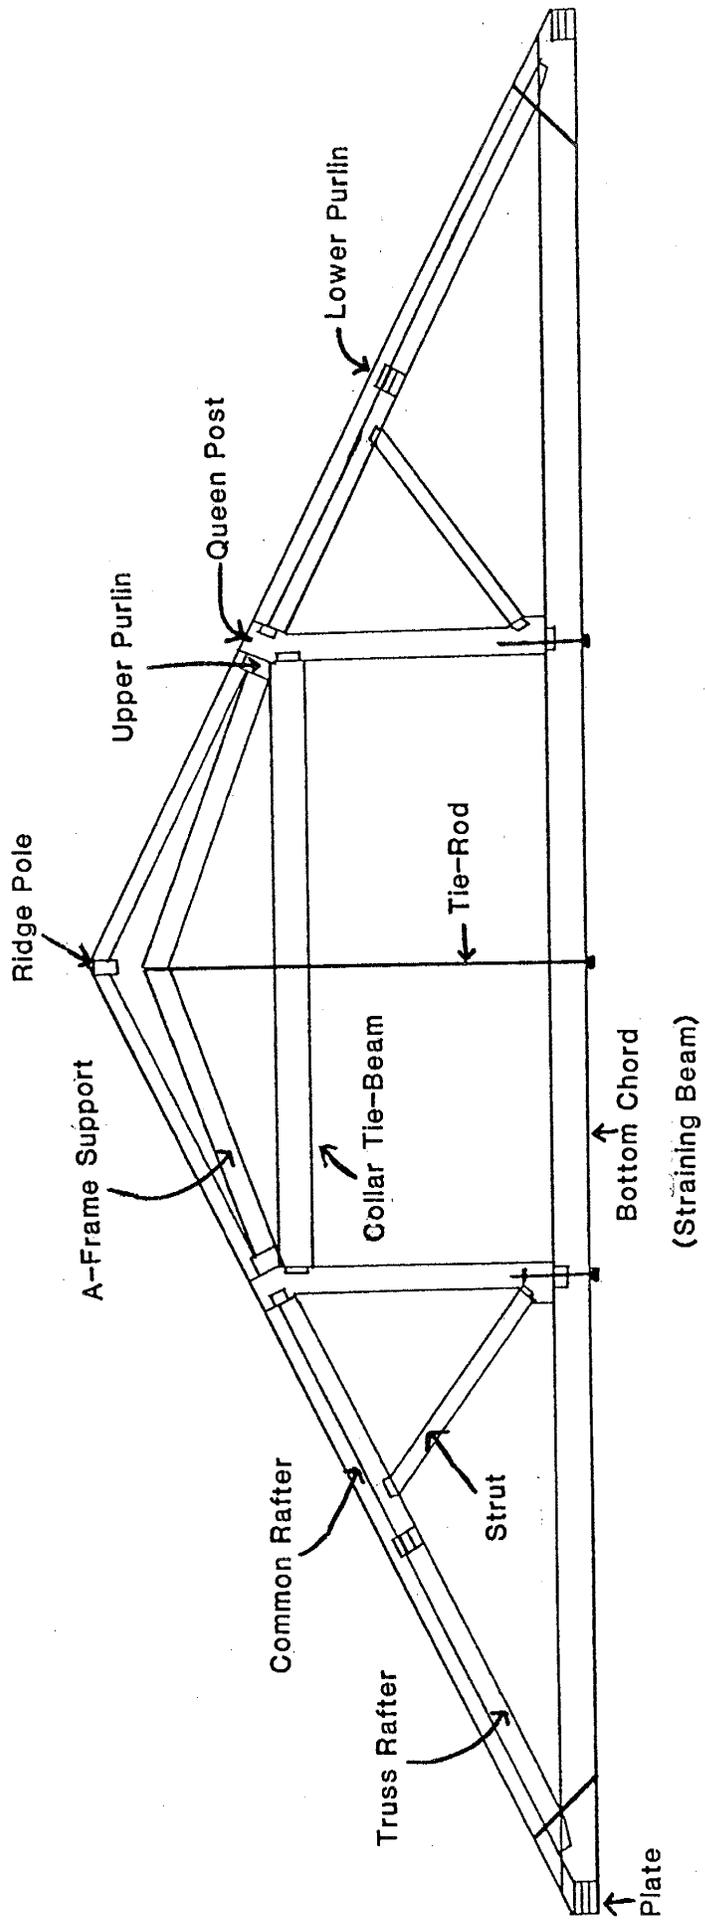
QUEEN-POST TRUSS

Building 19 - Long Storehouse and Stables, SPAR NHS, framing. Annotated by J. Quinn, 11/1/91, from original drawing dated to 1866.
