**Re: Vessel, “DESERT PRINCESS” Official Number 978704  
Alternate Hull Examination with Diver Video and UT Gauging/Diver Survey**

## ***M/V DESERT PRINCESS, O.N. 978704***

### **ALTERNATE HULL EXAMINATION (AHE) & ULTRASONIC GAUGING SURVEY**

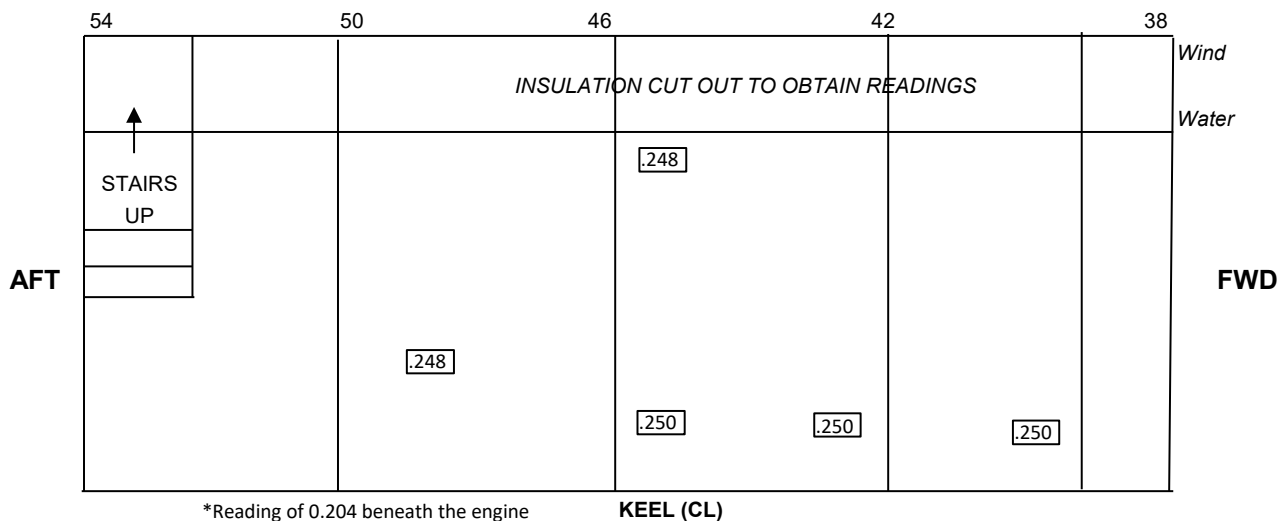
**PORT SIDE - VOID #4**

One area of note during the UT inspection was the PORT bow between Frames 0 and 2 which had pitting and readings of 0.194 inches compared to a nominal thickness of 0.250 inches. Another area of interest was the hull (beneath the engine) in void 4 with a thickness of 0.204 inches compared to a nominal thickness of 0.250 inches. The lower STARBOARD side had pitting and a reading of 0.216 inches compared to a nominal thickness of 0.250 inches on Frame 44. The STARBOARD intake between Frame 24 and Frame 22 had a deflection in the bottom that was 0.75-inches deep and 6-inches wide.

\*Reading of 0.204 beneath the engine
