## Structures

**Summary Analysis.** Four types of structures are present within the park. These include the remnant earthworks associated with the siege, large monuments such as state memorials, engineered features such as bridges and culverts, and a tensile structure.

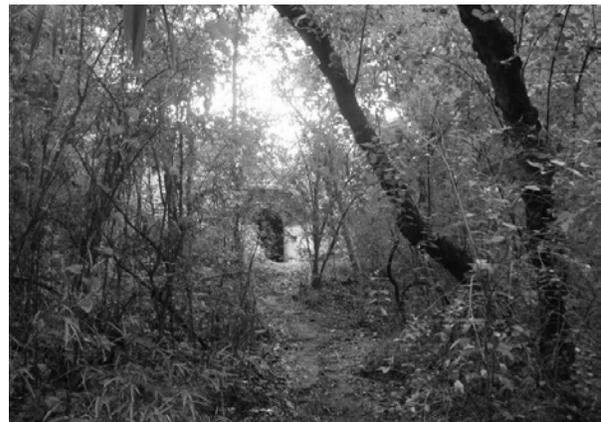
**FIGURE 221.** The same view, 2007. The tunnel and the road corridor that crosses it survive, but a large earthen mound to the right in the historic photograph appears to have been lost or removed, and there is far more woody vegetation.

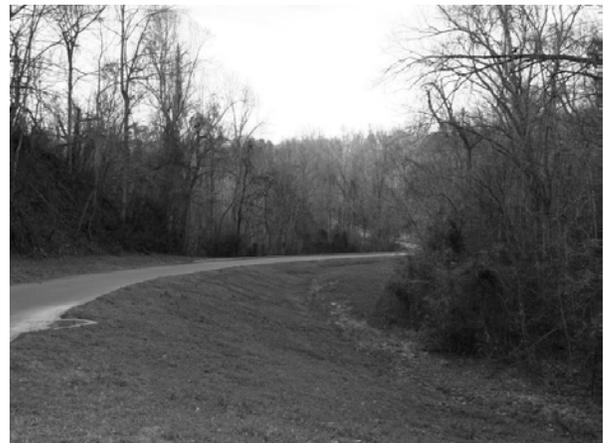
**FIGURE 223.** A similar view, 2007. Woody vegetation in the contemporary photograph obstructs views. The early bridge was removed and replaced circa 1970.

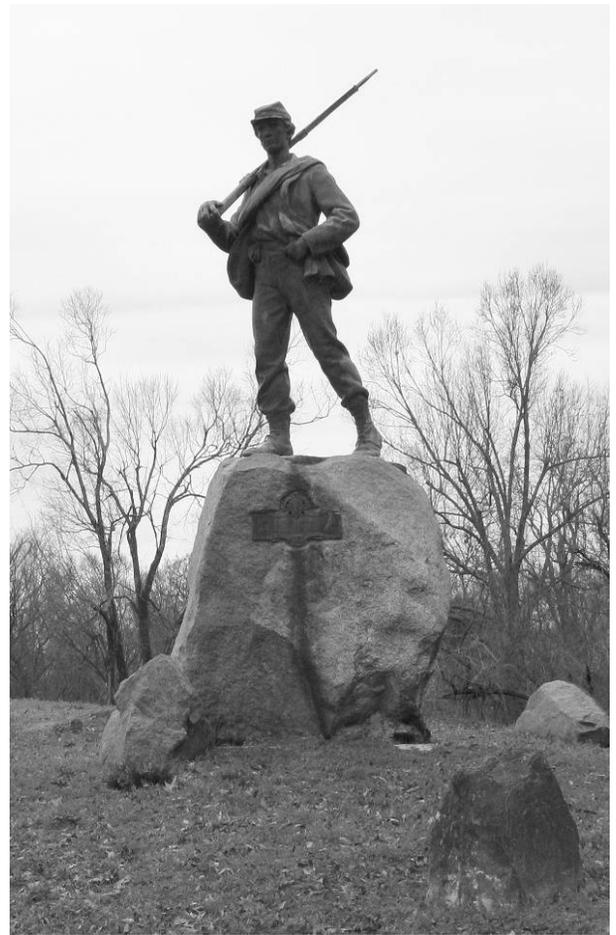
**FIGURE 225.** The same view, 2007. The monument appears to survive in good condition, although some of the boulders at the base of the monument shown in the historic image appear to have been moved in the 2007 image. Otherwise the primary difference in the views is the dramatic increase in vegetation seen behind the monument.

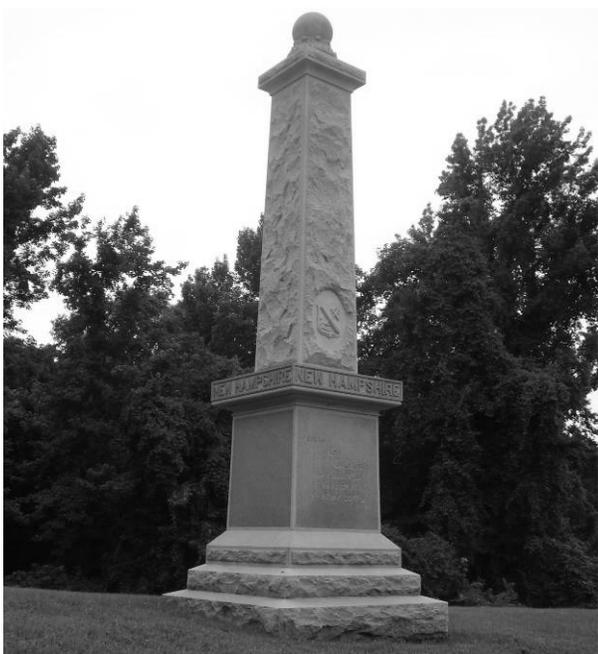
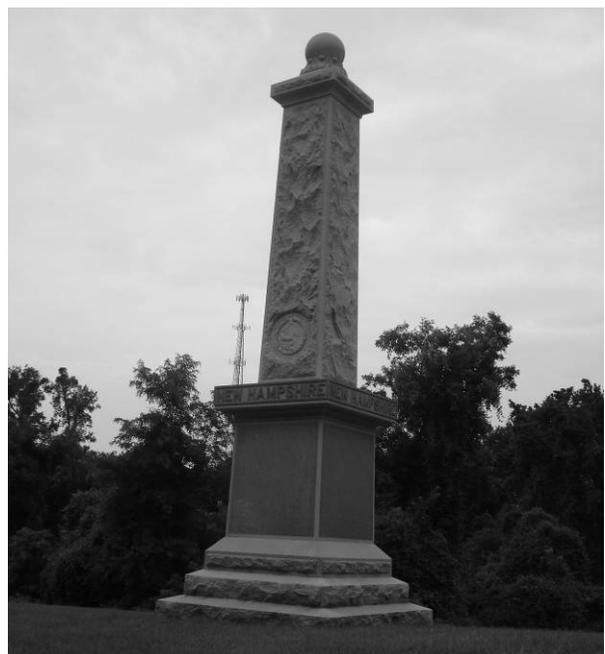
**FIGURES 228 and 229.** The New Hampshire State Memorial, similar views, 2007. Located with many other state monuments along Grant Circle, the New Hampshire State Memorial was the second state monument placed at the park. Both views indicate that the monument itself retains a high degree of integrity, and continues to be set on a knoll maintained in open turf lawn. Behind the monument both to the east and to the west, however, the setting has changed through the addition of extensive expanses of woodland. The woodland cover obscures views of the park to the west, and the rolling terrain to the east. In the contemporary view looking east, a transmission tower is visible in 2007 that was not present during the early twentieth century.

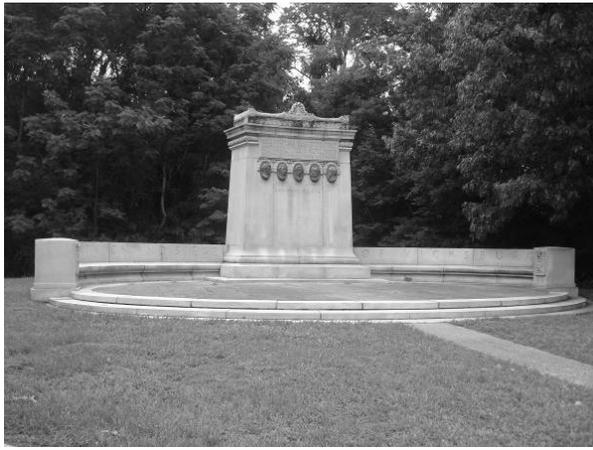
**FIGURE 232.** The same view, 2007. Dedicated in 1906, the Pennsylvania State Memorial is located along Grant’s Circle. The memorial survives with a high degree of integrity. Changes to the landscape include the addition of dense woodland vegetation behind the monument, and a narrow concrete walk leading to the monument from the road nearby. Historic maps indicate that a circle drive was intended for this monument, which is no longer present.

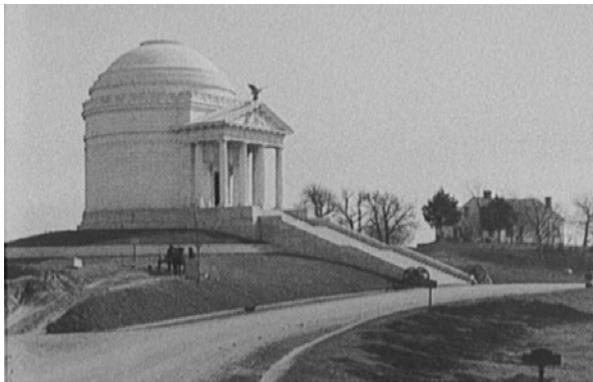
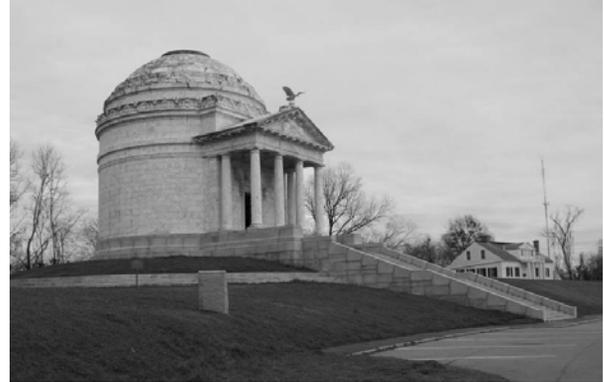
**FIGURE 233 and 234.** Left: The Illinois State Memorial, looking east toward the Shirley House, circa 1910–1920. Right: The same view, 2007. Dedicated in 1906, the Illinois State Memorial is one of the largest and most ornate state monuments in the park. Changes that have occurred in association with the monument over time include the addition of a parking area in front of the monument, a shift in the alignment of Jackson Road fronting the monument, revegetation of an access route leading around the western side of the memorial with grass, loss of trees edging the Shirley House precinct beyond the monument, and the addition of a transmission tower in the far distant view. Cannon that once flanked the stairs leading to the memorial are no longer present. There are many more trees visible behind the monument in the 2007 photograph than in the historic image.

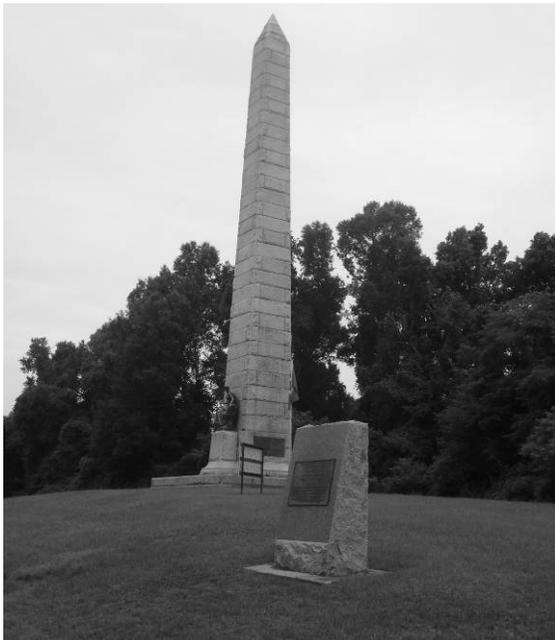
**FIGURE 237.** The Minnesota State Monument, looking south, 2007. Erected in 1907, the Minnesota State Monument was recently recognized for its centennial. Comparison of historic and contemporary views of the monument indicates the changes that have occurred to the structure and its setting over the past 100 years. The contemporary photograph includes temporary interpretive signage marking the centennial. The photographs suggest that the monument itself is little changed since its dedication. In addition, it continues to be sited on a broad, gently-sloping knoll maintained in turf grass that edges Union Avenue. Changes to its setting include the large increase in woodland behind the monument, loss of the circle drive that once afforded views of the monument from all sides, and the more open nature of the knoll that allowed for these views.

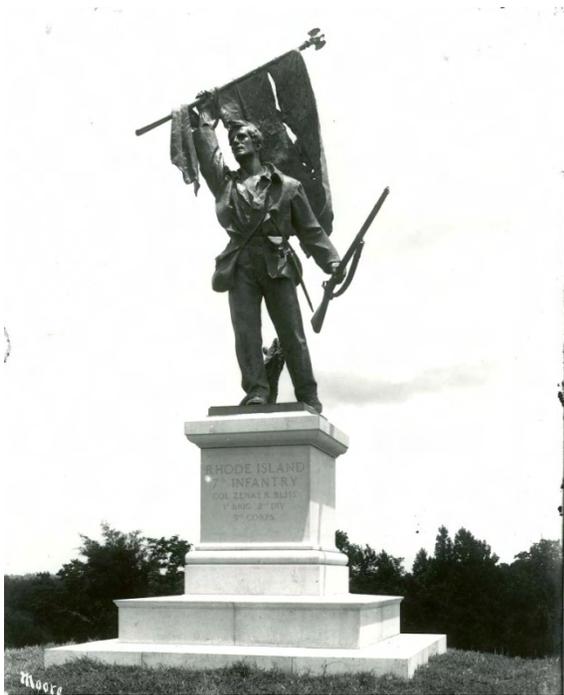
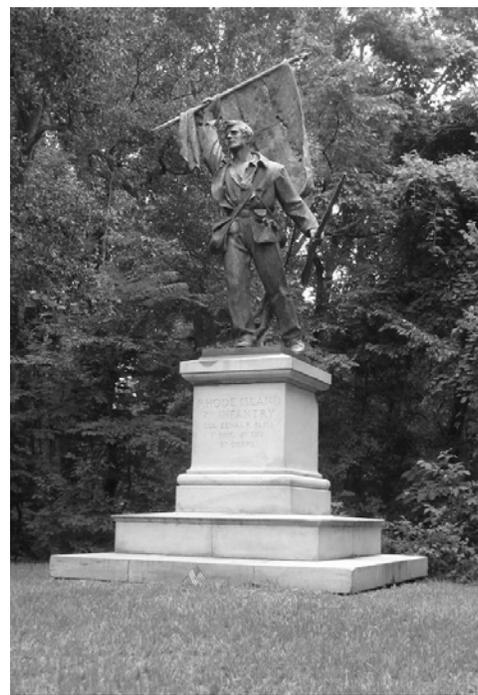
**FIGURE 238 and 239.** The Rhode Island State Memorial, looking east, 1908; and the same view, 2007. The Rhode Island State Memorial is located along Grant Avenue near Grant Circle. It was dedicated in 1908. Comparison of an early twentieth century view and a 2007 photograph from a similar perspective suggests that the monument survives in good condition. Once again, tree cover behind the monument is far more extensive, changing the character of the monument's setting.

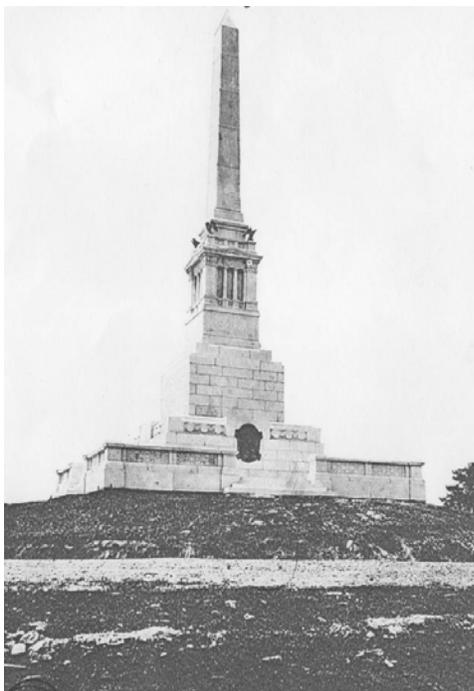
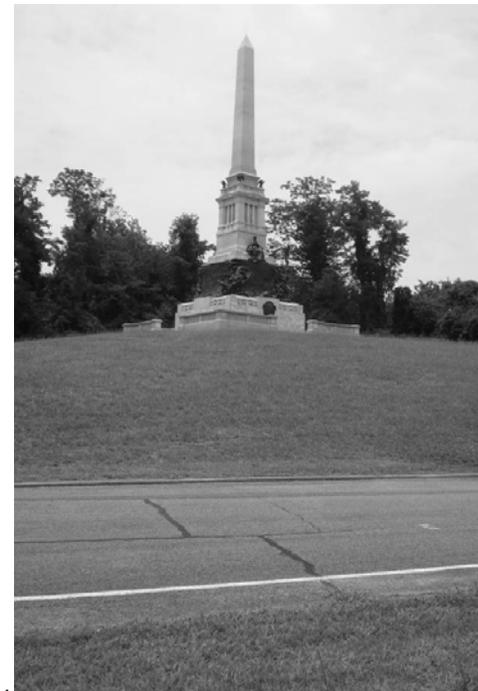
**FIGURE 240 and 241.** The Mississippi State Memorial, looking northwest, 1908; and the same view, 2007. Dedicated in 1909, this memorial is located along Confederate Avenue. A postcard dated 1908 illustrates the monument soon after its construction in 1907. Comparison of the postcard with a similar view suggests that the road may have been realigned away from the monument at some point. Once again, tree cover behind the monument is more extensive in the contemporary view than in the historic image. Bronze sculpture known to have been installed in 1912 is absent from the monument in the historic view.

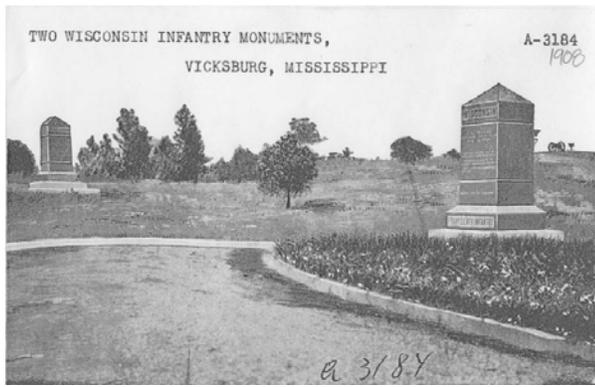
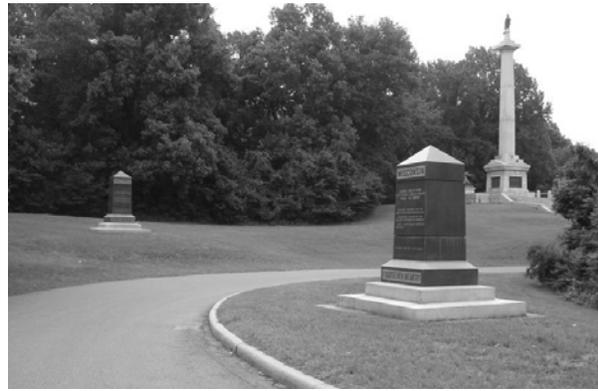
**FIGURE 242 and 243.** Left: Wisconsin Infantry Monuments flanking Union Avenue, looking northeast, 1908. Right: The same view, 2007. Much of the landscape retains its historic character of 100 years ago. Union Avenue retains a similar character and alignment, although the road has since been surfaced with asphalt and curbing along the uphill side of the road in the historic view has been removed. The predominant land cover is turf grass in both images. However, the historic image suggests that meadow grasses and flowering bulbs formerly grew at the base of the monument. The postcard predates construction of the Wisconsin State Memorial, which appears in the 2007 photograph. The earlier view indicates the open nature of the knoll behind the monuments that is now wooded.

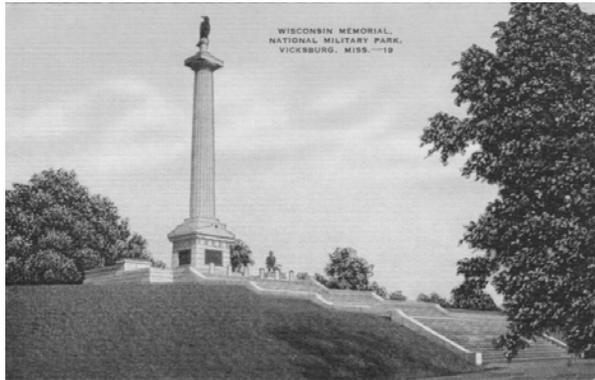
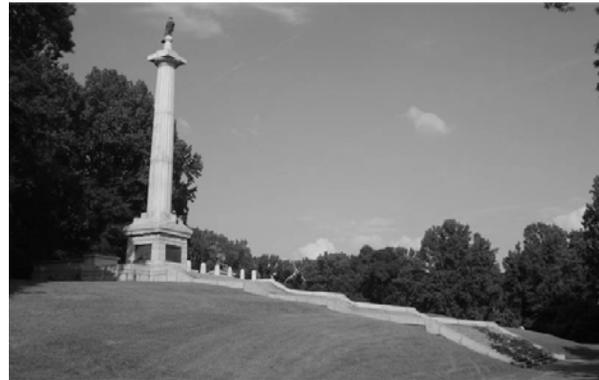
**FIGURE 244 and 245.** Left: The Wisconsin State Memorial, looking east, circa 1912. Right: The same view, 2007. The Wisconsin State Memorial was erected in 1911. The memorial remains remarkably consistent in appearance since its construction. Like many of the park's memorials, the setting around the monument continues to be maintained in turf lawn, but trees are seen to have encroached on the landscape behind the monument by 2007. The original circle drive that afforded views of the monument from all sides is no longer extant.

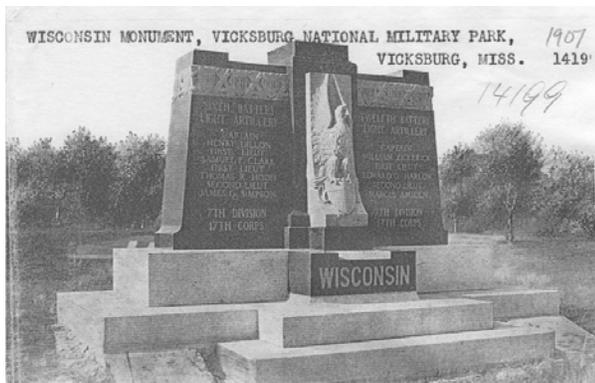
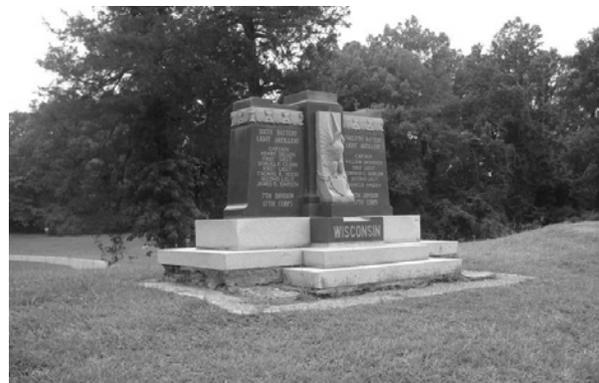
**FIGURE 246 and 247.** Left: The Wisconsin Twelfth Battery Monument, looking southwest, 1907. Right: The same view, 2007. Sited on a knoll overlooking Union Avenue, the monument marks the location of a Federal battery. Comparison of the views shows that the monument base was altered through the placement of a concrete apron to protect the monument from damage by mowers. The setting for this monument is changed by the growth of trees, although the 1907 view shows a grove of young trees near the monument.

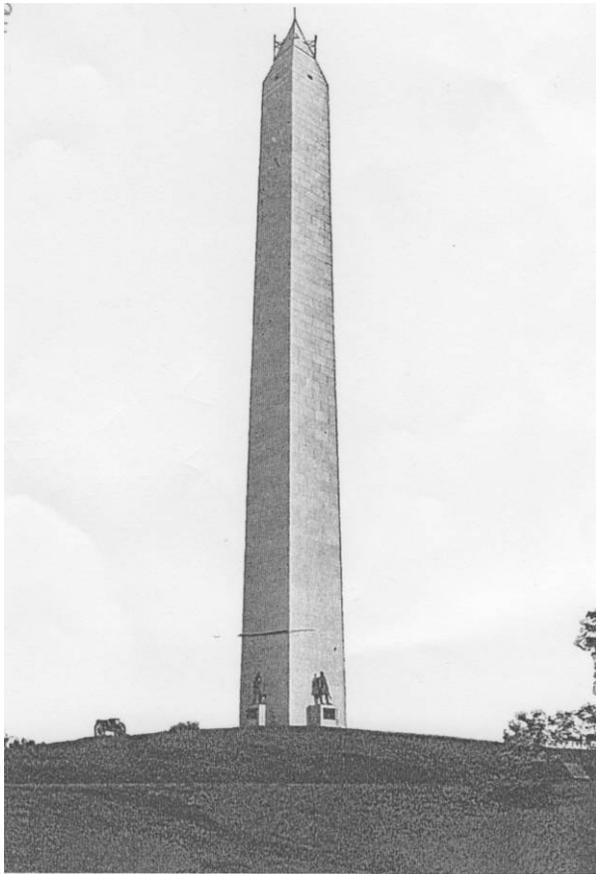
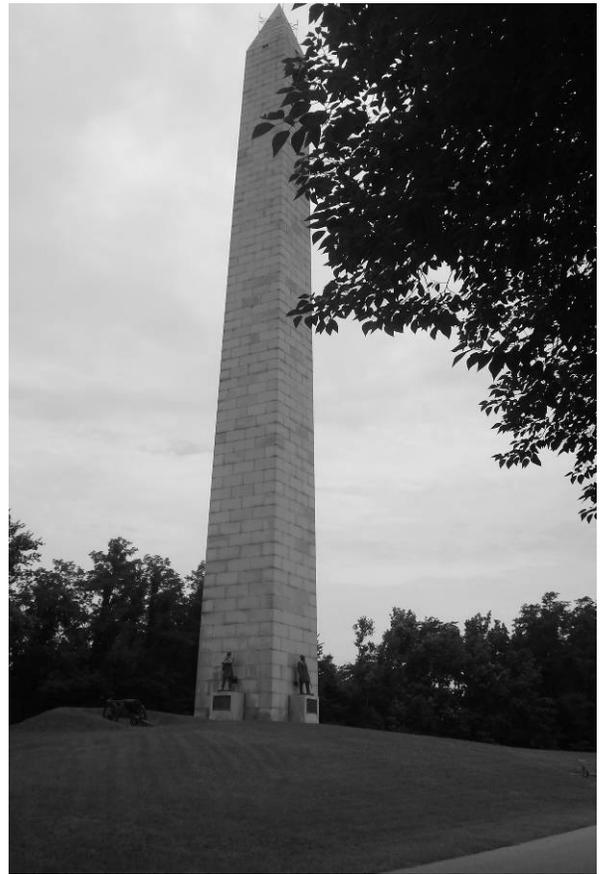
**FIGURE 248 and 249.** Union Navy Memorial, looking west, 1911; and the same view, 2007. The Union Navy Memorial was constructed in 1911. The monument remains consistent in appearance from its original design and construction. The setting for the monument, however, has changed through the establishment of woodland on the slopes behind the monument.

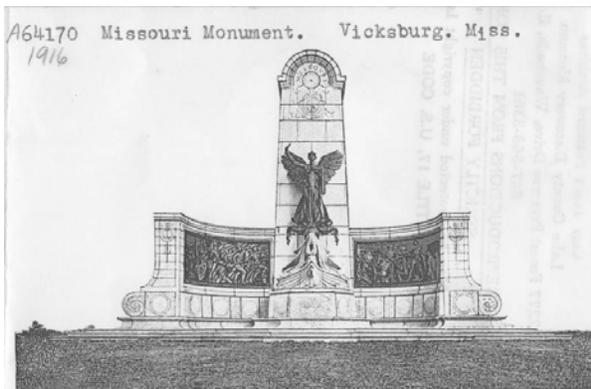
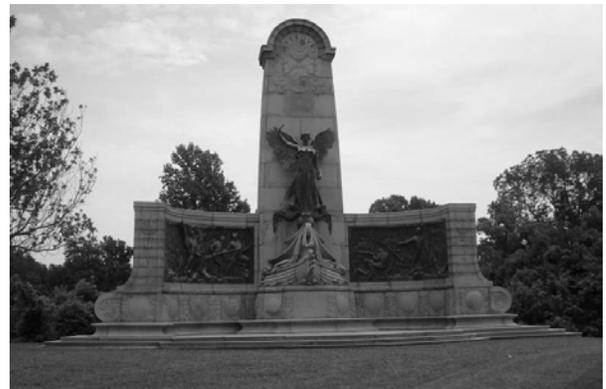
**FIGURE 250 and 251.** Left: The Missouri State Memorial, looking southeast, circa 1916. Right: The same view, 2007. Dedicated in 1917, this monument is located along Confederate Avenue south of Stockade Redan. The monument survives with a good degree of integrity, although the monument's setting has changed due to the growth of woody vegetation behind it. Visitor appreciation of the monument has been affected by the reorientation of Confederate Avenue. Designed to be viewed from the south, the monument is now approached from the north, altering the intention of the designed view of the monument.

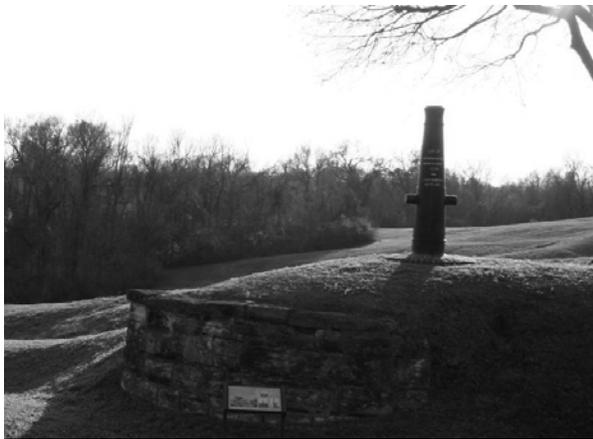
**FIGURE 253.** Attempt to photograph a similar view, 2007. This pair of images suggests a great degree of change has occurred in the landform and topography below the monument. Given the more steeply sloped landscape below the monument in the historic image, this photograph may have been taken from a different angle. However, the monument and its surrounding stone wall appear similar in the two images.

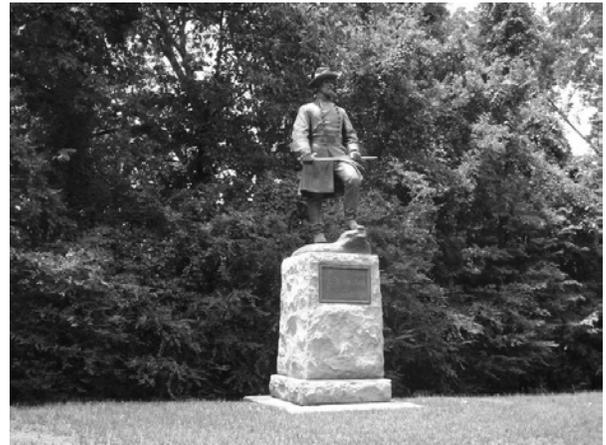
**FIGURE 255.** A similar view, 2007, along the South Loop of Confederate Avenue. The statue appears to retain a high degree of integrity. Tree cover behind the monument is extensive in the contemporary view.

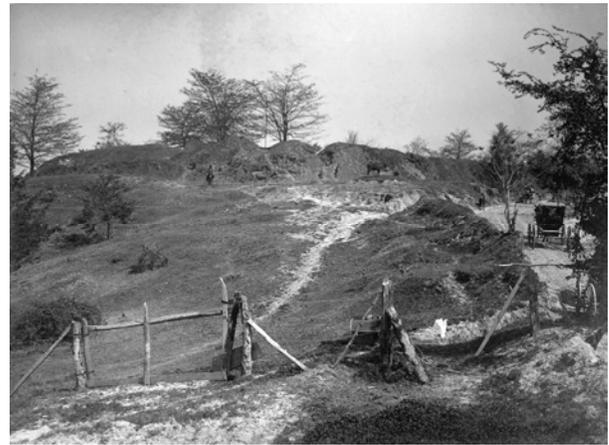
**FIGURE 265.** View of erosion at South Fort, circa 1899.
