National Park Service
U.S. Department of the Interior

Yosemite National Park
California

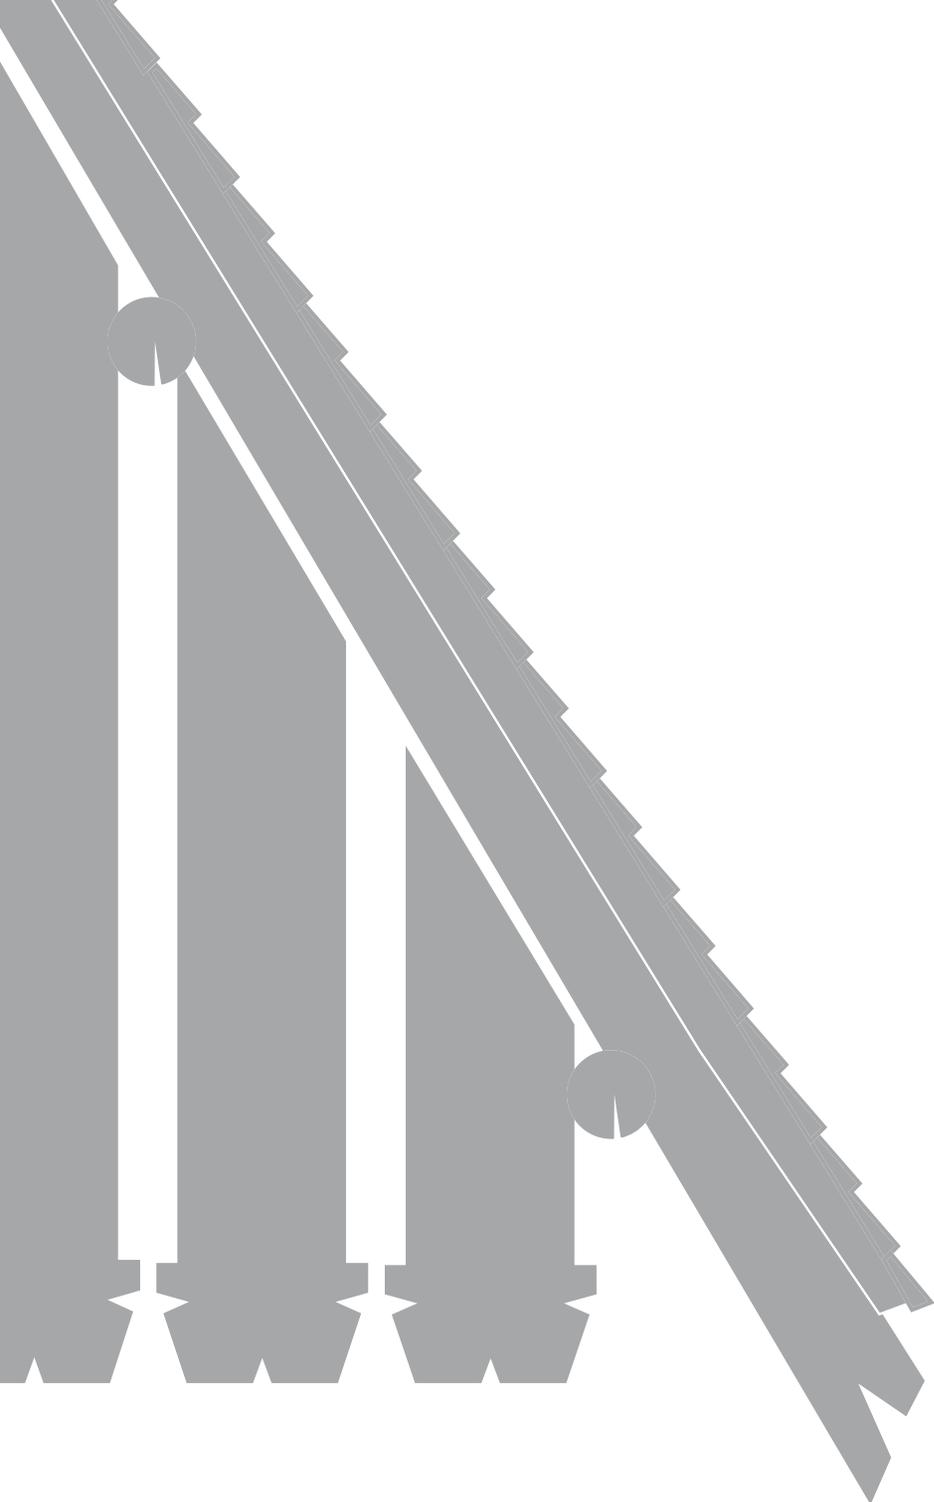
This HSR was funded by a grant from the National Park Service Cultural Resources Preservation Program.

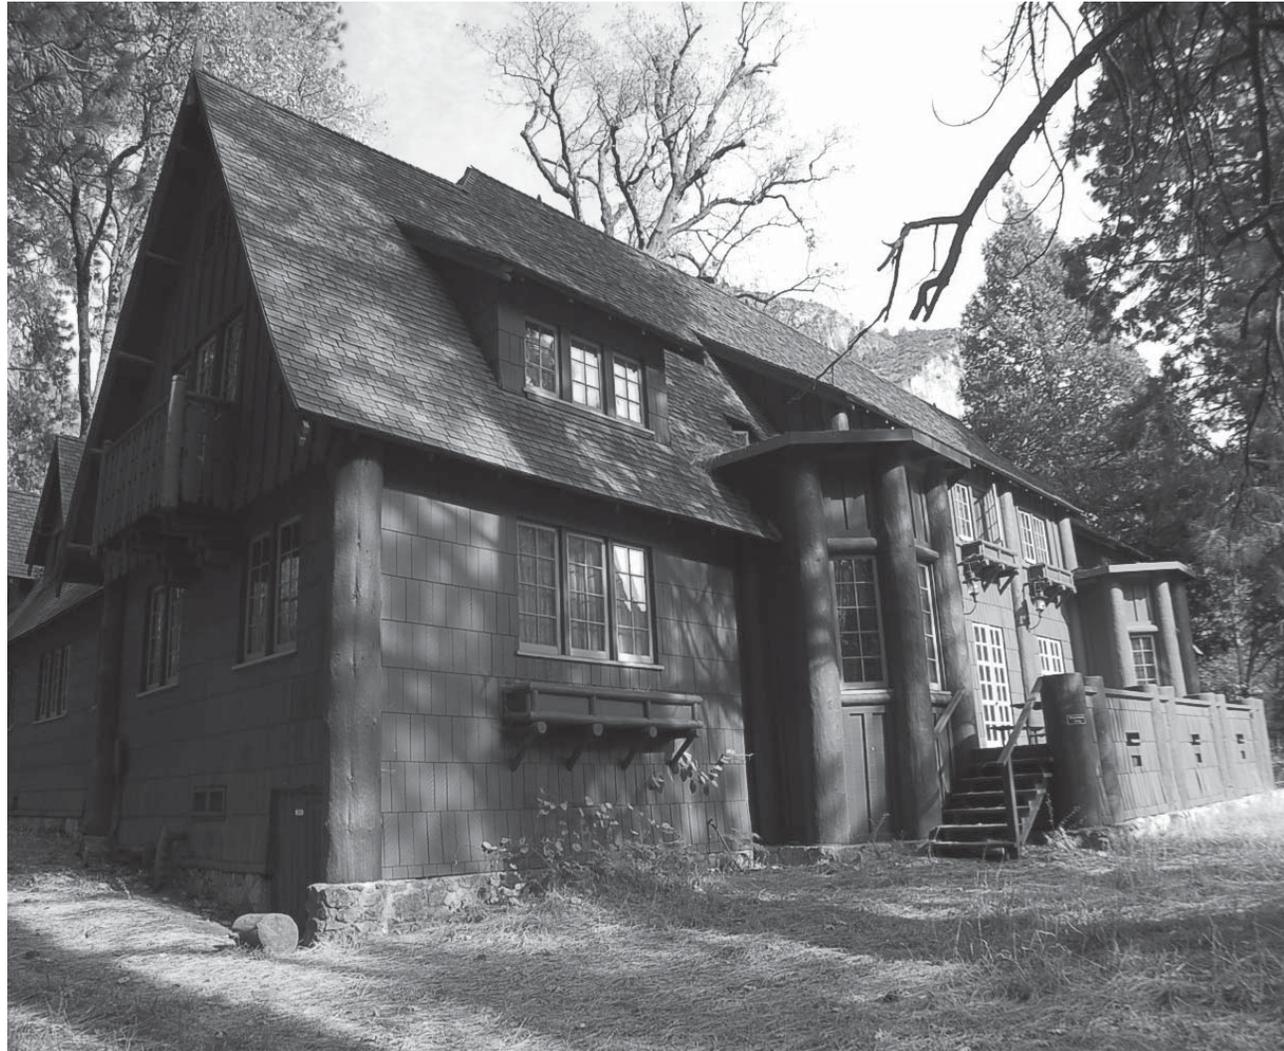
Figure 1.3: Southwest view of clubhouse (Jaramillo, 2009)

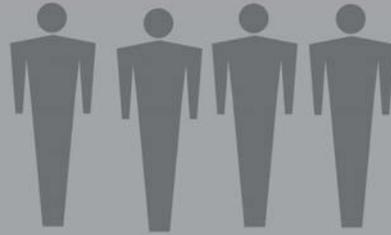
FORT YOSEMITE
CAVALRY

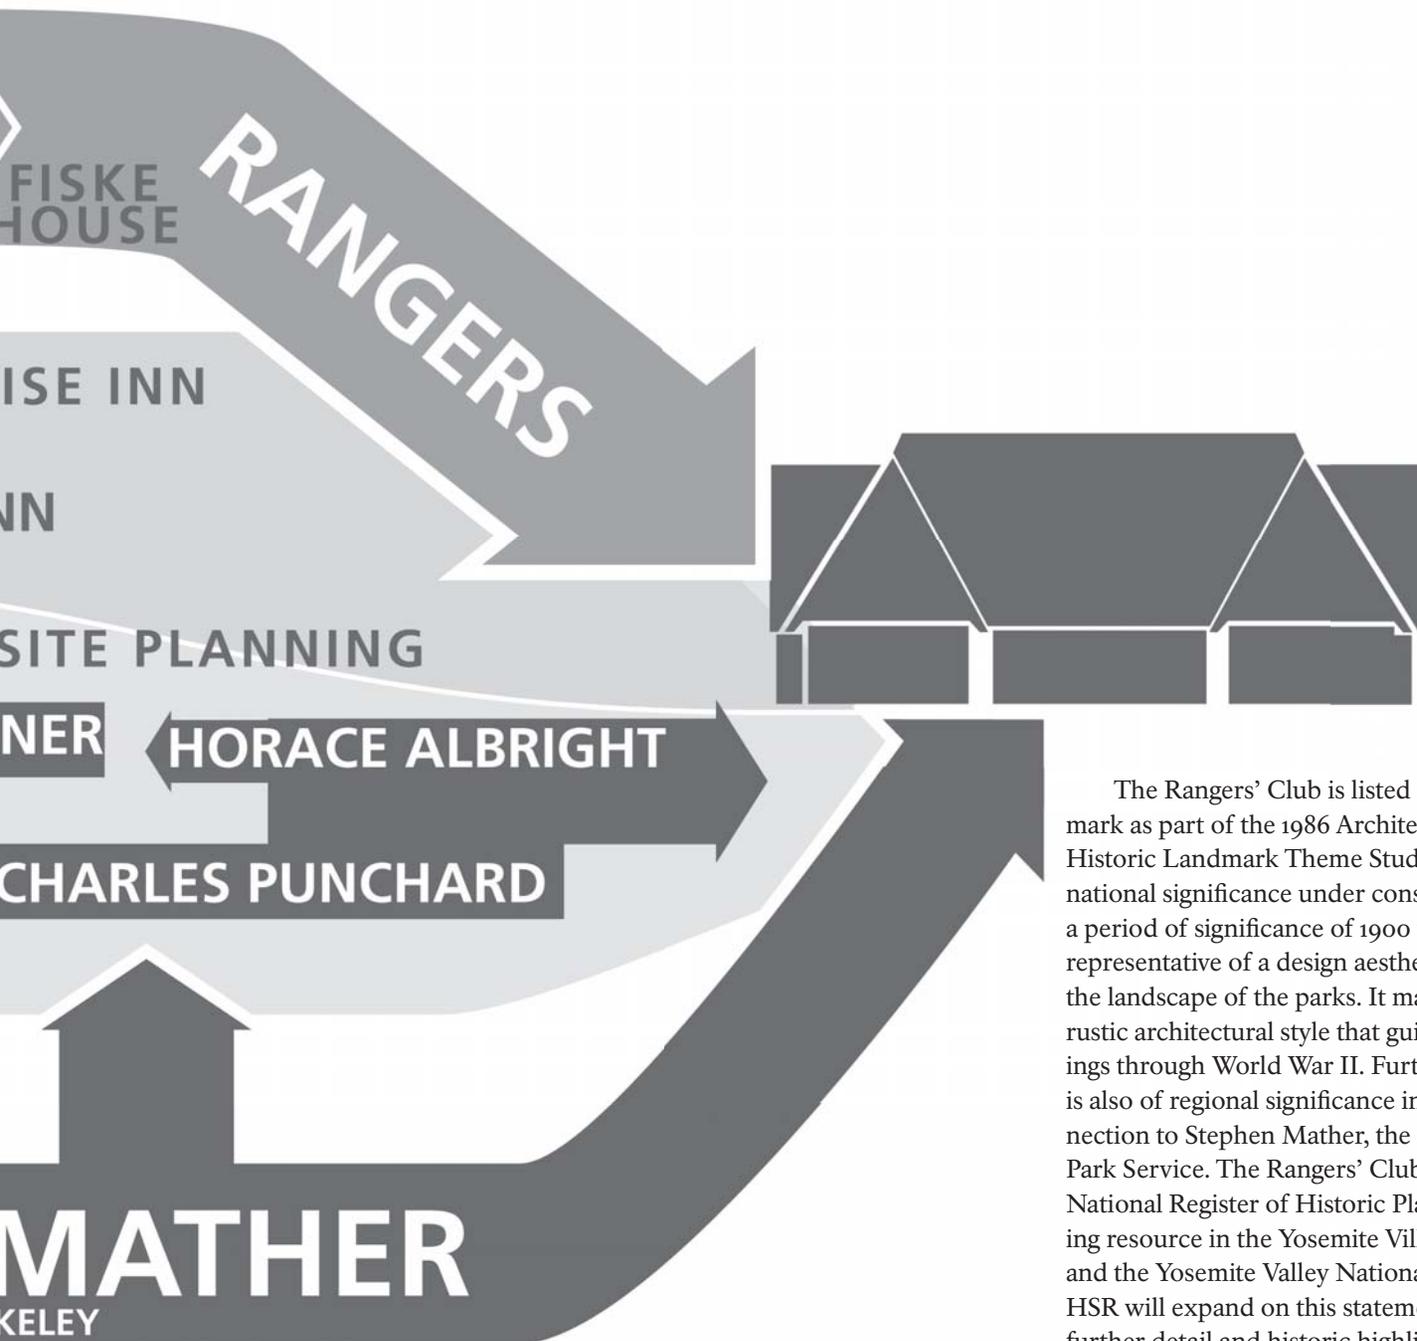
STEPHEN
UNIVERSITY OF CALIFORNIA-BERK

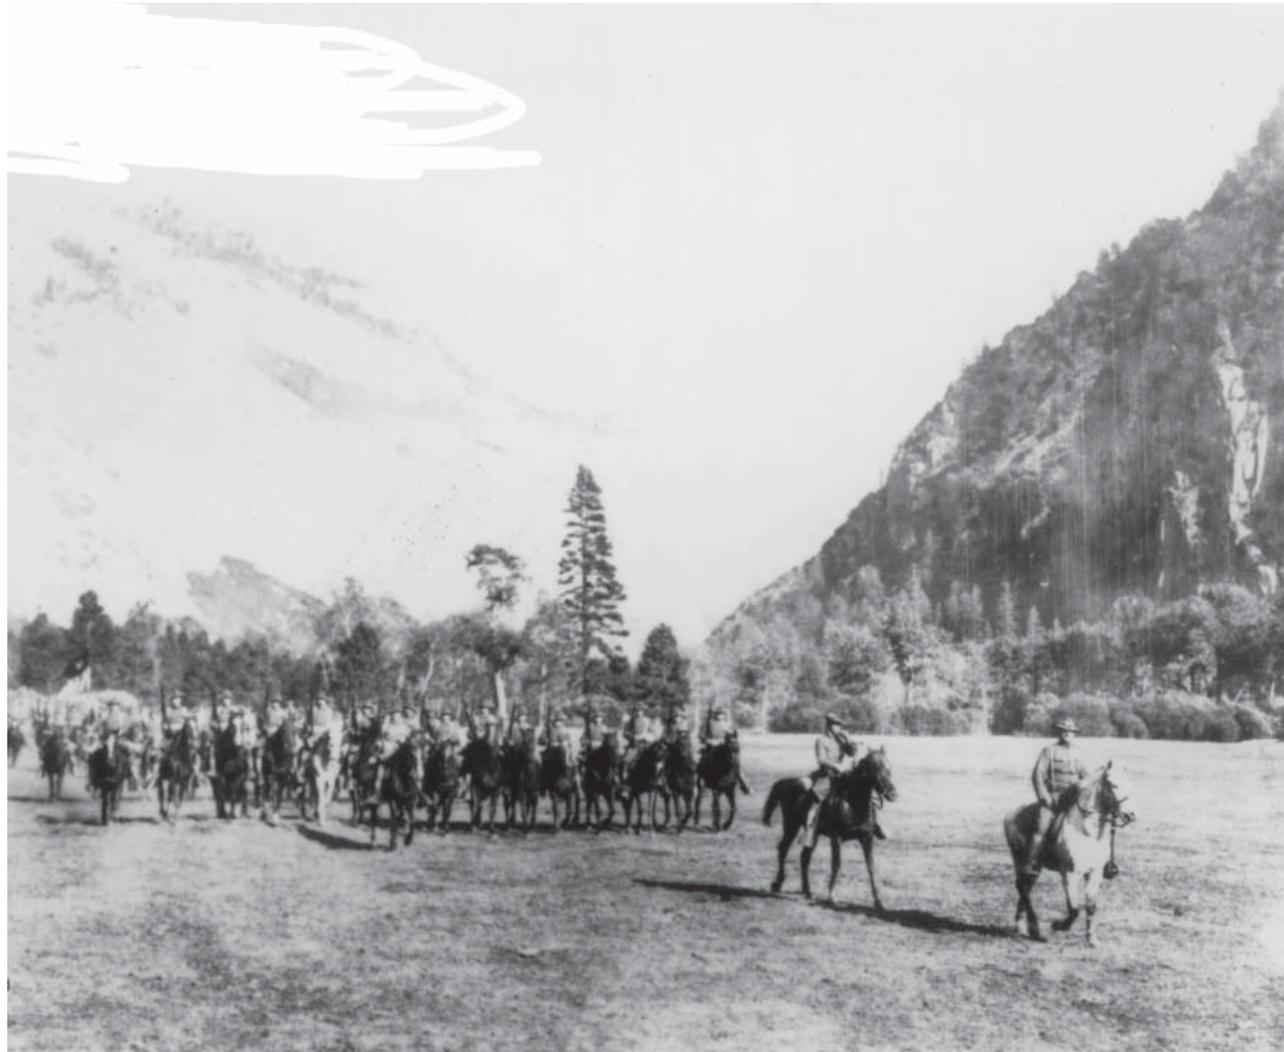
Figure 3.3: 14th Cavalry near Camp Yosemite, date unknown (YRL 04399)

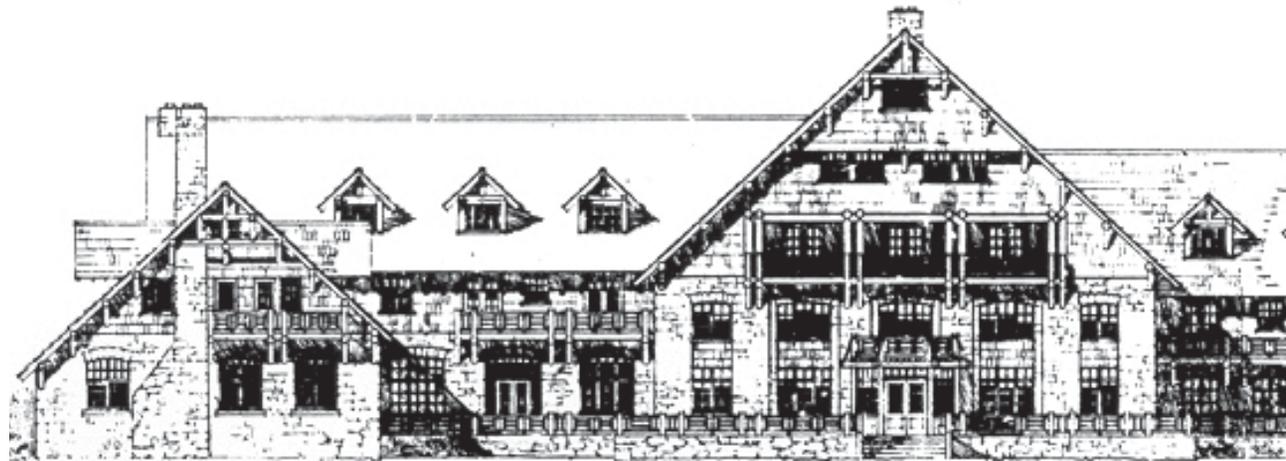
One of the earliest structures designed for Yosemite Valley was the Sierra Club’s LeConte Memorial Lodge. Built in 1903, the lodge is a memorial to Joseph LeConte the famous geologist and one of the founders of the Sierra Club. Designed by John White, Bernard Maybeck’s brother-in-law and a member of the Maybeck firm, the lodge is a compact masonry building constructed of native granite. Its distinctive roofline and gabled wings, along with the medieval flavor of the building’s detailing has led some scholars to classify the building as “Tudor Revival”. The interior reflects the influence of the Bay Area Arts and Crafts movement with its use of native materials, high ceilings, and open wooden truss work. During the early 20th century the lodge served as the meeting place for the Sierra Club and as the park’s first visitor center.

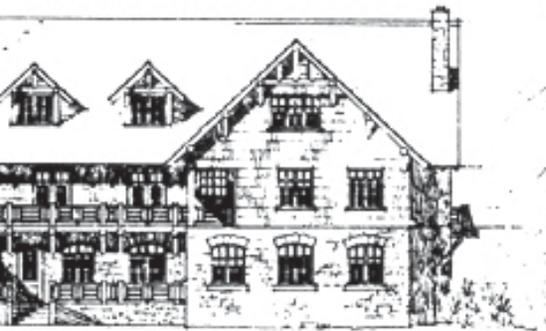
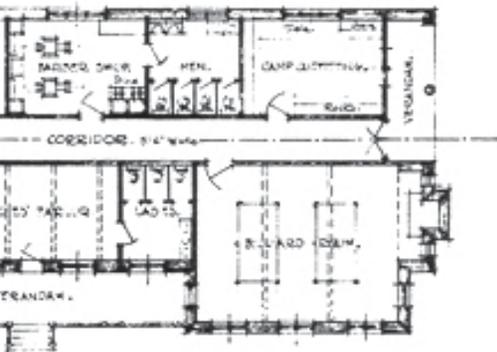
PROPOSED HOTEL FOR PARADISE VALLEY,
RAINIER PARK, WASH. for MR. REESE.
PLANS BY MR. MARK DANIELS

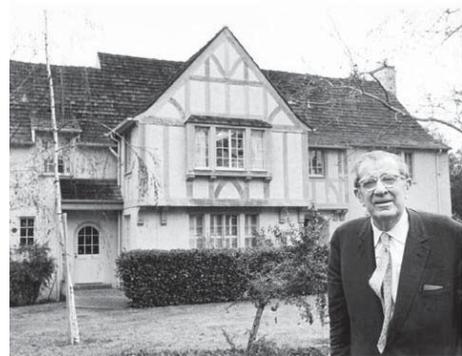
Figure 3.13 & 3.14:
Sumner (Palo Alto
Historical Society,
2008)

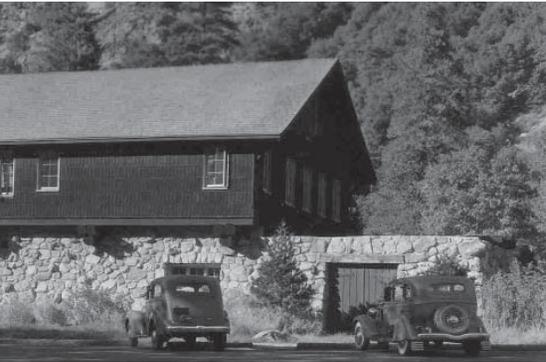
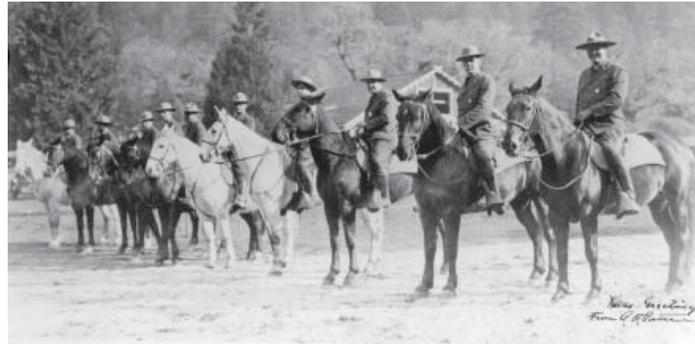
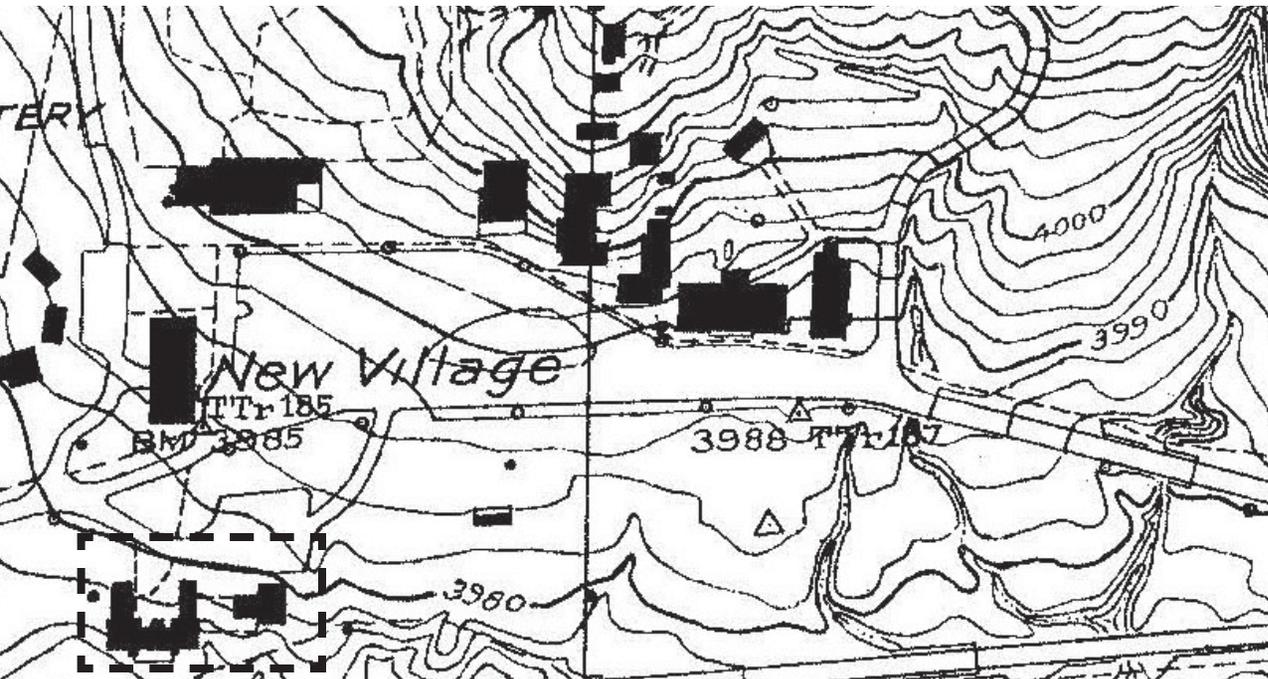
Through the following years life in the Rangers' Club ebbed and flowed adapting to the needs of the rangers, the effects of nature and the whims of park management. Above all, by continuing in its original purpose for ninety years, the building has provided a continuing witness to the determination of one man and his desire to create a professional and dedicated National Park Service.

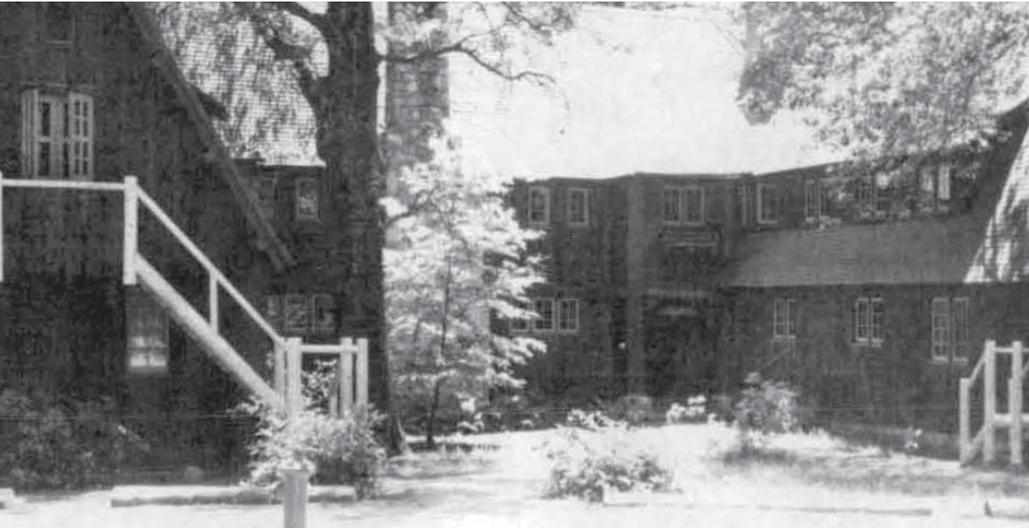
1947 Installation of fire escapes

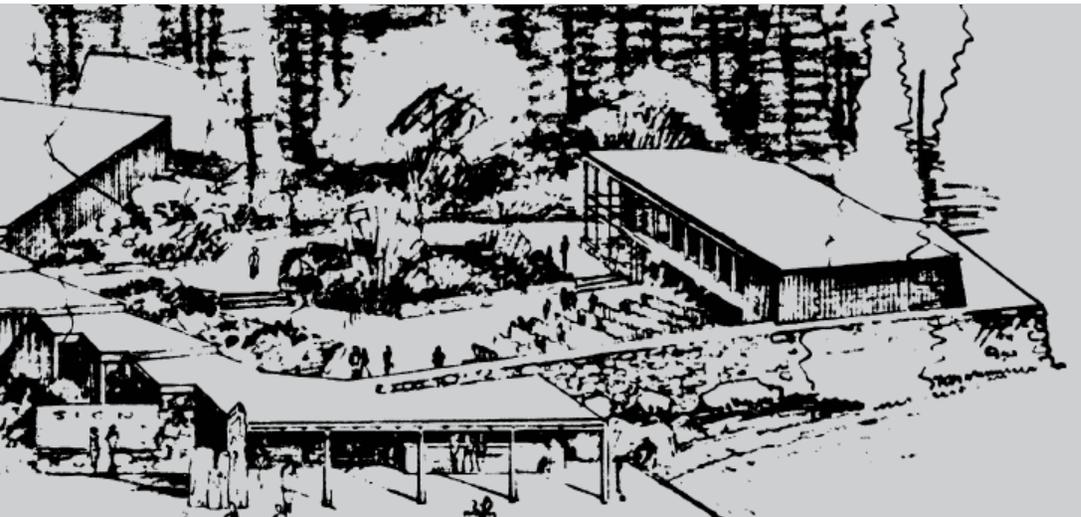
1961 Design of Visitor Center

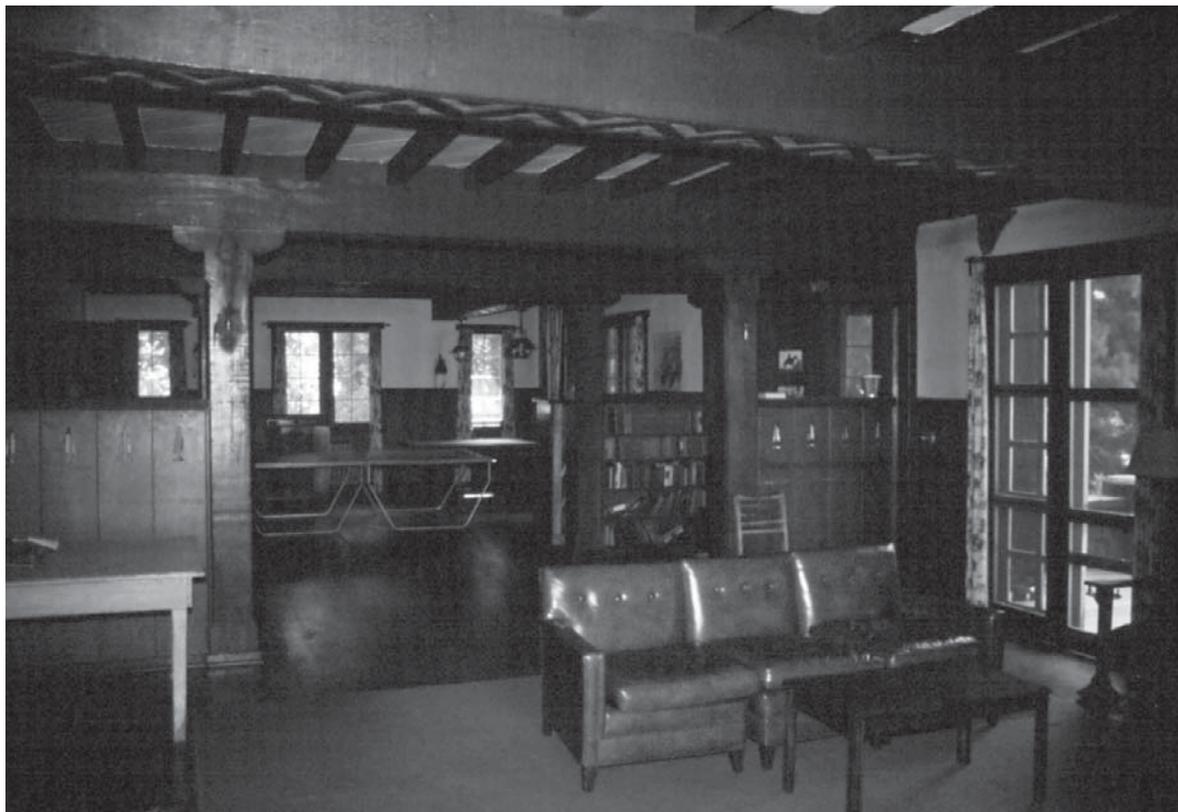
Figure 4.1: Interior of great room, 1966 (Yosemite Archives)

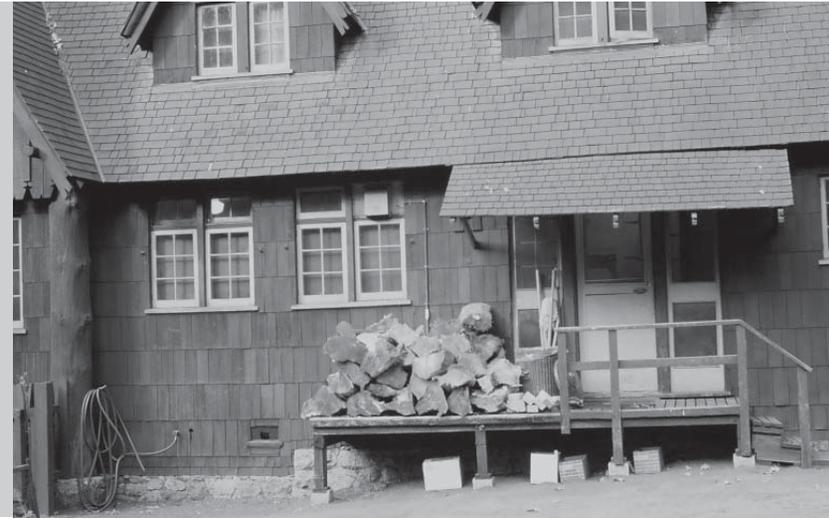
1970s Service porch with deterioration

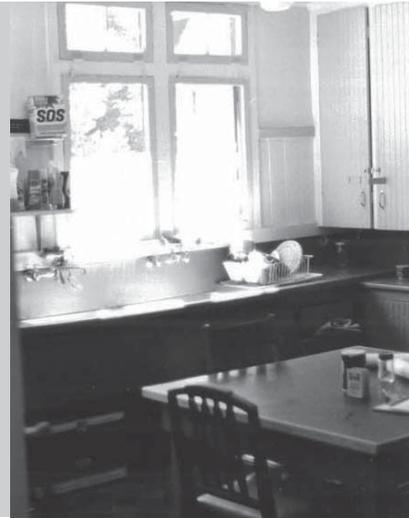
1972 Kitchen prior to renovation

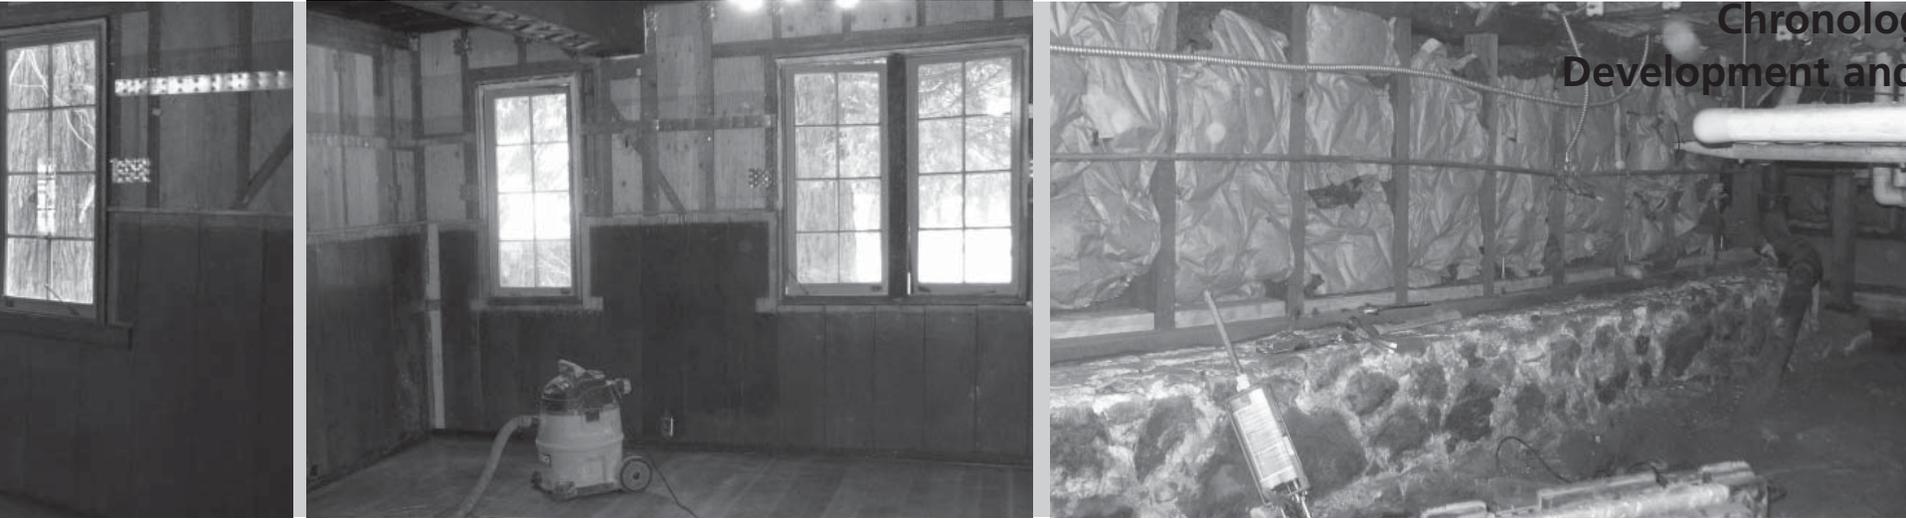
In 2008 as part of an upgrade to many structures in the park, the clubhouse underwent a seismic retrofit. The work included stabilization of numerous walls with plywood and structural hardware, as well as reinforcement of the existing stone foundation with concrete. Baseboards, wainscoting and other architectural details that had been removed to install the plywood and structural hardware were reinstalled.¹⁴ The work kept much of the addition hidden and large portion of the historic fabric remains intact.

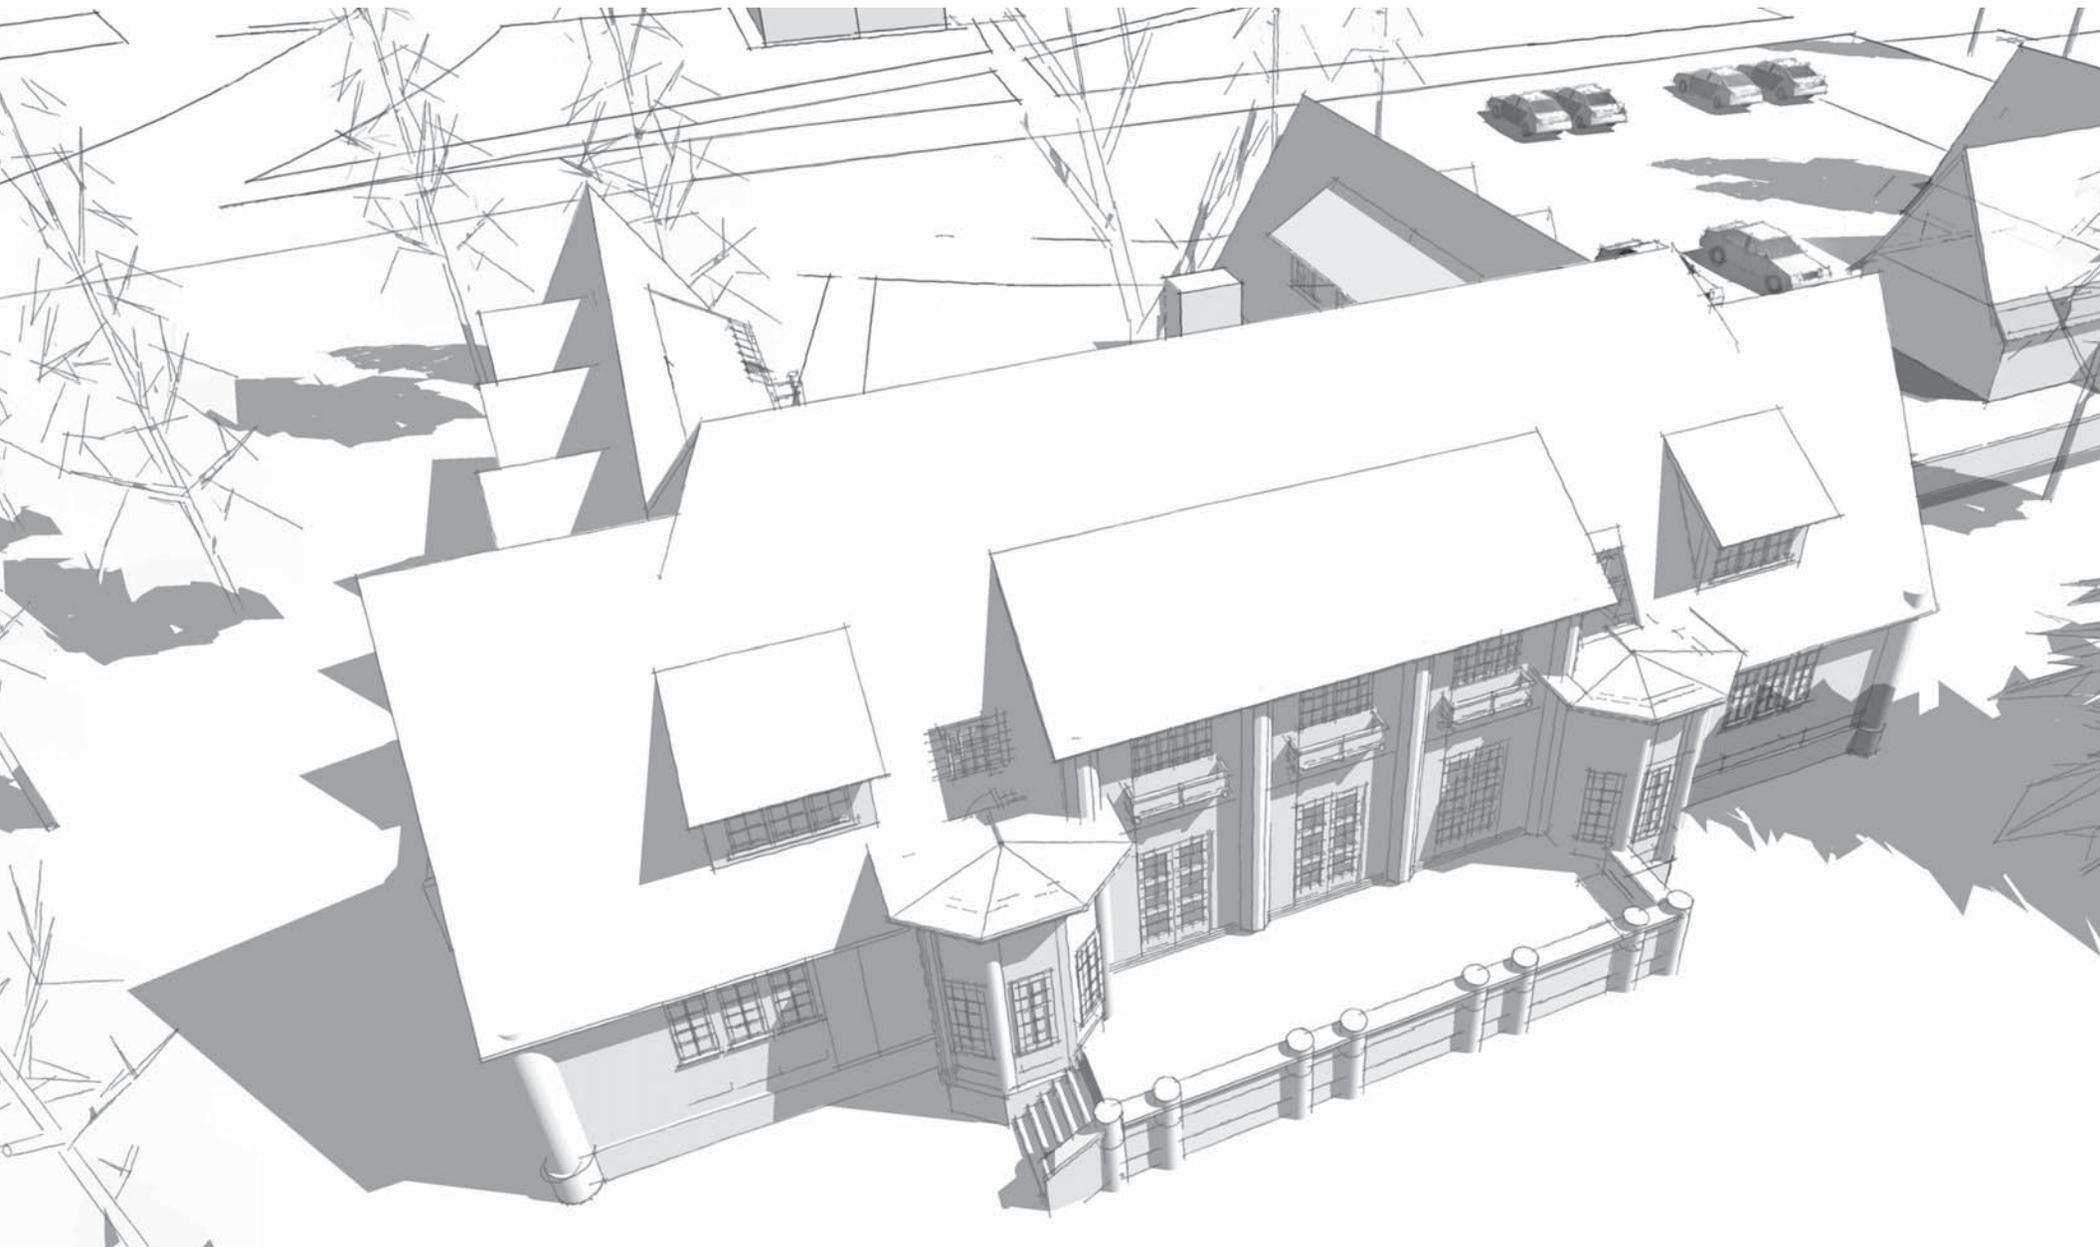
¹⁴ Martin and Martin Consulting Engineers. "Seismic Evaluation, Rangers' Club." Yosemite National Park, 2001.

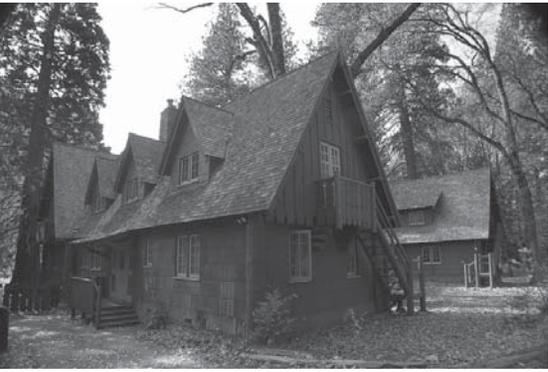
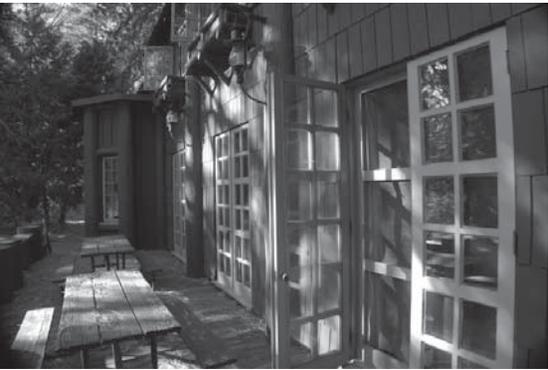
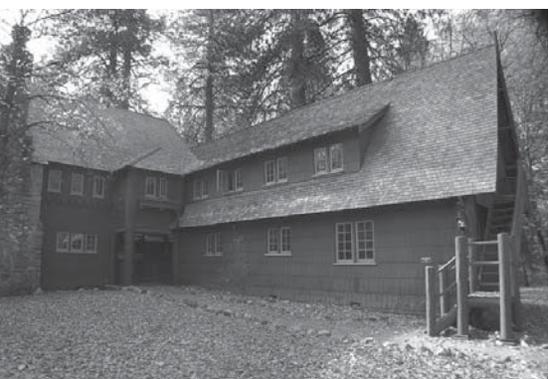
The granite stone foundation varies in height from a few inches to a few feet as the site slopes south. The foundation extends by several inches beyond the face of walls in some areas, and beyond all the pilasters. The roofing material on pitched roofs is cedar shingles. The edges of the pitched roof surfaces flare out slightly due to an extra layer of shingles. A built-up roof material is used on the flat roofs on the bays extending south on each side of the porch.

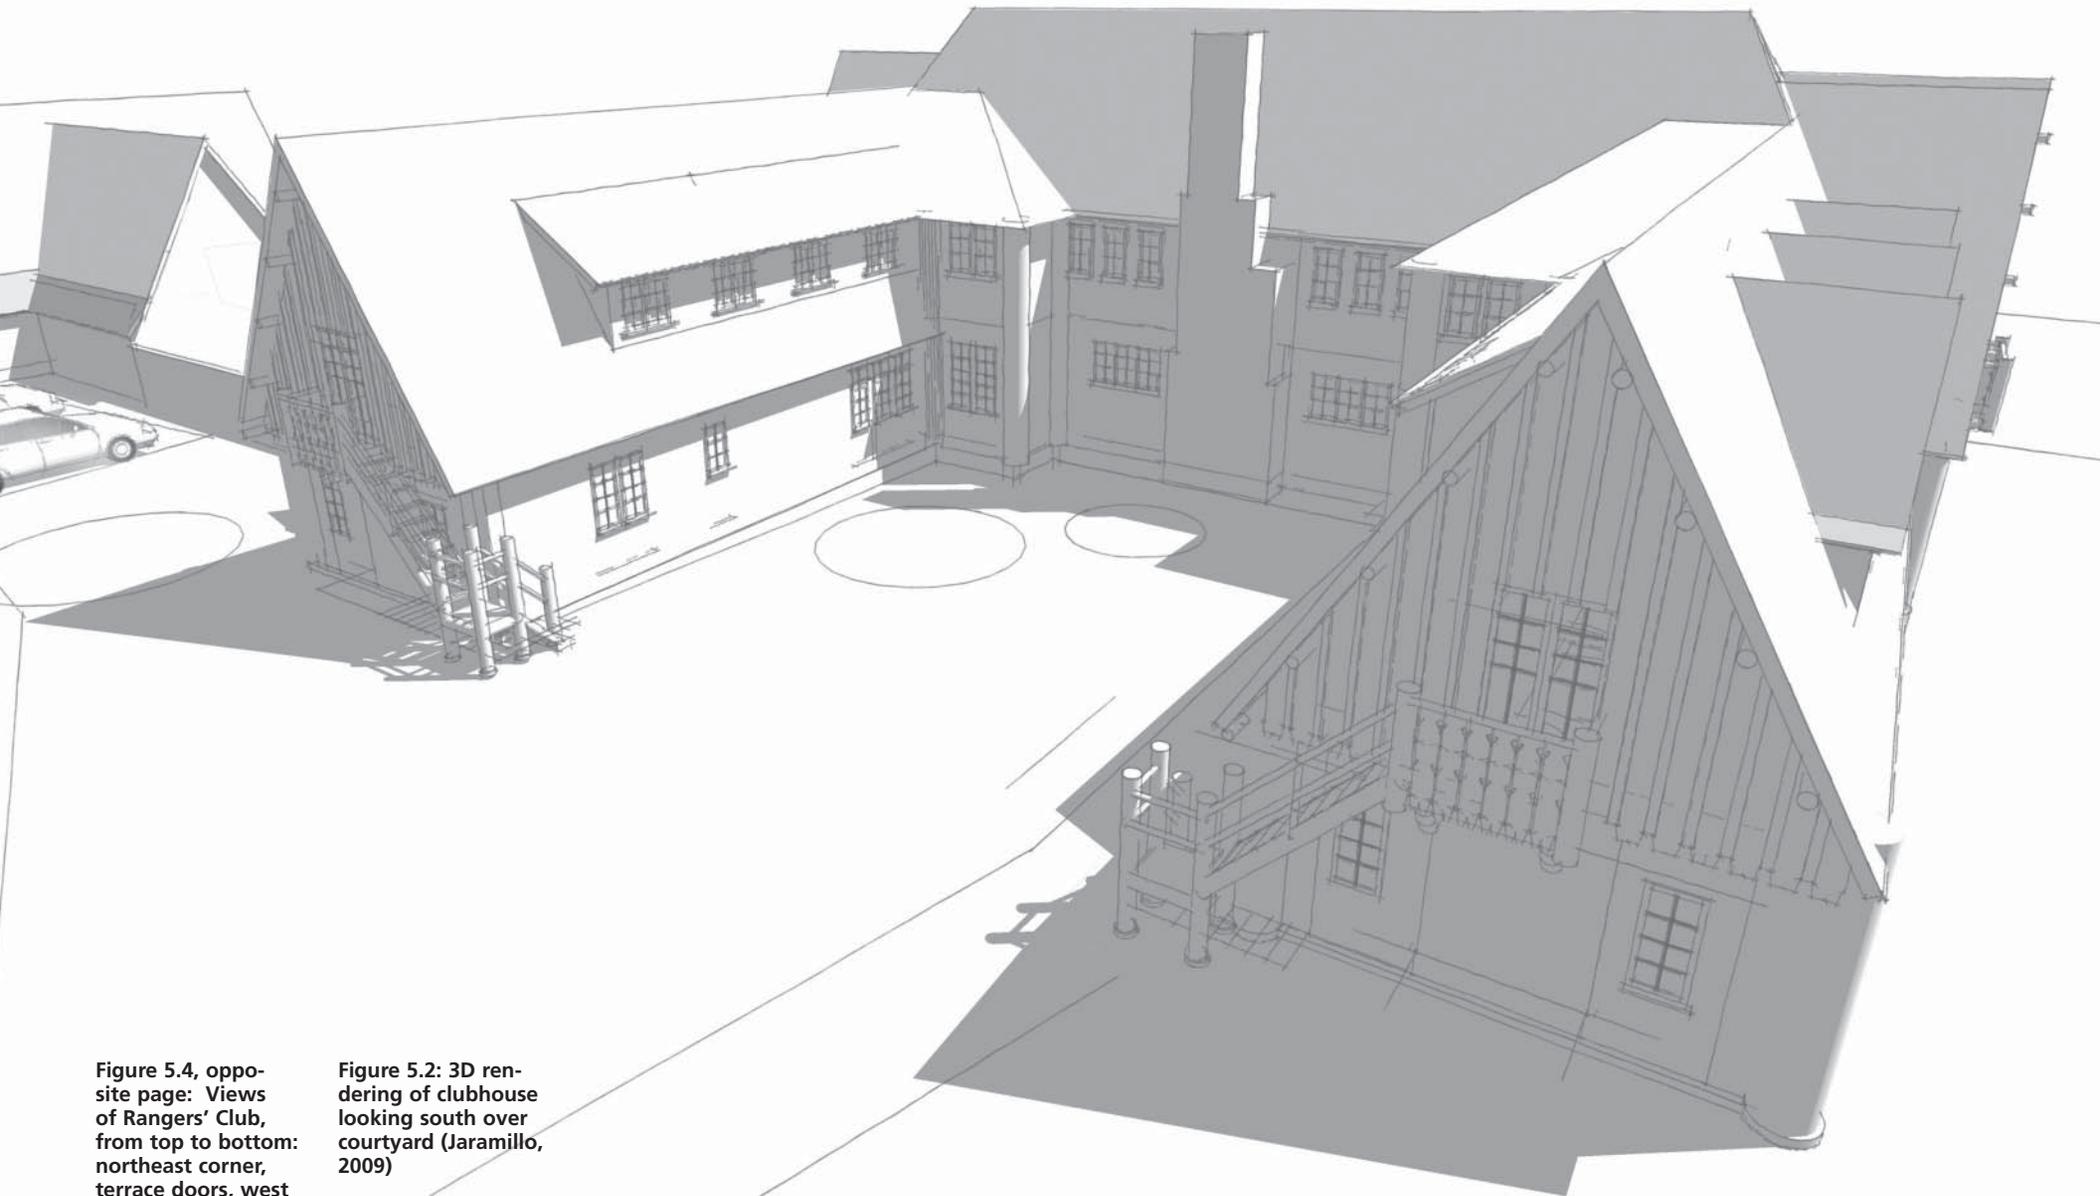
Figure 5.4, opposite page: Views of Rangers' Club, from top to bottom: northeast corner, terrace doors, west wing inner courtyard (Jaramillo, 2010)

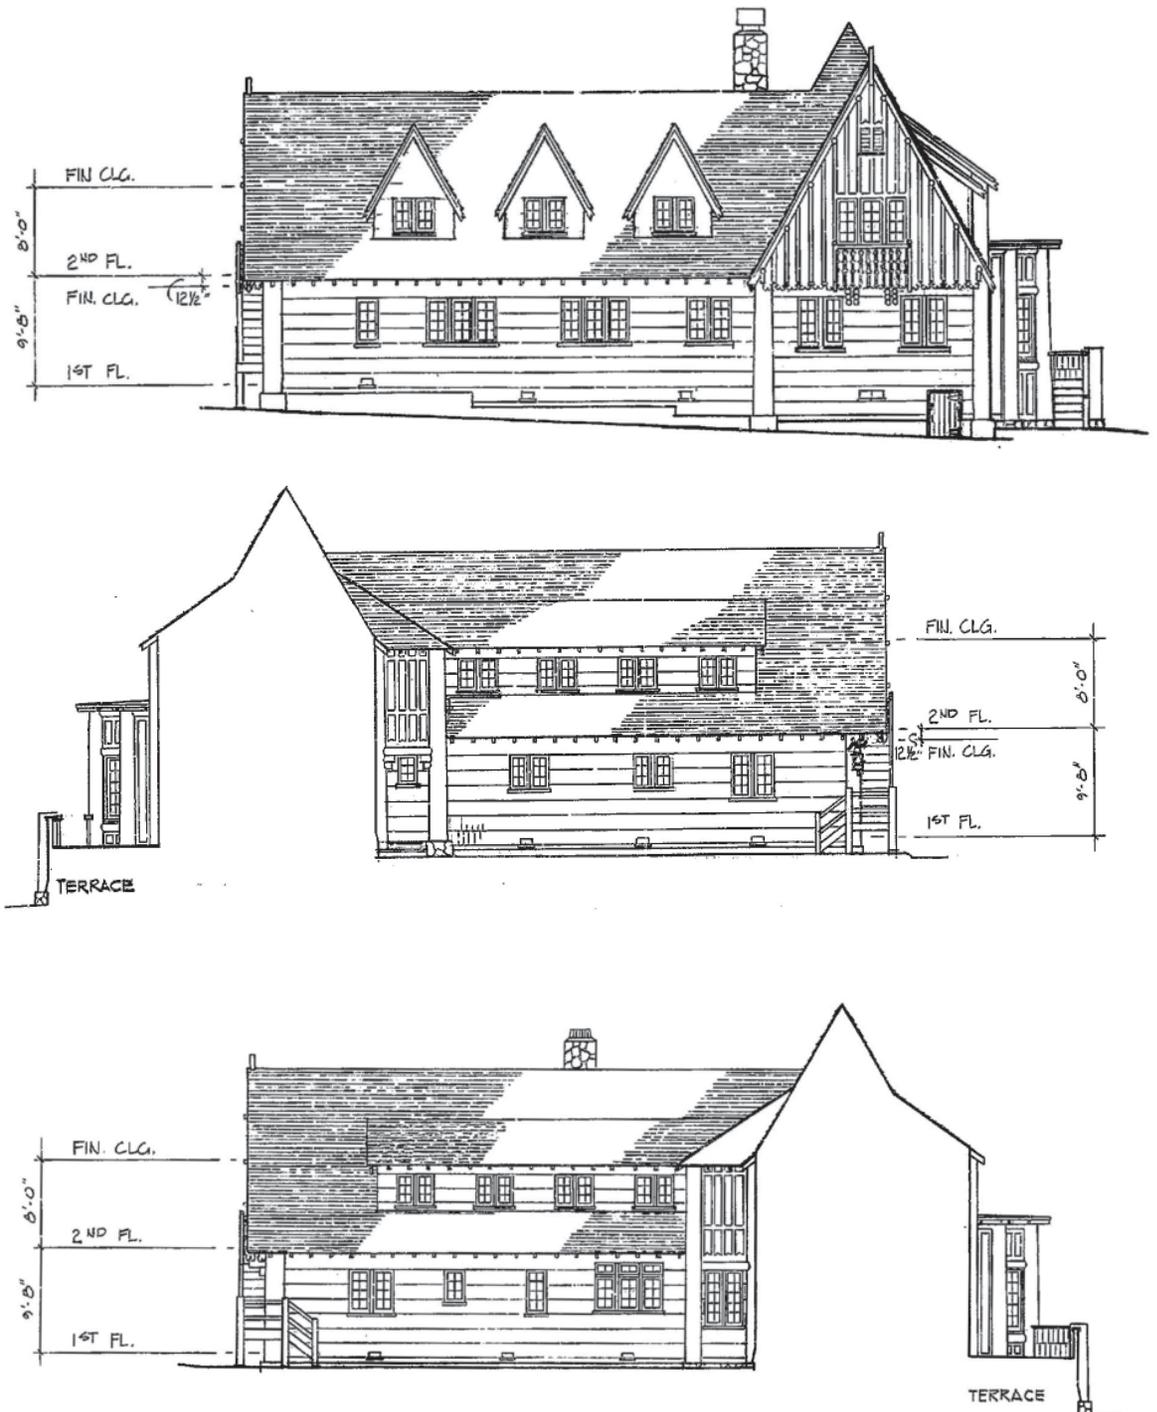
Figure 5.5: Elevations of Rangers' Club (As-Built Drawings, 1977, eTIC)

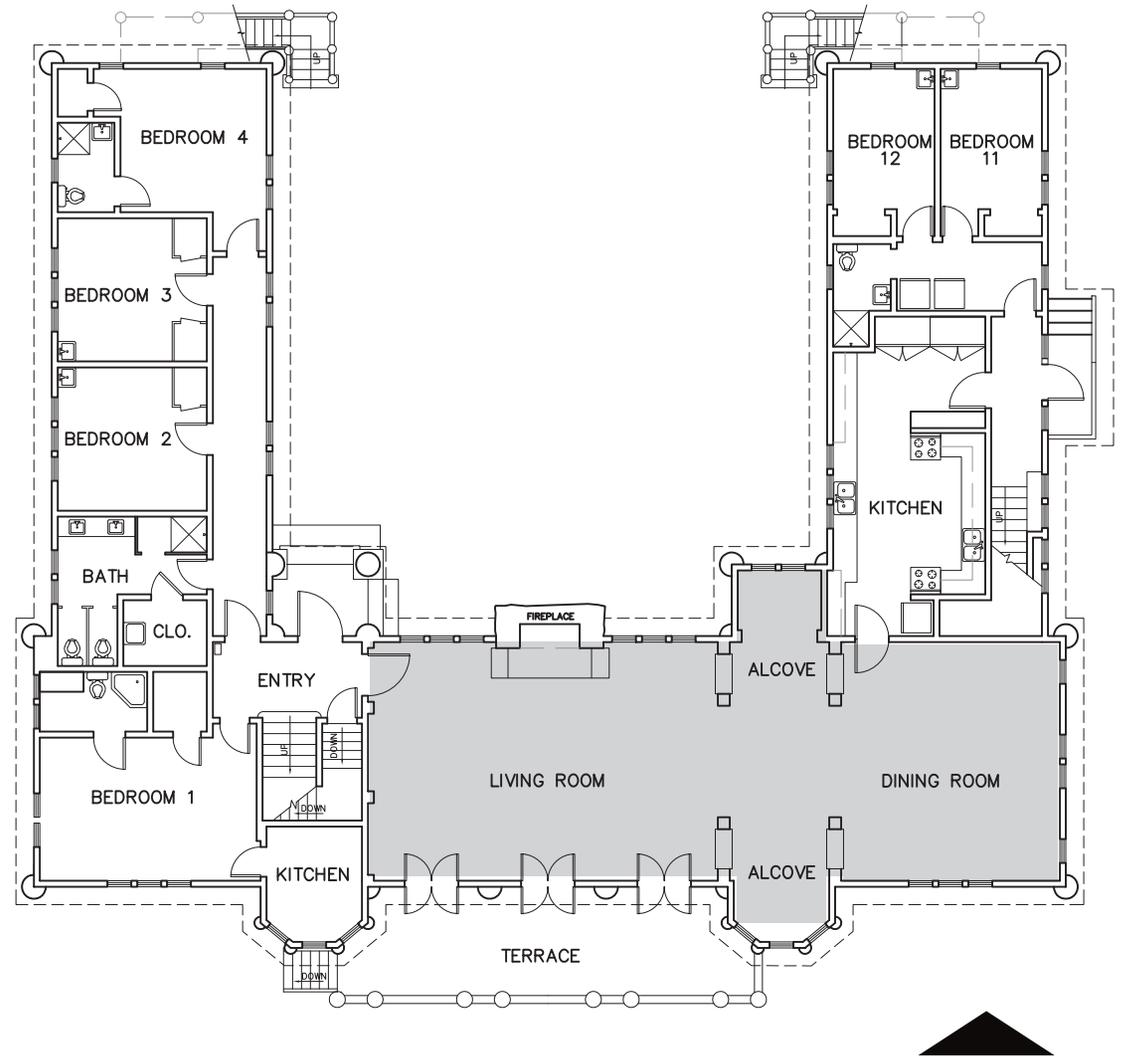
Figure 5.6: First floor plan with great room in grey (Jaramillo, 2009)

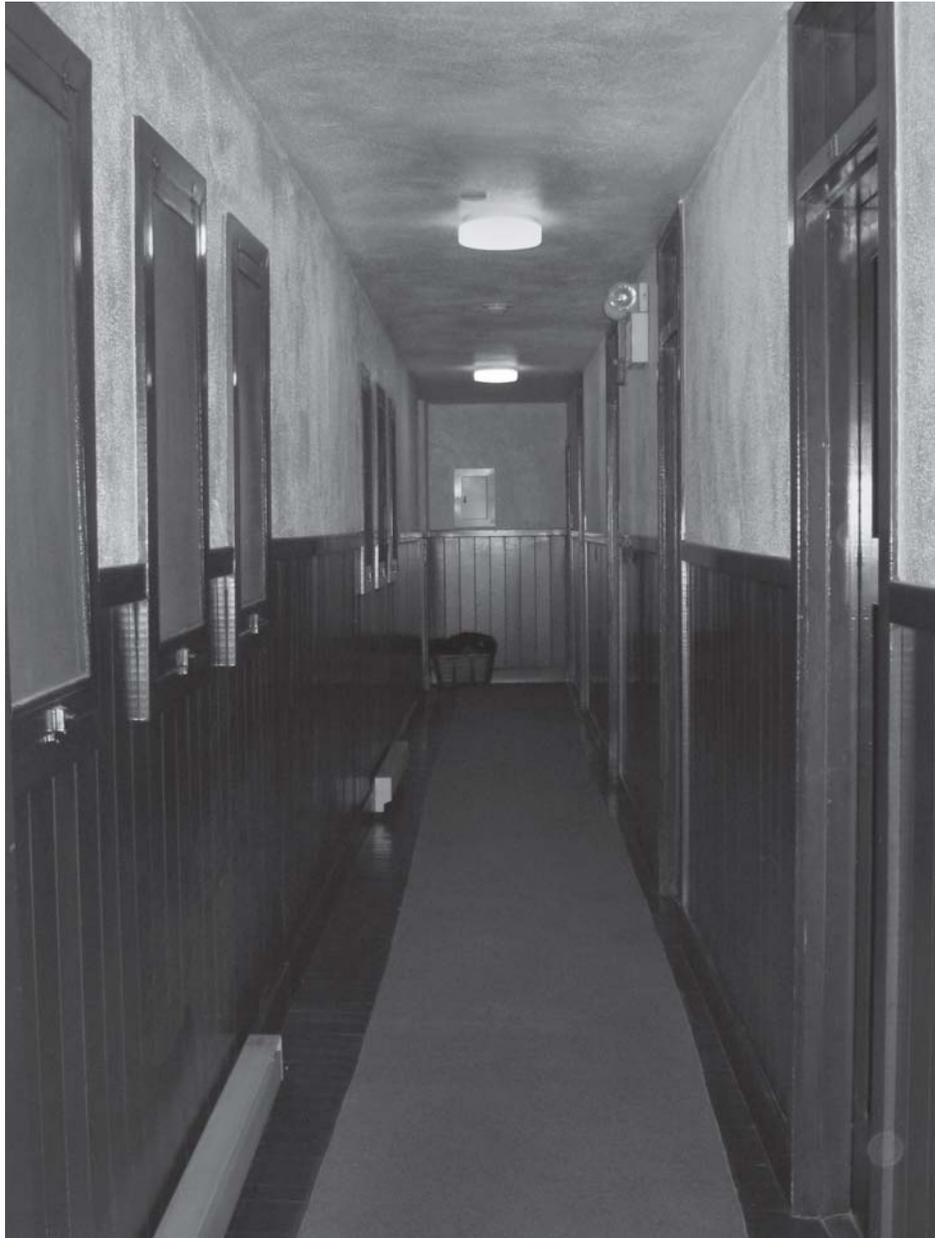
Circulation/Utility spaces
