National Park Service
U.S. Department of the Interior

Yosemite National Park
California

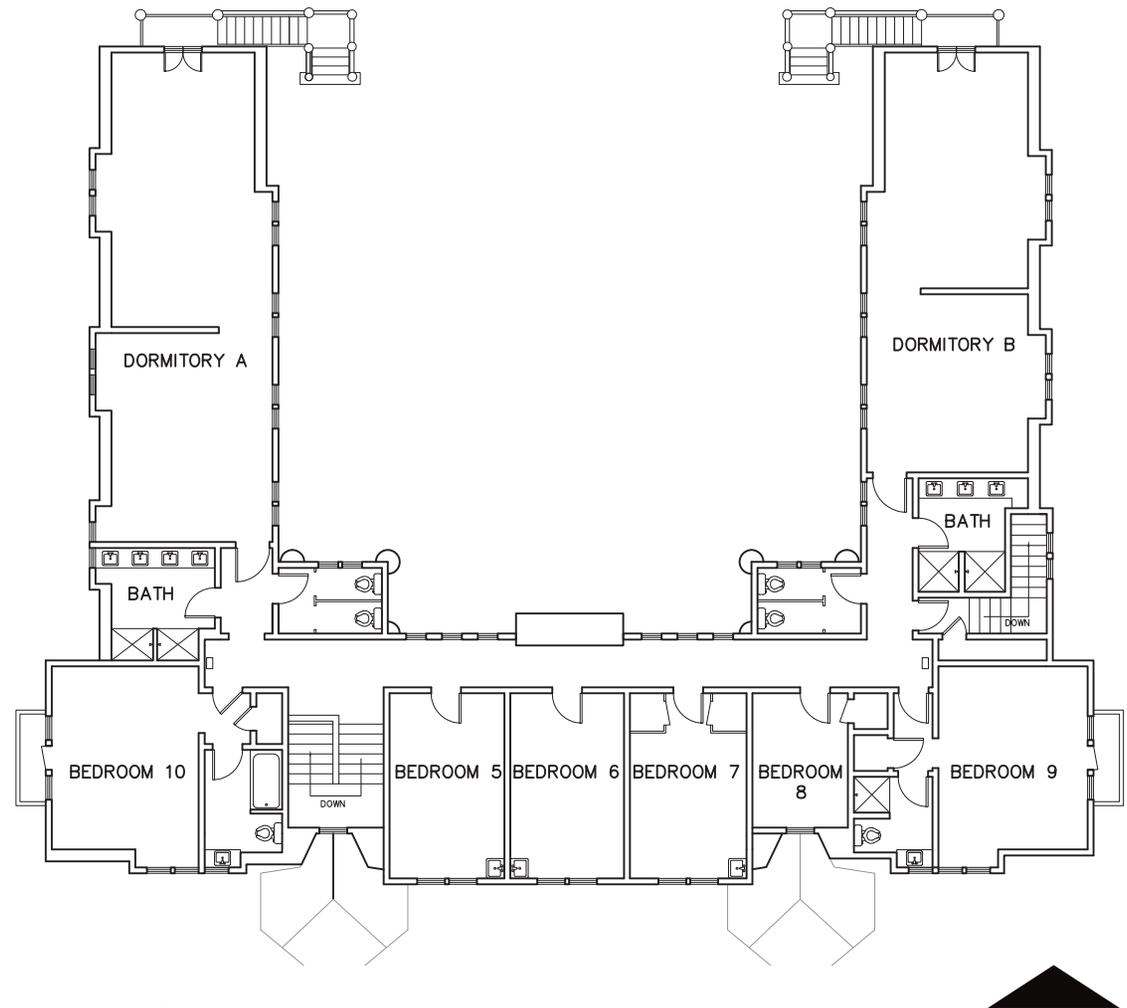
Figure 5.9: Second floor plan of Rangers' Club with bedrooms and dormitories (Jaramillo, 2009)

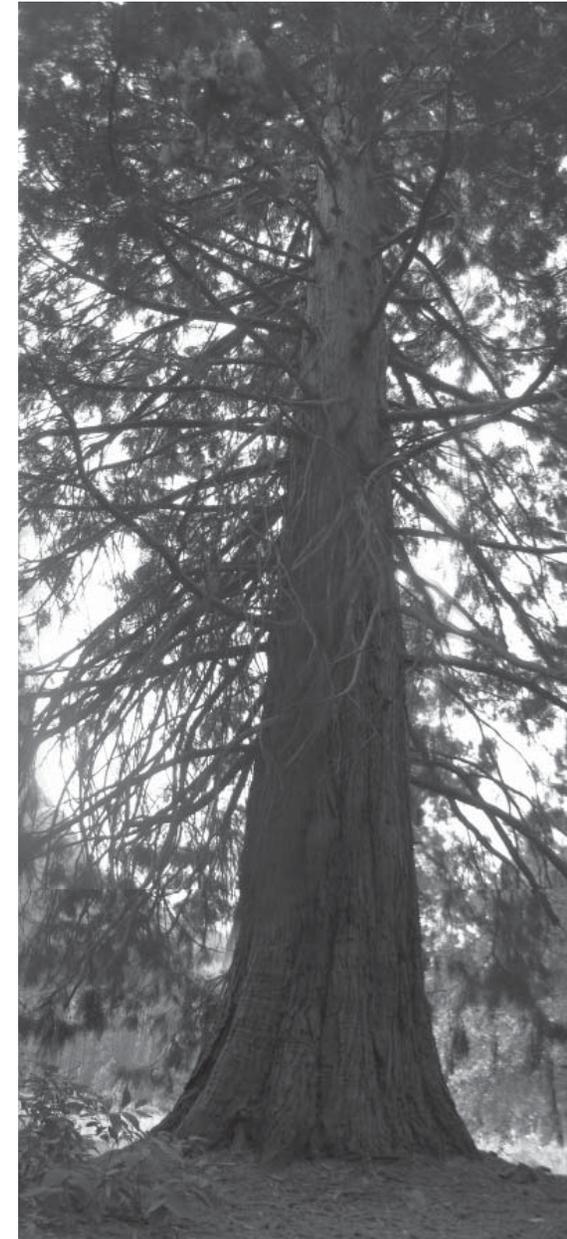
Low vegetation grows throughout the site including native blackberry (*Rubus ursinus*) and Himalayan blackberry (*Rubus discolor*) as well as other types of crawling plants. Most of the soil is fairly permeable. There is a layer of decaying leaves and pine duff over the site.

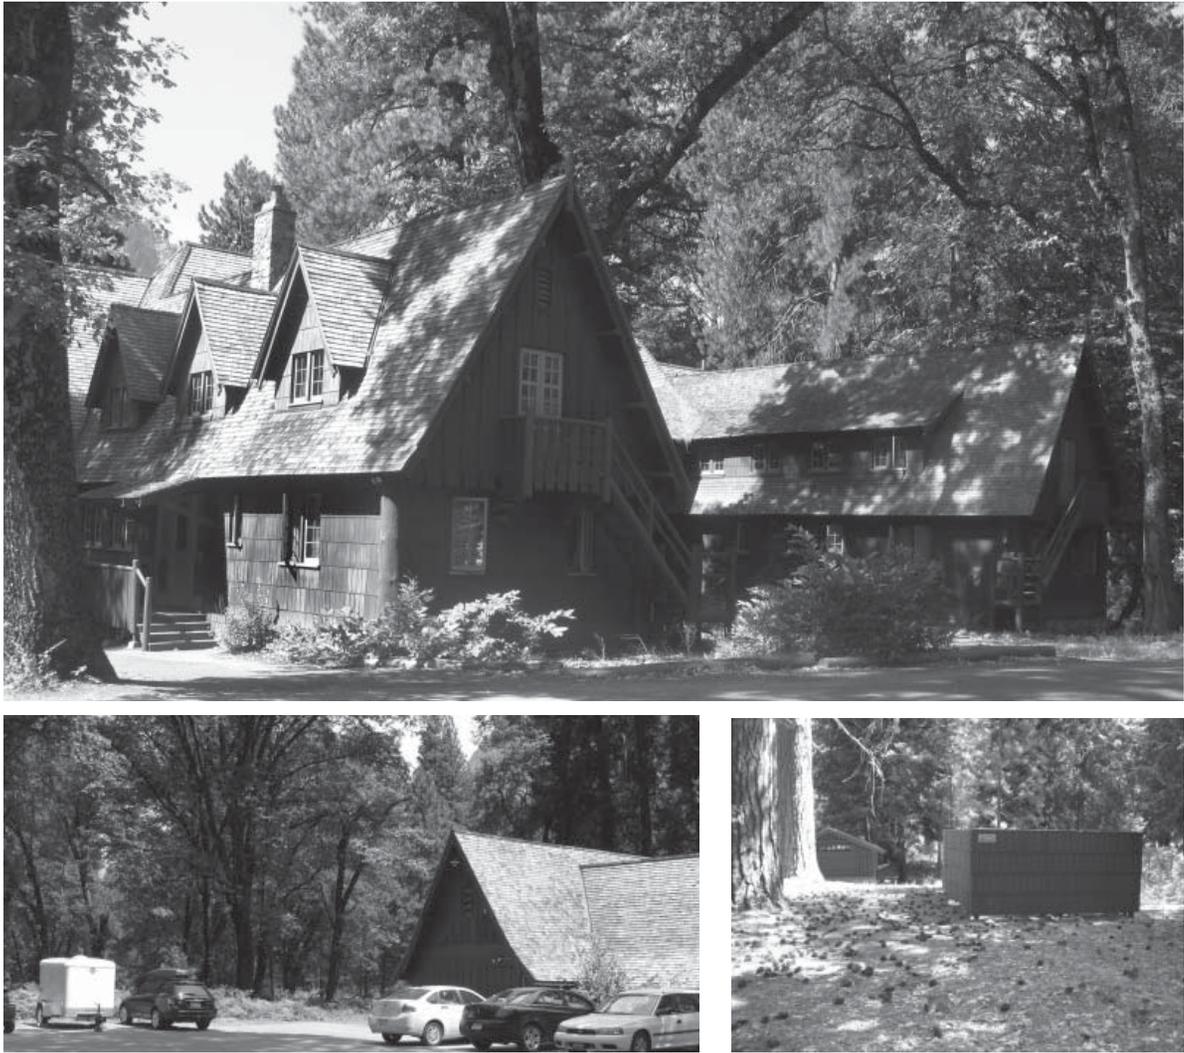
Figure 6.3, clockwise from top: North view into courtyard, south terrace, high voltage lot with transformer beyond, parking lot (Jaramillo, Summers, 2009)

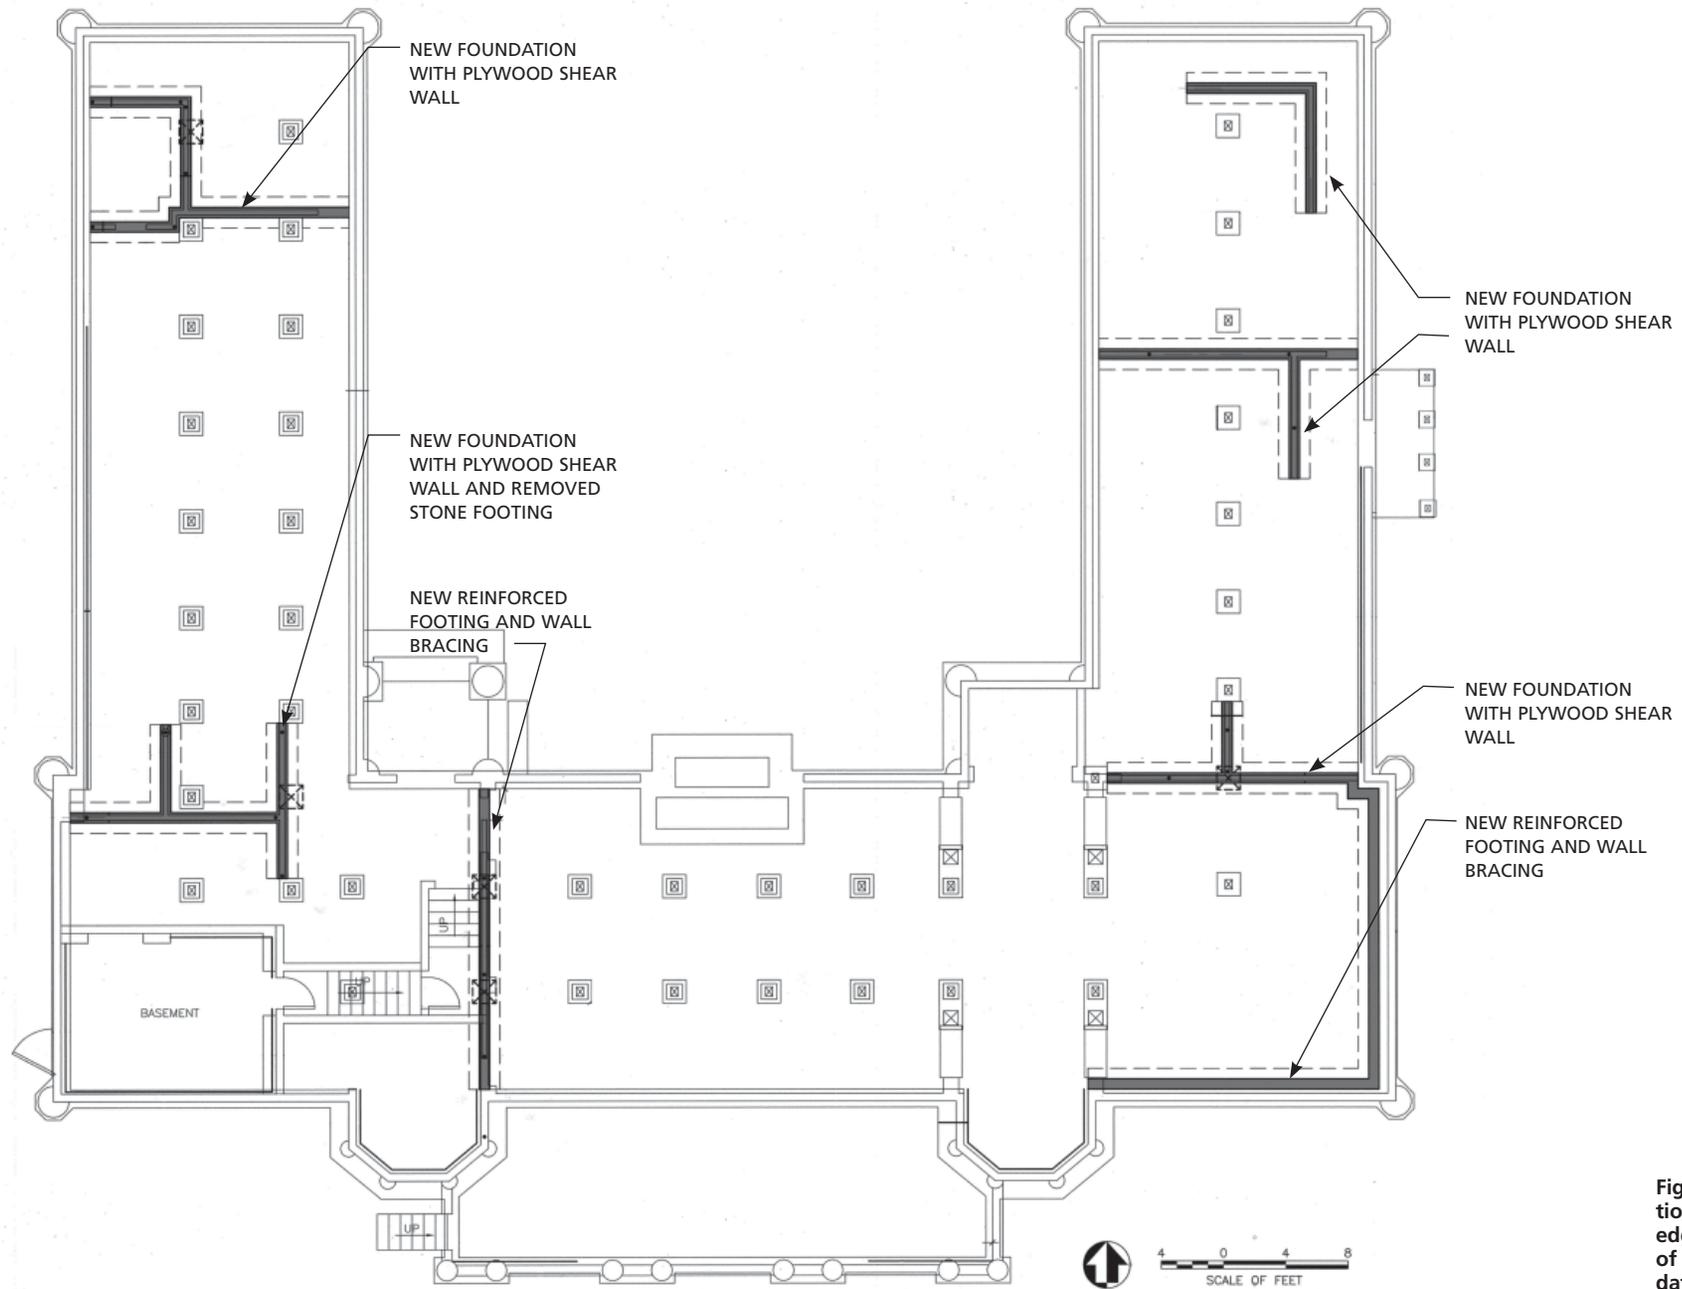
Figure 6.4: Foundation plan, darker edges signify areas of reinforced foundation (2008 Seismic drawings)

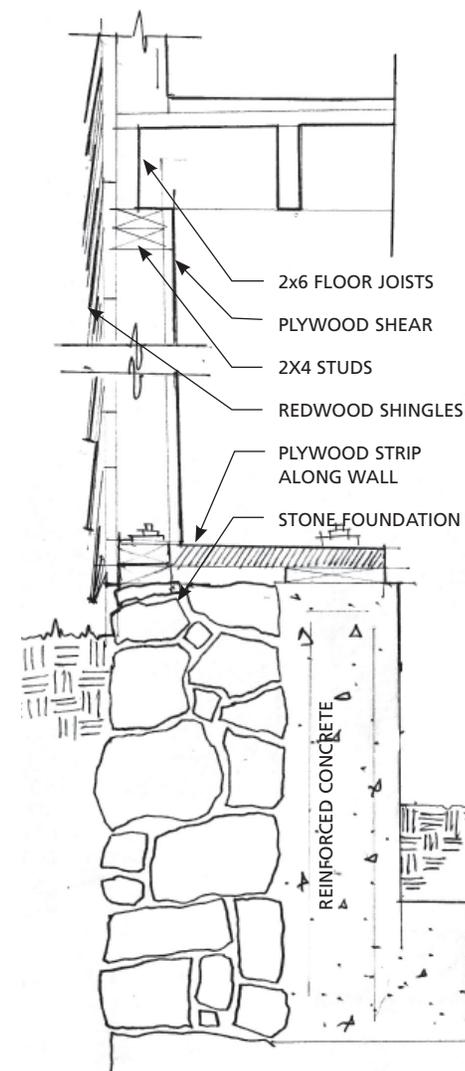
Figure 6.5: Typical foundation section (Jaramillo, 2010)

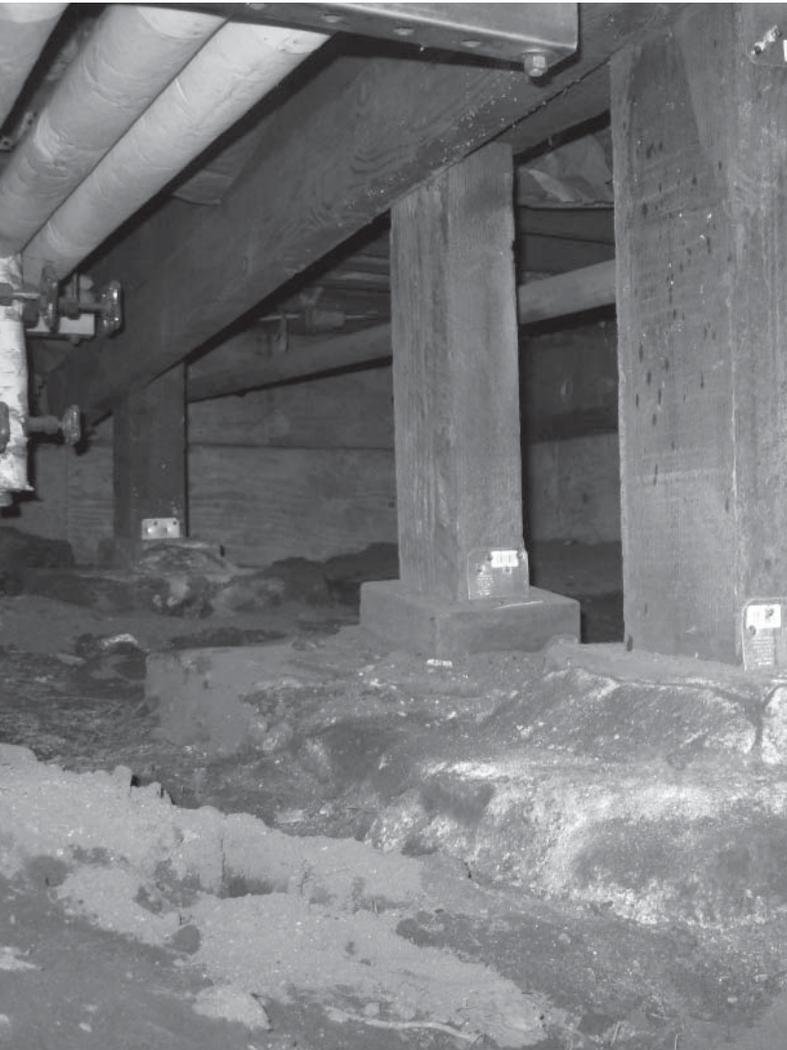
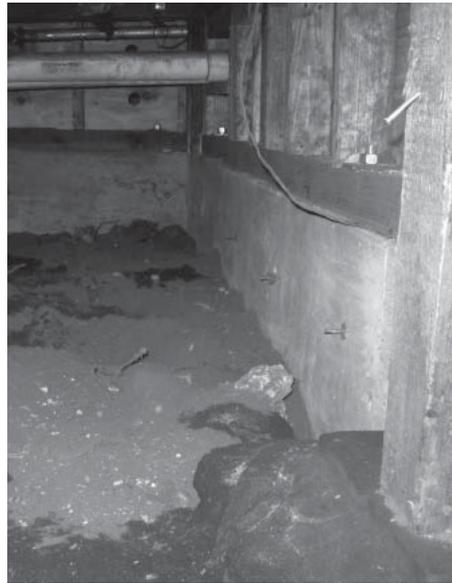
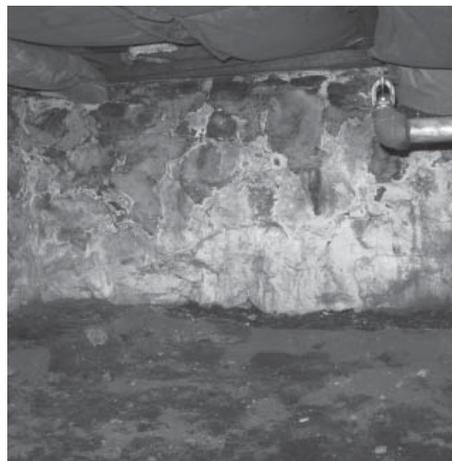
Figure 6.6, clockwise from left: Foundation stone pier footing and post, reinforced foundation, existing stone foundation with efflorescence, note moisture on ground (Summers, 2009)

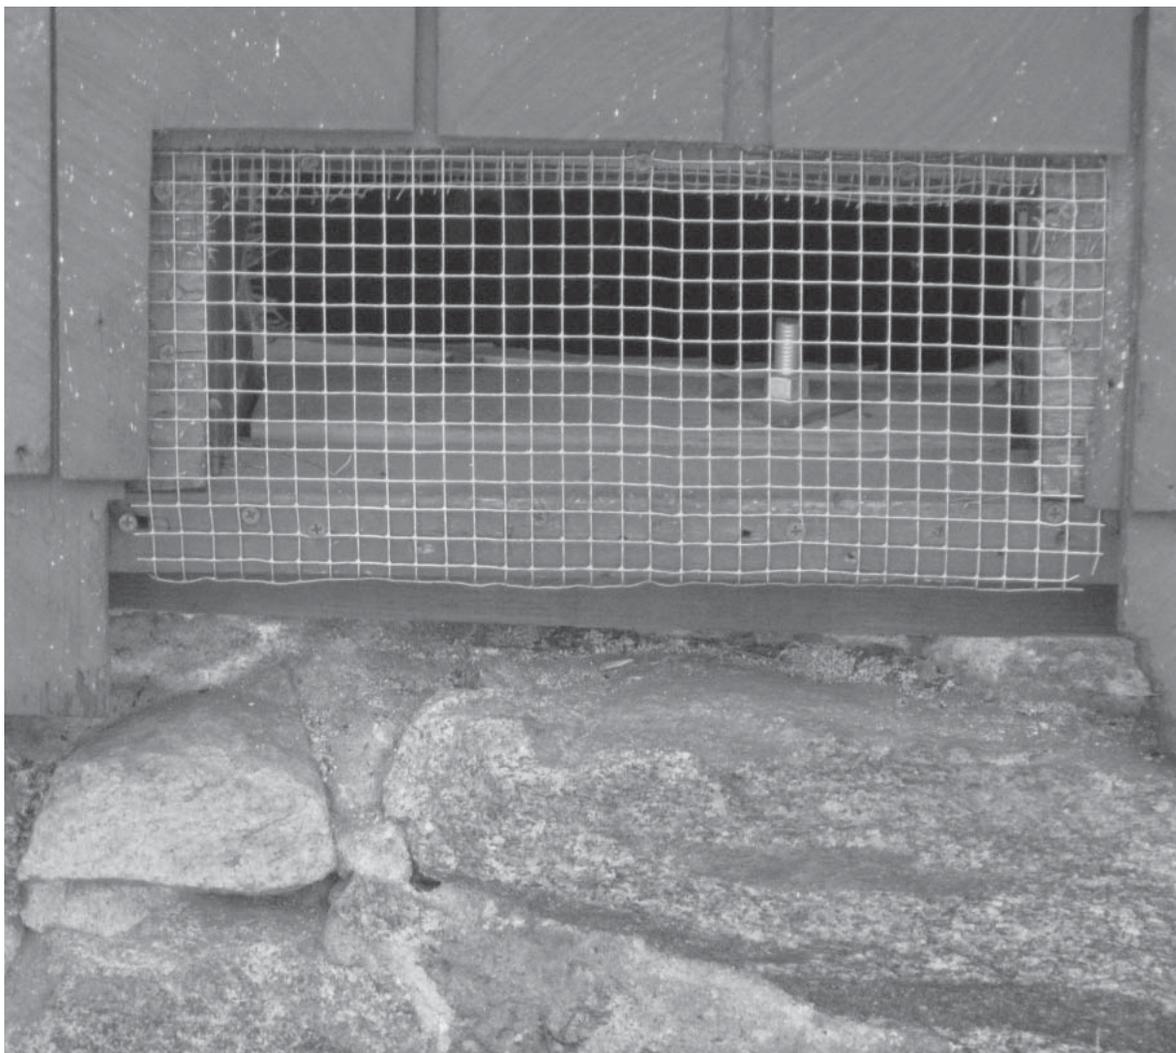
Figure 6.7: Crawlspace vent with added 1/4" metal screen. Although this treatment has kept some pests out it also keeps many of them in. (Jaramillo, 2008)

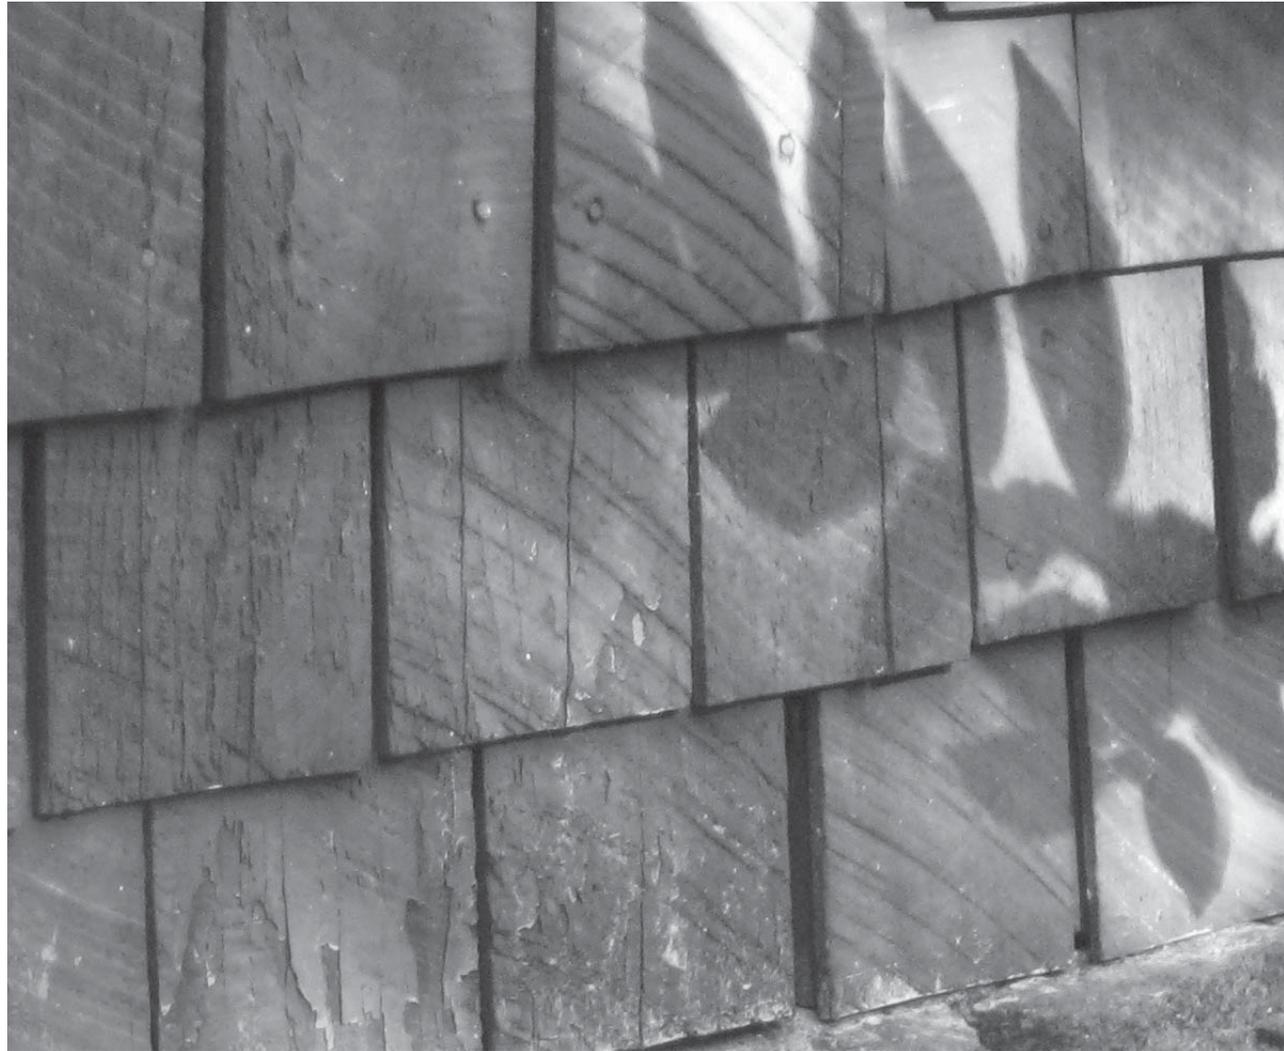
1. Monitor soil moisture in the crawl space. Improve drainage in crawl space to prevent moisture accumulation.
2. Limit water penetration from both snow melt and roof water to minimize efflorescence.
4. Check for rodents and animals periodically.

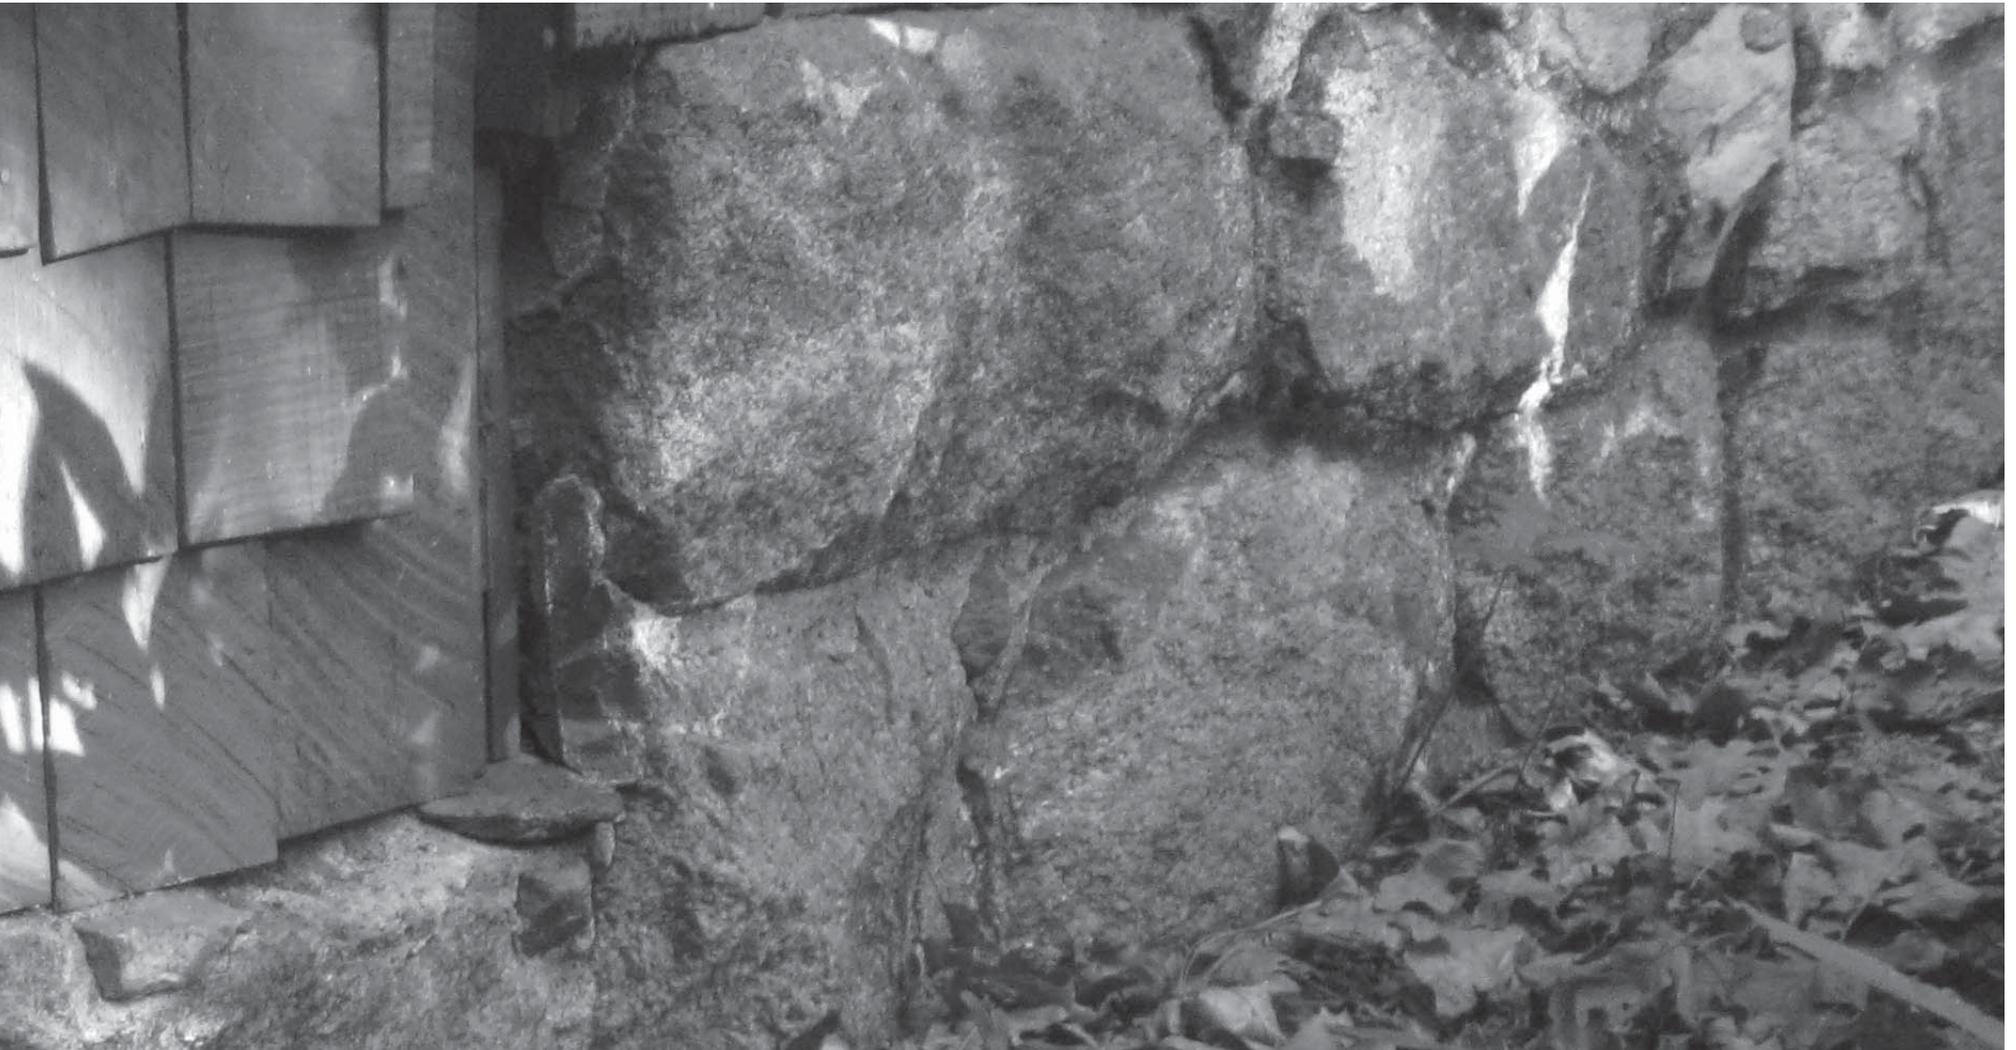
Figure 6.8: Stepped stone foundation with shingled wall. Note the accretion of duff and paint splatter. (Summers, 2008)

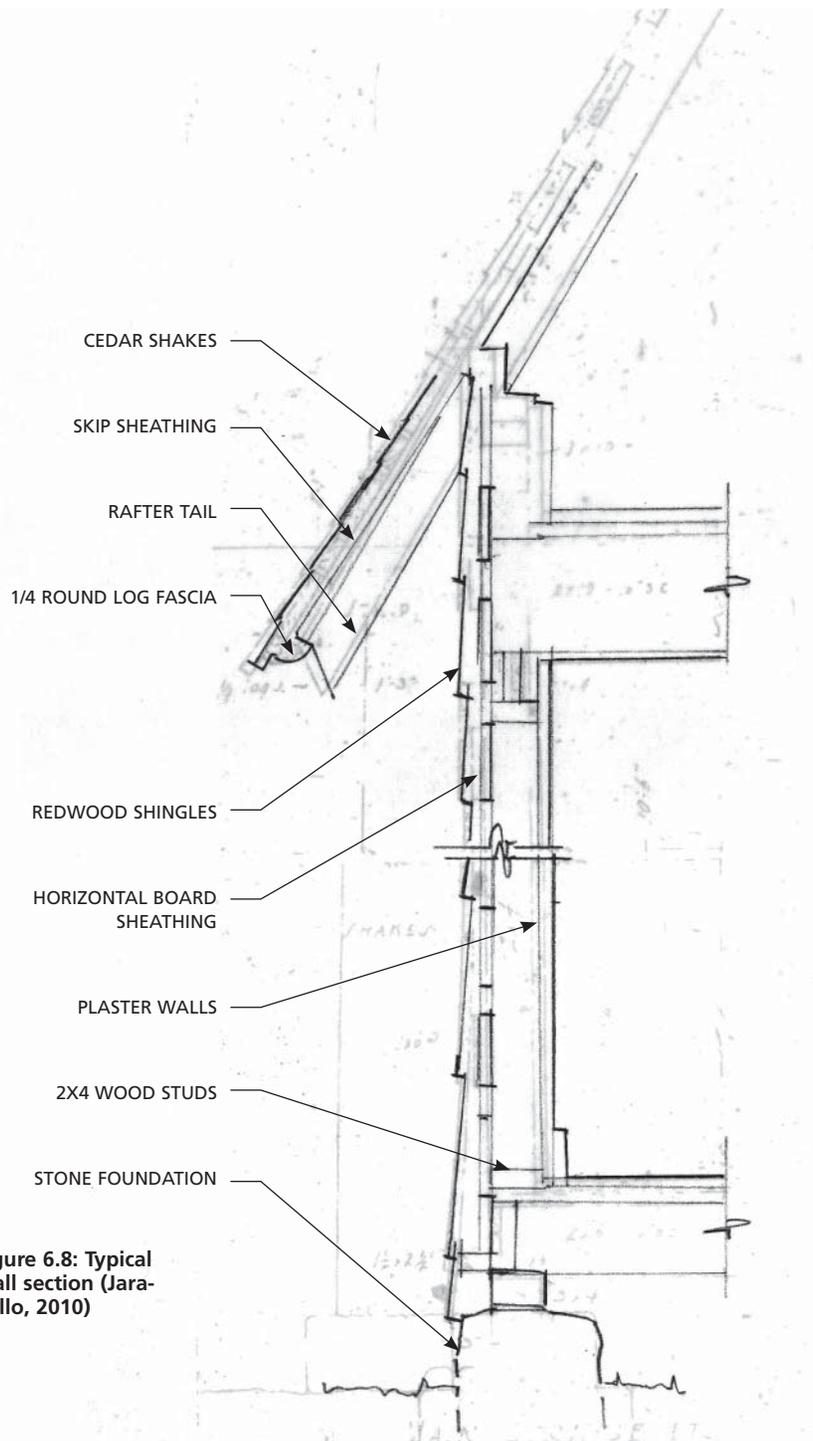
Figure 6.8: Typical wall section (Jaramillo, 2010)

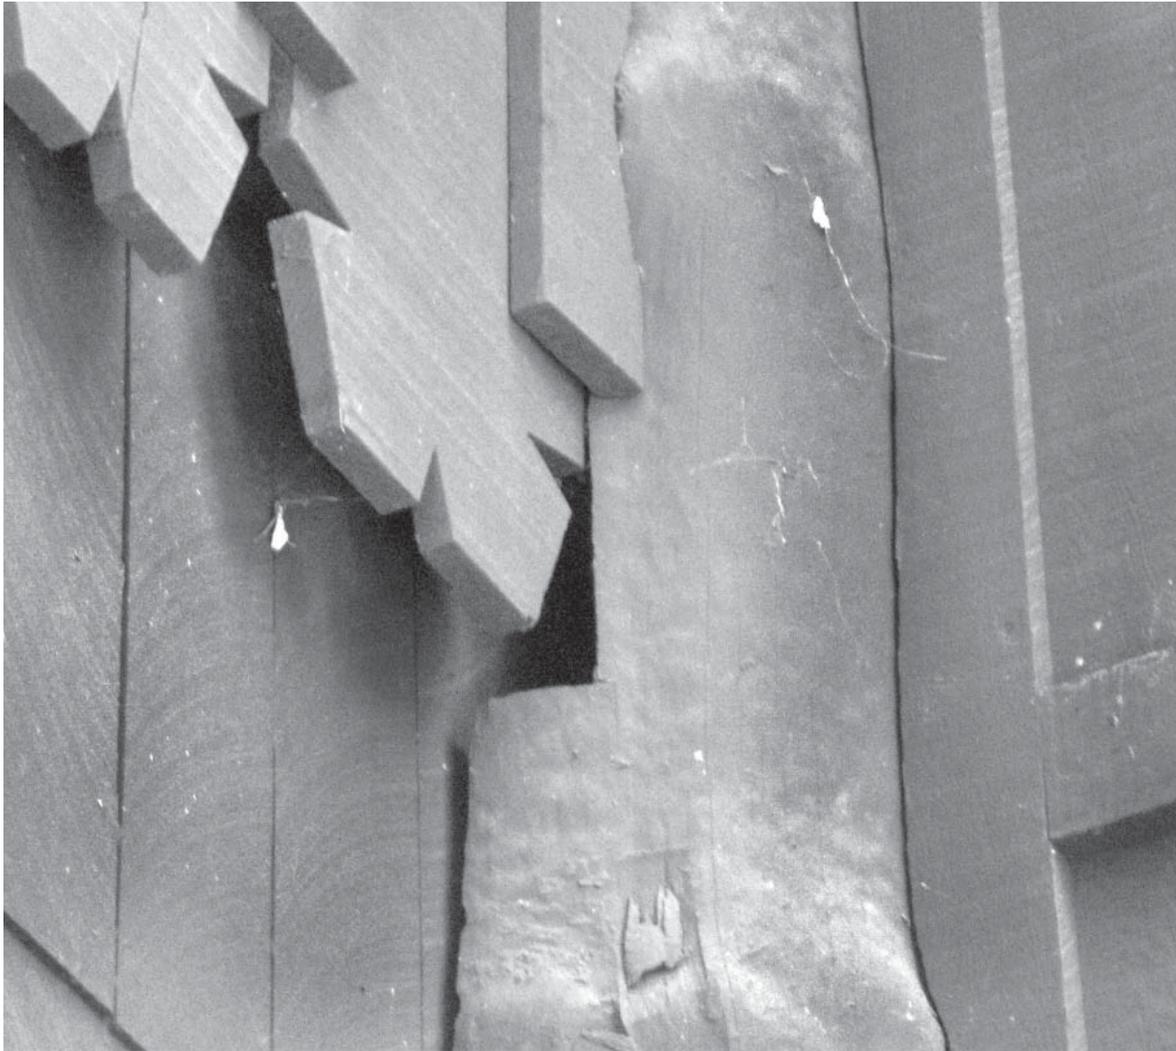
Figure 6.12: Above, connection detail, between board and battens, log pilaster, and entry bump out. (Jaramillo, 2009)

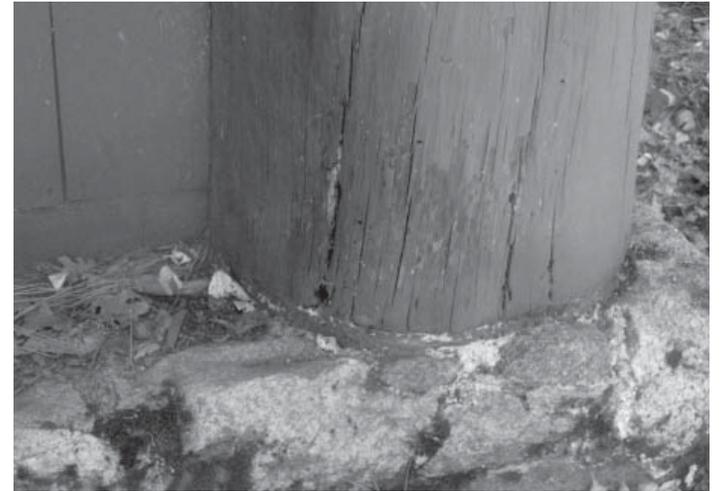
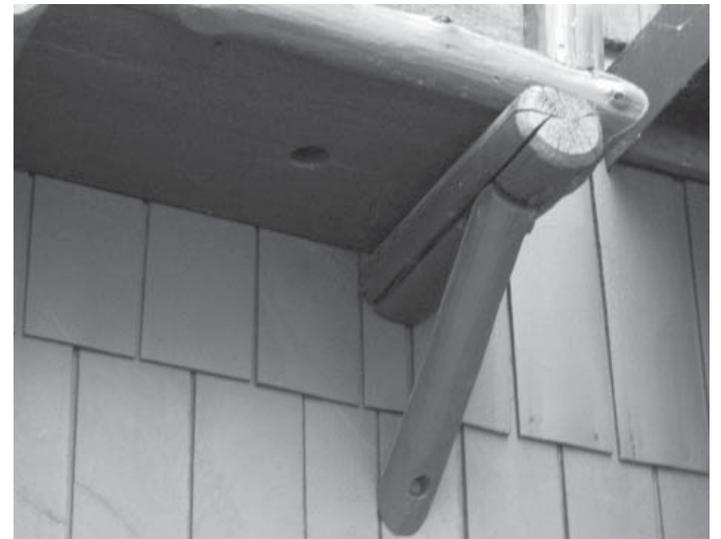
Figure 6.13: Above, water damaged log pilaster base, below, checked and split planter bracket. (Sommers, 2009)

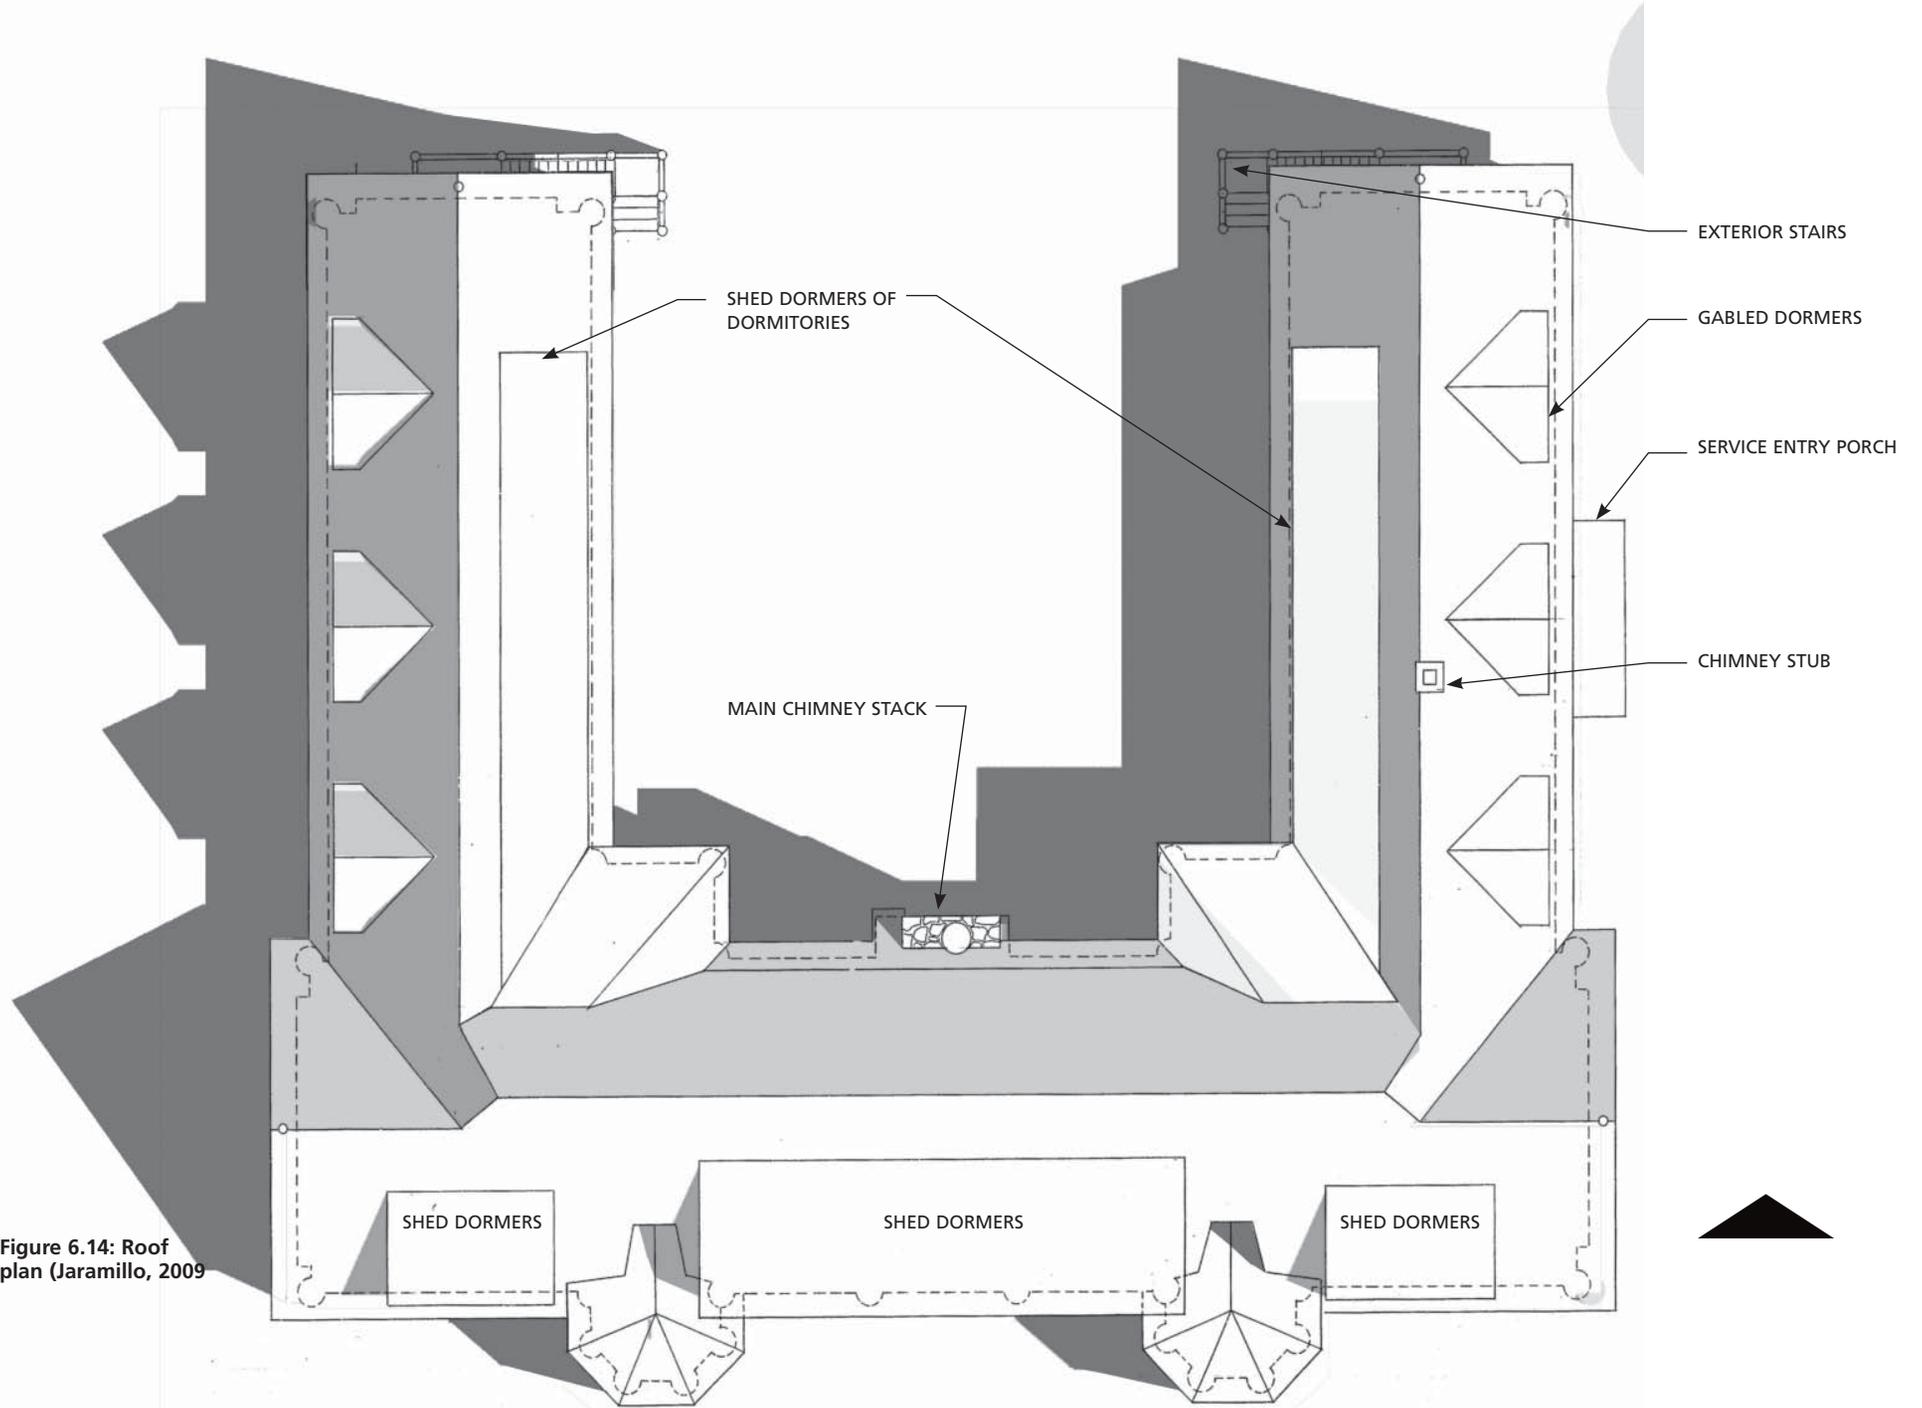
Figure 6.14: Roof plan (Jaramillo, 2009)

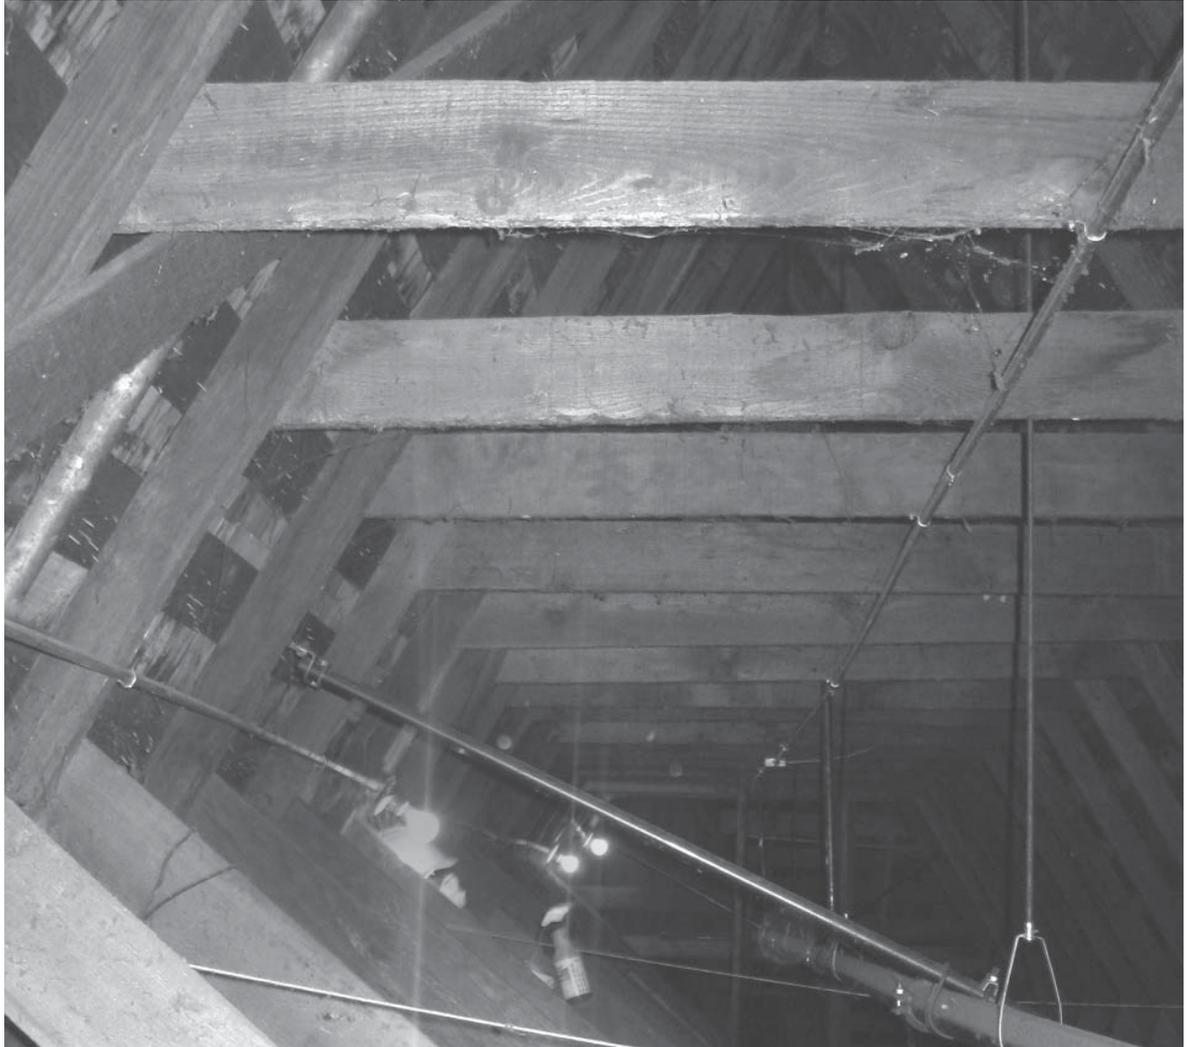
Figure 6.17: Attic view (Sommers, 2009)

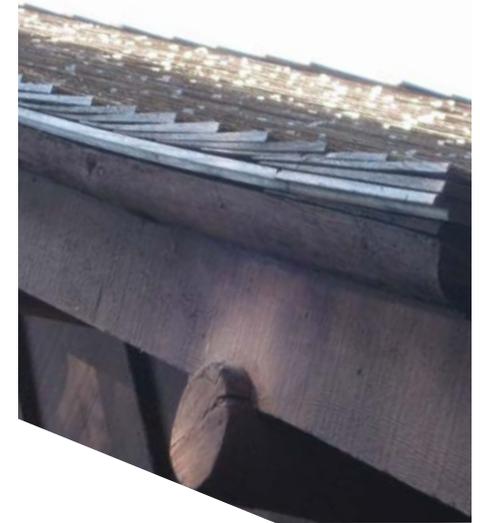
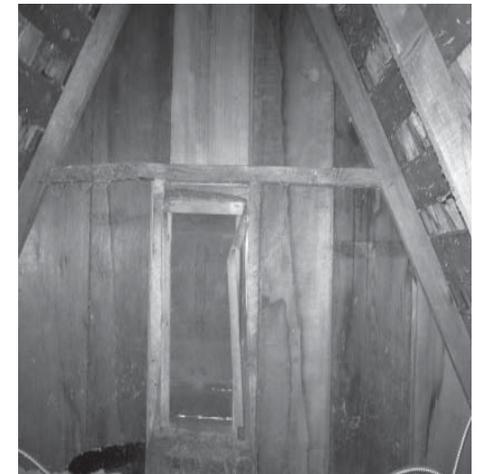
Figure 6.19: Above, North eave of roof, with detail of roof shingles and flared edge. Below, interior view of end gable vent. (Jaramillo, Sommers, 2009)

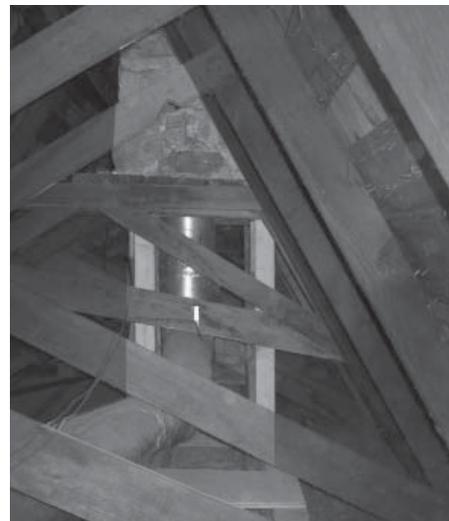
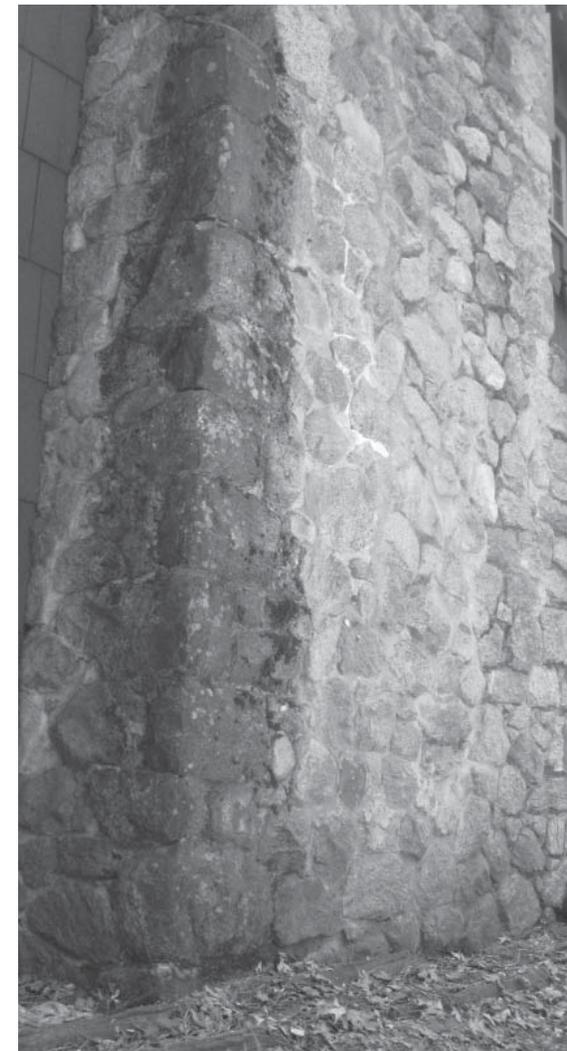
Figure 6.21: Left, interior stub of kitchen chimney supported by wood cribbing, right, organic growth from moisture retention on chimney (Jaramillo, 2009)

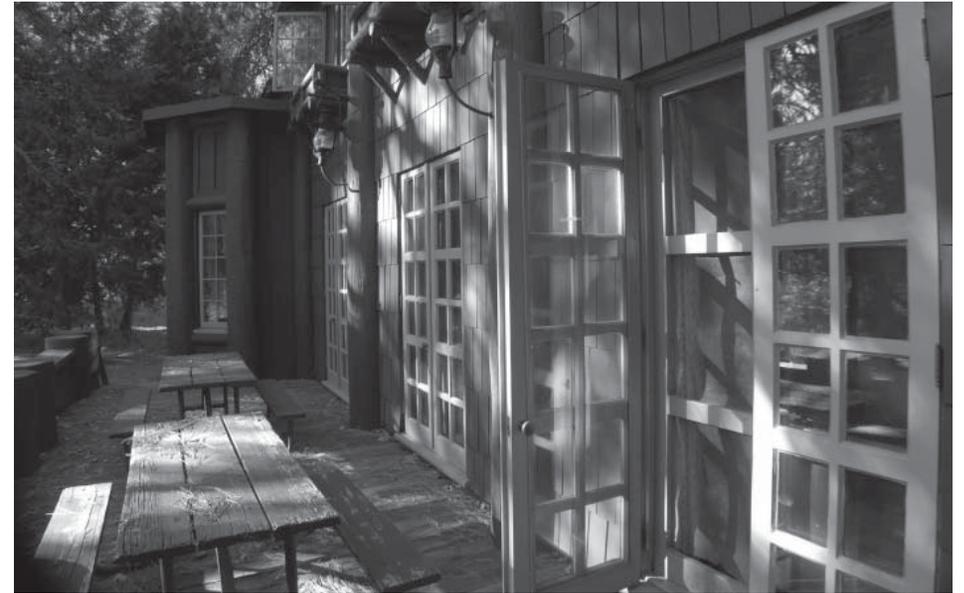
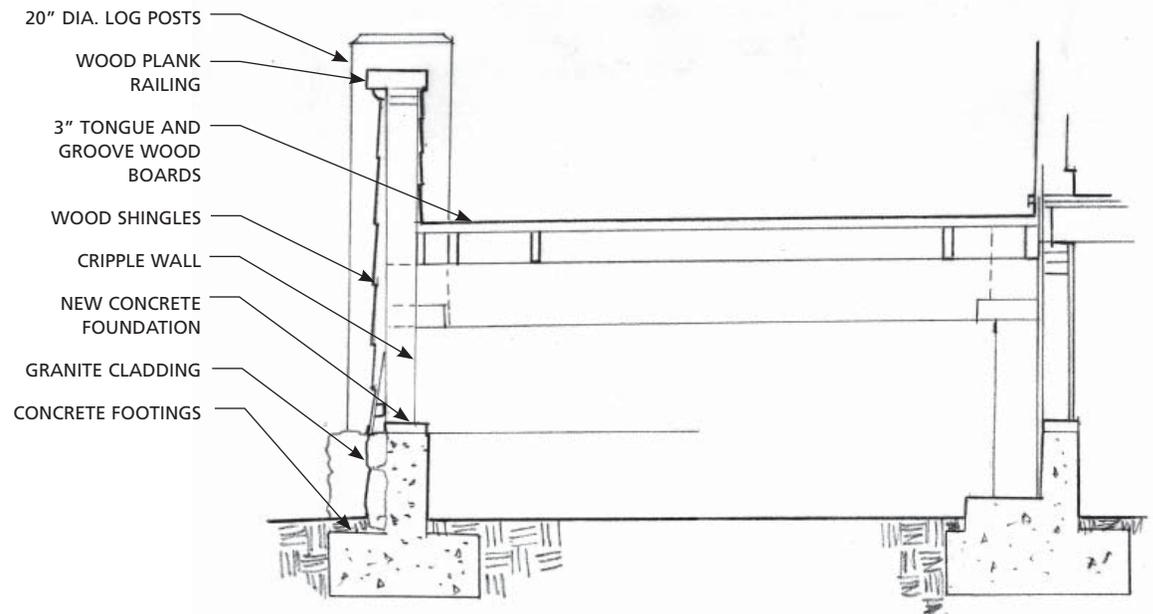
Figure 6.26: Above, View of South Terrace. Below, cross-section of terrace (Jaramillo, based on 1920s drawing, 2009)

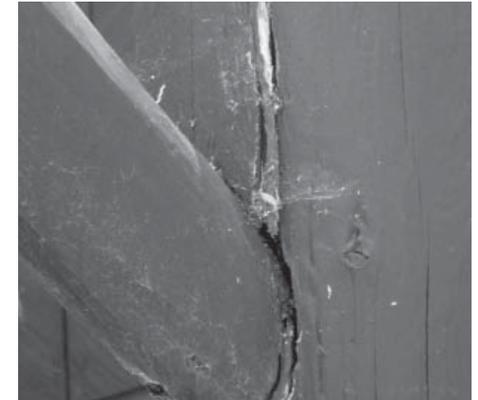
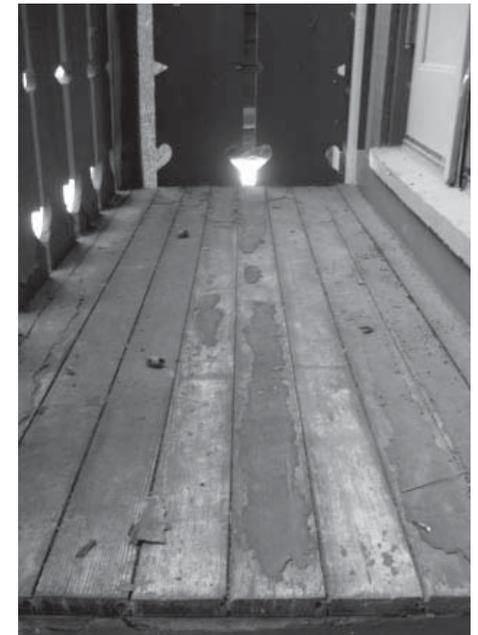
Figure 6.28: Above, damaged and racking balcony railing, above right, checked railing post infilled with silicone (detaching), below right, worn and deteriorated deck on north balcony/fire stair (Jaramillo, 2009)
