National Park Service
U.S. Department of the Interior

Yosemite National Park
California

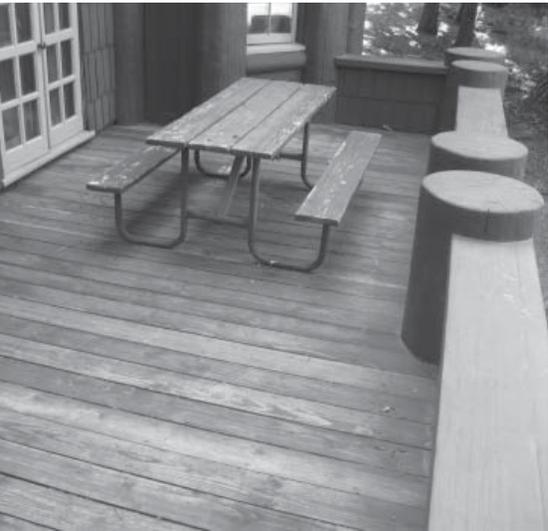
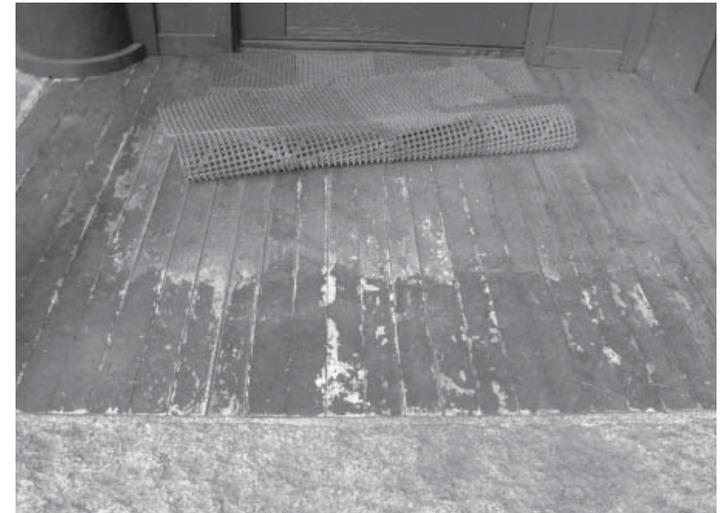
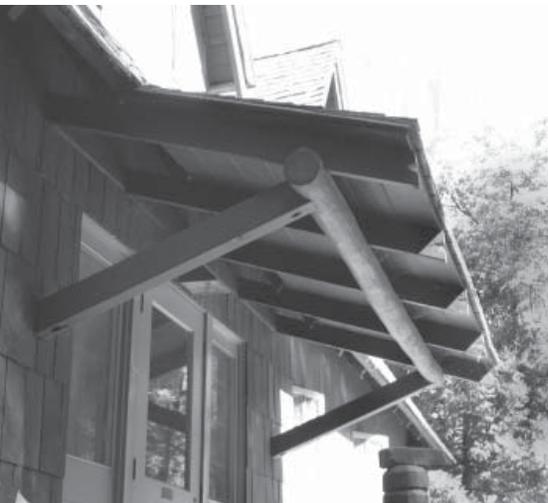
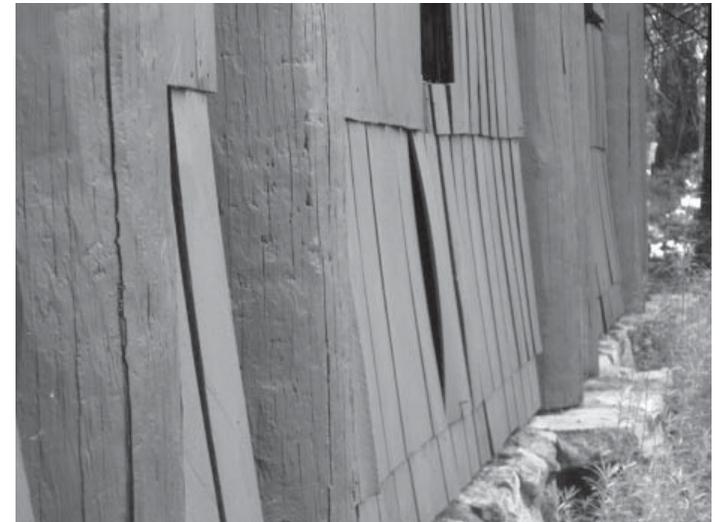
Figure 6.29: Clockwise, upper left, deteriorated deck on south terrace, below left, shed roof of service entry, middle, checked log column, upper right, damaged entry porch floorboards, lower right, damaged shingles on terrace. (Jaramillo, Sommers, Durbin, 2009)

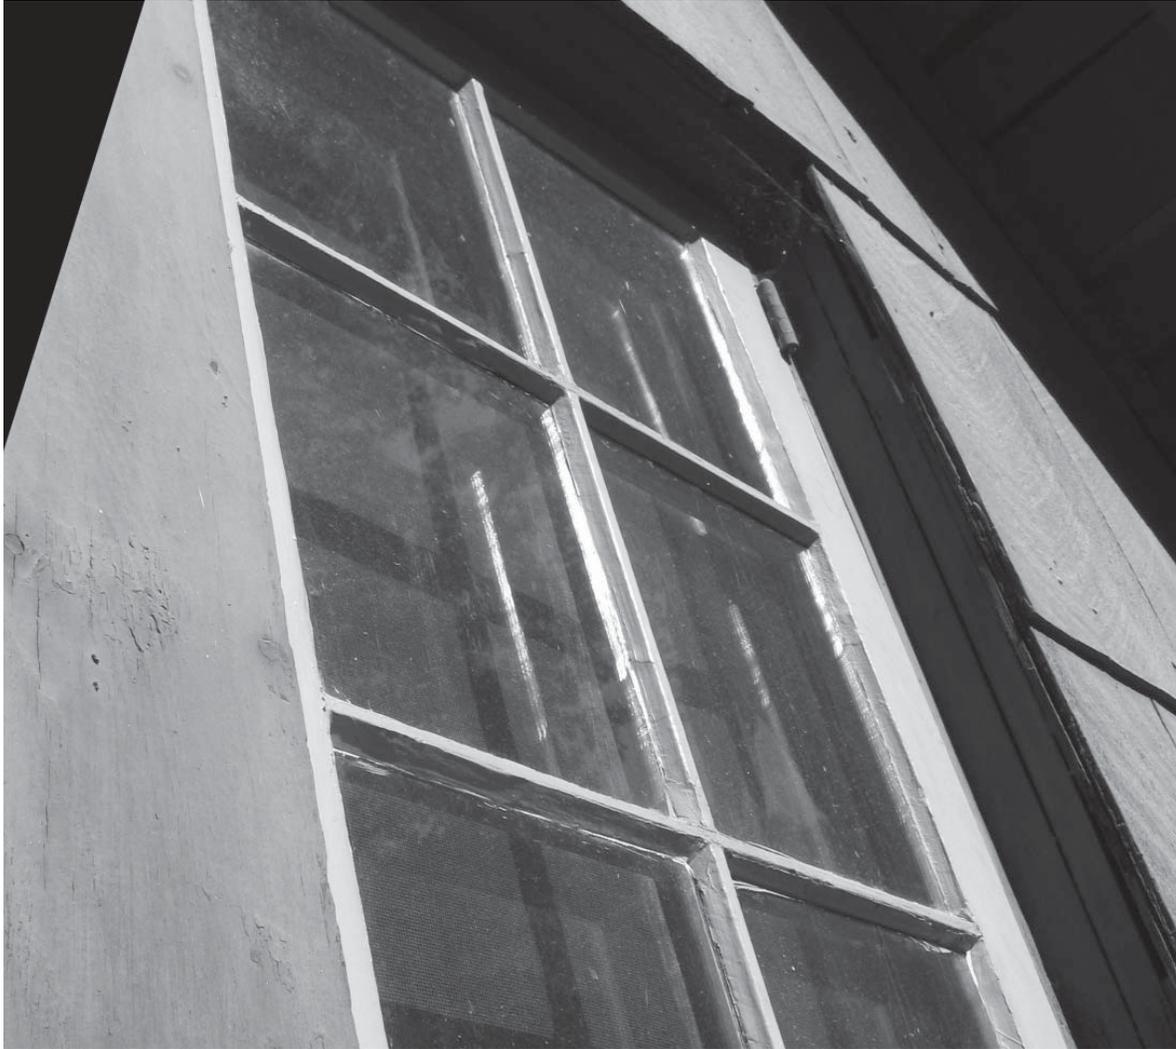
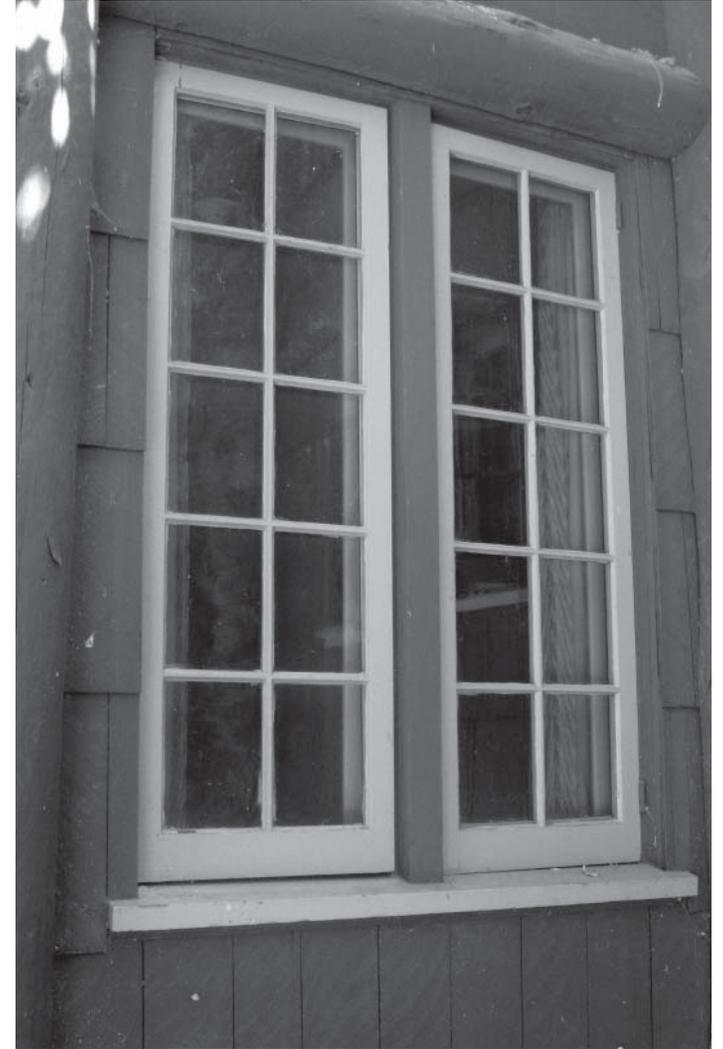
Figure 6.30: Left, Exterior of dormer window. Right, Bay window into reading nook. (Jaramillo, 2009)

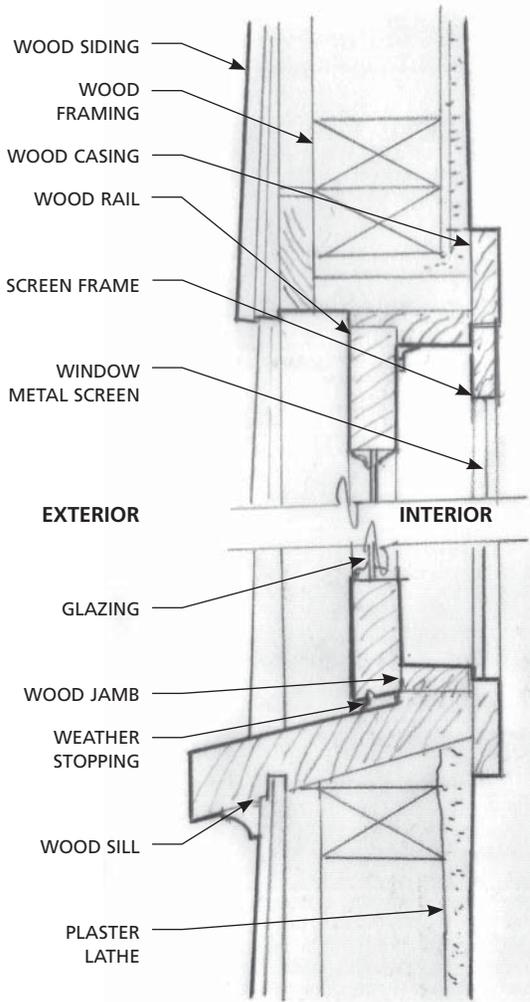
1. Devise a plan to replace storm windows and use a different method of weather stripping.

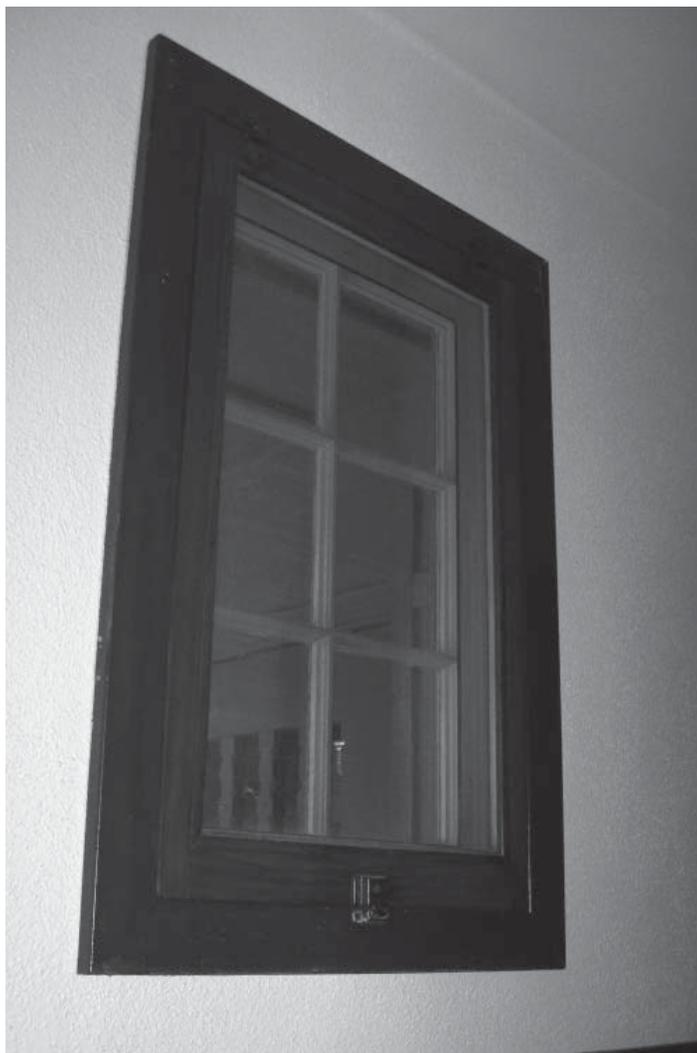
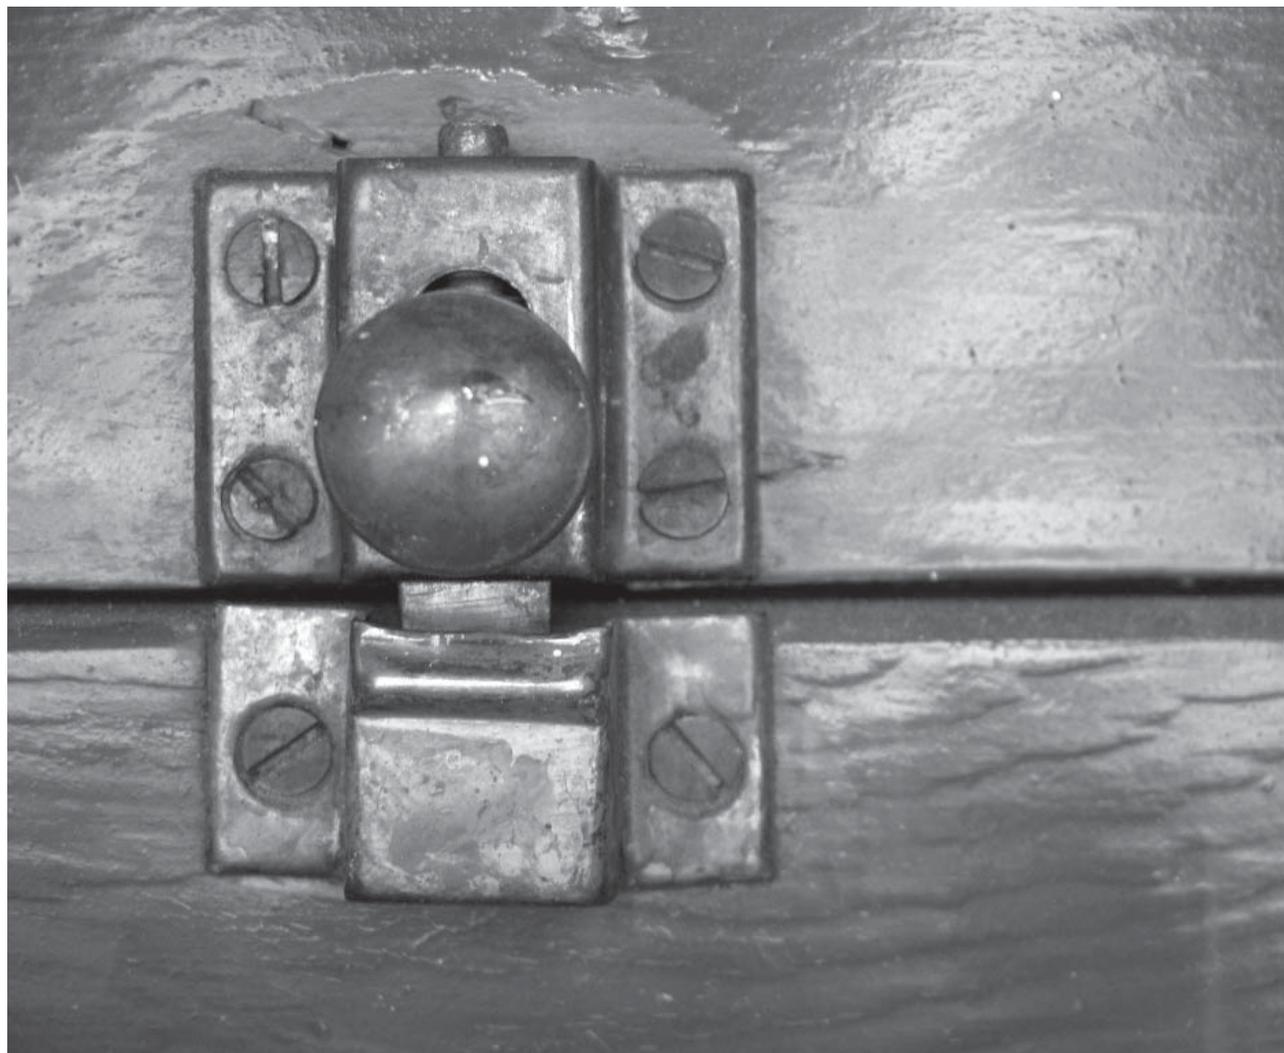
Figure 6.32: Opposite page, window section diagram, Left, Window in second floor hallway. Right, Typical window screen lock (Jaramillo, 2009)

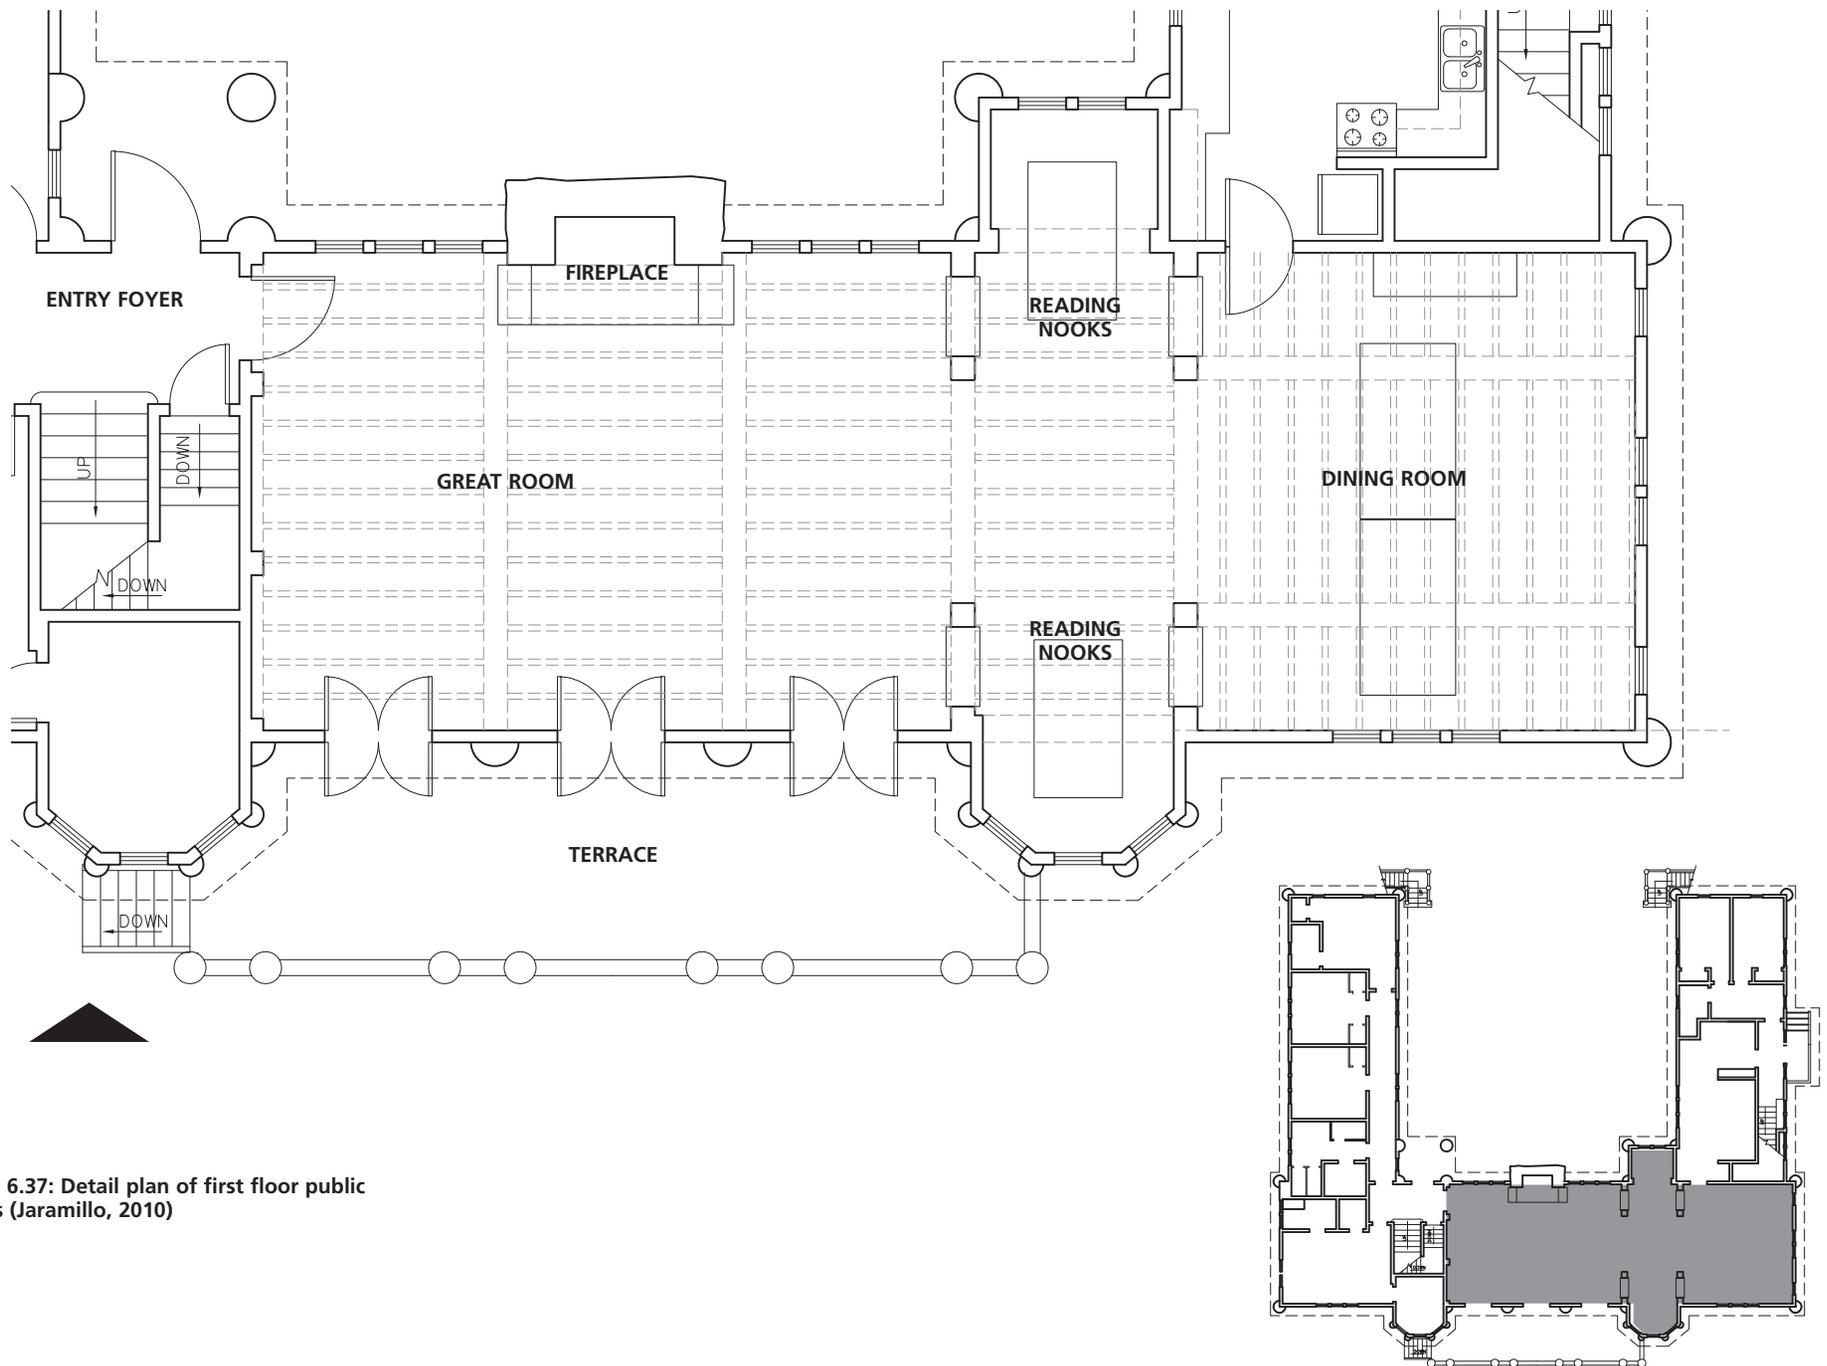
Figure 6.37: Detail plan of first floor public spaces (Jaramillo, 2010)

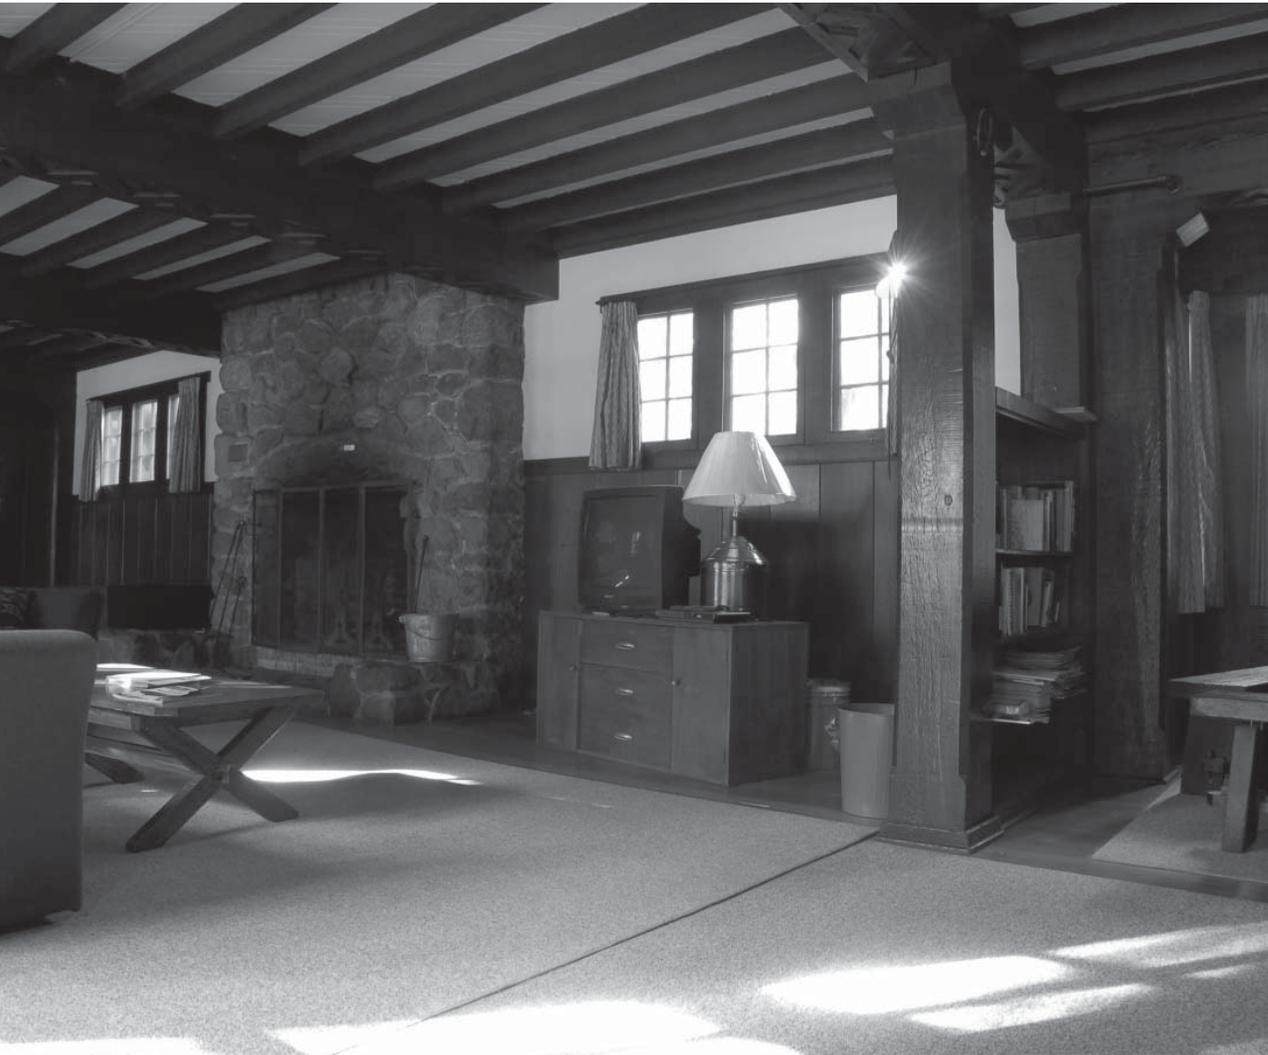
Figure 6.42: View towards fireplace and north wall of Great Room (Jaramillo, 2010)

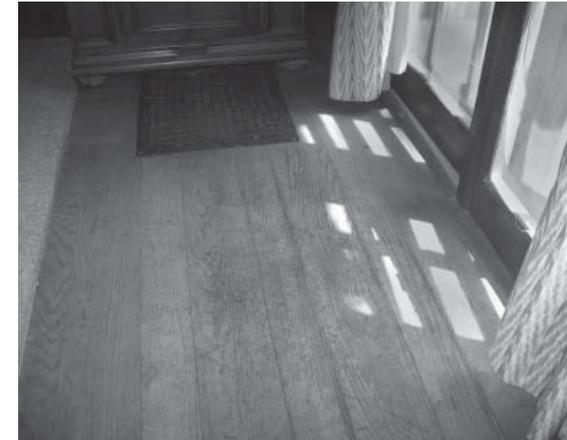
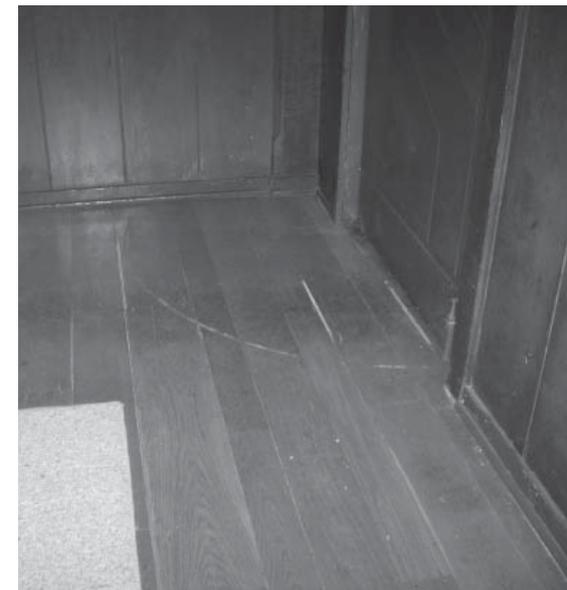
Figure 6.43: Above, Damaged floor at terrace doors, below, damaged and scuffed floor at kitchen entry (Jaramillo,2010, Sommers, 2009)

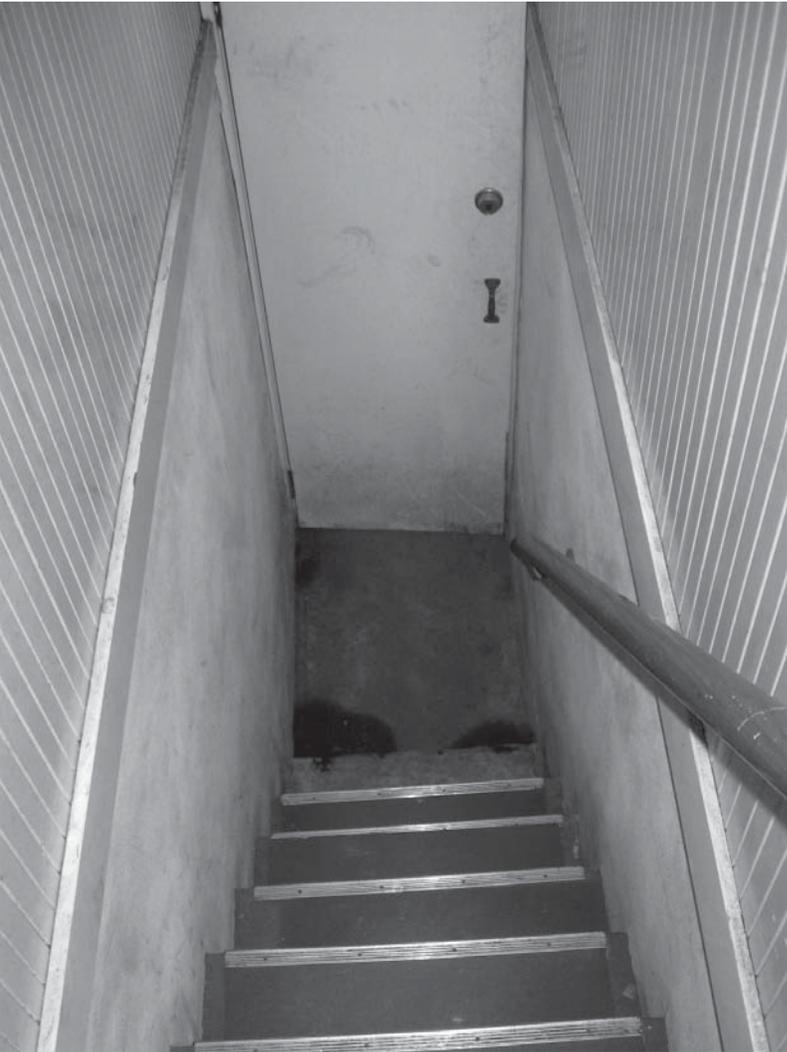
Figure 6.44: View towards basement door from staircase (Sommers, 2009)

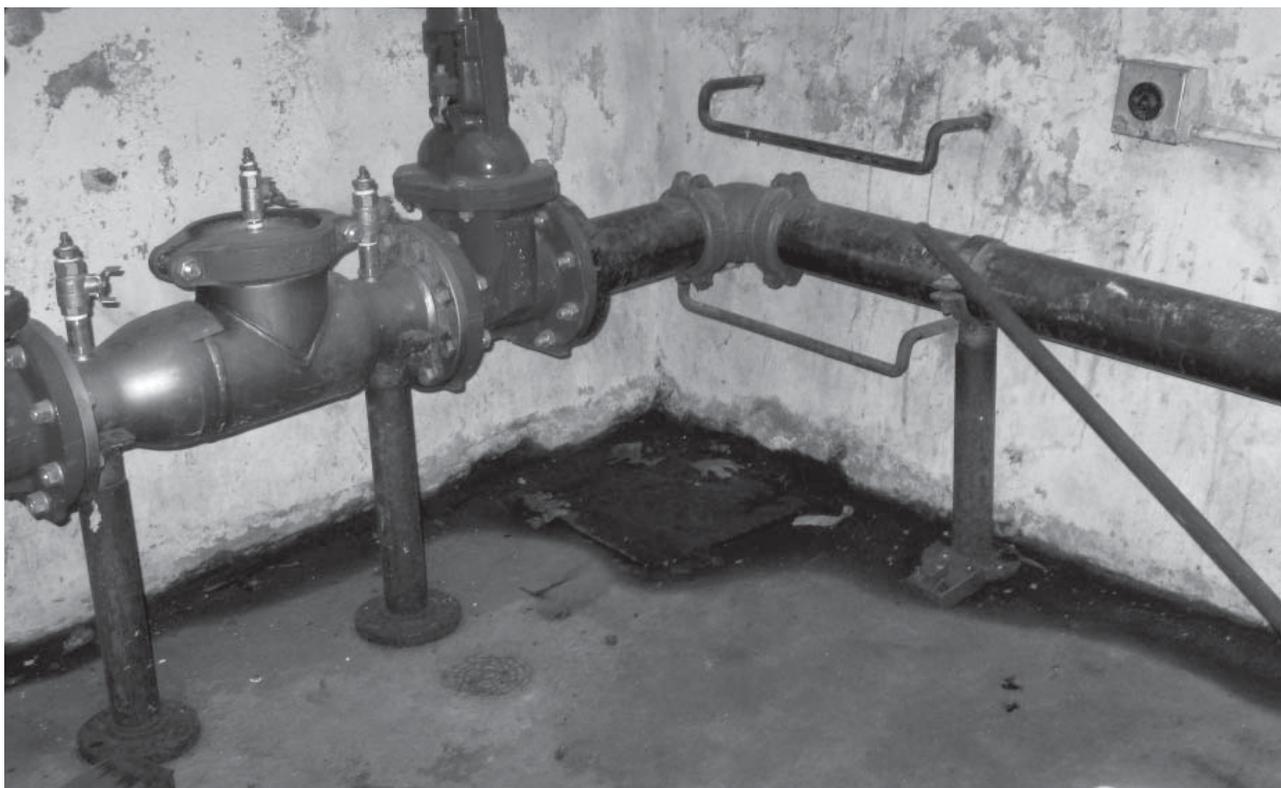
Figure 6.46: Basement water supply pipe (Sommers, 2009)

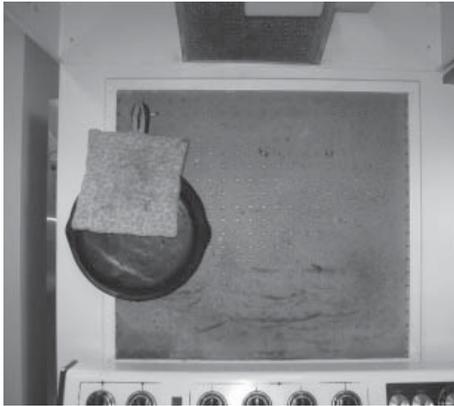
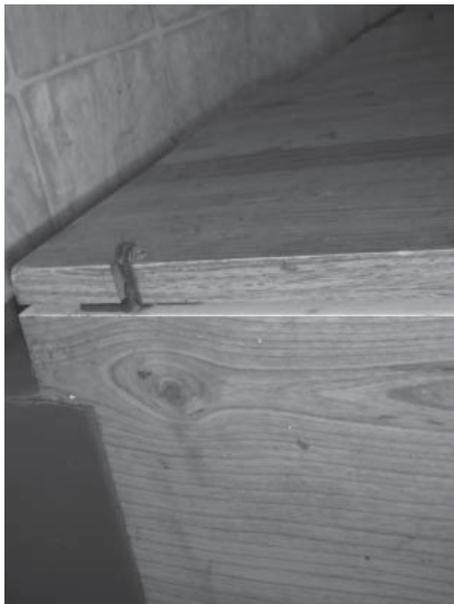
Figure 6.49: Above, corkboard above stove, below, damaged formica cabinet doors (Sommers, 2009)

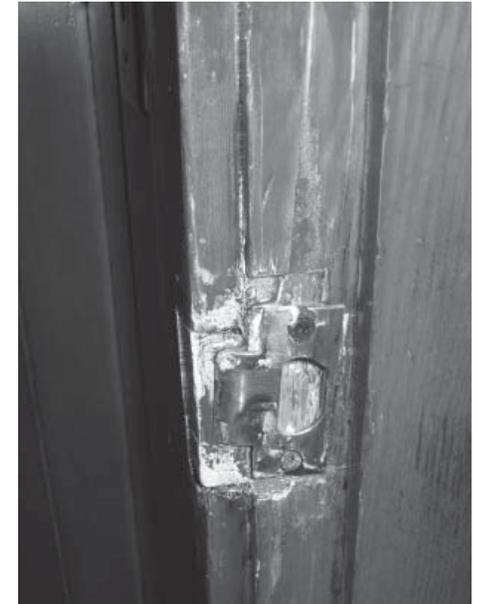
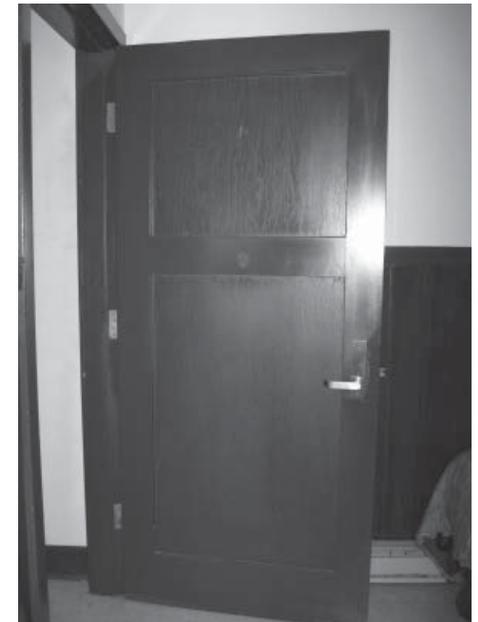
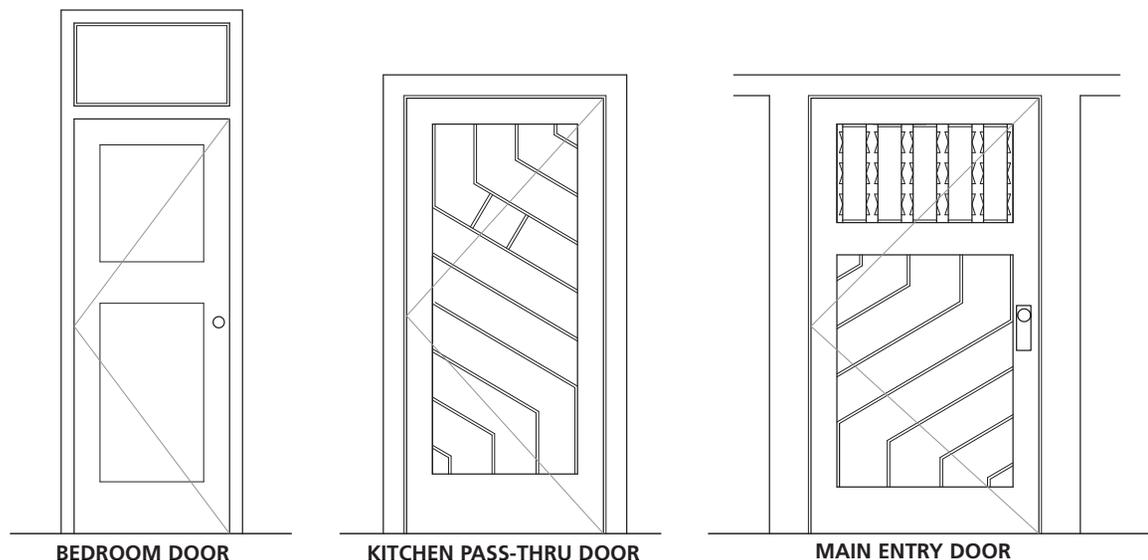
The following section reviews all of the bedrooms and other private/semi-private spaces. It is followed by a description and assessment of the components that make up the rooms. This allows combination of many similar issues into one concise section

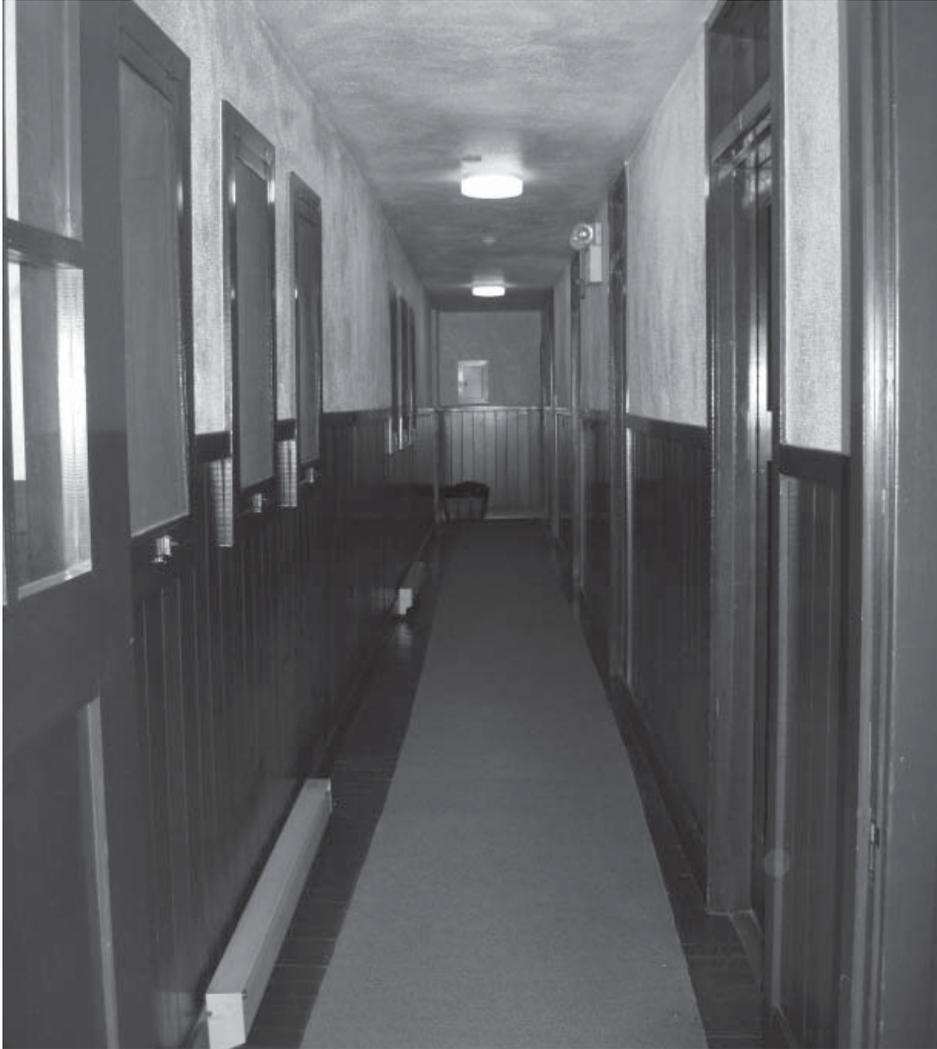
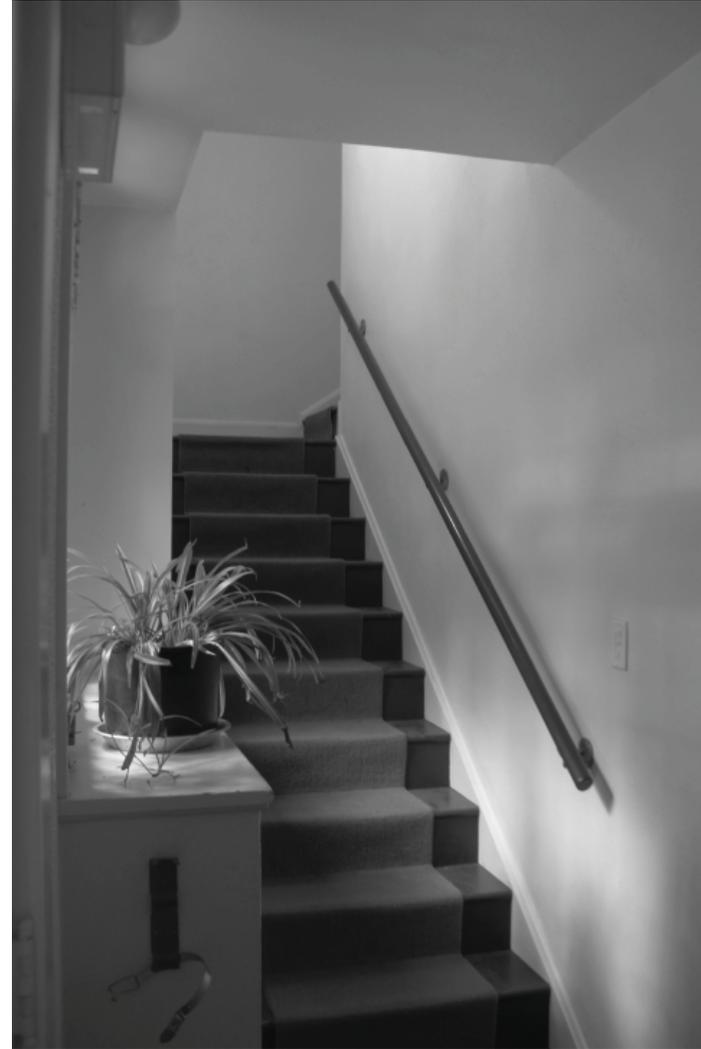
Figure 6.60: Left, Second floor hallway, with wainscoting and plaster walls. Right, service stair with plaster walls and ceiling. (Somers, 2009)

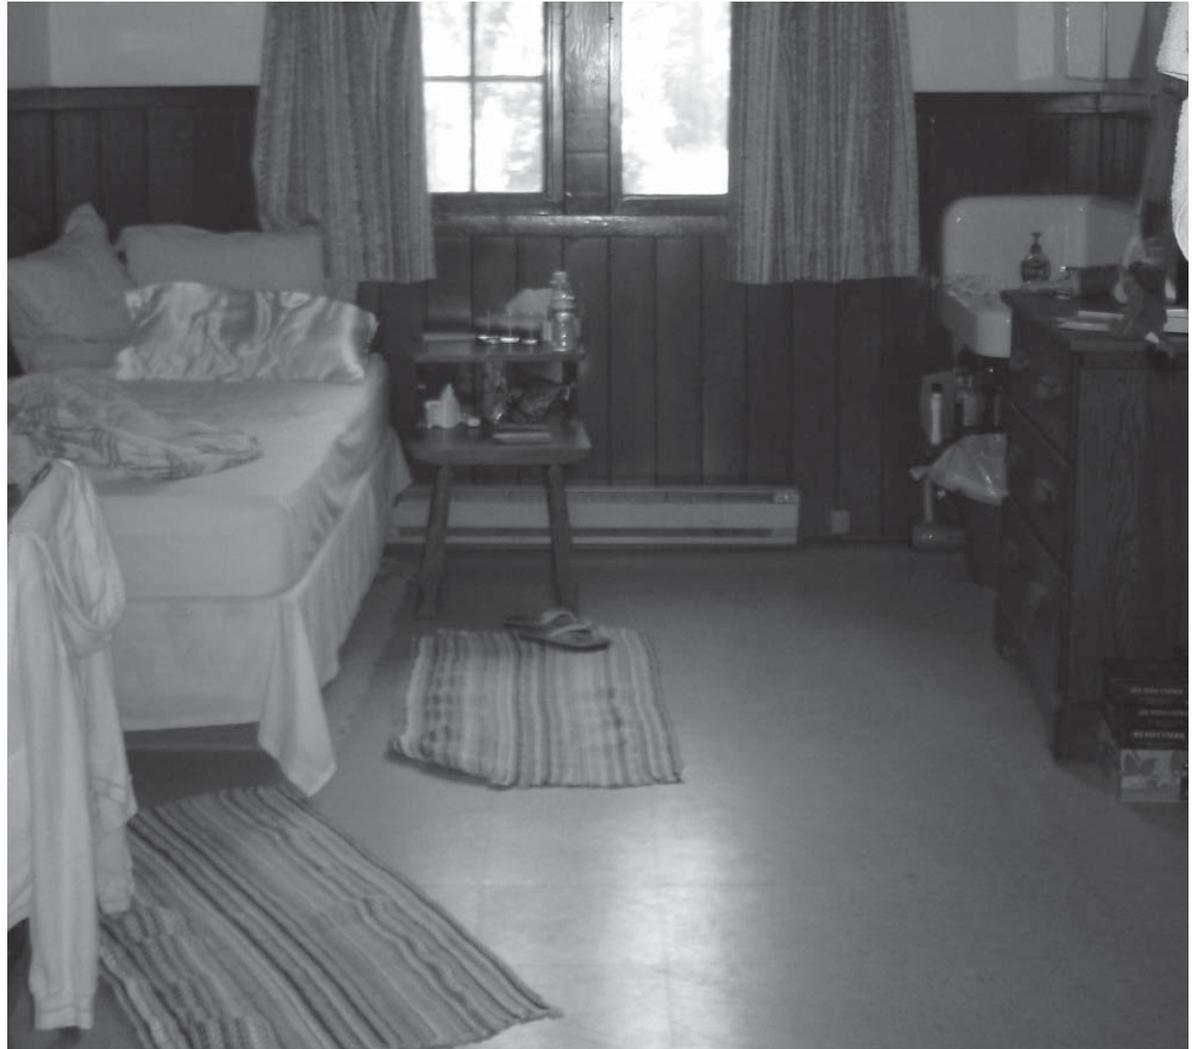
Figure 6.61: Room 7 with vinyl tile flooring (Sommers, 2009)

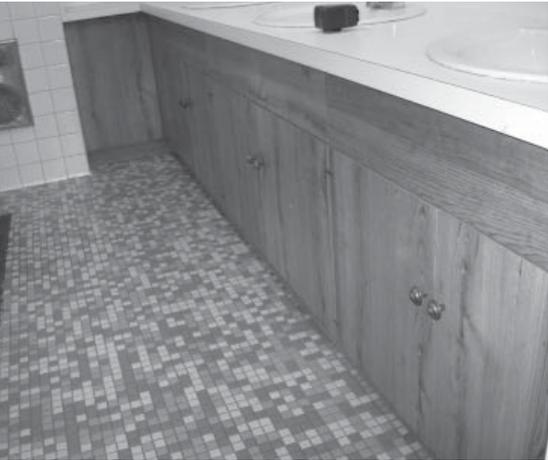
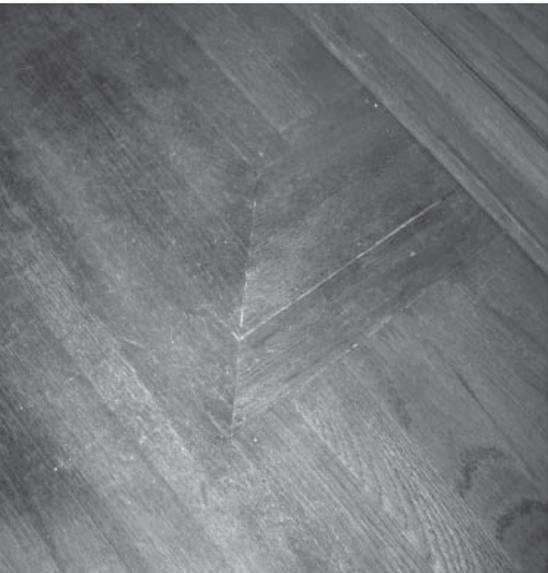
Figure 6.62: Above, Bathroom 18 tile floor, below, Room 2 wood floor with edge on upper corner (Jaramillo, 2009)

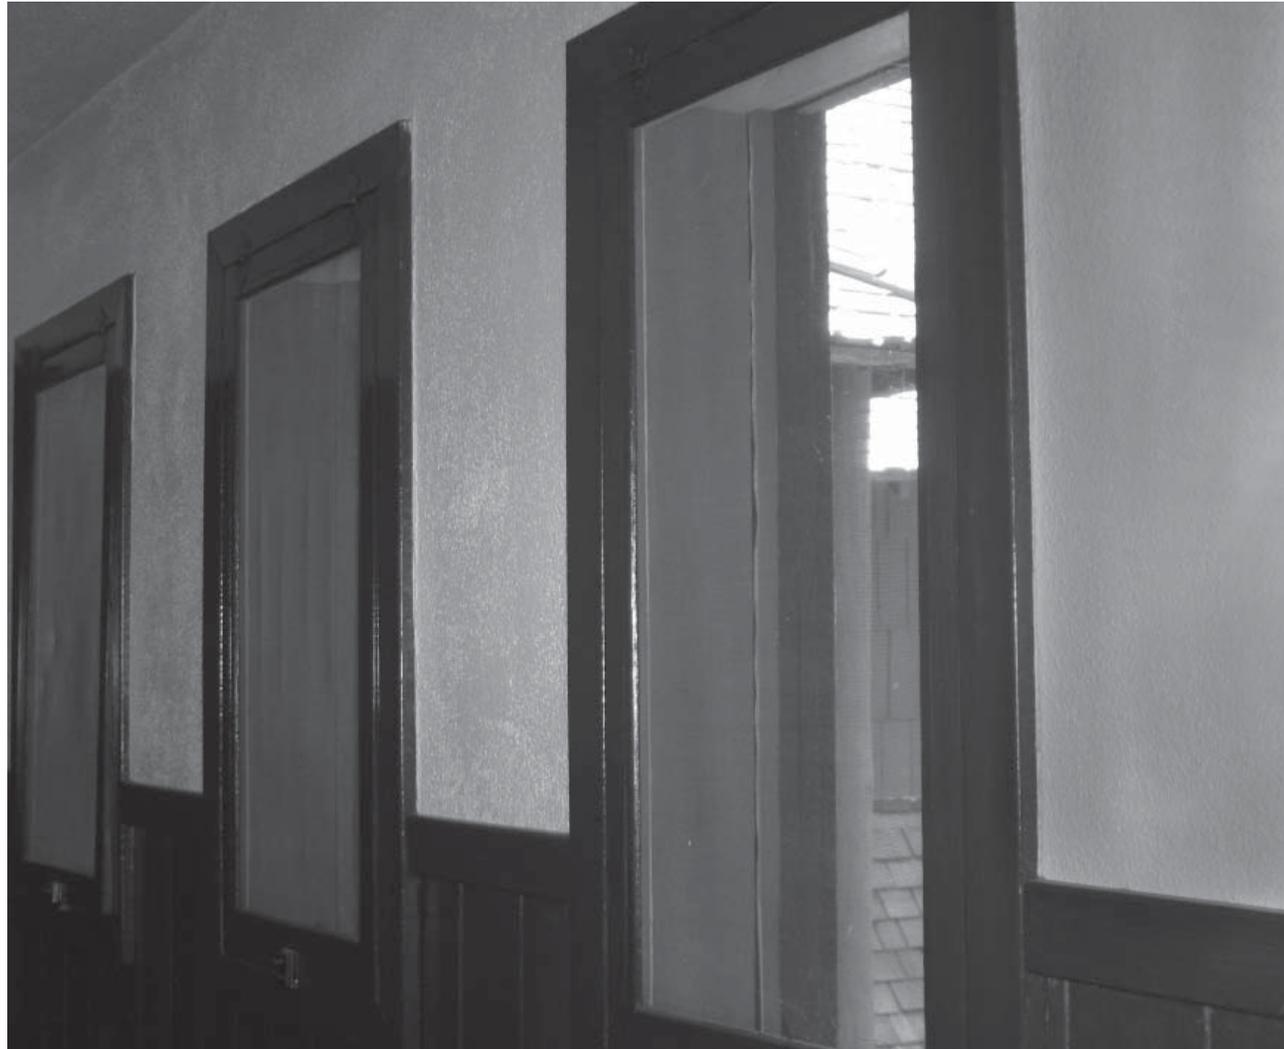
Figure 6.63: View of hallway windows on second floor, note simple trim details connecting with wainscoting (Jaramillo, 2010)

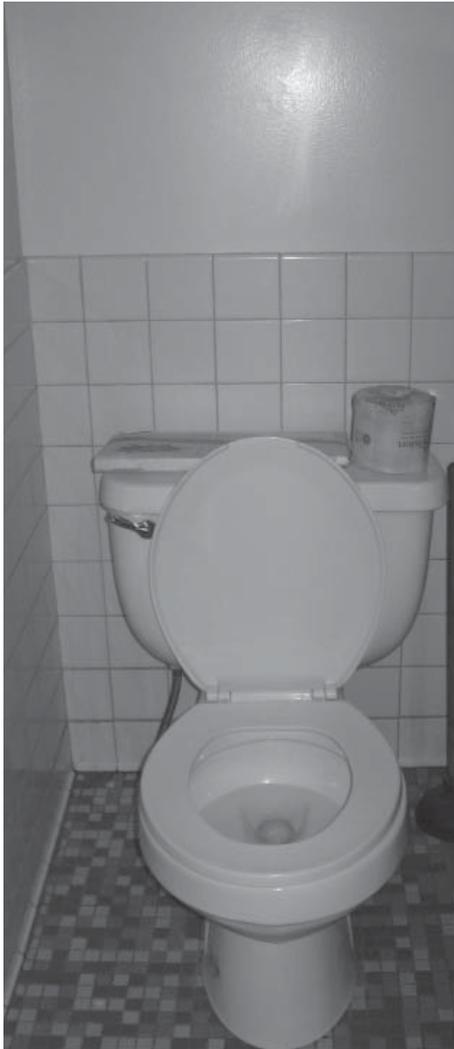
Figure 6.65: Bathroom 16 toilet (Durbin, 2009)

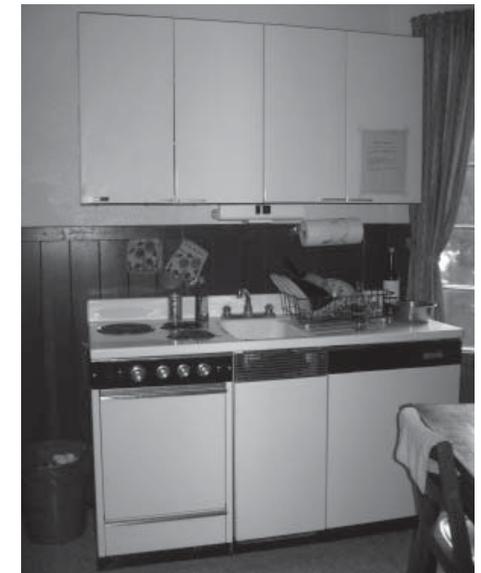
Figure 6.66: Mather suite, kitchen unit (Somers, 2009)

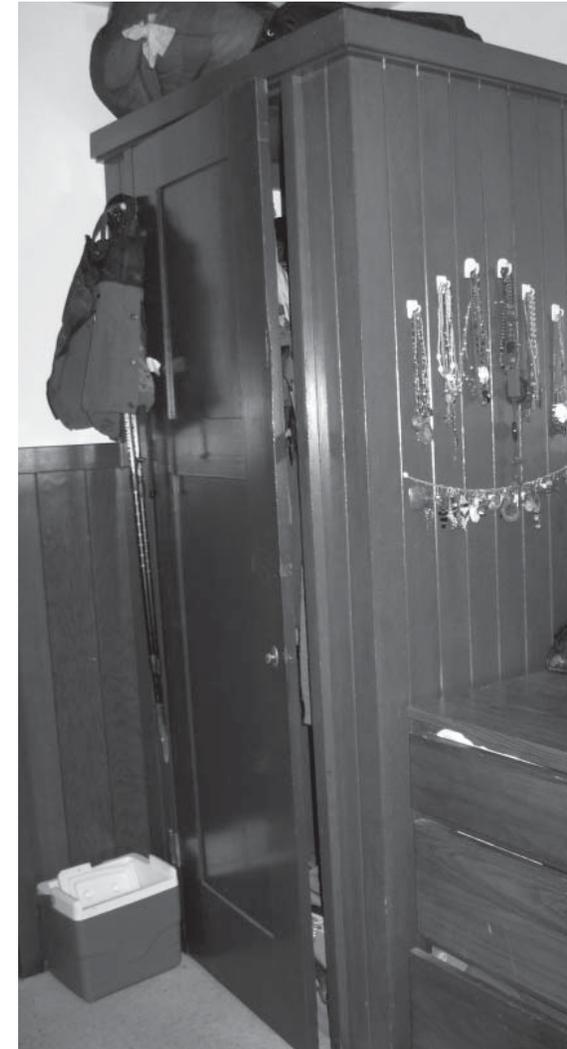
Figure 6.67: Closet in Bedroom 6 (Sommers, 2009)

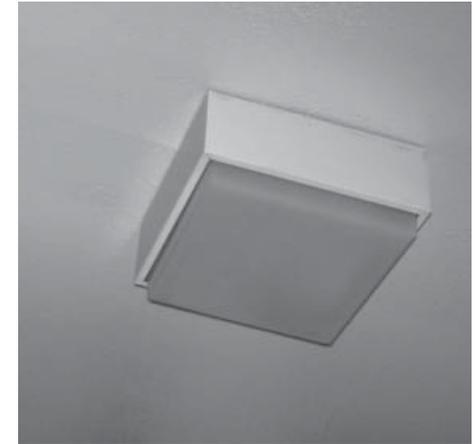
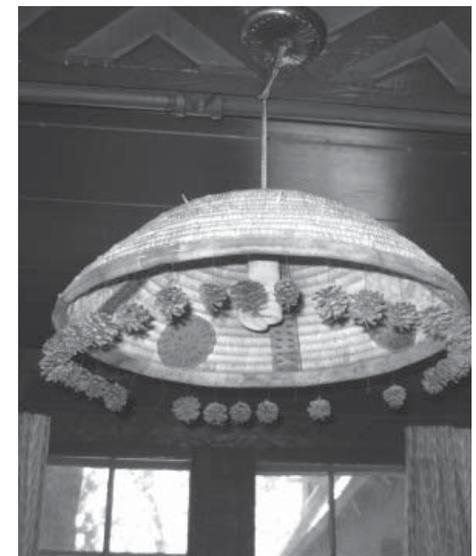
Figure 6.69: Fluorescent light fixture in Room 1, below, pine cone ceiling lamp over reading nook (Sommers, 2009)

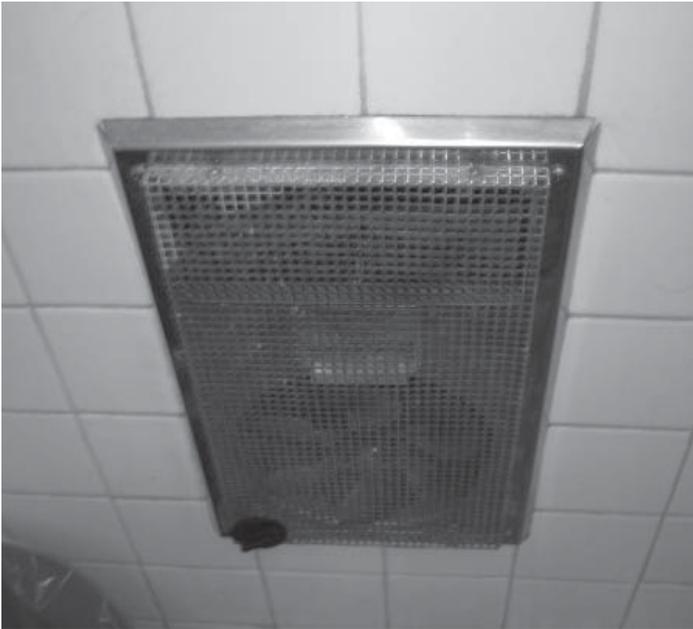
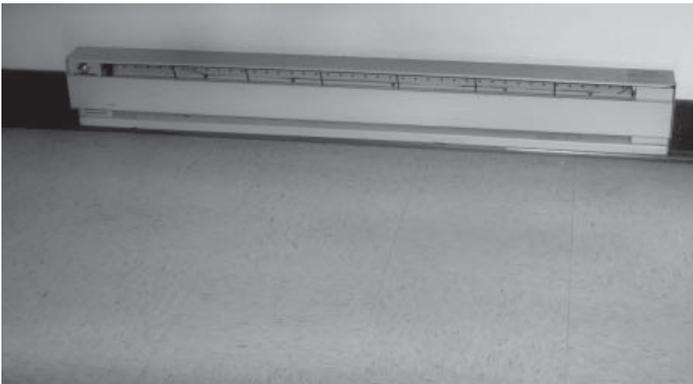
Figure 6.70: Above, electric heater in second floor shower room, below, baseboard heater in Dormitory B (Sommers, 2009)

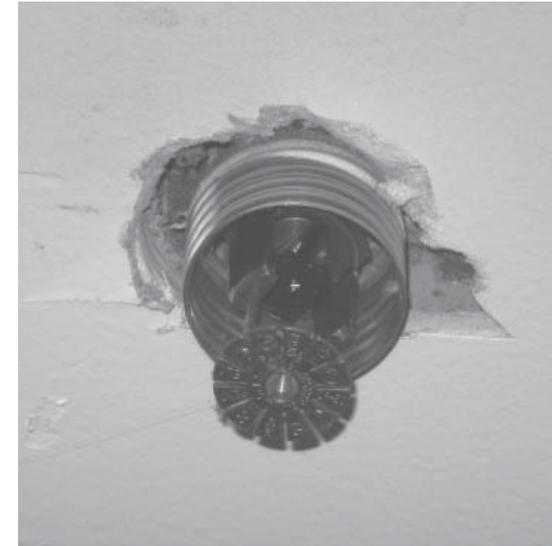
Figure 6.72: Exposed sprinkler head in second floor bathroom (Durbin, 2009)

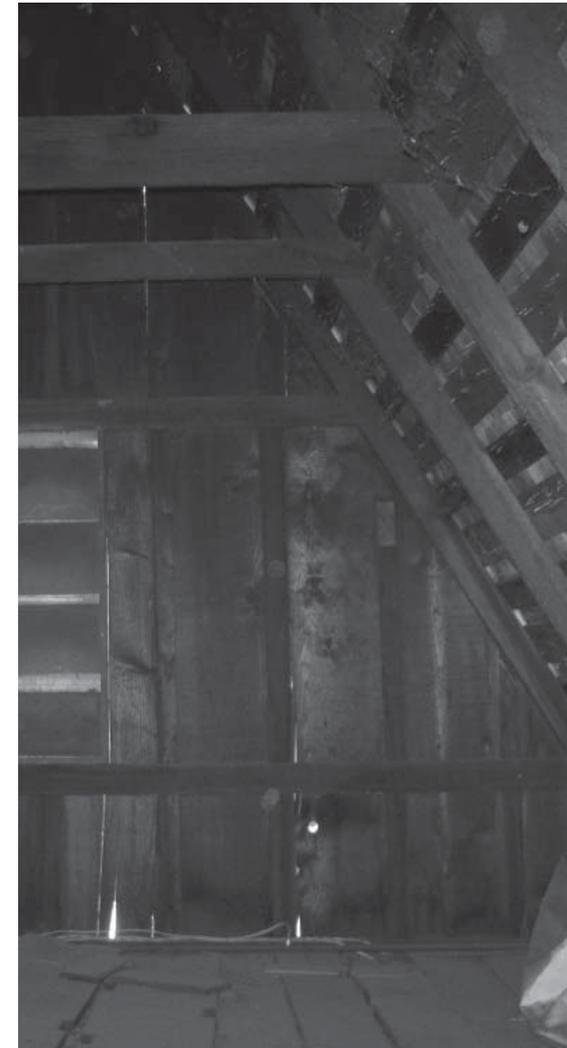
Figure 6.75: Attic interior of garage, note the vent to left of photograph (Jaramillo, 2009)
