National Park Service
U.S. Department of the Interior

Yosemite National Park
California

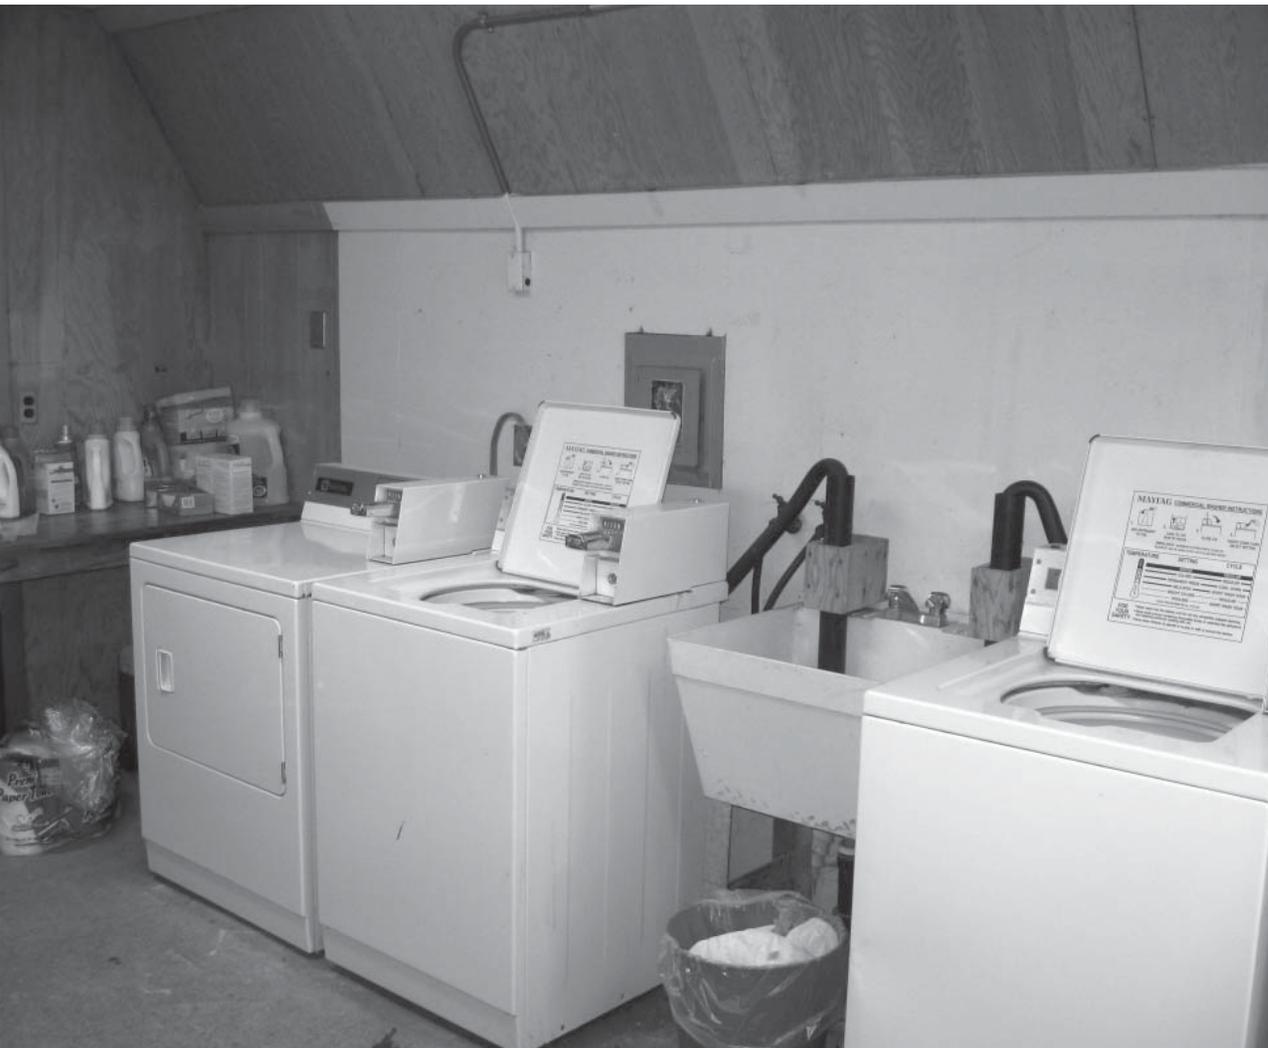
Figure 6.76: Interior of Garage with washer dryer units on west wall (Durbin, 2009)

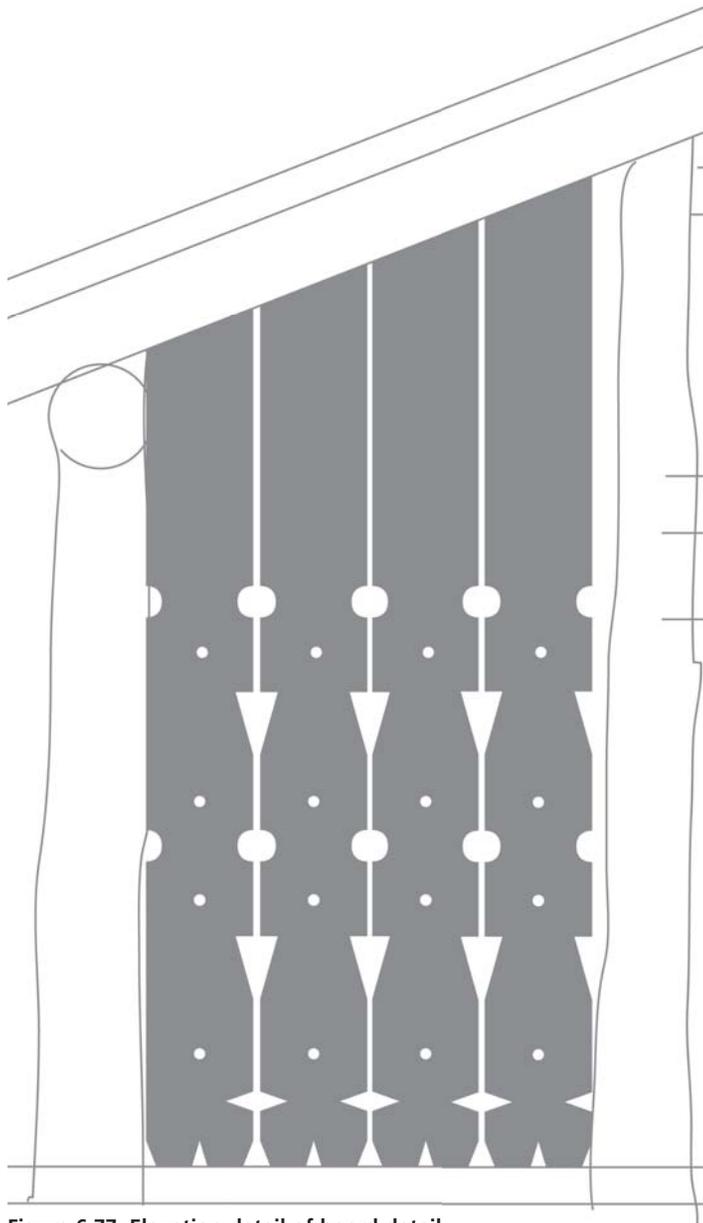
Figure 6.77: Elevation detail of board detail with notched edges creating circle and triangle pattern (Jaramillo, 2010)

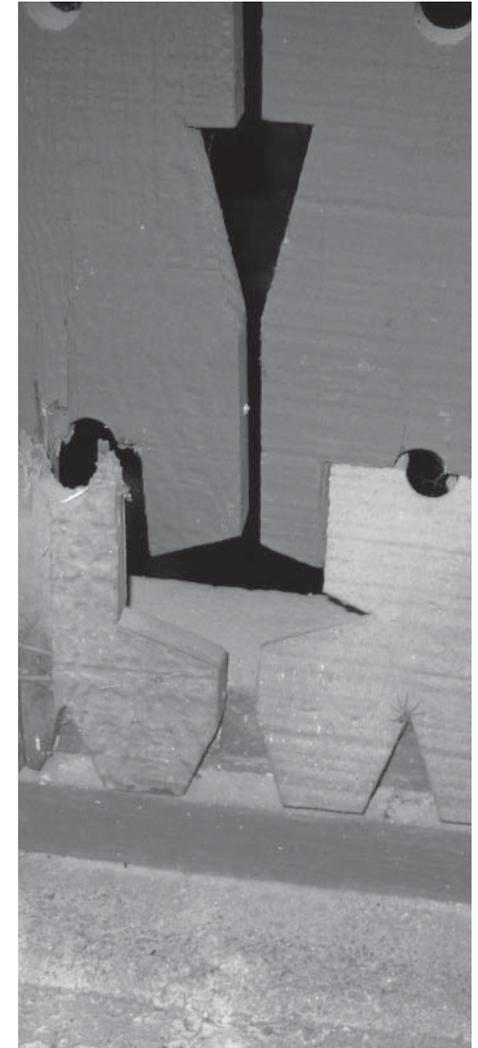
Figure 6.79: Left, Interior of transformer building, right, damaged boards detail. (Jaramillo, 2009)

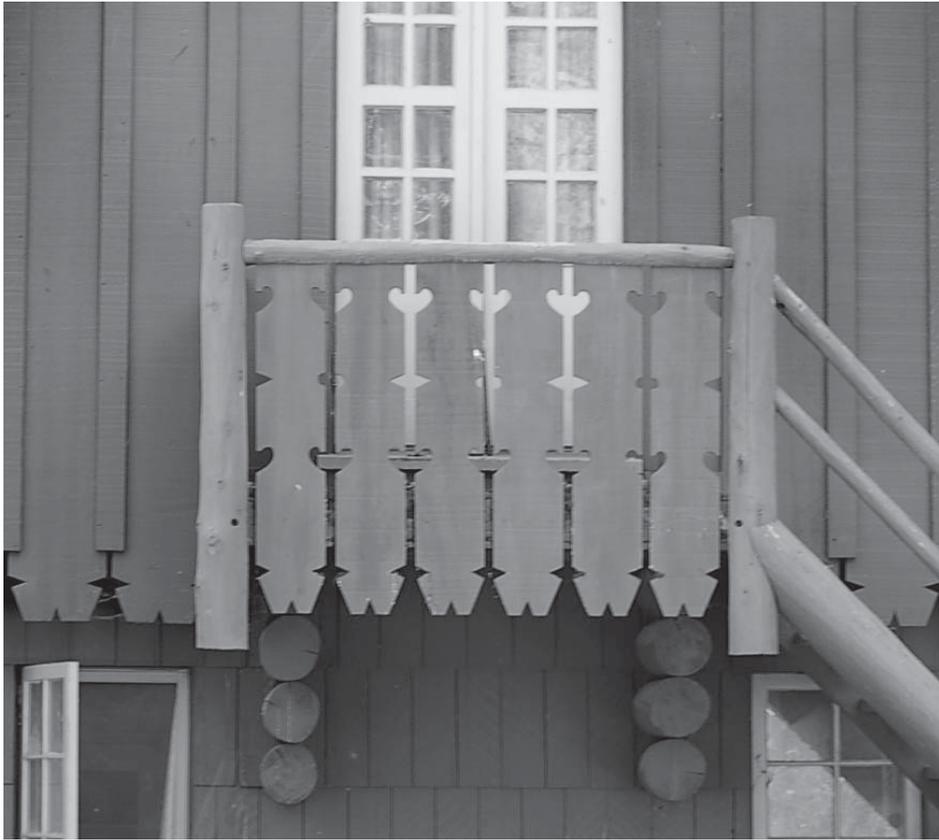
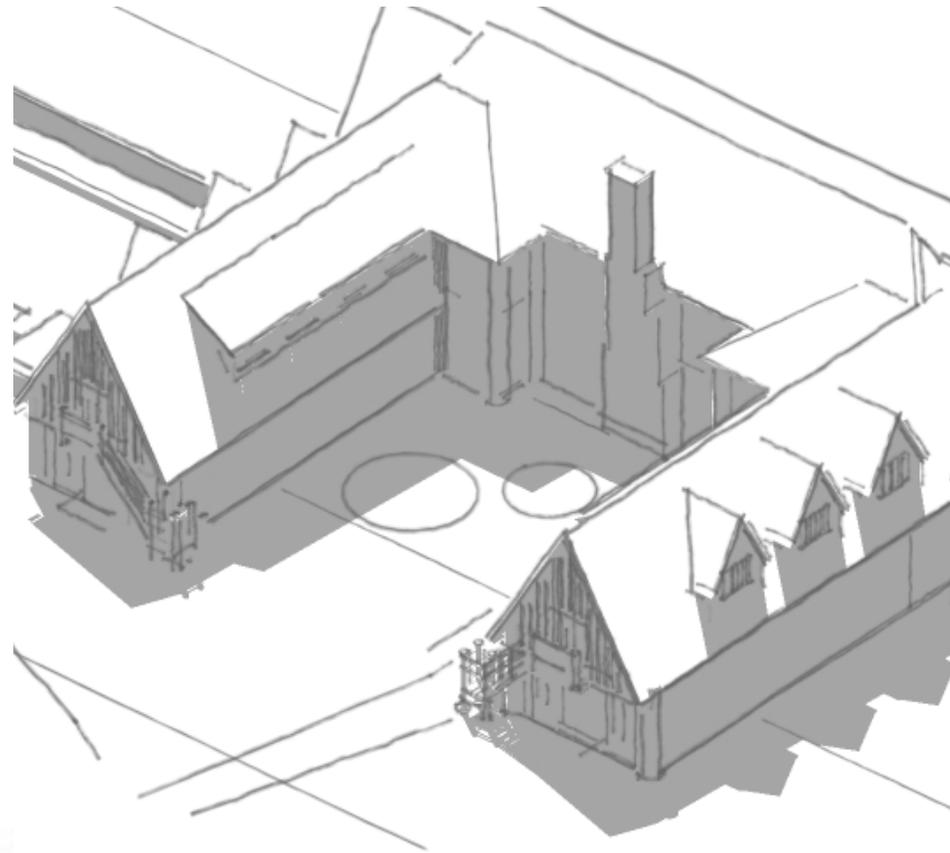
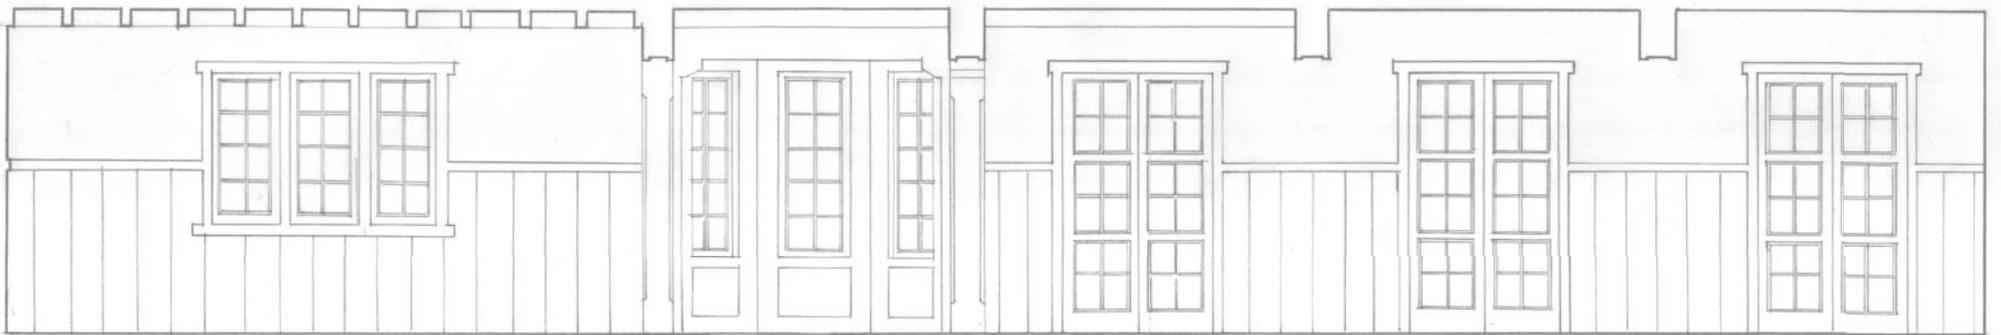
Character Defining Features

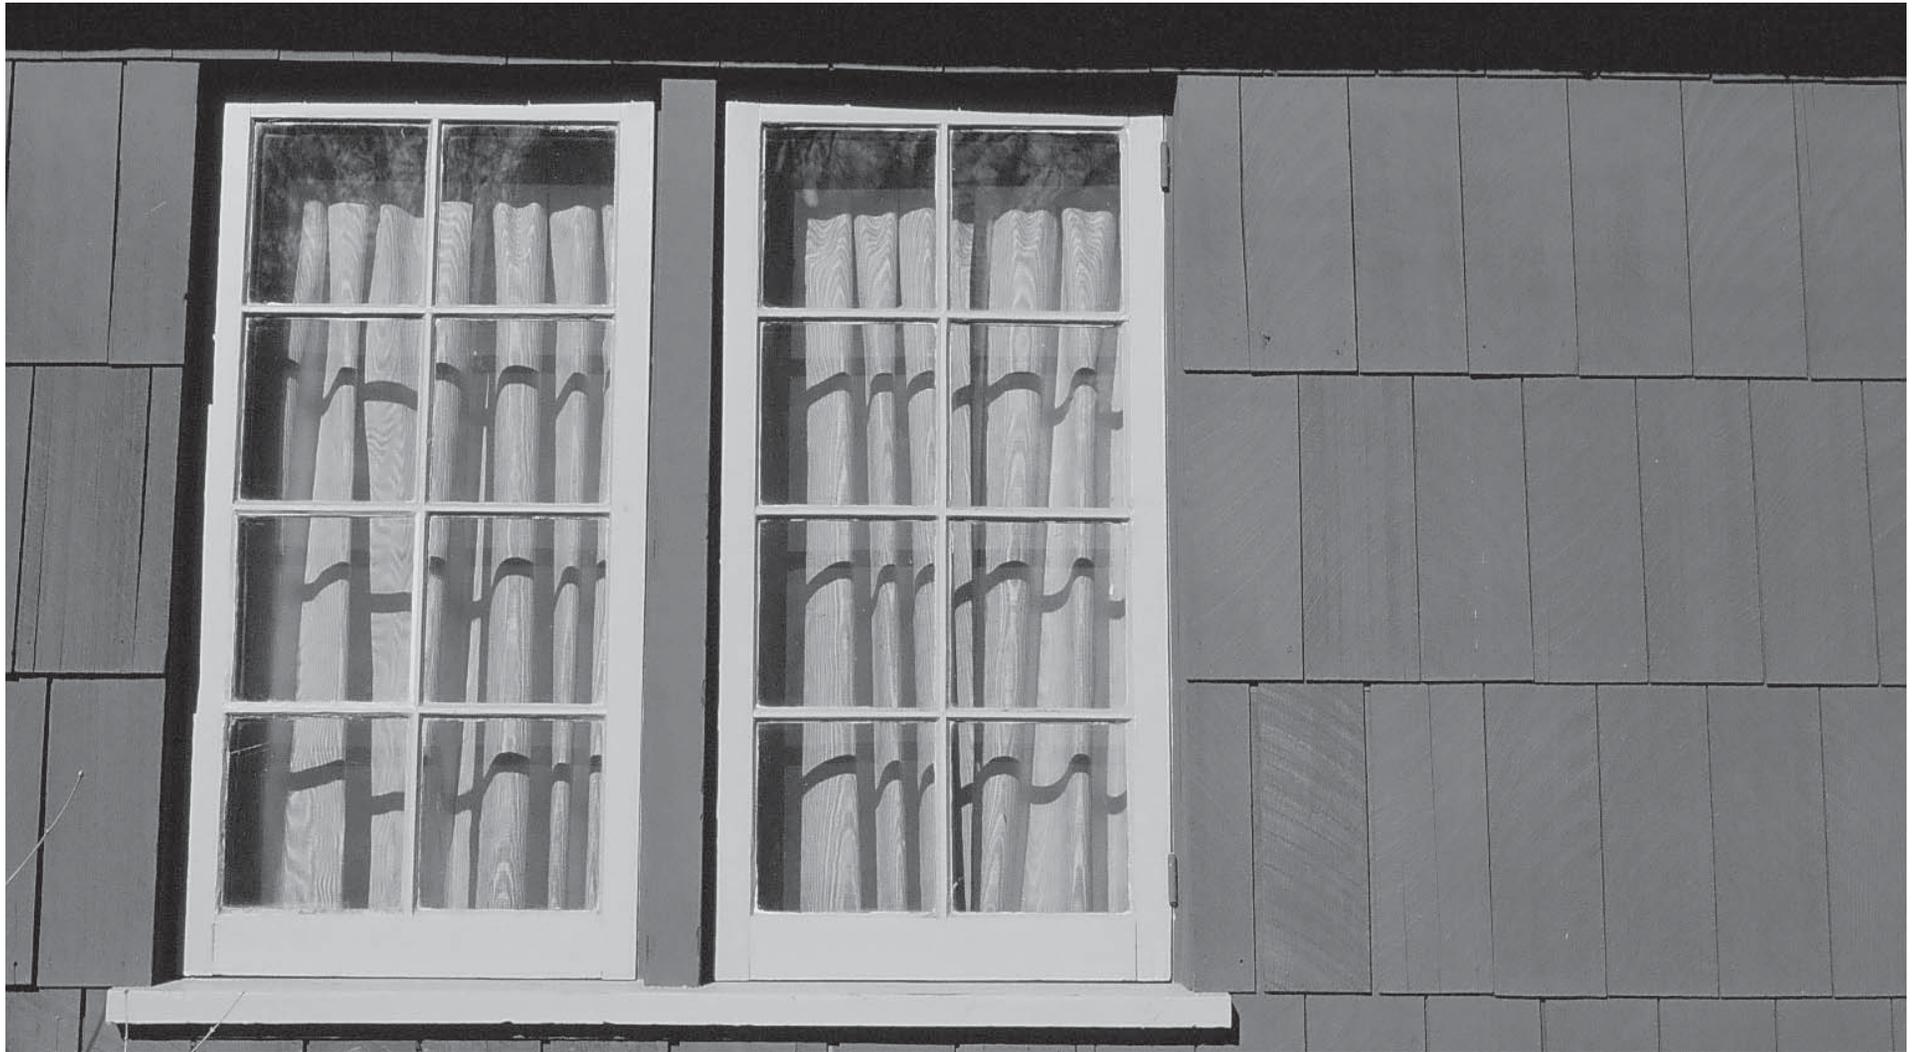
Figure 7.2: Eastern elevation gabled end (Jaramillo, 2009)

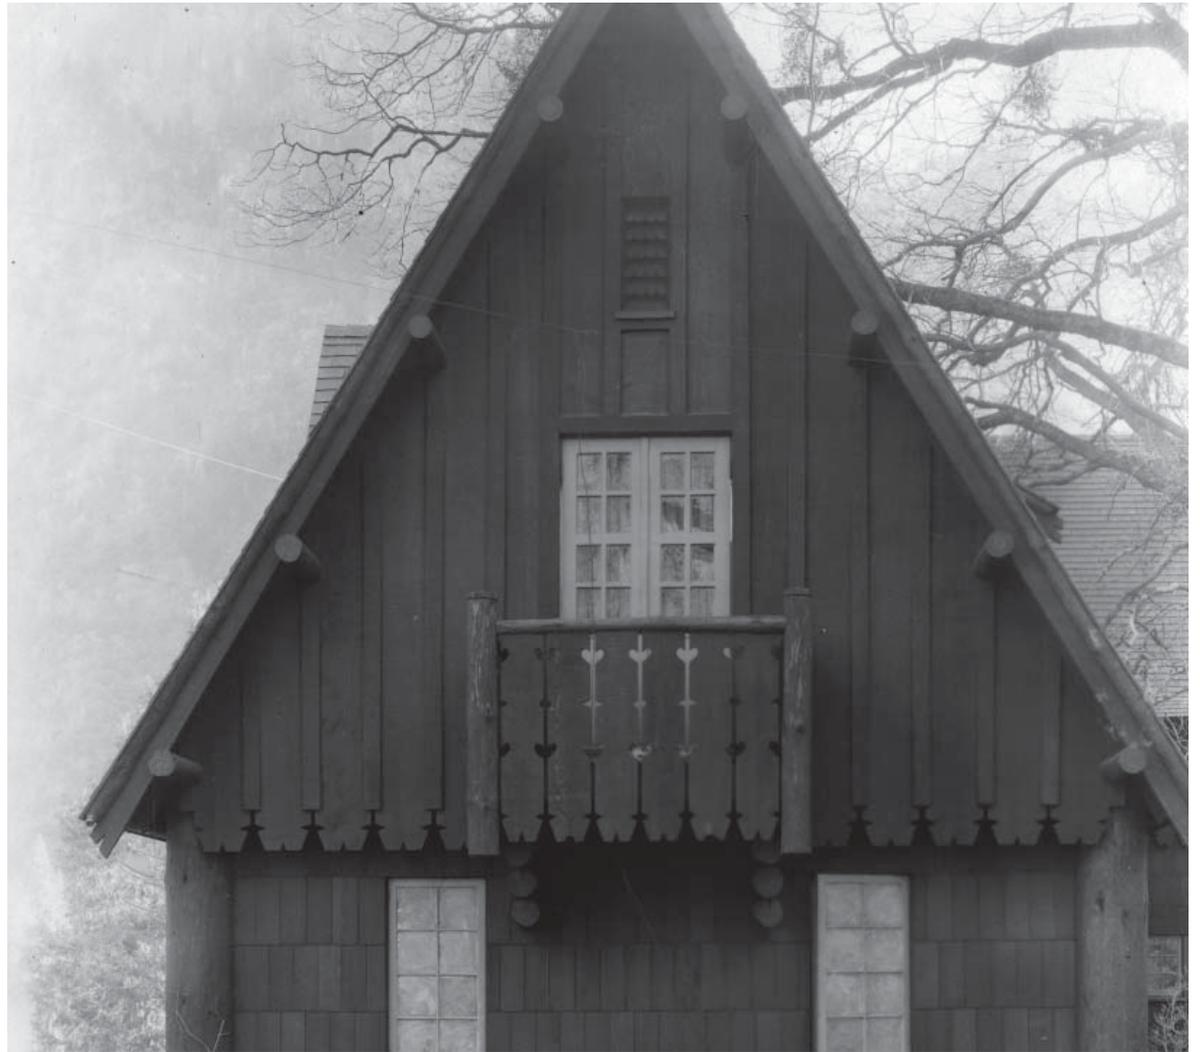
Figure 8.3: Rangers' Club exterior side (YRL 6736)

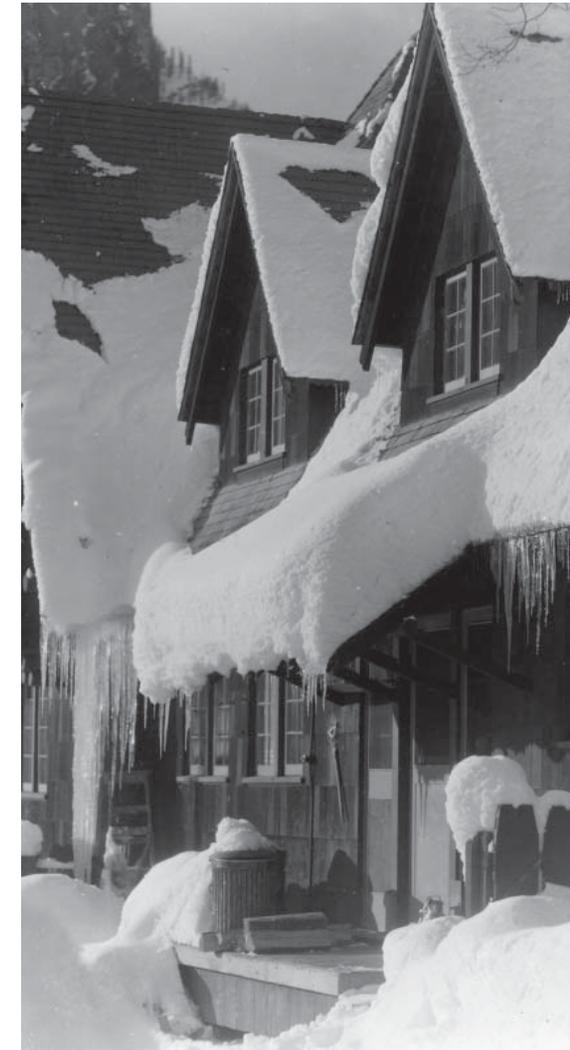
Figure 8.4: Rangers' Club with snow on service entrance (YRL 3601)

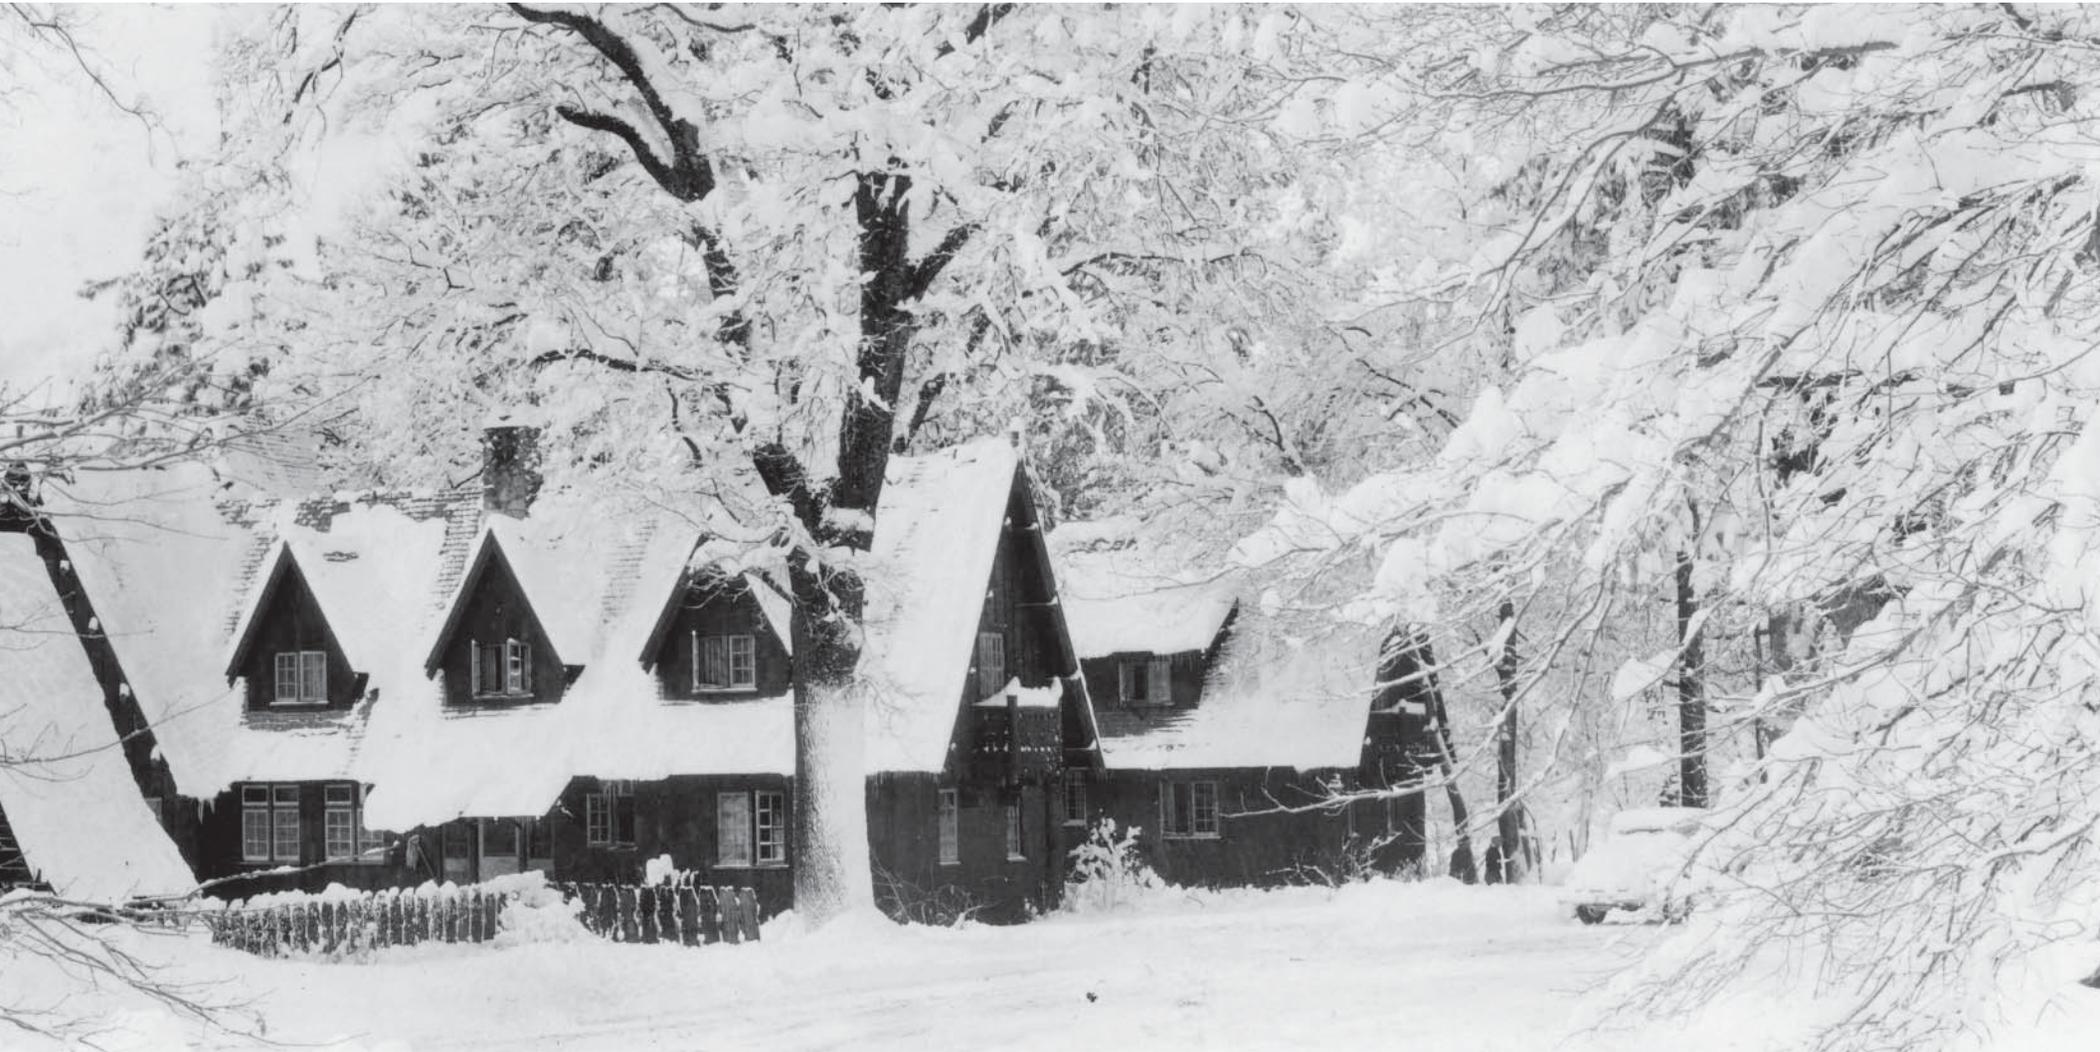
Figure 8.5: Rangers' Club view from northeast (YRL 6744)

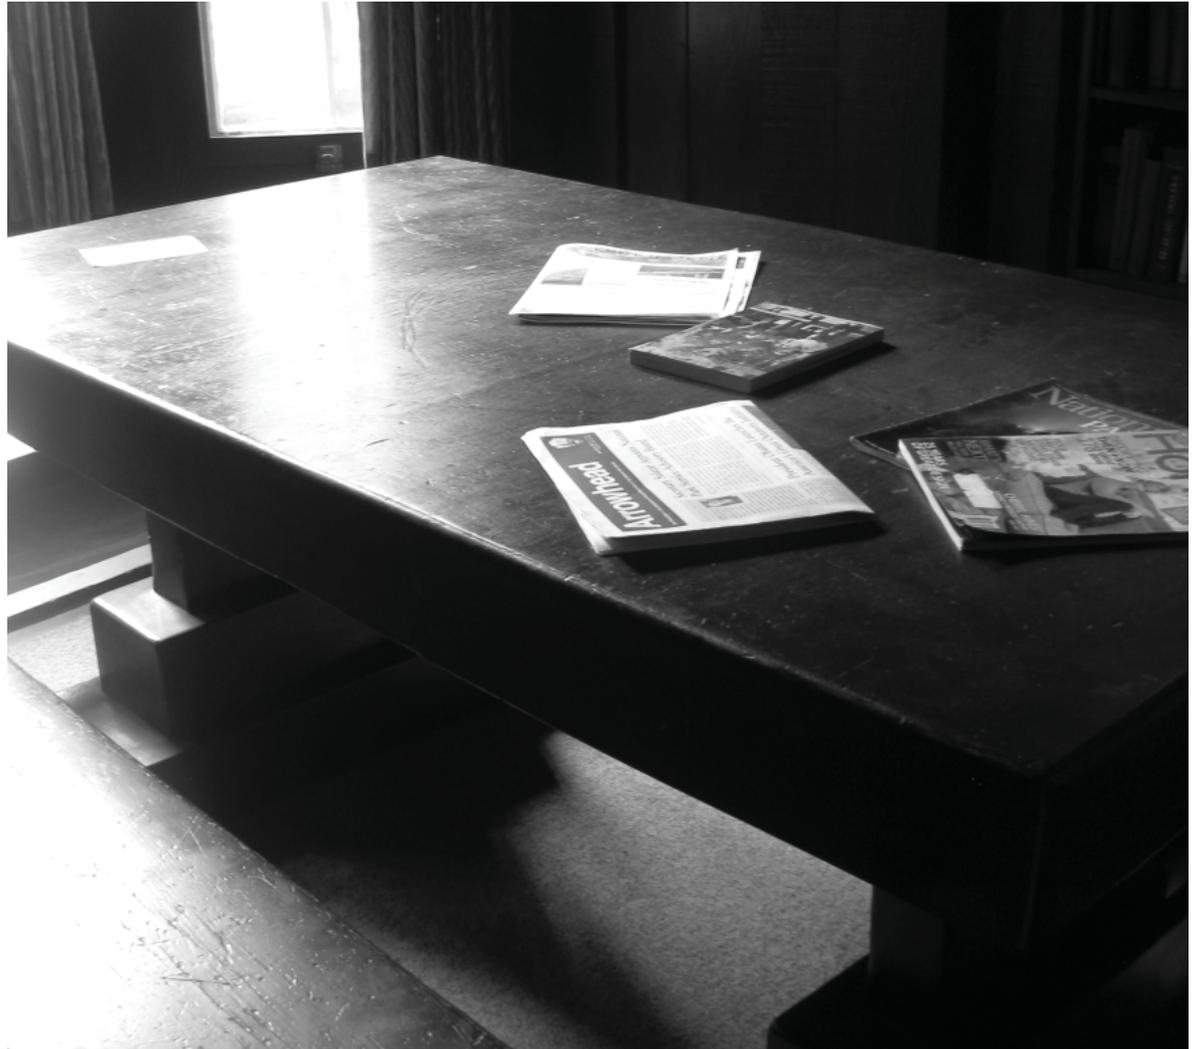
Figure 8.6: Reading nook (Jaramillo, 2010)

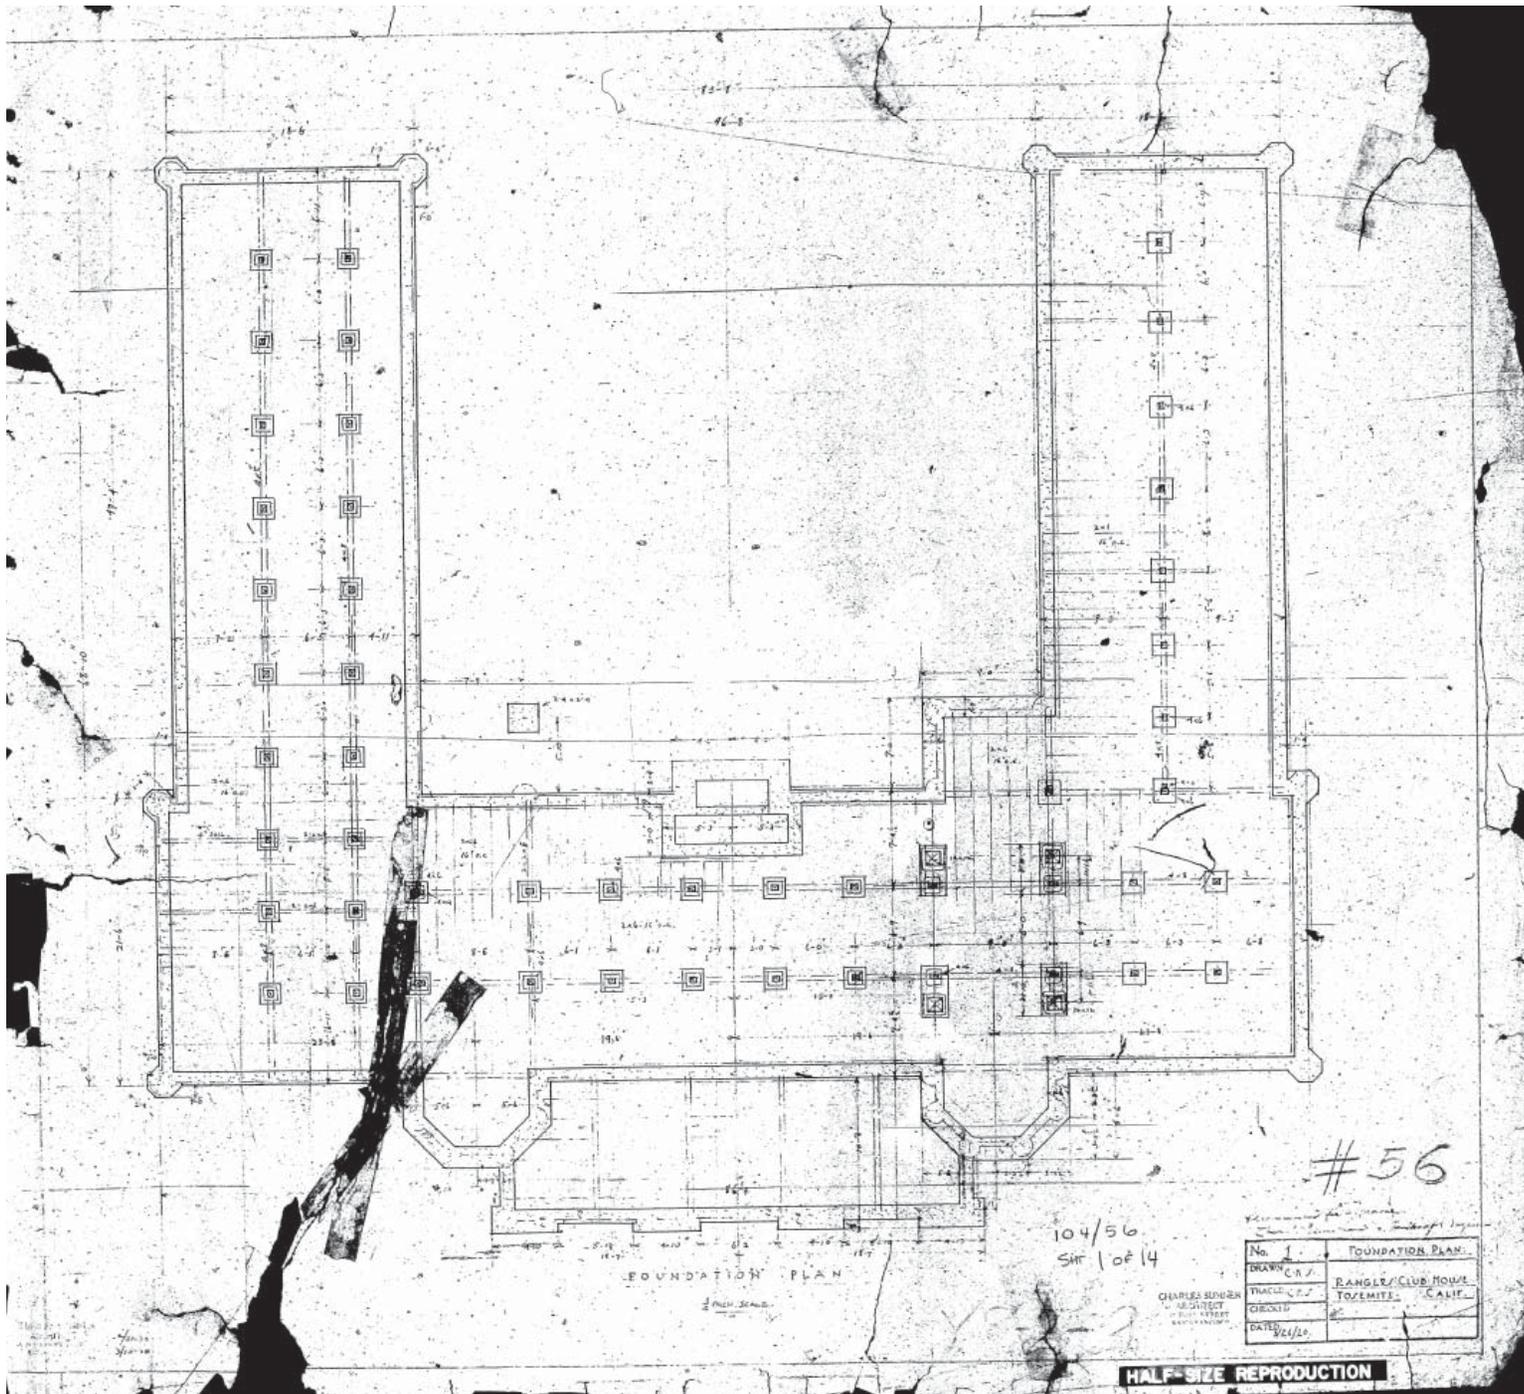
Sheet 1 - Foundation Plan
Sheet 2 - 1st Floor Plan
Sheet 3 - 2nd Floor Plan
Sheet 4 - Elevation and Section
Sheet 5 - East and South Elevation
Sheet 6 - Trans Section
Sheet 7 - Main Cornice and Balconies
Sheet 8 - Cornice Etc.
Sheet 9 - Cornice and Bays and Terrace Rail
Sheet 10 - Frames
Sheet 11 - Details Living and Dining Room
Sheet 12 - Entrance Hall and Stairs
Sheet 13 - Misc. Interior Details
Sheet 14 - Full Size Interior Details
