Mariposa County Fire
FIRE INVESTIGATION
SUPPLEMENTAL REPORT

Incident: MMU#4767, YNP#08-0896
Mariposa County Fire#330, YNP Fire#08-042

April 21, 2008
Structure Fire 'El Portal Market'
10893 Hwy 140, El Portal, CA 95318

PHOTOGRAPHIC LOG

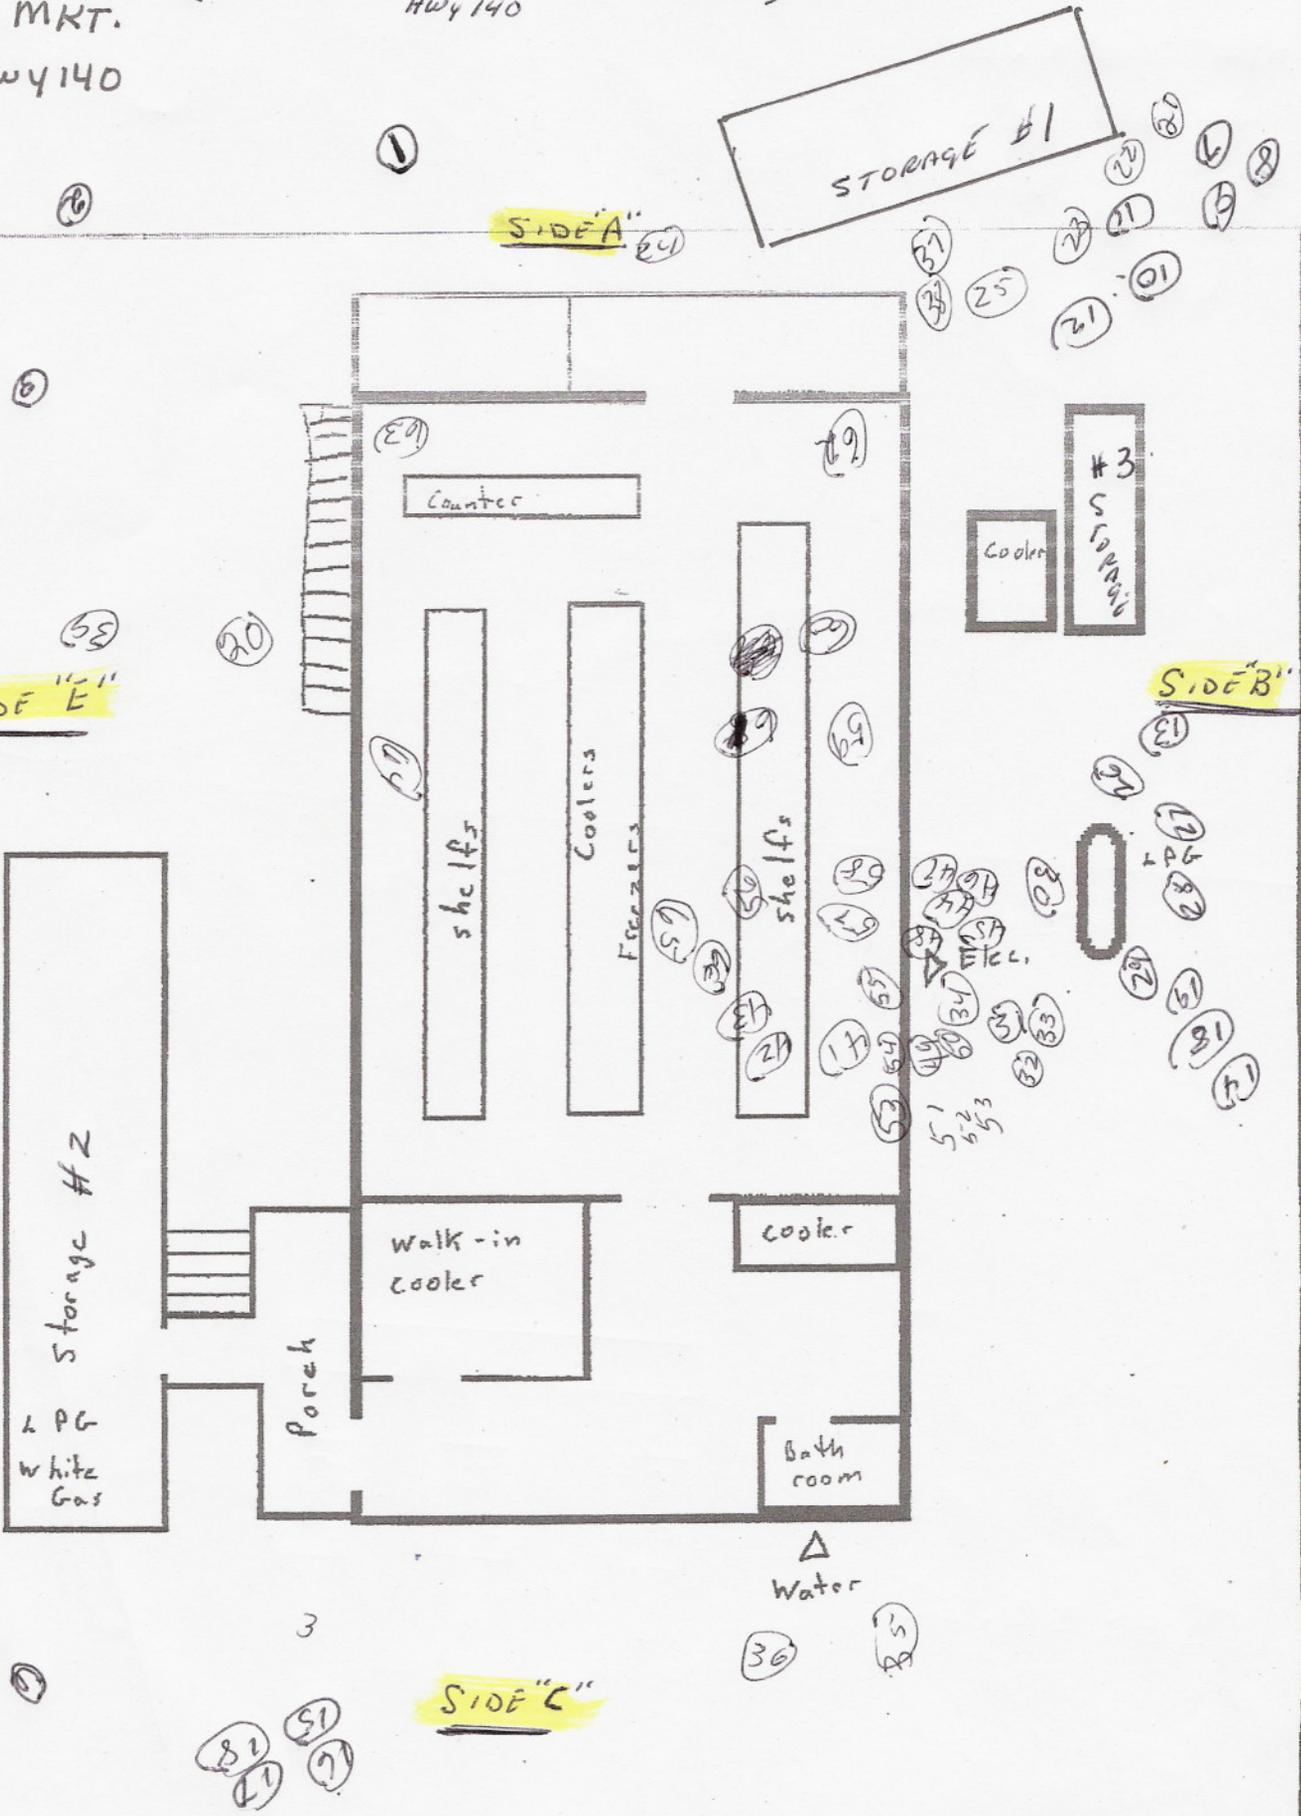
PHOTO SKETCH
EL PORTAL MKT.
10893 Hwy 140
4-21-08

See attached photo sketch for placement of pictures in area of which they were taken.
