# Blackstone River Valley National Heritage Corridor Commission Blackstone Canal Alternative Transportation Feasibility Study Uxbridge and Northbridge, MA

NPS Contract No. GS-10F-0281R; VHB Project No. 33281.02  
Document No.

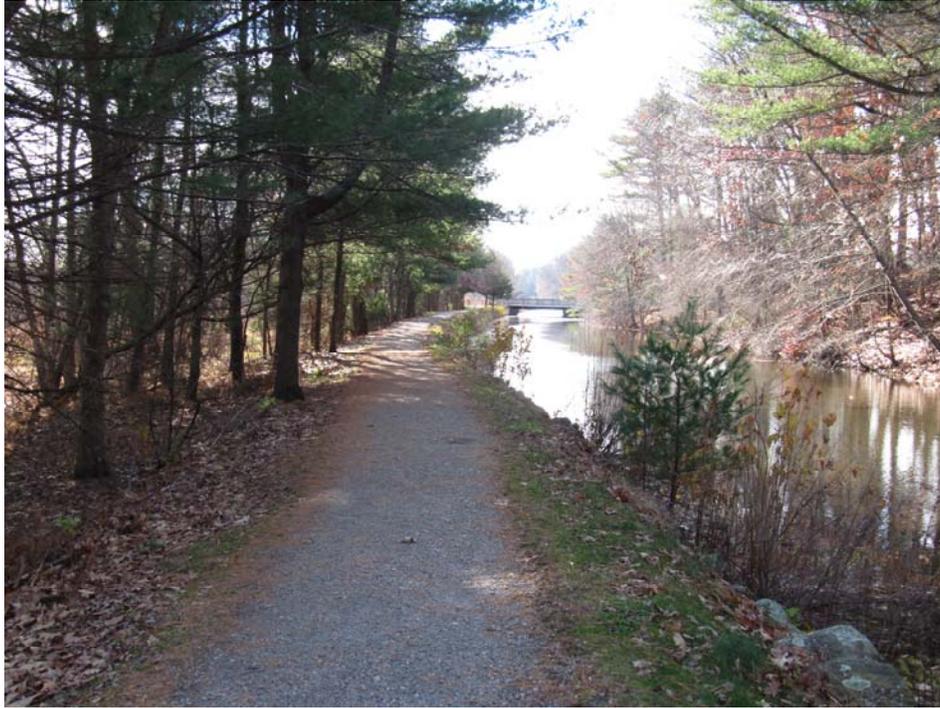
**Photo 1 – Canal Tow Path Looking South Towards Visitor Center Foot Bridge**

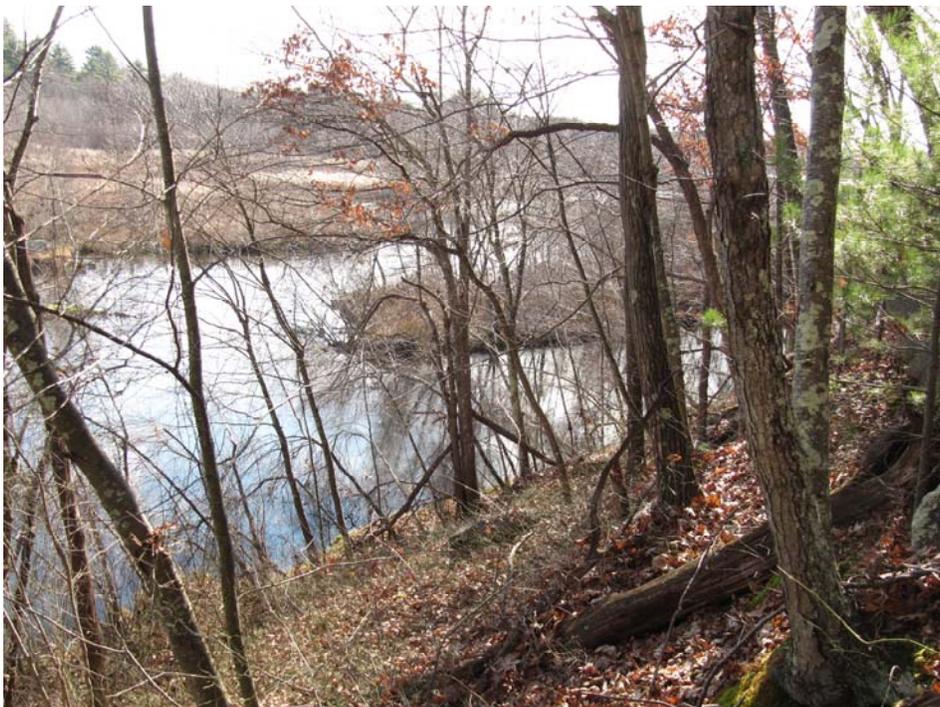
**Photo 2 – Remains of Canal Trench and Towpath at Rice City Pond/Goat Hill, Looking South**

Rising water levels have resulted in significant erosion in this section of the Canal trench and towpath, especially at Rice City Pond along the base of Goat Hill. A dam was built near Hartford Avenue ca. 1850, raising the water level significantly compared to when the Canal was operational and completely submerging the Canal trench and towpath. The ca. 1850 dam was damaged during a flood in 1955 and the dam was rebuilt soon after with a lower crest elevation. It seems likely that the Canal and towpath incurred significant damage during the 1850-1955 period from River flood flows and moving ice floes during the spring thaws.

Extensive work would be required to restore this segment of the Canal trench and towpath to original condition, including vegetation removal, dredging of the Canal trench, and filling of open water and wetland areas to replace eroded sections of towpath embankment. Rebuilding the Canal and towpath to original configuration and elevations may not preclude repetitive flooding and erosion, however, since the current River hydraulics/flood routing and water levels in Rice City Pond have been significantly altered by the dam and spillway at Hartford Avenue. A complete reconstruction of the dam at Hartford Avenue would be necessary to restore the River/Canal hydraulics and water level in Rice City Pond to those elevations dating from the original Canal construction. This reconstruction would significantly alter sensitive wildlife habitat and obtaining the required federal and state environmental permitting approvals for this work is doubtful. Also, as per discussion with Heritage Corridor staff, studies by the US Environmental Protection Agency have shown that sediments in Rice City Pond are contaminated. Other projects in the Blackstone Valley involving removal of river sediment have required soil testing, handling and disposal of these soils as contaminated material and/or hazardous waste. Given the anticipated permitting difficulties and cost of design, permitting, construction and contaminated soils disposal, restoration of this section of the Canal and towpath is not recommended.

It is recommended that the intact section of Canal trench just downstream from Goat Hill Lock be kept clear of downed trees to prevent collection of debris and possible scour during River flood events. Additionally, repairing the towpath breaches upstream from the lock (as outlined in other sections of this report) will eliminate the periodic flood flows through the lock and prevent damage to this intact section of Canal trench.

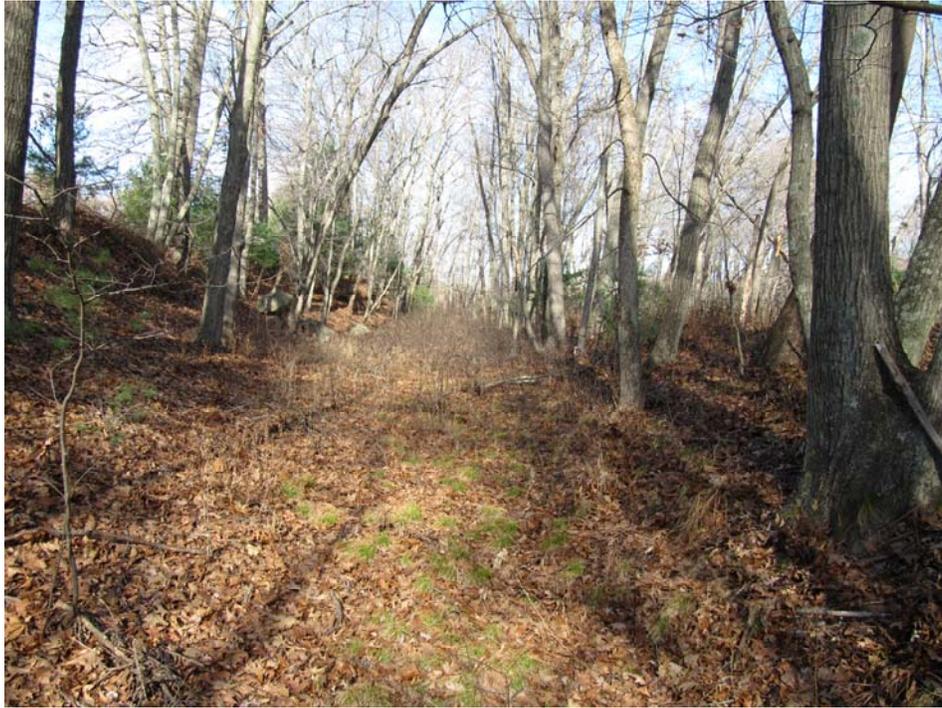
**Photo 3 – Dry Canal Trench North of Lock, Looking North**

**For the Canal section from Goat Hill Lock north to the former farm bridge site –** It is recommended that the Canal trench be cleared of vegetation, debris and fill that has been deposited over the years. The low point in the towpath embankment just north of Goat Hill Lock should be restored to its original shape and elevation to shield the Lock from occasional River floods. The work shall meet the *Secretary of Interior’s Standards for the Treatment of Historic Properties*.

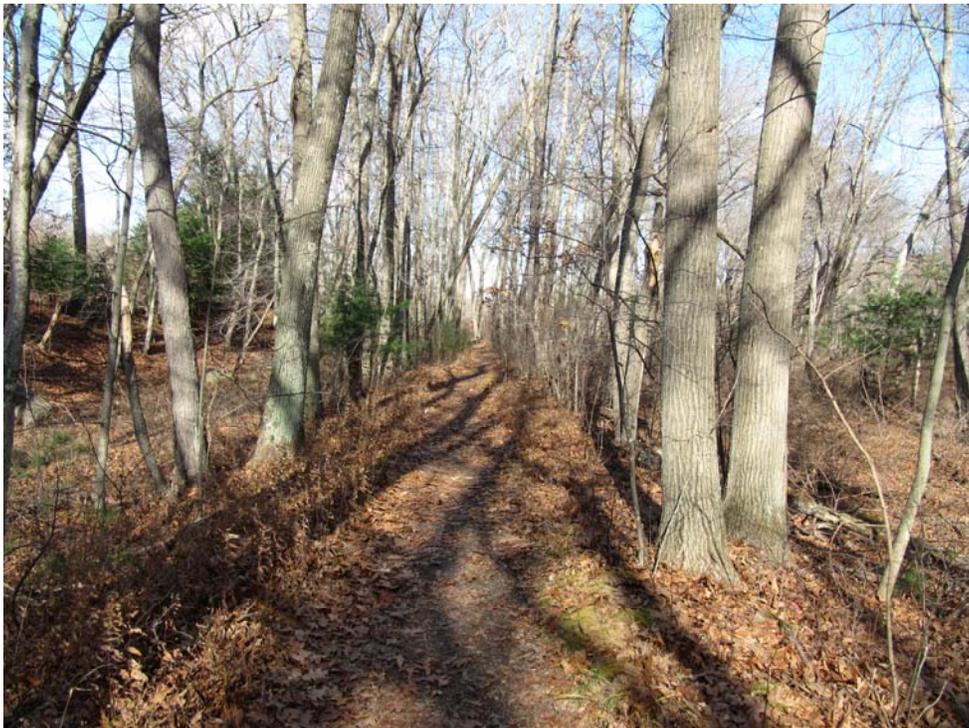
**Photo 4 – Towpath Embankment and Dry Canal Trench North of Goat Hill Lock, Looking North**

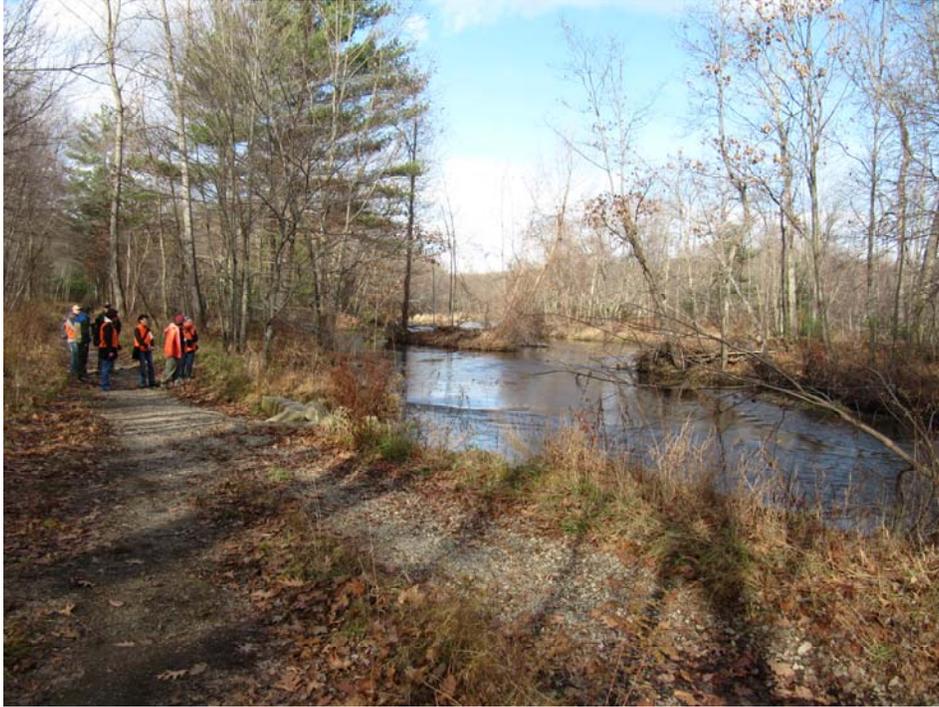
**Photo 5 – River Breach Into Canal Trench, Looking North**

- Repair the northern breach of the River into the Canal trench by rebuilding the Canal towpath embankment to the original dimensions and elevation. The River side and Canal side of the embankment should be armored with rip-rap to prevent future breaches (see Figures 3 and 4). The rip-rap should sized and laid in courses to replicate the rip rap used in the original Canal construction. (Refer to the photos of original rip rap construction at Skull Rock Lock.) All work would meet the Secretary's Standards. Any interpretation should explain the use of historic erosion control techniques.

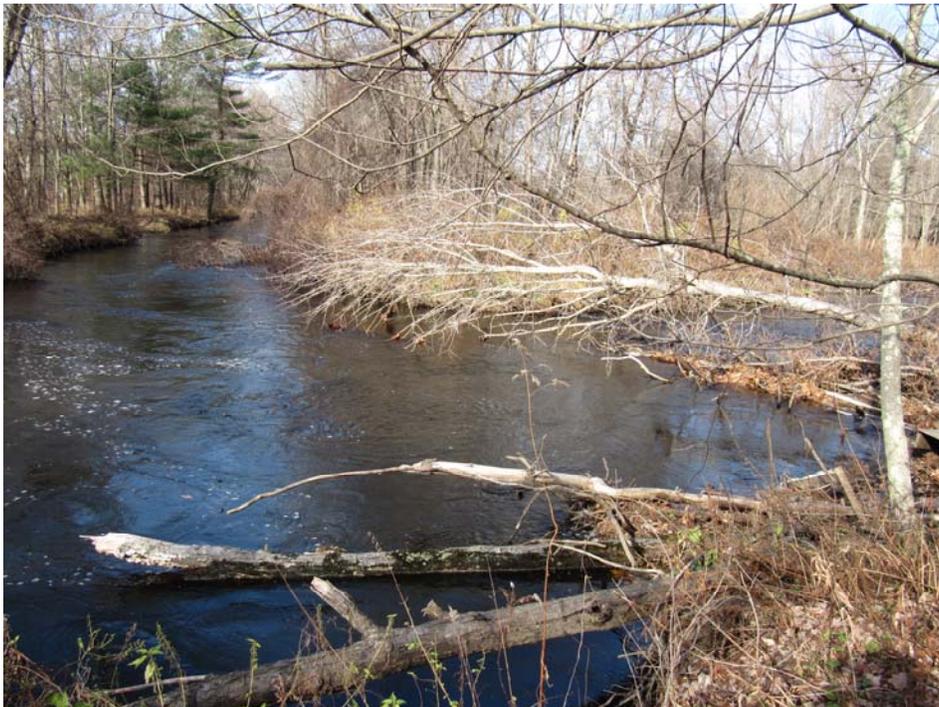
**Photo 6 – Canal Breach Into River at Old Stone Culvert Crossing, Looking North**

- Remove the old stone culvert Canal crossing and associated debris/silt and repair the southern breach of Canal into the River in a similar fashion. This should effectively “shut off” the flow of water in this section of the Canal trench and the subsequent flow in the new channel that is eroding the towpath berm. Note that the old stone culvert crossing, though not from the Canal era, is a historic resource and its removal would constitute an adverse effect in a Section 106 review. Documentation of the structure could serve to mitigate the adverse effect.

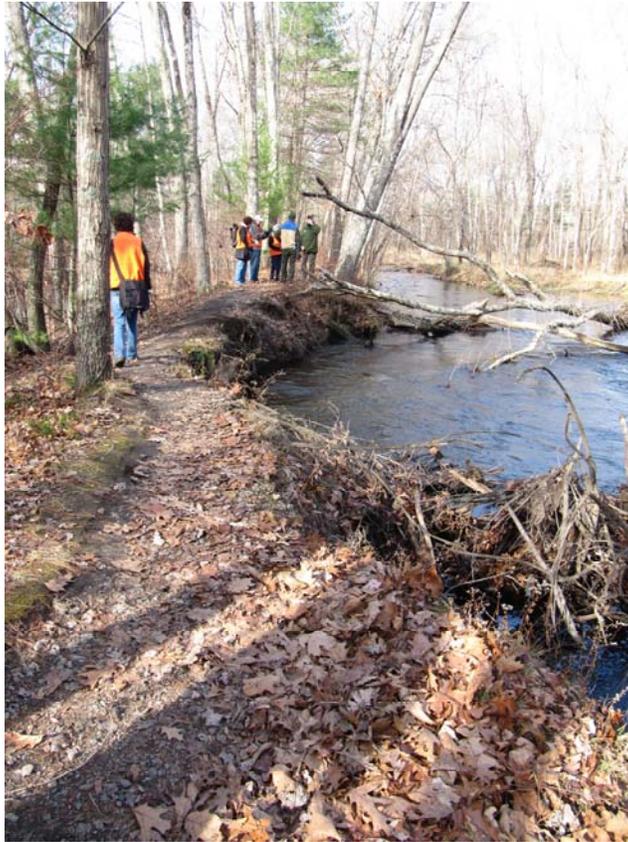
**Photo 7 – Channel on Eroding Outside of Towpath Berm, Looking North**

Portions of the trail on the towpath embankment between Goat Hill Lock and Plummer’s Landing are being eroded by the Canal breach flow. The trail is undercut by the breach flow and could result in hikers falling into the fast flowing water in flood channel. Otherwise, except for isolated sections of steep downgrades where runoff is eroding the trail surface, the trails are for the most part stable and in good condition.

- Repair the eroded sections of the towpath embankment by rebuilding the Canal towpath embankment to the original dimensions and elevations and restore the channel to a wetland section. The reconstruction of the towpath embankment would need to meet the Secretary's Standards.

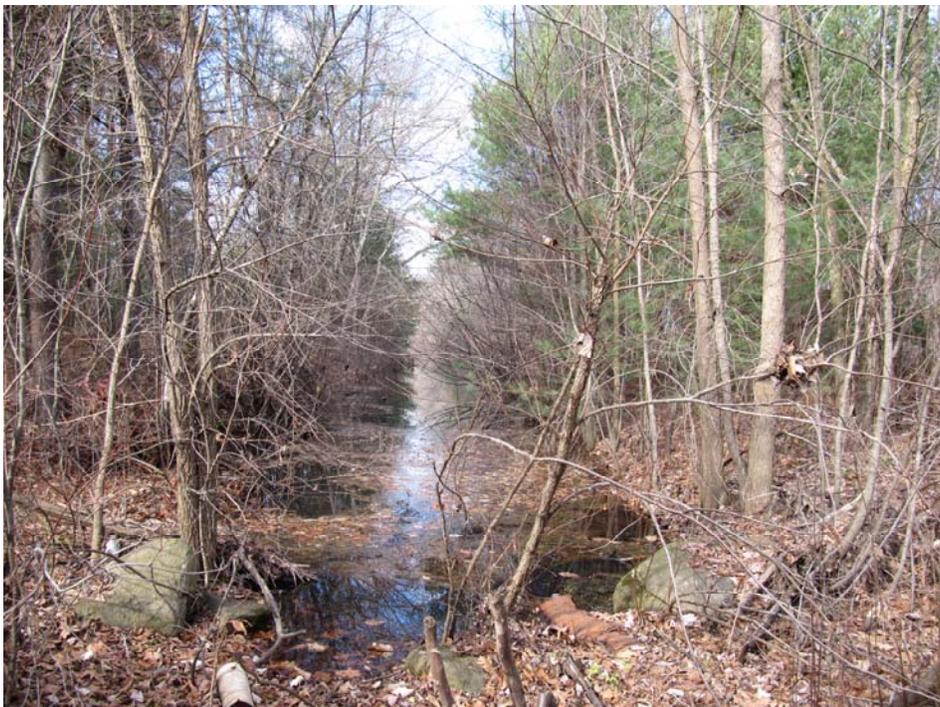
**Photo 8 – Canal Trench and Towpath (on right) Looking North Gravel Crossing in Foreground**

rainfall runoff (see Photo 8). The Canal trench has become filled with some debris, vegetation and leaf litter. This section is bordered on the west side by a gravel surfaced access road over a sanitary sewer interceptor (see Photo 9). A gravel crossing and small corrugated metal pipe provide access from the sewer access road to the towpath. It appears that this gravel crossing is frequently overtopped by flow in the Canal trench. The pipe is heavily damaged and significantly clogged with silt and debris (see Photo 8). The towpath itself has become overgrown with brush making walking along the towpath difficult.

**For the Section of Canal and Towpath from the Breach North to Plummer's Landing –** It is recommended that debris, vegetation and leaf litter be removed from the Canal trench. The

corrugated pipe should be removed and the crossing rebuilt as a “watered crossing” consisting of crushed stone. This crossing would allow access to the towpath while allowing water in the trench to flow through. Minor clearing on the towpath for a hiking trail would provide an opportunity for interpretation and views of the River.

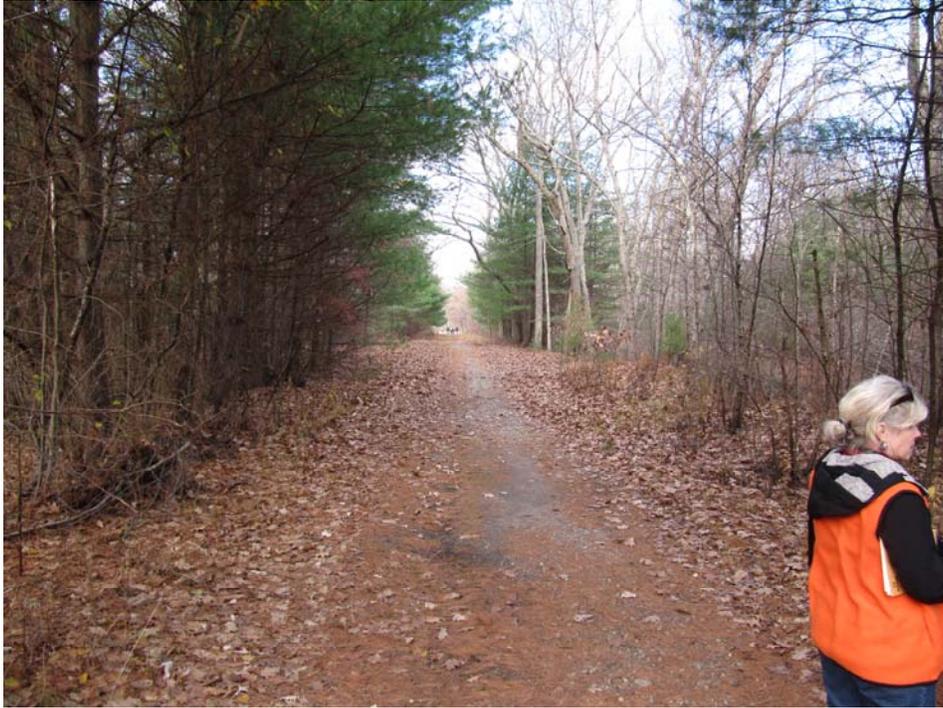
**Photo 9 – Sewer Access Road, Canal Trench on Right, Looking North**

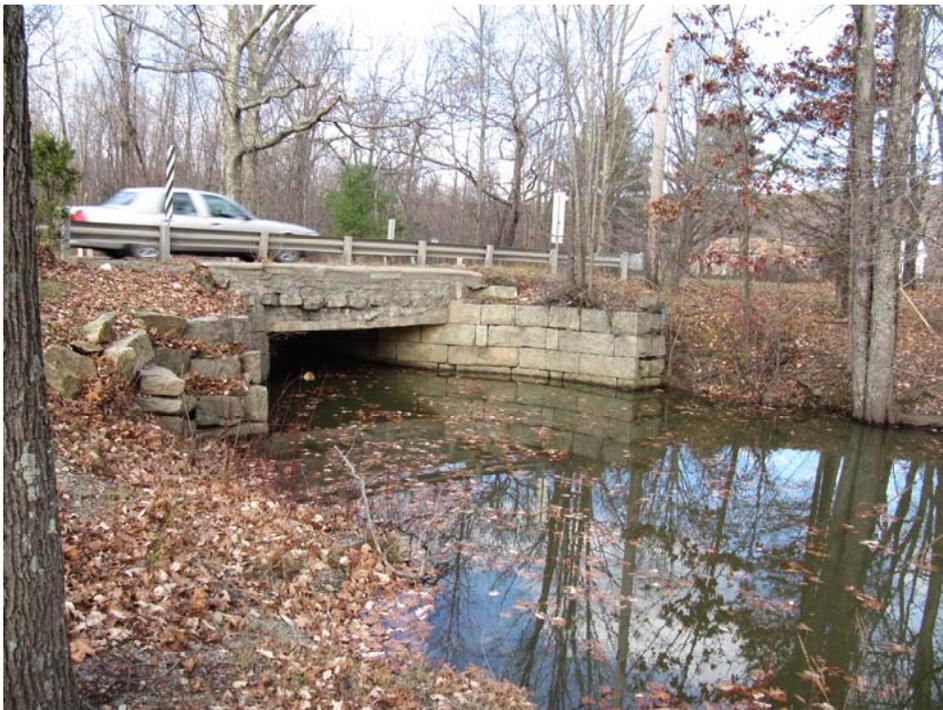
**Photo 10 – South Side of Church Street Bridge Founded on Canal Lock, Looking North**

Existing conditions prevent boats from navigating this length of the canal unimpeded, without portaging. Vertical clearance under the Church Street bridge over the River is very limited even for canoes (see Photo 10). Boat/canoe/kayak passage through Gate #1 is not possible as the inlet is blocked by a metal trash rack and is submerged for most of the year. In any case, passage

Increasing the vertical clearance at the Church Street Bridge to provide passage of watercraft would require significant rise in the profile of Church Street. This would most likely require filling or wall construction which would impact the Landing site, adjacent wetlands and private properties. The work would need to meet the *Secretary’s Standards* due to the likely impacts to the Plummer’s Landing site. Raising the Church Street profile is therefore not recommended.

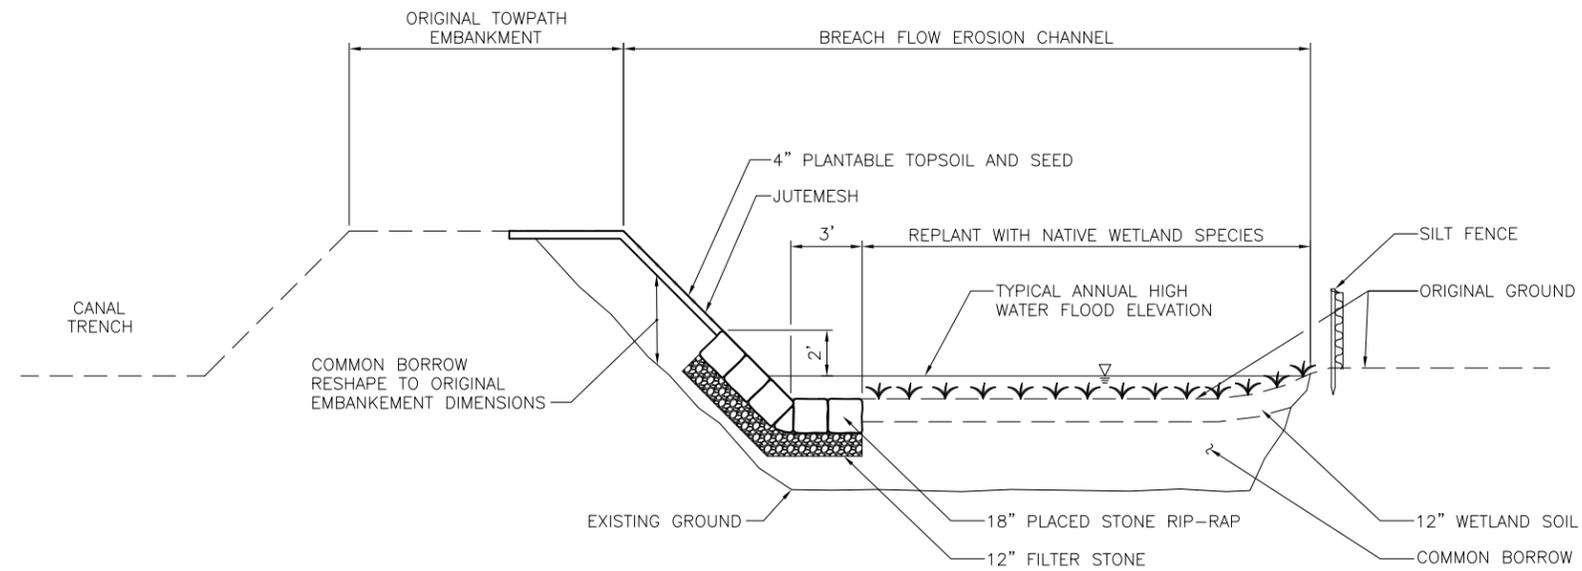
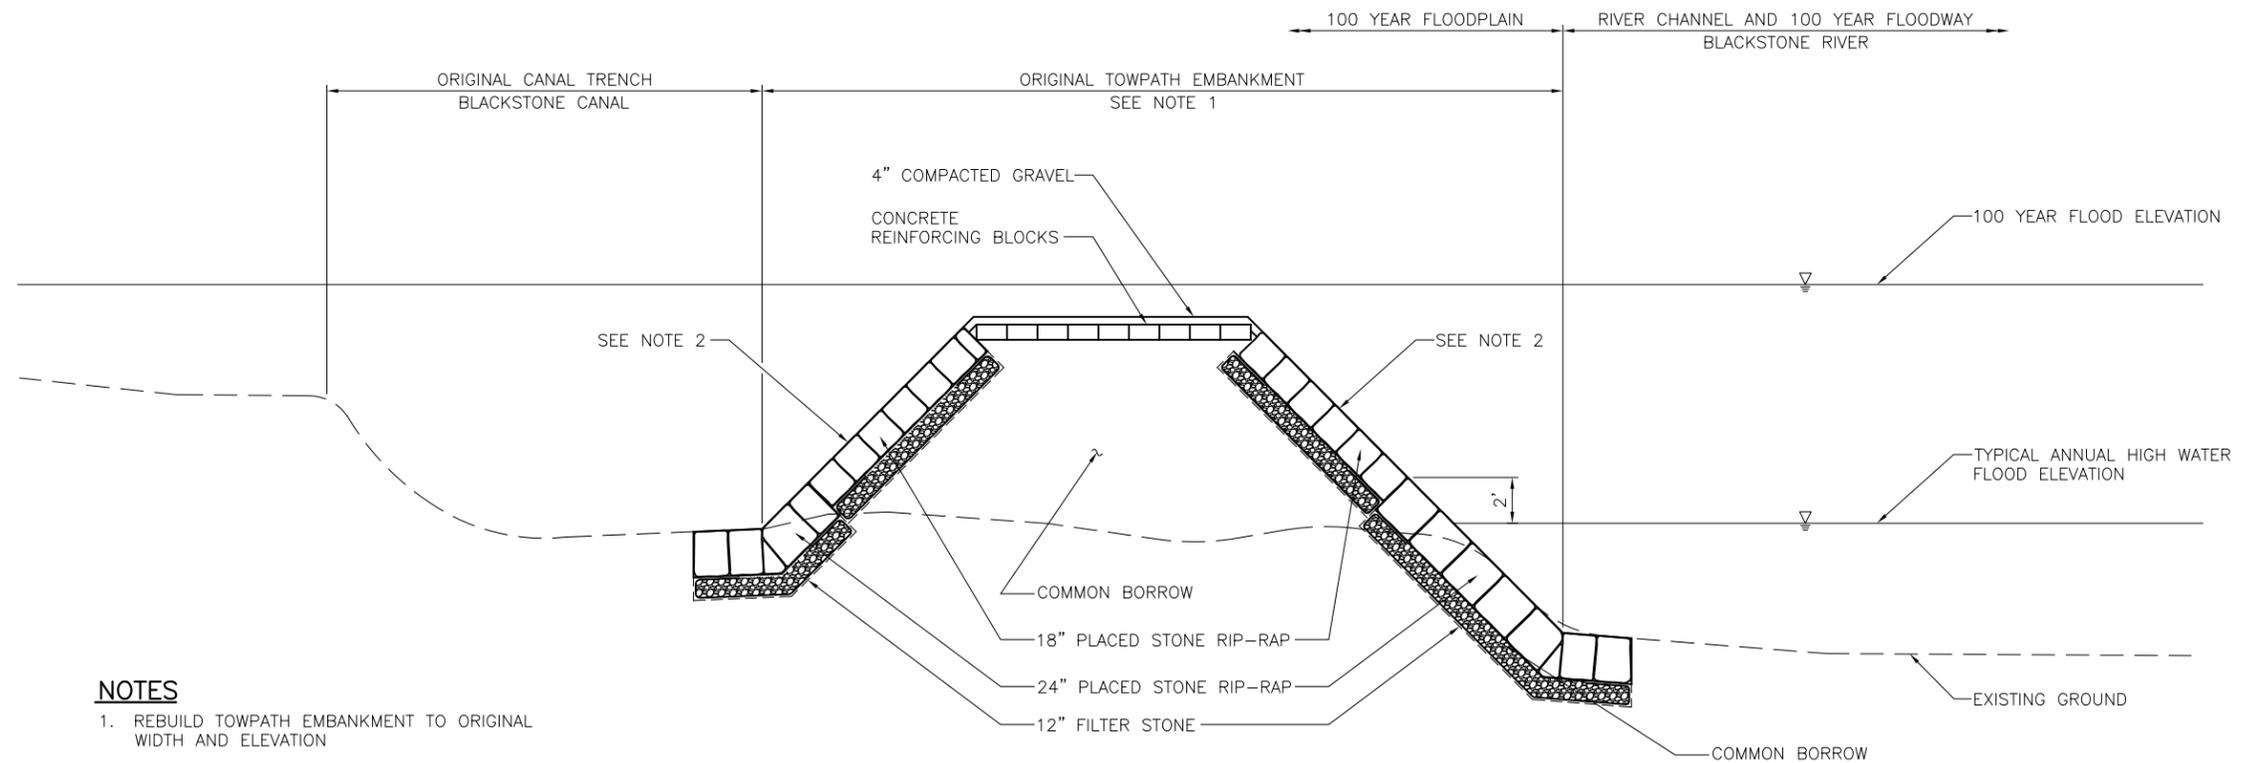
**Figure 4**

**RESTORATION OF ERODED TOWPATH BERM  
LOOKING NORTH**  
SCALE: 1"=8'

1. REBUILD TOWPATH EMBANKMENT TO ORIGINAL WIDTH AND ELEVATION
2. ARMOUR BOTH SIDES TO PROTECT AGAINST RIVER SCOUR AND OVERTOPPING

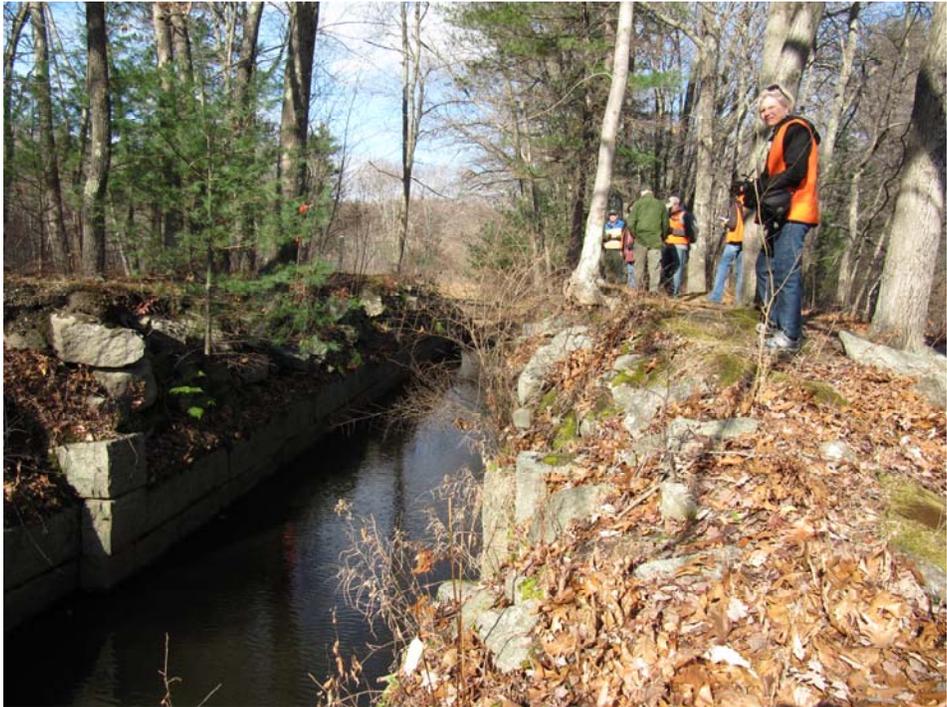
Goat Hill Lock remains largely intact although the top courses of stone along the lock walls and wingwalls have dislodged and fallen into the canal. It appears the causes are a combination of frost heaving and disruption from the roots of nearby large trees (see Photo 11). In addition, the lock is regularly inundated during river floods as water passes over the eroded low point of the towpath embankment north of the lock. This most likely also contributes to the deterioration of the lock; several stones were dislodged after flooding in the spring of 2010.

**Photo 11 – Goat Hill Lock Remains, Looking North**

Goat Hill Lock is an outstanding historic resource and, if restored, it could become an important interpretive amenity for park visitors. Since the lower portion of the lock has been submerged for over 100 years, it seems reasonable to assume that the lower portions of the lock including the timber miter sills that sealed the lower edges of the gates and the timber floor are intact. Thus the rebuilding of the lock itself to an operable condition is possible; a functioning lock would require dredging and restoration of the layby pond. Since the layby pond upstream of the lock is now a regulated wetland it is unlikely that the required environmental permits can be obtained to restore the canal as a functioning navigational feature. Rebuilding the lock as a static feature is possible without dredging the layby pond therefore a static lock restoration is recommended, due to the high interpretive impact.

a granular material and filter fabric to promote free-flowing drainage of the subgrade behind the lock walls. The cut granite stones which have fallen into the lock should be retrieved and reset into the lock walls and wingwalls. Replica timber leaf gates could then be fabricated and installed. This would require temporary dewatering of the Canal and lock. A historically sensitive timber walkway with railings could be constructed to replace the substandard existing structure (see Figure 5).

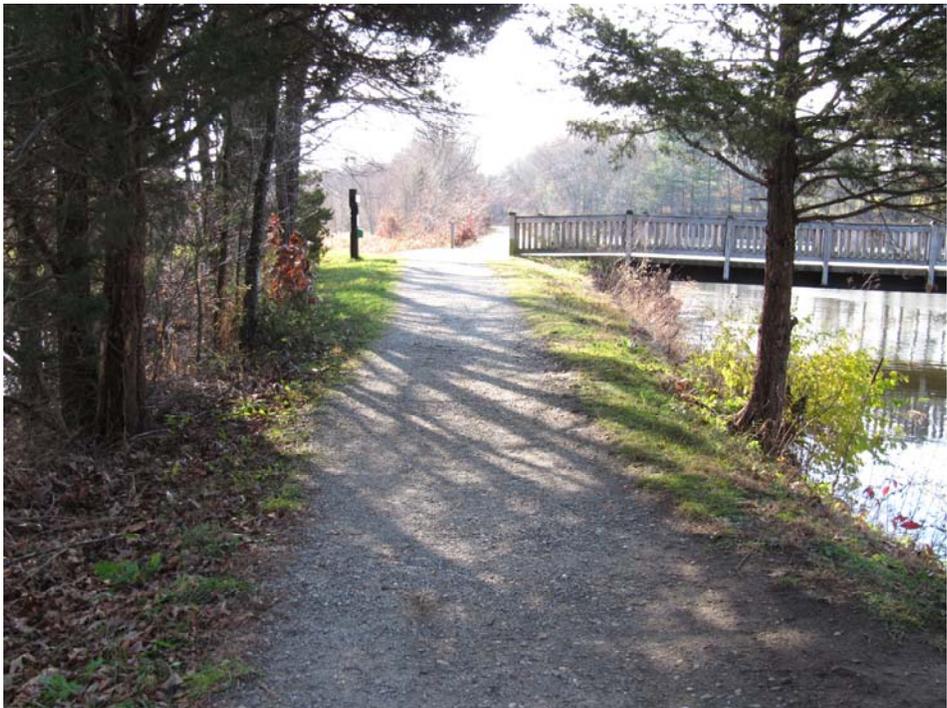
**Photo 12 – Towpath and Footbridge at Visitor Center, Looking South**

To access the half mile section of Canal trench north of the Visitor’s Center, replacement of the existing footbridge over the canal to provide 12 foot vertical clearance would be required. Provision of these clearances may not be feasible since it would require an elevated/ramped approach from the towpath up to the bridge. It is anticipated that this would not fit within the context of the original Canal towpath construction and therefore is not recommended.
