Chapter 11:

Treatment Projects

BROMIDE SPRINGS AREA: REHABILITATION TREATMENT

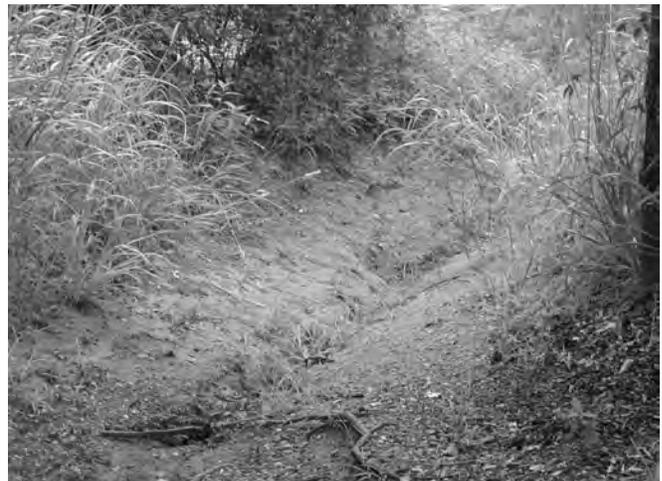
Rationale: A volunteer pathway near the steps to the low-water causeway (Figures 11-4 and 11-5) from the dump station parking area is forming a deep gully as water erodes the pathway.

Figure 11-4. Causeway steps. Eroded area is to the left (out of view). Steps should be maintained, but eroded area should be revegetated.

Recommendations: The bank should be regraded to eliminate the pathway and gully and should be stabilized with new soil or stones, geotextile, bank-stabilizing vegetation of medium-high shrubs or a combination of all three. Snow or temporary fencing should be placed to prohibit foot traffic down the bank until vegetation has established itself. Since the causeway steps are not that well-constructed, another, but more costly approach

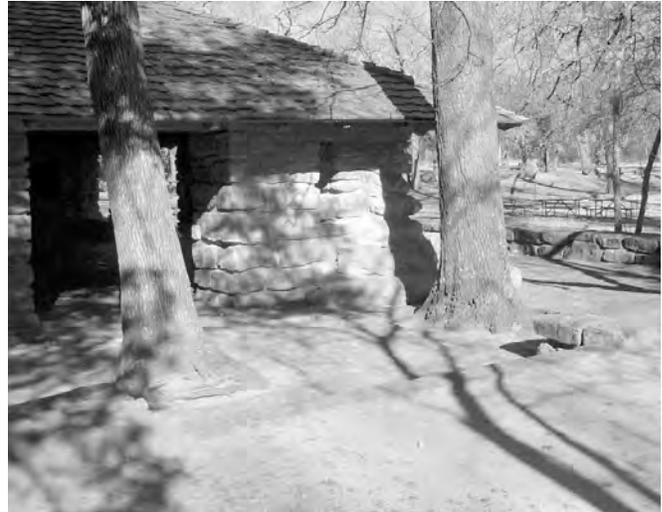
Rationale: The terrace surrounding the pavilion has changed over the years. The two trees within the terrace are in poor condition (Figure 11-9).

Figure 11-9. Two trees in eastern terrace are in poor condition.

Recommendations: French drains in terrace at entrance to pavilion should be cleaned on a regular basis. Mortar joints within the terrace, though not original, should be retained. Joints should be maintained by weed pulling or herbicide treatment, to prevent deterioration of the joints due to water infiltration. Stones at the gap in the wall at the northwest corner should be maintained, and cleared

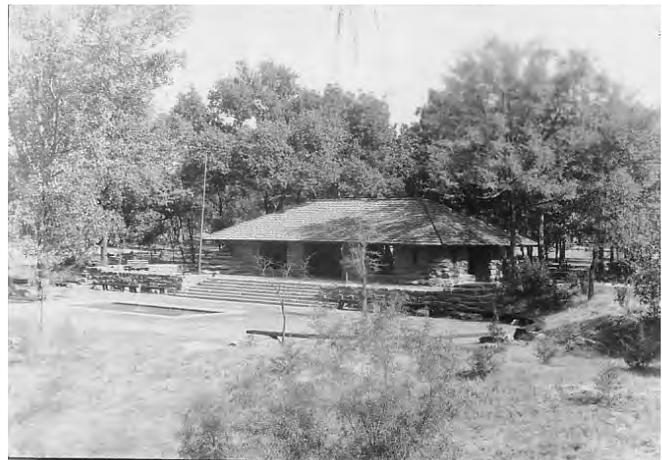
Figure 11-10. Bromide Pavilion, circa 1937. Semi-circular bench at base of terrace should be reconstructed as per original plans and drawings. Plantings around bench should be restored.

Rationale: The semi-circular bench (Figures 11-10 and 11-11) is a missing part of the pavilion and an important lost landscape feature.

Recommendations: Replace the bench based on historic photos and historic plans (such as Figure 11-12), utilizing extant stone bases. Cedar or other rot-resistant laminated wood should be used to reconstruct the bench surface. Brown Trex® plastic lumber might be investigated as a bench material, but while durable, it may prove to be too

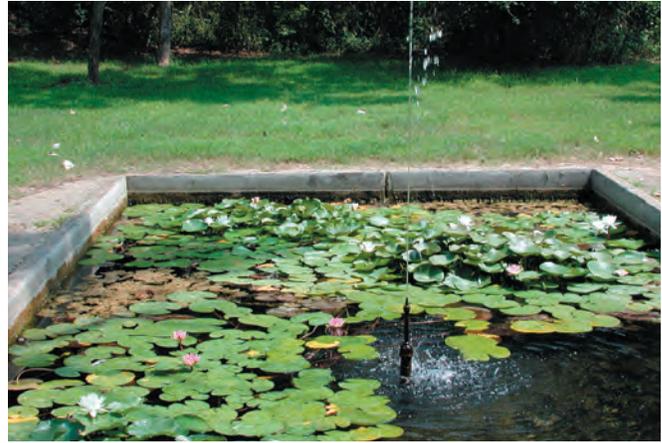
Rationale: This rectangular basin (Figure 11-14) was repaired about 5 years ago and filled with sand to a shallow depth. The pond's water system is connected to the 12th Street fountain, which is filled by city water. The pool has on-going leak so that it requires consistent refilling.

Figure 11-14. Lily pond with jet, existing conditions. Pool should be repaired and grass joints should be replaced on flagstone coping.

Recommendations: The Lily Pond should be reconstructed in concrete at its existing size and location, but at a new, shallower depth, with water stops utilized in its construction. As part of the reconstruction, the pool's concrete curb should be replaced with a flagstone coping with grass joints to match the original. Once the leak is repaired, a recirculating water pump should be used to create the pool's central water jet, with a flow and appearance matching those seen in historic photographs. A fountain timer might also be useful to regulate the jet and a float used to help resupply water lost to evaporation. New plumbing, drain, and electrical systems will therefore be required. Care should be taken during construction to protect the nearby cottonwood tree. Lily plants should continue to be grown in pots. The addition of small fish (a local species) would help naturally reduce algae growth in the pond. This project should be linked with the rehabilitation of the 12th Street fountain (see **Project B12** below).

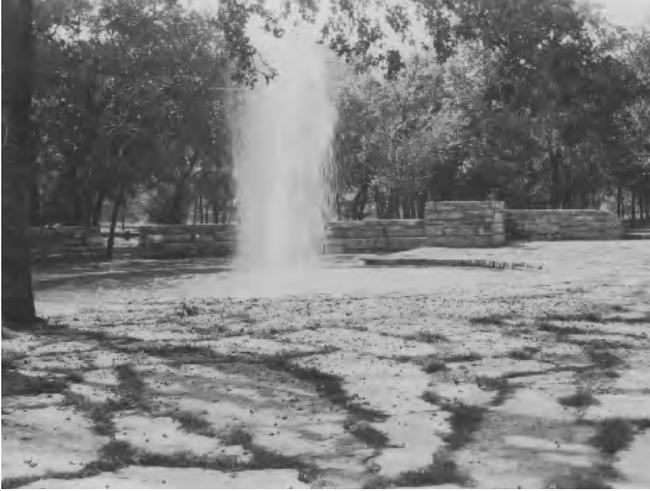
Figure 11-16. 12th Street Fountain shortly after construction, circa 1935.

Recommendations: Given water supply issues within the region, it is unlikely that an artesian well to supply a jet at the scale of the original will be practical to locate

and drill, either within or without the park. The easiest way to recreate the water feature as it appears in historic photographs would be to install a mechanical fountain supplied by a re-circulating water pump to save water. This will require an electrical line and, most likely, new plumbing, and a timing system may be useful to regulate the jet and to replenish evaporation. For efficiency, this project should be linked with the repair of the lily pond (see above), since these two water features are currently linked. The rehabilitation should install two valves for the two water features; currently they both utilize the same valve and line. Depending on the status of the existing piping and requirements of a new jet, this project has the potential to be disruptive to the existing masonry paving and walls. Therefore, this work should also be coordinated with other water and masonry repair projects at the entire fountain area (see **Project B13** below).

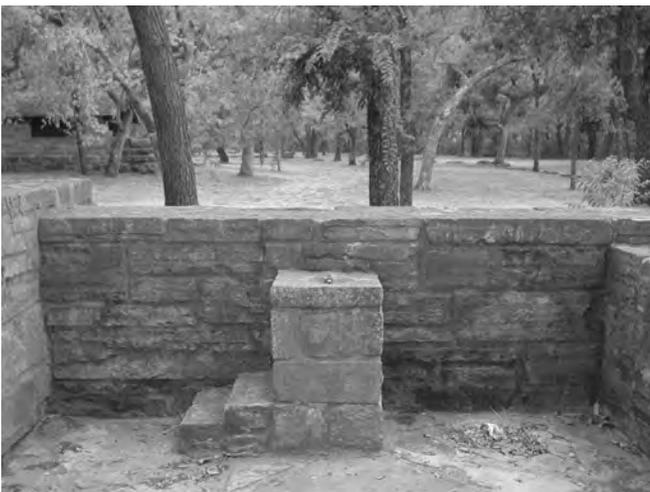
Figure 11-18. One of a pair of unused drinking fountains on both sides of the 12th Street Fountain.

Recommendations: Spigots should be replaced and if possible, existing piping, presumably still present within the structures, should be re-used, possibly after being slip-lined with nylon or polypropylene pipe (Figure 11-19). If lines are no longer functional, feasibility of replacing lines should be carefully assessed to ensure that pipe replacements do not irreversibly damage extant wall fabric. Like the 12th Street fountain, these drinking fountains should be connected to the city water supply, unless a mineral water well is available (see **Project B9**, above). This project should also be coordinated with the lily pond and 12th Street fountain rehabilitations.

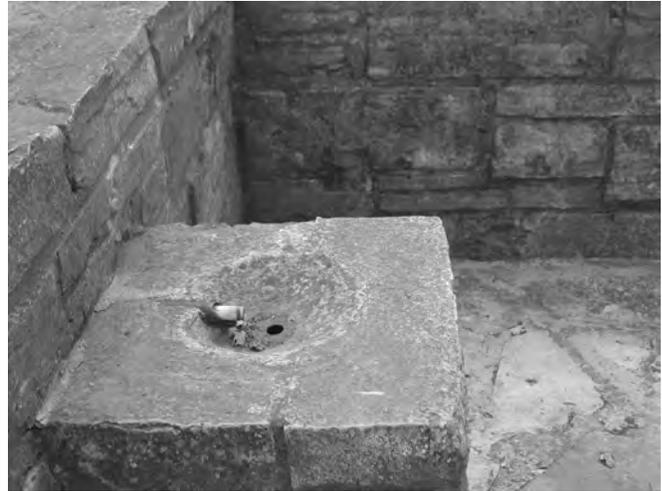
Figure 11-19. Detail of drinking fountain to be replaced at the 12th Street Fountain. New plumbing and fixtures will be required.

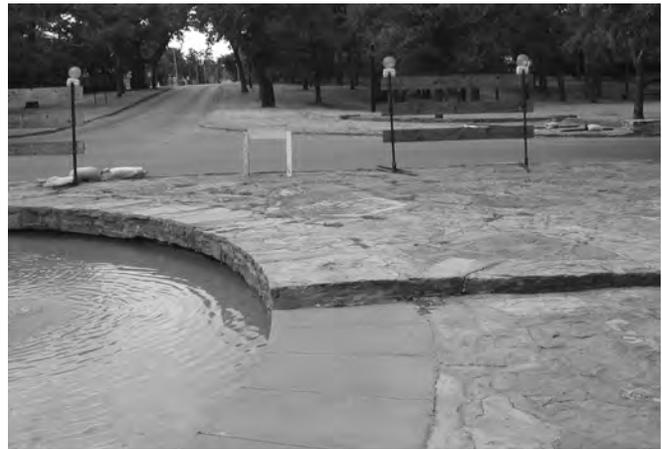
Rationale: Flagstone paving and masonry are beginning to show wear at the 12th Street Fountain paved area (Figure 11-20) and on the entry walkways paralleling 12th Street.

Figure 11-20. Concrete coping along southern half of pool edge should be replaced with flagstone to match the other half. Flagstone terrace should be maintained by sweeping and weed removal.

Recommendations: The concrete coping should be replaced by large, mortared flagstones matching those on the other half of the pool, as shown in historic photographs. Work might be triggered by or coordinated (if possible) with the rehabilitation of the fountain and plumbing or with other masonry repair projects in the area.

Recommendations: Mortared flagstone joints should be repointed as necessary and kept free of weeds and grass by pulling or with an herbicide such as Round-up®. Flagstones which are loose or severely split should be replaced in-kind or repaired. The historic tree once located within the paved area around the fountain is not recommended for replacement.

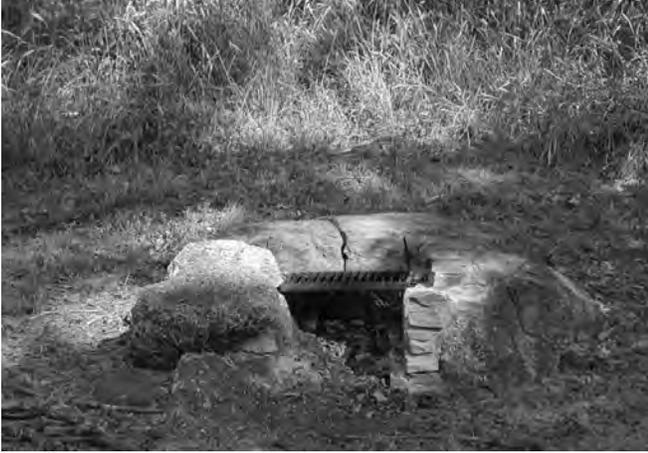
Figure 11-26. One of four firepits to be preserved at Walnut Grove. Obtrusive fire brick should be removed, and replaced. Grills should be repaired or replaced and chained or cabled to structure.

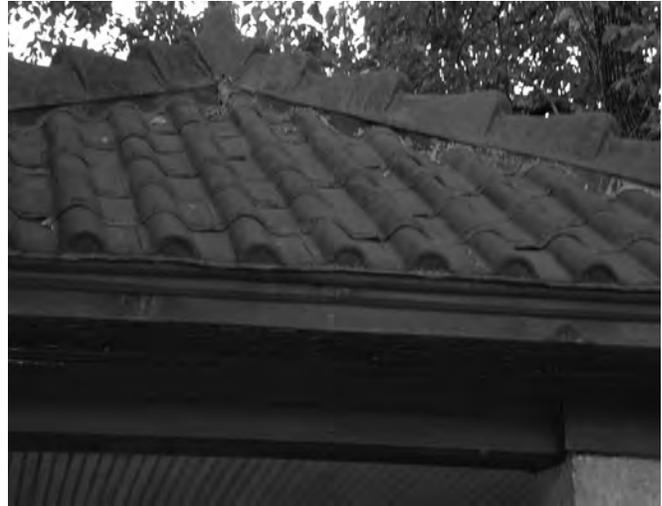
Figure 11-33. Pavilion roof requires repair or replacement after further investigation.

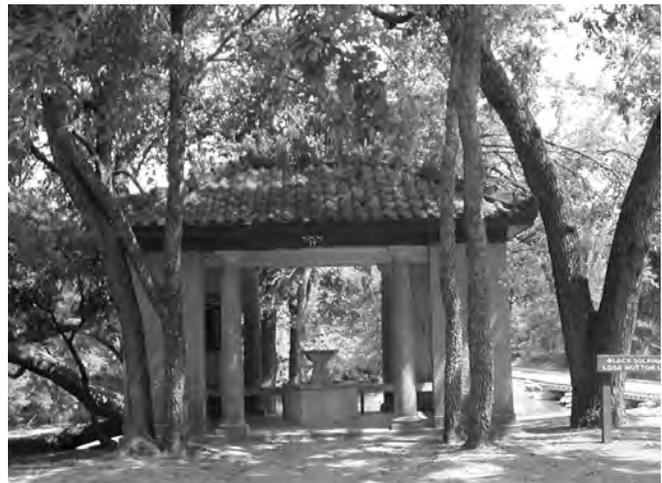
Figure 11-34. Building repairs may impact trees around pavilion. Plantings should be rehabilitated.

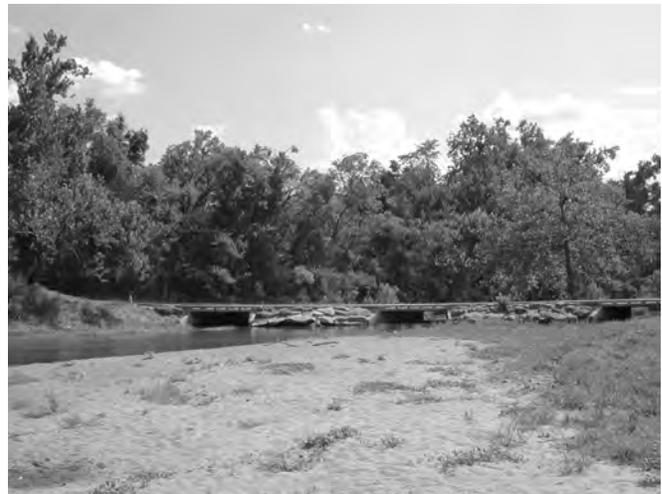
Figure 11-39. Undercutting of bridge occurs due to silt and sand build up and blockage of western waterway under causeway. Removal of sand will improve these conditions and help reinstate former favorite swimming beach.

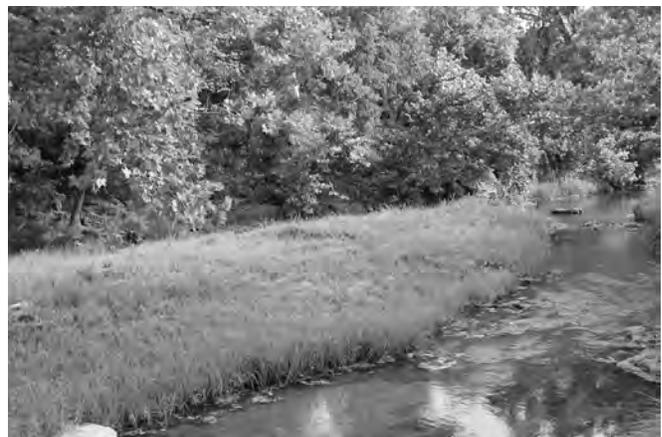
Figure 11-40. Island downstream of causeway is another result of silt and sand deposition in Rock Creek.

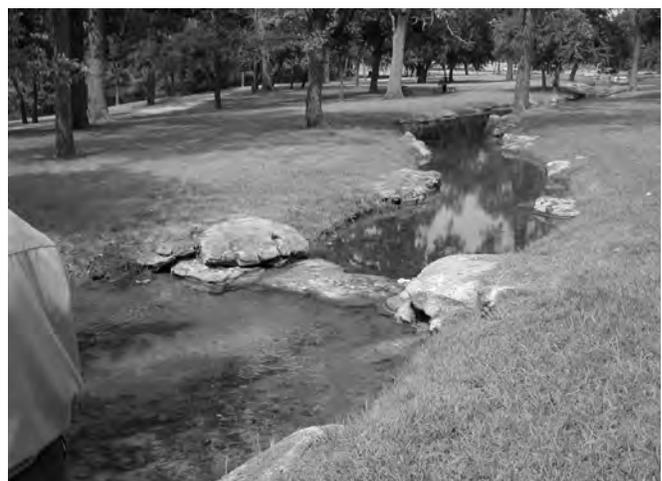
Figure 11-45. Stream and pool edges are being undercut in some locations and should be stabilized as needed. Edges should be carefully reinstated to match historic conditions (Figure 10-44).

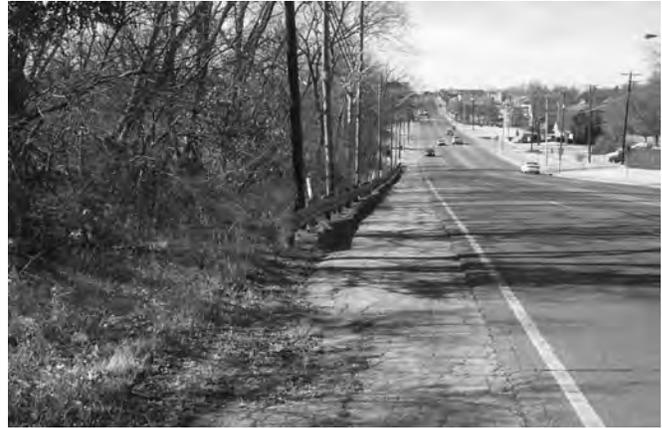
Figure 11-49. Frontage along Broadway presents a somewhat disheveled appearance to the town, and should be improved in conjunction with Sulphur’s proposed streetscape improvements.

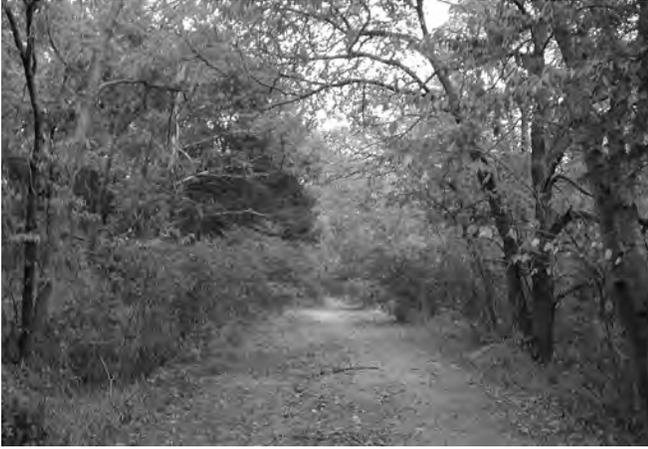
Figure 11-51. Upper trails in Flower Park are enclosed by vegetation. Dense cedars and understory plants should be thinned as part of Project FP5.

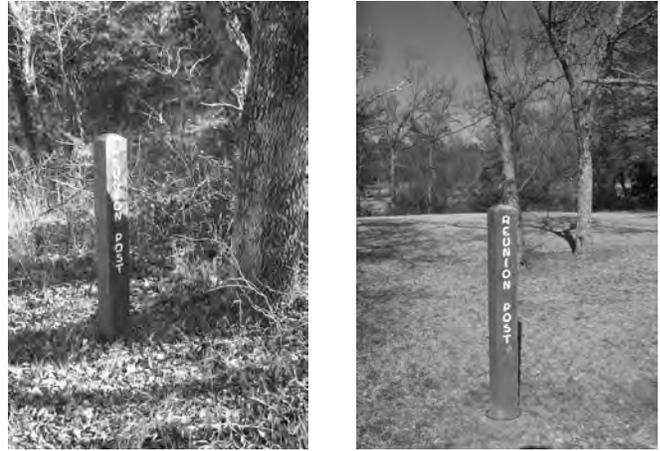
Figure 11-54. Reunion posts near Flower Park should be removed.

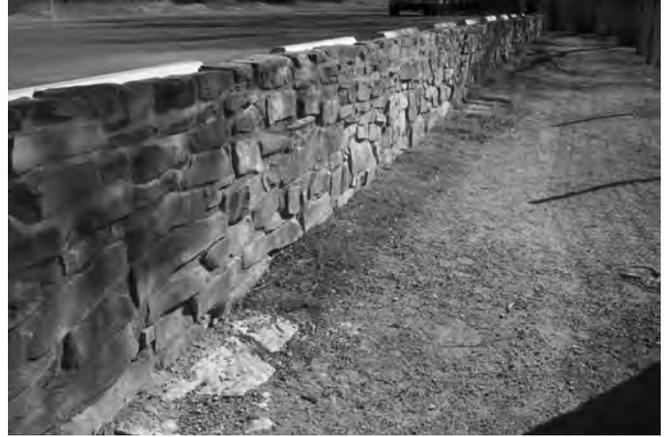
Figure 11-57. Stone wall at the Buffalo Pasture overlook needs relatively minor repairs.

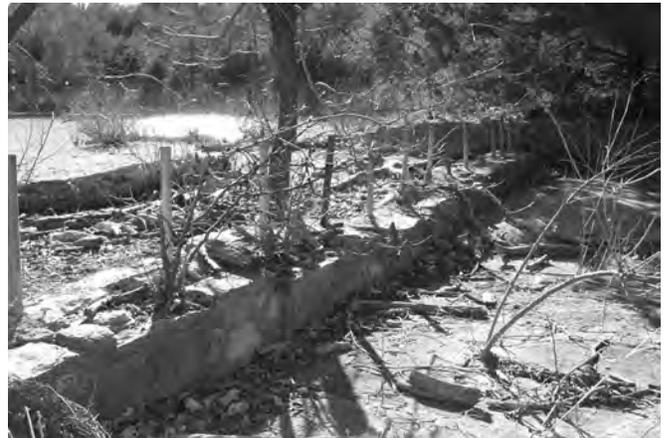
Figure 11-58. The Buffalo Pasture dam is spalling, cracking and being undercut. Masonry repairs are needed.

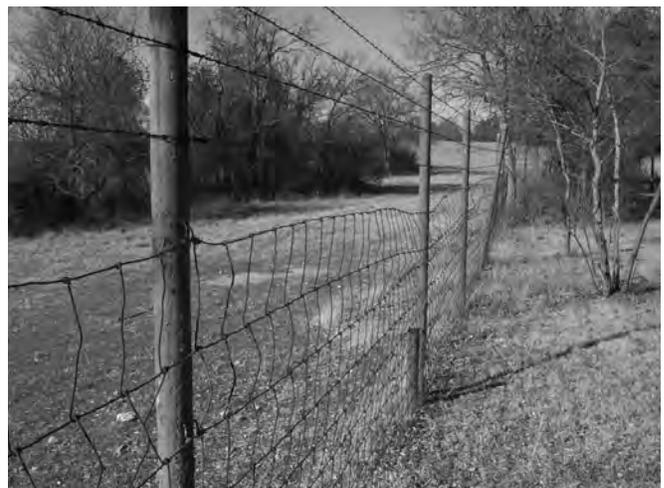
Figure 11-59. Buffalo Pasture fence requires painting and minor repairs.

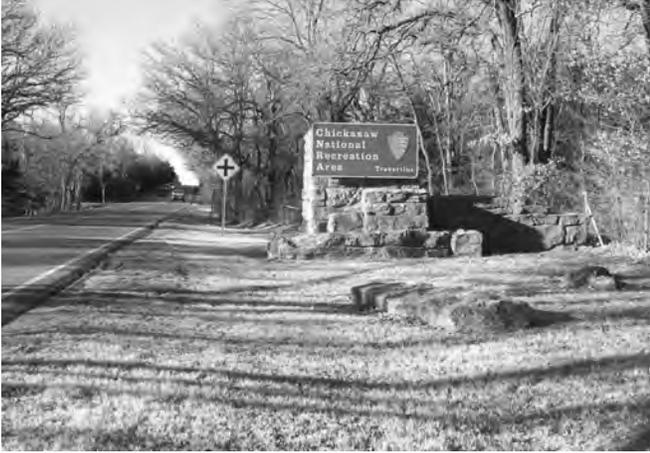
Figure 11-60. Extant piers at the south entry lack a strong historic presence or purpose.

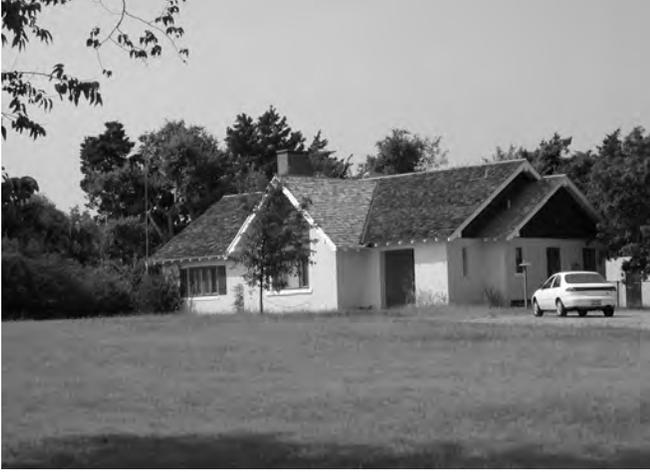
Figure 11-63. The windows and doors on the Superintendent's Residence should eventually be replaced with ones duplicating the historic features in appearance. without foundation plantings, looks forlorn in the landscape. Foundation plantings should also be returned.

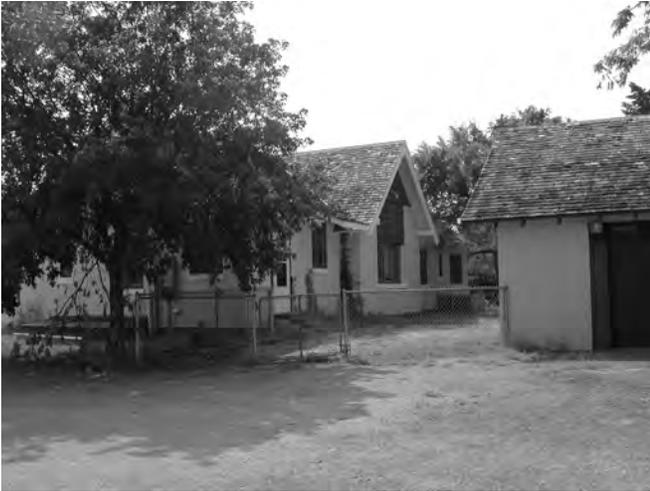
Figure 11-64. Non historic features, such as the chainlink fence, should be removed.

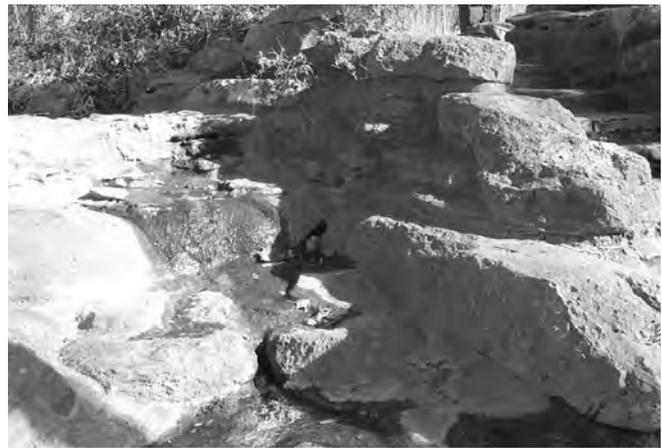
Figure 11-68. Drain line on the north side of the pavilion should be repaired.

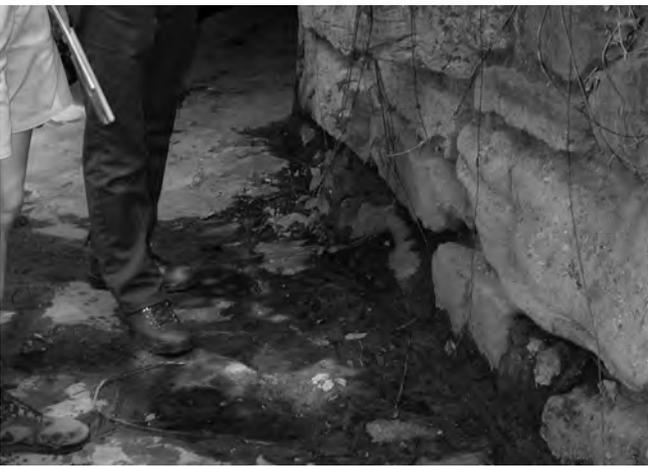
Figure 11-71. Seepage from springs behind underpass wall should be redirected via minor masonry repairs.

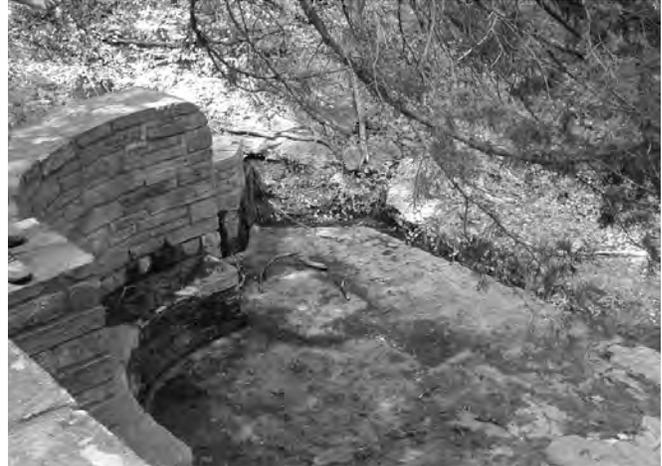
Figure 11-72. Algae covers not only pools, but masonry. Regularly scheduled cleaning, plus increasing the sun in the area should help make the area less damp and more pleasant.

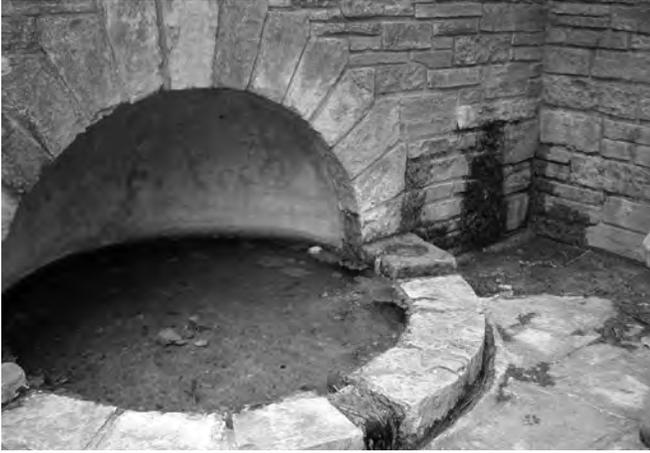
Figure 11-73. In addition to cleaning the pool, the lack of flow from the spring's bubblers should be investigated, and pipes leading to them cleaned or replaced. Note seepage from spring through wall to the right.

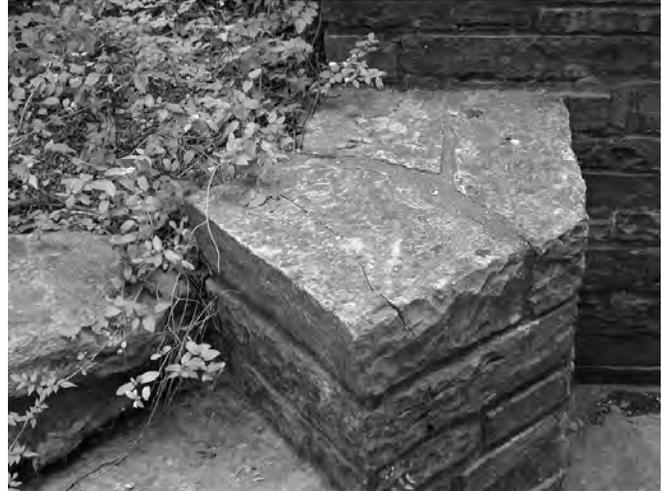
Figure 11-76. Stone at entry wall is cracked and should be repaired before it is lost or further damaged. Masonry throughout the district should be annually inspected for these types of issues.

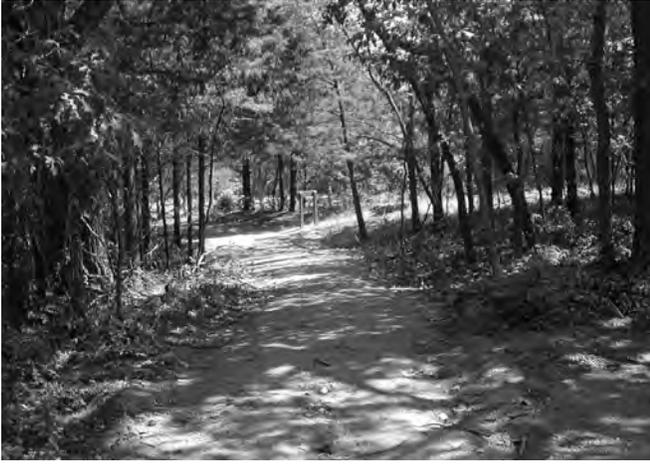
Figure 11-78. Trail below Hillside Springs has erosion problems and stone swale here should be reconstructed.

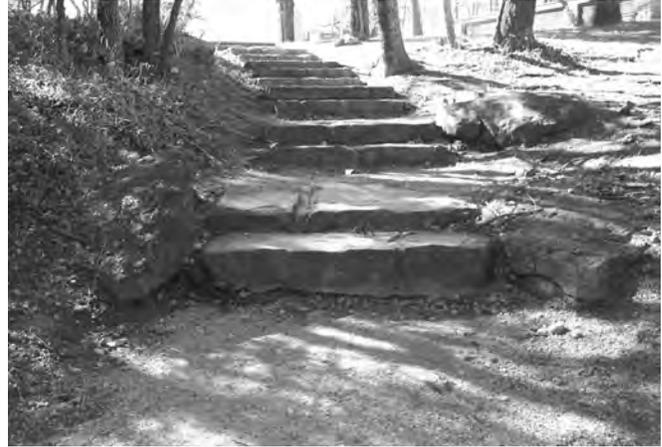
Figure 11-80. Treads on steps leading to the Leeper House should be repaired.

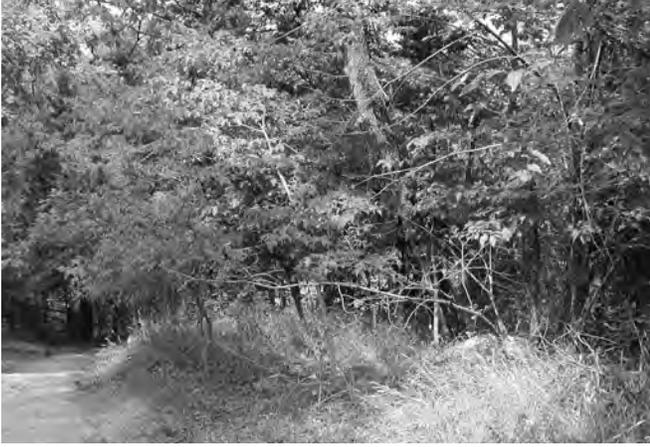
Figure 11-81. Vegetation around the Leeper House should be thinned, to better reflect historic conditions and to allow for regeneration over time.

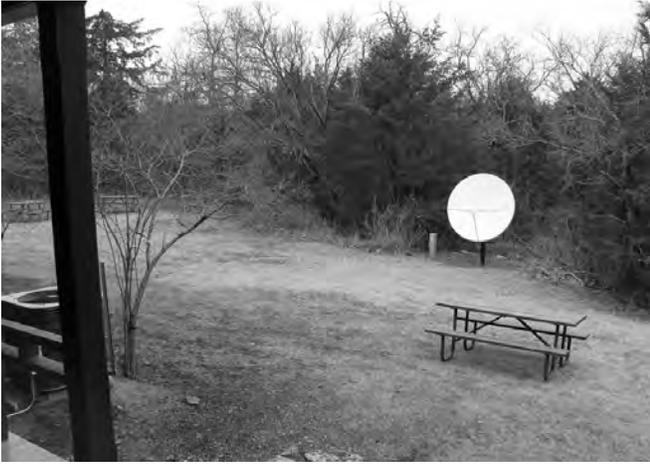
Figure 11-82. Satellite dish behind the Leeper House should be painted brown to make it less obtrusive in the landscape.

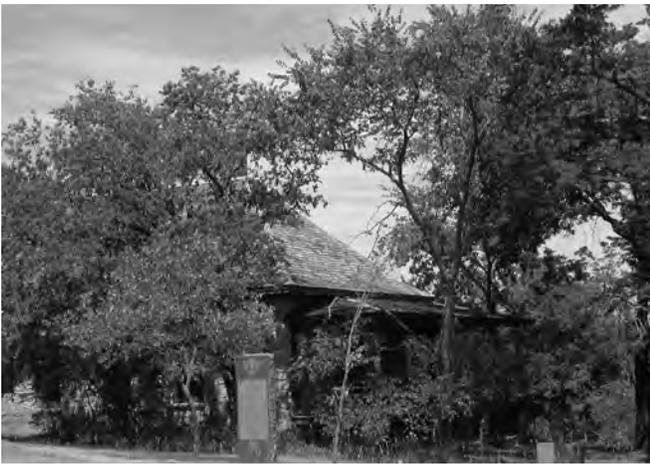
Figure 11-83. Foundation plantings hide the Leeper House, neither enhancing the building nor reflecting historic conditions.

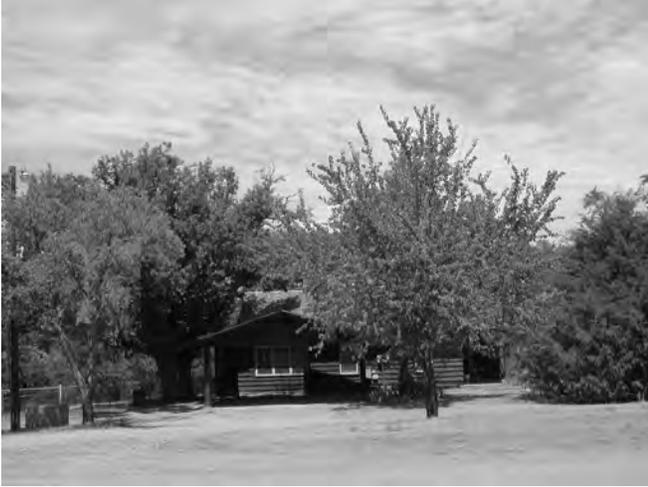
Figure 11-84. Drainage around Residence 6 should be improved by creating swales to drain water away from the building and its garage and carport.

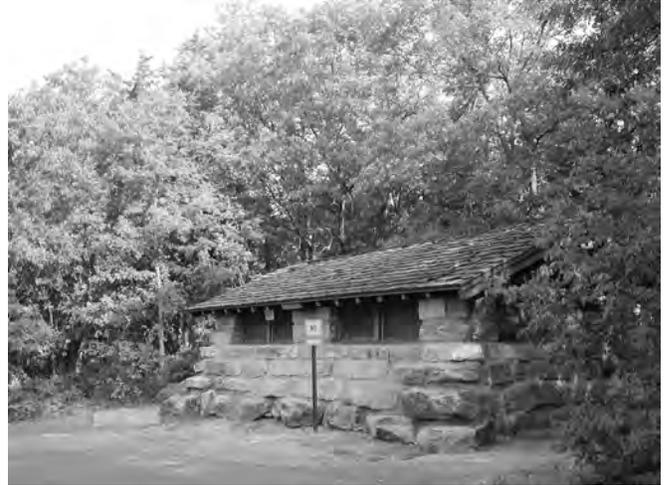
Figure 11-85. Standard highway "No Parking" sign should be replaced with a half-log sign.

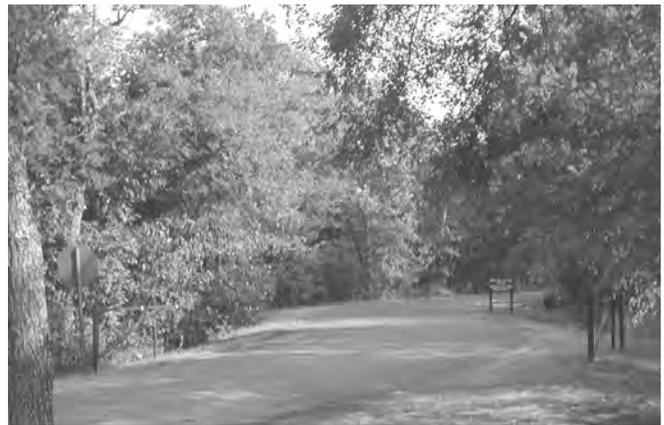
Figure 11-86. Entry gate should be replaced with new gate, as per district wide guidelines.

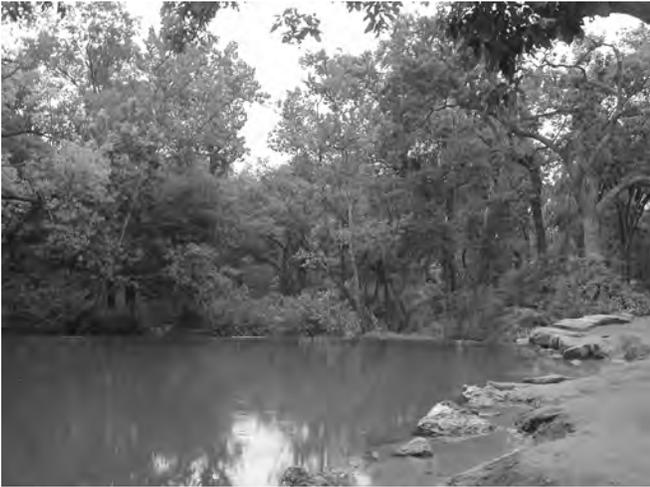
Figure 11-89. Edge of pool at Panther Falls should be repaired.

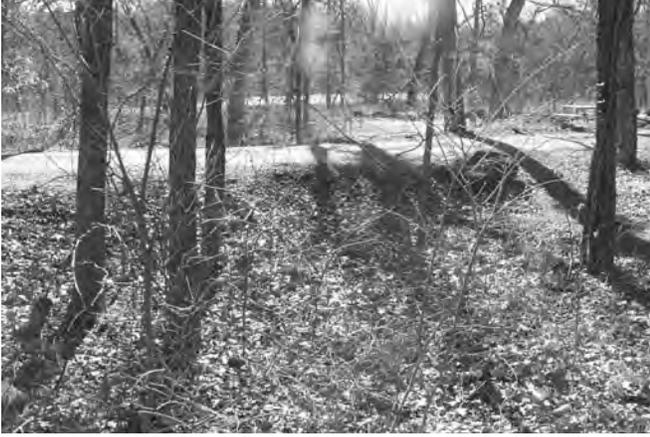
Figure 11-92. Clogged culvert in campground is just one issue contributing to poor drainage in Cold Springs Campground. Culvert should be cleared.

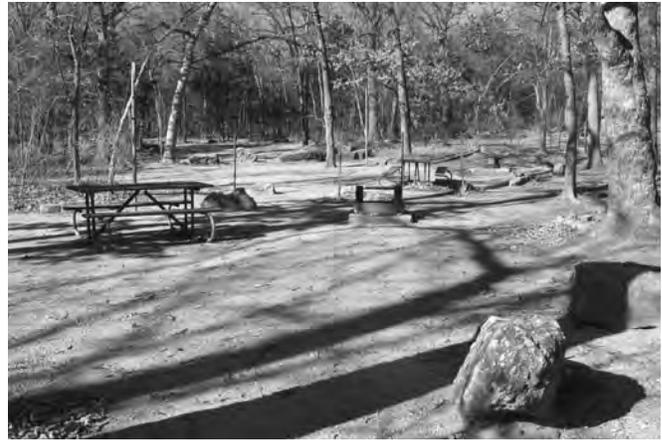
Figure 11-94. Existing campsites lack privacy and multiple volunteer paths connect sites. New understory plantings should be installed in conjunction with drainage repairs. Boulders should be embedded in grade.

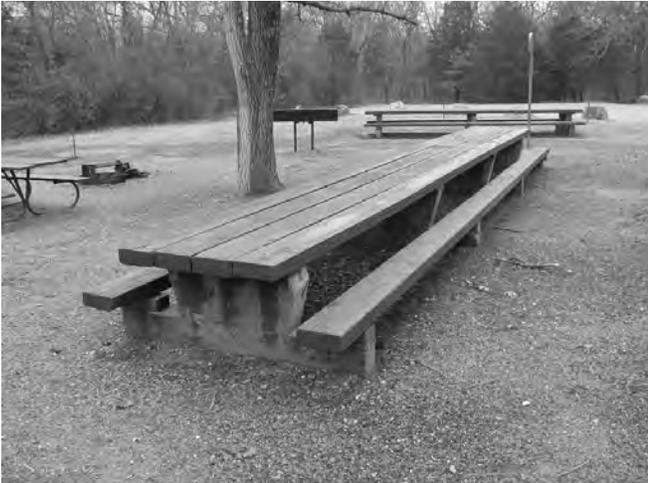
Figure 11-97. Large picnic tables in Cold Springs need repairs to wooden planking and concrete bases.

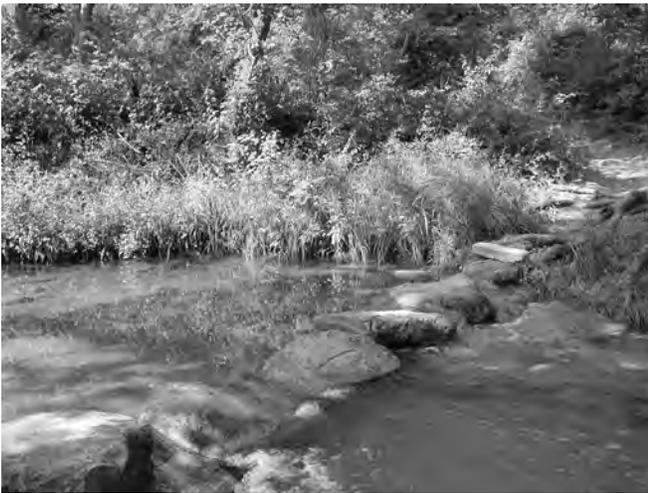
Figure 11-98. Cold Springs crossing should be rebuilt to provide stable footing.

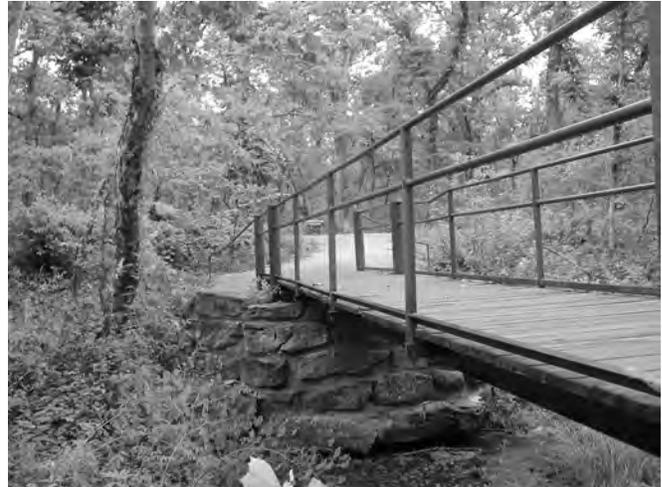
Figure 11-102. Bridge at Little Niagara should be eventually replaced as per district-wide guidelines.

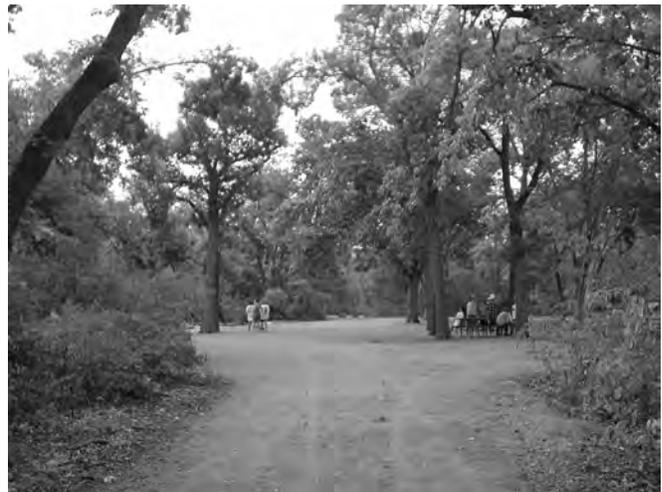
Figure 11-103. Beach area at Little Niagara should be periodically replenished.

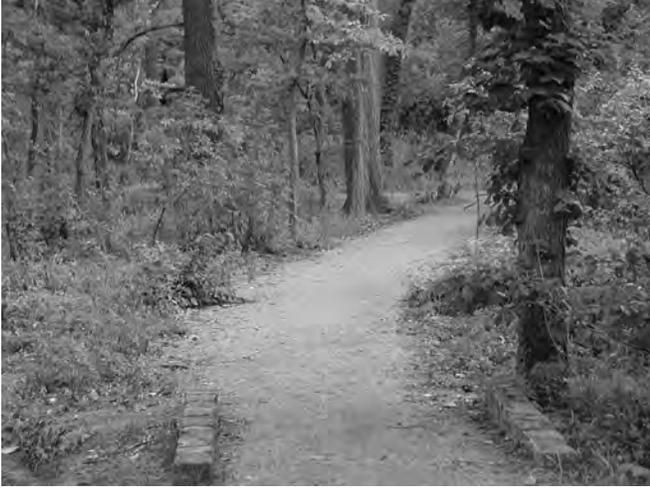
Figure 11-104. Path width at Travertine Island should be reduced slightly by reducing width of mowing band on each side of path.

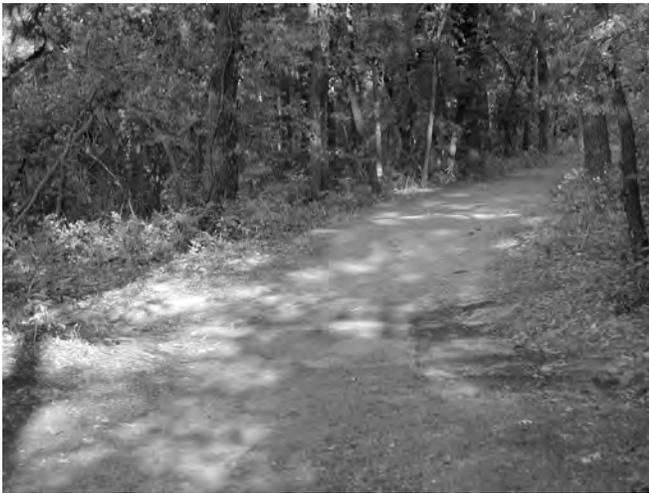
Figure 11-107. Trail to Antelope Springs has a number of rough paved swales which reduce ADA accessibility. Trail grades should be evened and paved swales reconstructed to create as level a surface as possible.

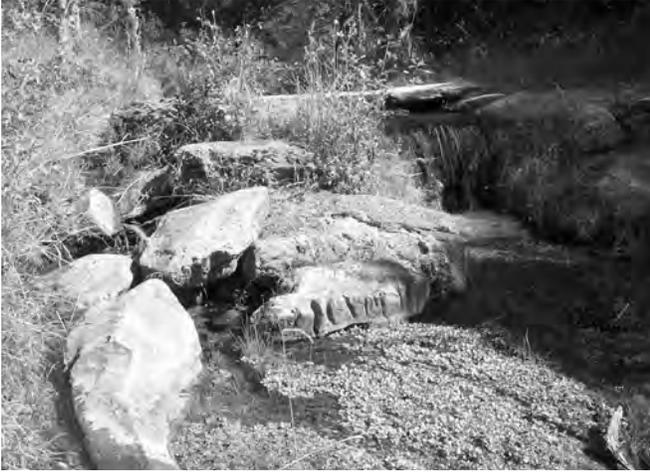
Figure 11-110. Lost tree at the uppermost dam at Antelope Springs has caused minor breach; this should be repaired.

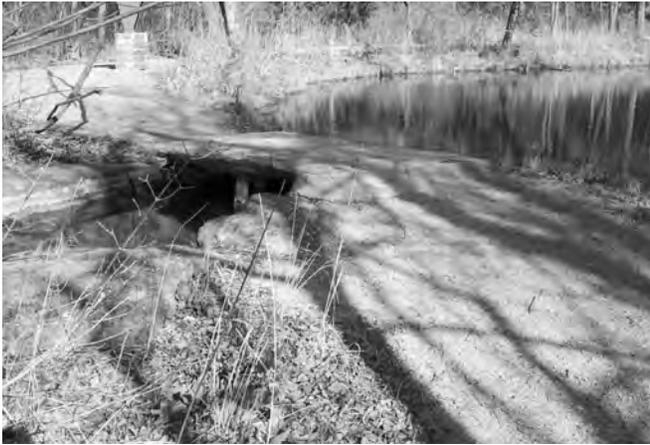
Figure 11-111. Stone bridge at lowermost crossing should be reset and made level. A fully ADA-accessible bridge in this location is not recommended.

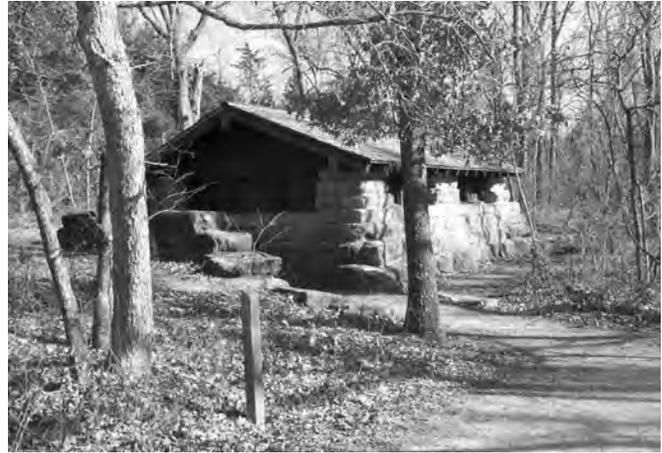
Figure 11-112. Buffalo Springs comfort station should be rehabilitated.

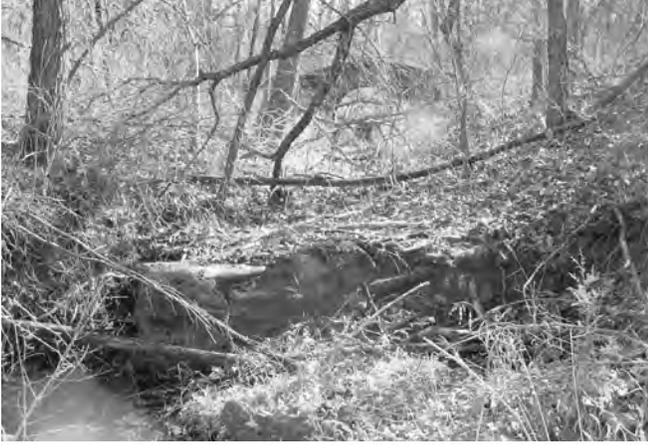
Figure 11-114. One of three dams below stone arch bridge. All three need repairs.

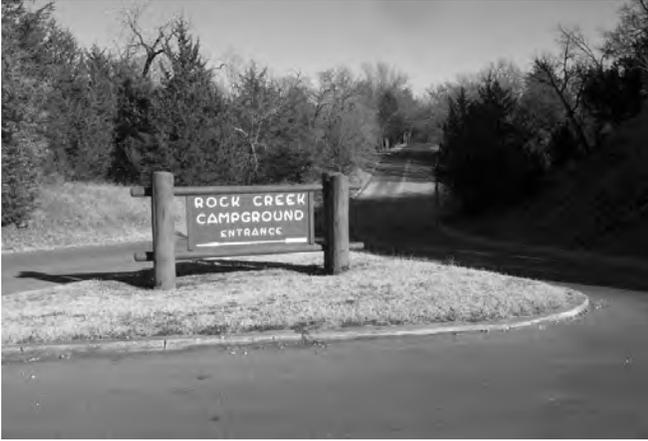
Figure 11-118. Entry sign should be repaired, with elements replaced in-kind to match historic sign.
