# The 2012 Rock Fall at Warm Springs Rapid

## *A Photographic Documentary*

Peter Williams  
Research and Resource Management  
Dinosaur National Monument

November 2012

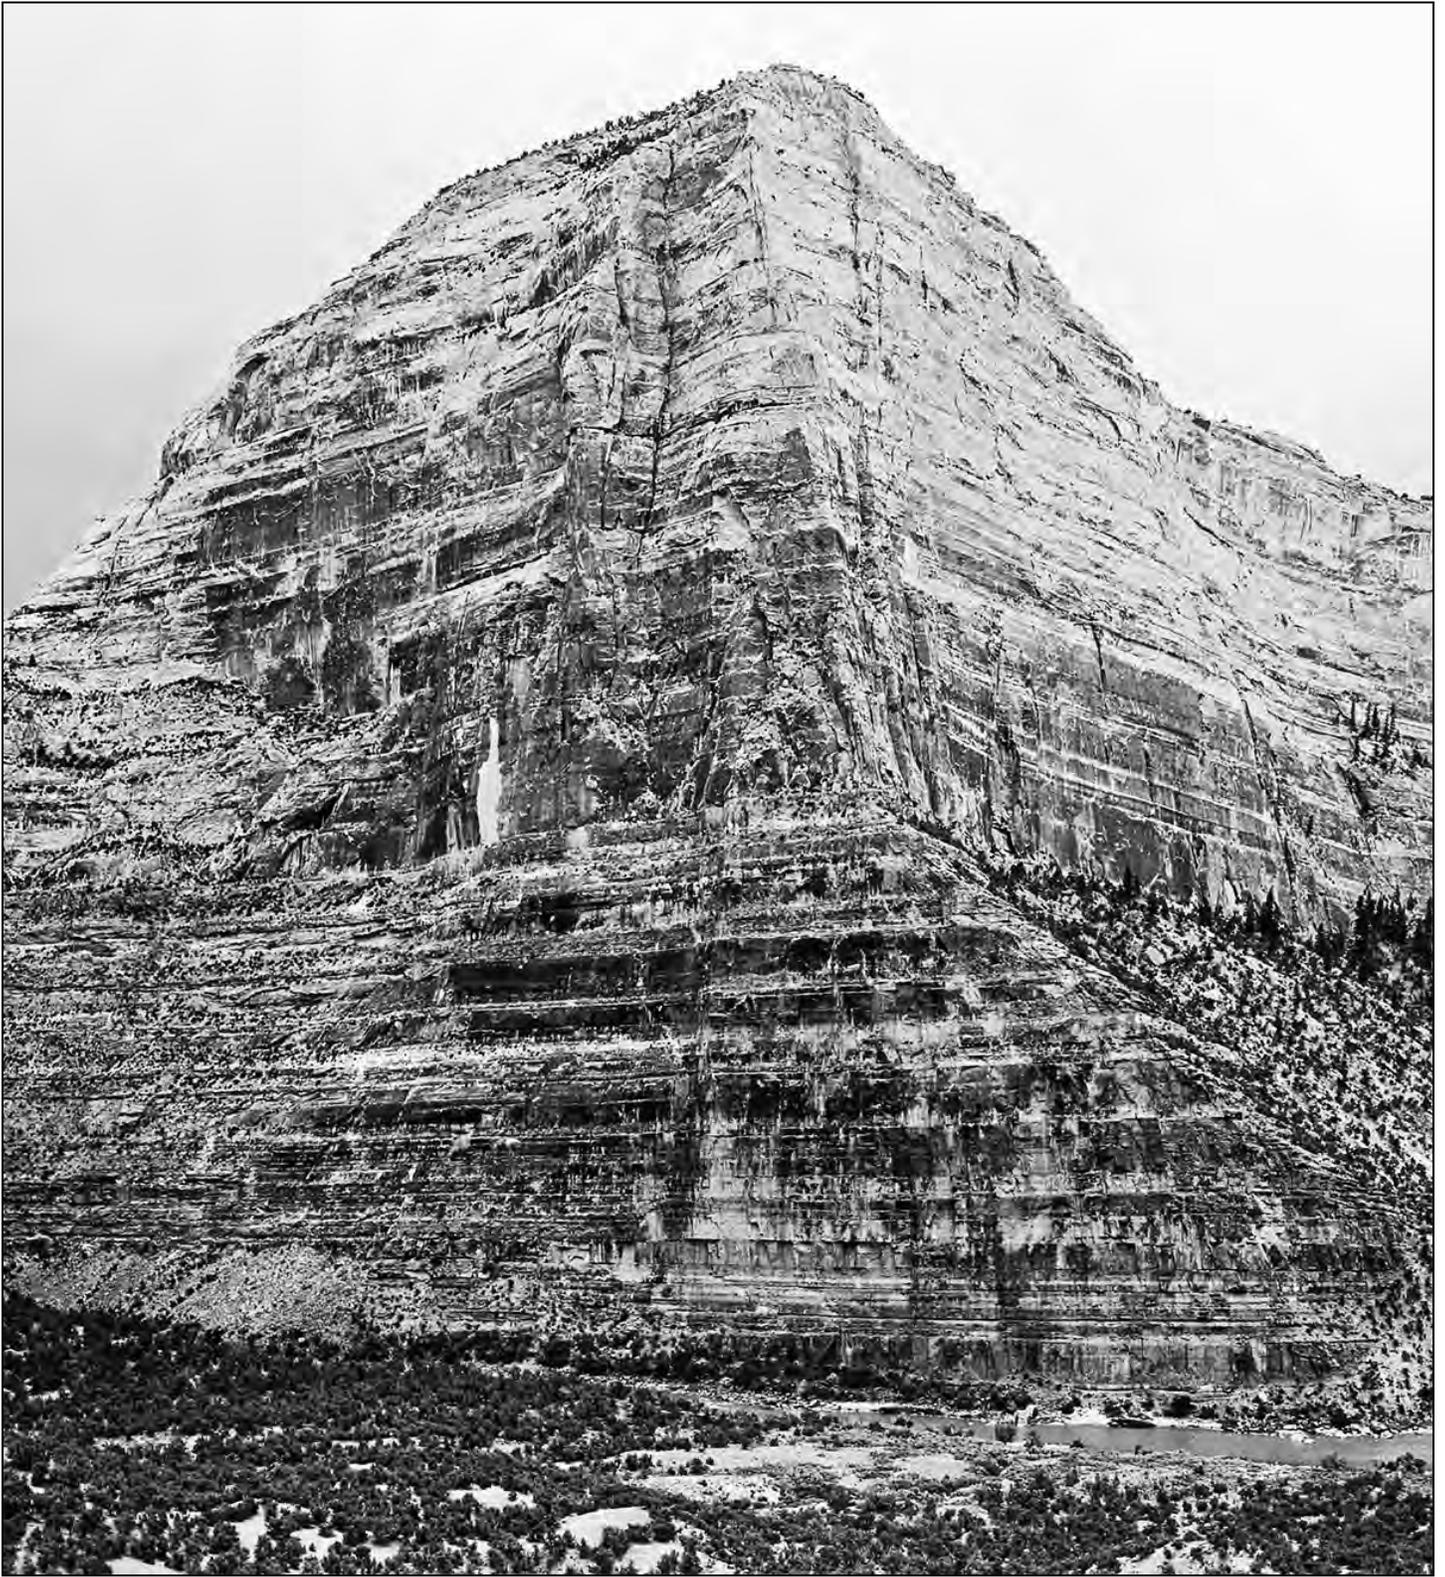
Warm Springs Cliff, August 8, 1935. Note the scars from previous rock falls.  
Photograph: NPS/George A. Grant.

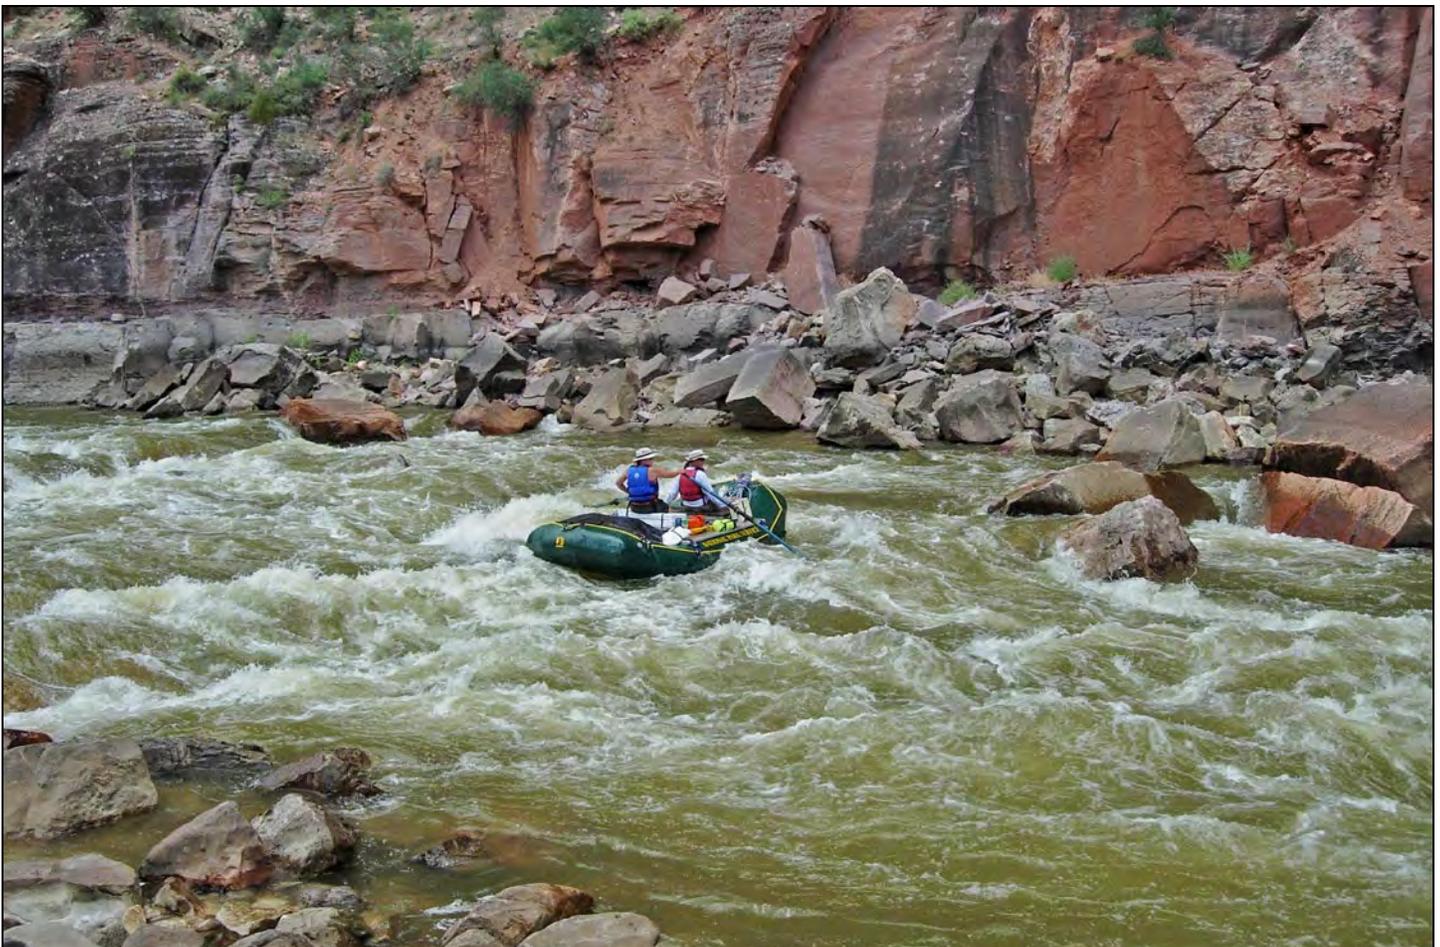
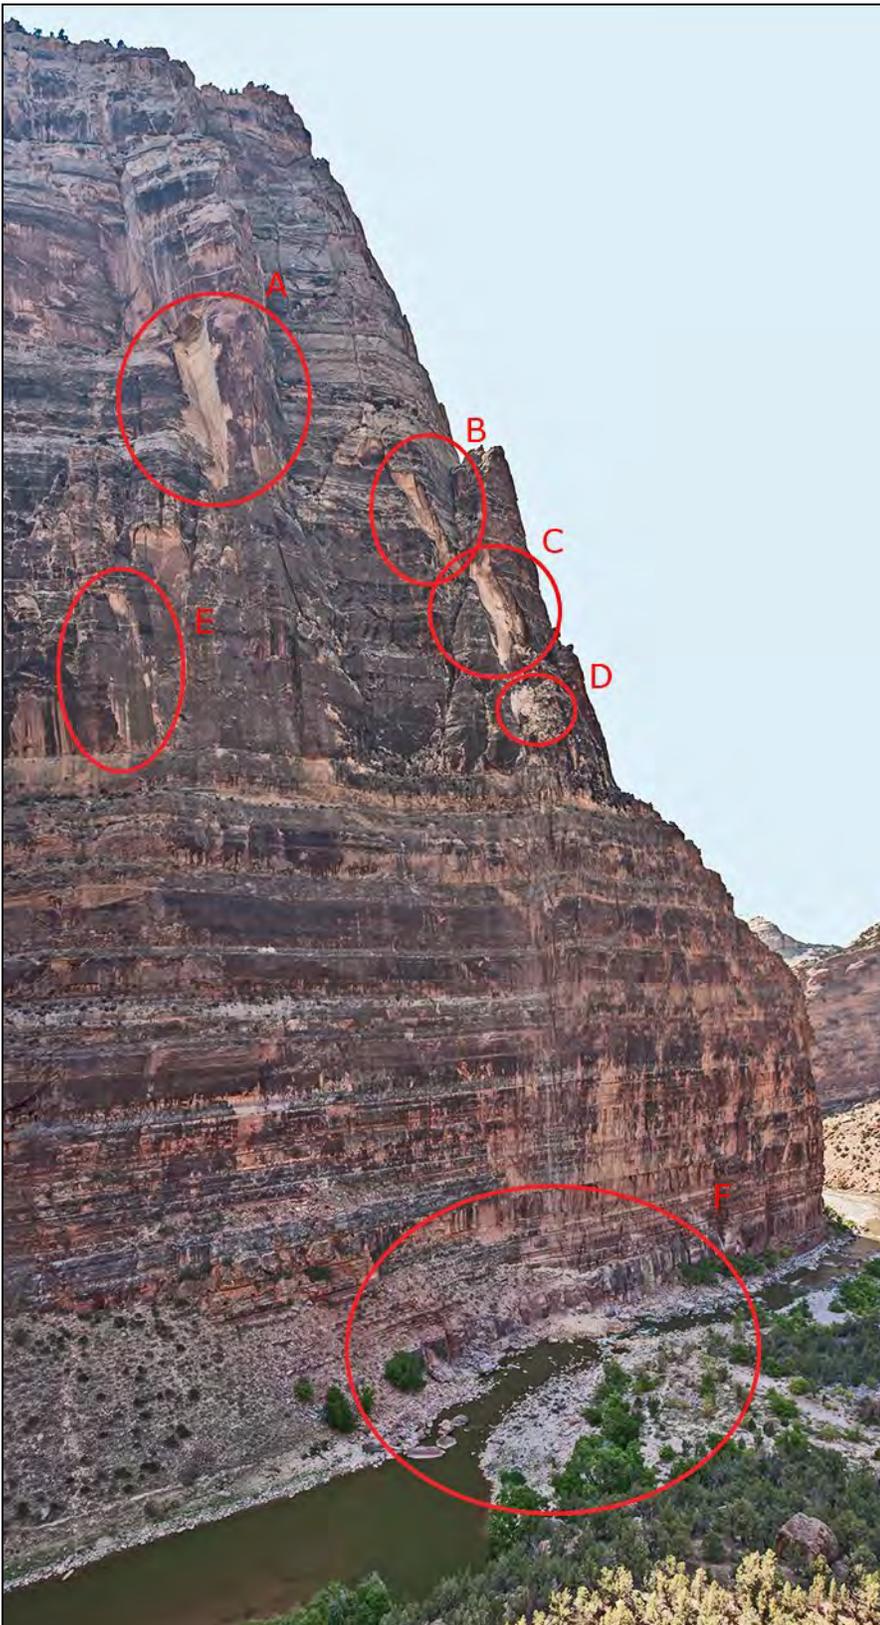
**A:** The “upside-down coke bottle” scar, prominently in view during the last mile-long stretch of river as boaters approach the rapid. This was probably the source of a rock fall in the early 1960s, depositing the large boulders on river left at the head of the rapid.

**B:** An older rock fall scar, visible in the 1935 photograph of Warm Springs Cliff taken by National Park Service photographer George A. Grant (see page 2).

**C:** The source of the 2012 rock fall.

**D:** This scar is on ledges, and appears to have been the result of impacts from the blocks falling from **C**. Some blocks may also have been knocked loose from this section, but its principal contribution to the event was probably the shattering of material falling from above.

**E:** This area appears as a very prominent long, narrow, light-colored rock scar in the 1935 photograph of the cliff, suggesting that it had been the most recent rock fall at that time. It now shows a much more advanced stage of weathering compared to **B**, perhaps because it is in a less sheltered position. The older scar just above and right of it is also visible in the 1935 photograph.

**F:** The area impacted by the 2012 rock fall (see photograph on next page).

An overview of the Warm Springs rapid and cliff, showing rock fall scars and the impact area. This panoramic photograph was taken August 18, 2012, when the Yampa was flowing approximately 90 cubic feet per second. Photograph: NPS/Peter Williams.

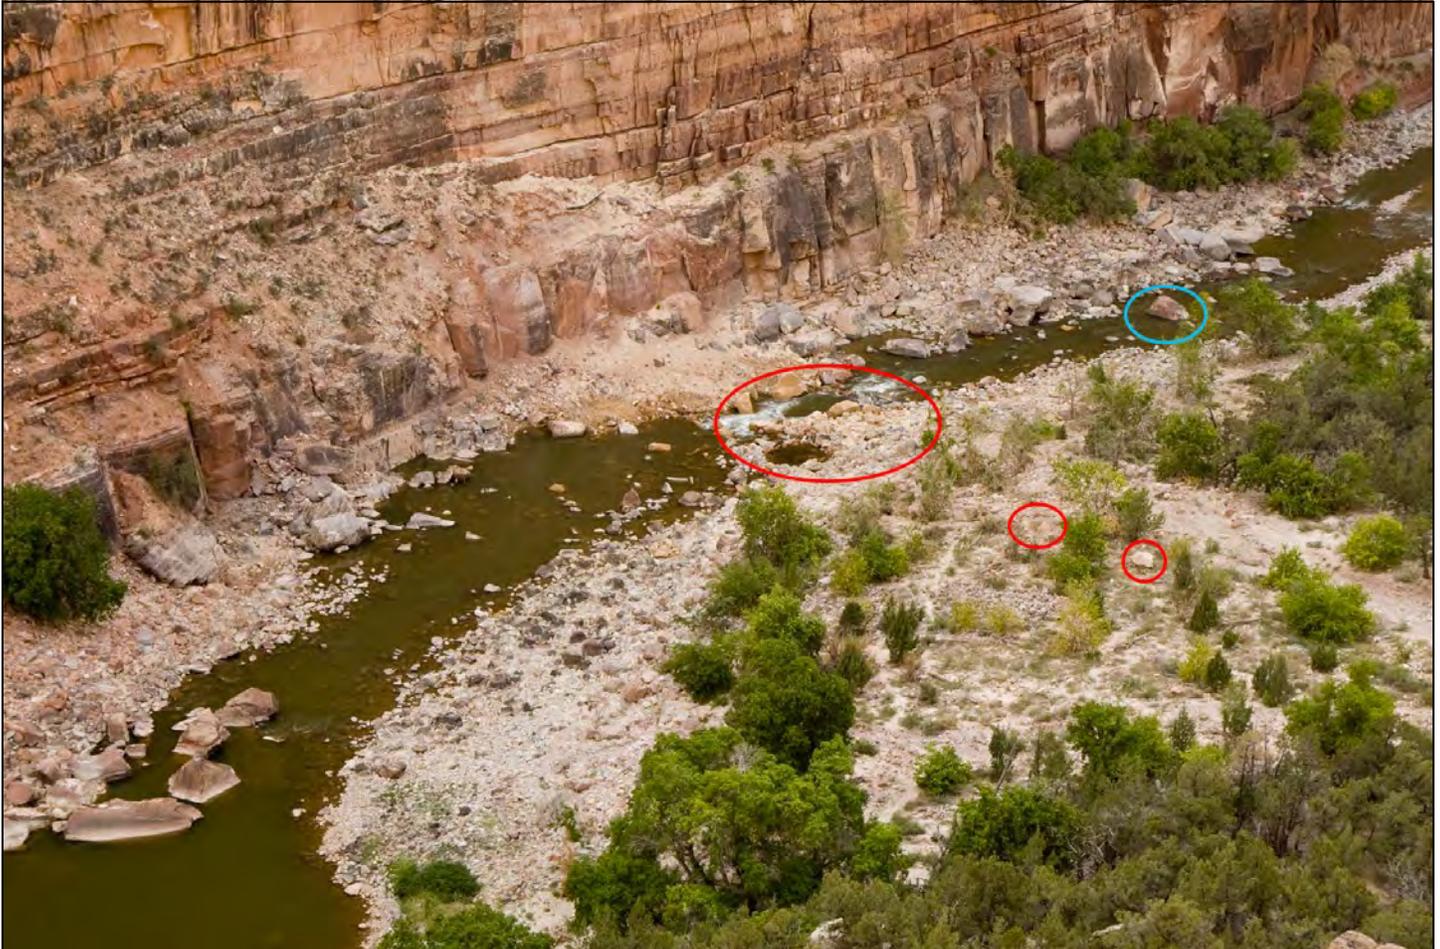
landed farther away. Just on the upstream side of the pile of blocks is an obvious impact crater, perhaps 20 feet or more in diameter. It is possible that a single very large block hit here and bounced in a downstream direction while shattering—this would explain why there's nothing presently in the crater big enough to have created such a large feature, and why the majority of the blocks are piled close by.

**Warm Springs Rapid, August 18, 2012. The largest circle shows the crater and the accompanying pile of large blocks. A large accumulation of pulverized debris can be seen between this impact zone and the cliff wall. The two smaller red circles show large blocks that landed farther from the cliff base. Note the area of blasted box elders between the large circle and the smaller red ones. The blue circle indicates the large boulder that creates the major hole in the middle of the wave train during high flows. Photograph: NPS/Peter Williams.**

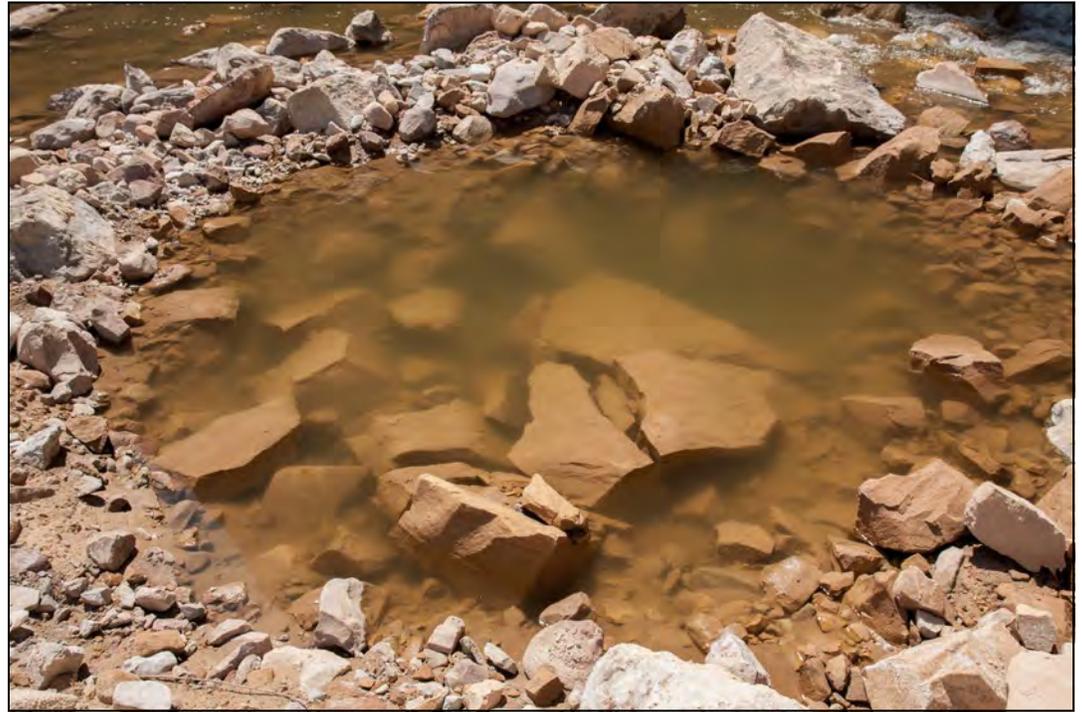
**A close-up of the crater and its contents.**  
Photograph: NPS/Peter Williams.

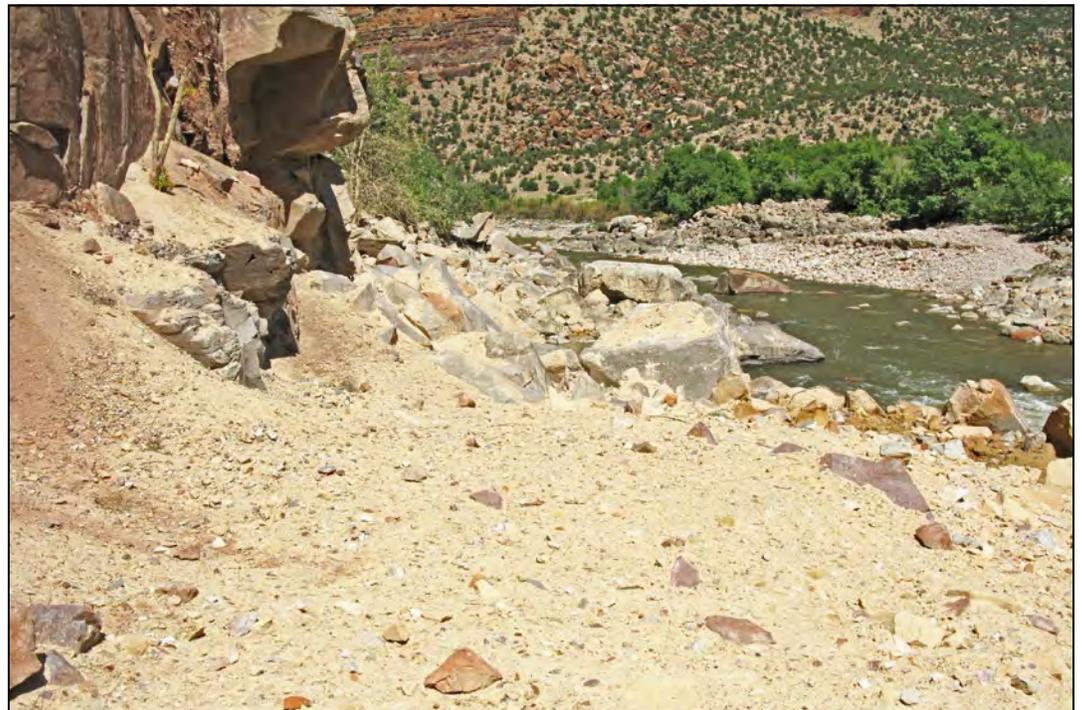
**Pulverized debris piled at the cliff base. The stripped remains of a box elder can be seen on the ledge at left.**  
Photograph: NPS/Peter Williams.

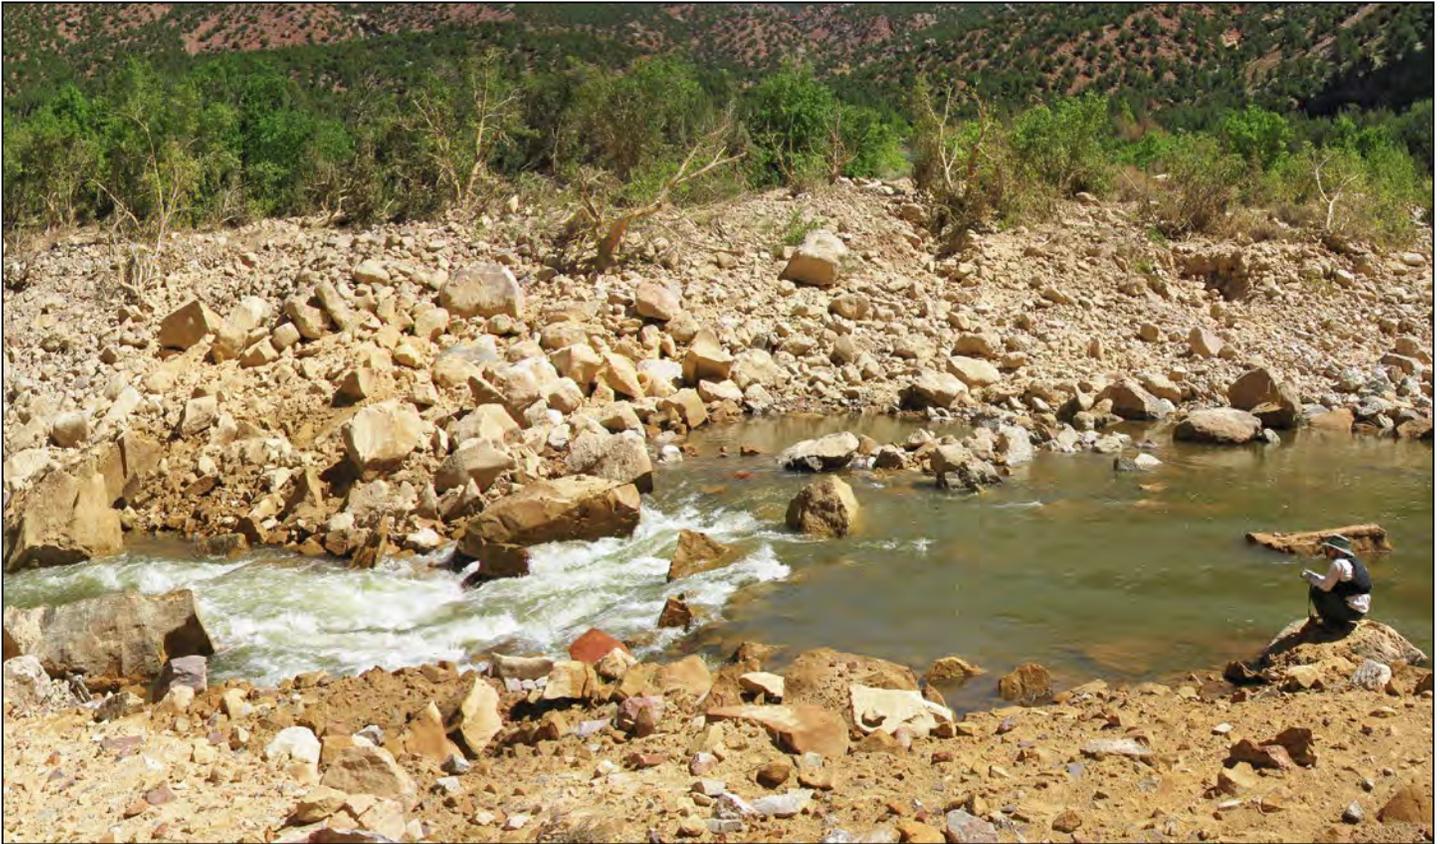
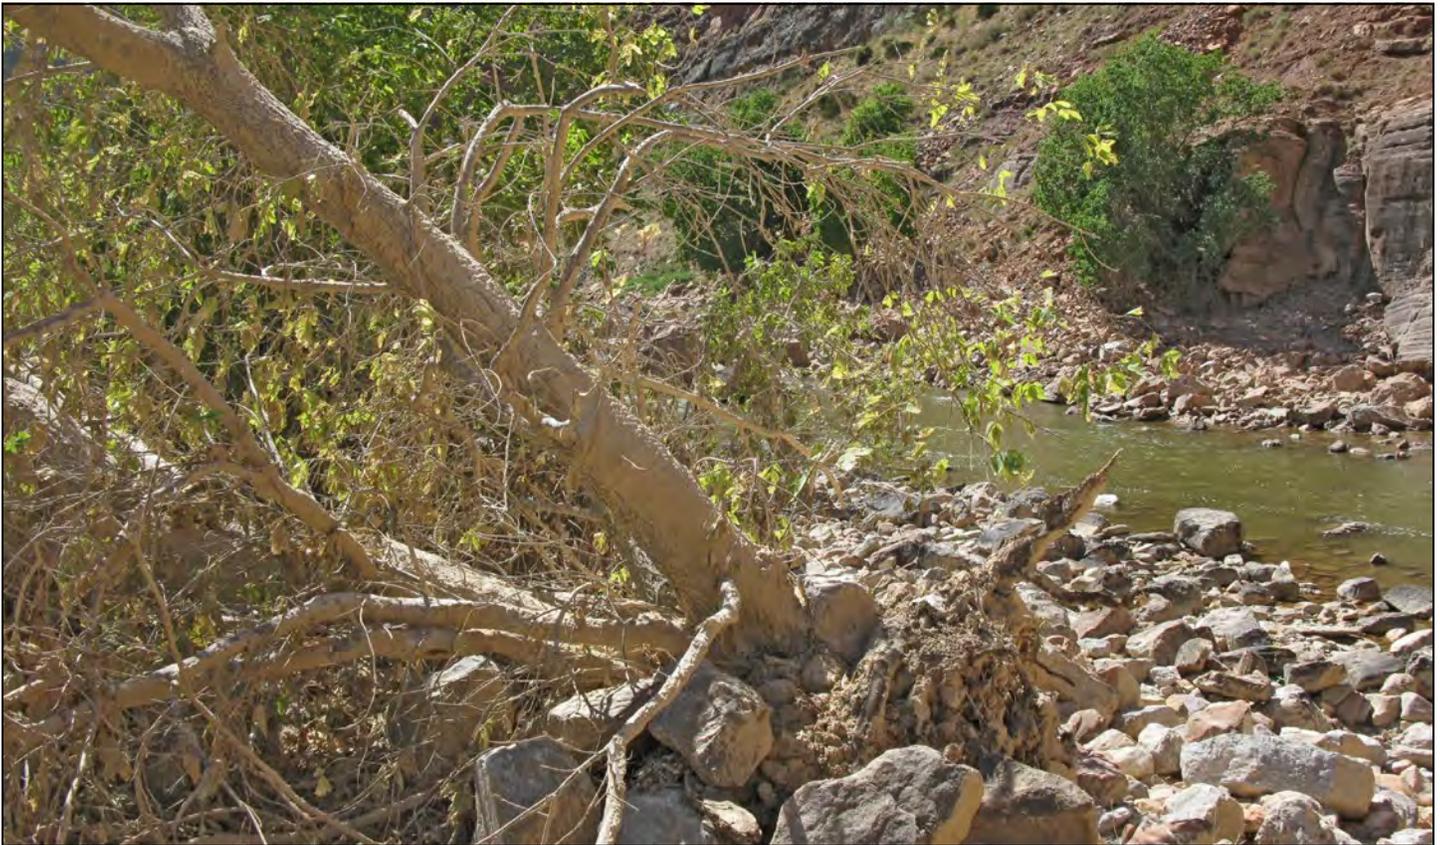
Above, shredded box elders are visible on the river-right bank just beyond the impact zone. Below, mud coating a blasted box elder trunk. Photographs: NPS/Peter Williams.

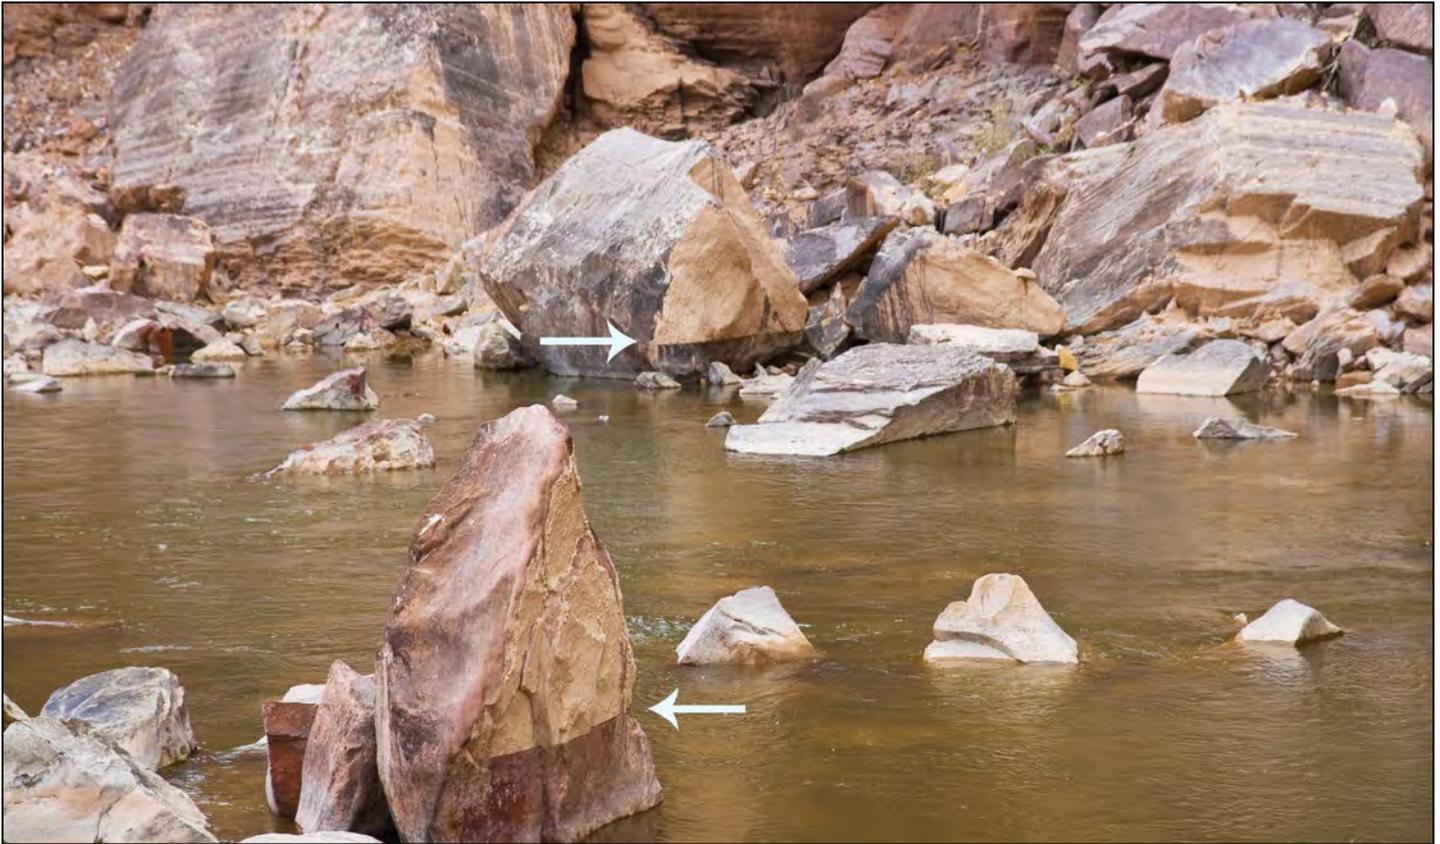
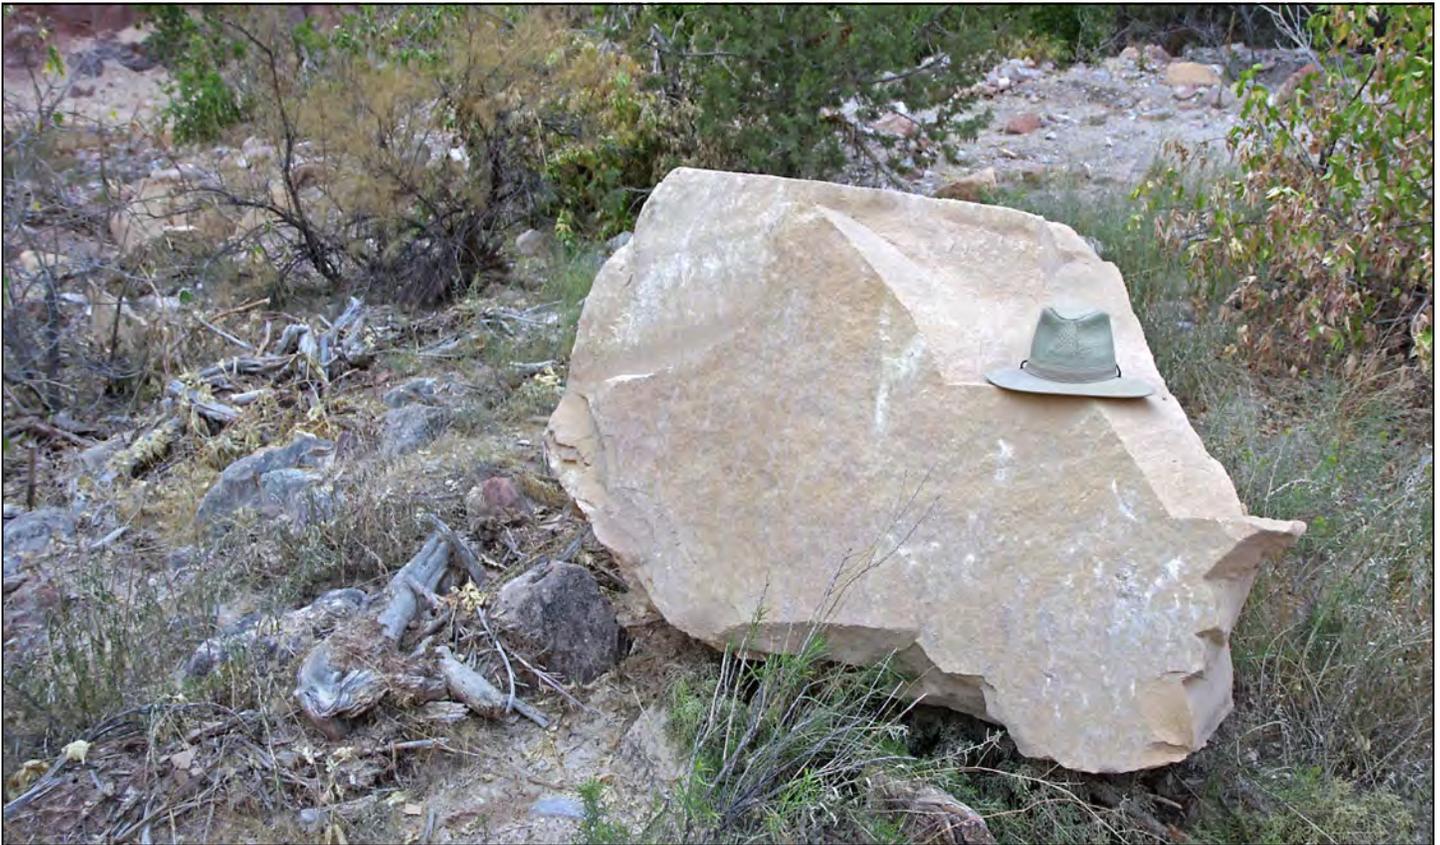
Above, mud-coated boulders in the river. Note the high water marks.  
Below, this block landed high on the 1965 debris fan, well over 200 feet from the cliff.  
Photographs: NPS/Peter Williams.

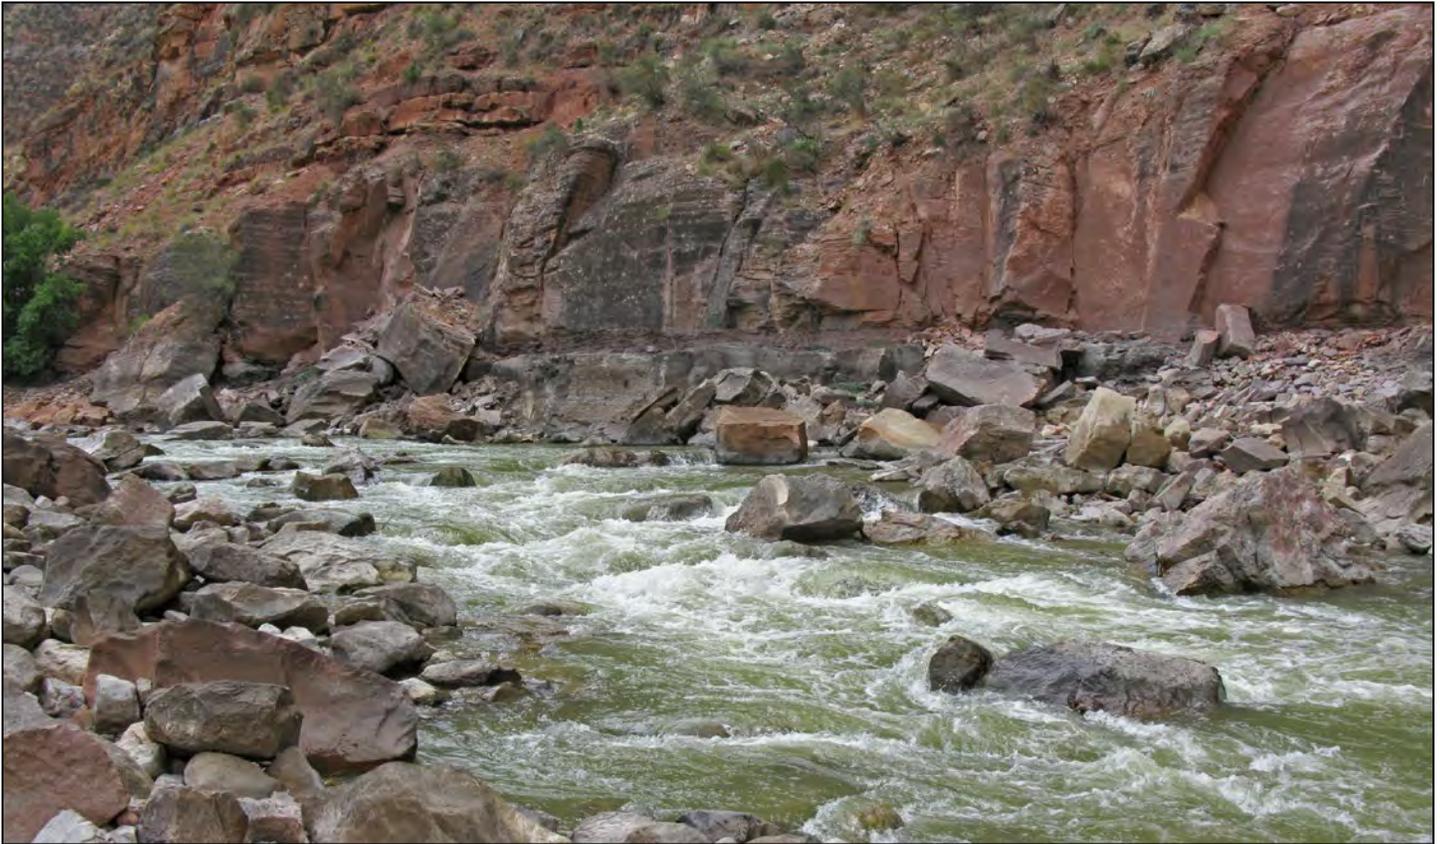
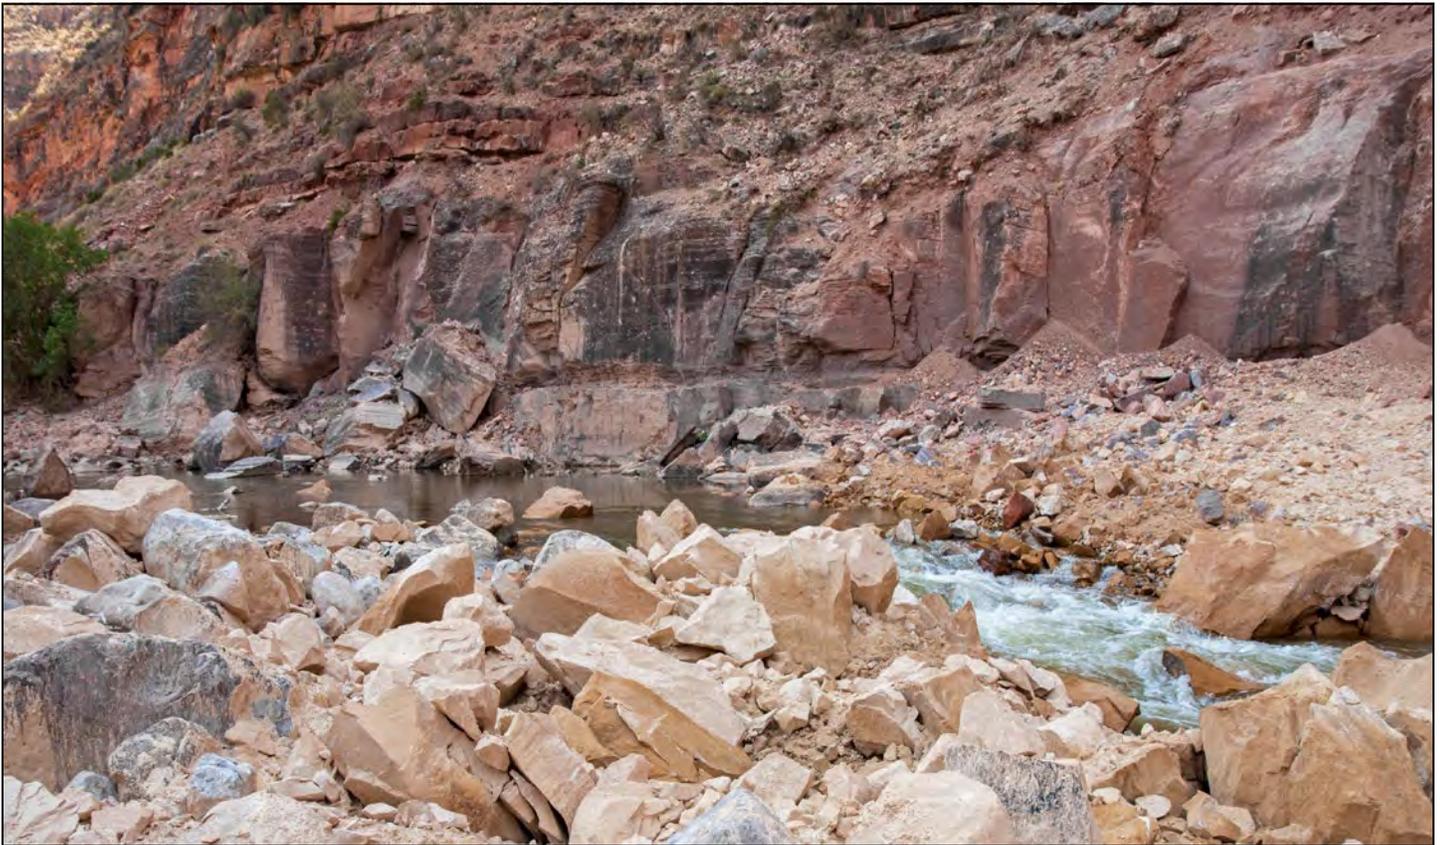
**Above, Warm Springs in August 2009, the river flowing at about 200 cubic feet per second. Below, approximately the same perspective in August 2012, at about 90 cubic feet per second. Photographs: NPS/Peter Williams.**

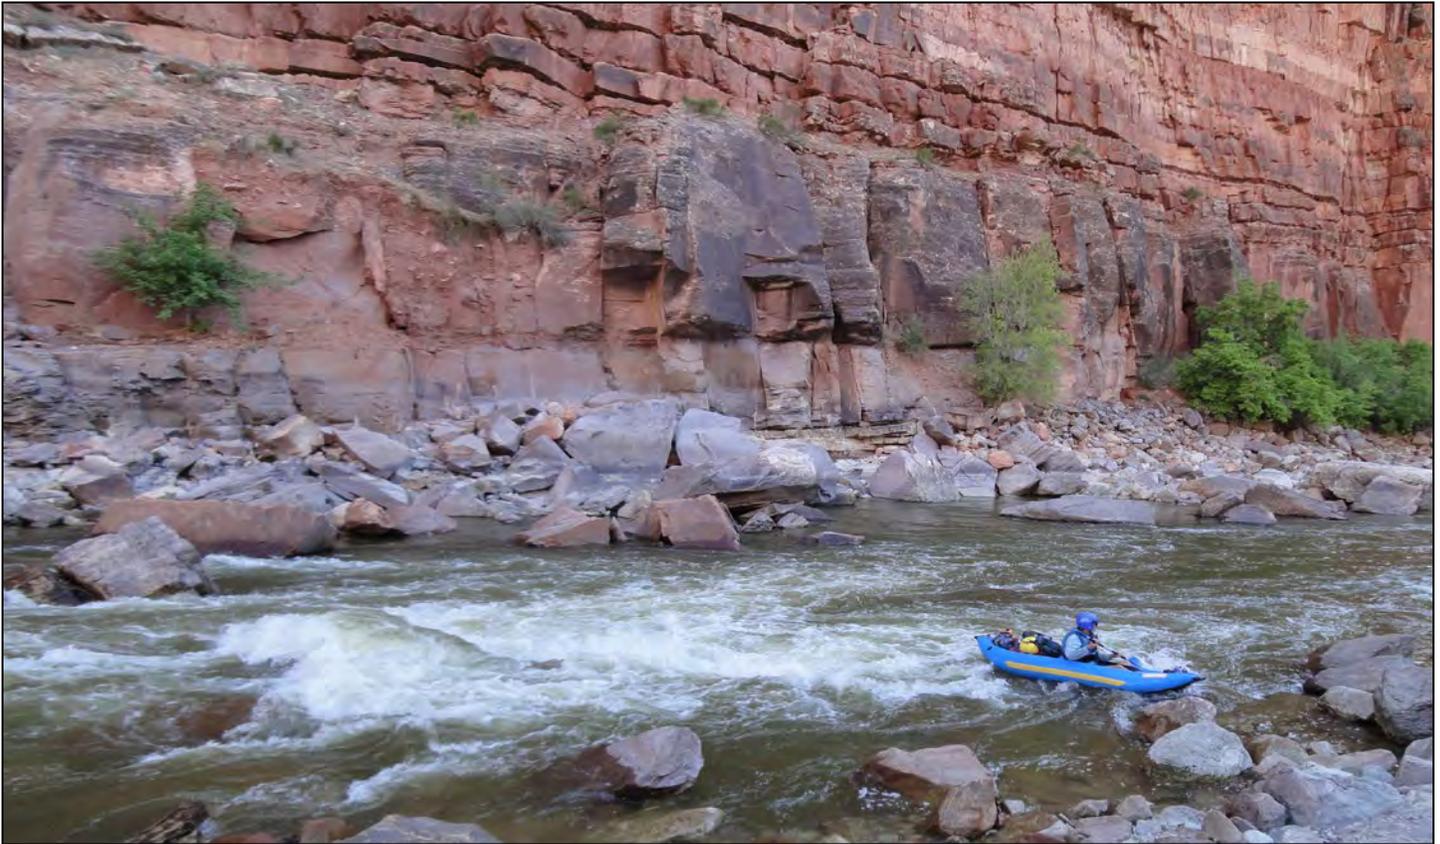
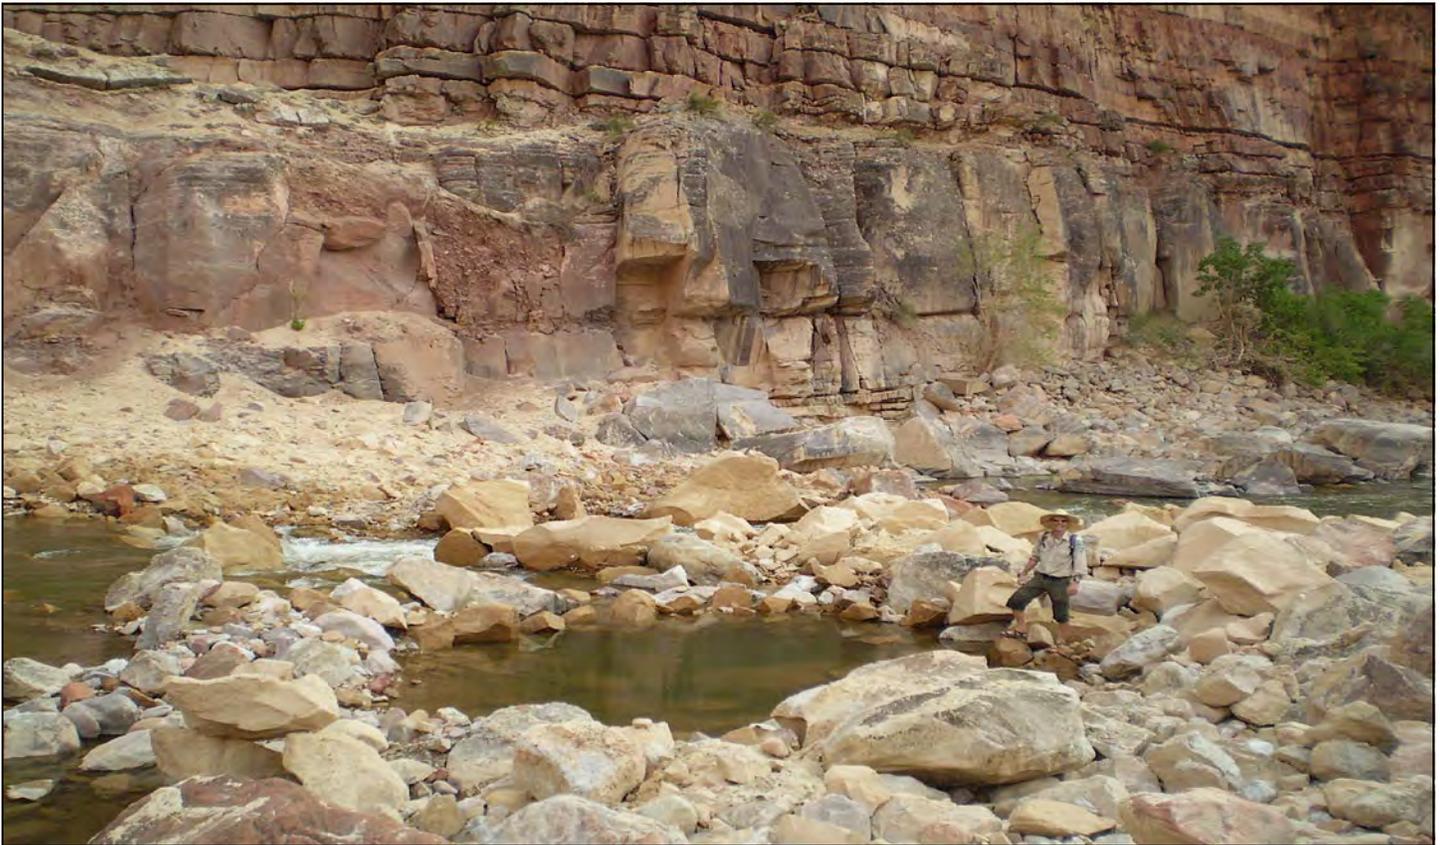
Above, Warm Springs Rapid taken on June 17, 2012, not long before the rock fall.  
Photograph: Robin Rabun, © Garold Fornander.  
Below, approximately the same perspective a month later.  
Photograph: NPS/Stuss Leeds.
