**Appendix 1. Historic Names for Alcatraz Island Features  
by Character Area**

## Appendix 4: 2007 Tree Inventory Report

### Evaluation of the Trees on Alcatraz Island

Joe R. McBride  
Consulting Forester  
Albany, CA  
January 20, 2007

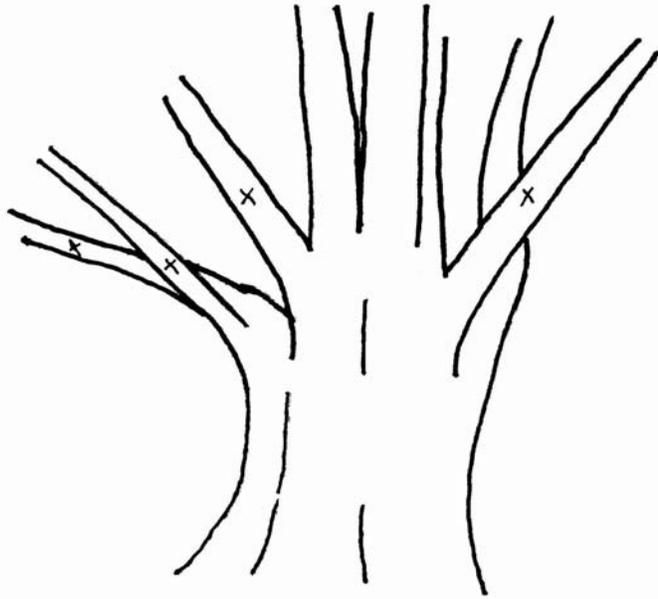
Figure A4-1. Branching pattern of tree # 15 as viewed from the north side of the tree (x = branches to be removed)

15	Monterey Cypress	Cupressus macrocarpa	43.8	60	ND	Fair condition - several lower branches have low angles of attachment and will have high potential for wind breakage as they grow heavier	Good condition - no evidence on problems, currently not growing against wall	1. Remove the four lower branches which are leaning our away from the main trunks (see illustration) 1. Prune off "knuckle" and branch above it 2. Lightly prune canopy to reduce weight on horizontal branches
16	Monterey Cypress	Cupressus macrocarpa	45	88	90	Good condition - well balanced canopy, no evidence of trunk or root rot; "knuckle" on left hand side of main trunk is a weak point	Good condition - no evidence on problems, currently not growing against wall	1. Prune off "knuckle" and branch above it 2. Lightly prune canopy to reduce weight on horizontal branches
17	Monterey Cypress	Cupressus macrocarpa	30.2	69	60	Good condition - no evidence on problems, currently not growing against wall	Good condition - no evidence on problems, currently not growing against wall	1. Light crown pruning to reduce wind resistance

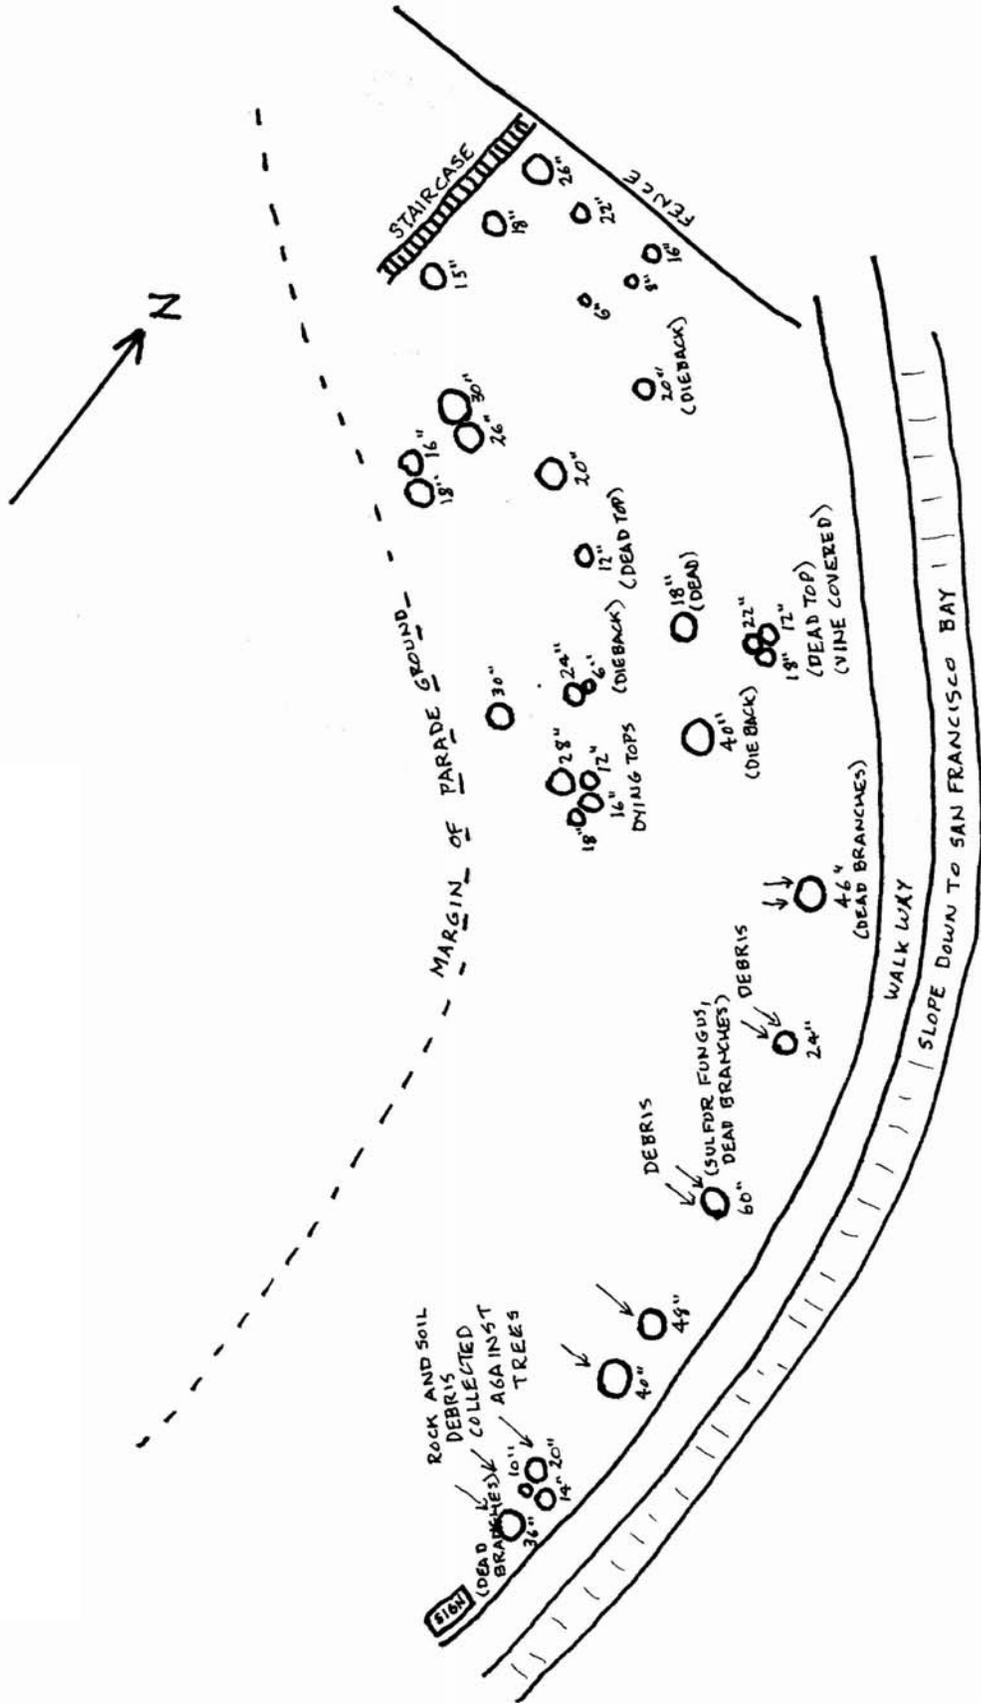
Map A4-2. Location of trees in the eucalyptus grove

The eucalyptus grove near the south eastern end of the island supports 32 trees over six inches in diameter, several of which have multiple trunks (Map A4-2). These trees were planted on a steep slope which may have been created by the dumping of rubble over the cliff when Army prisoners in the 19<sup>th</sup> century carved the parade ground out of the cliffs at the south end of the island. Irrespective of the mode of formation of this slope it is unstable. The lack of stability has resulted in rocks and other debris sliding down against the base of the trees. The movement of the slope and the prevailing wind through the Golden Gate has contributed to the tree leaning in an easterly direction over the walkway along the edge of the island. Several trees in the grove exhibit die back of their tallest branches, possibly in response to their exposure to higher wind velocities as their tops have grown above the elevation of the parade ground. There are also dead standing trees in the grove. The trees show evidence of having been topped at two times with major branching occurring at 15 to 18 feet above the ground and again at around 20 to 24 feet. This was a common tree maintenance procedure used by the U. S. Army at the Presidio on eucalyptus to control problems of wind breakage. Unfortunately after the practice is terminated, the branches grow heavy and can be vulnerable to wind breakage, as is the case for a number of trees in the grove. These eucalyptus trees present the greatest tree fall and limb fall hazard to visitor to the island. The condition of these trees, coupled with their proximity to a commonly used pathway makes them very dangerous. I recommend that the existing trees be cut down and allowed to sprout back. They will produce numerous vigorous sprouts which should be thinned over a period of five years to select the straightest, most vigorous sprout on each stump. These sprouts should be allowed to grow as replacements for the trees originally planted by the U. S. Army. I would further recommend the tree topping practices used by the Army be adopted to control the height and wind breakage problem which will be associated with these trees in the future.
