# CULTURAL LANDSCAPE REPORT FOR UPPER FORT MASON

GOLDEN GATE NATIONAL RECREATION AREA

VOLUME II: TREATMENT STRATEGY

SAN FRANCISCO, CALIFORNIA

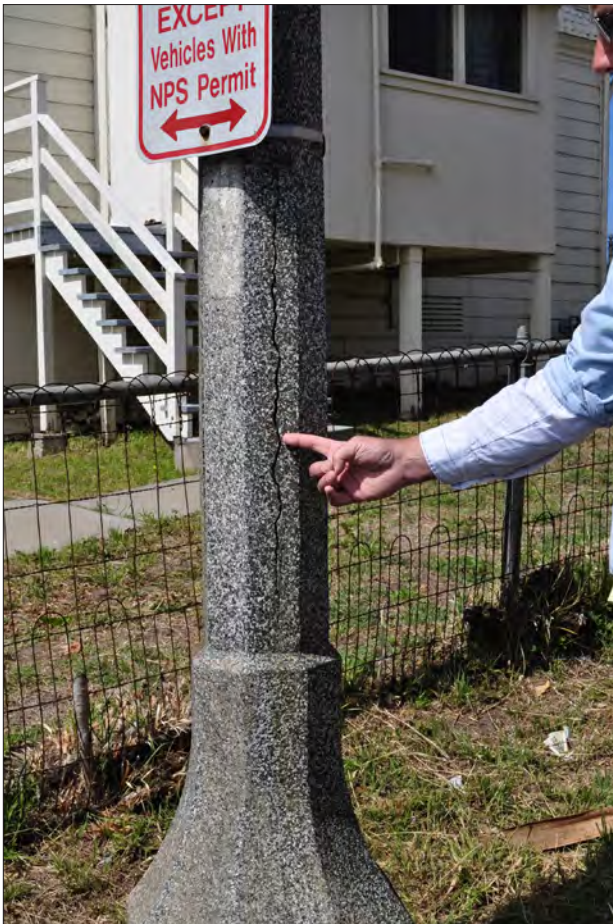
Figure 2.7. Cracked cast-concrete pole light to the west of Building 231. View looking southeast, 2011 (OCLP).

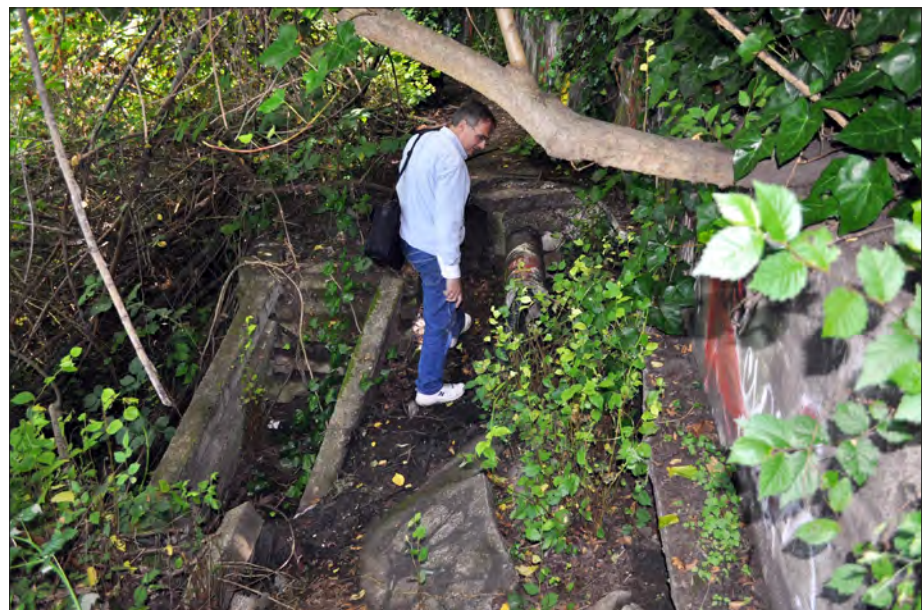
Figure 3.11. Collapsed concrete walks and drainage structures on the East Black Point slope to be rehabilitated to support visitor use. View looking south, 2011 (OCLP).

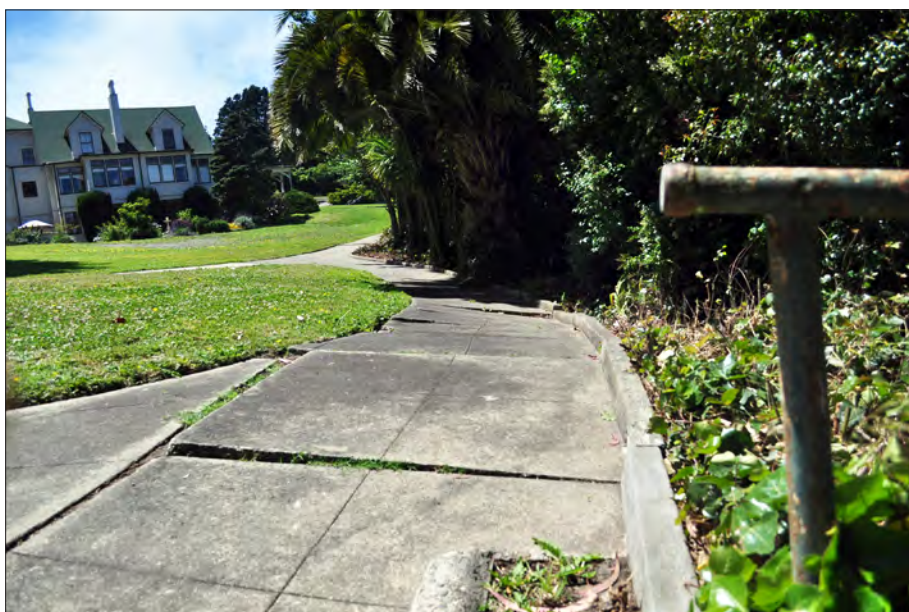
Figure 3.12. Heaved and cracked concrete walks at the crest of the East Black Point slope to be replaced in-kind to accommodate safe public access. View looking north, 2011 (OCLP).

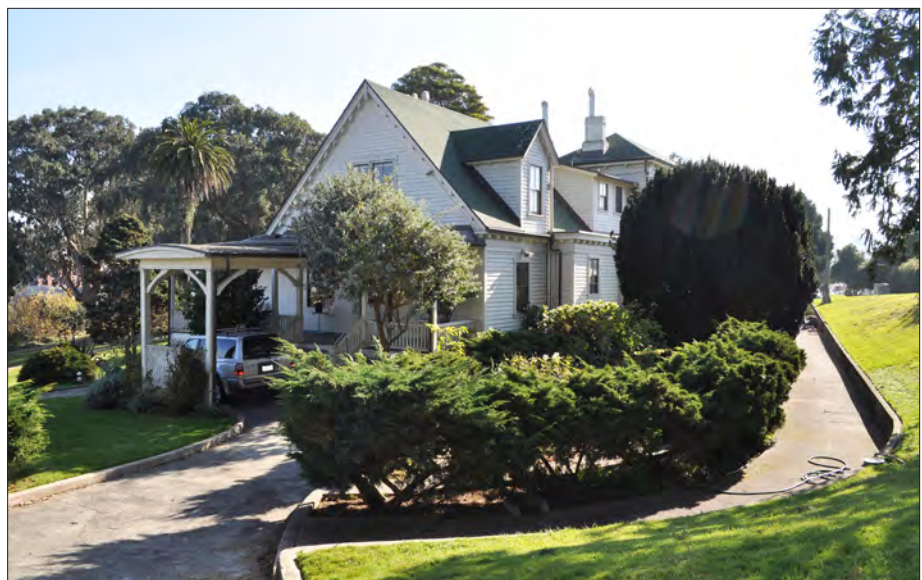
Figure 3.14. Overgrown yew at Quarters 2 to be replaced in-kind and junipers surrounding the rose garden to be replaced with low boxwood edging. View looking southeast, 2011 (OCLP).

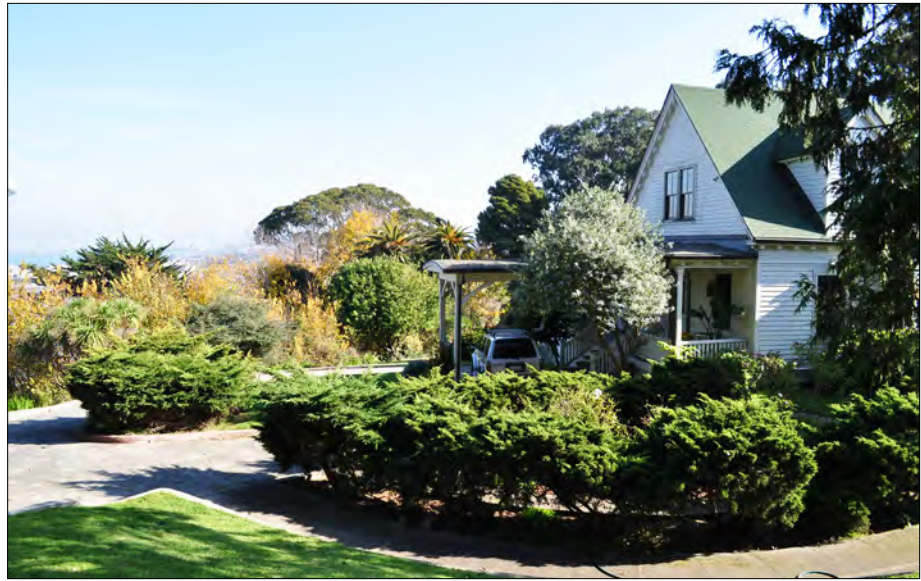
Figure 3.16. Overgrown junipers surrounding the Quarters 2 rose garden to be replaced with low boxwood edging. View looking north, 2011 (OCLP).

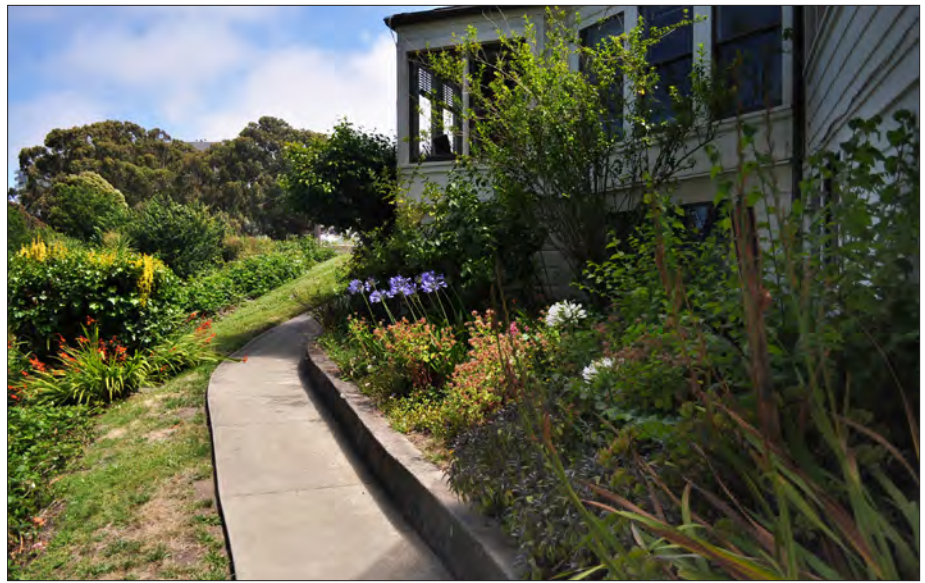
Figure 3.19. Missing landscape lighting along the walk between Quarters 3 and 4 to be replaced with compatible fixtures. View looking south, 2011 (OCLP).

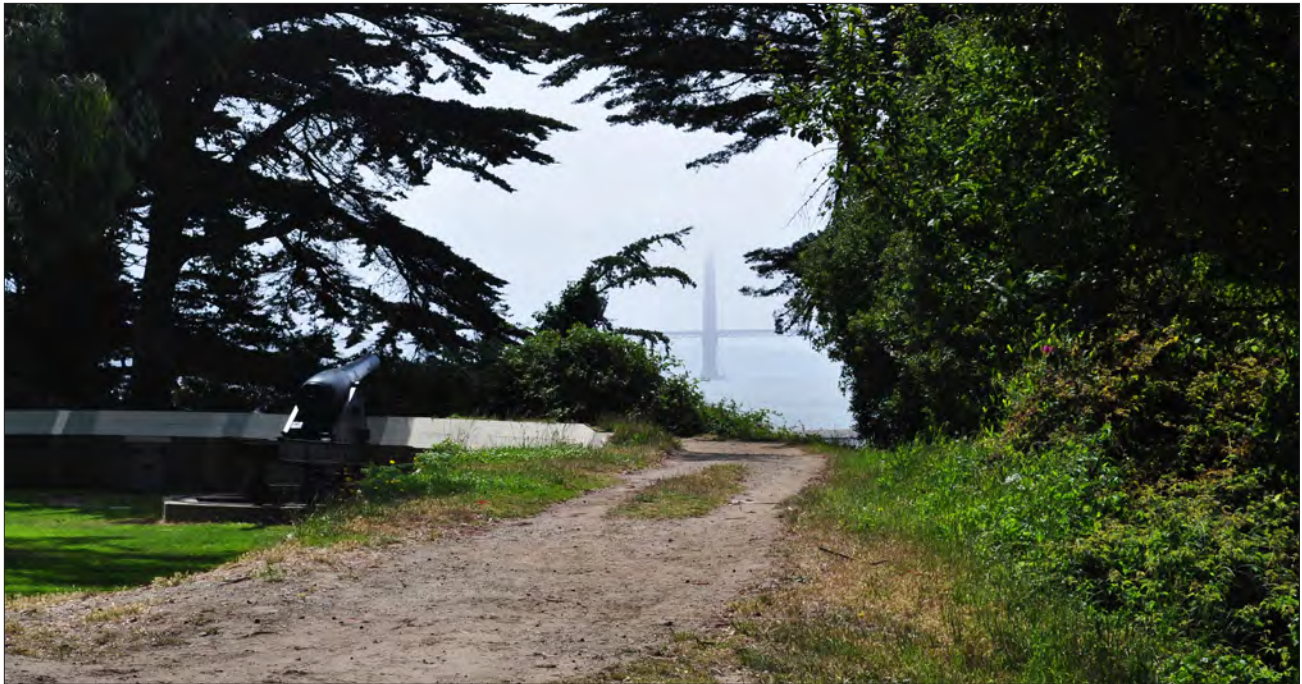
Figure 3.28. Mature plantings and invasive vegetation now obstruct views to the San Francisco Bay from the Civil War era fortifications. View looking west, 2011 (OCLP).

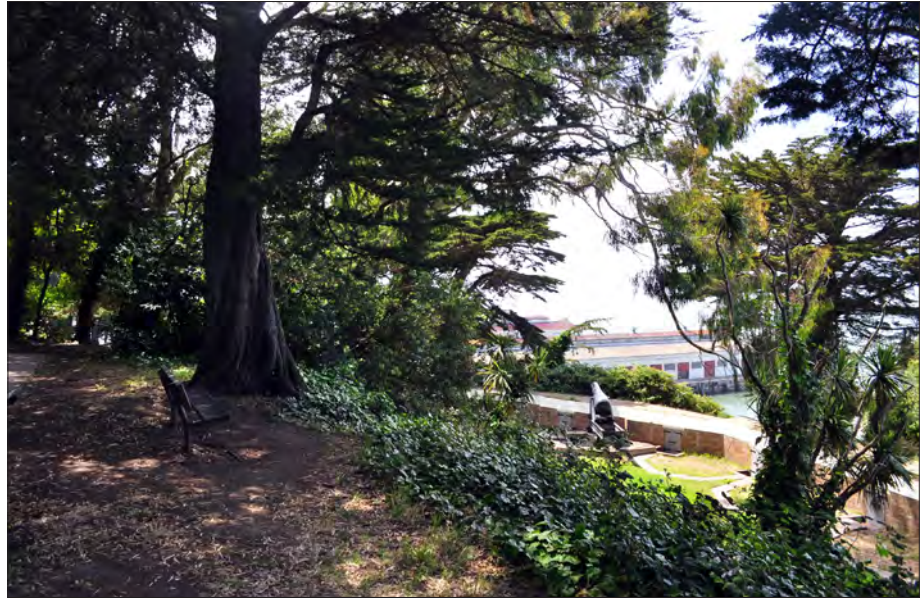
Figure 3.29. Mature Monterey cypresses and overgrown shrubs obstruct westward views toward the Golden Gate from the earthen terrace below Battery Burnham. View looking west, 2011 (OCLP).

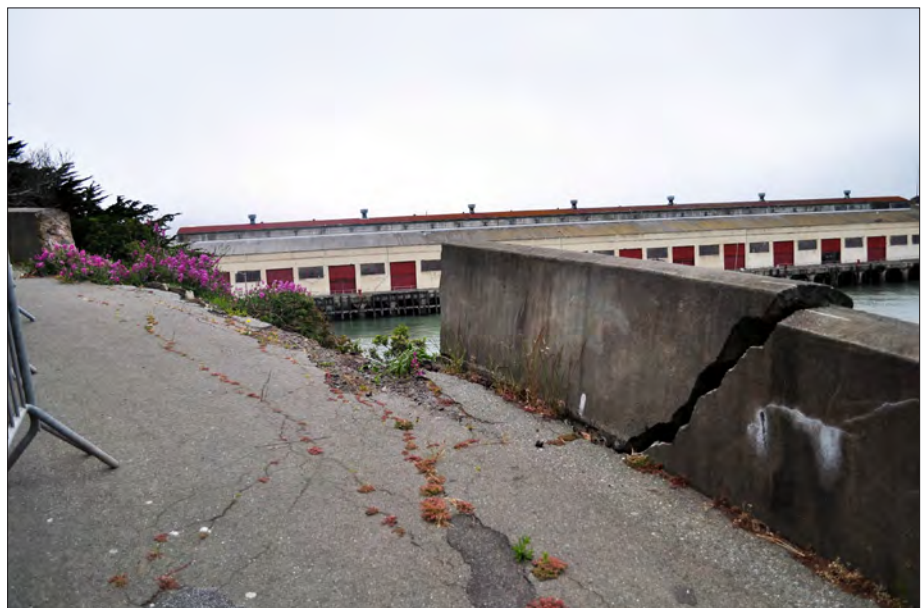
Figure 3.42. Collapsed concrete retaining wall along McDowell Avenue to be replaced consistent with road narrowing to enhance visitor safety. View looking west, 2011 (OCLP).

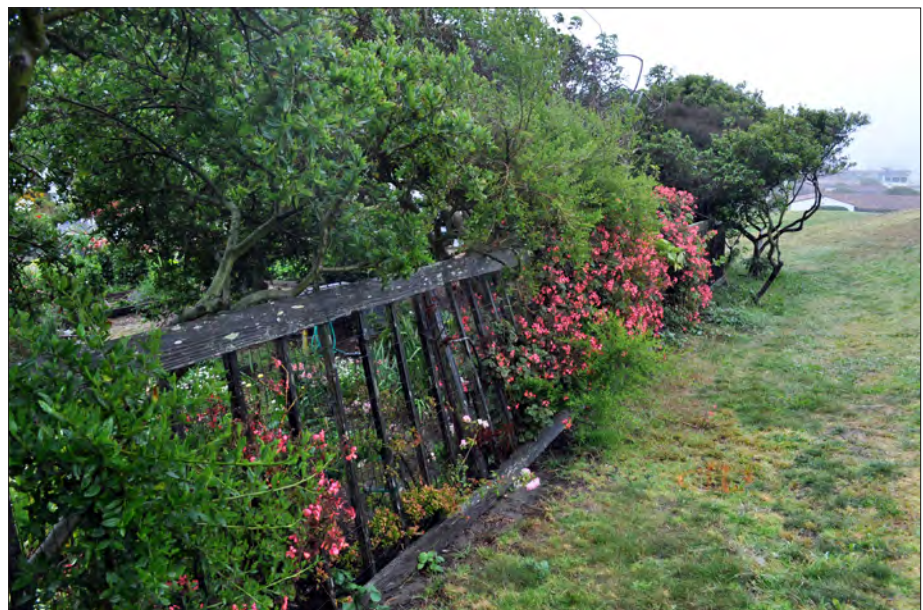
Figure 3.55. West side of the community garden showing the deteriorated wood and wire mesh perimeter fence to be relocated to accommodate reestablishment of the Parade Ground. View looking south, 2011 (OCLP).

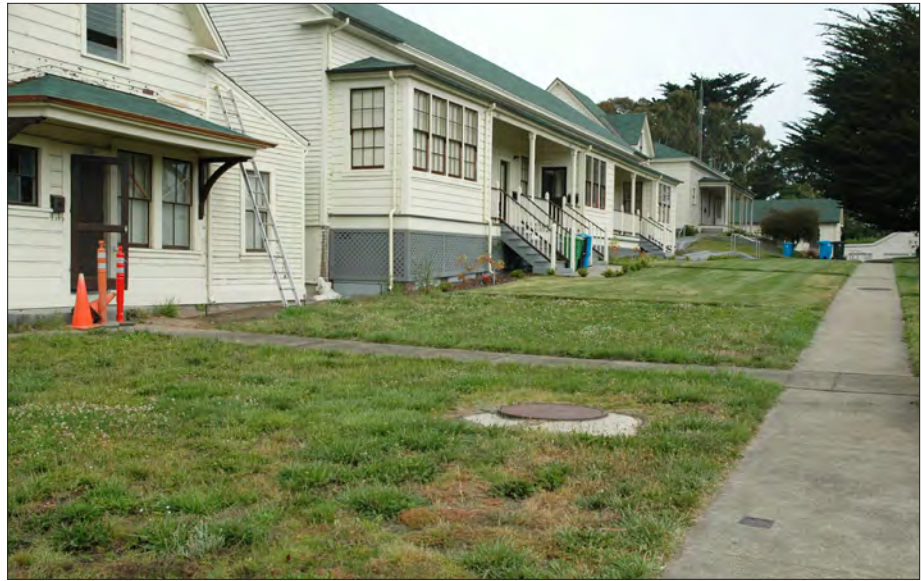
Figure 3.59. Missing foundation plantings to be reestablished along the east facades of all NCO Quarters, including Building 234, shown here at far left. View looking northwest, 2012 (GGNRA).

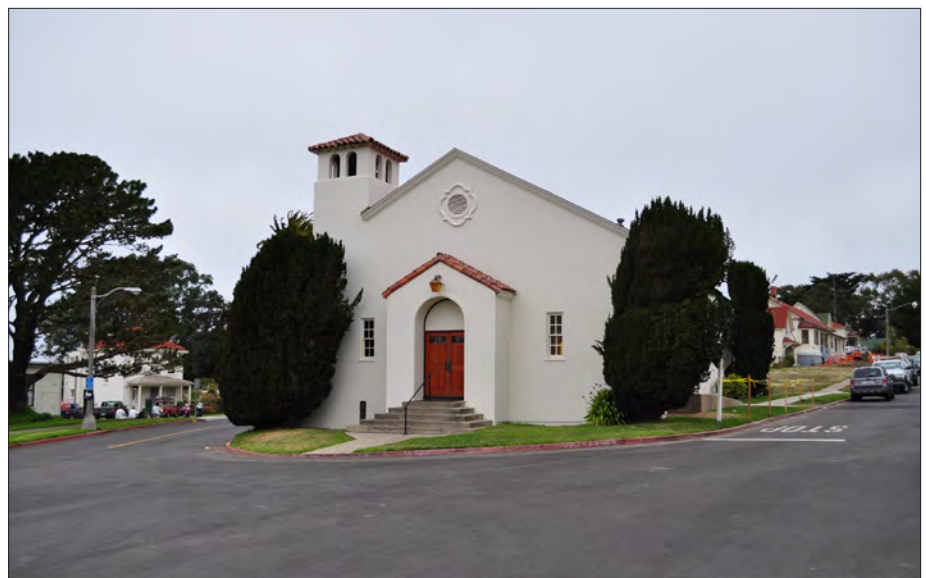
Figure 3.64. Overgrown, out-of-scale yews flanking the main entrance to the Chapel to be replaced in-kind. View looking north, 2011 (OCLP).

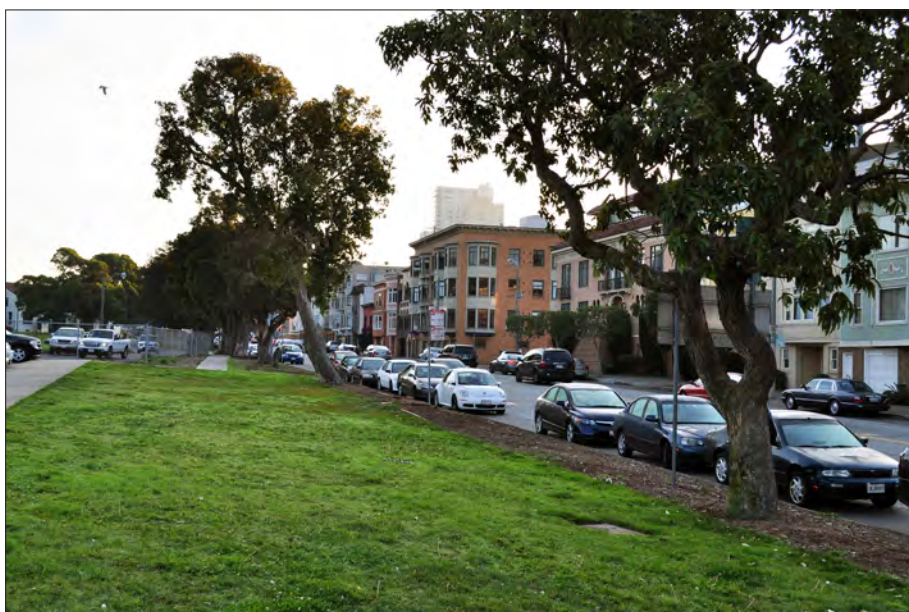
**Figure 3.99. Hazardous street trees and missing street trees to be replaced along Bay Street. View looking east, 2011 (OCLP).**

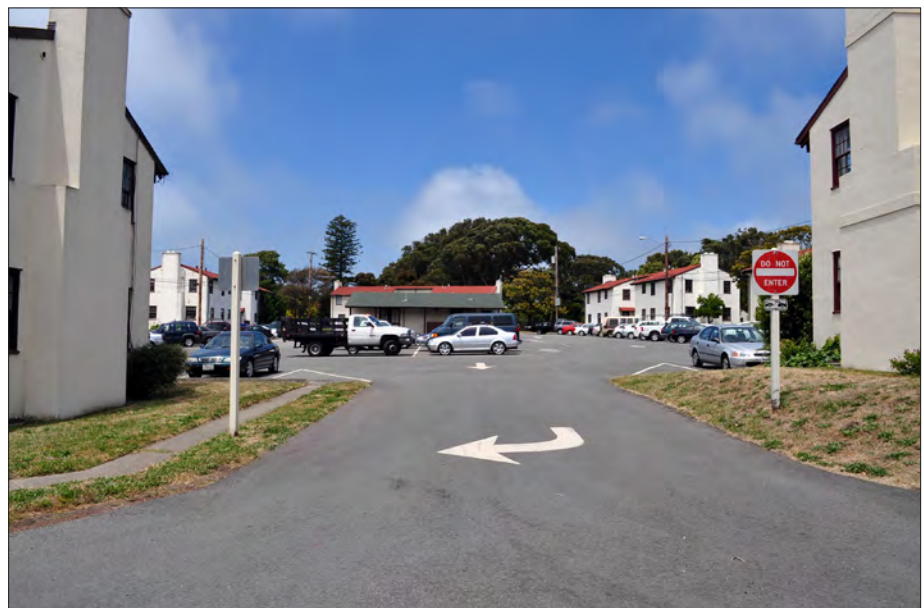
Figure 3.113. The stark interior of the Quad from the parking area exit (between Buildings 33 and 39) to be improved with the addition of planted medians and foundation plantings. View looking north, 2011 (OCLP).

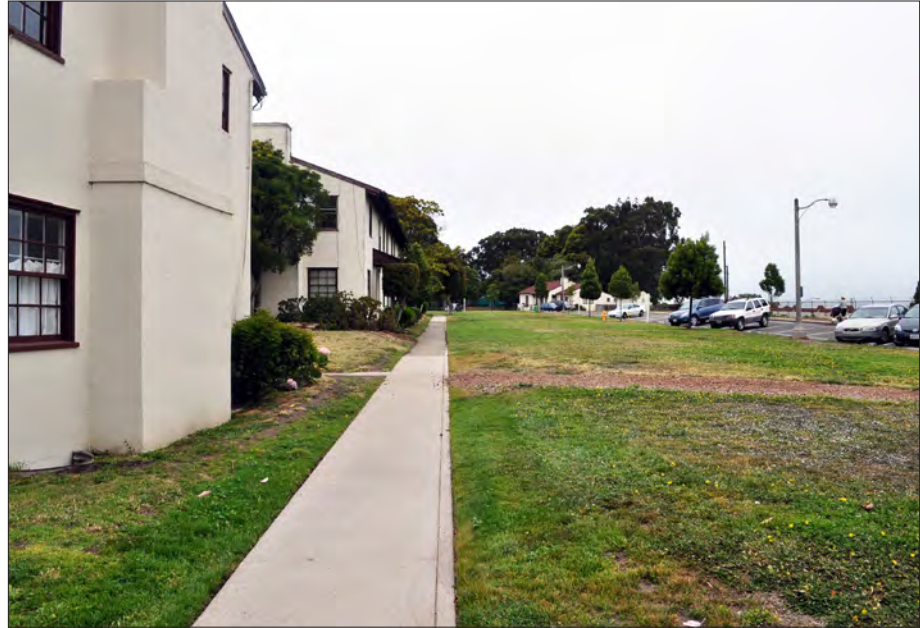
**Figure 3.119. Missing street tree planting along MacArthur Avenue adjacent to the Quad buildings. View looking north, 2011 (OCLP).**

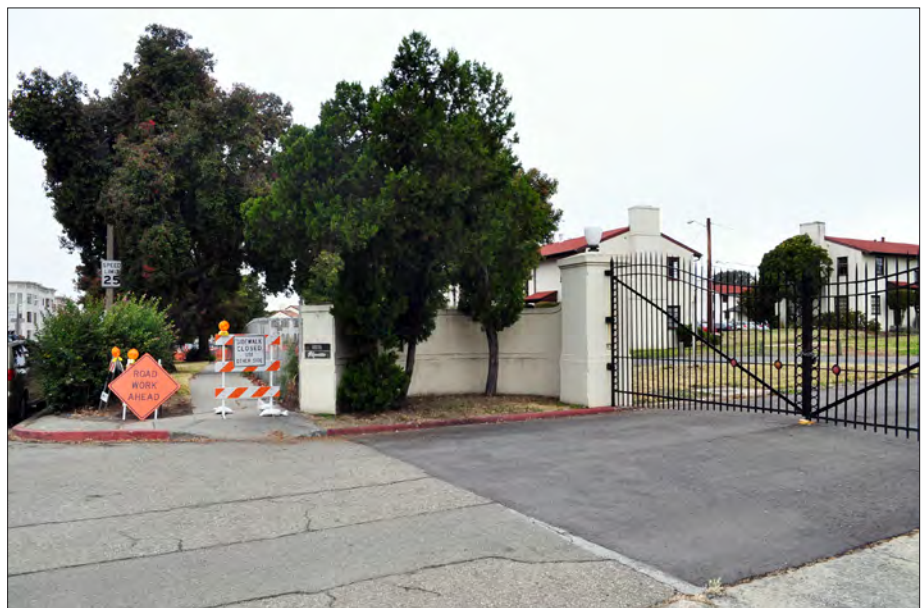
Figure 3.121. Overgrown cryptomeria at the Van Ness Avenue gate to be replaced with draft specimens to better reflect the historic condition. View looking northwest, 2011 (OCLP).
